Building and Timber Pest Inspection Report

Inspection Date: Mon, 9 Mar 2026

Property Address: 27 Turnipwood Dr, Buderim QLD 4556,
Australia

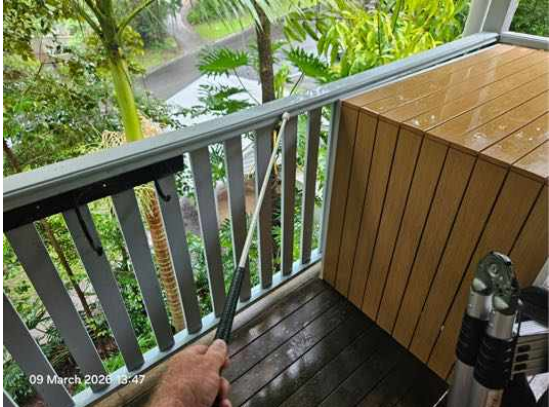
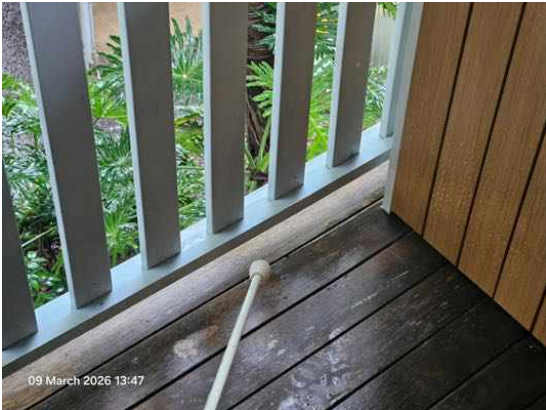
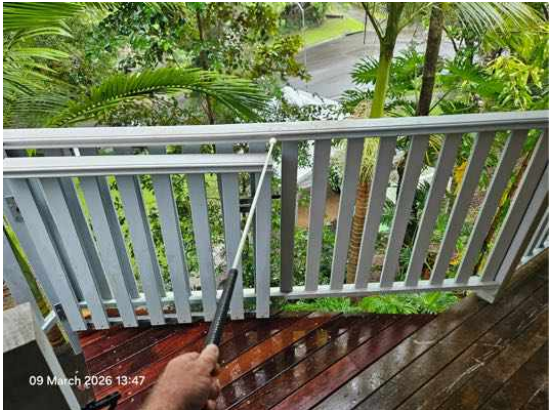
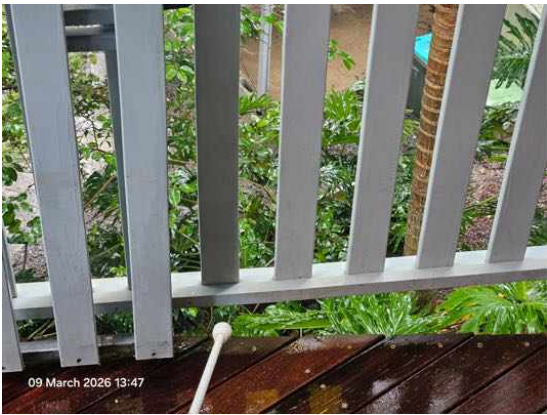
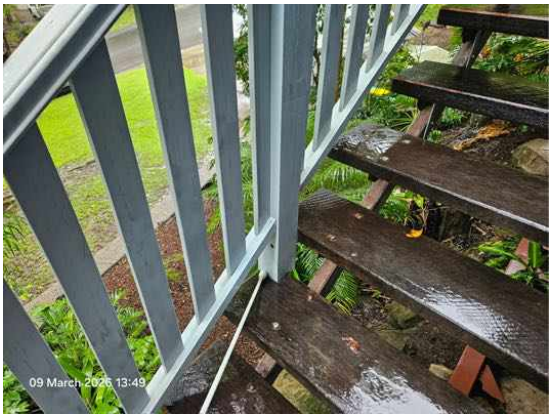
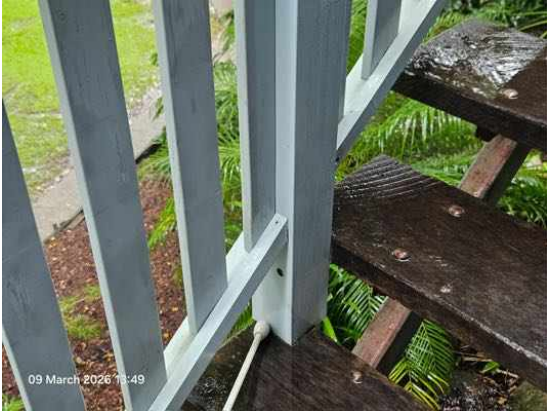
Building: Main Building
Location: Front stairs and deck
Finding: Deck / stairs - Balustrade / handrails
Information: The front stairway and deck handrails at the entry of the property are not adequately affixed in place. They can be readily moved and are loose in their current fixings. This could become a safety hazard if pressure is applied.

A licensed builder or licensed carpenter could be appointed to provide necessary works to the stair flight.

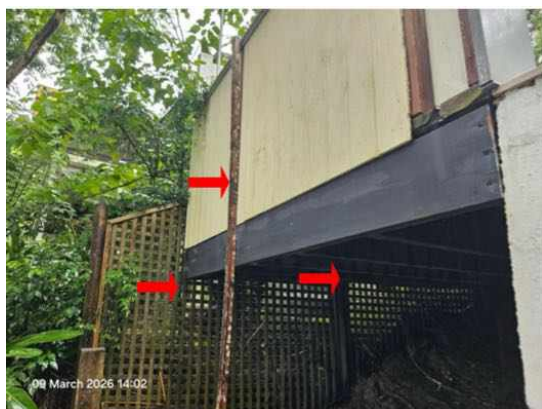
Finding 2.01

Building: Yard
 Location: Pool Area
 Finding: Decking support
 Information: On the day of inspection it was noted that the front left corner of the front pool decking is not supported adequately. It will require a post to the front corner to provide satisfactory stability. To a degree, the deck had a bounce when walked on. It appears that there is currently a 50 x 50mm pine batten fixed to the front of the deck to provide support to the deck and support to the barrier / privacy wall .

The front corner cantilevers by approximately 1.5m.

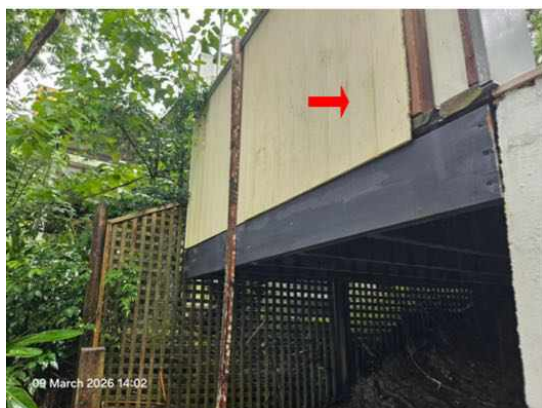
Finding 2.02

Building: Yard
 Location: Pool Area
 Finding: Pool deck - Balustrade / wall
 Information: The front privacy wall / balustrade of the pool deck at the front left of the property is loose and does not feel stable.

A licensed builder or licensed carpenter could be appointed to provide necessary works to the wall.

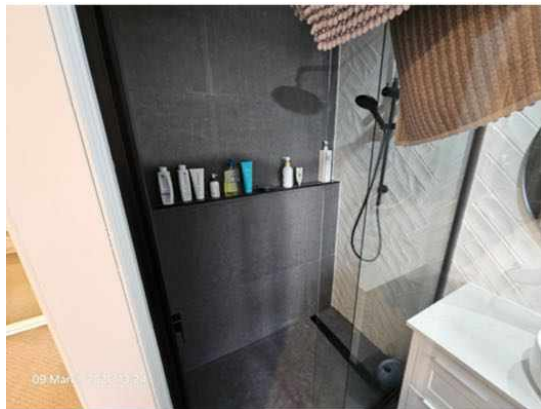
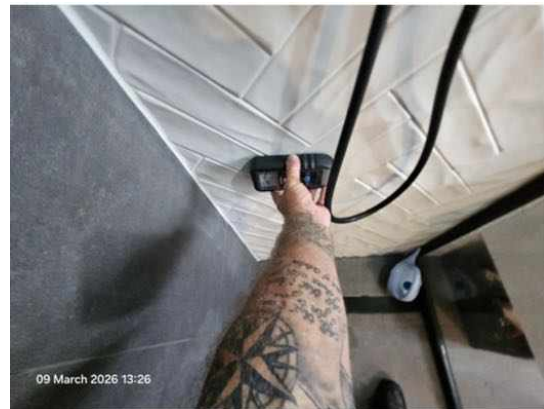
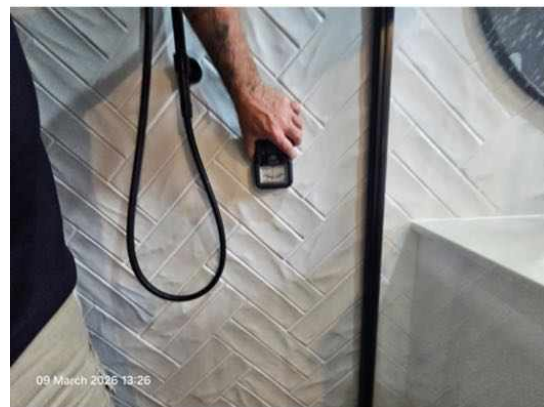
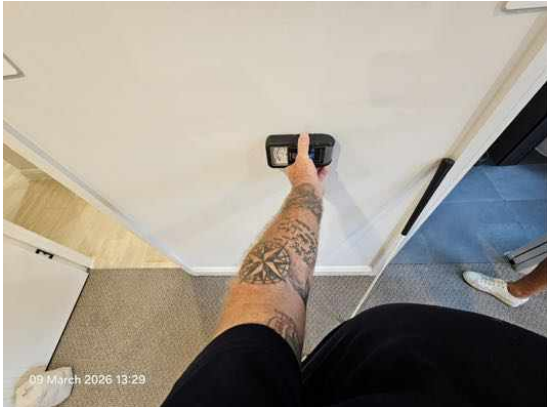
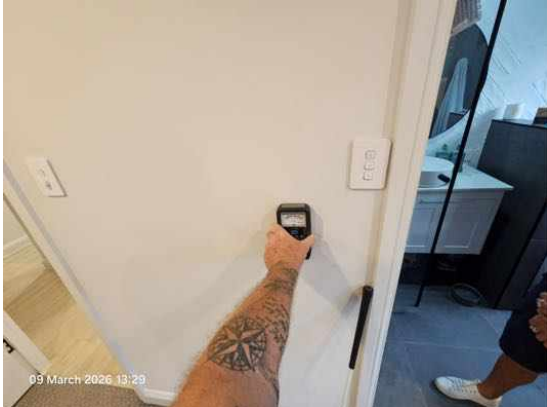
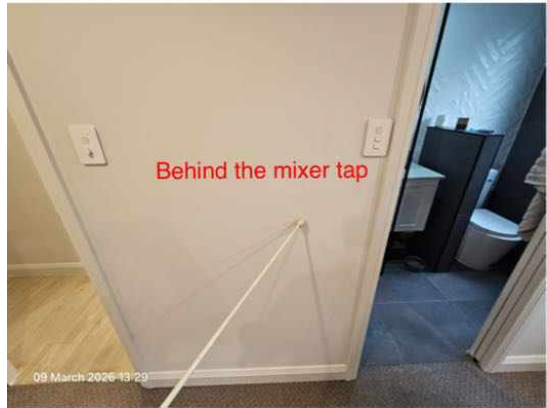
Building: Main Building
 Location: Ensuite - Master
 Finding: Elevated moisture present - ensuite shower
 Information: Elevated moisture was noted in the tiled wall surfaces of the ensuite shower.

The levels varied at differing points throughout the recess. This could possibly be due to deteriorated grout and silicone sealants and / or plumbing fittings and fixtures. The grouts and sealants can break down over time and become porous, allowing moisture to enter the wall sheet surface behind the tiles. It was reported on the day that this shower has recently been sealed by a shower restoration service; therefore, the moisture detected in the tile surface may be residual. The readings on the reverse side,

Moisture was also detected the in the walls on the reverse side of the shower in the bedroom. This wall surface is behind the tap combination.

Elevated moisture can attract timber pests and vermin, and produce conditions that promote timber pest attack, fungal growth and wood decay.

It is recommended that the moisture levels in these areas be monitored over time to confirm that the tiles surface restoration work was successful.

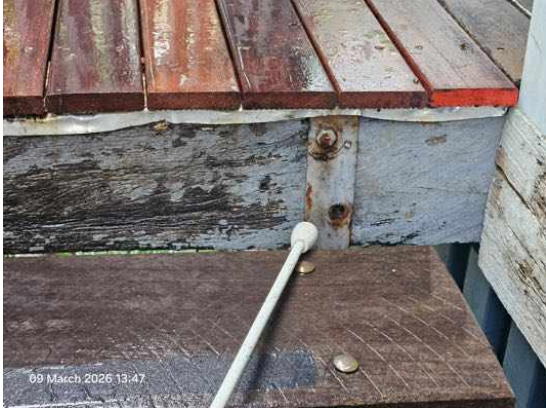
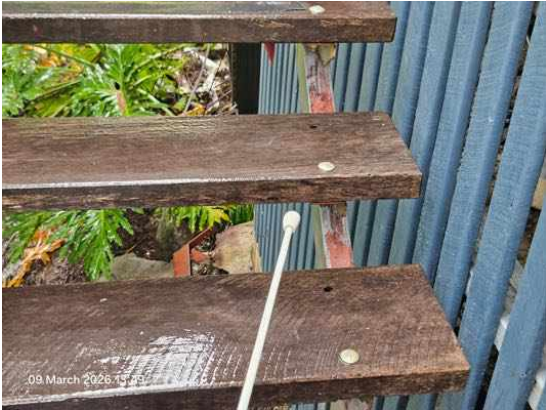
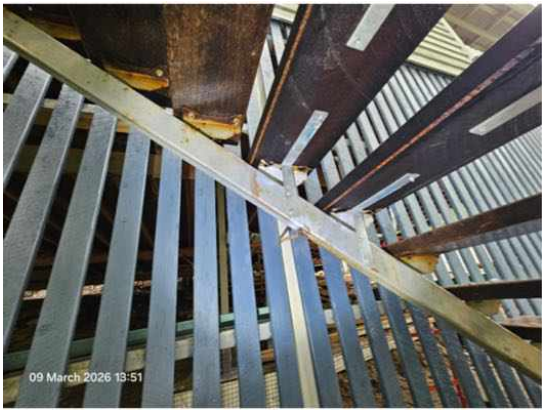
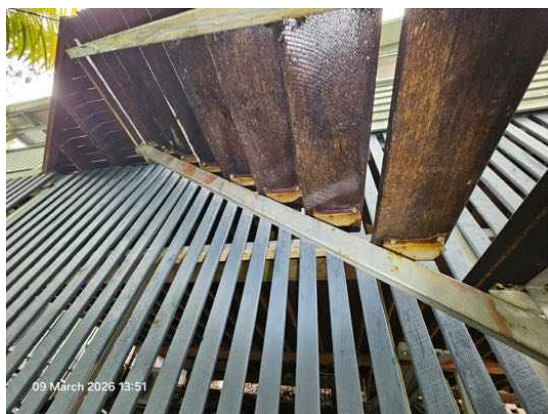
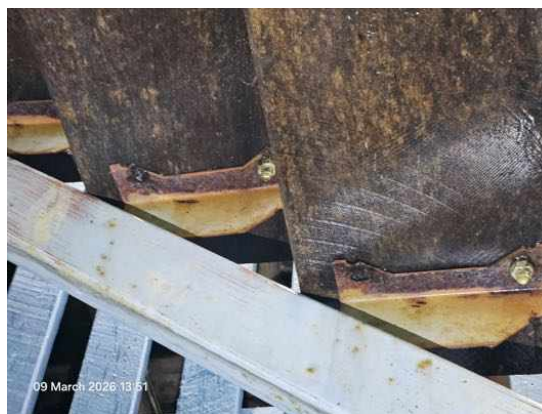
Finding 3.01

Building: Main Building
Location: Front entry
Finding: External stairs - disrepair
Information: On the day of inspection the front exterior stairs were assessed for soundness. Whilst being reasonably firm to traffic, there is rust visible in brackets and fixings missing. A noticeable bounce was evident and may require support if the client desires.

A licensed carpenter or licensed builder may be required to replace affected building materials.

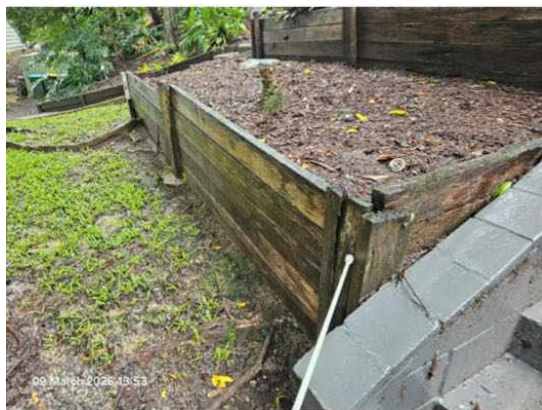
Finding 3.02

Building:	Yard
Location:	Front yard
Finding:	Retaining wall , timber - Defective
Information:	The retaining wall in this area was found to be defective at the time of inspection. Generally, defective retaining walls are caused by poor original design or material use. However, deteriorated retaining walls may also be a result of substandard construction, poor site drainage or unmanaged stormwater flows.

Repair and replacement should be expected. A landscaper may be appointed to repair or replace the wall, at the discretion of the client.

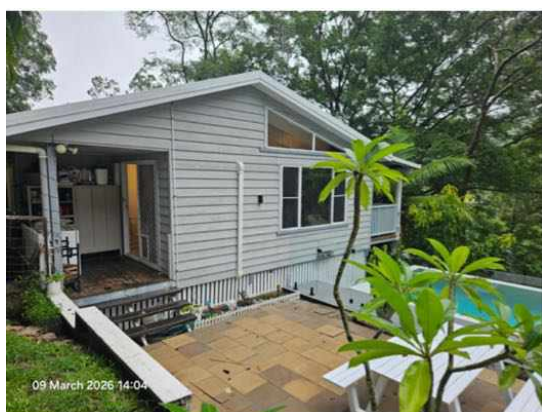
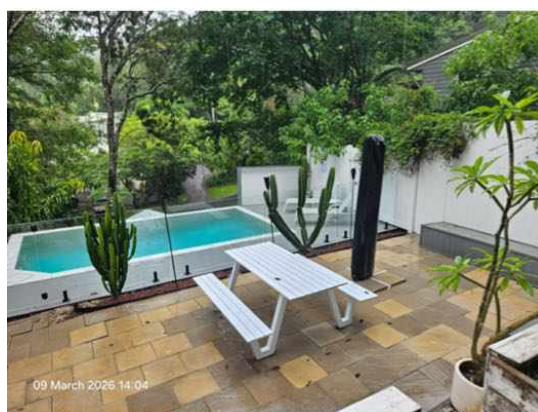
Finding 3.03

Building:	Yard
Location:	Pool Area
Finding:	Paving - subsided
Information:	The external paved area to the pool area is uneven and subsided in places. This is most likely due to moisture induced subsidence over an extended period of time. Given the observed overland flow of water and site drainage issues, it is likely that excessive moisture has affected the base materials. This can be common issue if the substrate is not prepared correctly during the initial installation / laying and with

exposure to the elements over time the base compacts. The initial base substrate may not be suitable for a pool area and excessive water exposure.

Re-paving of the area could be done at the clients discretion.

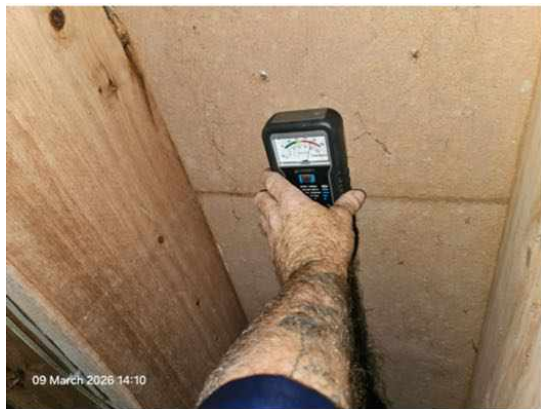
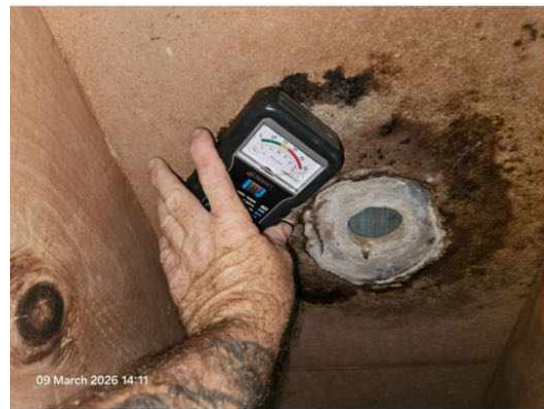
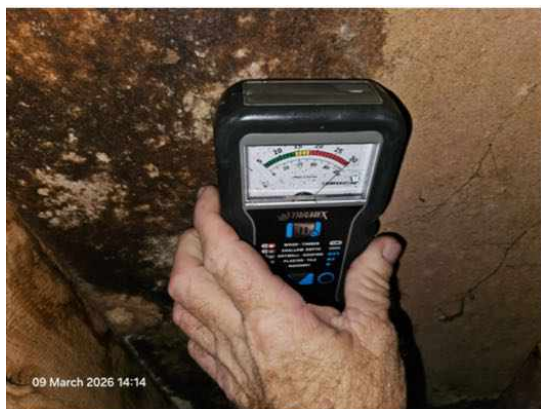
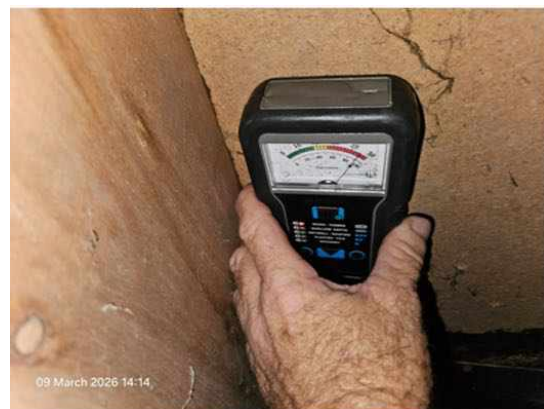
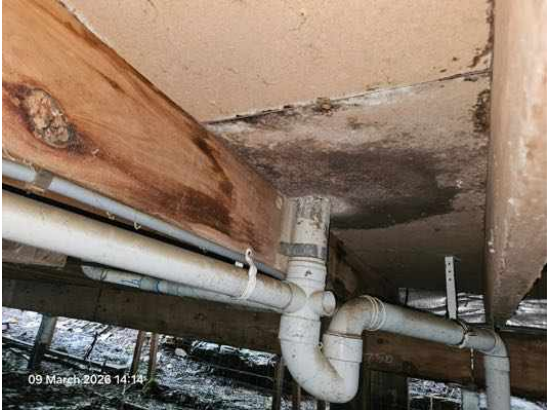
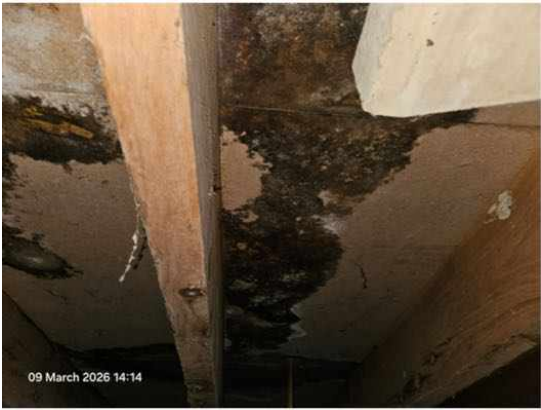
Building: Main Building
 Location: As shown
 Finding: Floor sheets - Water stained
 Information: Water staining to underside of the floor sheets in the areas beneath the bathroom, hallway and laundry were evident at the time of inspection. Water staining indicates that surfaces have been exposed to moisture over time. The stains did read as high in

moisture in some locations on the day of inspection; however they should be monitored over time and if they indicate an increase in moisture level, the floor surfaces and plumbing fixtures in these areas should be assessed. The conditions on the day were wet environmentally and it appears that some of the stains are remnants of a previous water leak. A current water leak has recently been repaired and it was reported that the elevated areas were from this bathroom shower rose leak. It is possible that many of these stains are remnants of a previous leak, occurring prior to the bathroom / ensuite renovations.

While mostly an appearance defect, water staining can be indicative of more serious defects, which may be currently concealed. Where water staining is active, a licensed plumber must be consulted to identify the cause of the staining and to provide advice on any reparation works that may be required.

Conversely, where water staining is old and inactive, affected building materials may be repaired or replaced at client discretion.

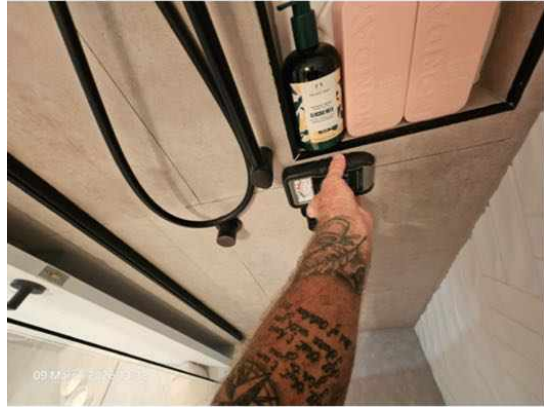
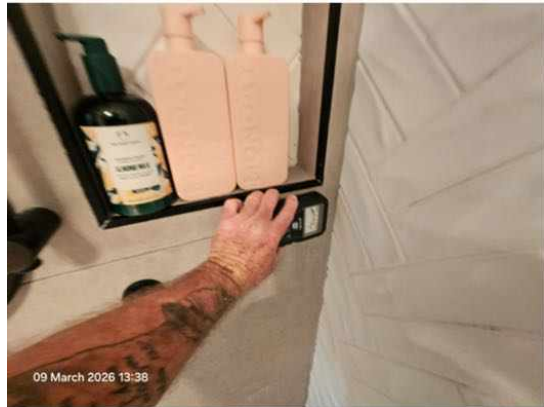
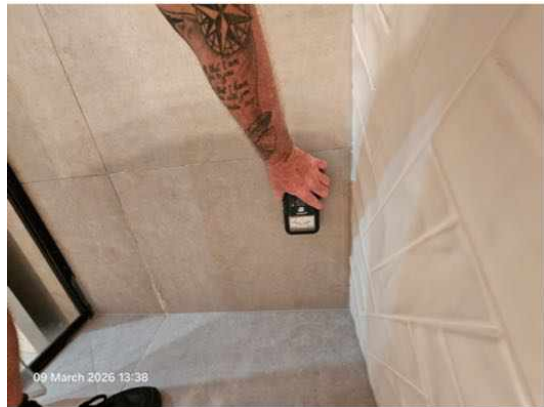
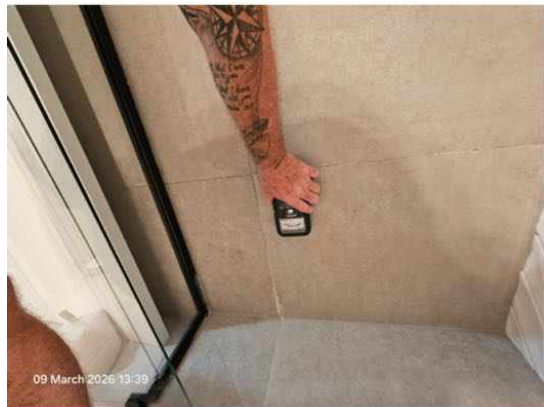
Building:	Main Building
Location:	Bathroom
Finding:	Elevated moisture present at the time of inspection - bathroom
Information:	Elevated moisture was noted in the tiled wall surfaces of the bathroom shower.

The levels varied at differing points throughout the recess. This could possibly be due to deteriorated grout and silicone sealants and / or plumbing fittings and fixtures. The grouts and sealants can break down over time and become porous, allowing moisture to enter the wall sheet surface behind the tiles. It was reported on the day that a shower restoration service was scheduled to attend to the grout and silicone and provide a seal to the shower surface.

Elevated moisture can attract timber pests and vermin, and produce conditions that promote timber pest attack, fungal growth and wood decay.

It is recommended that the moisture levels in these areas be monitored over time to confirm a positive outcome of the shower alcove sealing.

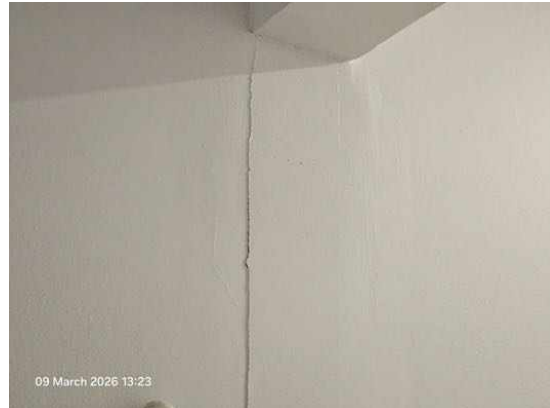
Building:	Main Building
Location:	Hallway
Finding:	Minor movement cracking
Information:	Minor movement cracking to the hallway wall, was observed at the time of the inspection.

Cracking of this nature is expected in this type of building and it appears to be associated with movement of the building elements. The fine but visible cracks can be patched and painted over by an experienced painter or handyman at the clients discretion.

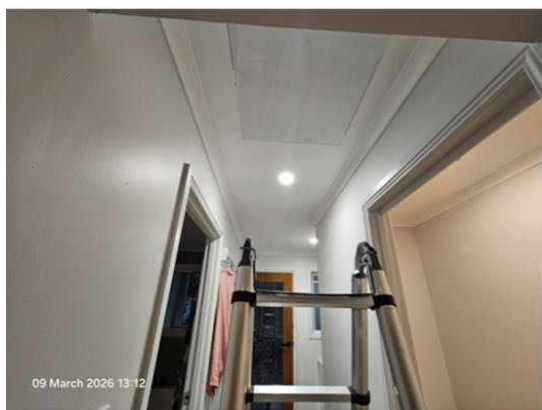
Building: Main Building
 Location: Laundry
 Finding: Ceiling access hatch - access obstructed
 Information: The ceiling space was not fully accessible due to the roof truss shown being positioned directly across the centre of the opening. The opening and the access are considered unsafe / difficult to attempt access.

Only a partial visual inspection from the ladder was possible.

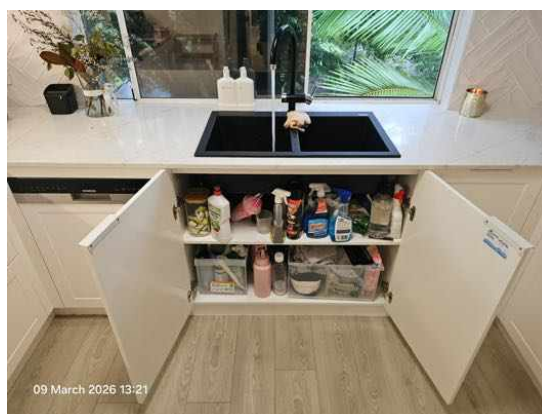
Building: Main Building
 Location: Meter box, kitchen cupboard
 Finding: Durable pest inspection notice - not assessable
 Information: On the day of inspection it was noted that the durable timber pest inspection / treatment notice was missing, not visible or out of date. These notices / stickers are to verify the timber pest inspection dates, the inspector, the currency and type of timber pest system / barrier in place or being used in and around the property.

It is recommended that a licensed timber pest controller be contacted to assess the properties needs and provide costings for an annual inspection programme.

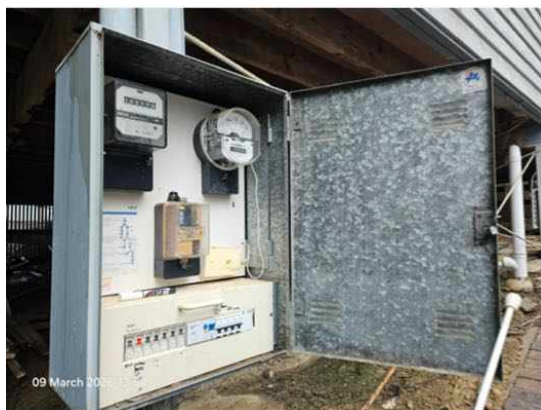
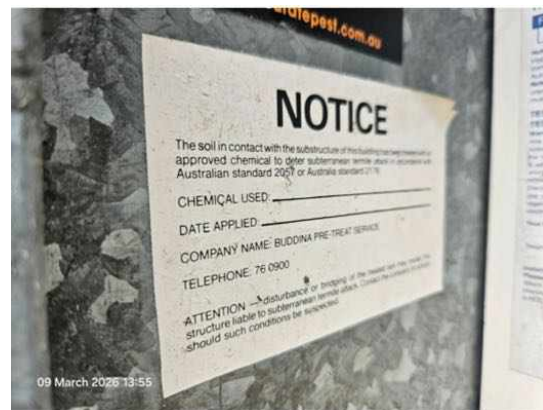
The building had a chemical barrier applied at construction. There is no evidence of a current barrier other than the visual inspection zone in the subfloor. In order for a barrier system to be effective, the property must have regular inspections at intervals of not greater than 12 months. Depending on the risk profile attributed to the property, these inspections may be recommended at lesser time periods.
