Building and Timber Pest Inspection Report

Inspection Date: Fri, 16 Jan 2026

Property Address: 15 Esplanade, Semaphore South SA 5019,
Australia

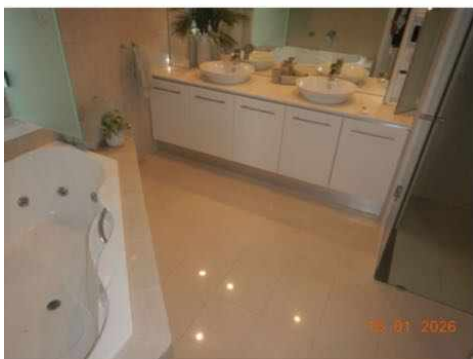
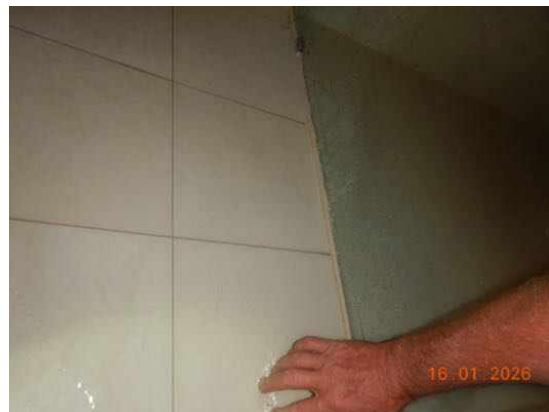
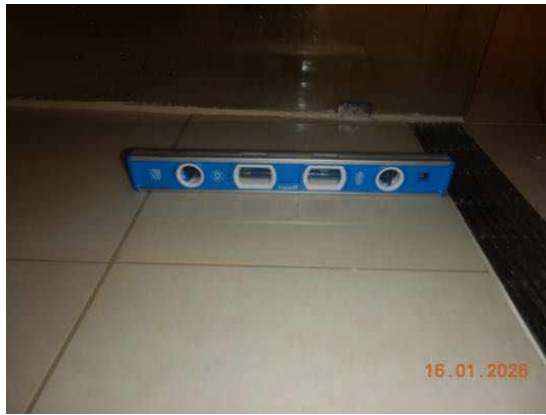
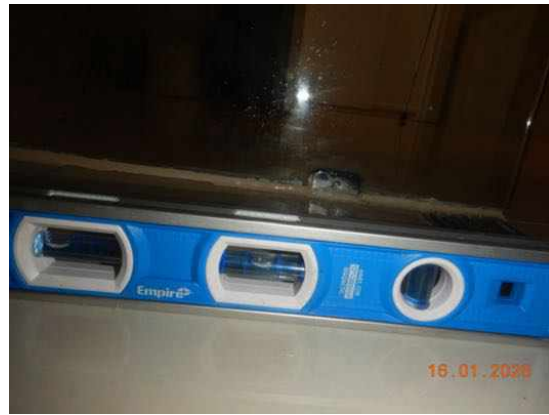
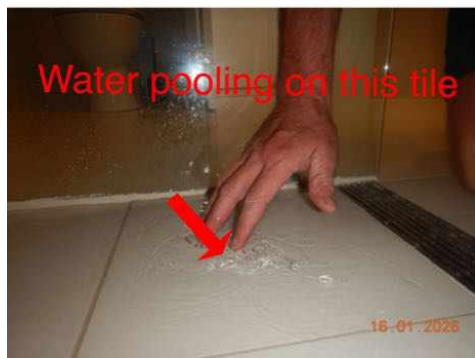
Finding 2.01

Building: Building 1
Location: Ensuite - Master
Finding: Shower base - Water pooling
Information: Evidence of water pooling around the floor waste in the ensuite shower recess was noticed at the time of inspection. It is suspected that this excessive moisture is attributed to insufficient fall in the shower floor tiles.

This pooling is minor overall but is still considered unsatisfactory, as standard tiling practices would not permit this situation to occur. Pooling water around floor wastes can create a slip hazard in extreme cases and create conditions that are conducive to mould growth over time. Where left unmanaged, the degradation of sealant and grouting is also likely to occur, possibly necessitating further repair works.

Remedial works may involve some sections of tiling and flooring repair and replacement. A tiling contractor or bathroom specialist should be appointed to provide further advice on reparation options and to perform works as necessary.

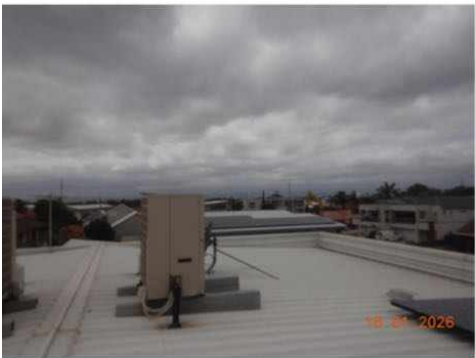
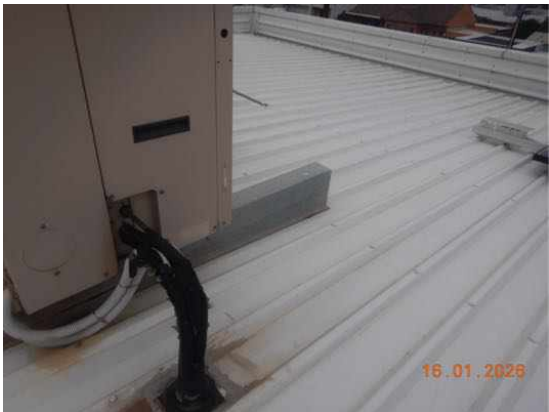
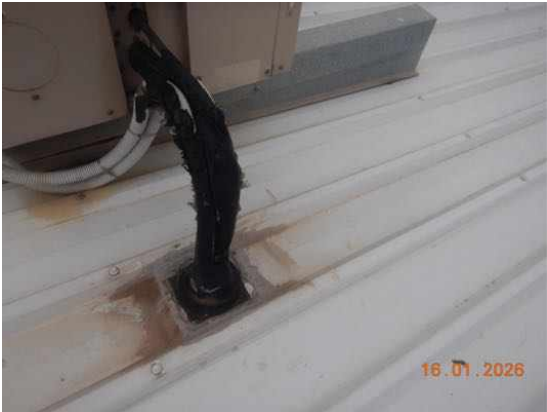
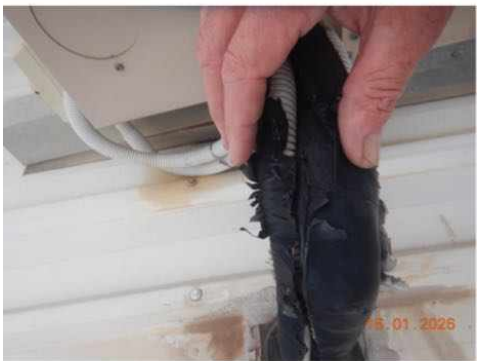
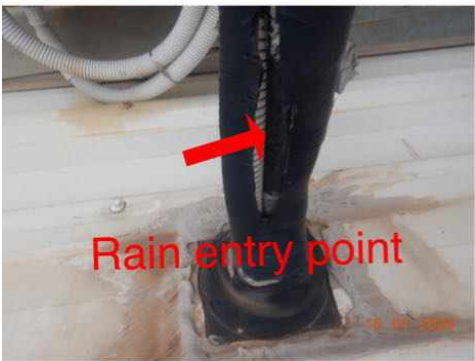
Finding 2.02

Building:	Building 1
Location:	Roof Exterior
Finding:	Roof covering - potential leak points identified
Information:	It appears that the air conditioning penetration has deteriorated and could easily allow moisture to enter the building. Protection should be provided to the pipework to prevent rain from entering between the pipes and therefore gaining access to the building envelope itself.

Where water leaks are active, rain penetration is likely to cause water damage to associated structures and building elements in this area, which can have a range of implications.

A refrigeration mechanic or air conditioning service technician should be appointed as soon as possible to provide works to the penetration to ensure no leaking occurs in the future.

Seal air conditioning penetration

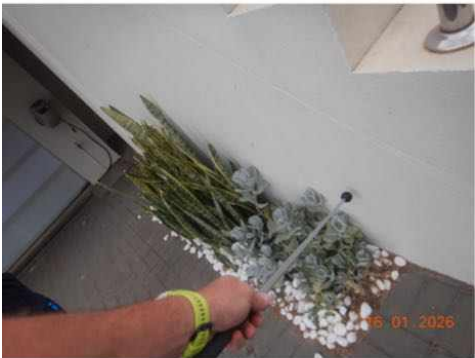
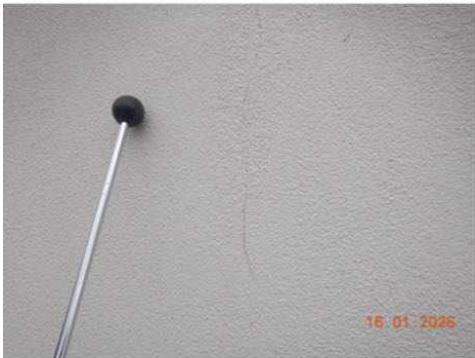
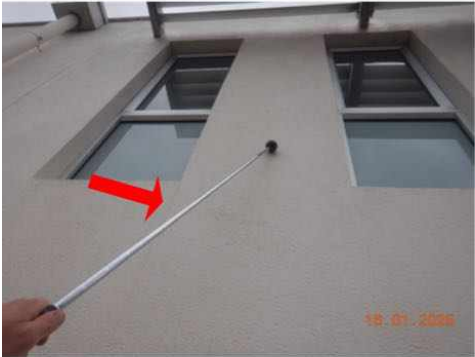
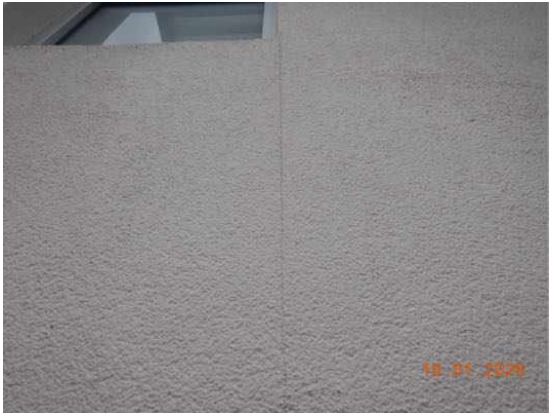
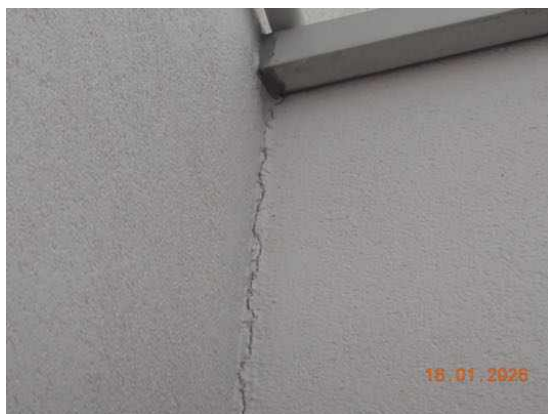
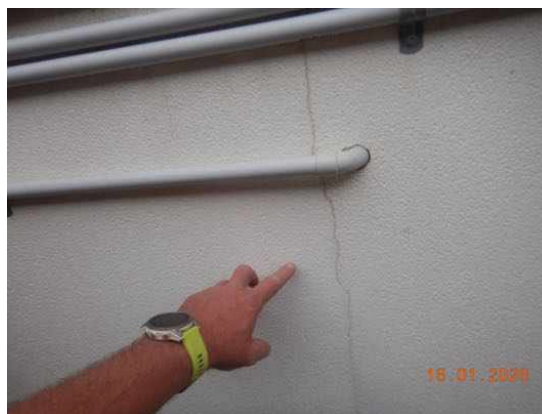
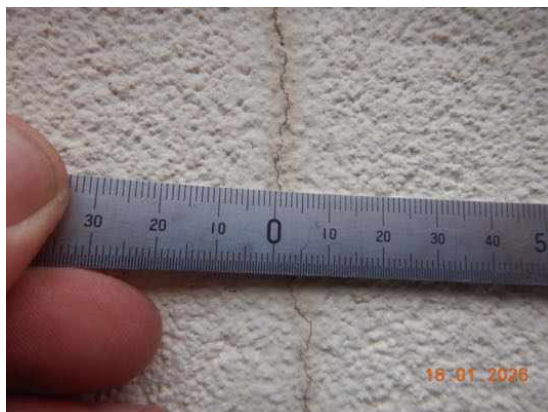
Finding 3.01

Building: Building 1
Location: Exterior walls
Finding: Render - Cracking [Fine] Hebel
Information: There are fine cracks evident to several small areas of rendered wall of the building which coincide with windows and or internal corners which is quite common in this type of hebel construction.

Although fine cracks are quite noticeable, they are often only considered to be an appearance defect and usually do not indicate any structural damage. Generally, the cause of a fine crack is indicative of general settlement or environmental/ seasonal factors.

Cracking of this nature can generally be repaired with minor filling and should be conducted by a qualified plasterer or painting contractor and could be carried out at the discretion of the client.

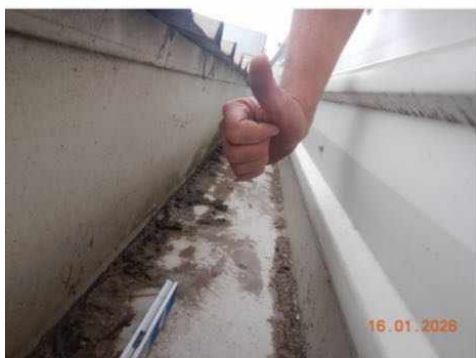
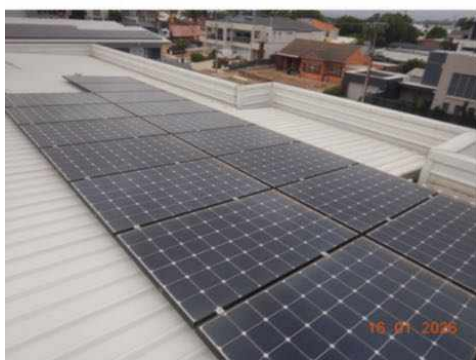
Finding 3.02

Building: Building 1
 Location: Roof Exterior
 Finding: Box gutters minor defects
 Information: It was noted that compliance issues exist with the box gutter system on the roof, main issues being

- Non compliant outlet and overflow size lower rear roof.
- Gutter changing direction upper roof.
- Some areas have inadequate fall.

Additional works would increase the functionality of the gutter system and could be a consideration in the short to mid term and should be carried out by a licensed, experienced roof plumber.

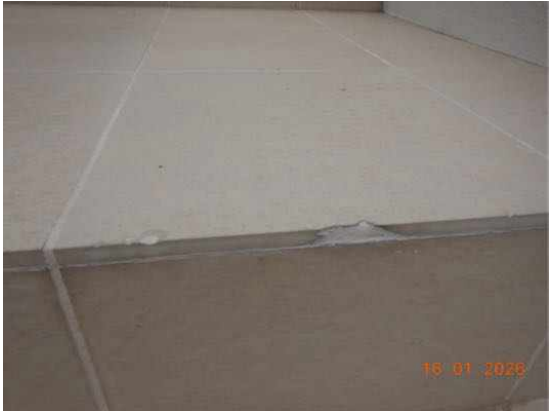
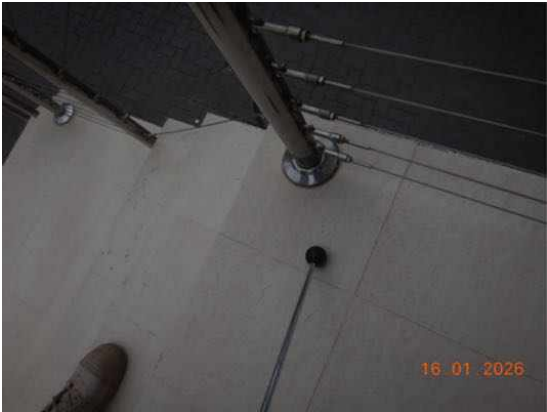
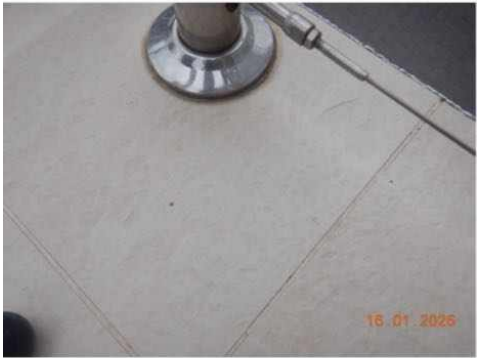
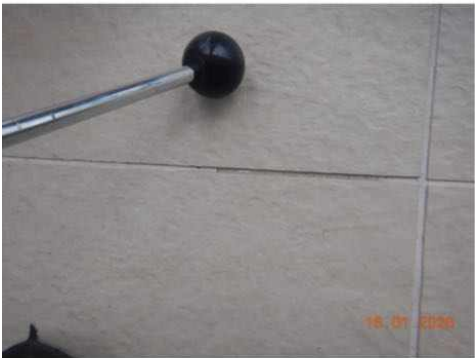
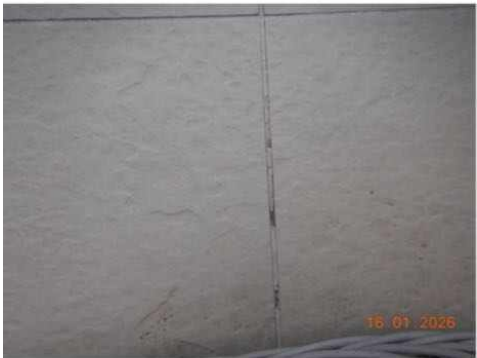
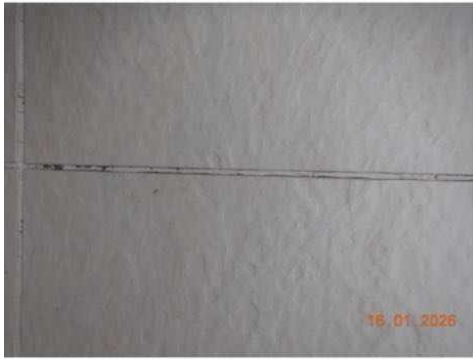
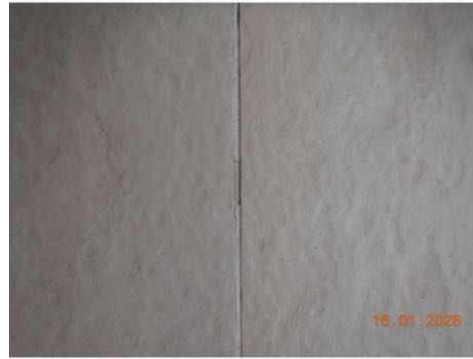
Finding 3.03

Building:	Building 1
Location:	Front Elevation
Finding:	Deteriorated Tiling, sealant and grout Balcony
Information:	It was noted on inspection that tiling, sealant or grout to the front porch and balcony is showing signs of deterioration with minor chips to stairway and deteriorated grout in some sections.

Flexible and mould resistant materials should be applied to any damaged areas to prevent any subsequent water damage that is likely to occur. Regular maintenance and replacement of damage or missing or damaged sealant and grout is highly recommended to the wet areas, as this is a regular wear and tear defect.

Deteriorated sealant and grouting in areas that come into regular contact with water should be maintained for the long term care of your property. A sealant specialist or tiling contractor should be appointed to complete these works as soon as possible

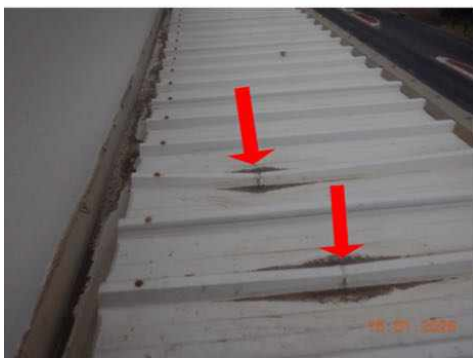
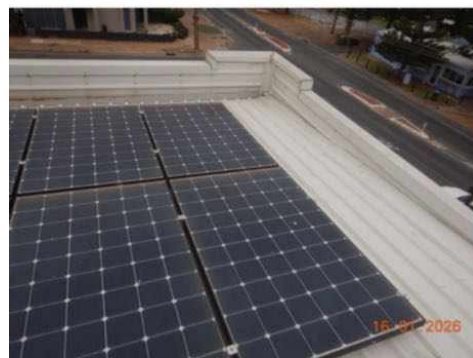
Finding 3.04

Building: Building 1
 Location: All Areas
 Finding: Minor defects present
 Information: There were several age and maintenance related defects evident to the dwelling at the time of inspection. These defects include but are not limited to

- Several dents to roofing
- Solar panels require cleaning
- Stormwater pipe appears to be leaking
- Front door twisted
- Minor mop/ moisture damage to floors

Appropriate licensed trades people could be appointed to make repairs at the discretion of the client.

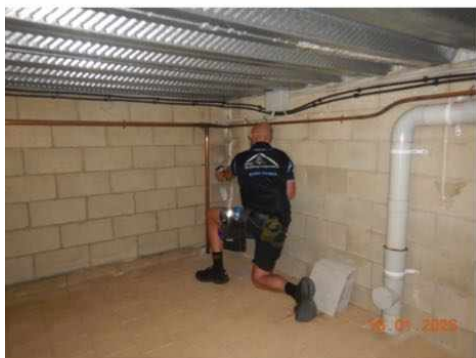
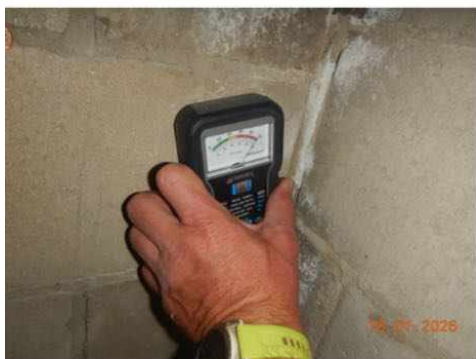
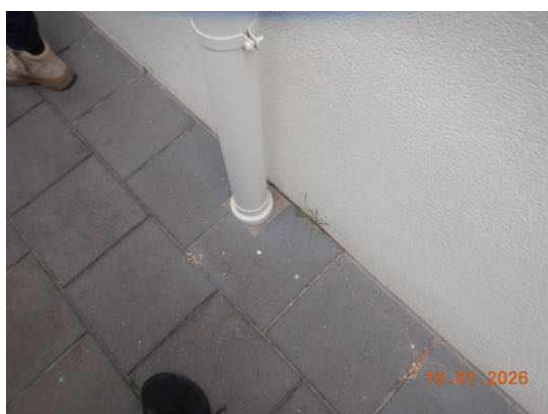
Building: Building 1
 Location: Stair well and lower wall
 Finding: Exterior walls - Lateral damp
 Information: There were high readings for moisture in the lower section of wall to the stair leading to the garage and the undercroft wall directly below this, at the time of inspection.

As moisture appears to be concentrated to one area, it is likely that a small issue is present, possibly linked to the stormwater pipe in the area.

Additionally, the development of damp in proximity of timber building elements provides an environment that is conducive to termite / timber pest attack.

It is recommended to have a licensed plumber inspect the area in an attempt to ascertain where the issue is and provide remedial advice and works to prevent further deterioration

Further investigate moisture issue in basement wall

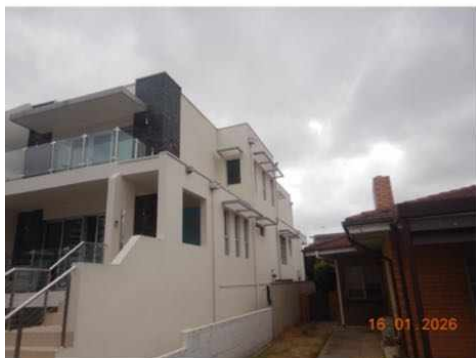
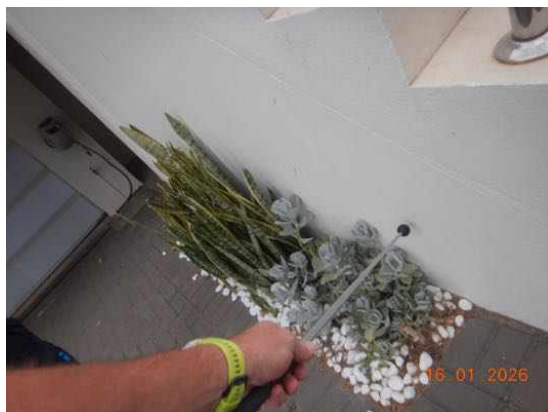
Finding 6.02

Building:	Building 1
Location:	All External Areas
Finding:	Slab Edge - Exposure
Information:	An inspection zone of at least 75mm in relation to the exposed slab edge, between the bottom brick and the perimeter pavement, is required. This inspection zone should be maintained in order to force termites into the open where they can be detected more readily during regular inspections. The slab edge should not be concealed by anything that may prevent inspection of the area, including render, landscaping, soil, turf, paving, concrete cladding or other structures.

If the slab edge is not properly exposed there is a high risk of concealed termite attack which your inspector will likely not be able to see. Sometimes, in order to determine the type of slab, a suitably qualified person such as an architect or builder may be required to consult construction plans.

Where the slab edge cannot be properly inspected, it is highly recommended that termite or timber pest inspections be carried out every 6-12 months to aid protection of the property against infestation and termite treatment advice is followed closely.

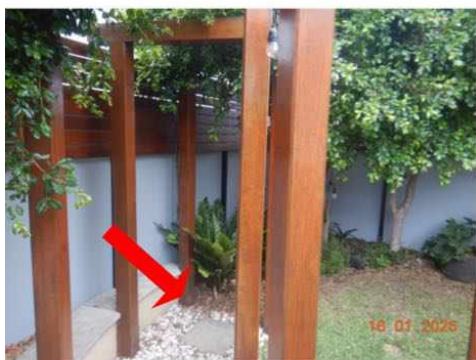
Finding 6.03

Building:	Building 1
Location:	Yard - Back
Finding:	Untreated or non-durable timbers in a hazardous environment
Information:	To reduce the risk of timber pest attack it is essential that timber used in a hazardous environment (e.g. in direct contact with the ground or frequently exposed to damp conditions) is of sufficient durability and/or is adequately preservative treated. Additionally any timber lying around or timber stumps should be removed.

Untreated timbers in direct contact with the ground are likely to develop severe wood rot and/or fungal decay if left unattended creating attraction for subterranean termites to infest the timbers from surrounding areas.

If untreated or non-durable timbers are found to be in a hazardous environment it is highly advised that replacement of these building elements be performed as soon as possible to aid the protection of the property against termite / timber pest attack. Failing this close monitoring is recommended in an attempt to identify termite infestation at an early stage.

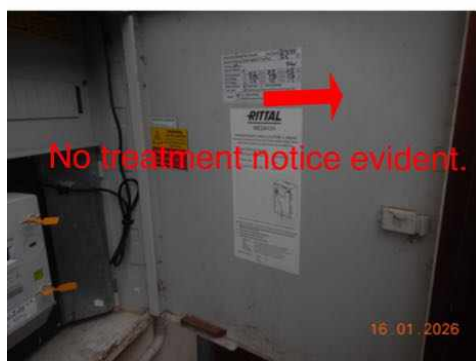
Finding 6.04

Building:	Building 1
Location:	All Areas
Finding:	Termite Management System - no evidence of a chemical installation
Information:	The application of a post-construction chemical termite barrier is highly recommended for all properties, particularly if live termite activity has been found on the site previously. Such barriers are highly effective in preventing termite attack on any timber building elements throughout the property.

At the time of inspection, it appeared as though no termite management system has been installed, with no evidence to suggest preventative works taking place.

The client may consider gaining further advice from a pest controller as to the costs and procedures involved with this application. It is recommended that obtaining such advice be a short-term priority.

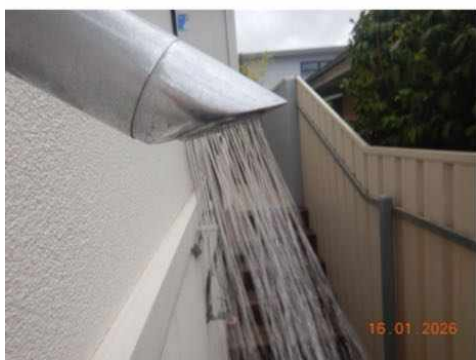
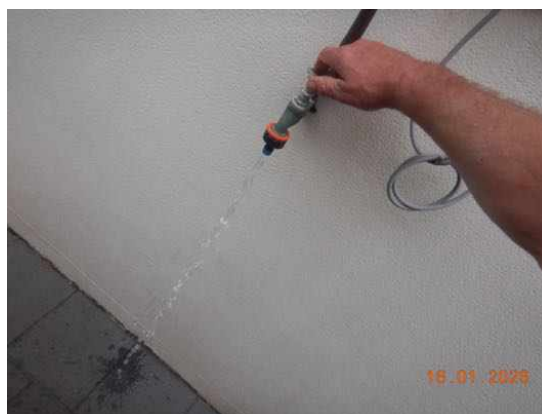
Finding 6.05

Building:	Building 1
Location:	Yard - Side

Finding: Shower/ tap adjacent to dwelling
 Information: Moisture around the perimeter of the building should be minimised to ensure that the area is kept dry and stable which in turn reduces the risk of water damage and termite infestation.

There is a drain Setup for the shower which appears to be operating efficiently therefore this is pointed out for information as moisture around the perimeter of the building creates an environment that is conducive to termite activity

Ensuring a current termite prevention program is in place is essential for situations like these and recommended .

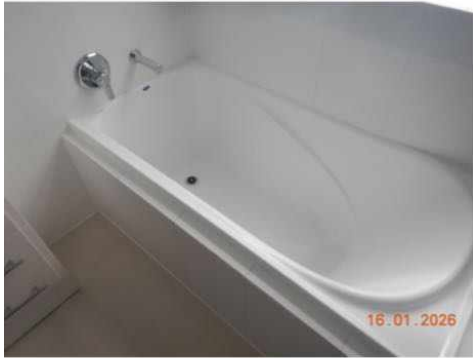
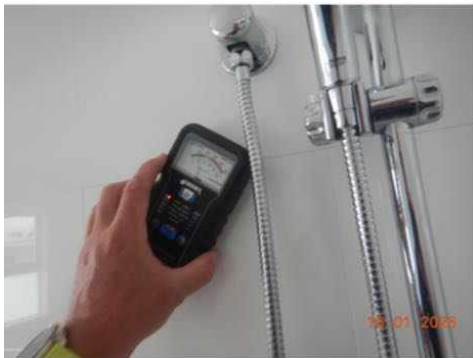
Finding 6.06

Building: Building 1
 Location: Bathrooms
 Finding: Sealant and grouting - Regular maintenance
 Information: It was noted on inspection that sealant and grout has small areas of deterioration evident to both shower alcoves at the time of inspection.

Silicone and grout generally need repair at least every 5 years and as such close monitoring should be carried out in the future after repairs are carried out.

Different materials and floor areas move at different rates, generally causing cracking to grout or sealant at this point. A flexible sealant is required to allow for expected expansion and contraction, while keeping the joint water tight and protective of all associated building materials.

Flexible and mould resistant materials should be applied to affected areas to prevent any subsequent water damage that is likely to occur. Regular maintenance and replacement of damage or missing or damaged sealant and grout is highly recommended to the wet areas, as this is a regular wear and tear defect. Sealant and grouting in areas that come into regular contact with water should be maintained for the long term care of your property.

A sealant specialist or tiling contractor should be appointed to complete these works as soon as possible
