Building and Timber Pest Inspection Report

Inspection Date: Mon, 9 Feb 2026

Property Address: 4/53 Horbury St, Sans Souci NSW 2219,
Australia

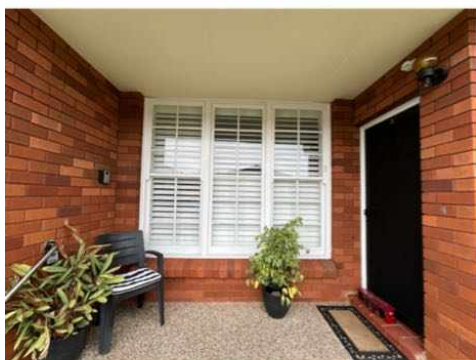
As such, associated building elements are likely to deteriorate at an accelerated rate, and major implications are expected if gaps are left unmanaged.

All excessive gaps should be adequately filled by a suitable sealant or trimmings as soon as possible to prevent any further damage.

Such works may be conducted by a licensed carpenter

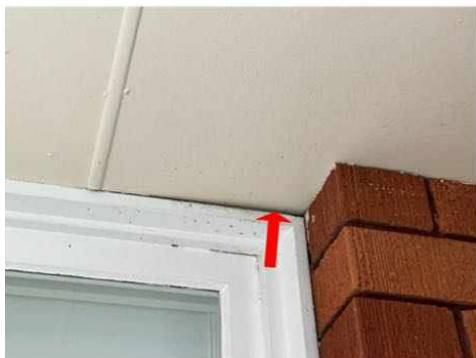
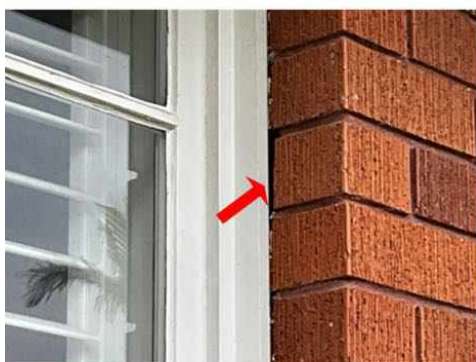
Finding 3.02

Building:	Main Building
Location:	Eaves
Finding:	Damaged Building Elements.
Information:	These type of defects generally occur when the building materials have either aged and decayed, or as a result of impact damage (accidental or deliberate).

Repair and/or replacement of the damaged elements is advised to ensure that additional secondary defects do not arise as a consequence.

Relevant tradespersons should be appointed to repair or replace the affected building elements prior to any subsequent damage being caused.

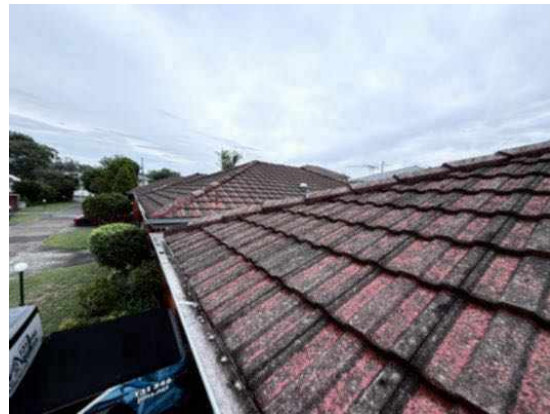
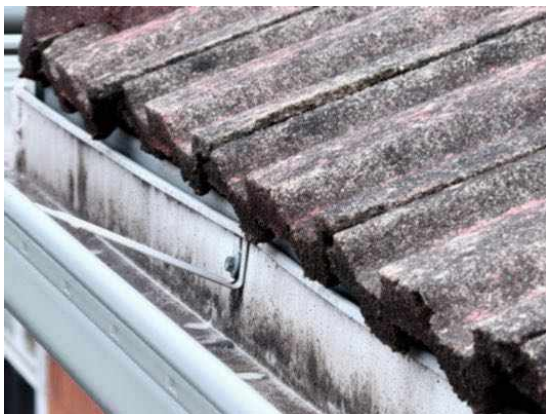
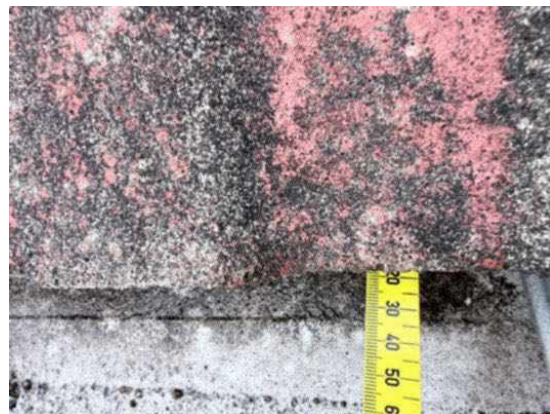
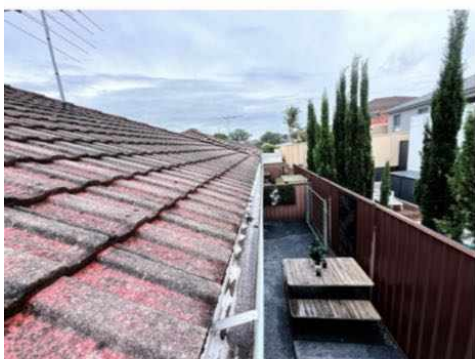
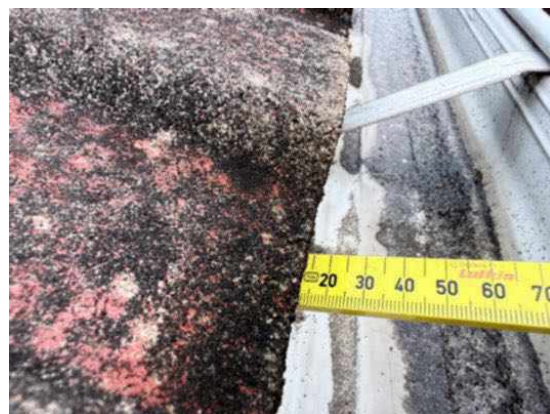
Building:	Main Building
Location:	Roof Exterior
Finding:	Suspected gutter leaking
Information:	Evidence observed during the inspection suggests that sections of the guttering may be leaking. Indicators include staining and dampness below the gutter line.

Leaking gutters can contribute to water damage of fascia, eaves, and adjacent building elements if not rectified.

In addition, leaking gutters may increase moisture levels around the structure, which can create conducive conditions for timber decay and termite activity.

The roof tiles to several areas appears to be under 35mm overhang from the inside face of the gutter leaving the area exposed to possible water damage.

Leaving this unmanaged may lead to water ingress into the building, accelerating deterioration to associated building elements.

Further investigation during wet weather is recommended, and repairs or replacement should be carried out by a licensed roofing contractor if confirmed.

A roof plumber or roofing tiler may be engaged to rectify this defect.

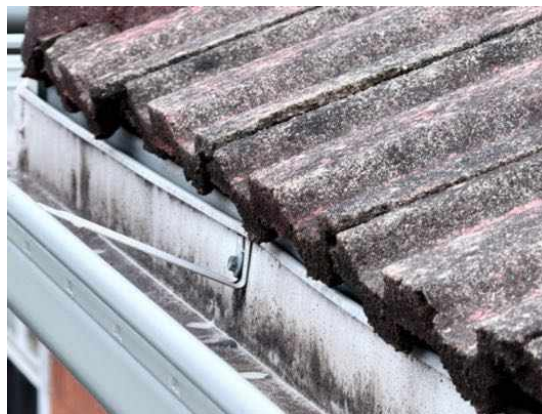
Finding 3.05

Building:	Main Building
Location:	Roof Exterior
Finding:	Roof tiles - Slippage
Information:	Upon inspection of the exterior roof covering, it was noted that numerous tiles have slipped from their original fixing. Tiles may slip over time due to a number of minor causes, including breakage of tiles, failings in the adjoining battens, or fixings that may have failed.

Roof tiles that have moved from their original position are very likely to allow water penetration into the roof void, exposing roofing structures to excessive moisture. This creates an environment that is conducive to water damage and accelerated deterioration of all associated building elements.

Replacement of loose or missing roofing tiles is recommended immediately to prevent the development of any secondary defects. A roofing restoration specialist should be appointed to complete such works as necessary.

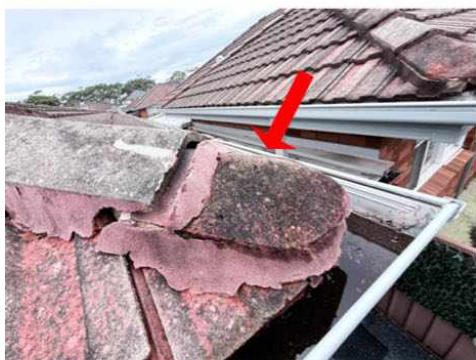
Finding 3.06

Building:	Main Building
Location:	Roof Exterior
Finding:	Mortar - Deterioration
Information:	Mortar, or 'bedding', is the material which fills joins and intersections between tiles and other building elements on the exterior roof covering, such as gable ends, hip capping and valleys. Upon inspection of the exterior roof, it was noted that sections of the mortar show varying levels of deterioration.

Mortar generally deteriorates as a result of frequent exposure to weather conditions over a prolonged period of time. Mortar that is deteriorating may allow water ingress into the roof void, putting associated building elements and roofing structures at risk of water damage. Deteriorated mortar also detracts from the functionality of roof tiles and other roofing elements, potentially decreasing weather tightness and roof drainage.

Mortar deterioration can be attended by a roofing contractor.

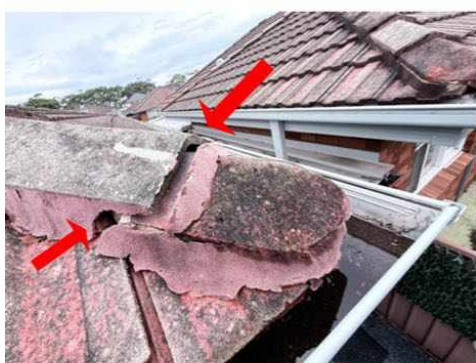
Finding 3.07

Building:	Main Building
Location:	Roof Exterior
Finding:	Roof tiles - Broken

Information: Upon inspection of some areas of the exterior roof covering, broken roofing tiles were identified. Broken and friable roof tiles are generally the result of ageing and weathering of what is essentially a porous material.

If left to further deteriorate, broken and brittle roof tiles are likely to lead to water penetration via the roof into the ceiling space, causing secondary damage to ceiling linings, insulation and roof structures. Broken roof tiles are also likely to detract from the effectiveness of the roof drainage system, creating potential for secondary damage to the exterior roof covering and roof plumbing.

Replacement of broken tiles is required and should be performed by a roofing contractor as soon as possible.

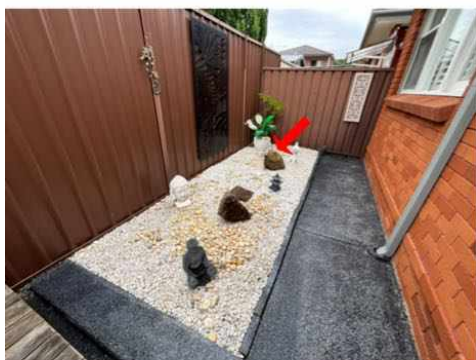
Finding 7.01

Please note that the cause of the fungal decay should be rectified prior to rectification of the affected timber elements.

Leaving this unmanaged may lead to further fungal decay which may include to structural elements,leading to a more costly repair.

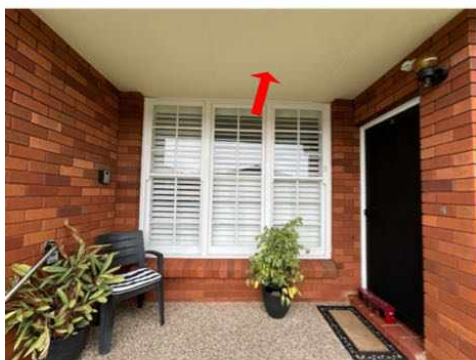
Building: Main Building
 Location: All Areas
 Finding: Asbestos - Suspected ACM Identified on Site
 Information: Reporting on Asbestos is outside the Scope of this Report. This suspected defect is highlighted as a caution only. We suspect, based on our experience in the building industry, that there is a higher risk of the identified building element containing asbestos.

As Asbestos Reporting is outside the scope of this report, we advise that you consider a separate Asbestos Inspection and Condition Audit, which can include the taking of samples for definitive confirmation of the presence of Asbestos.

In the interim, the client is advised to act with caution, especially when considering any damage to building materials general wear and tear renovations extensions demolition and general maintenance activities due to the suspected presence of Asbestos.
