Building and Timber Pest Inspection Report

Inspection Date: Mon, 23 Feb 2026

Property Address: 18 Stockade Pl, Woodcroft NSW 2767,
Australia

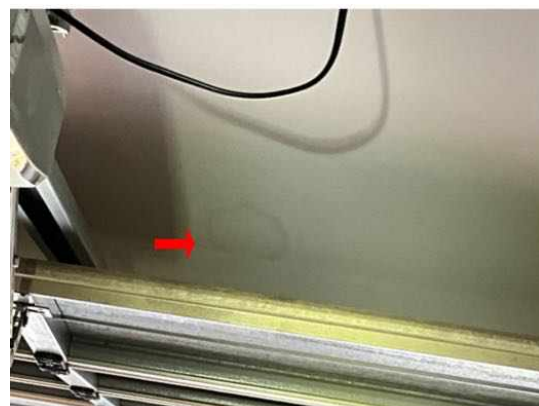
Finding: Ceiling - Water stained

Information: Water staining to ceiling linings in this area was evident at the time of inspection. Water staining indicates that surfaces have been exposed to excessive moisture over time. The minerals and other elements in the water lead to staining, which may graduate to corrosion and deterioration if left unmanaged.

While mostly an appearance defect, water staining can be indicative of more serious defects, which may be currently concealed by interior ceilings.

Where water staining is active, a licensed plumber must be consulted to identify the cause of the staining and to provide advice on any reparation works that may be required. Replacement of any damaged structures is advised.

Conversely, where water staining is old and inactive, affected building materials may be repaired or replaced at client discretion.

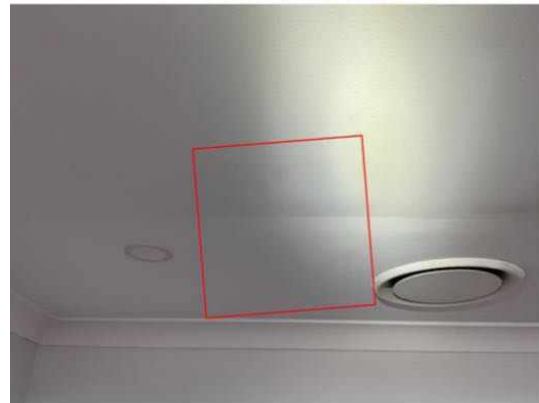
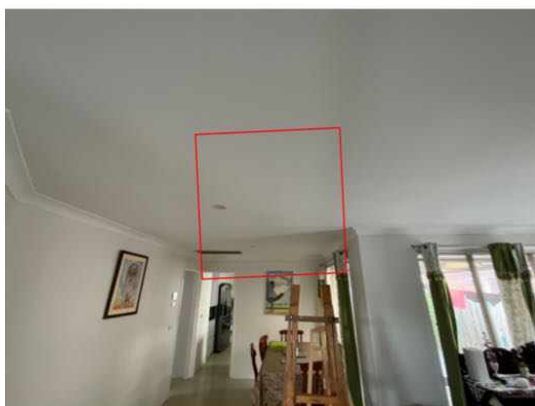
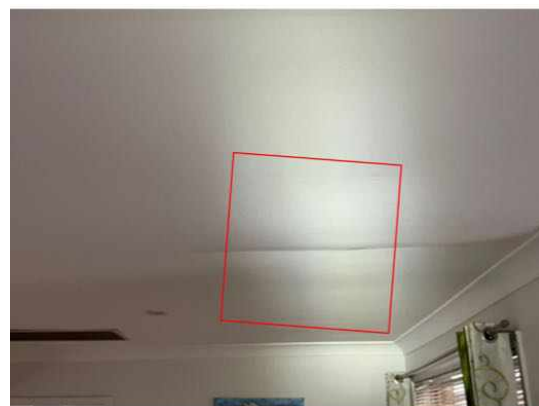
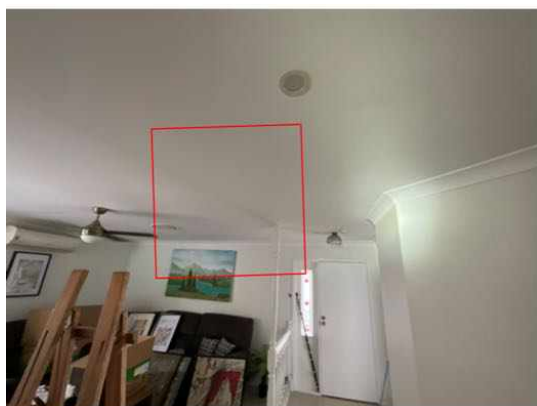
Finding 3.02

Building: Main Building
Location: Multiple areas
Finding: Ceiling - Sagging
Information: Sections of the ceiling were found to be sagging at the time of inspection. Sagging to the fixed ceiling structure generally indicates that the building materials have swollen, due to contact with water, or that fixings (e.g. nails or glue) have become loose and require reattachment.

Where minor sagging is evident, comparatively minor works, such as re-gluing of ceiling sheets, may be required. Such works may be performed by relevant tradespeople, such as plasterers and painters. Where excessive moisture has caused the roofing structure to swell and sag, the source of the water leak should primarily be identified prior to any remedial works being performed.

The appropriate action should be taken by the client as soon as possible to ensure that any potential further damage is limited.

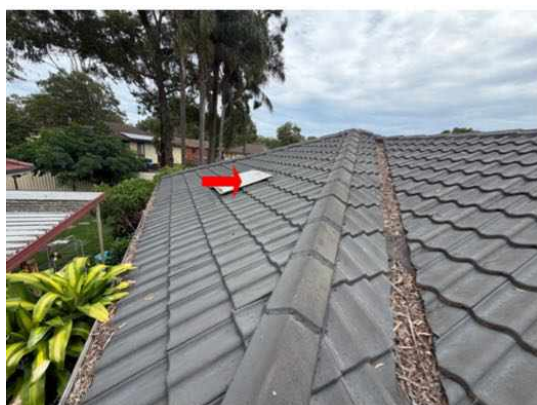
Finding 3.03

Finding: Skylight - Damaged cover

Information: The skylight covering appears to have been subject to minor damage and is cracked as a result. Although the surface was found to have been patch repaired, however it is likely to allow rain penetration and provides potential for water damage to the surrounding ceiling area.

Repair or replacement of the skylight covering is required to prevent any further damage to the surrounding area. Works should be completed as soon as possible by a qualified carpenter or general handyperson.

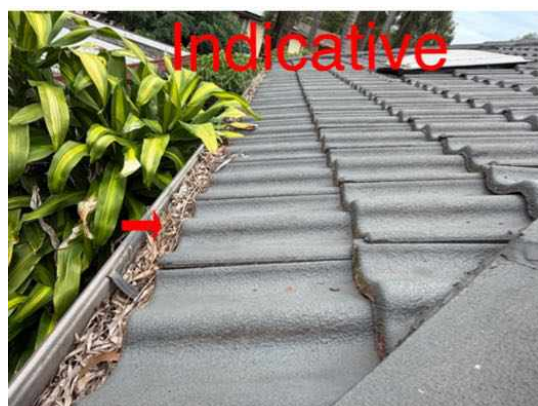
Finding 3.04

Blocked gutters are likely to lead to high levels of moisture in the affected areas. Such moisture will not only cause rust and decay of the associated building materials, but can also provide conditions that are conducive to termite and timber pest activity. Blockages in gutters should therefore be removed immediately to ensure dry conditions are maintained.

Consult a Licensed Plumber for further specific advice on remedial works that may be required. In the interim, it is highly advised that blocked gutters be removed by the homeowner or a general handyperson as a matter of urgency.

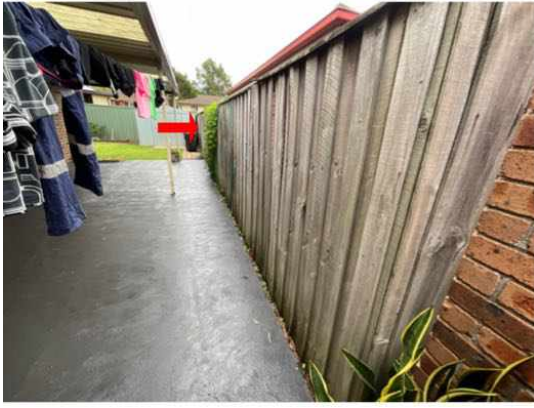
Finding 3.05

Building:	Main Building
Location:	Fencing
Finding:	Fencing - Deteriorated
Information:	It was noted at the time of inspection that sections of the fencing in this area has deteriorated. Typically fencing deteriorates due to age and or wear, rot and or rust which is generally expected for a structure of this age, due to prolonged exposure to weather conditions. Sometimes inadequate installation or maintenance can be to blame.

If left unattended, it is likely that further damage will occur. It is suspected that repair of several elements of the fencing may be required however replacement may be a consideration of the client also.

A licensed fencing contractor should be appointed to provide further advice and perform rectification works as necessary.

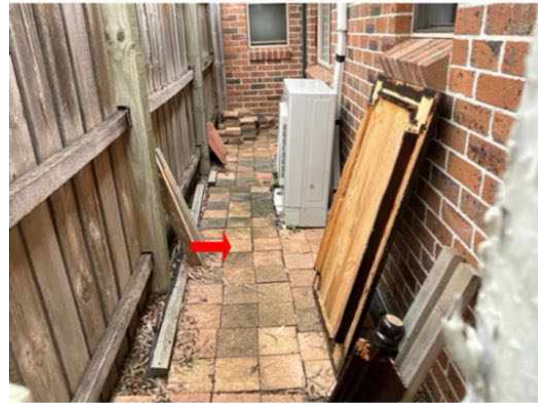
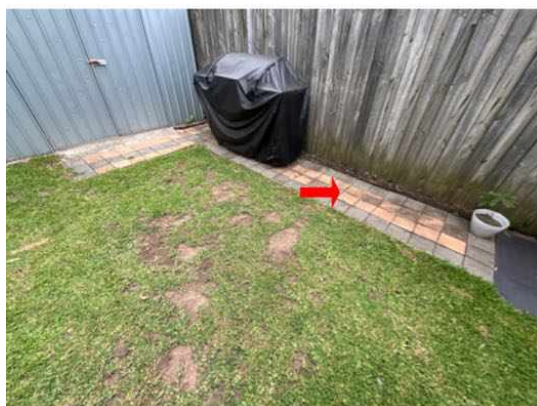
Finding 3.06

Sections of the external paved area are uneven, which may develop into a trip hazard. It appears as though the area has been subject to rough installation, or that paving sections have lifted due to movements in the foundation.

Left unmanaged, the May develop into a safety hazard due to trip and fall.

Re-paving of the area is required to remedy this situation. Further consultation with a specialist concreter is advised.

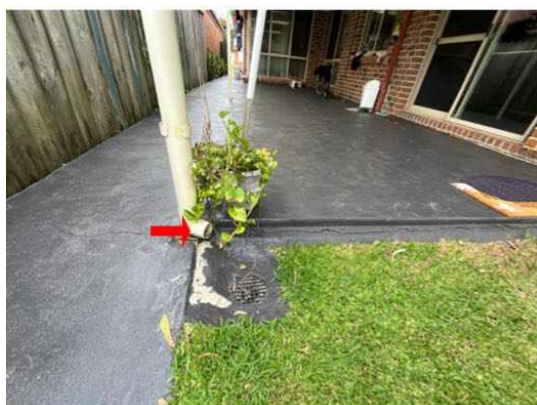
Finding 3.07

Building:	Main Building
Location:	Alfresco
Finding:	Plumbing - Point of connection non-compliant
Information:	At the time of inspection it was noted that connections between above ground pipe work and below ground sewer/storm water systems were incomplete.

Additionally, where sewer pipes are concerned, gases can escape from unsealed connections which can pose a serious health risk.

Engagement of a certified plumber is strongly recommended to ensure all connection points are sealed in accordance with the plumbing construction guidelines.

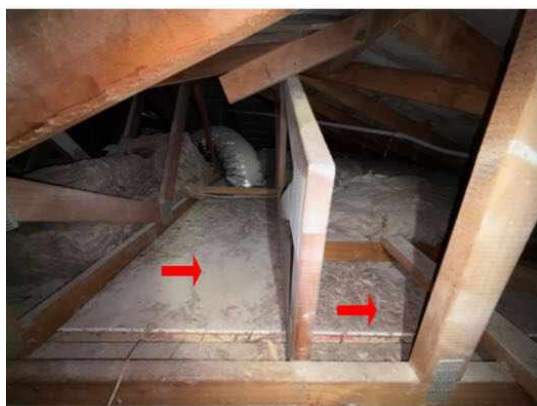
Finding 3.08

Building:	Main Building
Location:	Roof Void
Finding:	Insulation - Inadequate
Information:	Upon inspection of the roof void it was noted that there is a lack of adequate

The level of insulation in the property does not meet current Australian Standards. Installation of adequate insulation is required and should be conducted as soon as possible.

Caution should be exercised when accessing the roof void. Do not attempt to stand on the framework to the underside of the trusses and be aware there is a potential for electric shock if contact is made with exposed or faulty electrical wiring.

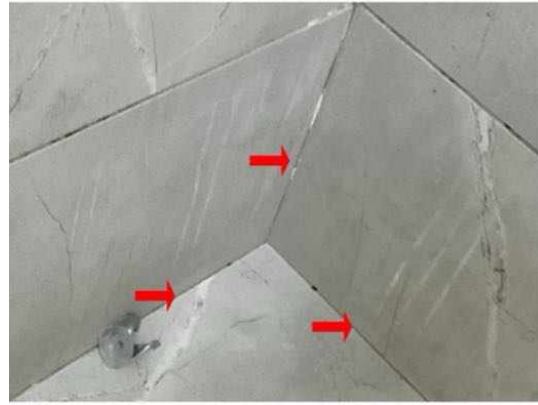
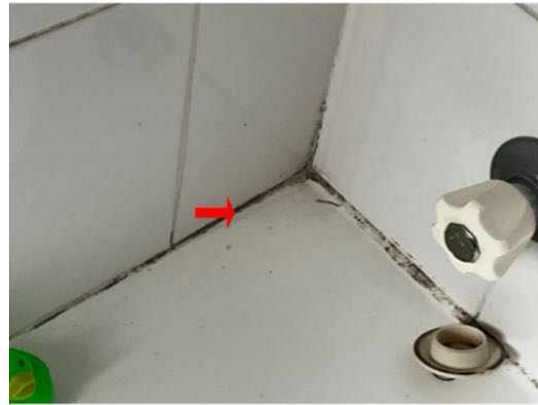
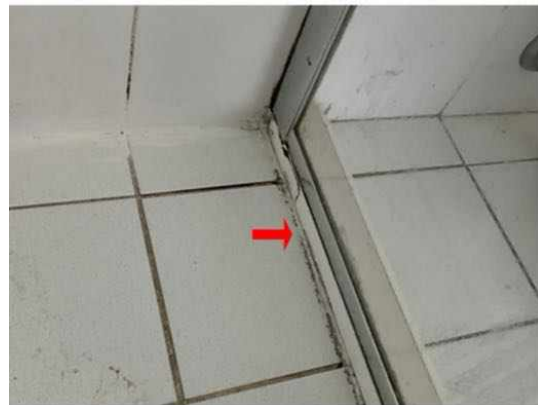
Finding 3.09

Building: Main Building
 Location: All Wet Areas
 Finding: Sealant and grouting - Missing or damaged
 Information:

It was noted on inspection that sealant or grout is degraded to this area.

Different materials and floor areas move at different rates, generally causing cracking to grout or sealant at this point. A flexible sealant is required to allow for expected expansion and contraction, while keeping the joint water tight and protective of all associated building materials.

Flexible and mould resistant materials should be applied to affected areas to prevent any subsequent water damage that is likely to occur. Regular maintenance and replacement of damage or missing or damaged sealant and grout is highly

recommended to the wet areas, as this is a regular wear and tear defect. Sealant and grouting in areas that come into regular contact with water should be maintained for the long term care of your property.

A sealant specialist should be appointed to complete these works as soon as possible.

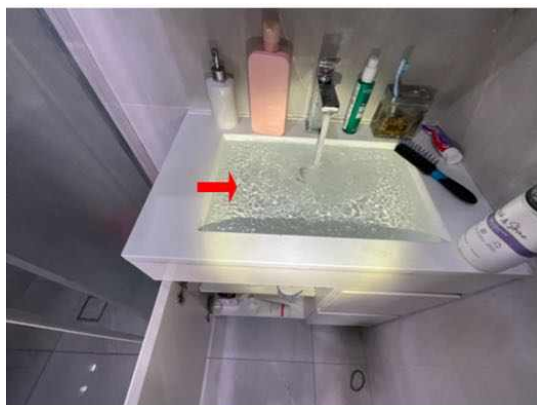
Finding 3.10

The sink/basin drain appeared to be partially blocked at the time of inspection. Blockages here are usually caused by hair and other debris. If left unmanaged, a lack of general maintenance may lead to the development of more significant defects, such as water damage to surrounding building materials.

A licensed plumber should be appointed to remove the blockage at the client discretion.

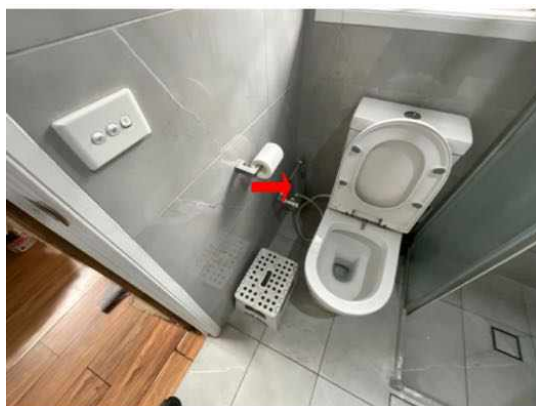
Building:	Main Building
Location:	Ensuite, yard
Finding:	Unconventional handyman work
Information:	This handyman work appears to have been completed to a substandard level and does not comply with regular building practices. Where handyman work is not completed satisfactorily, accelerated deterioration of the associated building elements is likely to occur and secondary defects to surrounding structures may develop.

It is highly recommended that the substandard work be rectified by professional services. Works to improve this area are likely to increase the safety and the operation of the associated building elements.

The client should exercise care when coming into the immediate vicinity of the substandard works. Rectification works are advised as soon as possible by the appropriate trades.

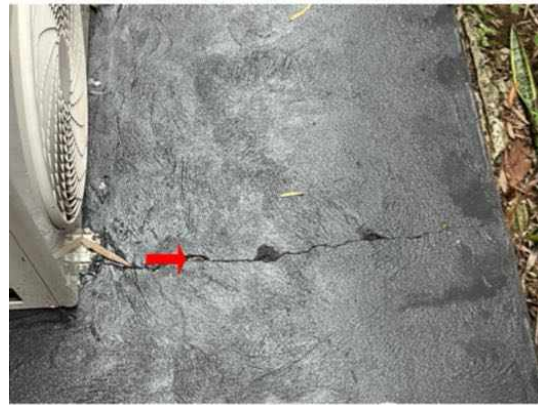
Finding 3.13

Building:	Main Building
Location:	Multiple areas
Finding:	Cracking - External Concrete Paving Damage Category 1 - Fine (less than 2mm)
Information:	Fine cracks were identified in external concrete paving. Although fine cracks are quite noticeable, they are often only considered to be an appearance defect, and usually do not indicate any structural damage. To be considered a Category 1 or fine crack, the crack is found to be less than 2mm in width.

Generally the cause of a hairline crack in existing concrete paving such as driveways and pathways is indicative of the expansion and contraction of the concrete. Such causes are generally due to environmental factors, such as moisture levels, weather conditions, root systems of nearby trees or the soil types on which they are laid.

Fine cracks may also be due to poor original installation of the concrete. Factors such as poor compaction of the sub surface and/or inadequate reinforcing of the slab may create cracking and other secondary defects.

Monitoring of all cracking should be conducted frequently. Always contact a building inspector should cracks widen, lengthen, or become more numerous.

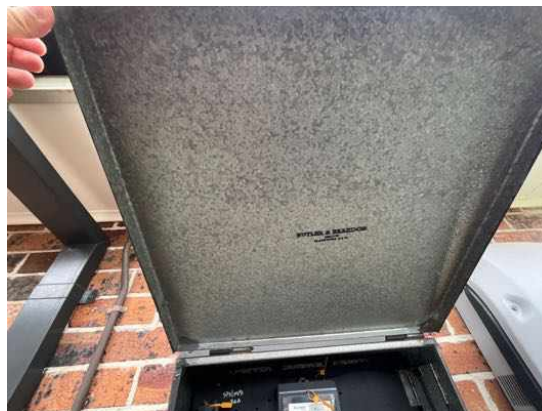
Building: Main Building
 Location: Meterbox
 Finding: Termite Management System - no evidence of installation
 Information: The application of a post-construction chemical termite barrier is highly recommended for all properties, particularly if live termite activity has been found on the site previously. Such barriers are highly effective in preventing termite attack on any timber building elements throughout the property.

system has been installed, with no evidence to suggest preventative works taking place.

The client may consider gaining further advice from a pest controller as to the costs and procedures involved with this application. It is recommended that obtaining such advice be a short-term priority.

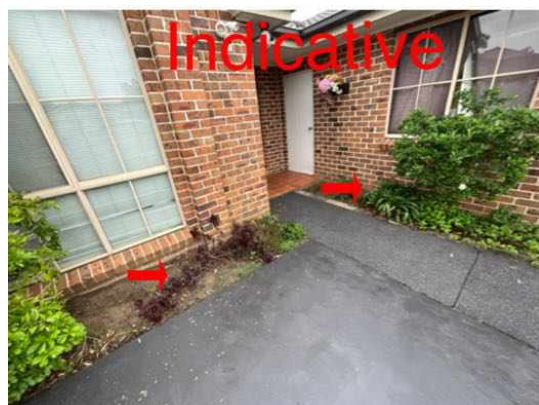
Finding 6.02

Not able to comment. A very high proportion of termite attacks are over the edge of both Infill and other concrete slabs types. Covering the edge of a concrete slab makes concealed termite entry easy. Infill slab type construction has an even higher risk of concealed termite ingress as the slab edge is concealed due to the construction design and cannot be exposed. The type of slab may only be determined by assessment of the construction plans by a qualified person e.g. Builder, Architect. Construction Plans may be obtainable by your local Council or Builder. Termite activity and or damage may be present in concealed timbers of the building. We strongly recommend frequent regular inspections in accordance with AS 3660.2. Where the slab edge is not fully exposed or the slab is an infill slab or the slab type cannot be determined then we strongly recommend inspections every 3 to 6 months in

accordance with AS 3660.2 or AS 4349.3.

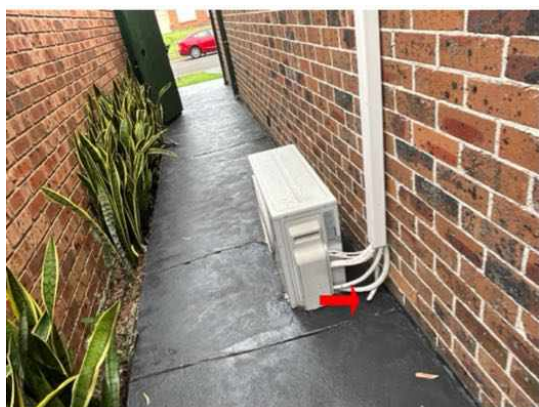
These damp conditions can lead to secondary defects such as rot, rust or corrosion of associated building elements, the formation of fungal decay, or even the creation of potential slip hazards. When coupled with poor site drainage, pooling of water may also attract termite activity to this area.

It is highly recommended that a licensed plumber be appointed to install adequate drainage to the overflow. These works will ensure that the area remains dry and free of any secondary defects.

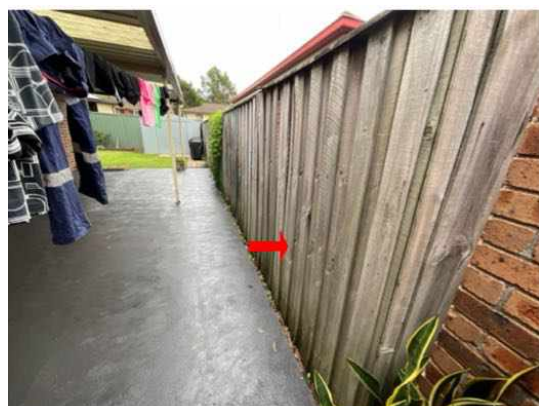
Finding 6.06

Building:	Main Building
Location:	Fencing & Landscaping
Finding:	Building materials in direct ground contact - conducive to termites
Information:	Where timber elements are in direct contact with the ground and consequently

moisture or dampness they become conducive to termite activity. Whether timber is used as a building element part of a fencing structure or stored as an unused item they can provide an environment that is attractive to termite infestation.

When met with excessive moisture timber begins to decay and develop wood rot. Any timbers that are in direct contact with external grounds especially if left untreated or non-durable also provide ingress for subterranean termites into that particular element.

The removal of any such materials that may be conducive to termite activity should be removed as soon as possible to minimise the risk of termite attack.

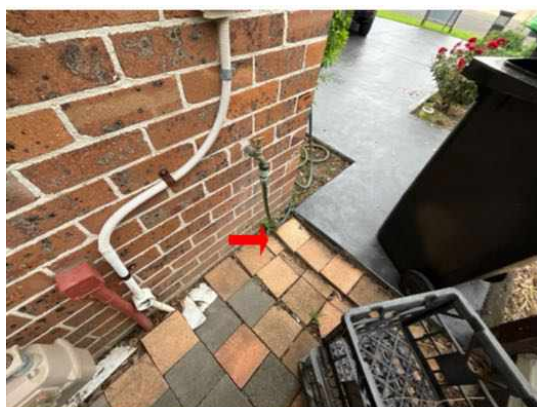
Building: Main Building
 Location: External tap
 Finding: Tap - No drain
 Information: The external tap in this area was noted to have no drain at the time of inspection.

This keeps the surrounding surfaces damp while using the tap, which becomes conducive to termite activity.

A licensed plumber must be appointed to ensure an appropriate drain is installed.

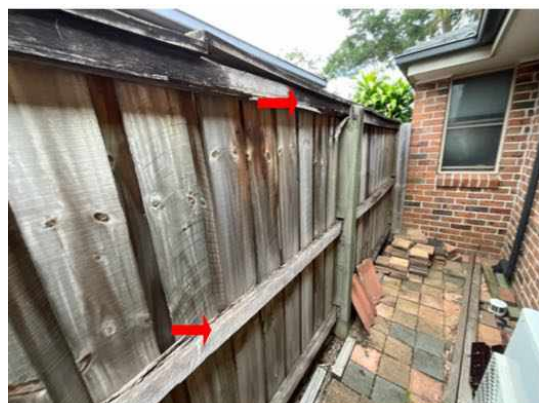
Building:	Main Building
Location:	Fencing
Finding:	Evidence of wood borer activity identified
Information:	Wood borers small beetles that colonise in exposed timber elements are a common timber pest that are regularly mistaken for termites. Although wood borer activity is generally not detrimental to the affected timber they may lead to serious damage and necessitate replacement of certain building elements if left unattended.

The other commonly known borer the Anobium borer is more likely to attack floorboards and may cause severe structural damage to flooring areas.

As no live wood borer activity was identified treatment is not required at this time. Replacement of affected timbers may be considered by the client for superficial reasons.
