Building and Timber Pest Inspection Report

Inspection Date: Fri, 20 Feb 2026

Property Address: 5 Sevens Ave, Euroa VIC 3666, Australia

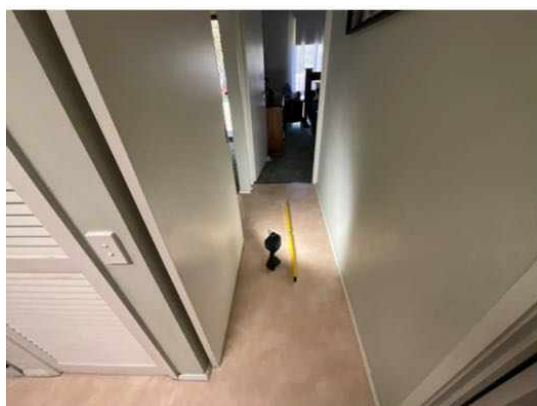
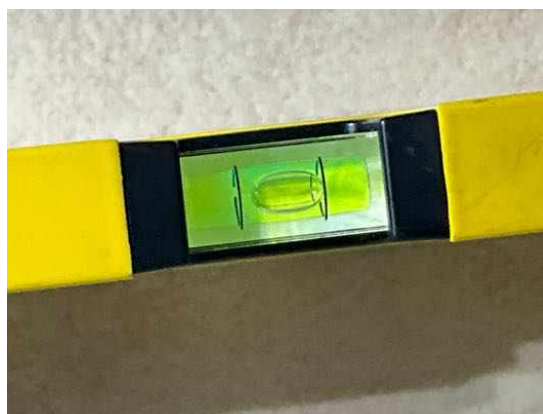
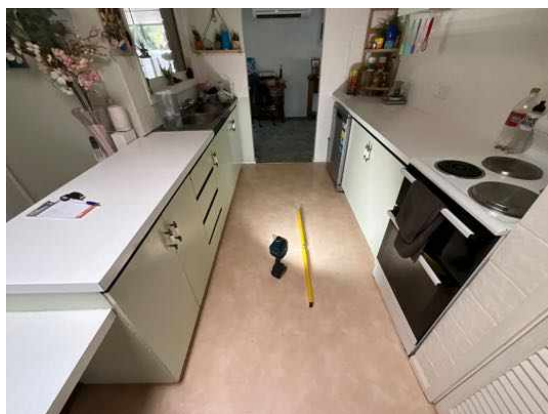
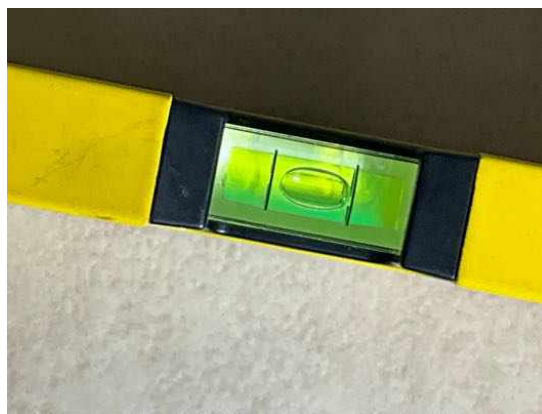
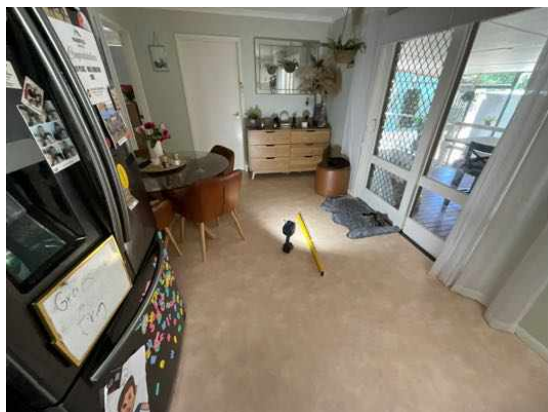
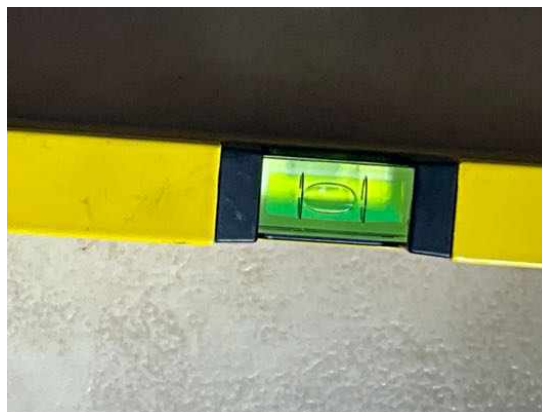
Finding 3.01

Building: Building 1
Location: All Internal Areas
Finding: Flooring - Uneven
Information: The internal flooring in this area is out of level and uneven. Uneven flooring is likely to indicate minor defects such as expected movement of the foundations of the property, but may also indicate subsidence of the associated subfloor stumps.

It is advised that the flooring be closely monitored to identify any further movement. Where flooring remains relatively unchanged for an extended period of time (i.e. several months), it is likely that this defect has been caused by expected movement of the foundations of the property.

However, where flooring is uneven further, potentially invasive inspection of the subfloor structures and stumps in this area is required. In this case, works to repair are likely to be required, and would be carried out by a registered builder specialising in re-stumping.

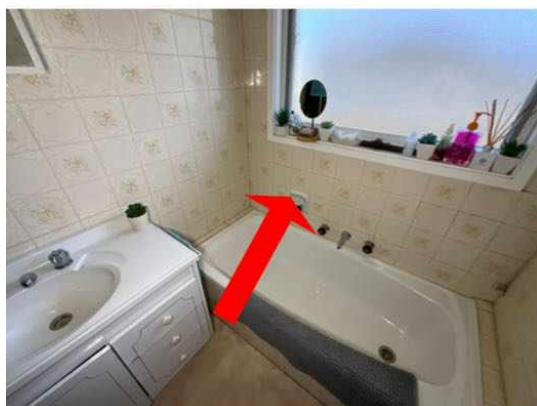
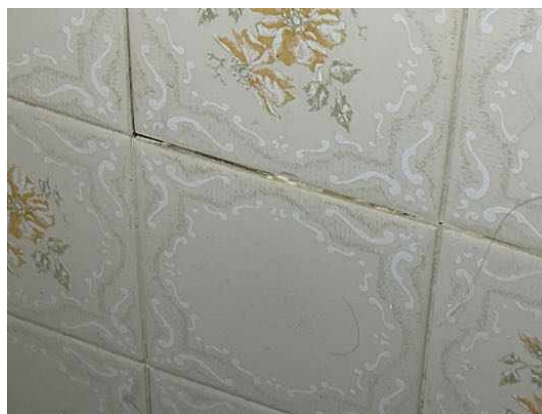
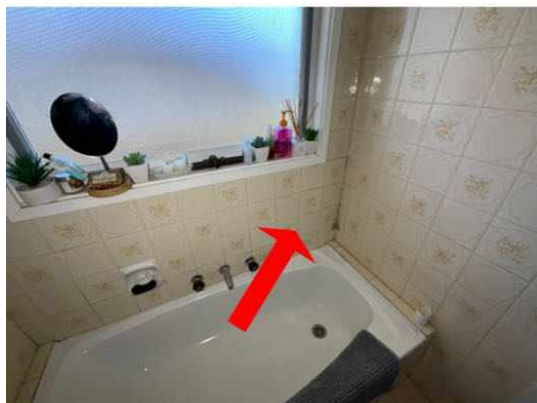
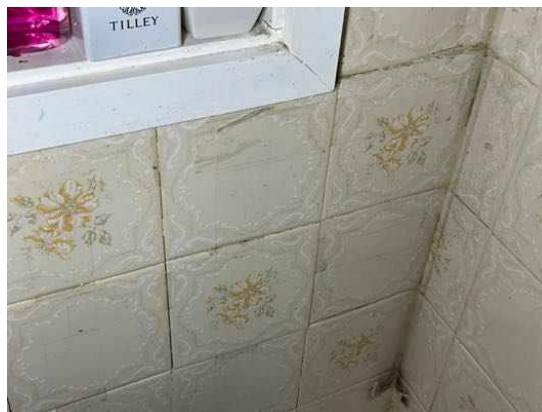
Finding 3.02

Location: Bathroom

Finding: Tiles - Drummy

Information: Drummy tiled areas were identified at the time of inspection. The term 'drummy' refers to tiles that have become detached from their fixing, despite otherwise being in relatively good condition. Such defects are generally caused by physical or moisture damage to the area. Drummy tiled areas may also be a direct result of poor workmanship during the construction process.

Tiled areas may swell and shrink with changes in air humidity if the area has sustained moisture damage. Any exposure to moisture is capable of causing tiled areas to become drummy and/or cracked over a prolonged period of time. Drummy tiled areas generally require removal and replacement of affected tiles, with adequate sealant and grouting.

It is advised that a tiling contractor be appointed to perform works as necessary. Immediate action is recommended to ensure that no further damage is sustained in the affected area.

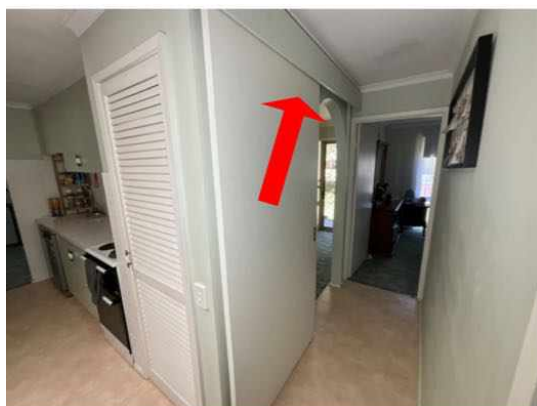
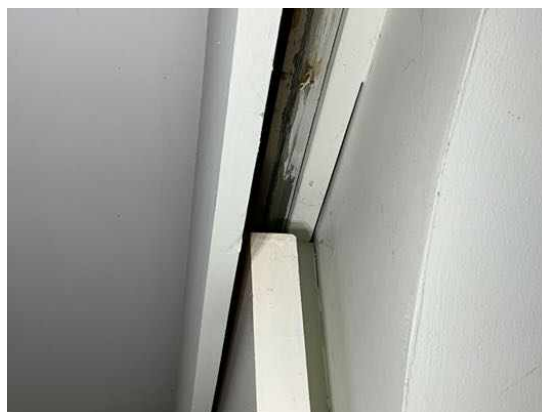
Finding 3.03

Building:	Building 1
Location:	Hall
Finding:	Door- Stiff to slide
Information:	The door in this area was jammed and difficult to slide along the associated tracks at the time of the inspection. Restricted function of the affected door may pose as a potential safety hazard if required for emergency egress from the building.

Generally, factors such as general age of the building element and a lack of maintenance are the usual causes for this type of defect.

Replacement of door hardware or tracks may be required, as well as minor repairs and cleaning. A registered builder or general handy person will be required to repair the affected doors.

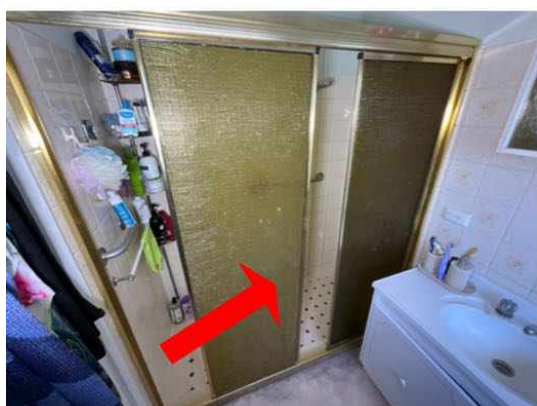
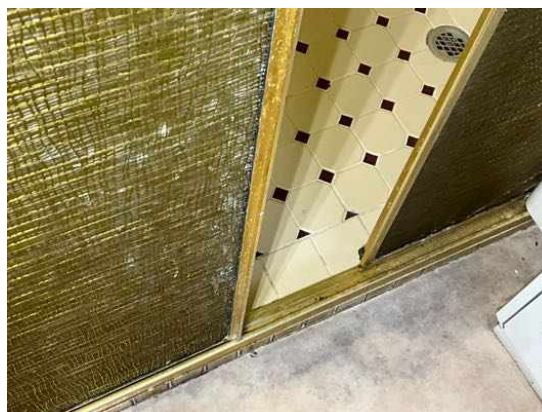
Finding 3.04

Building: Building 1
 Location: Bathroom
 Finding: Shower Door- jamming
 Information: The door to the shower alcove is sticking during normal operation. Poor operation of building elements is inconvenient and potentially dangerous to the elderly or younger members of the home.

The middle section appears to be missing.

A Handy person or bathroom specialist should be contacted soon to adjust the door to prevent any further deterioration.

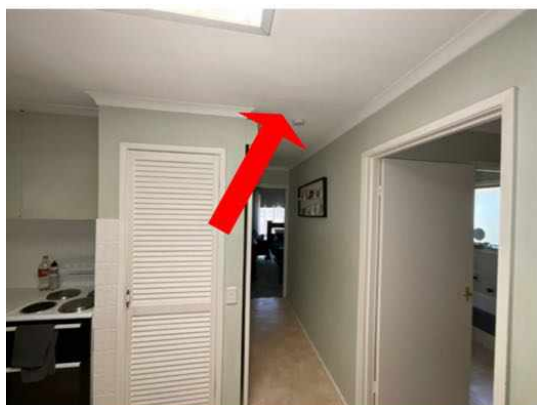
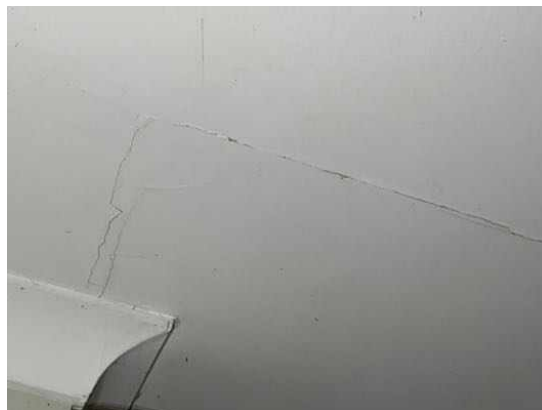
Finding 3.05

Building: Building 1
 Location: Hall
 Finding: Cracking - Damage Category 1 - Fine (up to 1mm)
 Information: Although fine cracks are quite noticeable, they are often only considered to be an appearance defect, and usually do not indicate any structural damage. Generally, the cause of a fine crack is indicative of a separation between building materials and finishes (e.g. paint, plaster, etc.) along joins.

Cracking of this nature can generally be repaired with minor sanding, filling and/or repainting. Such works should be performed by a qualified painter or a general handyman.

Monitoring of all cracking should be conducted frequently. Always contact a building inspector should cracks widen, lengthen, or become more numerous.

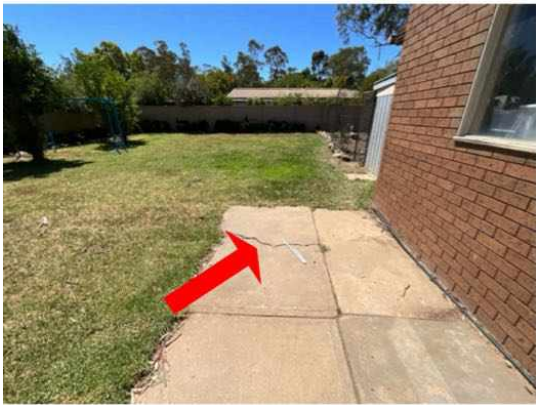
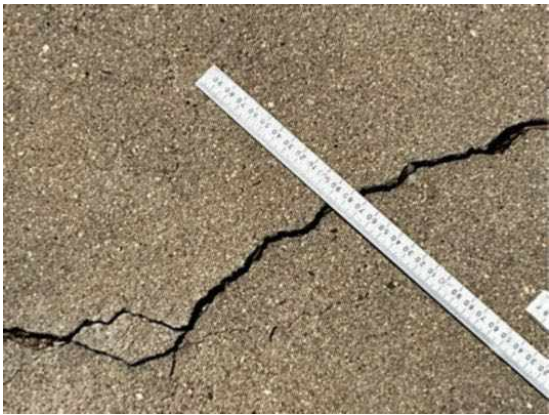
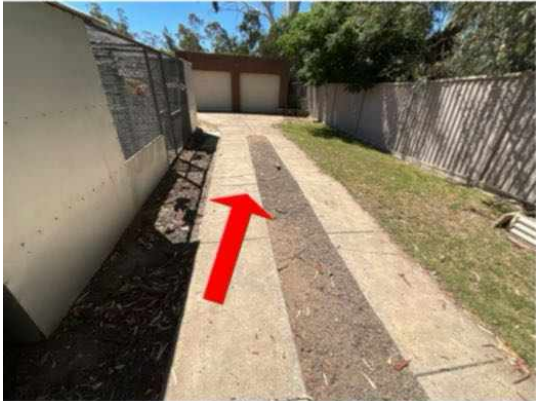
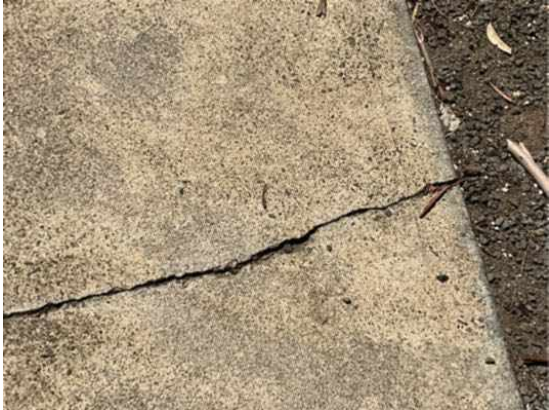
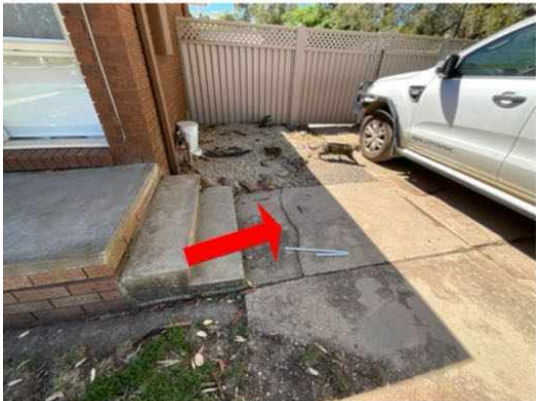
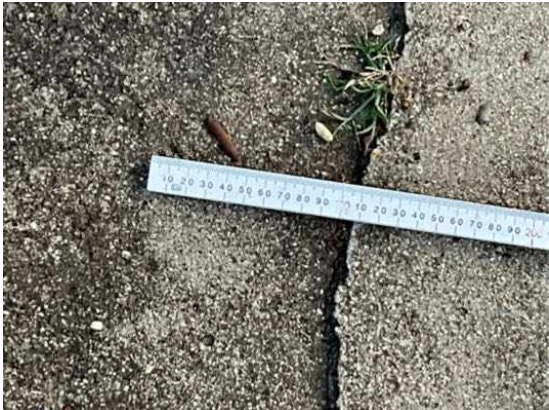
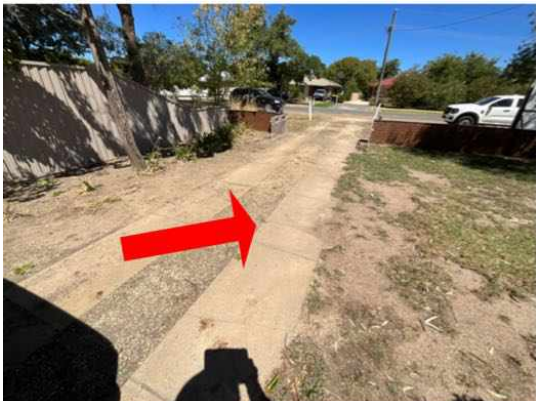
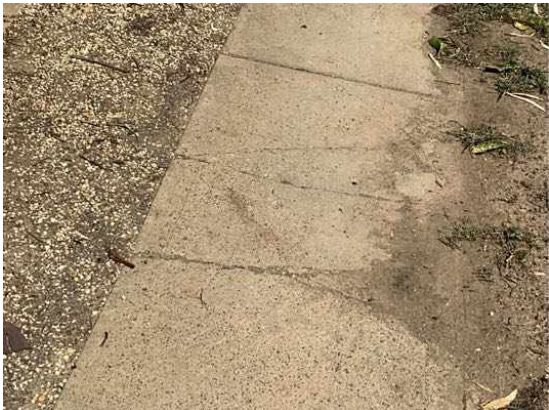
Finding 3.06

Building:	Building 1
Location:	Yard- front ,back, driveway
Finding:	Cracking - External Concrete Paving Damage Category 3 - Wide Cracks (2mm - 4mm)
Information:	Wide cracks were identified in external concrete paving Wide cracks are significant and are likely to lead to the development of safety hazards and secondary defects if left unmanaged.

General age and expected deterioration of the paved areas is a common cause of this type of cracking. However, expansion and contraction of the slab may also have occurred due to environmental factors. Such factors include variable moisture and weather conditions, the presence of trees and their roots having a settling or lifting affect on the soil, or the effect of load bearing, e.g. heavy vehicles over a sustained period of time.

Cracking to this degree may also be due to poor original installation of the concrete. Factors such as poor compaction of the sub surface and/or inadequate reinforcing of the slab may create cracking and other secondary defects. Wide cracks may also have a more significant structural cause, such as subsidence of soils.

Where the crack is located adjacent to structural elements of the building, the advice of a Structural Engineer is advisable before undertaking repairs. Significant repair and likely replacement of the concrete paving is probable.

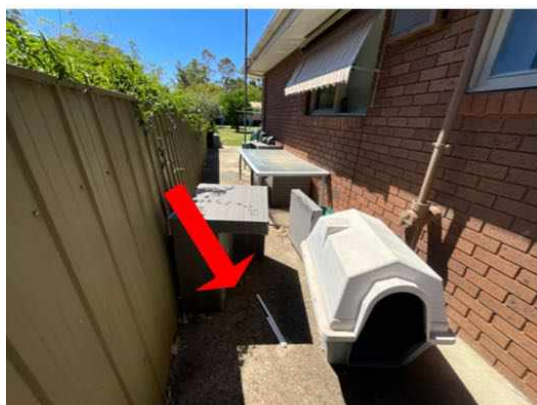
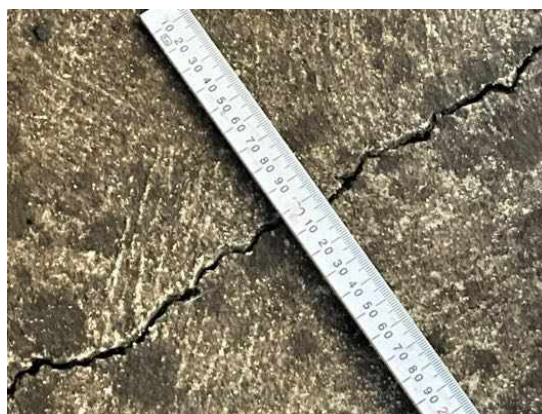
Finding 3.07

Building:	Building 1
Location:	Yard - Side
Finding:	Cracking - External Concrete Paving Damage Category 1 - Fine (less than 2mm)
Information:	Fine cracks were identified in external concrete paving. Although fine cracks are quite noticeable, they are often only considered to be an appearance defect, and usually do not indicate any structural damage. To be considered a Category 1 or fine crack, the crack is found to be less than 2mm in width.

Generally the cause of a hairline crack in existing concrete paving such as driveways and pathways is indicative of the expansion and contraction of the concrete. Such causes are generally due to environmental factors, such as moisture levels, weather conditions, root systems of nearby trees or the soil types on which they are laid.

Fine cracks may also be due to poor original installation of the concrete. Factors such as poor compaction of the sub surface and/or inadequate reinforcing of the slab may create cracking and other secondary defects.

Monitoring of all cracking should be conducted frequently. Always contact a building inspector should cracks widen, lengthen, or become more numerous.

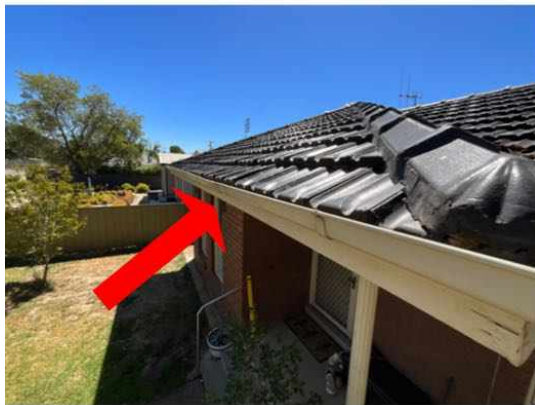
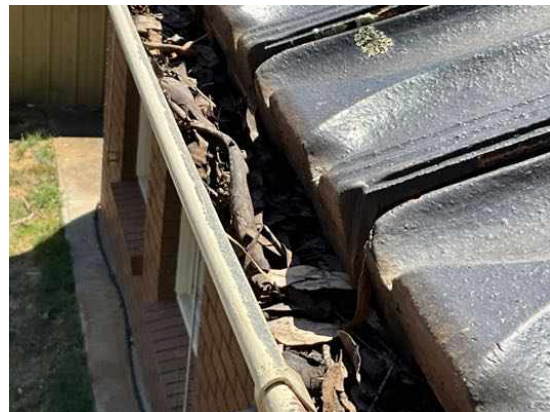
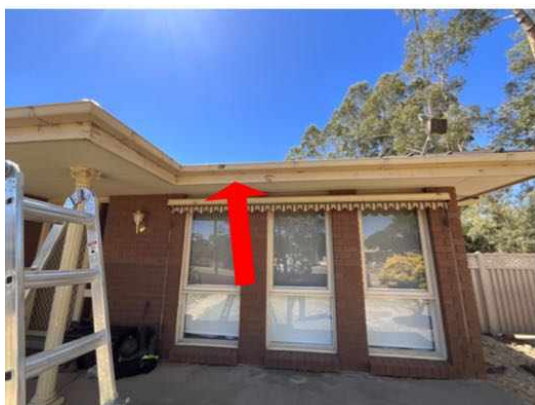
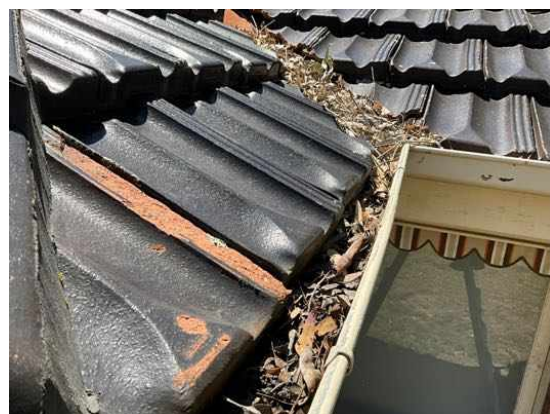
Finding 6.01

Location: Eaves
 Finding: Gutters- Blocked
 Information: Roof plumbing structures, such as guttering and downpipes, should be free of all debris to prevent blockages. Blockages of the guttering and downpipes will lead to pooling and accumulated water overflows, which is likely to subsequently flood eaves and exterior walls.

Blocked gutters are likely to lead to high levels of moisture in the affected areas. Such moisture will not only cause rust and decay of the associated building materials, but can also provide conditions that are conducive to termite and timber pest activity. Blockages in gutters should therefore be removed immediately to ensure dry conditions are maintained.

Consult a Licensed Plumber for further specific advice on remedial works that may be required. In the interim, it is highly advised that blocked gutters be removed by the homeowner or a general handyperson as a matter of urgency.

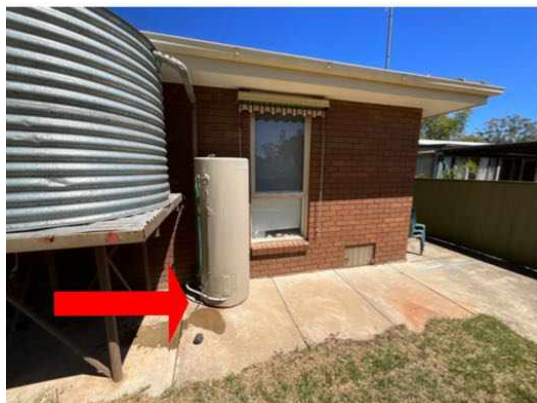
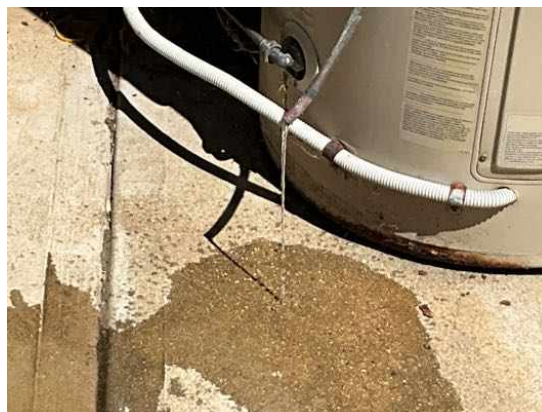
Finding 6.02

Building: Building 1
 Location: Yard - Back
 Finding: HWS Overflow - Not Connected
 Information: The Hot Water System (HWS) overflow was found to be disconnected from storm

water drainage and is creating excessive moisture in the surrounding area.

These damp conditions can lead to secondary defects such as rot, rust or corrosion of associated building elements, the formation of fungal decay, or even the creation of potential slip hazards. When coupled with poor site drainage, pooling of water may also attract termite activity to this area.

It is highly recommended that a licensed plumber be appointed to connect the HWS overflow in order to prevent such an environment from being created. These minor works should be carried out as soon as possible.

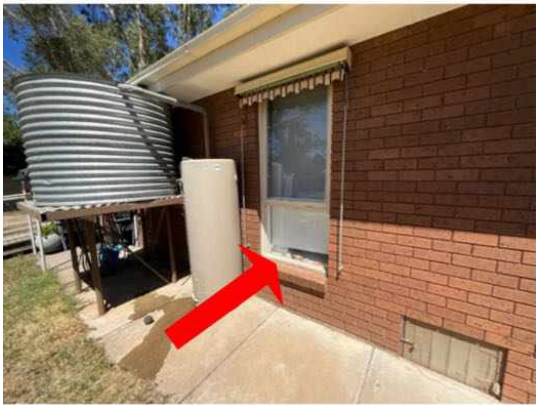
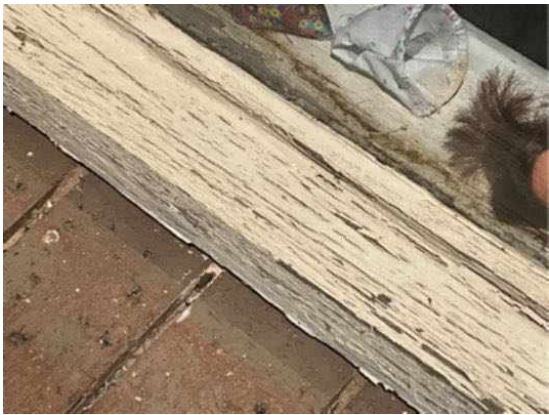
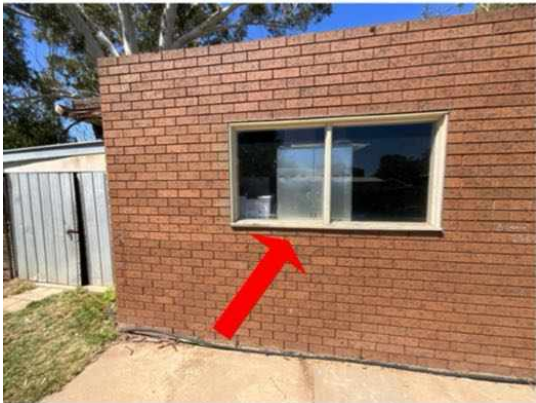
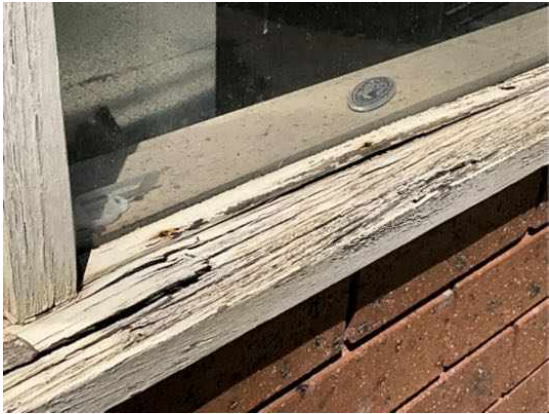
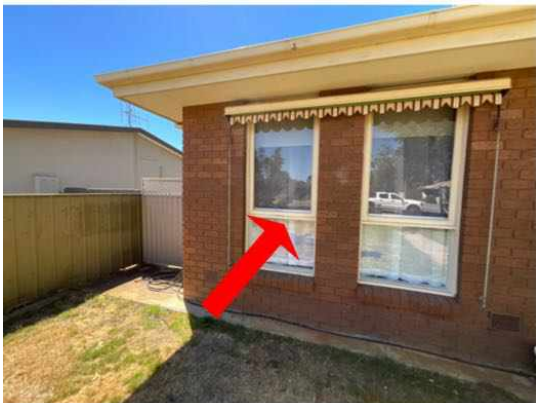
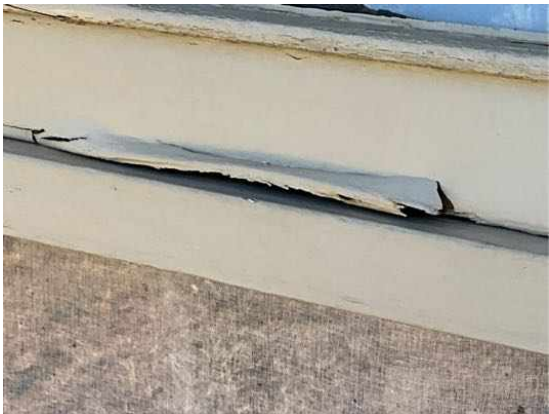
Finding 6.03

Building:	Building 1
Location:	Timber windows
Finding:	Timber - exposed to weather
Information:	External timbers that are frequently exposed to harsh weather conditions require adequate protection in order to maintain their condition. Where timbers have not been painted or treated adequately, general deterioration is likely to occur at an accelerated rate.

If left unattended, replacement of these timbers is likely to be necessary in the short-term future. Adequate treatment of these timbers is required as soon as possible by a painting contractor or general handyman.

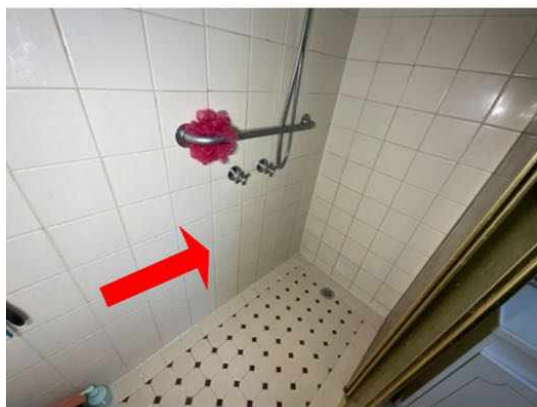
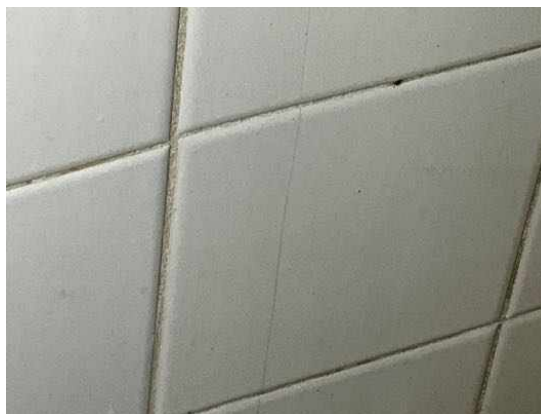
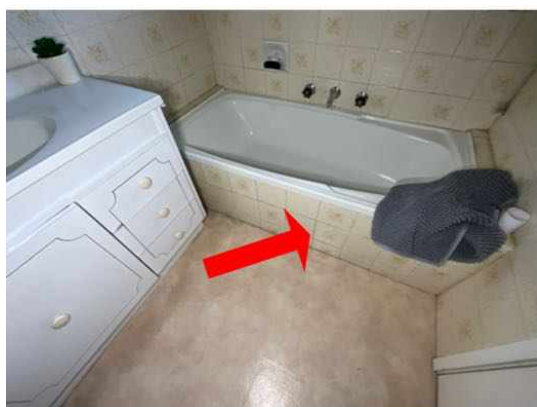
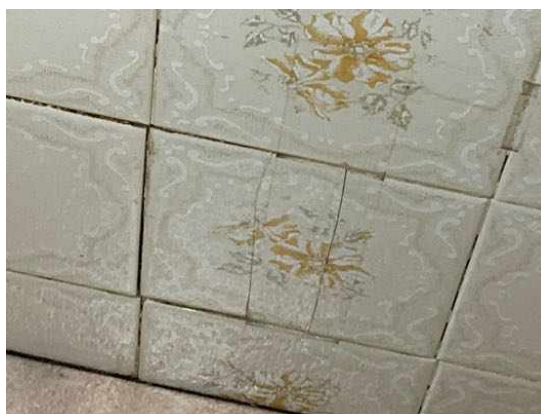
Finding 6.04

Building: Building 1
Location: Bathroom
Finding: Wall Tiles- Cracked
Information: Cracked tiles within the household detract from the overall appearance of the affected areas, as well as creating potential for water penetration to adjoining building elements. If left unmanaged, water damage may occur as a result of constant water penetration over a prolonged period of time.

While not considered a matter of urgency, replacement of tiles is advised as a solution. A Tiling Contractor may be appointed to perform these works at client discretion.

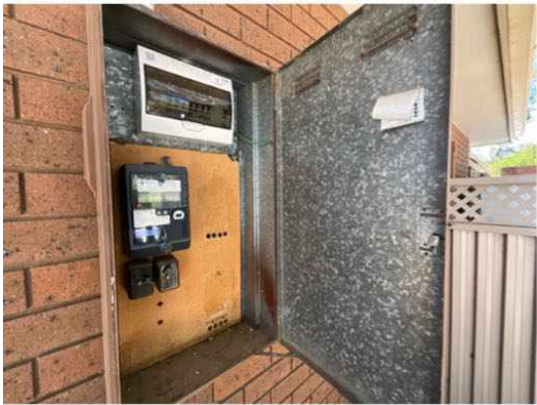
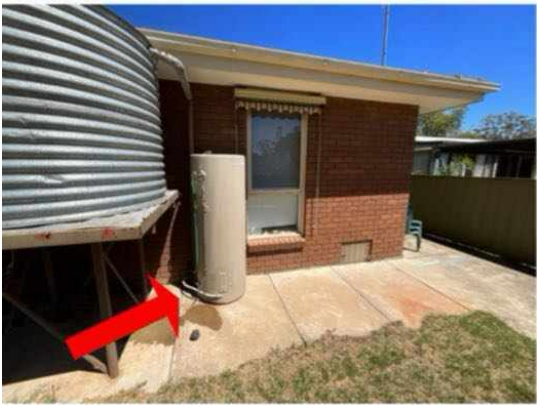
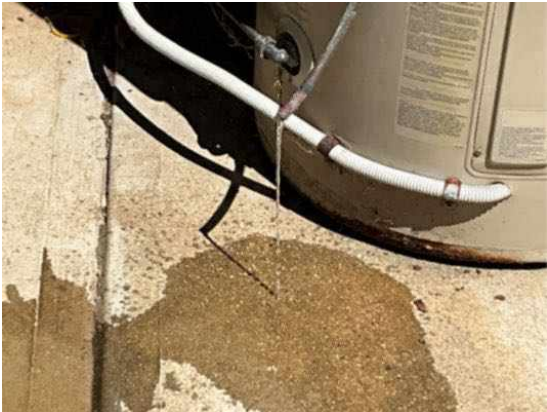
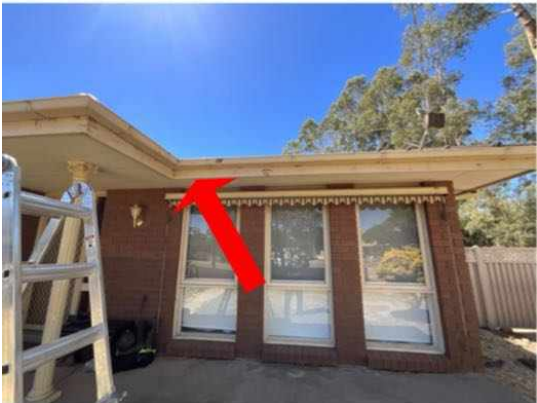
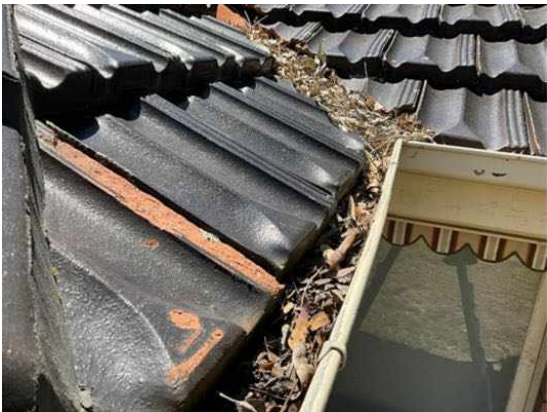
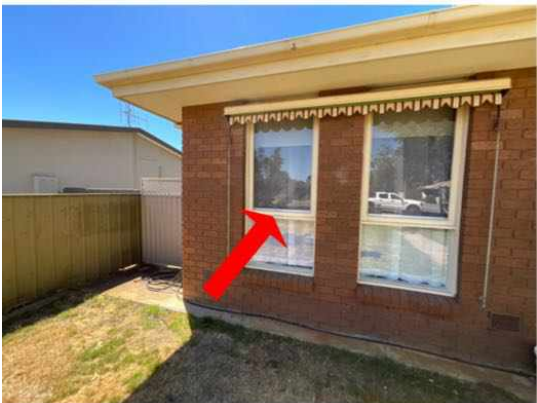
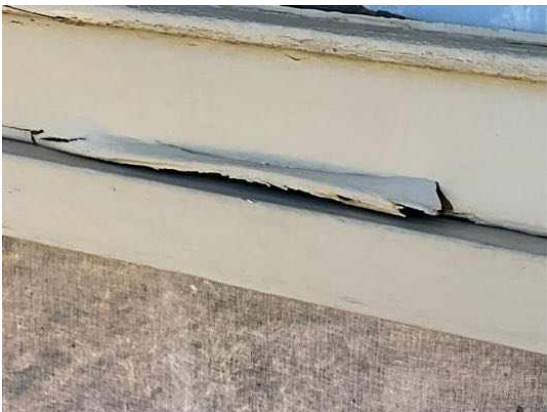
Finding 6.05

Building:	Building 1
Location:	All External Areas
Finding:	Termite Management System - no evidence of a chemical installation
Information:	The application of a post-construction chemical termite barrier is highly recommended for all properties, particularly if live termite activity has been found on the site previously. Such barriers are highly effective in preventing termite attack on any timber building elements throughout the property.

A durable notice should be placed in the switchboard unit to indicate current termite barriers. At the time of inspection, it appeared as though no termite management system has been installed, with no evidence to suggest preventative works taking place.

The client may consider gaining further advice from a pest controller as to the costs and procedures involved with this application. It is recommended that obtaining such advice be a short-term priority.

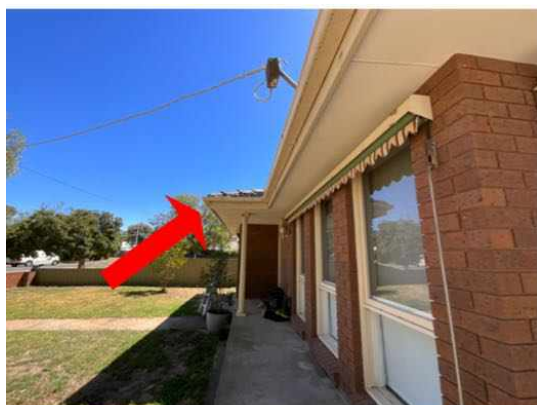
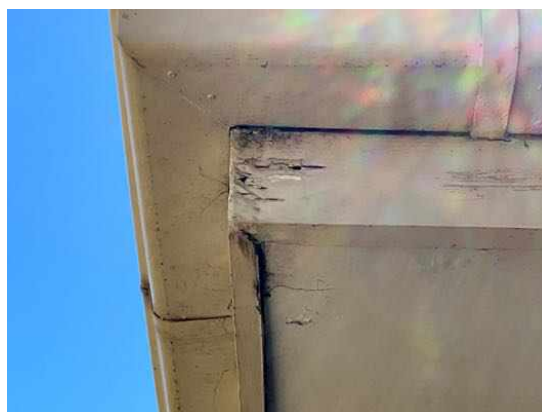
Finding 7.01

Building:	Building 1
Location:	Eaves
Finding:	Fungal decay - present (localised)
Information:	Fungal decay also known as wood decay or wood rot generally refers to the deterioration of timber elements when in contact with excessive levels of moisture for a prolonged period of time.

The development of fungal decay is accelerated by temperatures in the range of 5degreeC to 40degreeC as well as the presence of oxygen. Generally fungal decay develops on timber elements that are in use in an external environment which are exposed to rain penetration.

In this case although the affected timber element is in a decaying state the extent of any visible damage appears to be localised to a specific area and is yet to spread to other parts of the building element or affect adjoining structures. The fungal decay is therefore likely to be of a relatively superficial nature with minimal impact on the structural integrity or tensile strength of the timber element.

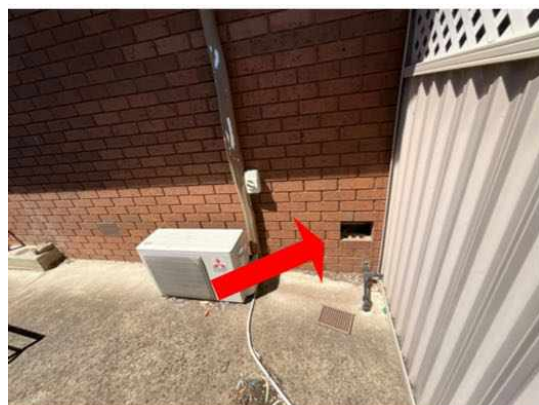
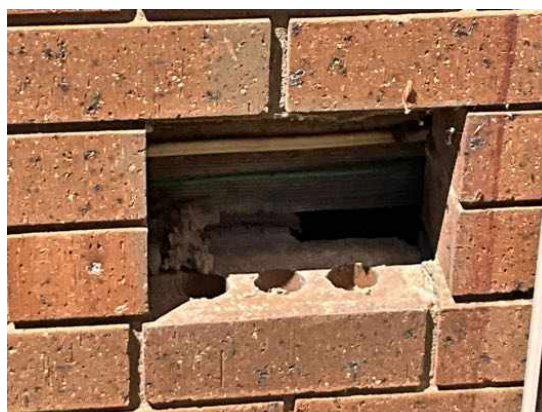
Building: Building 1
 Location: Yard - Side
 Finding: Installation - substandard or incomplete
 Information: The installation of this building element appears to have been completed to a substandard level of workmanship or is incomplete. Generally substandard repairs or installation are related to poor workmanship, the use of inappropriate materials, or a failure to complete installation to a suitable standard.

Where installation is substandard and/or incomplete, the client should contact the responsible trade to undertake rectification. Unfinished and substandard building works are likely to degrade more quickly and may create potential for secondary defects to associated building elements.

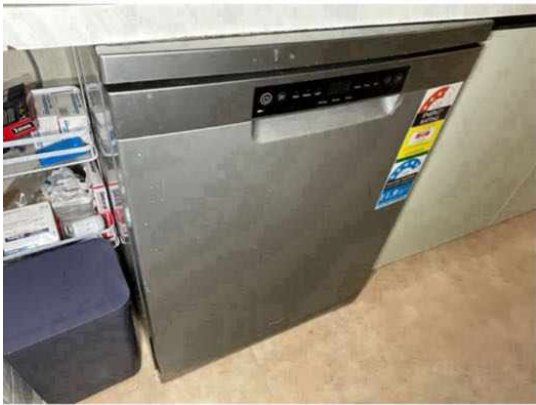
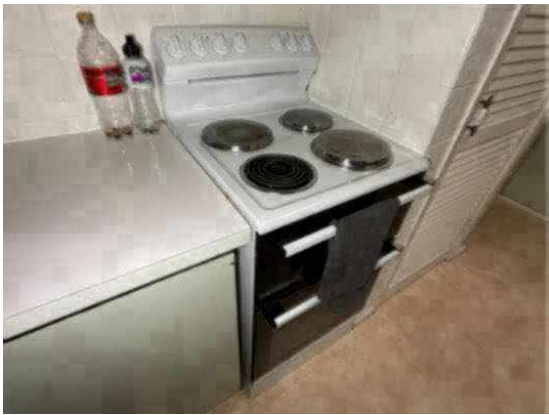
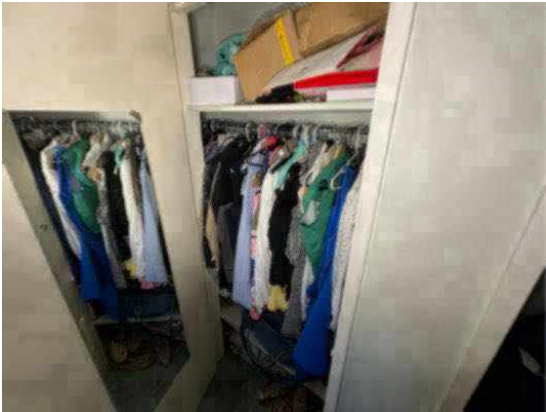
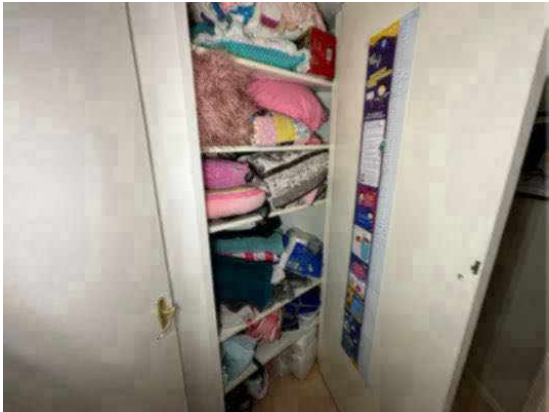
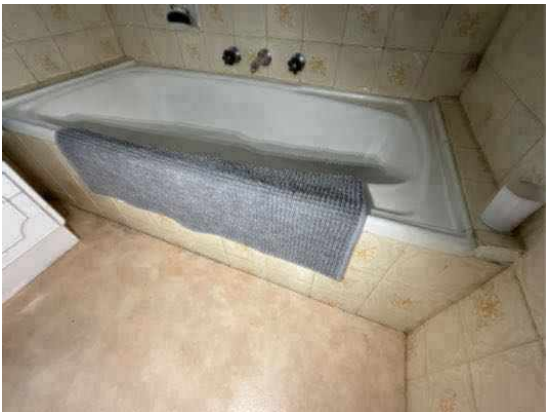
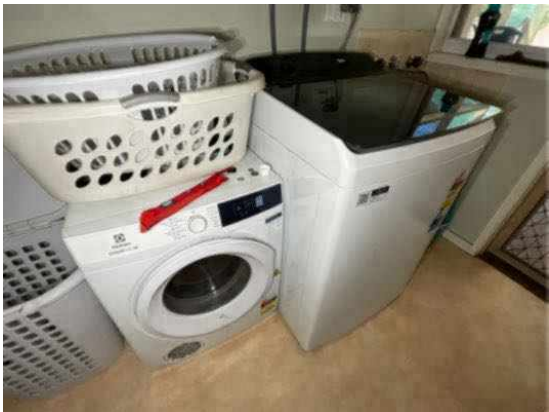
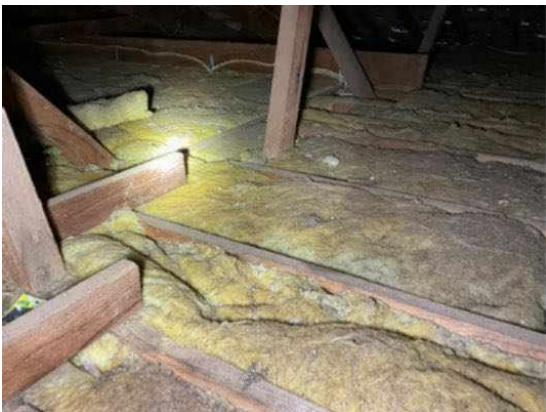
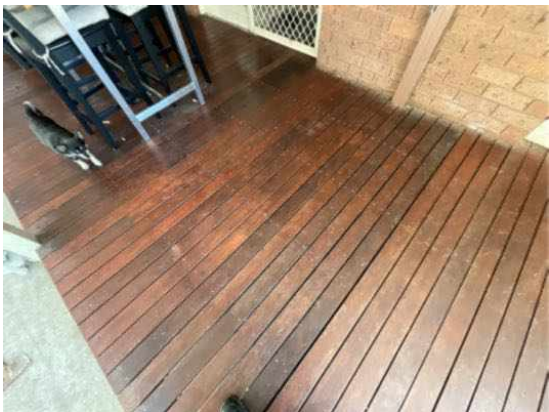
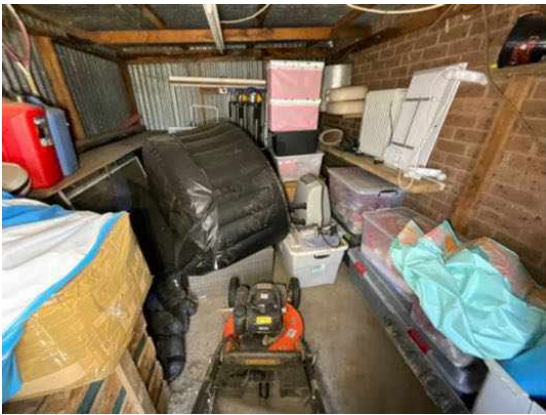
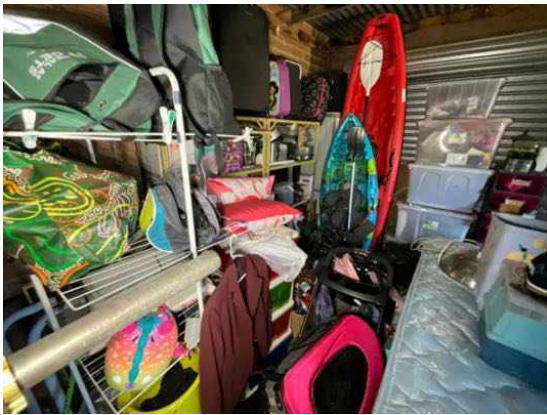
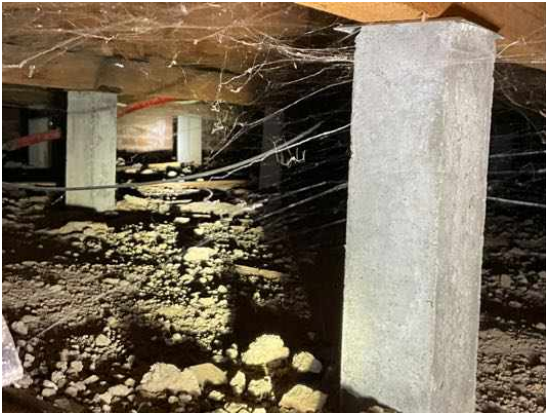
Building: Building 1
 Location: All Areas
 Finding: Additional Photos - Obstructions and Limitations
 Information: These photographs are an indication of the obstructions and limitations which impeded full inspection of the property at the time of inspection. These obstructions can hide an array of defects and should be removed to allow full inspection to be carried out. A re-inspection is recommended once the areas are made accessible.
