# Building and Timber Pest Inspection Report

Inspection Date: Thu, 22 Jan 2026

Property Address: 45 Chandler St, West Wodonga VIC 3690,  
Australia

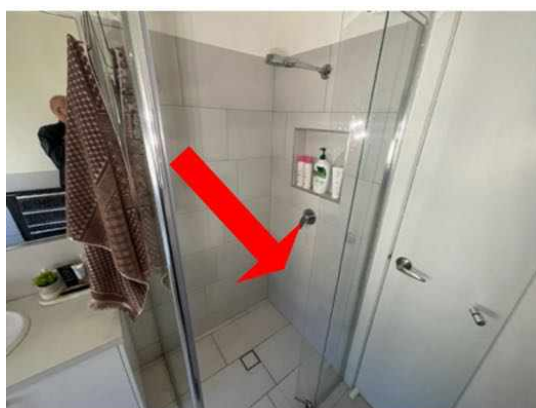
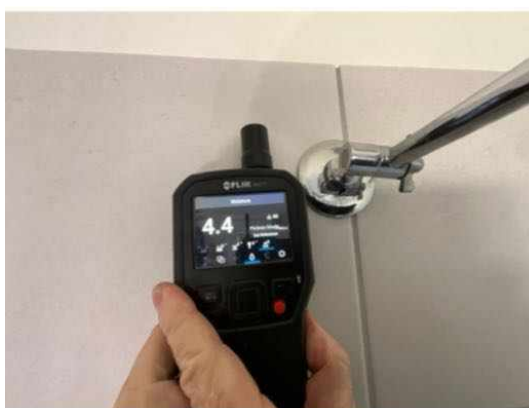
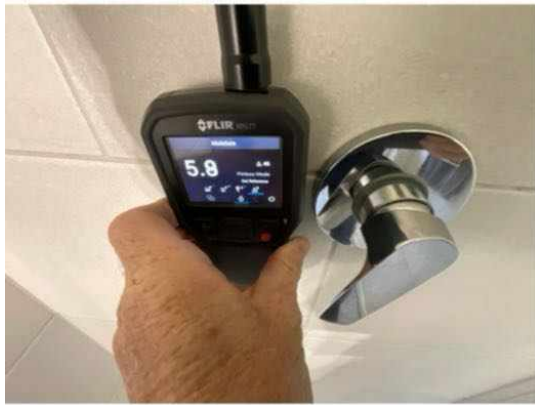
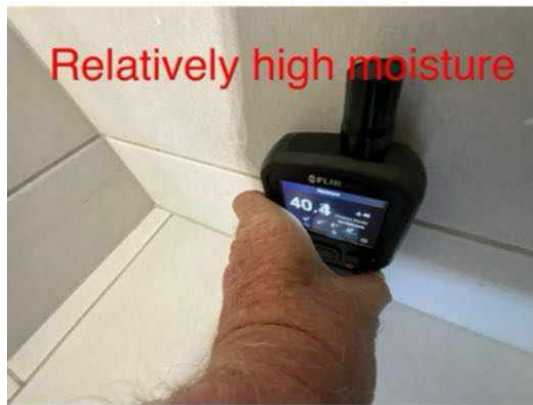
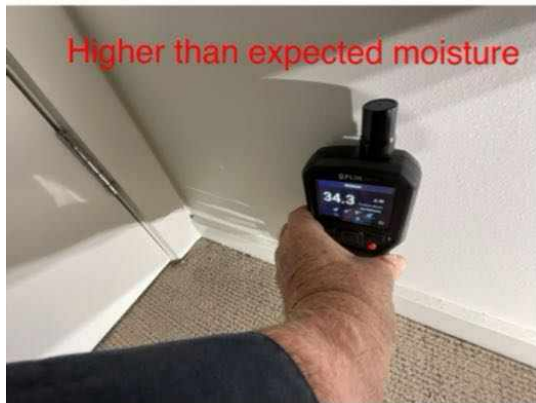
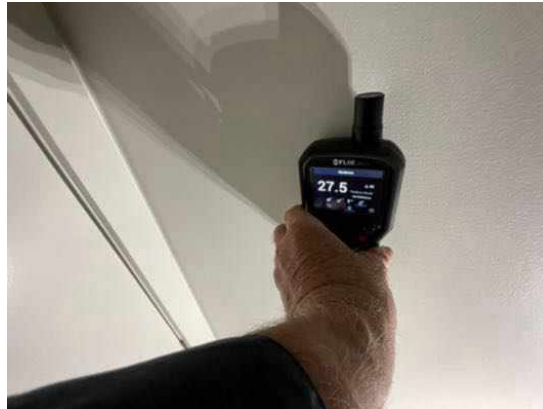
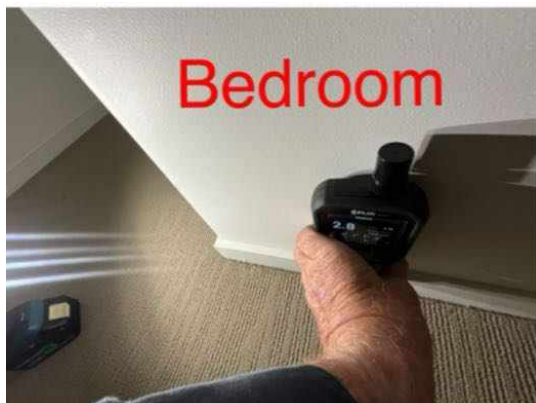
#### Finding 2.01

Building: Building 1  
Location: Bathroom  
Finding: Shower Damp- Significant  
Information: Damp is evident to the lower wall to the Shower Alcove. This is suspected to have been caused by moisture permeating through the grouting in this area.

Relatively High levels of moisture were observed on the outside of the shower walls in the opposite wall.

Damp (or structural damp) refers to the presence of unwanted moisture in the structure of the building, either as a result of intrusion from outside, or condensation from within the structure. In the Shower area, internal water leaks or other sources of excessive moisture are generally the cause of damp.

A major defect is noted. The moisture in the shower wall is significant. After review of the separate Plumbing investigation this defect can now be considered a Major defect. Rectification must be carried out as soon as possible to avoid further deterioration of the property. A plumber or bathroom specialist should be contacted to advise on all further works.

Consultation with a qualified Plumber or Bathroom Specialist is advised immediately to identify the cause of damp and to perform remedial works as required.

Always ensure that sealant and grout is in good condition to prevent any moisture issues occurring in the future.

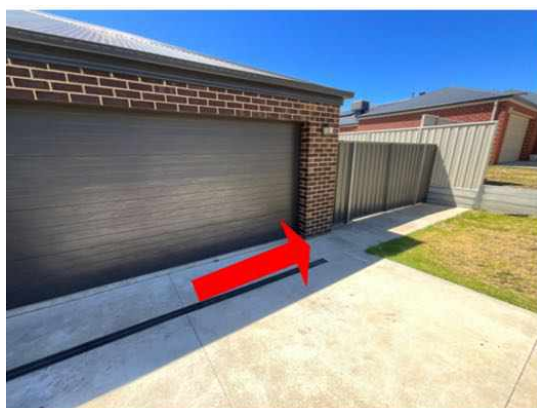
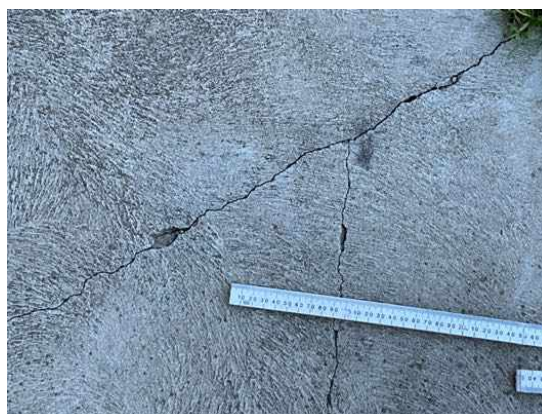
### Finding 3.01

Building:	Building 1
Location:	Driveway
Finding:	Cracking - External Concrete Paving Damage Category 1 - Fine (less than 2mm)
Information:	Fine cracks were identified in external concrete paving. Although fine cracks are quite noticeable, they are often only considered to be an appearance defect, and usually do not indicate any structural damage. To be considered a Category 1 or fine crack, the crack is found to be less than 2mm in width.

Generally the cause of a hairline crack in existing concrete paving such as driveways and pathways is indicative of the expansion and contraction of the concrete. Such causes are generally due to environmental factors, such as moisture levels, weather conditions, root systems of nearby trees or the soil types on which they are laid.

Fine cracks may also be due to poor original installation of the concrete. Factors such as poor compaction of the sub surface and/or inadequate reinforcing of the slab may create cracking and other secondary defects.

Monitoring of all cracking should be conducted frequently. Always contact a building inspector should cracks widen, lengthen, or become more numerous.

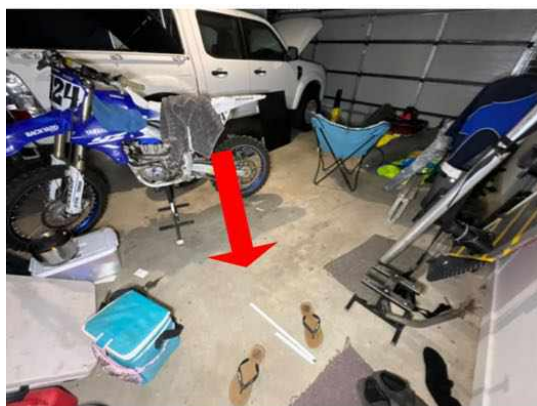
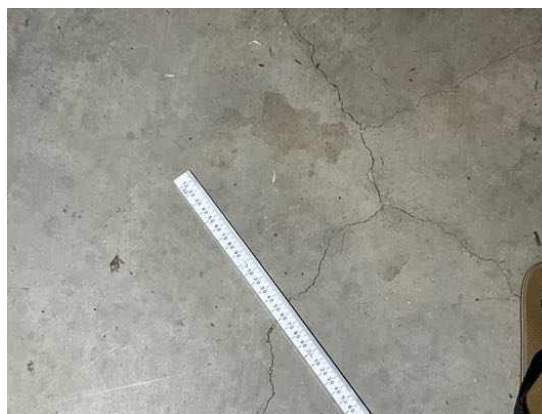
### Finding 3.02

Building:	Building 1
Location:	Garage
Finding:	Crack in concrete slab - Category 1
Information:	A crack coded as Category 1 was identified in the slab. A Category 1 crack is described as a fine but noticeable crack, with the slab at an otherwise reasonable level.

To be considered Category 1, the approximate width of the crack is less than 1.0mm, or a less than 10mm change in offset when a 3m straight edge is placed over the defect.

Category 1 cracks should be monitored for a period of 12 months. At the end of the monitoring period, identified cracks that are rated greater than Category 2 are considered defects, and require rectification.

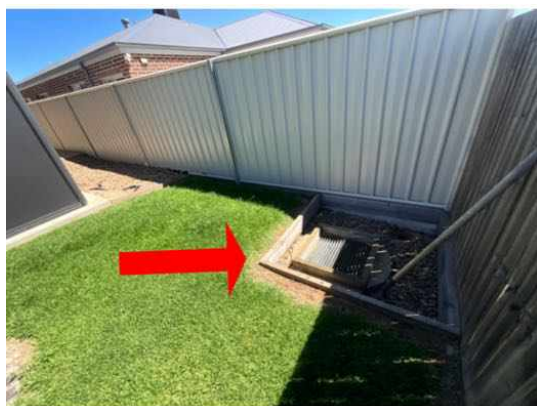
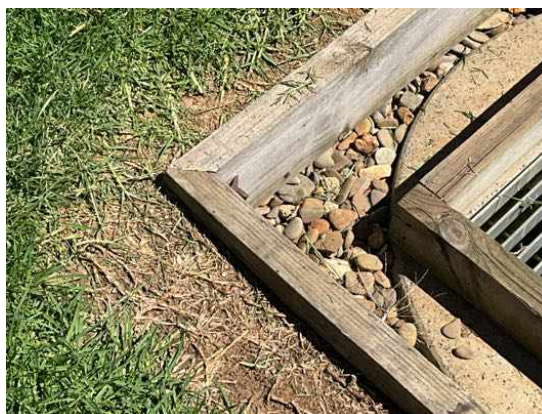
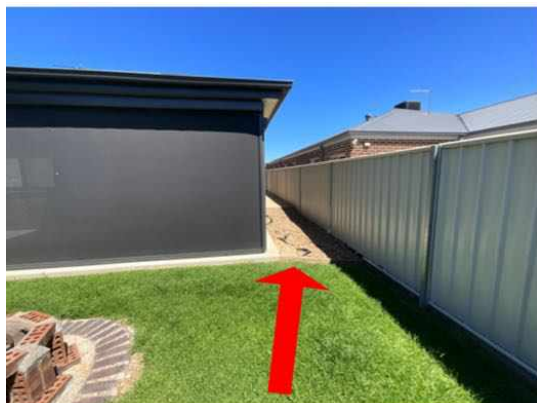
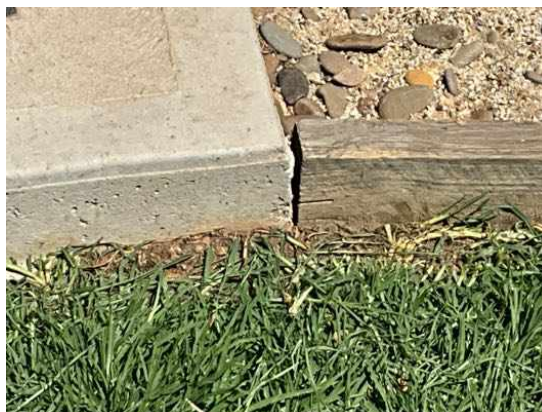
### Finding 6.01

Building:	Building 1
Location:	Yard - Back
Finding:	Untreated or non-durable timbers in a hazardous environment
Information:	To reduce the risk of timber pest attack it is essential that timber used in a hazardous environment (e.g. in direct contact with the ground or frequently exposed to damp conditions) is of sufficient durability and/or is adequately preservative treated.

Untreated timbers in direct contact with the ground are likely to develop severe wood rot and/or fungal decay if left unattended creating attraction for subterranean termites to infest the timbers from surrounding areas.

If untreated or non-durable timbers are found to be in a hazardous environment it is highly advised that replacement of these building elements be performed as soon as possible to aid the protection of the property against termite / timber pest attack.

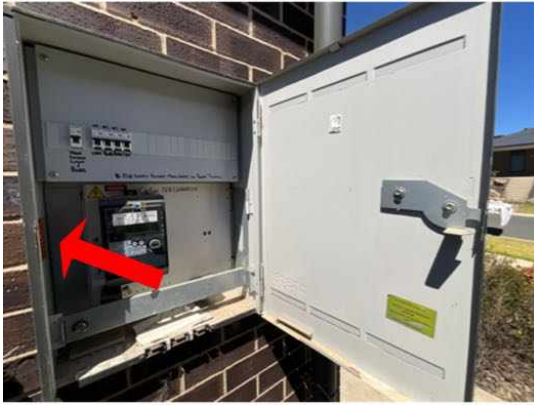
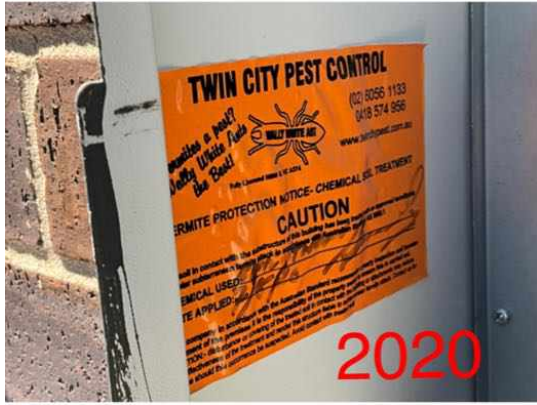
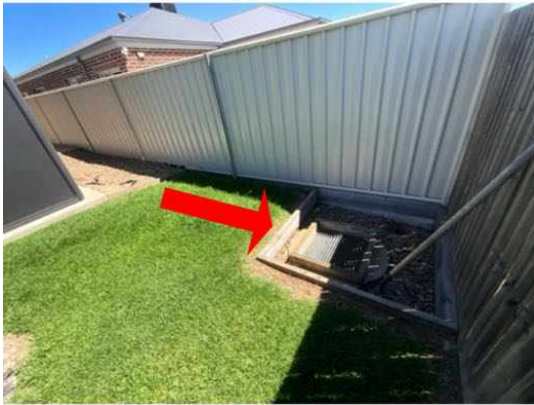
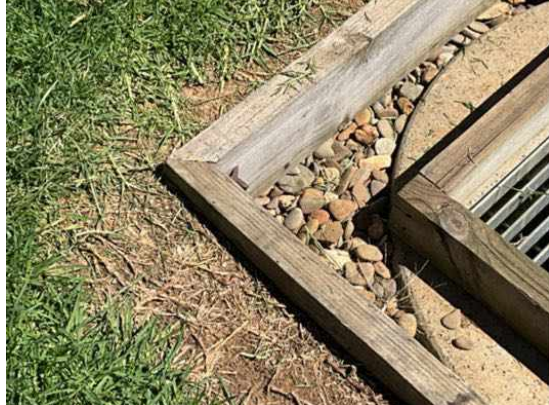
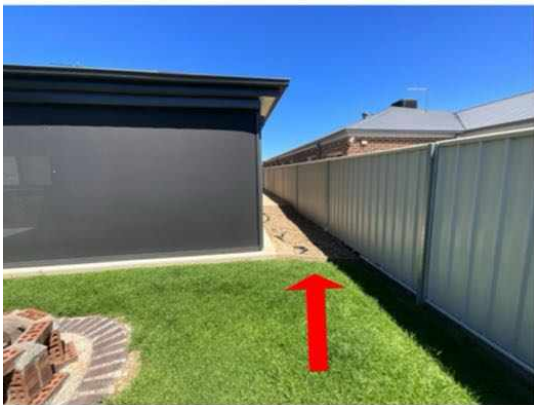
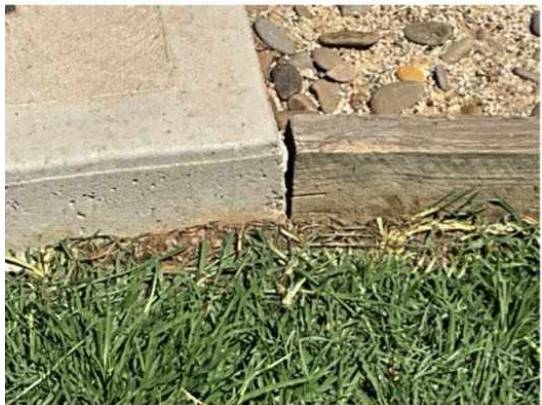
### Finding 6.02

Building:	Building 1
Location:	All External Areas
Finding:	Termite Management System- evidence of a chemical installation
Information:	The application of a post-construction chemical termite barrier is highly recommended for all properties, particularly if live termite activity has been found on the site previously. Such barriers are highly effective in preventing termite attack on any timber building elements throughout the property.

A durable notice has been placed in the switchboard unit to indicate current termite barriers. At the time of inspection, it appeared as though a termite management system has been installed. The recency of any treatment cannot be determined.

The client may consider gaining further advice from a pest controller as to the costs and procedures involved with this application. It is recommended that obtaining such advice be a short-term priority.

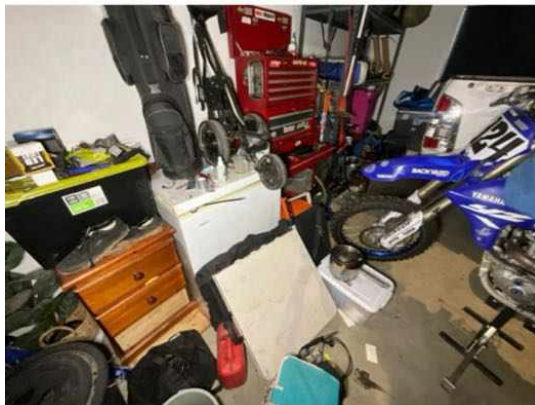
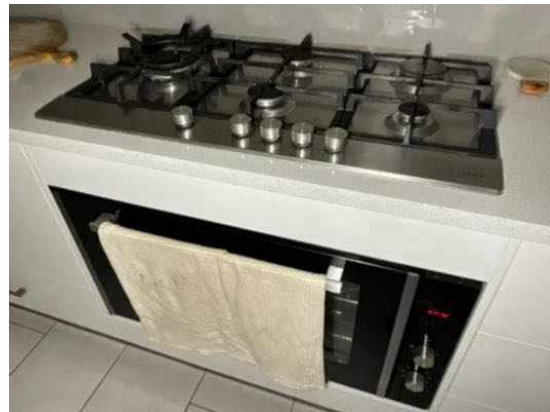
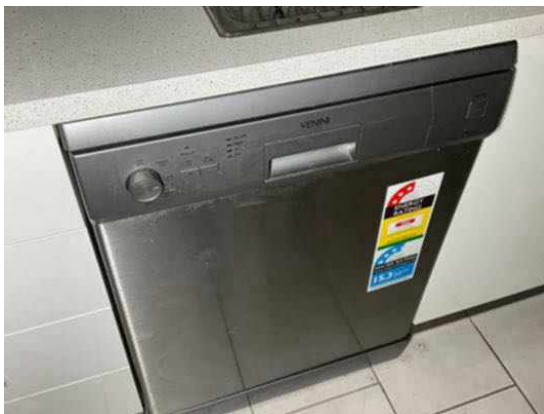
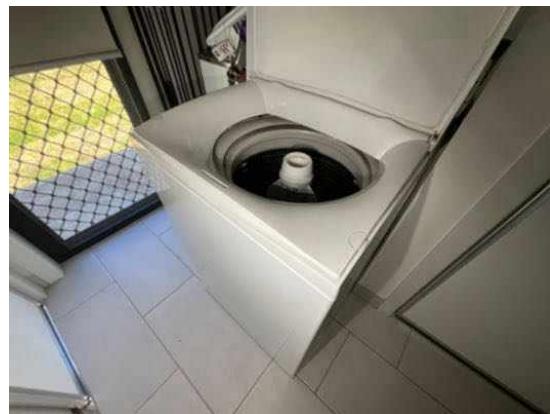
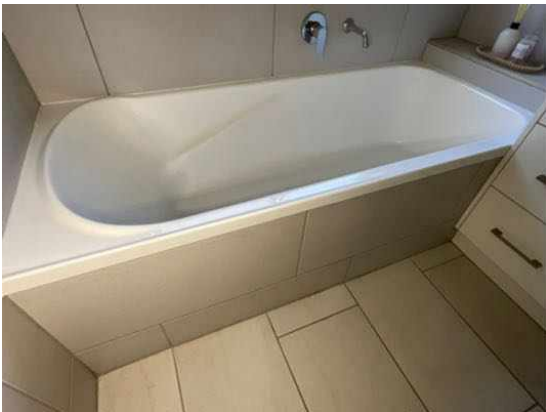
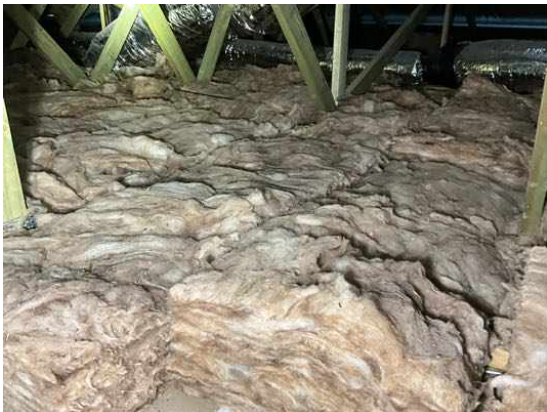
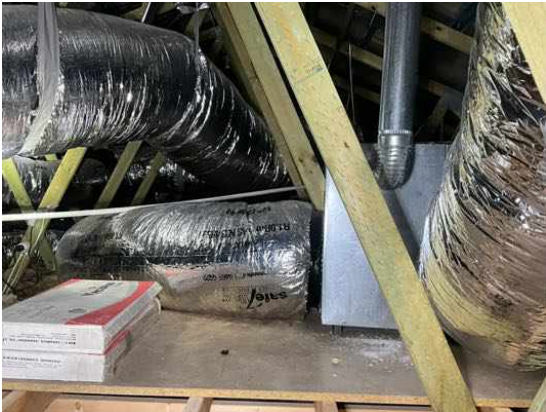
### Noted Item

Building: Building 1  
Location: All Areas  
Finding: Additional Photos - Obstructions and Limitations  
Information: These photographs are an indication of the obstructions and limitations which impeded full inspection of the property at the time of inspection. These obstructions can hide an array of defects and should be removed to allow full inspection to be carried out. A re-inspection is recommended once the areas are made accessible.
