Building Inspection Report

Inspection Date: Mon, 23 Feb 2026

Property Address: 18 Nisbett St, Reservoir VIC 3073, Australia

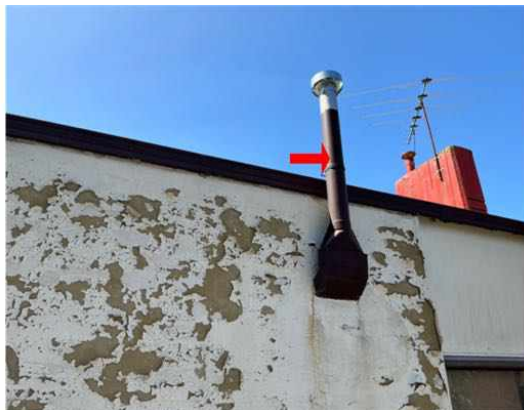
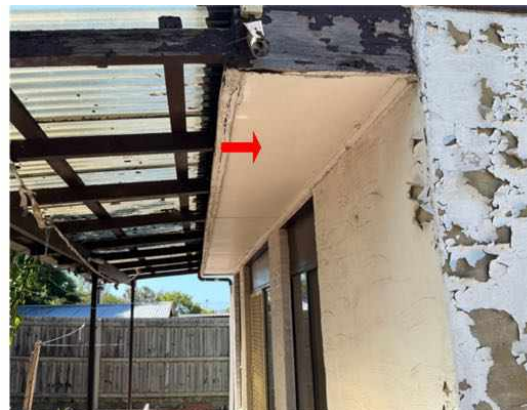
Defects 1.01

Building:	Main Building
Location:	Eaves and flu
Finding:	Asbestos - Suspected ACM Identified on Site
Information:	Reporting on Asbestos is outside the Scope of this Report. This suspected defect is highlighted as a caution only. We suspect, based on our experience in the building industry, that there is a higher risk of the identified building element containing asbestos.

As Asbestos Reporting is outside the scope of this report, we advise that you consider a separate Asbestos Inspection and Condition Audit, which can include the taking of samples for definitive confirmation of the presence of Asbestos.

In the interim, the client is advised to act with caution, especially when considering any damage to building materials general wear and tear renovations extensions demolition and general maintenance activities due to the suspected presence of Asbestos.

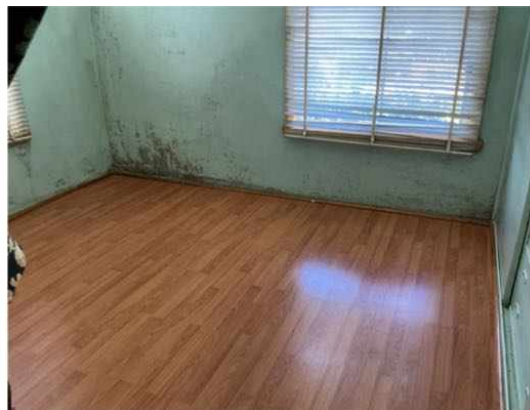
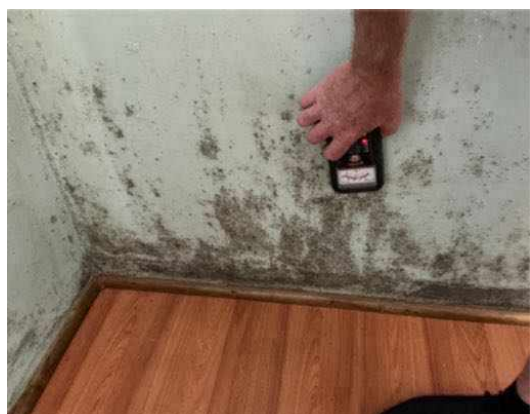
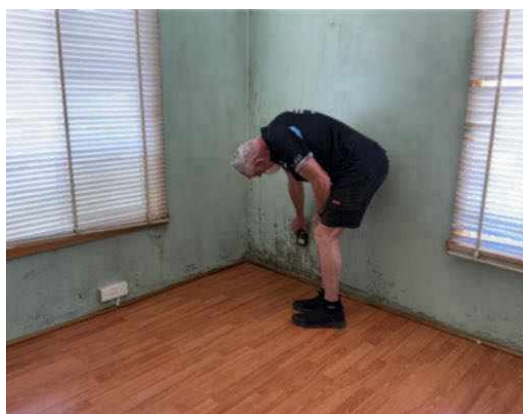
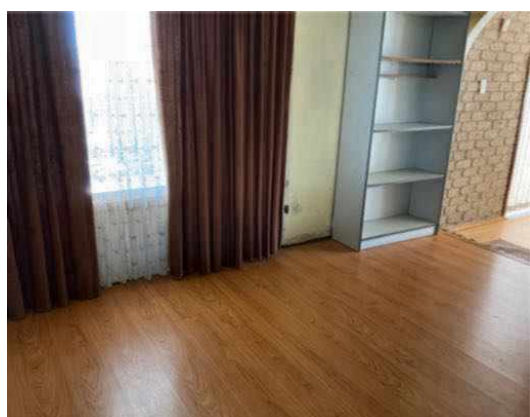
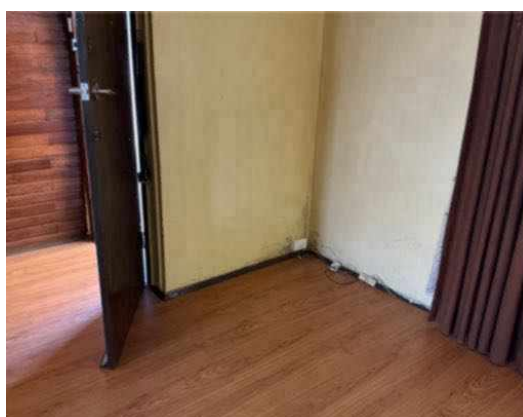
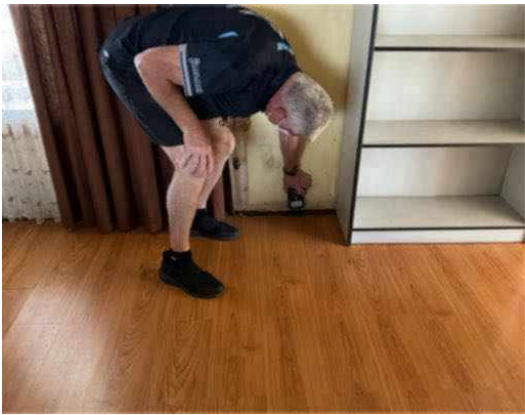
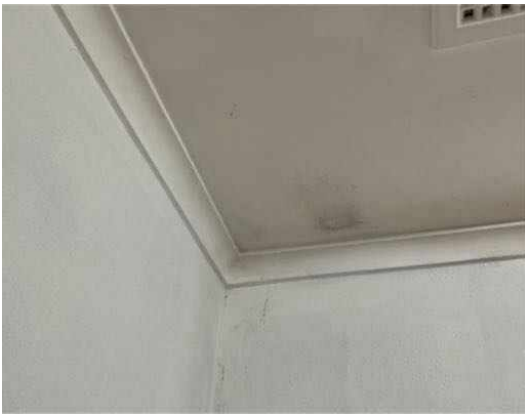
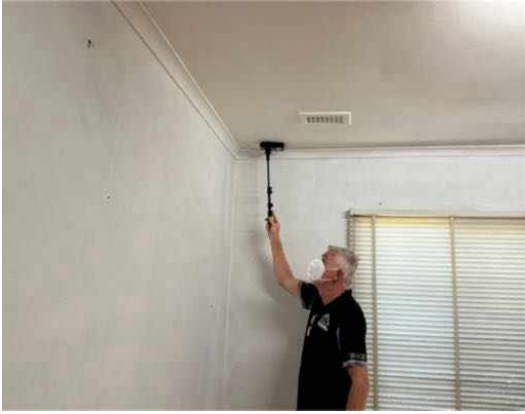
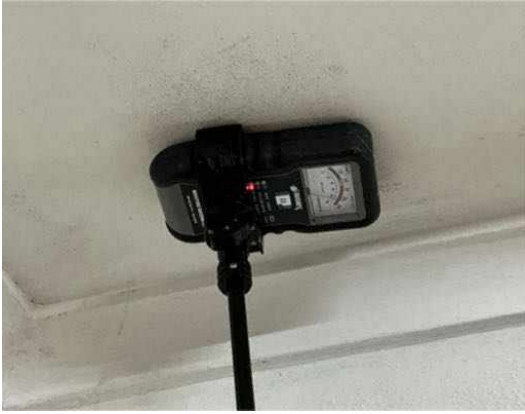
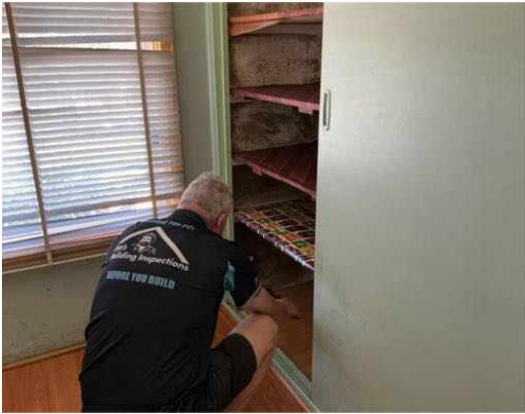
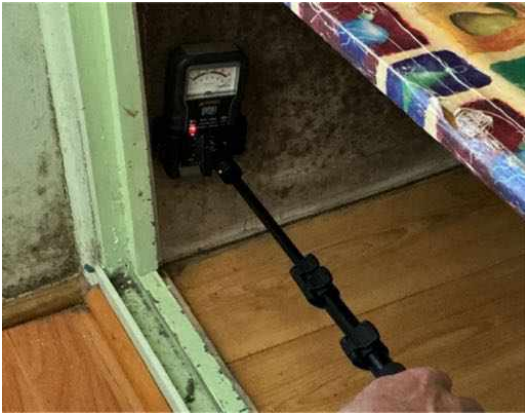
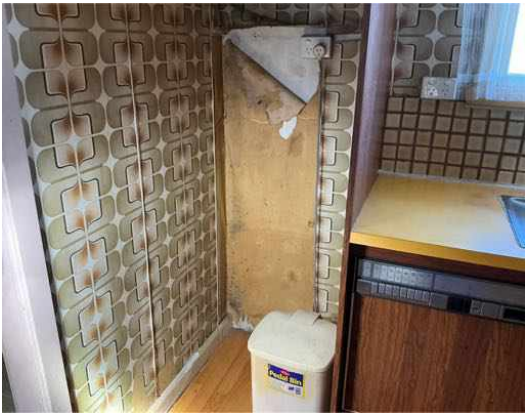
Defects 1.02

Building:	Main Building
Location:	All Areas
Finding:	Mould - Present
Information:	Where evidence of mould growth was noted, there may be environmental, biological or health issues associated with the report. A specialist inspection by a suitably qualified environmental health inspector is warranted, where mould is extensive or where any queries regarding air quality spores or other related issues apply.

Generally, the client is advised to ensure that the general environment is free of moisture and humidity to aid in the prevention of mould formation and development.

Any mould found during the inspection should be cleaned immediately by a cleaning contractor or the homeowner as applicable.

Please note that severely affected building elements may require replacement by a registered builder or qualified carpenter.

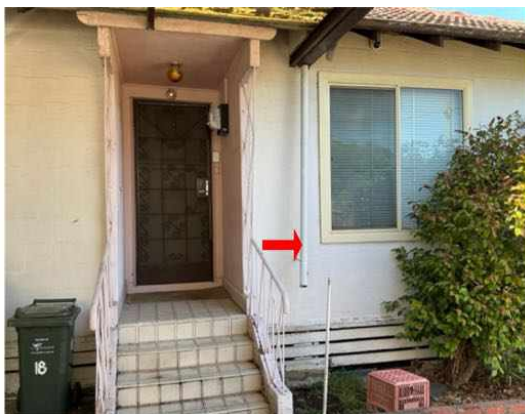
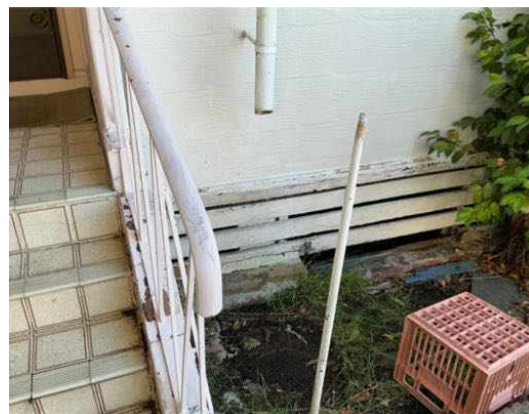
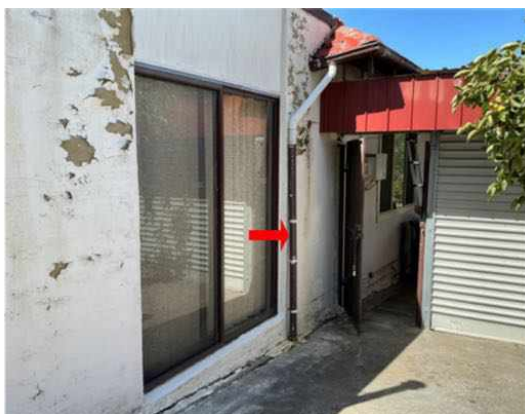
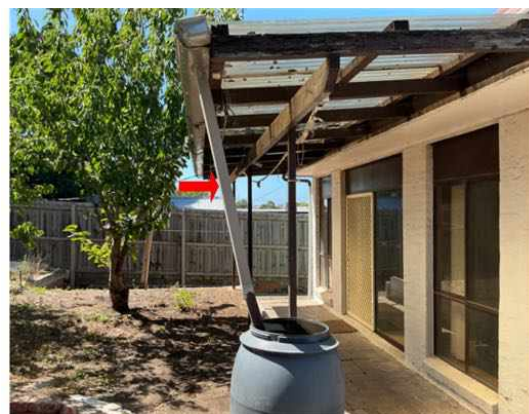
Defects 2.01

Where roof plumbing doesn't drain adequately, the area at the base perimeter can become excessively damp, potentially creating an environment that is susceptible to rust and corrosion of surrounding building elements, as well as attracting termites and other pests.

Roof plumbing needs to be upgraded as some Gutters are rusted and most downpipes were found to be disconnected, allow allowing water to dump at the base of the property.

It is highly recommended that a plumber be appointed to further inspect the area and to install adequate drainage equipment where necessary.

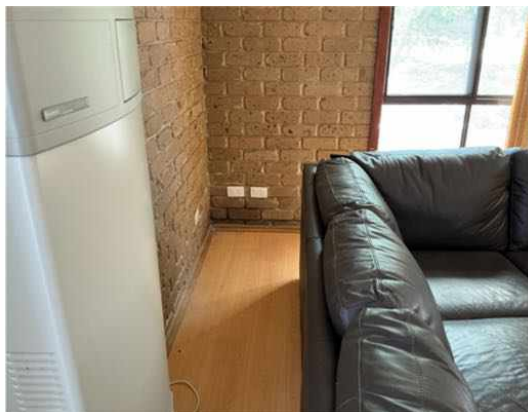
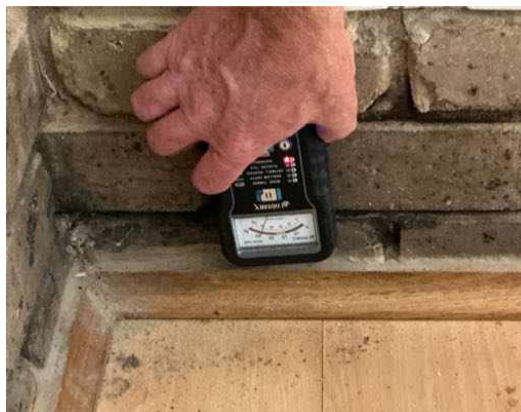
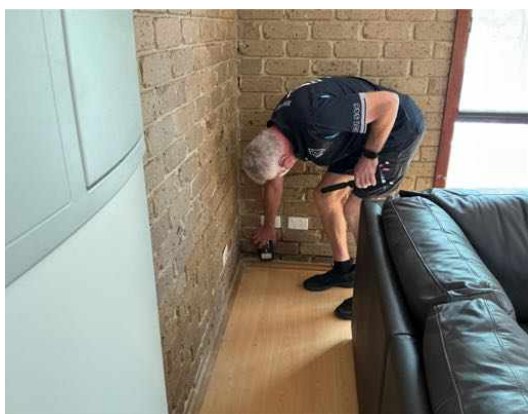
Defects 2.02

Building:	Main Building
Location:	Lounge Room
Finding:	Evidence of excessive moisture and mould was present at the time of inspection

Information: Excessive moisture can attract termites and produce conditions that promote termite attack, fungal growth and wood decay. Excessive moisture is generally caused by deteriorated, inadequate or missing roof drainage, leaking plumbing pipes or fixtures, poorly plumbed HWS overflows or condenser units and poor site drainage. It is highly recommended that all plumbing and drainage fixtures and fittings be maintained regularly in order to prevent excessive moisture being present in the external / internal property.

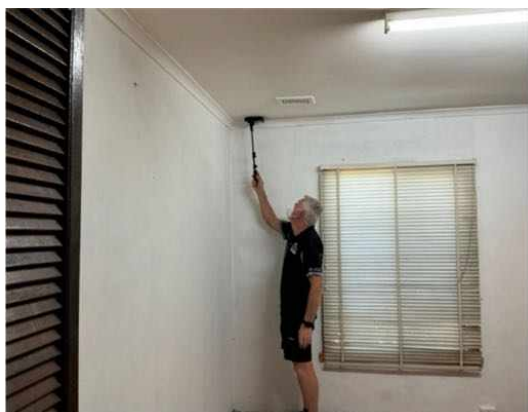
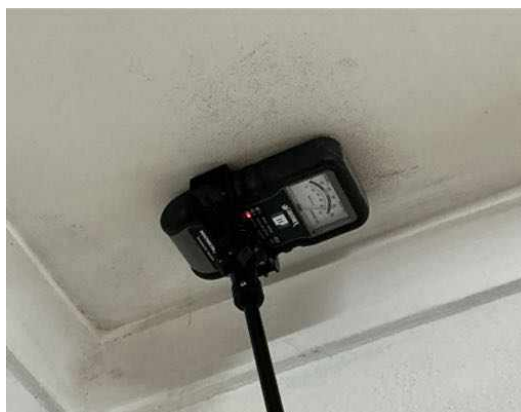
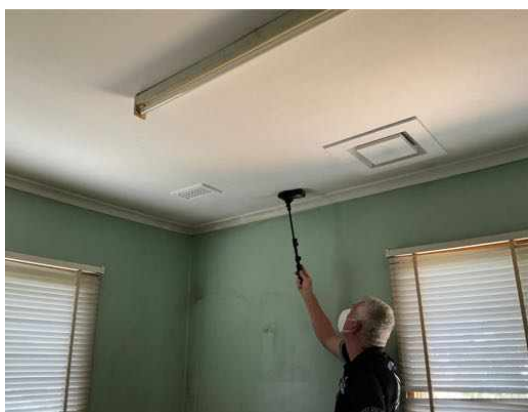
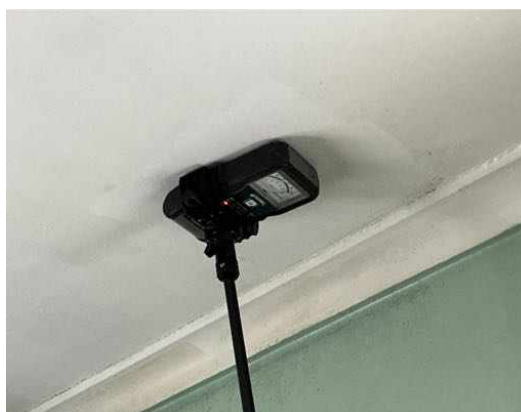
Defects 2.03

Building: Main Building
Location: Bedroom 2
Finding: Ceiling - Water stained
Information: Water staining to ceiling linings in this area was evident at the time of inspection. Water staining indicates that surfaces have been exposed to excessive moisture over time. The minerals and other elements in the water lead to staining, which may graduate to corrosion and deterioration if left unmanaged.

While mostly an appearance defect, water staining can be indicative of more serious defects, which may be currently concealed by interior ceilings.

Where water staining is active, a licensed plumber must be consulted to identify the cause of the staining and to provide advice on any reparation works that may be

required. Replacement of any damaged structures is advised.

Conversely, where water staining is old and inactive, affected building materials may be repaired or replaced at client discretion.

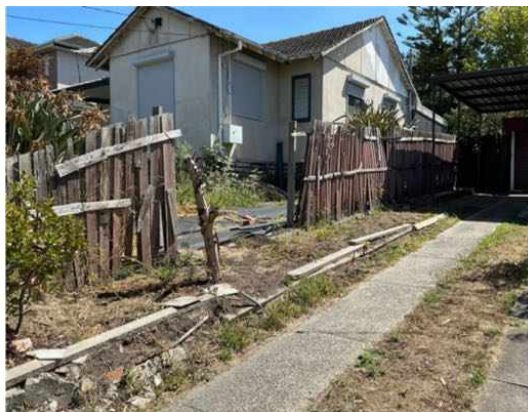
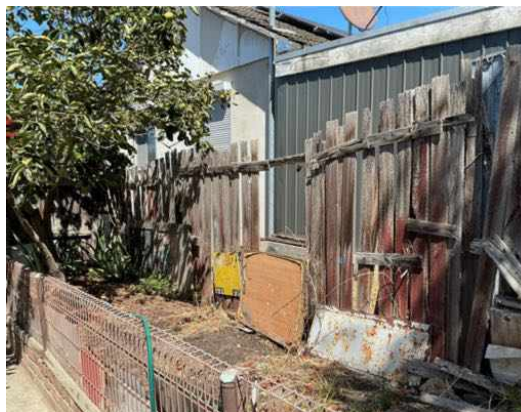
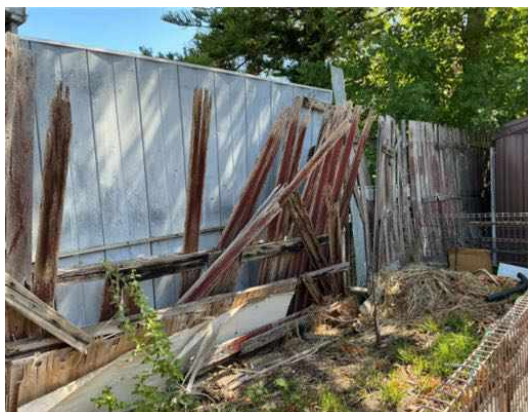
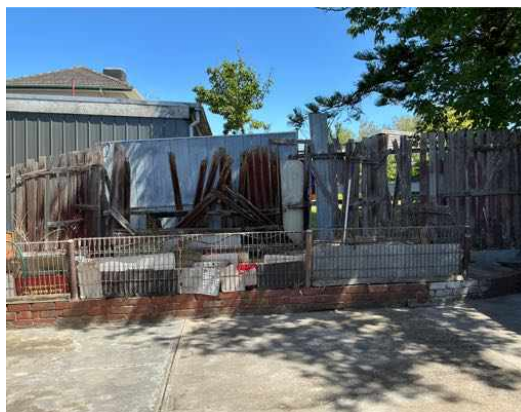
Defects 3.01

Finding: Fencing - Deteriorated

Information: It was noted at the time of inspection that sections of the fencing throughout the property have deteriorated. Typically fencing deteriorates due to age and or wear, rot and or rust which is generally expected for a structure of this age, due to prolonged exposure to weather conditions. Sometimes inadequate installation or maintenance can be to blame.

If left unattended, it is likely that further damage will occur. It is suspected that repair of several elements of the fencing may be required however replacement may be a consideration of the client also.

A licensed fencing contractor should be appointed to provide further advice and perform rectification works as necessary.

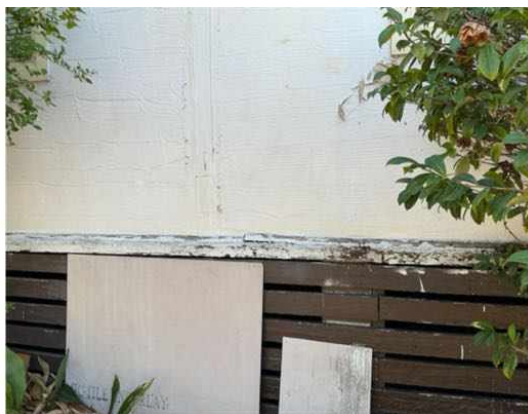
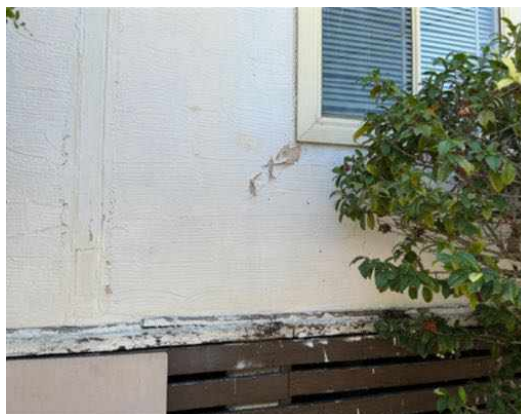
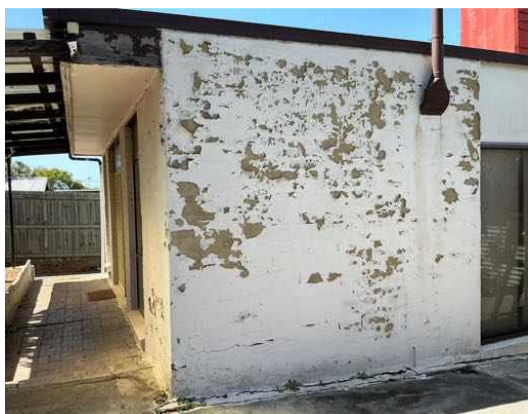
Defects 3.02

Building:	Main Building
Location:	All Areas
Finding:	External painting deteriorated
Information:	Much of the external paintwork including but not limited to windows, fascias, guttering, veranda and other external fitments have been neglected and require attention to prepare and re-paint.

Whilst incomplete or missing paint finish is generally an appearance defect, it can also lead to the development of secondary building defects over time. Incomplete areas of paint finish expose the area to moisture, potentially accelerating the deterioration of underlying building materials.

Degraded paint finishes should be sanded back, filled, leveled and painted, as applicable. Where inadequate or missing paint protection has led to the deterioration of the associated building element, repair and/or replacement of this building element may be required.

A painting contractor should be appointed as soon as possible to perform necessary works to aid the appearance of the affected area and to ensure the area is protected against further deterioration. Alternatively, the homeowner following manufacturer instructions may perform these works.

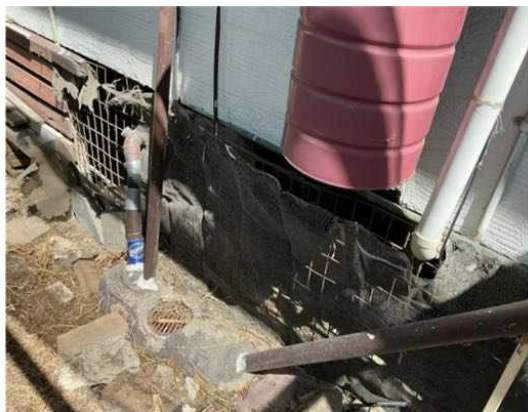
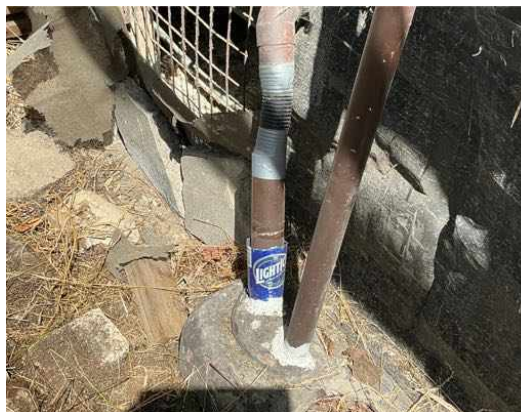
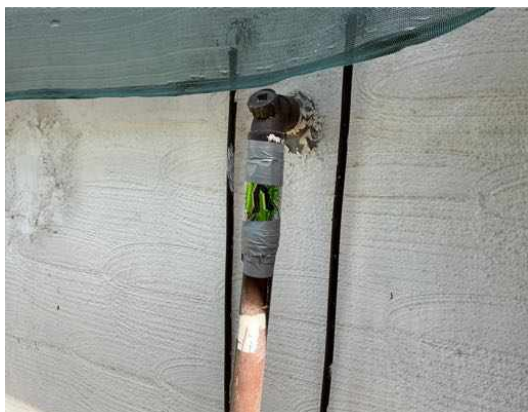
Defects 3.03

Building:	Main Building
Location:	Exterior walls - right side
Finding:	Unconventional handyman work
Information:	This handyman work appears to have been completed to a substandard level and does not comply with regular building practices. Where handyman work is not completed satisfactorily, accelerated deterioration of the associated building elements is likely to occur and secondary defects to surrounding structures may develop.

It is highly recommended that the substandard work be rectified by professional services. Works to improve this area are likely to increase the safety and the operation of the associated building elements.

The client should exercise care when coming into the immediate vicinity of the substandard works. Rectification works are advised as soon as possible by the appropriate trades.

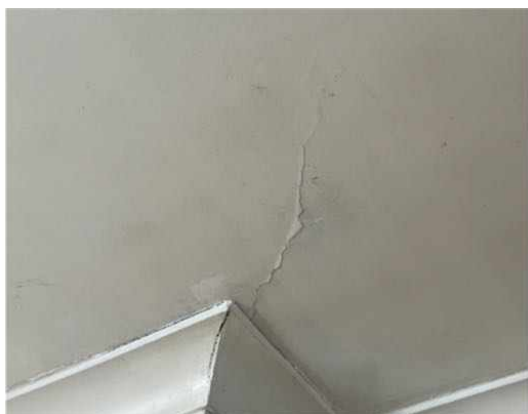
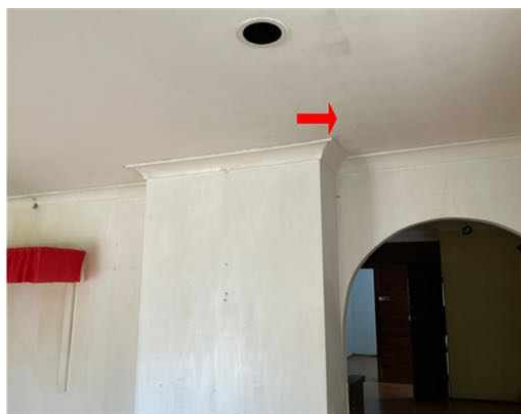
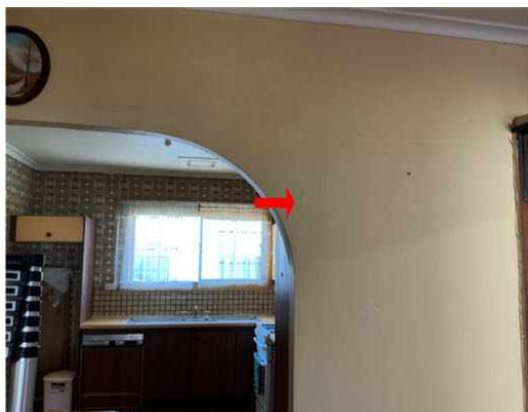
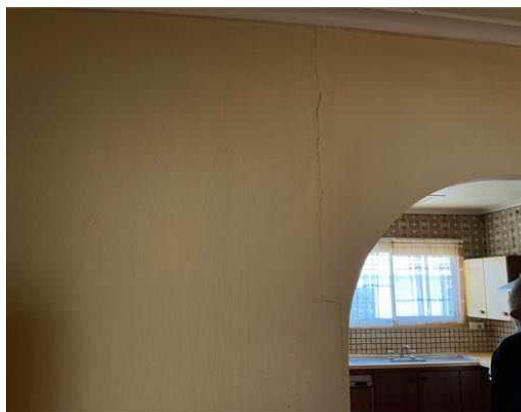
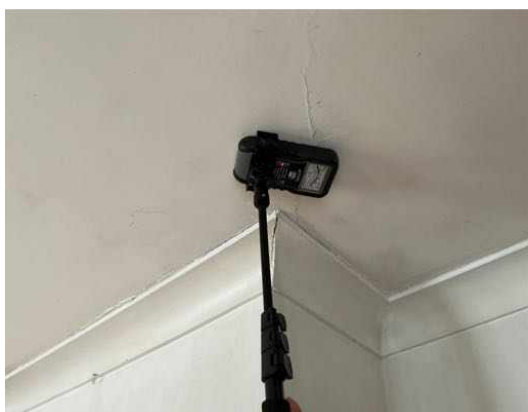
Defects 3.04

Building:	Main Building
Location:	All Areas
Finding:	Cracking - Damage Category 1 - Fine (up to 1mm)
Information:	Although fine cracks are quite noticeable, they are often only considered to be an appearance defect, and usually do not indicate any structural damage. Generally, the cause of a fine crack is indicative of a separation between building materials and finishes (e.g. paint, plaster, etc.) along joints.

Cracking of this nature can generally be repaired with minor sanding, filling and/or repainting. Such works should be performed by a qualified painter or a general handyman.

Monitoring of all cracking should be conducted frequently. Always contact a building inspector should cracks widen, lengthen, or become more numerous.

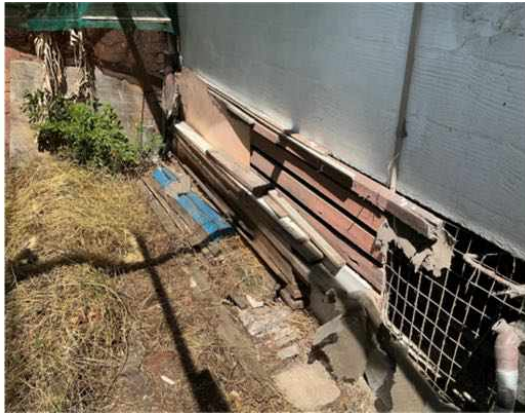
Defects 3.05

Building:	Main Building
Location:	Exterior walls - right side
Finding:	Stored timbers - subfloor space or external area
Information:	The storing of timbers in the subfloor space or around the external property increases the risk of termite activity being present. As they are likely to come into contact with weather conditions or excessive moisture wood rot is likely to develop on timbers that are not treated.

It is highly recommended that any stored timbers be immediately removed from areas in which they may attract any termite / timber pest attack. Minimisation of risk / prevention of termite attack is far more adequate than dealing with the presence of

termite activity.

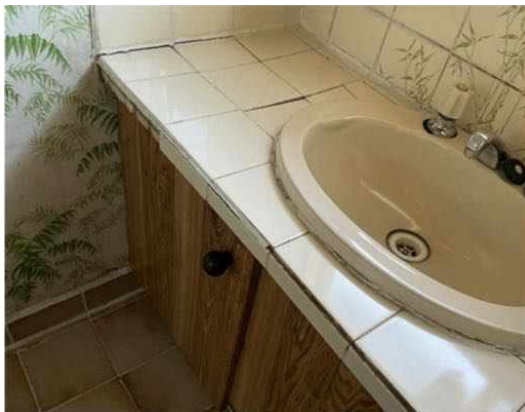
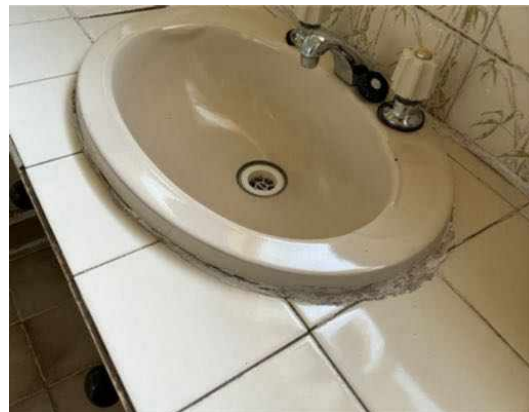
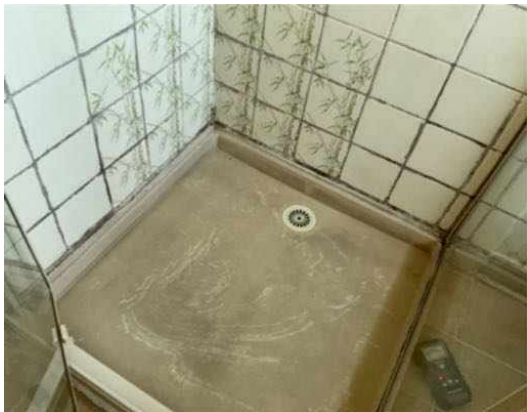
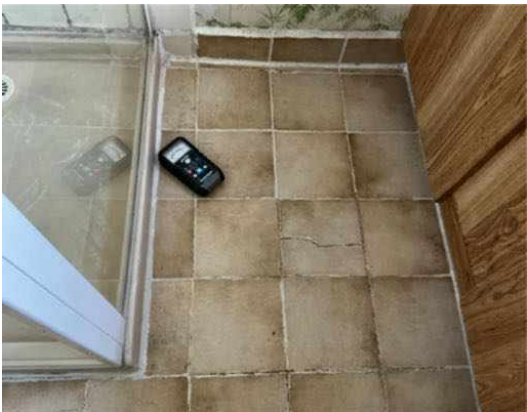
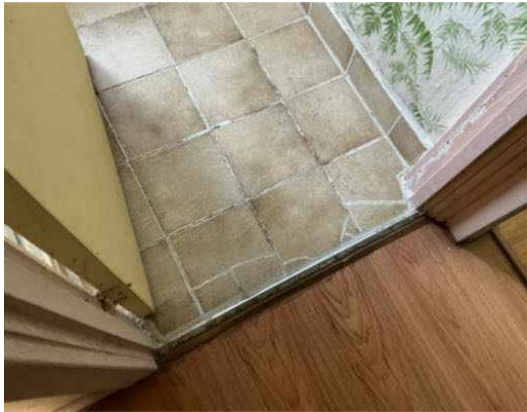
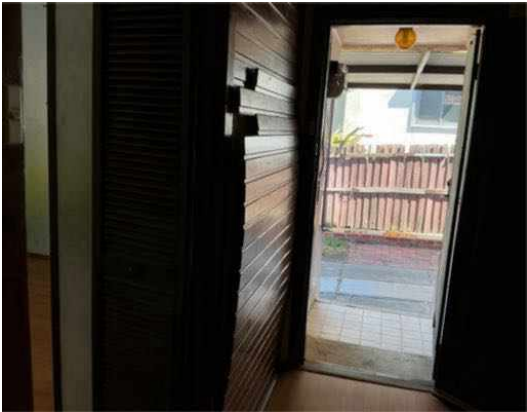
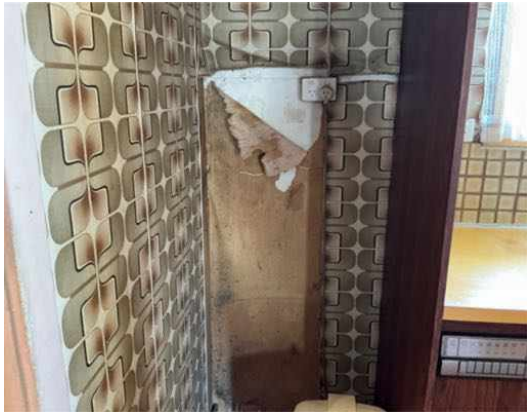
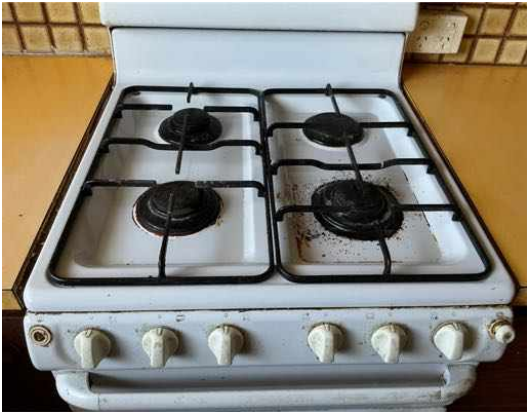
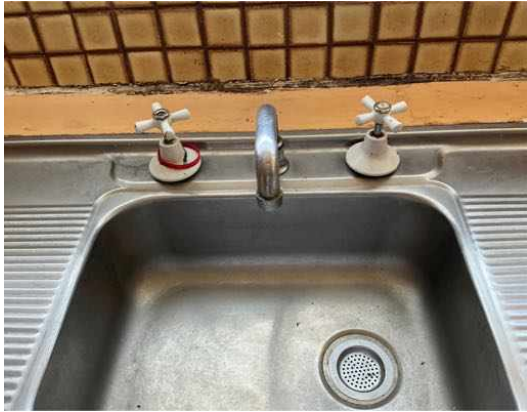
Defects 3.06

Finding: Deteriorated elements

Information: It was identified that some items around the home have suffered from environmental effects and wear and tear with replacement required.

Secondary defects are likely if the issue is not addressed.

Elements such as bolts and structural brackets may require the services of a builder where replacement is required other wise a carpenter or handy man can attend to the more general replacement requirements such as loose hinges, door handles, fixtures etc.

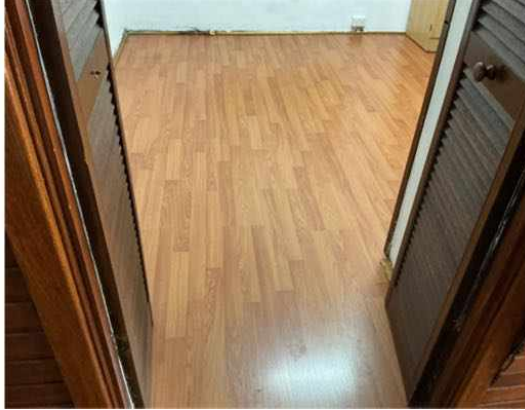
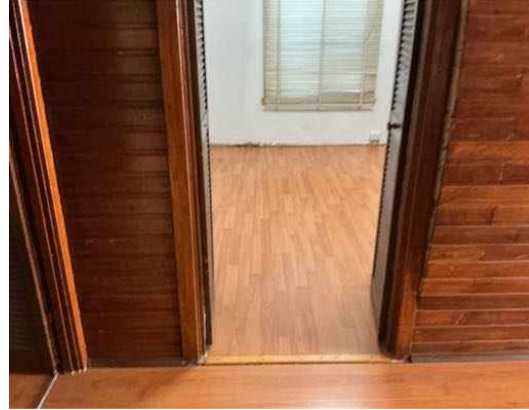
Defects 3.08

Bouncy floors generally indicate that the floorboards or the subfloor structures are coming loose from the joists that they are installed on. Bouncy flooring may also be the result of gaps between flooring and stumps or joist structures, which require packing.

The client is advised to seek quotations for required repairs from a Registered Builder specialising in re-stumping. The potential resolution may range from packing gaps in subfloor structures through to replacement of subfloors stumps and refixing of flooring.

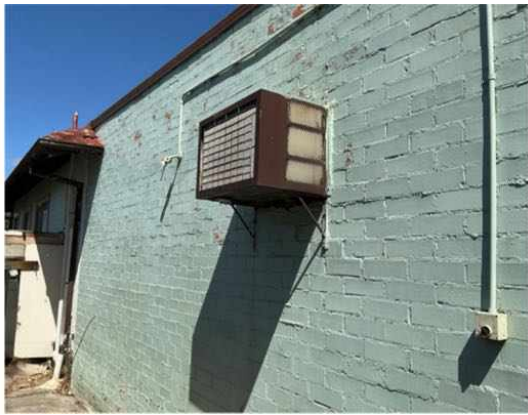
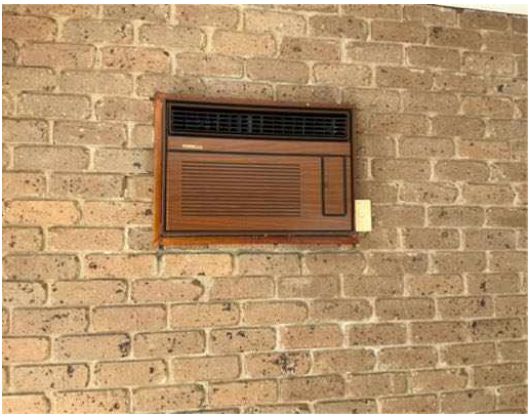
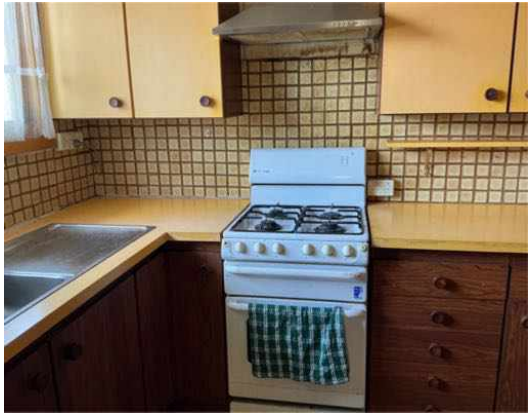
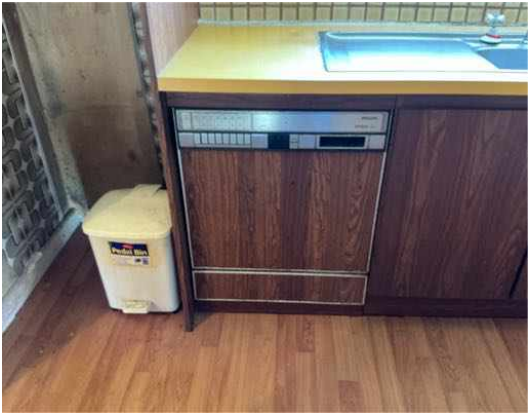
Building:	Main Building
Location:	All appliances
Finding:	Warranty - Expired
Information:	Where appliances are beyond their warranty period, the owner should be prepared to meet the cost of replacement or repair of the item at any time. The operation of the appliance can not be guaranteed and further inspection by an appropriately qualified tradesperson may be required.

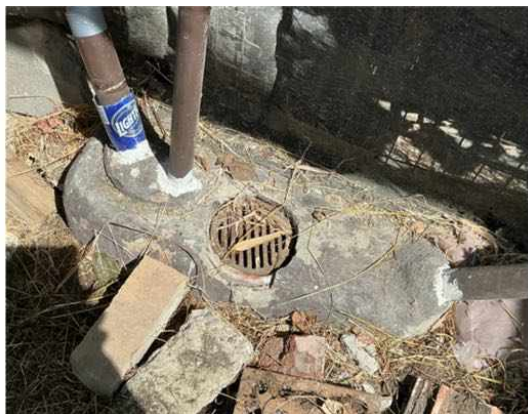
Building: Main Building
 Location: All Areas
 Finding: Terracotta pipes
 Information: Terracotta drainage pipes (sometimes referred to as clay or vitrified clay pipes) have been used for many many years. The use of clay drainage pipes dates back to the Romans, who used the clay pipe system as it was easy to manufacture, straightforward to lay and, for the most part, reliable. However, due to the rigid and brittle nature of clay or terracotta pipes problems can begin to occur over time. Even if they're functioning fine now, clay pipes will need replacing eventually.

The average lifespan of a clay pipe sewer system is 60 years — which means an upgrade is decades overdue for many homes. For your peace of mind you may wish to have your sewer pipes inspected and replaced before a major problem occurs

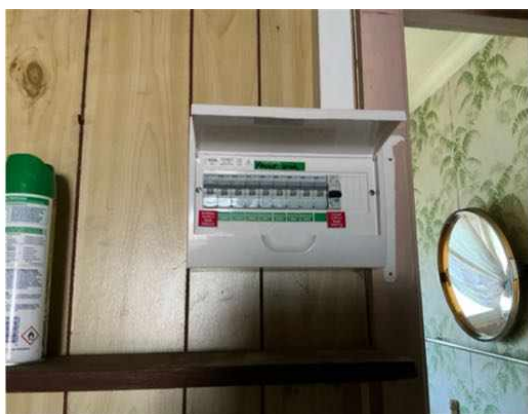
Building: Main Building
 Location: Electrical Switchboard
 Finding: For information only
 Information: No remedial works are required at the current time.

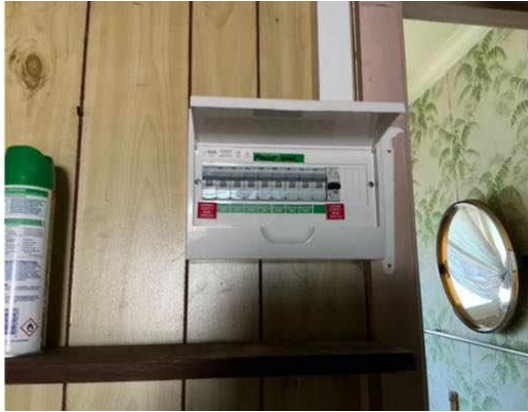
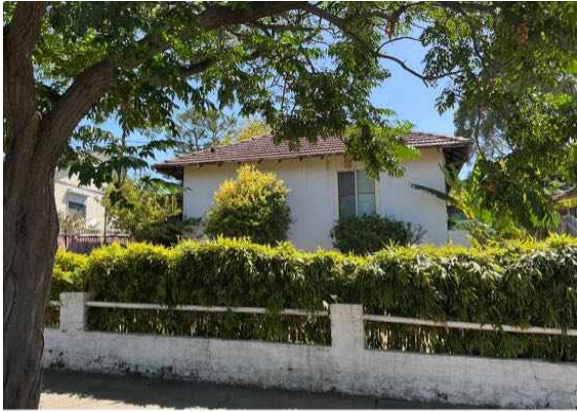
Building:	Main Building
Location:	All Areas
Finding:	Termite Management System - no evidence of a chemical installation
Information:	The application of a post-construction chemical termite barrier is highly recommended for all properties, particularly if live termite activity has been found on the site previously. Such barriers are highly effective in preventing termite attack on any timber building elements throughout the property.

A durable notice should be placed in the switchboard unit to indicate current termite barriers. At the time of inspection, it appeared as though no termite management system has been installed, with no evidence to suggest preventative works taking place.

The client may consider gaining further advice from a pest controller as to the costs and procedures involved with this application. It is recommended that obtaining such advice be a short-term priority.
