Building and Timber Pest Inspection Report

Inspection Date: Tue, 27 Jan 2026

Property Address: 29 Tarra Cres, Oak Flats NSW 2529,
Australia

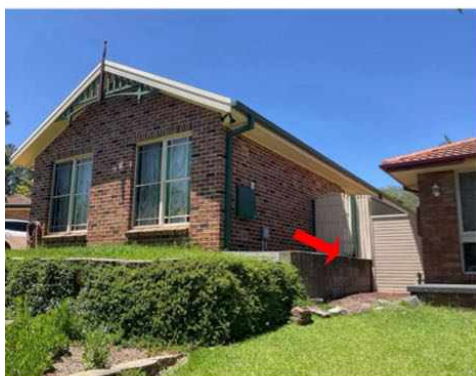
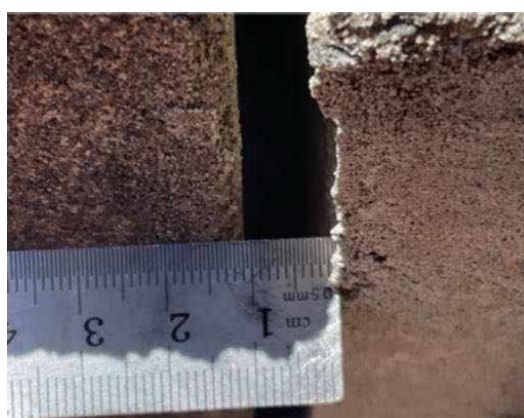
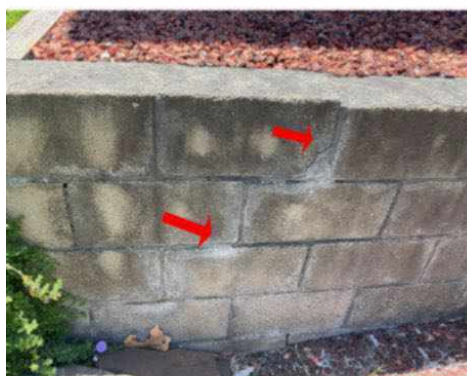
Finding 2.01

Location:	Exterior right front retaining wall
Finding:	Step cracking to wall - major (over 5mm)
Information:	Step cracking of up to 11mm was identified to the blockwork in the front right external wall area at the time of inspection.

The NSW Standards and Tolerances 2017 states cracks over 5mm in width are a major defect requiring rectification work. This applies to photo 2 and 3.

Step cracking, which is similar to other forms of cracking, has a variety of possible causes. However, the most common is the subsidence of adjacent footings.

Where step cracking is extensive or severe, the client is advised to consult a structural engineer. Minor step cracking can be used as a warning sign to address factors causing stress to the wall, which can include the effect of surrounding trees, water leaks, soil erosion, or even the presence of reactive soils in the surrounding area.

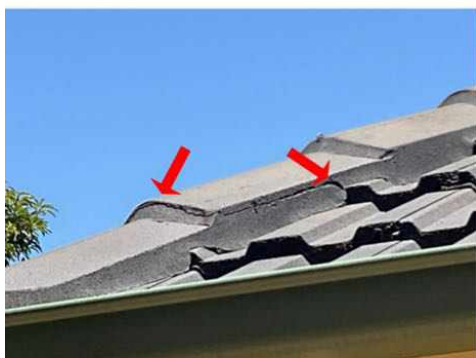
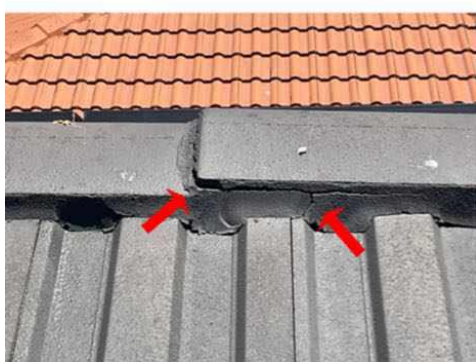
Building: Building 1
 Location: Roof Exterior
 Finding: Roof tiles - Weathered
 Information: Upon inspection of the exterior roofing, the majority of roof tiles were considered to be in a good condition. While weathering of the mortar is consistent with the age of the property, maintenance works are required.

Isolated areas of mortar have cracked and come loose. Re-pointing and re-sealing the may be considered as an interim solution by the client to help preserve and extend the life span of the tiles.

Where left unmanaged, deteriorating roof tiles are likely to lead to a number of secondary defects, including minor water leaks and weather exposure to internal roofing structures.

Consultation with a roofing contractor is highly advised to gain advice on cost of remedial works that may be required.

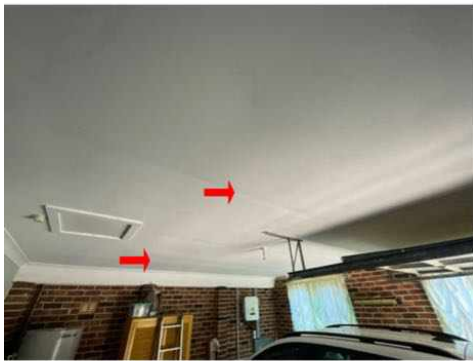
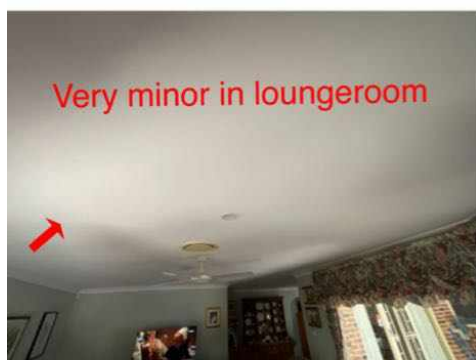
Finding 3.04

Building: Building 1
 Location: Garage, rear lounge room, ensuite shower
 Finding: Ceiling - Sagging

Information: Sections of some ceilings sagging and minor pulling of some ceiling nails (mainly in the garage) was found. Sagging to the fixed ceiling structure generally indicates that the building materials have swollen, due to contact with water, or that fixings (e.g. nails or glue) have become loose and require reattachment.

Where minor sagging is evident, comparatively minor works, such as re-gluing of ceiling sheets, may be required. Such works may be performed by relevant tradespeople, such as plasterers and painters. Where excessive moisture has caused the roofing structure to swell and sag, the source of the water leak should primarily be identified prior to any remedial works being performed.

The appropriate action should be taken by the client, mainly in the garage, to ensure that any potential further damage is limited. The other rear areas should be monitored annually for further movement. No moisture was found in any ceilings or wall areas.

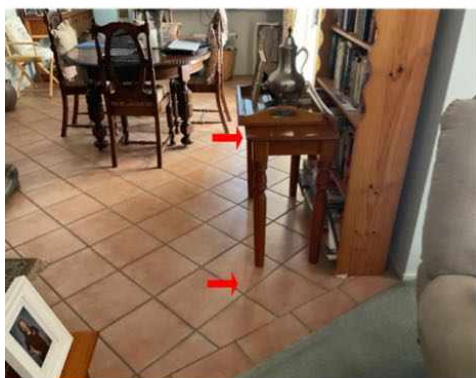
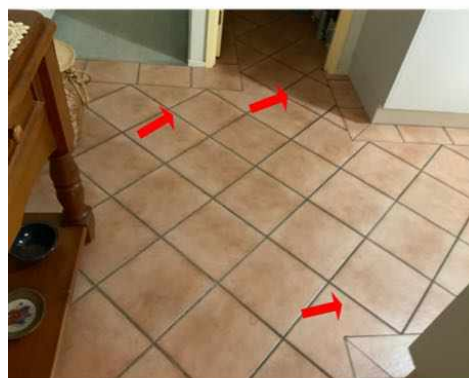
Finding 3.05

Building:	Building 1
Location:	Some tiled areas
Finding:	Tiles - Drummy
Information:	Drummy tiled areas were identified in many tiled areas at the time of inspection. The term 'drummy' refers to tiles that have become detached from their fixing, despite otherwise being in relatively good condition. Such defects are generally caused by physical or moisture damage to the area. Drummy tiled areas may also be a direct result of poor workmanship during the construction process.

Tiled areas may swell and shrink with changes in air humidity if the area has sustained moisture damage. Any exposure to moisture is capable of causing tiled areas to become drummy and/or cracked over a prolonged period of time. A tiling contractor can be appointed to perform works as necessary.

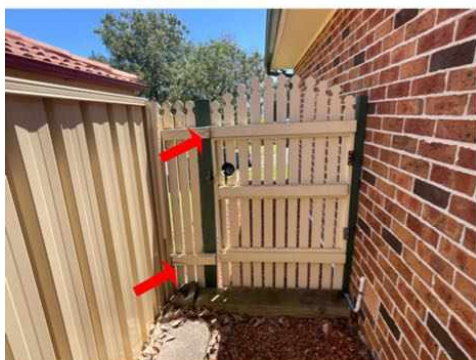
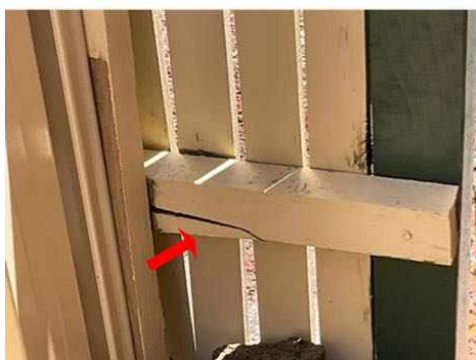
Finding 3.06

Building:	Building 1
Location:	Exterior right front wall
Finding:	Gate - Binding/ jamming/ damaged
Information:	Binding of this gate and minor fence splitting was found. The lock on this gate was also severely rusted. This gate binding inhibits the functionality of the affected gate

making it hard to operate. A gate that binds to the post or adjoining fence usually occurs as a result of minor movement of the post/fence or deteriorated hinges.

A qualified carpenter or general handyperson should be appointed to perform minor rectification works at client discretion.

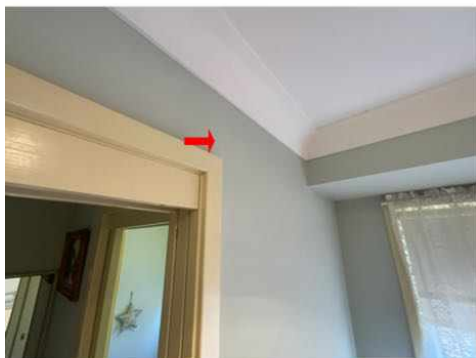
Building:	Building 1
Location:	Lounge Room, bathroom and other small areas
Finding:	Cracking - Damage Category 1 - Fine (up to 1mm)
Information:	Although fine cracks are quite noticeable, they are often only considered to be an appearance defect, and usually do not indicate any structural damage. Generally, the cause of a fine crack is indicative of a separation between building materials and finishes (e.g. paint, plaster, etc.) along joins.

Cracking of this nature can generally be repaired with minor sanding, filling and/or repainting. Such works should be performed by a qualified painter or a general handyman.

Monitoring of all cracking should be conducted frequently. Always contact a building inspector should cracks widen, lengthen, or become more numerous.

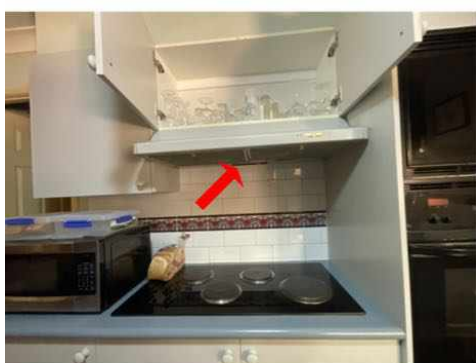
Finding 3.09

Building: Building 1
 Location: Kitchen
 Finding: Rangehood - Light not working
 Information: While the range hood appears to be working at a satisfactory level, the light to the appliance was not working at the time of inspection.

A licensed electrician should be appointed to replace the light on the range hood to restore it to a fully operational state.

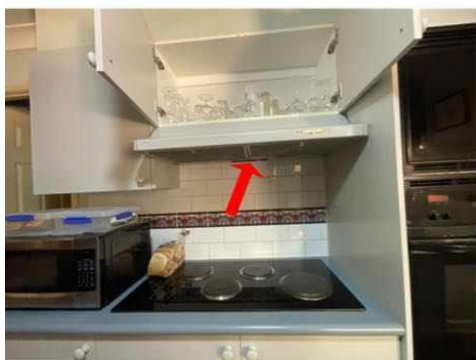
Building:	Building 1
Location:	Meter Box
Finding:	Termite Management System - no evidence of a chemical installation
Information:	The application of a post-construction chemical termite barrier is highly recommended for all properties. Such barriers are highly effective in preventing termite attack on any timber building elements throughout the property.

A durable notice should be placed in the switchboard unit to indicate current termite barriers. At the time of inspection, no durable notice was evident and it appeared as though no chemical termite management system has been installed, with no evidence to suggest preventative works taking place since the property was built.

The client may consider gaining further advice from a pest controller as to the costs and procedures involved with a 'chemical' application. It is recommended that obtaining such advice be a short-term priority.

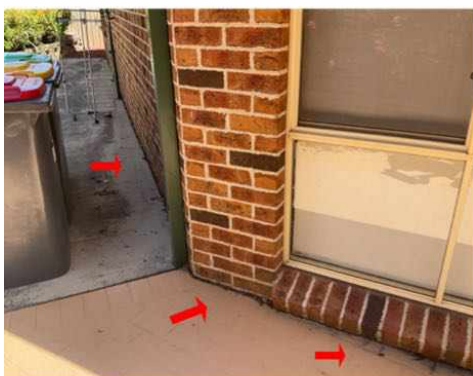
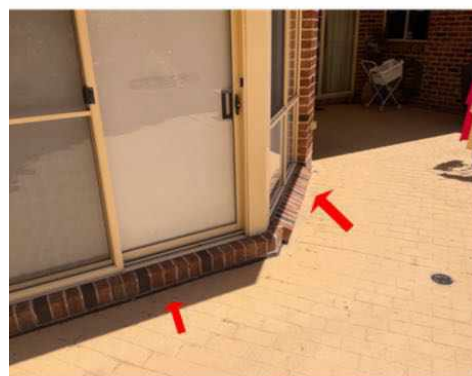
If the slab edge is not properly exposed there is a high risk of termite attack. Sometimes, in order to determine the type of slab, a suitably qualified person such as an architect or builder may be required to consult the construction plans.

Where the slab edge cannot be properly inspected, it is highly recommended that termite or timber pest inspections be carried out every 6-12 months to aid protection of the property against infestation.

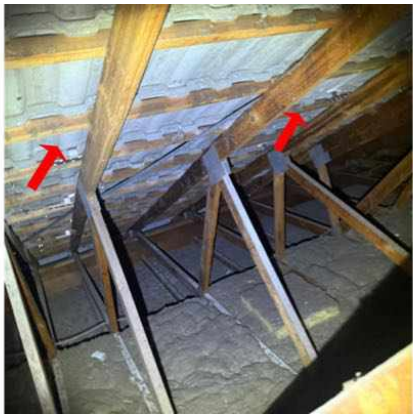
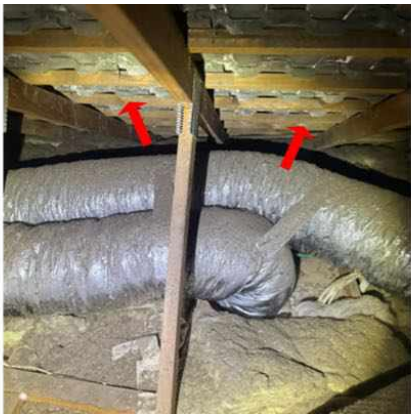
Building:	Building 1
Location:	Roof Cavity
Finding:	Sarking - Missing
Information:	Sarking is missing under the roof sheeting. Sarking acts as an insulator that helps with noise reduction and protects against water penetration. Sarking plays a key role in the operation and function of the overall roofing structure and its performance.

Although not a requirement at the time of construction, replacement of any missing building element is advisable (although this can be quite expensive to do after the time of construction). Where sarking is missing, regular inspections of the roof tiles for cracking and potential moisture penetration is required. Often when rain falls with wind blowing, rainwater can enter the roof void “uphill” through small gaps in tiles.

Sarking may be retrospectively fitted by a registered builder at the discretion of the client.
