Building and Timber Pest Inspection Report

Inspection Date: Tue, 17 Mar 2026

Property Address: 60 Moora Rd, Rushworth VIC 3612,
Australia

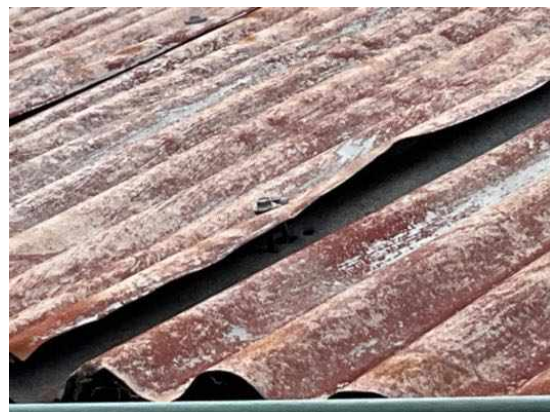
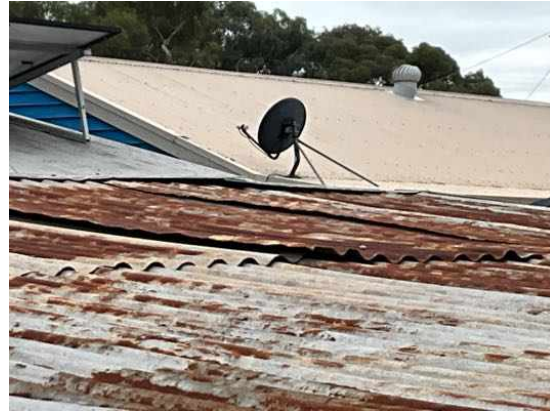
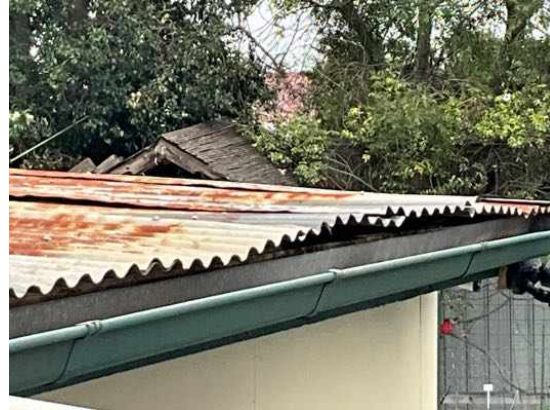
Building: Building 1
Location: Bedroom 2, shed
Finding: Roof sheets - Loose
Information: Upon inspection of the exterior roof covering, it was noted that numerous roof sheets have become loose from their original fixings. It is suspected that this defect has developed as a result of a lack of adequate maintenance, but may also have been caused by inappropriate fixings being used in the construction process.

Loose roof sheeting detracts from the weather tightness of the roof covering, making the internal roofing structure susceptible to water penetration and subsequent damage. If left unaddressed, it is likely that secondary damage to associated building elements will develop, potentially necessitating remedial works to these structures.

A roofing restoration contractor should be appointed to advise on rectification options and on the cost of repair. It is advised that remedial works be performed as soon as possible to prevent any further damage.

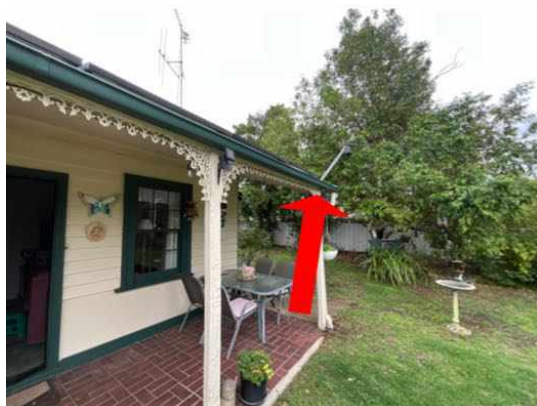
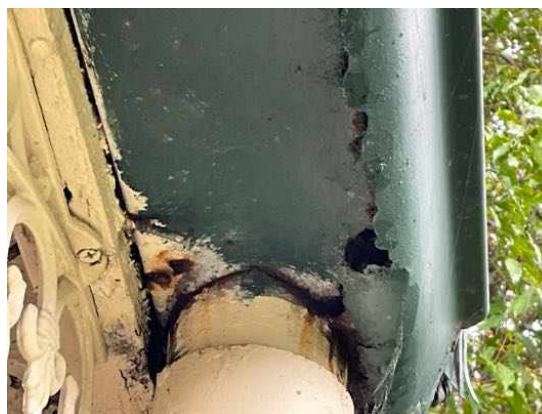
Finding 3.02

Building: Building 1
 Location: Eaves
 Finding: Gutters- Deteriorated
 Information: The guttering and some downpipes have deteriorated.

Although not a major problem now, they will deteriorate further if left for an extended period.

Sagging can be seen in the gutter.

A Licensed Plumber should be engaged as soon as possible to advise on any repairs or maintenance that may be required.

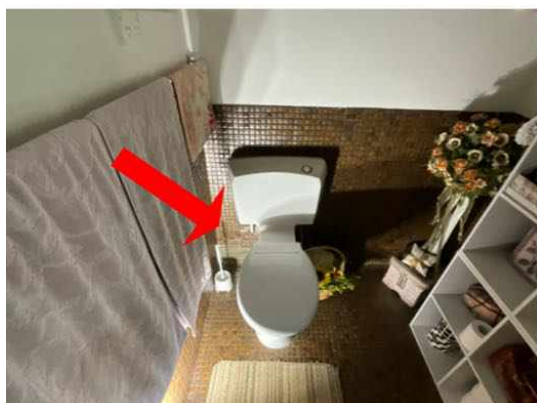
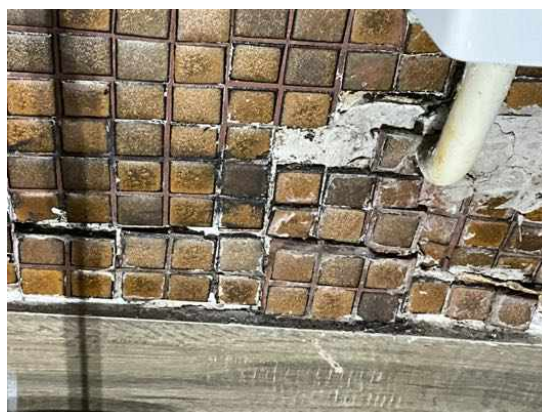
Finding 3.03

Building:	Building 1
Location:	Bathroom
Finding:	Tiles - Drummy
Information:	Drummy tiled areas were identified at the time of inspection. The term 'drummy' refers to tiles that have become detached from their fixing, despite otherwise being in relatively good condition. Such defects are generally caused by physical or moisture damage to the area. Drummy tiled areas may also be a direct result of poor workmanship during the construction process.

Tiled areas may swell and shrink with changes in air humidity if the area has sustained moisture damage. Any exposure to moisture is capable of causing tiled areas to become drummy and/or cracked over a prolonged period of time. Drummy tiled areas generally require removal and replacement of affected tiles, with adequate sealant and grouting.

Specialist trades are available for these types of services. A registered builder may be required to undertake works if damage is extensive or if secondary building defects have resulted. Otherwise, it is advised that a tiling contractor be appointed to perform works as necessary. Immediate action is recommended to ensure that no further damage is sustained in the affected area.

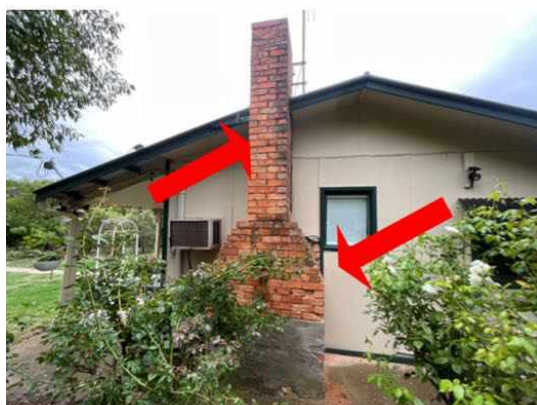
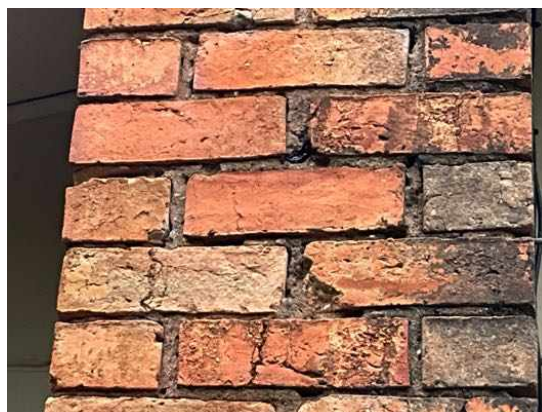
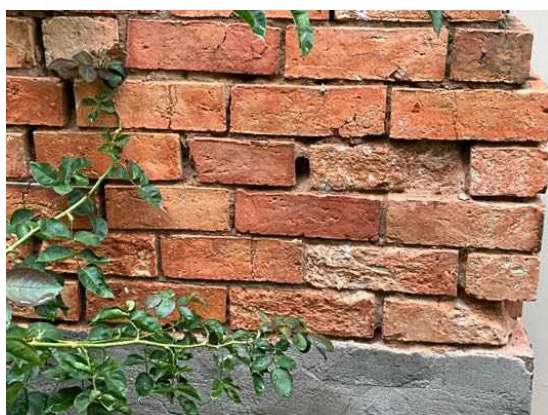
Finding 3.04

Building:	Building 1
Location:	Chimney
Finding:	Brickwork - Deteriorated mortar
Information:	Mortar, or 'bedding', is the material which fills joins and intersections between bricks in masonry walls and structures. Sections of mortar in this brickwork were identified as having deteriorated, which is generally expected for a property of this age and condition.

Mortar may deteriorate as a result of age of building materials, minor movement of bricks, or frequent exposure to weathering. Mortar should be replaced to ensure that bricks remain in their intended location and to prevent gaps, which would allow water or moisture ingress and secondary damage as a result.

Mortar deterioration can be addressed by a bricklayer where areas of deterioration are localised and easily accessible. Alternatively, appointment of a registered builder is advised, to repoint large areas of decaying mortar. Where secondary structural defects have become evident, consultation with a structural engineer may be required.

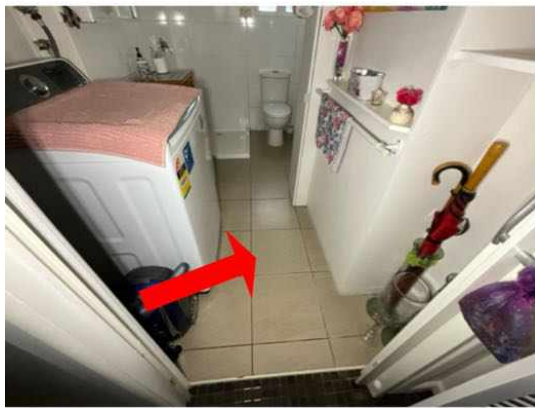
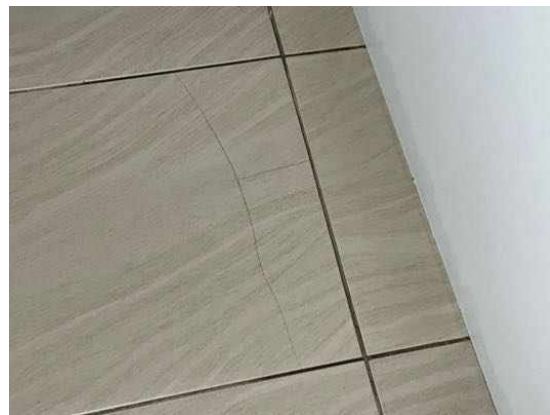
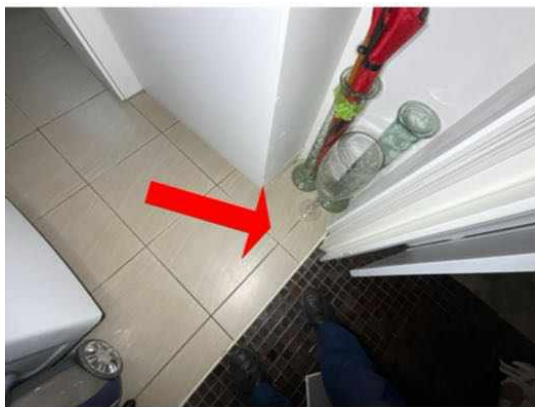
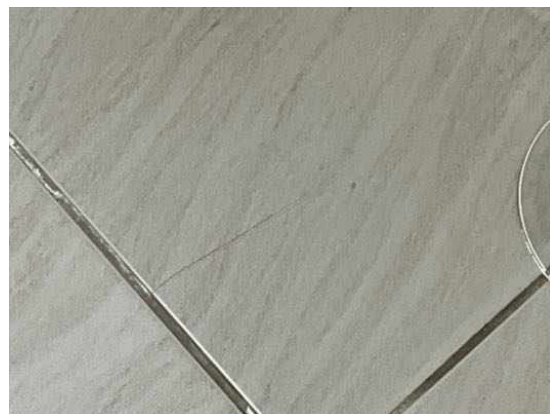
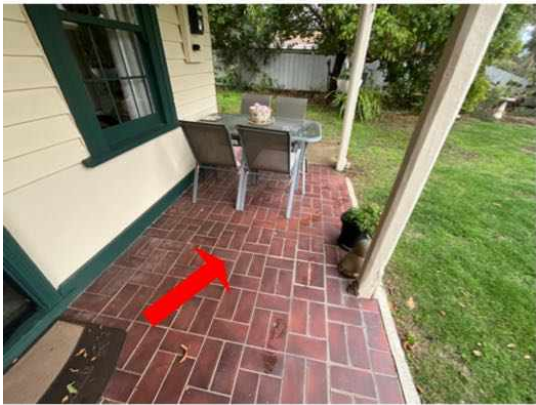
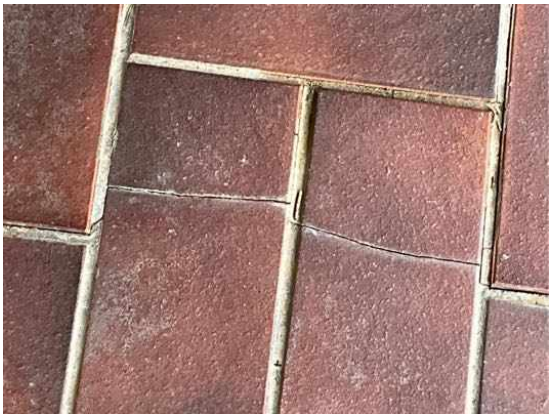
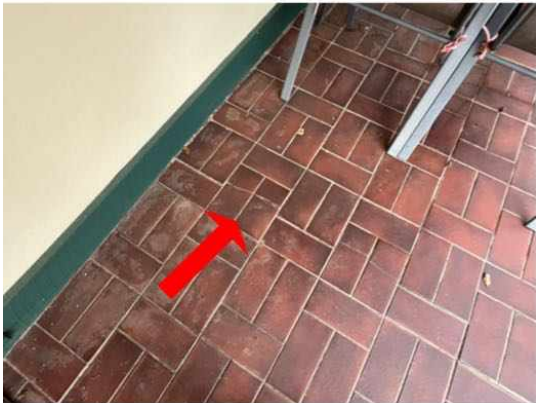
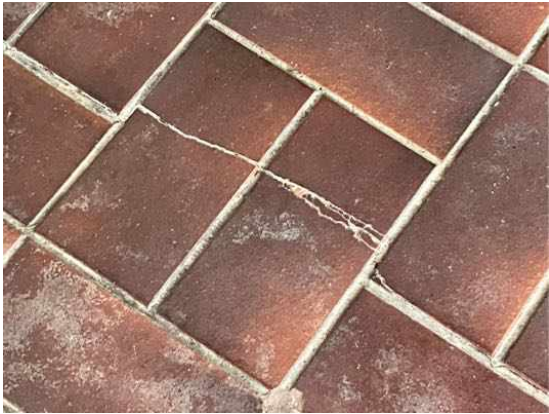
Finding 3.05

Location: Bathroom, verandah
Finding: Cracked floor tiles
Information: Cracking in the floor tiles was evident in this area at the time of inspection. It is suspected that this cracking has occurred as a result of minor settlement or impact damage.

Cracked tiles throughout the household detract from the overall appearance of the affected areas however it is unlikely to create or lead to any secondary defects.

While not considered a matter of urgency, replacement of cracked floor tiles is recommended at the clients discretion. A tiling contractor may be appointed to perform these works. Where cracks become more numerous, contact a licensed building inspector for further investigation.

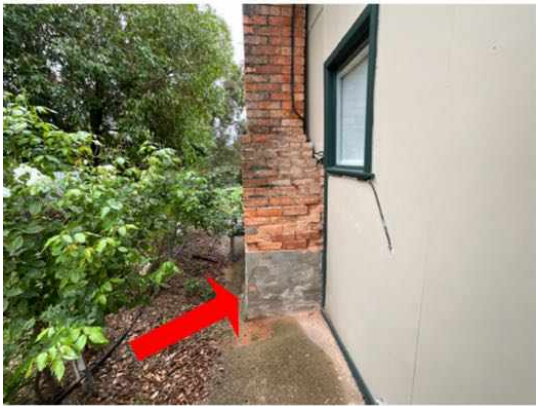
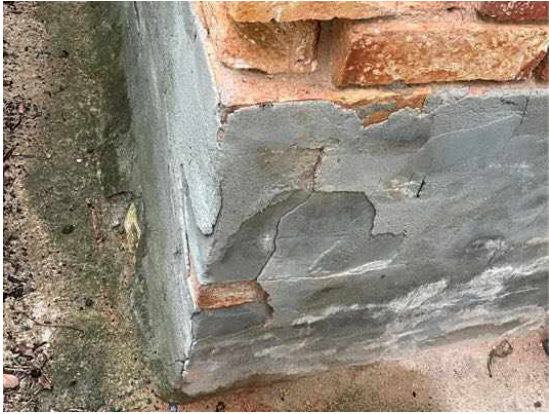
Finding 3.06

Building: Building 1
Location: Chimney
Finding: External Render- deterioration
Information: The external rendered surfaces show signs of deterioration. This can be seen in the sections of render cracking/flaking away from the substrate. This can be caused by initial poor quality installation work or excessive moisture over time.

A Renderer should be contacted soon to consult on the best method of restoration. Repairs will prevent further deterioration of the render and underlying structure.

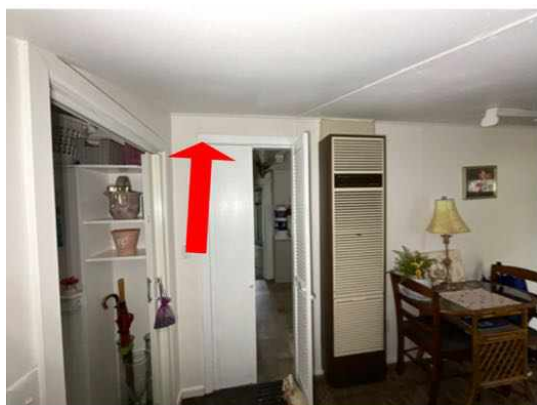
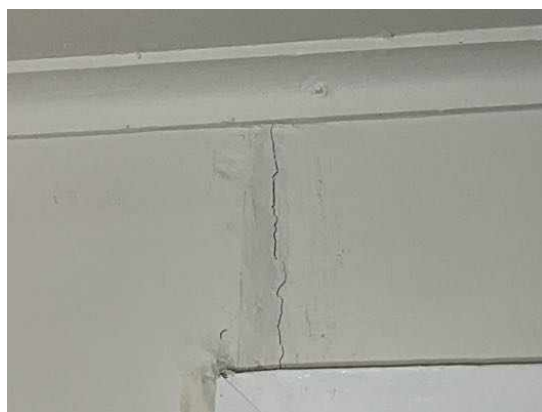
Finding 3.07

Building:	Building 1
Location:	Bathroom area
Finding:	Cracking - Damage Category 1 - Fine (up to 1mm)
Information:	Although fine cracks are quite noticeable, they are often only considered to be an appearance defect, and usually do not indicate any structural damage. Generally, the cause of a fine crack is indicative of a separation between building materials and finishes (e.g. paint, plaster, etc.) along joins.

Cracking of this nature can generally be repaired with minor sanding, filling and/or repainting. Such works should be performed by a qualified painter or a general handyman.

Monitoring of all cracking should be conducted frequently. Always contact a building inspector should cracks widen, lengthen, or become more numerous.

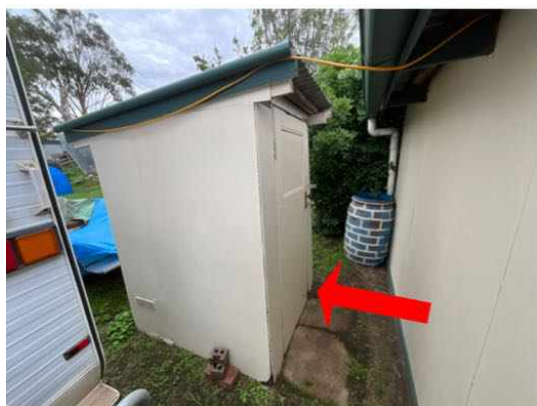
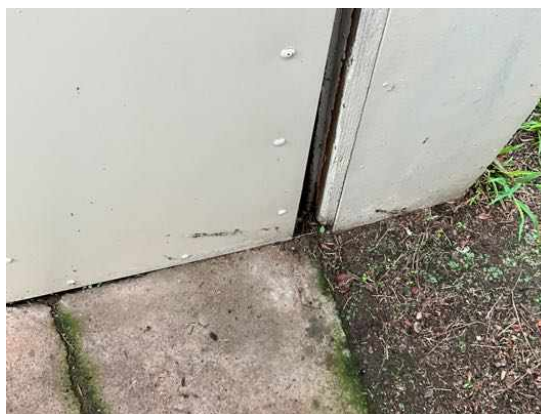
Finding 3.08

Building:	Building 1
Location:	Toilet (WC) - 2
Finding:	Door- Binding/jamming
Information:	Binding and/or jamming of this door is evident during standard operation. This defect inhibits the functionality of the affected door as well as creating potential for secondary defects to associated building elements, such as damage to the floor covering.

A door that binds to flooring or to the associated door frame may have several causes, ranging from minor defects, such as poor installation of the door or deteriorated hinges, through to major structural issues, such as damage to subfloor structures.

A qualified carpenter or general handyperson should be appointed to perform minor rectification works at client discretion.

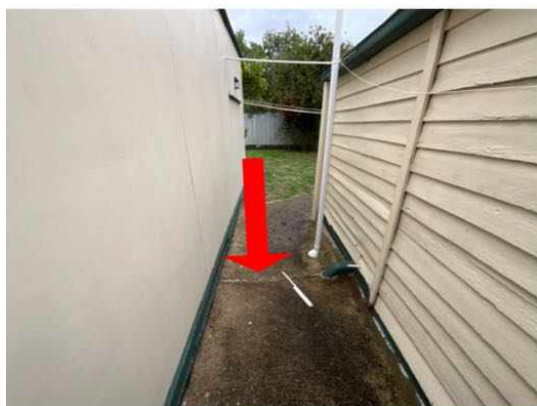
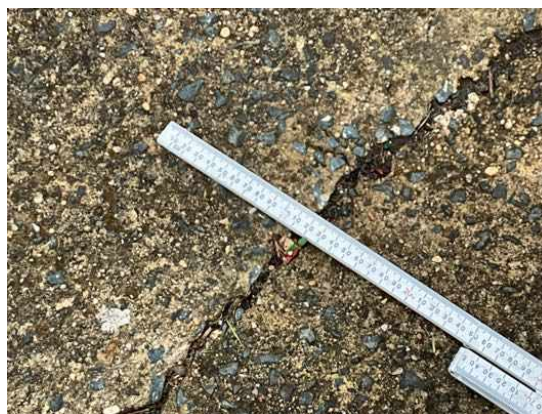
Finding 3.09

Building:	Building 1
Location:	Yard - Back
Finding:	Cracking - External Concrete Paving Damage Category 3 - Wide Cracks (2mm - 4mm)
Information:	Wide cracks were identified in external concrete paving. Wide cracks are significant and are likely to lead to the development of safety hazards and secondary defects if left unmanaged.

General age and expected deterioration of the paved areas is a common cause of this type of cracking. However, expansion and contraction of the slab may also have occurred due to environmental factors. Such factors include variable moisture and weather conditions, the presence of trees and their roots having a settling or lifting effect on the soil, or the effect of load bearing, e.g. heavy vehicles over a sustained period of time.

Cracking to this degree may also be due to poor original installation of the concrete. Factors such as poor compaction of the sub surface and/or inadequate reinforcing of the slab may create cracking and other secondary defects. Wide cracks may also have a more significant structural cause, such as subsidence of soils.

Where the crack is located adjacent to structural elements of the building, the advice of a Structural Engineer is advisable before undertaking repairs. Significant repair and likely replacement of the concrete paving is probable.

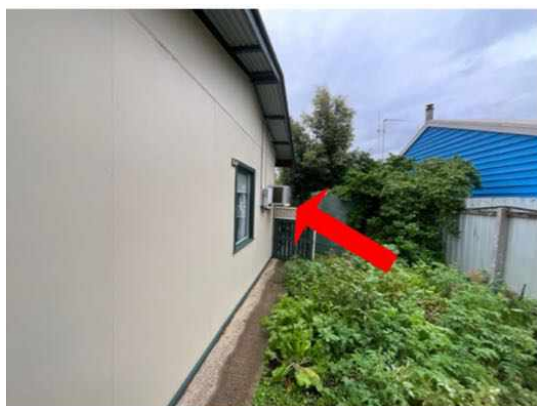
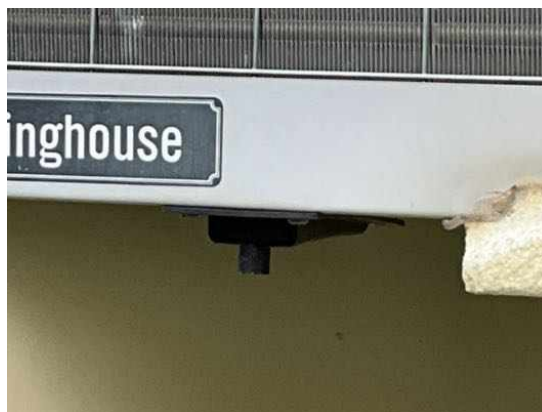
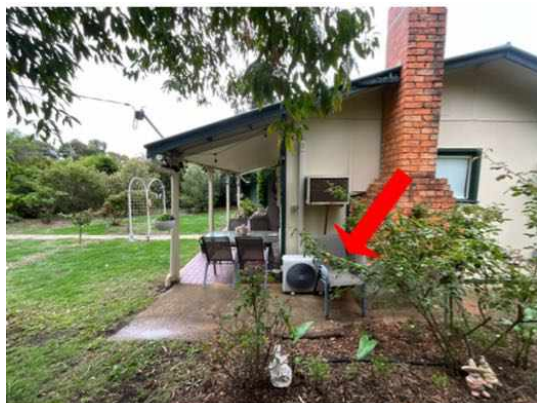
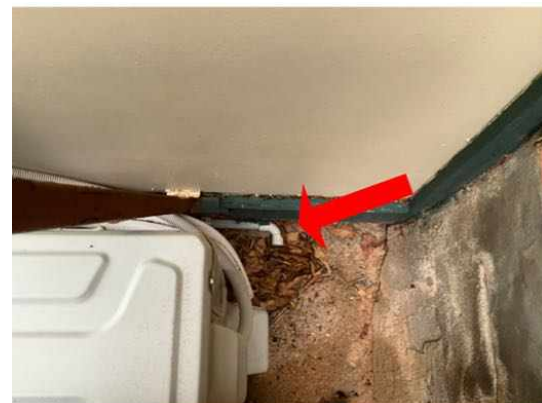
Building:	Building 1
Location:	Yard - Back, side
Finding:	Air conditioner - Disconnected overflow
Information:	The Air Conditioner (A/C) overflow was found to be disconnected from storm water drainage and is creating excessive moisture in the surrounding area.

Such leaking creates an environment which is conducive to an array of defects, including water damage to associated building elements and the attraction of termite or timber pest infestation.

It is highly recommended that a licensed plumber be appointed to connect the A/C overflow in order to prevent such an environment from being created. These minor works should be carried out as soon as possible.

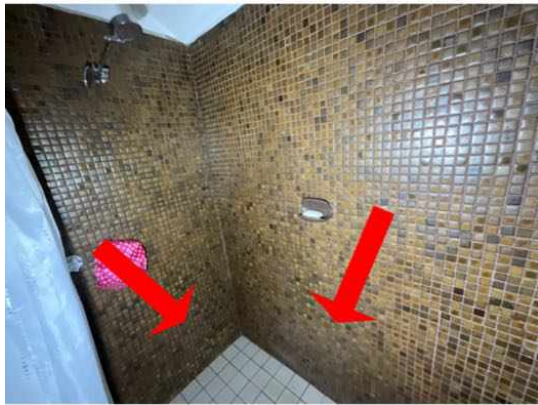
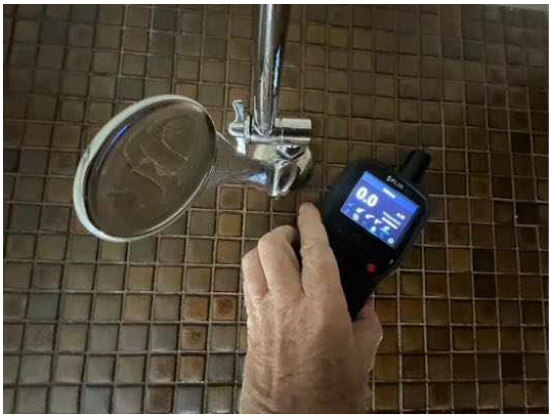
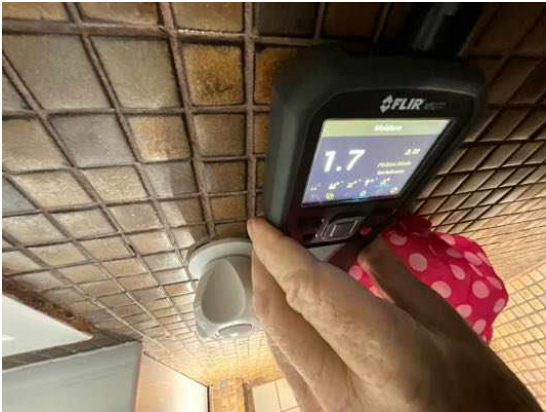
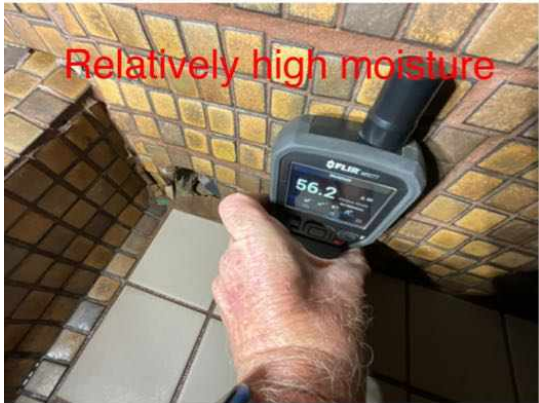
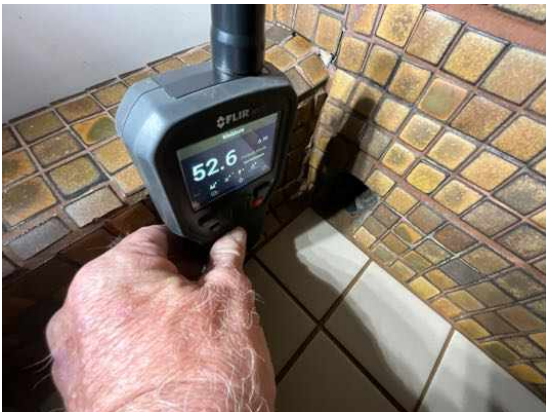
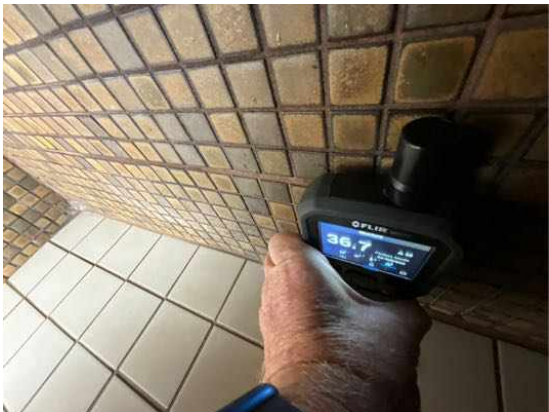
Finding 6.02

Building:	Building 1
Location:	Bathroom
Finding:	Shower damp- Monitor
Information:	Damp is evident to the lower 400mm of wall to the shower alcove.

This defect is quite common, and is suspected to have been caused by moisture permeating or leaching through the grouting and perhaps gaps in the sealant prior to repair.

Monitoring the area is advised and if any visual signs of excessive moisture appear (peeling paint, mould) then consultation with a qualified plumber or bathroom specialist would be advised to identify the cause of damp and to perform remedial works as required.

Always ensure that sealant and grout is in good condition to prevent any moisture issues occurring in the future.

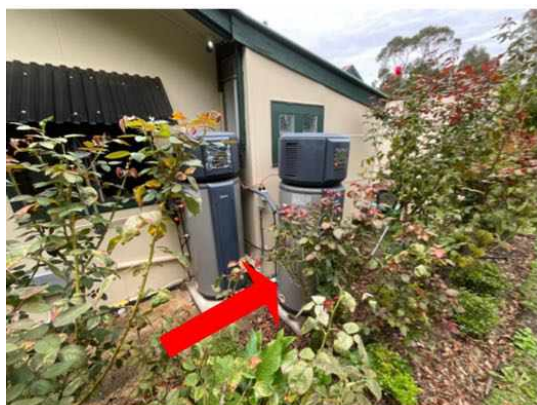
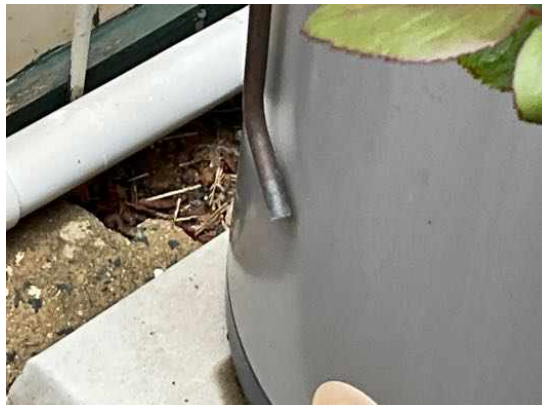
Finding 6.03

Building: Building 1
 Location: Yard - Side
 Finding: HWS Overflow - Not Connected
 Information: The Hot Water System (HWS) overflow was found to be disconnected from storm water drainage and is creating excessive moisture in the surrounding area.

These damp conditions can lead to secondary defects such as rot, rust or corrosion of associated building elements, the formation of fungal decay, or even the creation of potential slip hazards. When coupled with poor site drainage, pooling of water may also attract termite activity to this area.

It is highly recommended that a licensed plumber be appointed to connect the HWS overflow in order to prevent such an environment from being created. These minor works should be carried out as soon as possible.

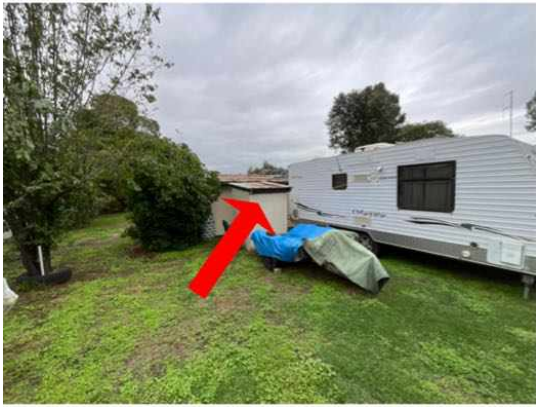
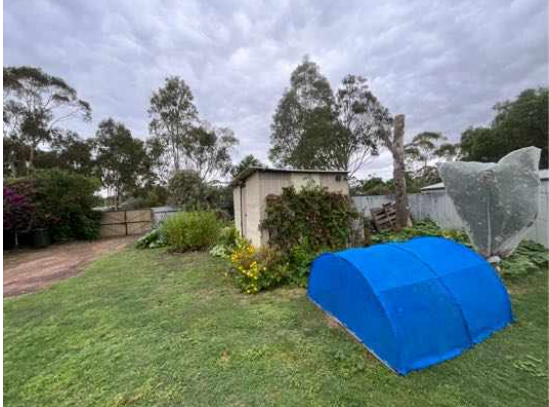
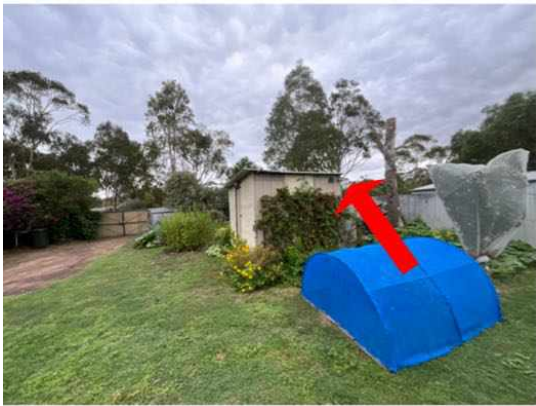
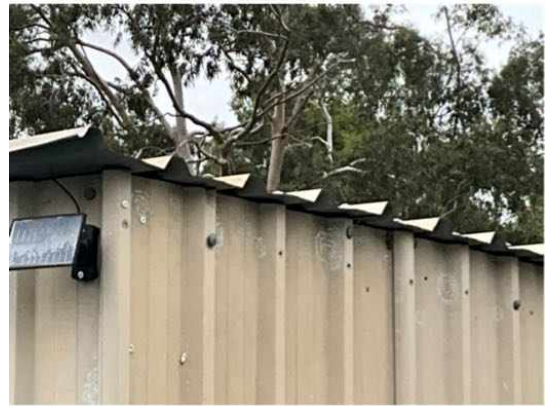
Finding: Guttering Missing

Information: The Guttering in this area was missing at the time of inspection. Guttering, Downpipes and Stormwater drainage are vital to protect the integrity of the structure and to prevent an environment conducive to Timber Pest attack.

A Plumber should be contacted as soon as possible to replace and connect to drainage the missing Guttering.

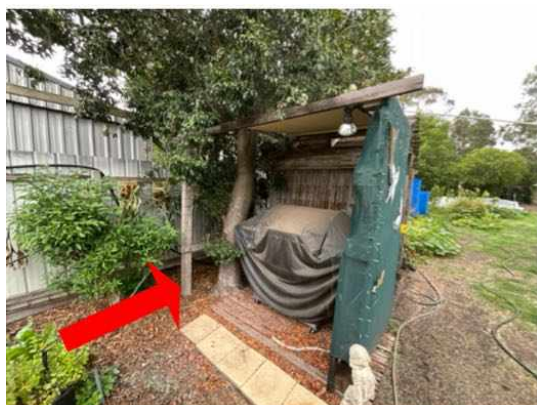
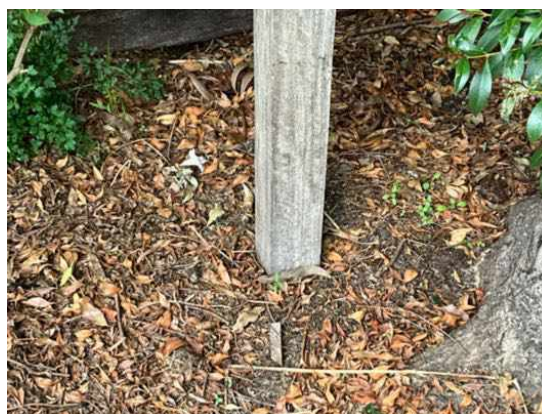
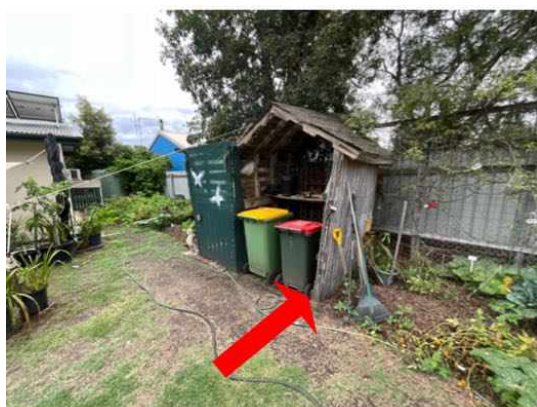
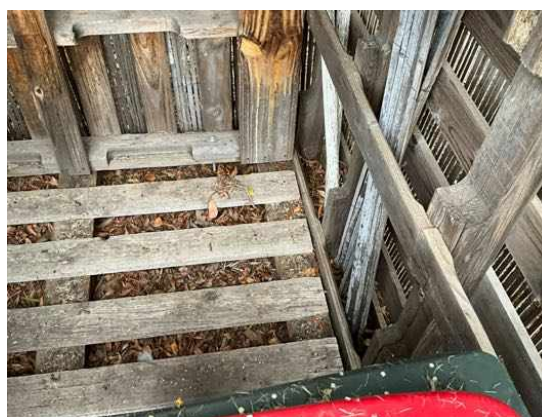
Finding 6.06

Building:	Building 1
Location:	Yard - Back
Finding:	Untreated or non-durable timbers in a hazardous environment
Information:	To reduce the risk of timber pest attack it is essential that timber used in a hazardous environment (e.g. in direct contact with the ground or frequently exposed to damp conditions) is of sufficient durability and/or is adequately preservative treated.

Untreated timbers in direct contact with the ground are likely to develop severe wood rot and/or fungal decay if left unattended creating attraction for subterranean termites to infest the timbers from surrounding areas.

If untreated or non-durable timbers are found to be in a hazardous environment it is highly advised that replacement of these building elements be performed as soon as possible to aid the protection of the property against termite / timber pest attack.

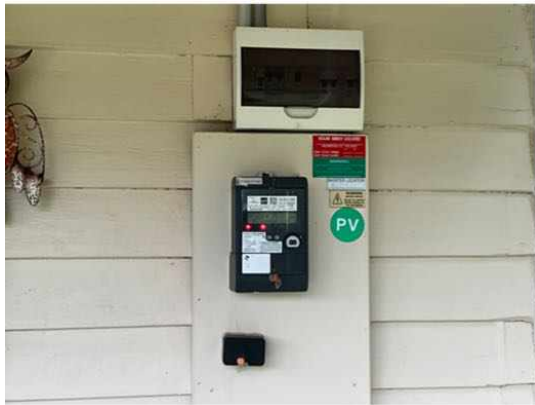
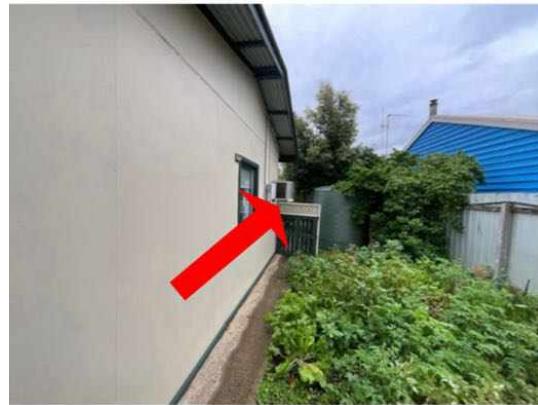
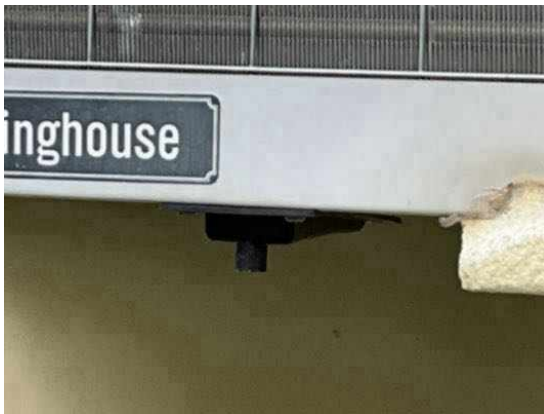
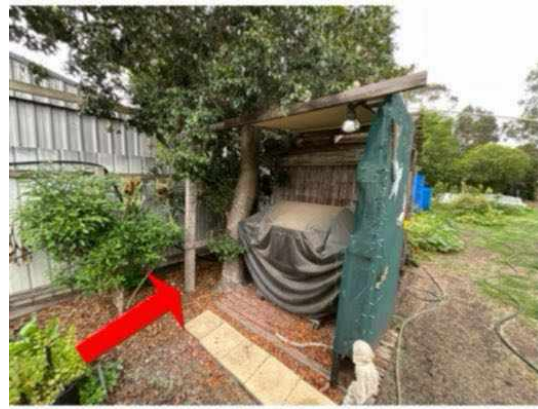
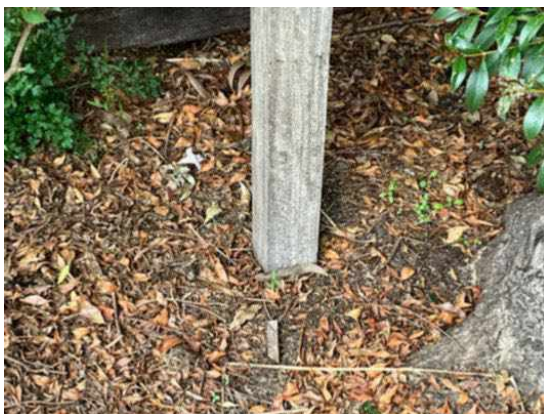
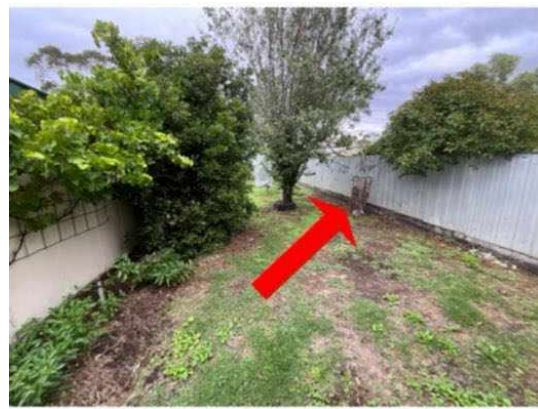
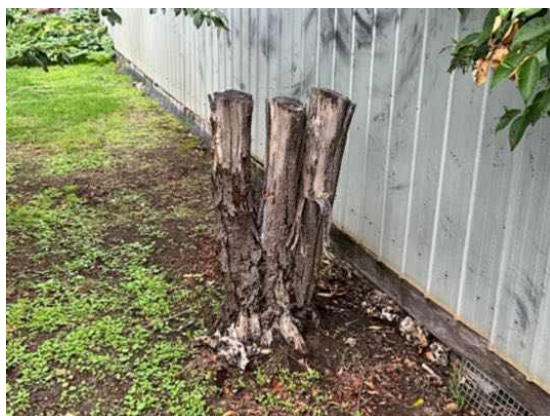
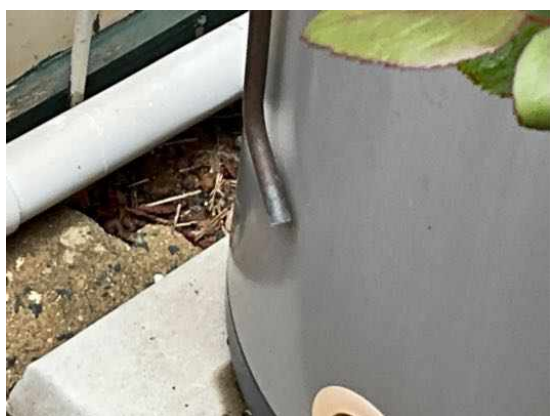
Finding 6.07

Building:	Building 1
Location:	All External Areas
Finding:	Termite Management System - no evidence of a chemical installation
Information:	The application of a post-construction chemical termite barrier is highly recommended

for all properties, particularly if live termite activity has been found on the site previously. Such barriers are highly effective in preventing termite attack on any timber building elements throughout the property.

A durable notice should be placed in the switchboard unit to indicate current termite barriers. At the time of inspection, it appeared as though no termite management system has been installed, with no evidence to suggest preventative works taking place.

The client may consider gaining further advice from a pest controller as to the costs and procedures involved with this application. It is recommended that obtaining such advice be a short-term priority.

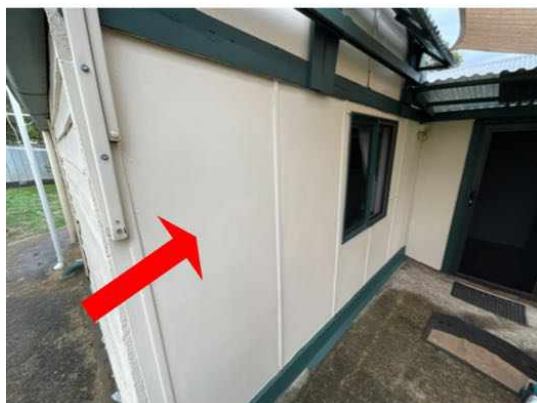
Building: Building 1
 Location: All Areas
 Finding: Asbestos - Suspected ACM Identified on Site
 Information: Reporting on Asbestos is outside the Scope of this Report. This suspected defect is highlighted as a caution only. We suspect, based on our experience in the building industry, that there is a higher risk of the identified building element containing asbestos.

As Asbestos Reporting is outside the scope of this report, we advise that you consider a separate Asbestos Inspection and Condition Audit, which can include the taking of samples for definitive confirmation of the presence of Asbestos.

In the interim, the client is advised to act with caution, especially when considering any damage to building materials general wear and tear renovations extensions demolition and general maintenance activities due to the suspected presence of Asbestos.

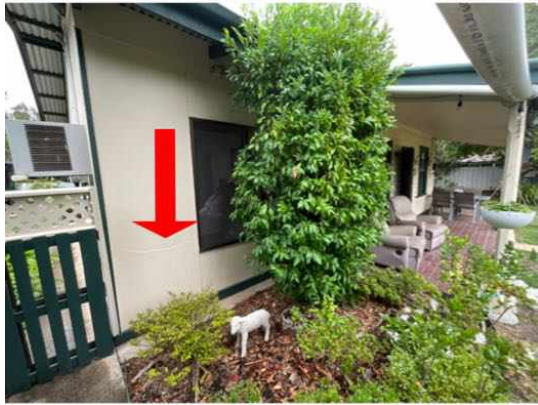
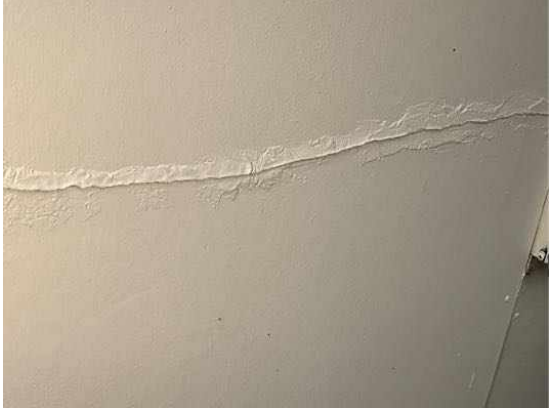
Building: Building 1
 Location: Front wall
 Finding: Cladding- deteriorated
 Information: The external cladding shows signs of damage in several areas. Although not serious at this point, monitoring should be undertaken at intervals to ensure no further damage occurs.

A cladding specialist or handyman could be contacted as needed to patch any damage to prevent further deterioration.

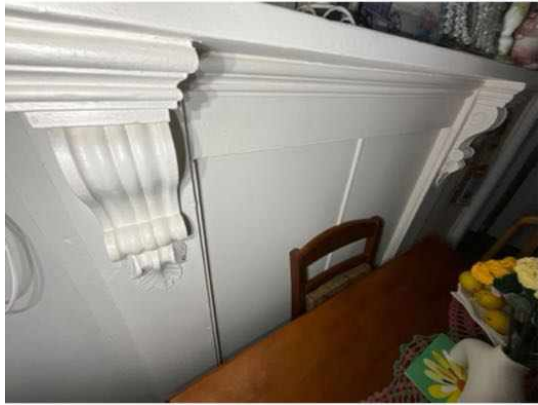
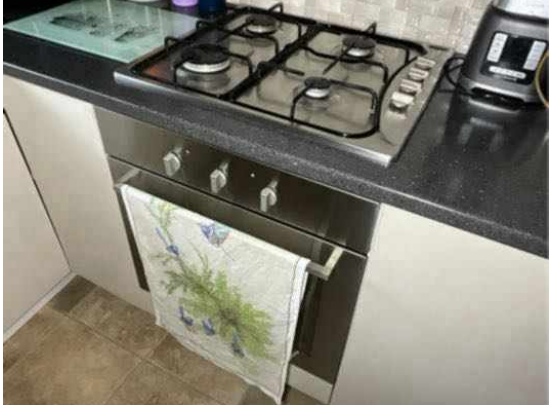
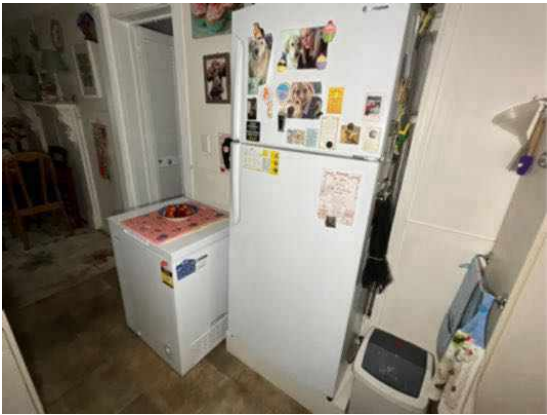
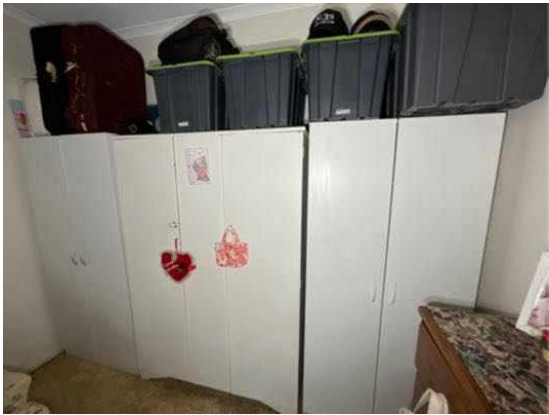
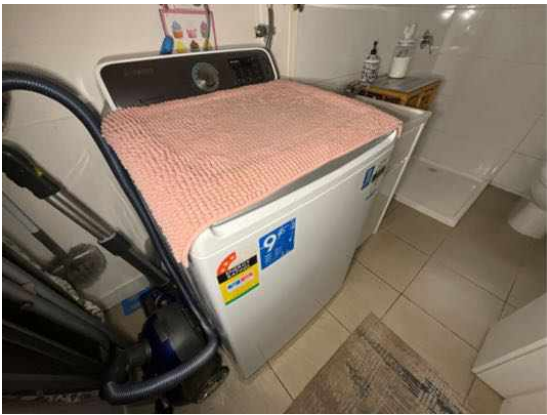
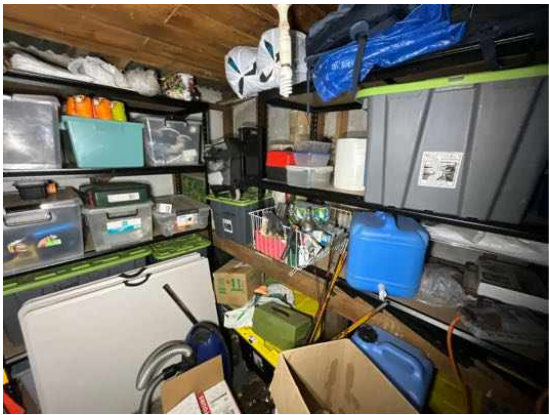
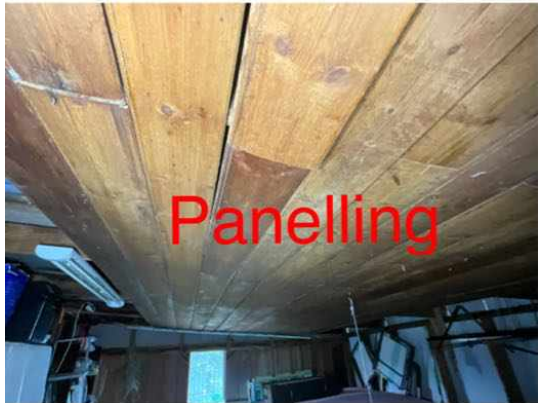
Building: Building 1
Location: All Areas
Finding: Additional Photos - Obstructions and Limitations
Information: These photographs are an indication of the obstructions and limitations which impeded full inspection of the property at the time of inspection. These obstructions can hide an array of defects and should be removed to allow full inspection to be carried out. A re-inspection is recommended once the areas are made accessible.
