Building and Timber Pest Inspection Report

Inspection Date: Fri, 20 Feb 2026

Property Address: 13/58-60 Falconer St, West Ryde NSW 2114,
Australia

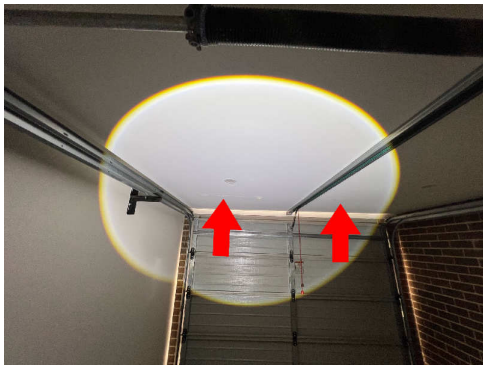
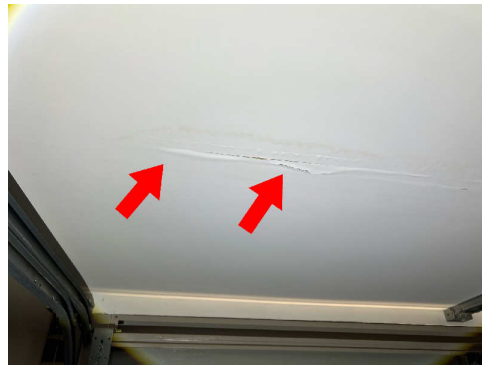
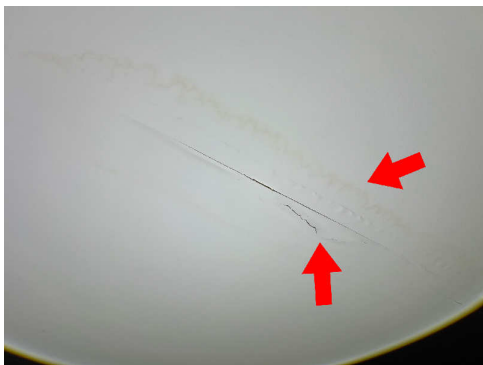
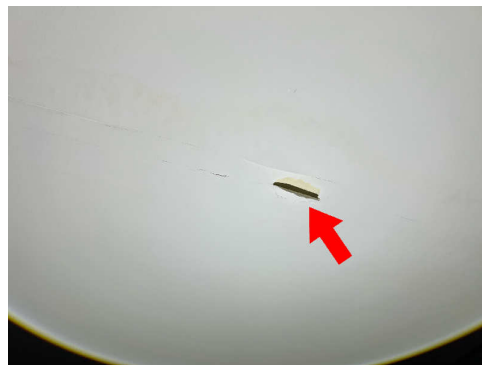
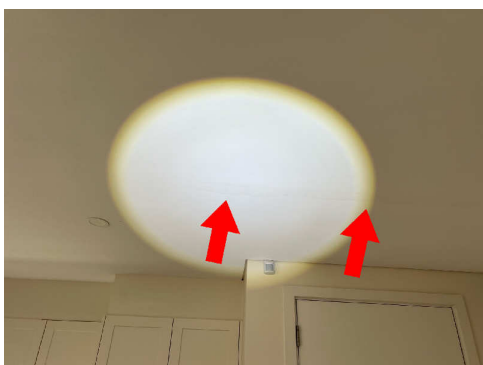
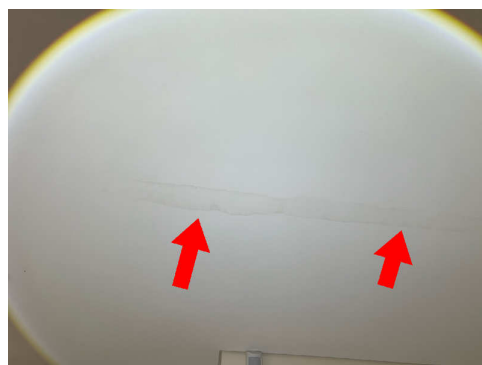
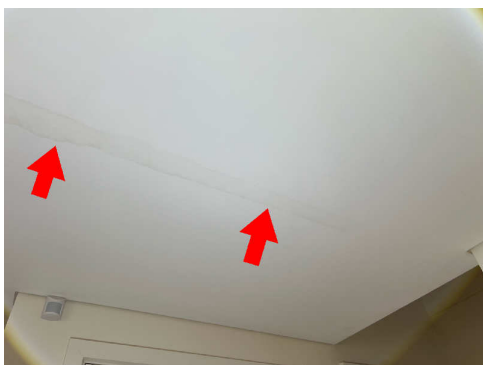
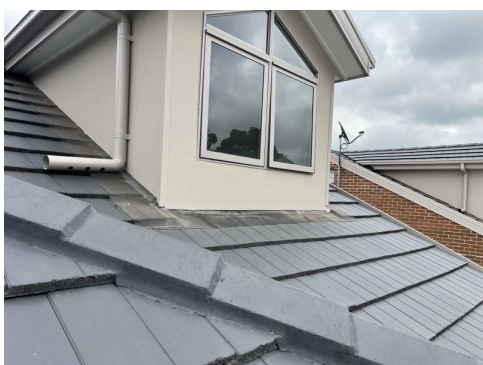
Building:	Main Building
Location:	Garage & Kitchen
Finding:	Water Staining and Possible Roof Flashing Defect – Garage and Kitchen Ceilings
Information:	<p>Water staining and associated ceiling damage were observed to the garage ceiling and kitchen ceiling internally, including discolouration, cracking and deterioration of the ceiling lining. These conditions are typically consistent with moisture intrusion from above.</p>

During the external roof inspection, the roof area and flashing junction directly below the upper-level windows was observed in the approximate location corresponding with the internal staining. Roof junctions and flashing details around walls and windows are common locations where moisture ingress may occur if flashings, sealants or roofing components are not performing effectively.

Although the precise source of the moisture could not be conclusively determined during the visual inspection, the proximity of the roof flashing and junctions in this area warrants further assessment. Moisture penetration through roof coverings or flashings can allow water to enter the roof space and affect ceiling linings internally.

It is recommended that a qualified roofing contractor inspect the roof coverings, flashings and junctions around the upper window area and carry out repairs as necessary. Following rectification of the moisture source, the affected ceiling areas should be repaired and repainted by a suitable tradesperson.

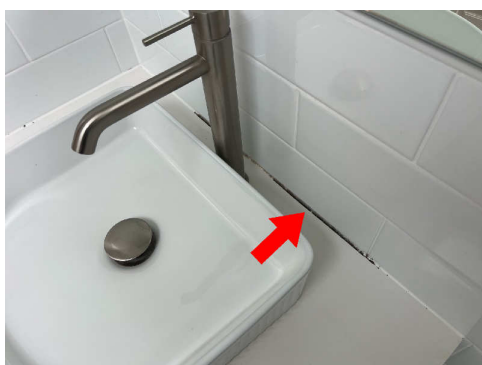
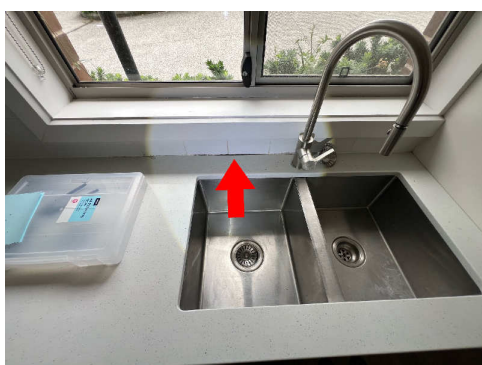
Finding 3.01

Mould and deterioration were observed to the silicone sealant at the junction between the benchtop/tiles and fixtures at the kitchen sink and the upstairs bathroom basin. The sealant along the rear edge of the kitchen sink splashback and around the bathroom basin shows visible mould growth and deterioration, indicating the sealant has likely aged and is no longer performing effectively as a hygienic waterproof barrier. Silicone in these wet areas is intended to prevent water from penetrating into gaps behind fixtures and benchtops; however, once mould develops or the sealant deteriorates, it can trap moisture and allow water to enter concealed areas, potentially leading to staining, ongoing mould growth, or deterioration of surrounding materials.

While this condition is common over time due to moisture exposure and normal wear, the affected silicone should be removed, the area thoroughly cleaned, and new mould-resistant sanitary-grade silicone applied to restore proper sealing and improve hygiene. This work would typically be carried out by a handyman, caulking contractor, or plumber and should be addressed as part of routine maintenance in the short term.

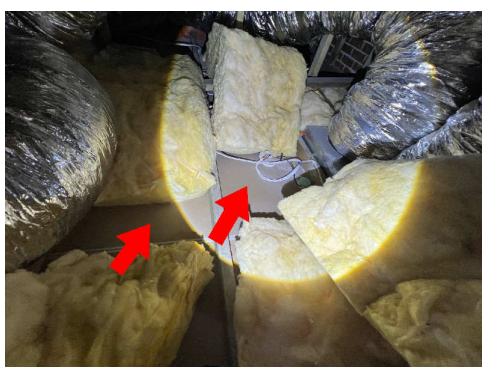
Finding 3.02

Building:	Main Building
Location:	Roof Void
Finding:	Incomplete Ceiling Insulation to Roof Space
Information:	Ceiling insulation within the roof space was observed to be incomplete and unevenly distributed, with some areas missing insulation coverage and other sections displaced. This condition was evident in the accessible areas at the time of inspection.

Incomplete or displaced insulation can reduce the thermal efficiency of the dwelling and may contribute to heat loss or gain, impacting occupant comfort and energy performance. It is recommended that the ceiling insulation be reviewed and made continuous by a suitably qualified insulation installer to achieve more consistent coverage. Rectification can be considered as part of routine maintenance in the medium term.

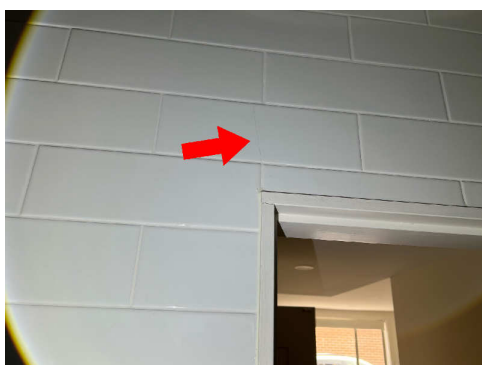
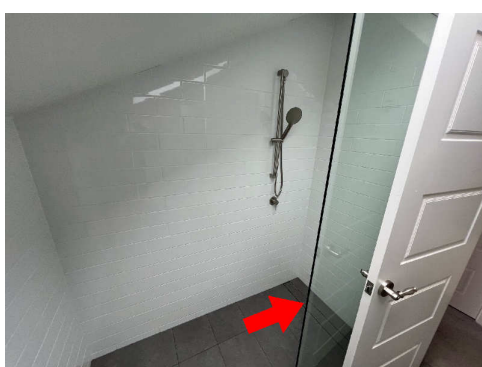
Finding 3.03

Building:	Main Building
Location:	Bathroom 1 & 2
Finding:	Cracked Tiles – Upstairs Shower Floor and Downstairs Bathroom Wall

Cracked tiles were observed to tiled surfaces within the bathrooms of the dwelling. A cracked floor tile was noted adjacent to the linear shower drain within the upstairs bathroom shower area, and a cracked wall tile was observed to the tiled wall surface in the downstairs bathroom near the doorway. Tile cracking can occur due to minor impact, installation stresses, or slight movement within the underlying substrate. While the affected tiles currently remain in place, cracks compromise the protective surface of the tiles and may allow moisture to penetrate through to the underlying bedding or wall materials, particularly in wet areas such as showers.

Although the cracking appears localised and does not presently indicate significant structural concerns, damaged tiles should be addressed to maintain the integrity, durability, and waterproof performance of the tiled surfaces. It is recommended that the affected tiles be assessed and replaced by a qualified tiler, with surrounding grout and joints appropriately reinstated as required. This work should be undertaken in the short to medium term as part of routine maintenance.

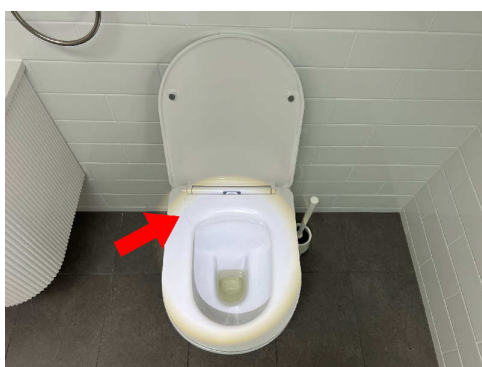
Finding 3.04

Finding: Cracked Toilet Seat

Information: A crack was observed to the toilet seat at the hinge area in the upstairs bathroom. The crack extends through the plastic seat material and appears to have developed due to wear, impact, or stress at the hinge fixing point. Damaged toilet seats may deteriorate further with normal use and could eventually fail or become uncomfortable or unsafe during use.

It is recommended that the toilet seat be replaced with a suitable compatible unit to restore normal function and hygiene. Replacement of the seat is a relatively straightforward maintenance task typically carried out by a handyman or plumber and should be addressed in the short term as part of routine maintenance.

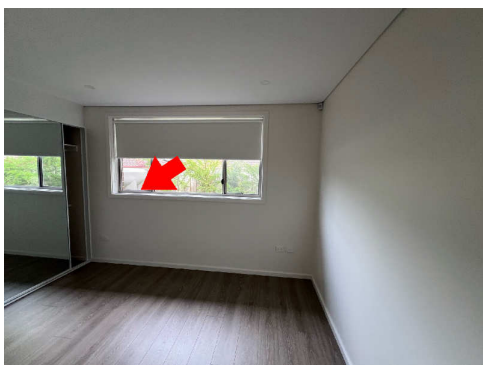
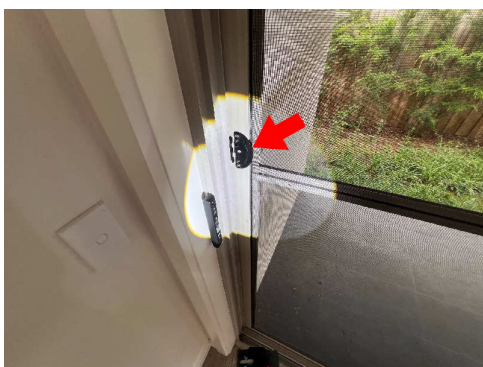
Finding 3.05

Finding: Damaged Flyscreen and Screen Door Lock

Damage was observed to the flyscreen of the downstairs bedroom window and to the locking mechanism of the external screen door. The flyscreen mesh to the bedroom window appears torn and partially detached along the lower edge, which reduces its effectiveness in preventing insects from entering the dwelling. Additionally, the lock mechanism to the external screen door appears damaged and may not operate as intended.

While these issues do not appear to affect the structural integrity of the dwelling, damaged flyscreens and faulty screen door locks reduce functionality and may impact security and usability. It is recommended that the flyscreen mesh be repaired or replaced and the screen door locking mechanism assessed and repaired or replaced by a suitable handyman or locksmith as required. These items should be addressed in the short term as part of routine maintenance to restore normal function.

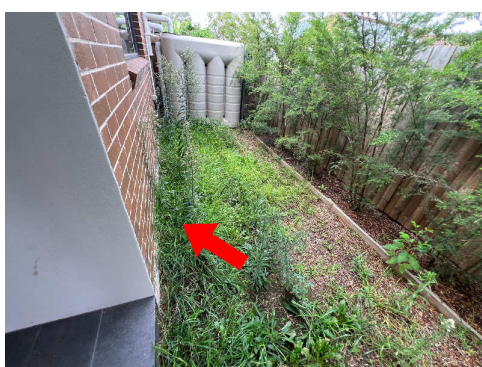
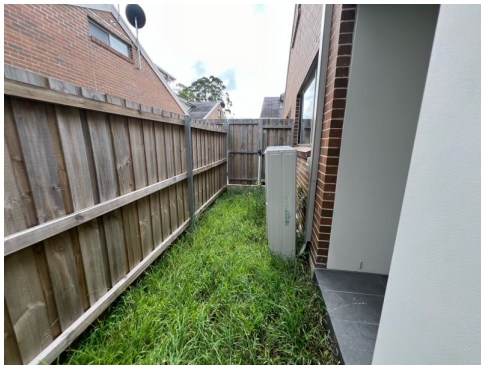
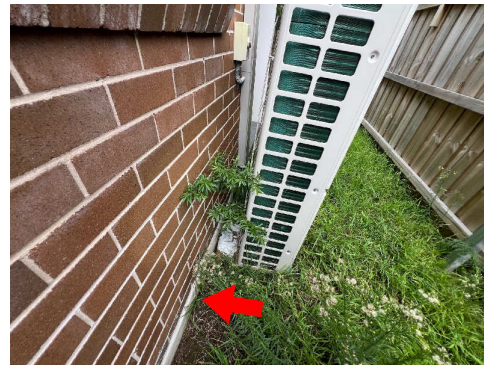
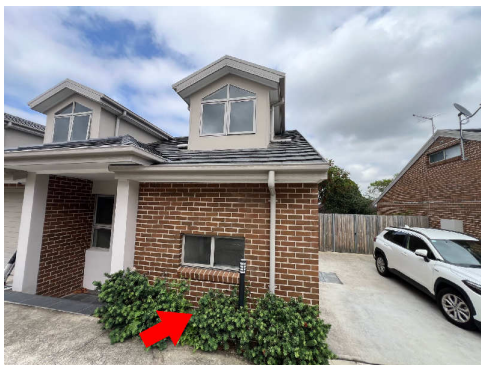
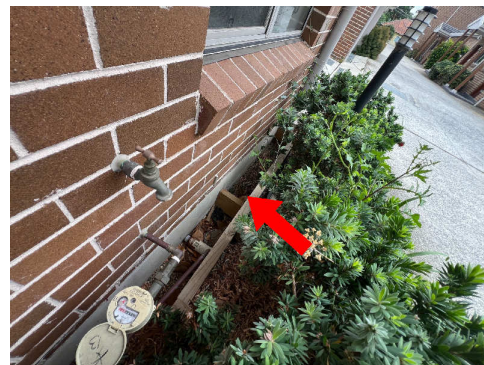
Information: Garden beds, vegetation and areas of grass were observed directly against the external walls of the dwelling in several locations around the property. Soil, mulch and vegetation positioned against external walls can create conditions that retain moisture against the building fabric and may obscure the lower wall areas from inspection. These conditions may also provide conducive environments for pest activity and moisture ingress, particularly where the finished ground level approaches the damp-proof course or weep holes within the brickwork.

Maintaining clear separation between garden beds, soil levels and the building structure is important to allow proper drainage, ventilation and visual inspection of the lower wall areas. Vegetation and soil build-up against walls can also contribute to moisture retention, which may affect building materials over time.

It is recommended that soil levels, garden beds and vegetation be trimmed back and maintained clear of the external walls, ensuring adequate clearance below the weep holes and damp-proof course. Ongoing maintenance of these areas should be undertaken as part of routine property maintenance to minimise the risk of moisture-related or pest issues.

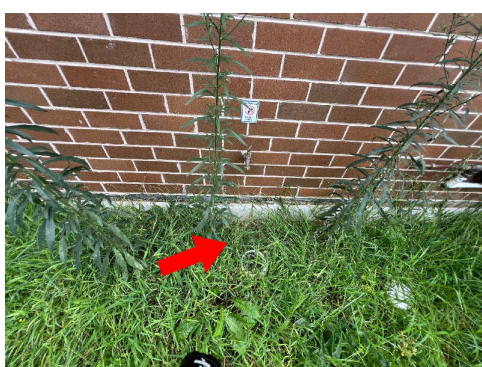
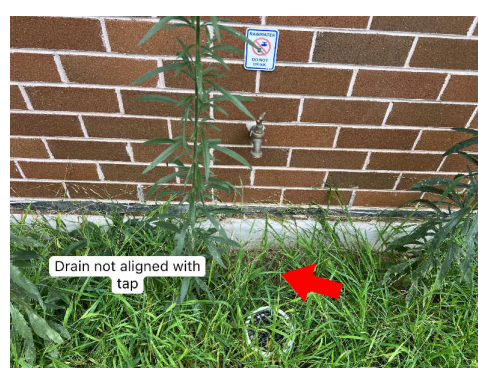
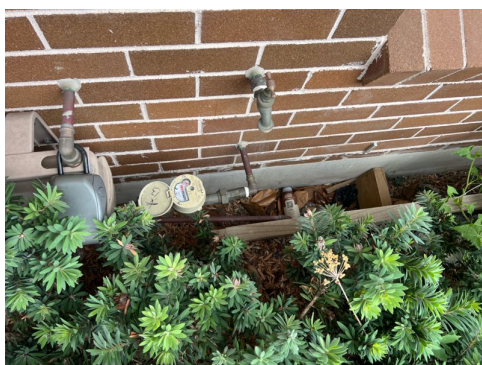
Finding 6.02

External hose taps were observed installed against the dwelling walls without any visible drainage provision beneath. No grated drain, spoon drain or adequate surface fall away from the structure was noted directly below the taps in the areas inspected. This condition allows water discharged from the taps, whether from use or minor leakage, to accumulate at the base of the wall and adjacent slab/footing areas.

The absence of drainage may contribute to ongoing moisture exposure to the wall base and surrounding materials. Prolonged wetting of these areas can increase the risk of moisture ingress, rising damp issues, or create conditions conducive to termite activity. Although no active moisture damage was noted at the time of inspection, the configuration presents a preventable moisture risk.

It is recommended that a licensed plumber assess the external taps and consider installation of an appropriate drainage solution (such as a grated drain connected to stormwater or improved surface grading) to direct water away from the structure. This should be addressed in the short term to reduce the risk of moisture-related deterioration.

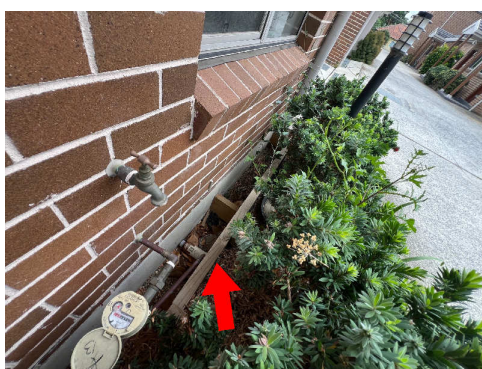
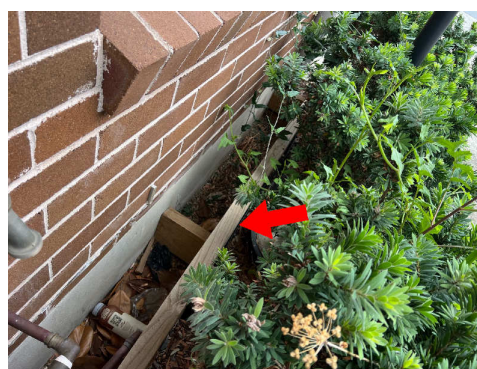
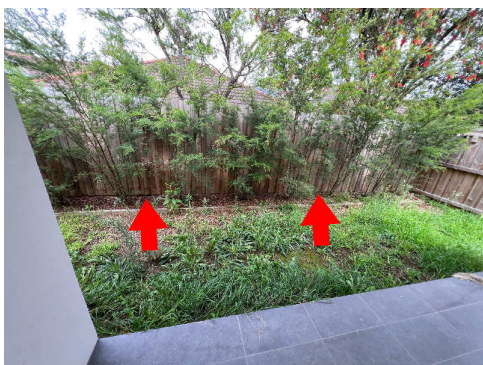
Finding 6.03

Building:	Main Building
Location:	Front & Rear
Finding:	Timber in Direct Contact with Soil – Conducive to Timber Pest Activity
Information:	<p>Timber elements were observed in direct contact with the soil and garden bed areas along sections of the property boundary and garden edging. Timber retaining pieces and garden bed edging materials were noted to be embedded in or directly touching the ground, which can create conditions conducive to timber pest activity and moisture-related deterioration.</p>

Timber placed directly in soil can retain moisture and may provide concealed pathways for termites or other timber pests to access nearby structures. These conditions can also lead to gradual timber decay over time. While the timber elements observed appear to be associated with garden edging and landscaping, their contact with soil is considered a conducive condition for termite activity and should be addressed to reduce potential risk.

It is recommended that timber elements in direct contact with soil be removed, replaced with suitable non-susceptible materials, or installed with adequate separation from the ground where possible. Ongoing monitoring and maintenance of landscaping materials around the dwelling should be undertaken to minimise conducive conditions for pest activity.

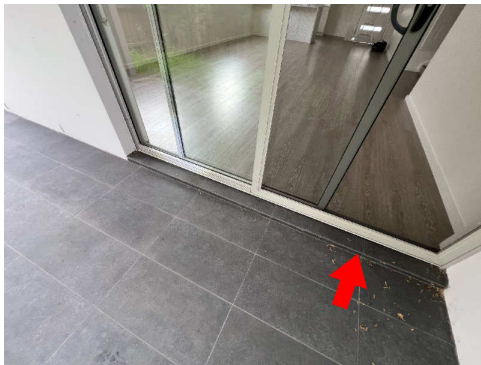
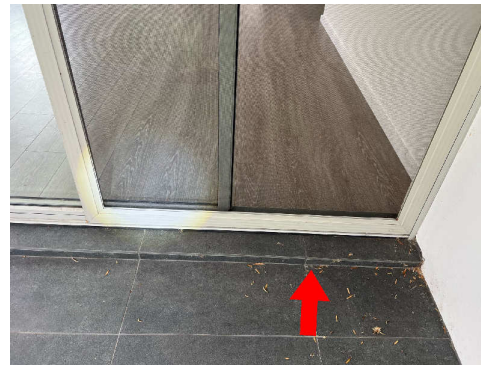
Finding 6.04

Information: External tiled paving was observed finished at a level close to the internal floor level at the rear sliding door. The external surface appears to be almost level with the internal flooring, which reduces the step-down typically provided at door thresholds to assist in preventing water ingress during heavy rainfall events.

Where external surfaces are installed at similar or higher levels than internal floor levels, there is an increased risk that wind-driven rain or surface water may enter the dwelling if drainage or weather seals are compromised. Adequate separation between internal floor levels and external surfaces is generally recommended to reduce the risk of moisture penetration into the building.

It is recommended that the door threshold and surrounding external surface levels be monitored, and that the area be assessed by a qualified builder if signs of moisture ingress become evident. Ensuring adequate drainage away from the doorway and maintaining the door seals will assist in reducing the likelihood of water entering the dwelling.
