Building and Timber Pest Inspection Report

Inspection Date: Wed, 1 Apr 2026

Property Address: 203 Fenchurch Dr, Springdale Heights NSW
2641, Australia

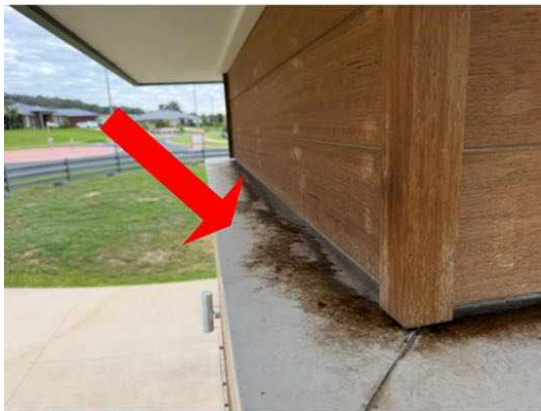
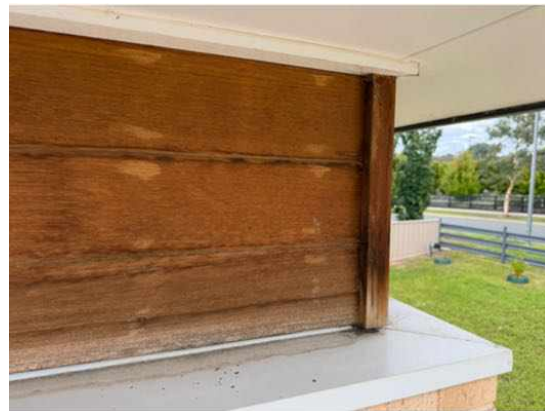
Finding 3.01

Building:	Main Building
Location:	Front Elevation
Finding:	Roof Capping - Insufficient fall
Information:	It appears that there is insufficient fall to the front elevation roof capping. Without adequate fall, deterioration of the capping is likely to occur overtime, due to water pooling in the area. Recommend engaging a licensed roof plumber, at clients discretion, to provide further advice & remedial works where necessary.

It appears that there is insufficient fall to the front elevation roof capping. Recommend engaging a licensed roof plumber, at clients discretion to provide further advice & remedial works where necessary.

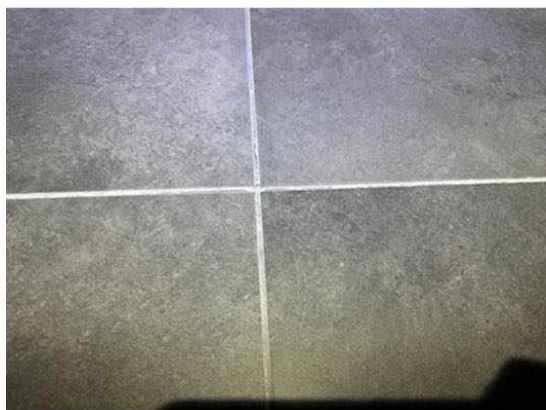
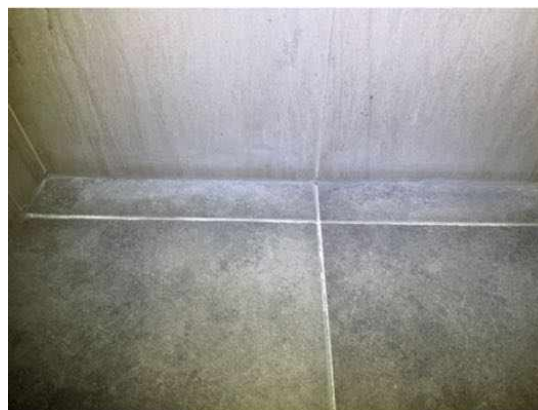
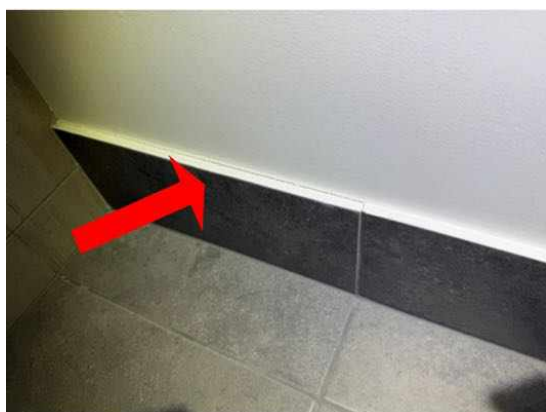
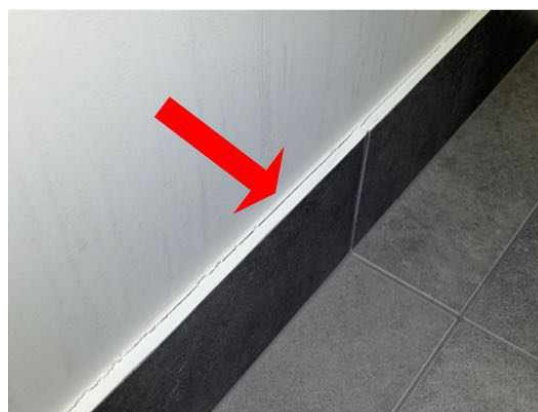
Finding 3.02

Building:	Main Building
Location:	Tiled Areas
Finding:	Sealant and grouting - deteriorated or missing
Information:	It appears that the sealant and grout has deteriorated / weathered, in some tiled areas. Some skirting tiles also appeared to be slightly loose. Sealant and grouting in areas that come into regular contact with water should be maintained for the long term care of your property.

A sealant specialist or tiling contractor should be appointed to complete these minor works, to prevent the potential development of secondary building defects overtime.

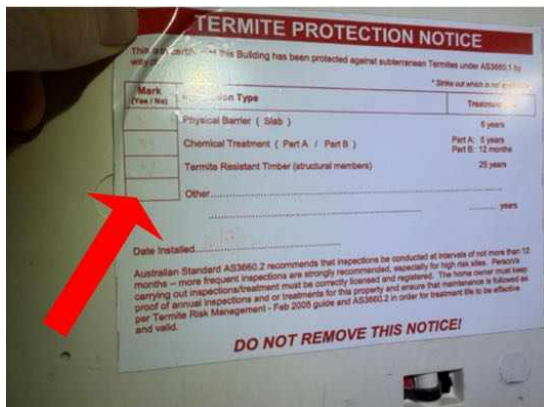
Finding 6.01

Building: Main Building
 Location: Switchboard
 Finding: Termite Management System - no evidence of a chemical installation
 Information: The application of a termite barrier is recommended, as it appears no termite management system has been installed. A durable notice was present in the meter box, however, there was no indication of a termite treatment or physical barrier in place.

Such barriers are effective in preventing termite attack on the building and therefore

should be installed.

Recommend seeking further advice from a licensed pest controller.

Installation of a termite barrier is recommended as there was no evidence of installation of a previous termite treatment or physical barrier. 12 monthly termite inspections, conducted by a qualified termite inspector are also advised. Recommend engaging a licensed pest controller, to provide further advice.

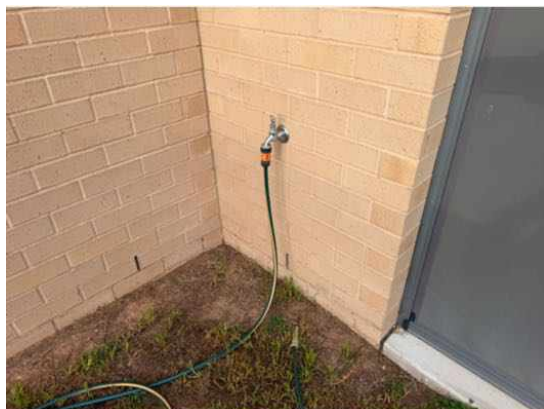
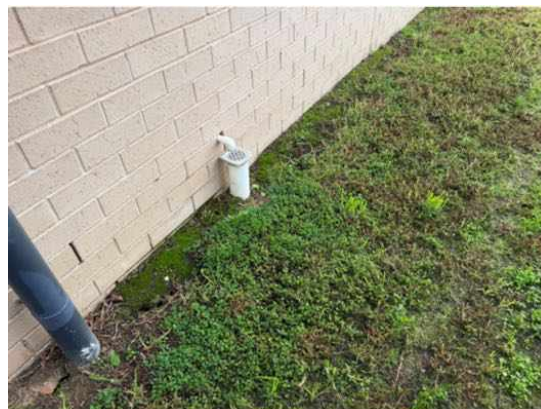
Finding 6.02

- Building: Main Building
- Location: All external areas
- Finding: Potential Water pooling - against property
- Information: Potential areas of water pooling around the perimeter of the property were identified. Where insufficient drainage of taps, and insufficient fall away from the building is present, water pooling is likely to occur, and can create areas conducive to timber pests. Recommend consulting with a licensed plumber and/or landscaping contractor to provide further advice.

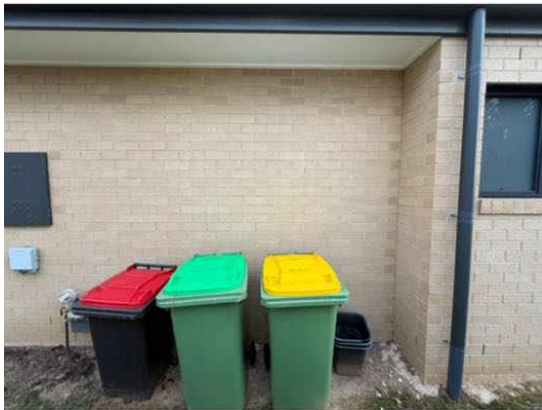
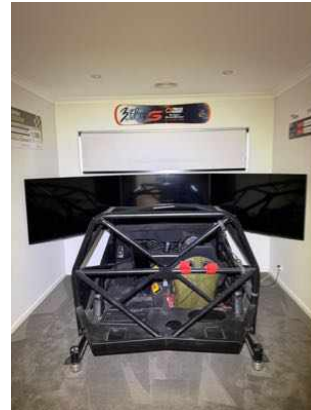
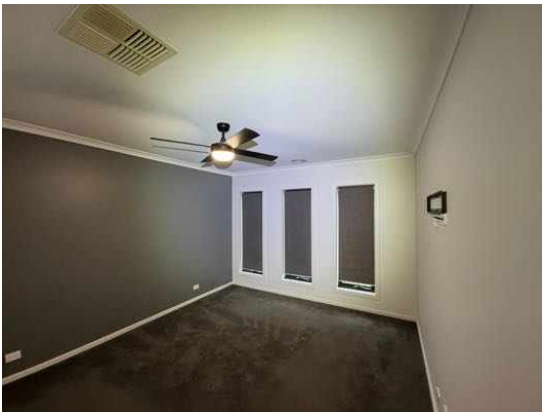
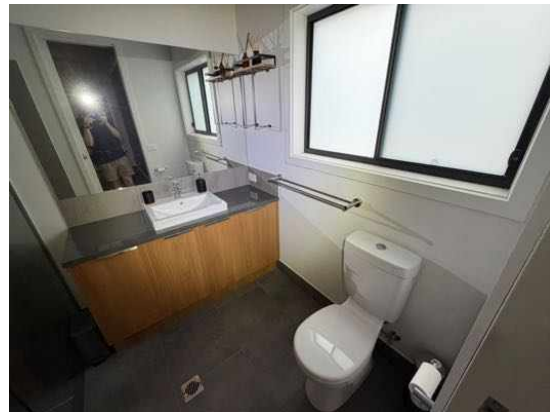
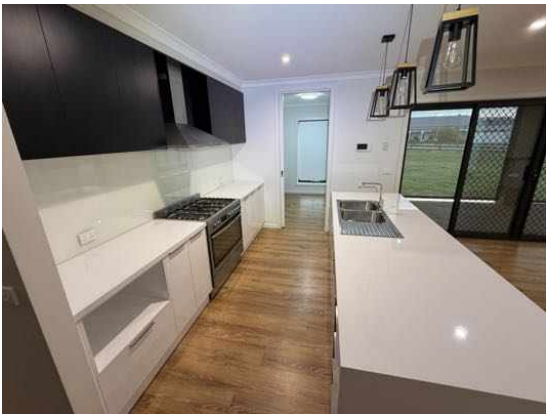
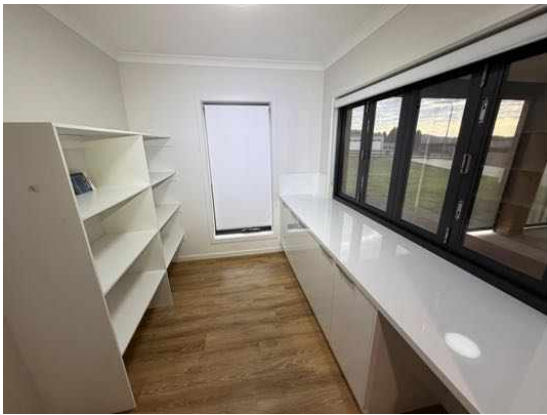
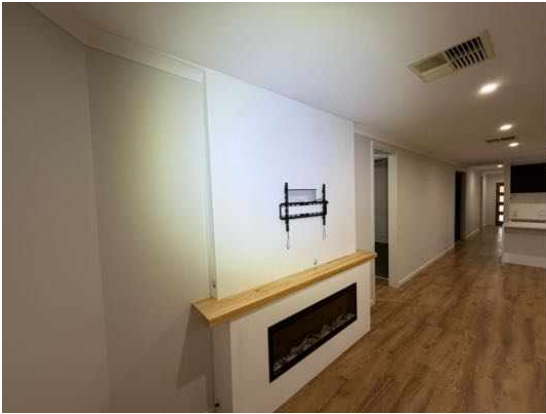
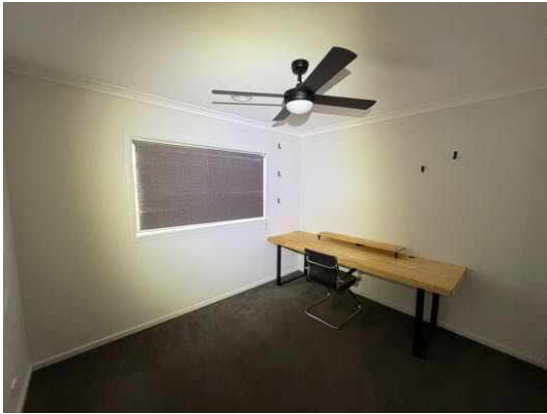
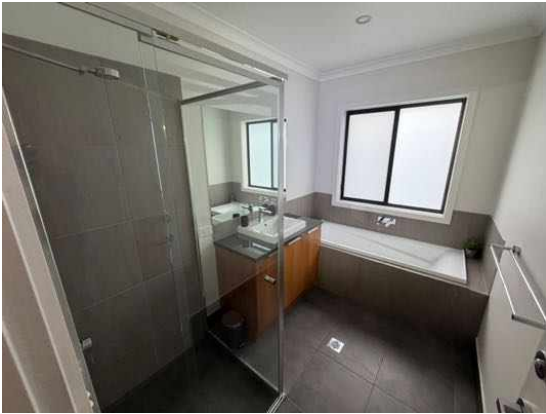
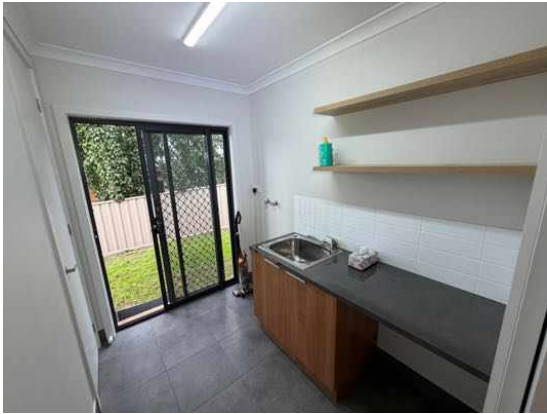
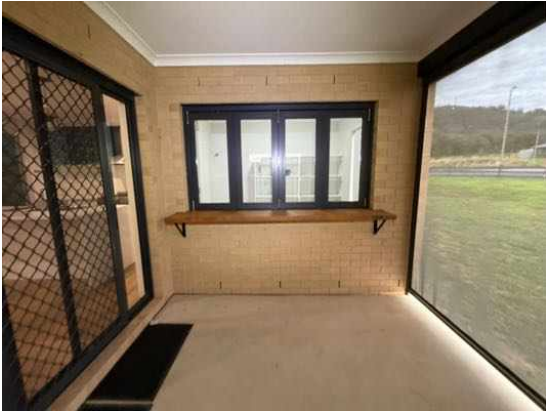
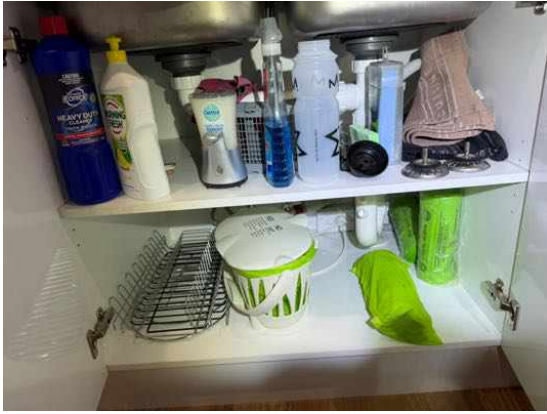
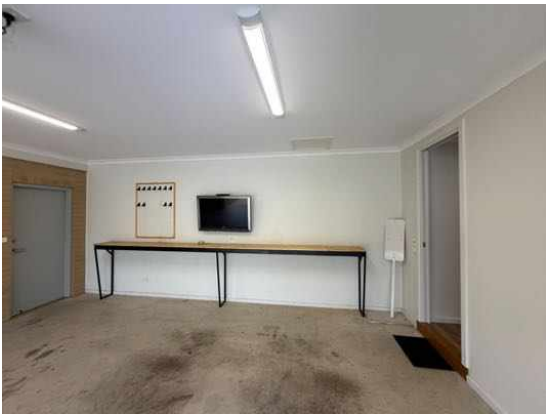
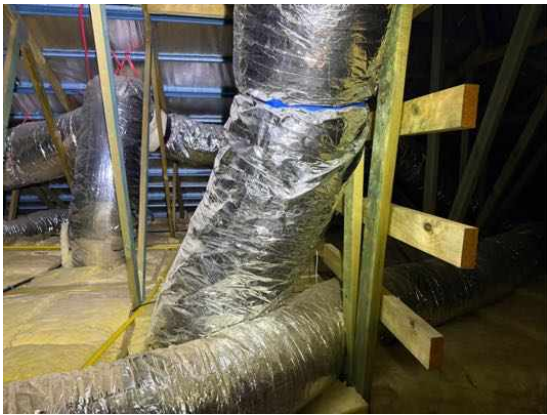
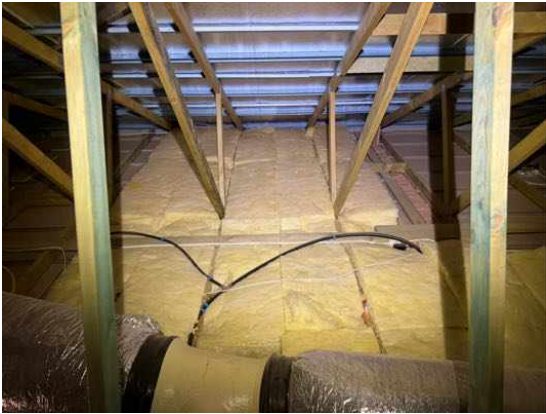
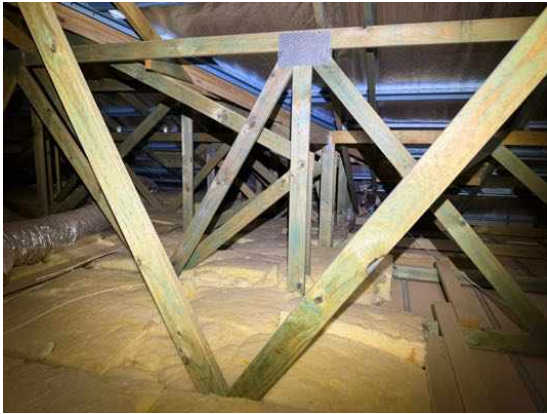
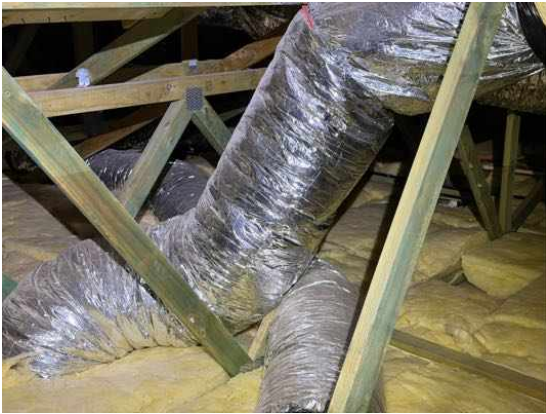
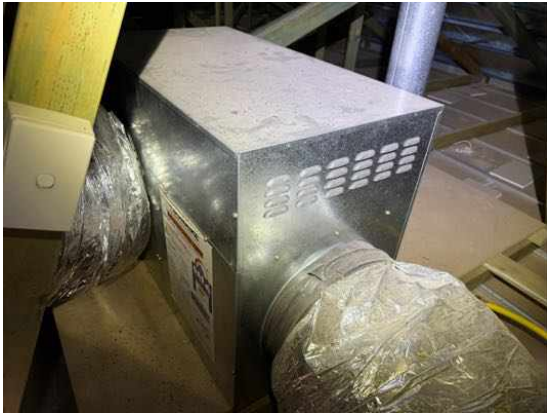
Building: Main Building
Location: All Areas
Finding: Additional Photos - Obstructions and Limitations
Information: These photographs are an indication of the obstructions and limitations which impeded full inspection of the property at the time of inspection. These obstructions can hide an array of defects and should be removed to allow full inspection to be carried out. A re-inspection is recommended once the areas are made accessible.

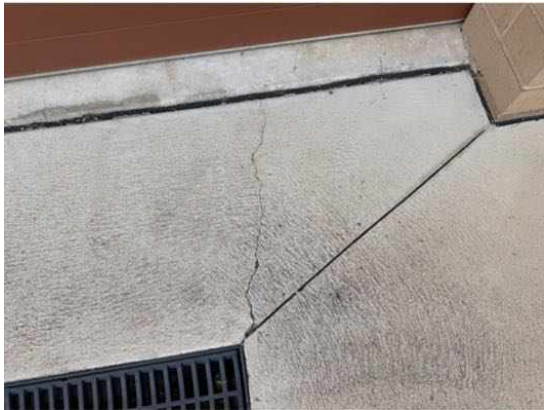
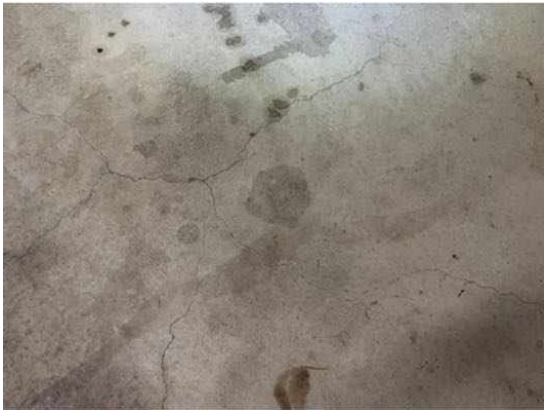
Building: Main Building
Location: Pavement, Garage Slab
Finding: Cracking - Garage Slab & Pavement
Information: Minor cracking was identified in the garage slab and external pavement. Cracking in concrete slabs and pavement is common, and can be caused by general movement over time or “settling” of the building after construction.

The client should monitor the cracking. Should the cracking of the garage slab widen, lengthen or become more numerous, a structural engineer should be engaged for further evaluation.

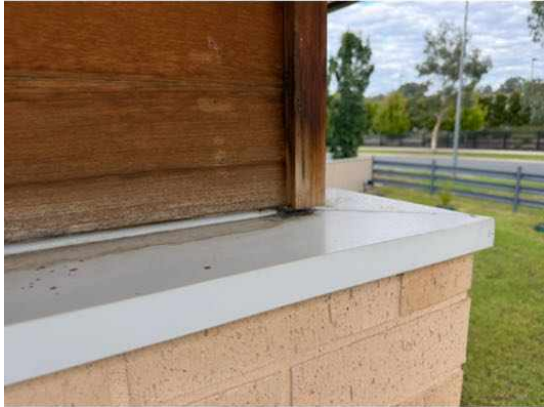
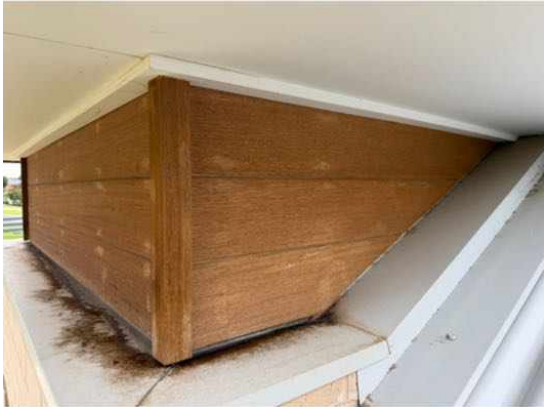
Building: Main Building
Location: External Timbers
Finding: External Timbers - General Weathering
Information: Some external timbers at, but not limited to the front elevation had areas of general weathering. This is a common defect in buildings of a similar age.

Recommend engaging a licensed painting contractor in the short term to provide additional protection to the external timbers to help extend the useful life of the materials.
