Building and Timber Pest Inspection Report

Inspection Date: Mon, 16 Mar 2026

Property Address: 4 Darley Rd, Bardwell Park NSW 2207,
Australia

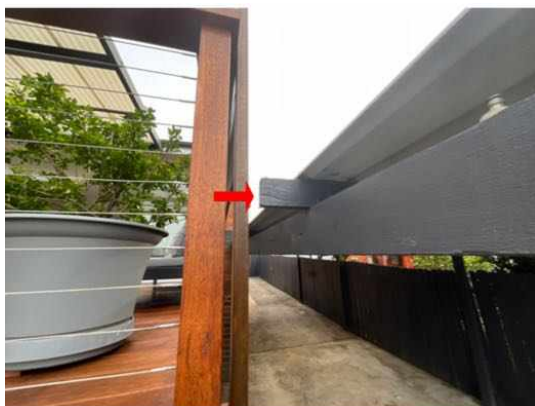
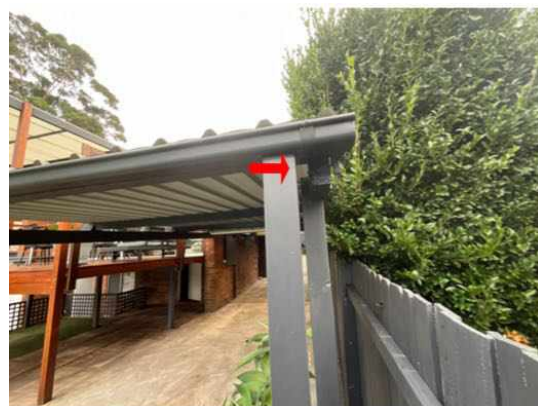
Finding 3.01

Building:	Main Building
Location:	External Areas
Finding:	Wood rot
Information:	This building element shows evidence of wood rot. Wood rot, also known as Fungal Decay, occurs when timbers and other cellulose building materials are exposed to damp conditions on an ongoing basis. This could be the result of exposure to weathering over a prolonged period of time, or the attraction of excessive moisture from other abutting building materials.

Early intervention and regular maintenance, particularly of exterior timbers, will prolong the useful life of these building elements. Prior to any works being performed, the cause of the moisture that has created the visible wood rot should be identified and addressed in a suitable manner. Replacement of affected timbers may then be a necessary step in protecting surrounding building elements from such deterioration.

A qualified carpenter or registered builder may also be required to replace affected building materials.

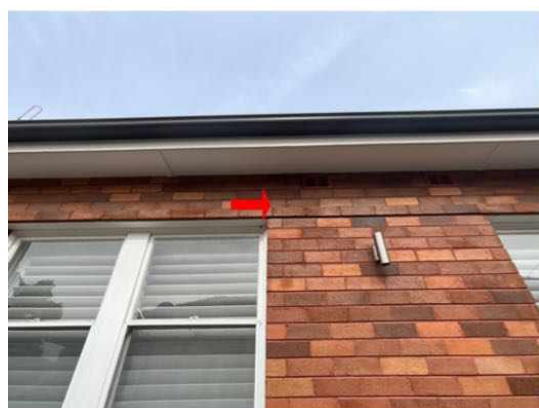
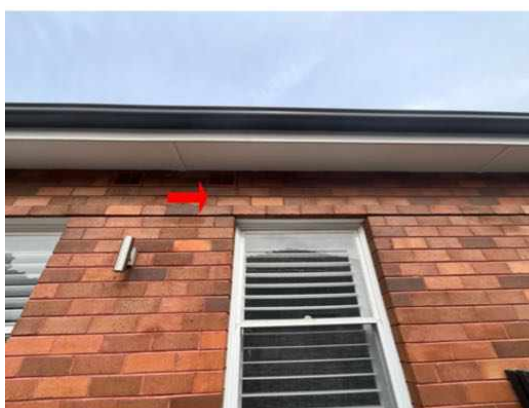
Finding 3.02

Building:	Main Building
Location:	Exterior walls
Finding:	Brickwork - Cracking noticeable
Information:	There were several cracks and or crack repairs evident to external brickwork.

Noticeable cracks are a common occurrence in external brickwork and are a likely result of age expected building movement, general expansion, and/or contraction of building materials in different weather conditions.

It is highly advised that a qualified bricklayer be appointed to provide necessary works to cracked brickwork to prevent any further damage.

Always monitor these cracks and contact a building inspector should cracks widen, lengthen, or become more numerous.

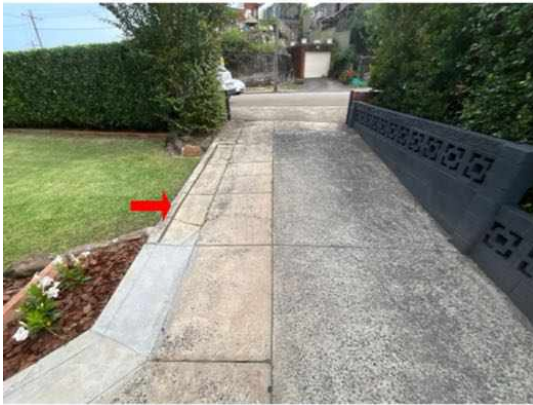
Finding 3.03

Building:	Yard
Location:	Pathway
Finding:	Cracking - External Concrete Paving Damage Category 1 - Fine (less than 2mm)
Information:	Fine cracks were identified in external concrete paving. Although fine cracks are quite noticeable, they are often only considered to be an appearance defect, and usually do not indicate any structural damage. To be considered a Category 1 or fine crack, the crack is found to be less than 2mm in width.

Generally the cause of a hairline crack in existing concrete paving such as driveways and pathways is indicative of the expansion and contraction of the concrete. Such causes are generally due to environmental factors, such as moisture levels, weather conditions, root systems of nearby trees or the soil types on which they are laid.

Fine cracks may also be due to poor original installation of the concrete. Factors such as poor compaction of the sub surface and/or inadequate reinforcing of the slab may create cracking and other secondary defects.

Monitoring of all cracking should be conducted frequently. Always contact a building

inspector should cracks widen, lengthen, or become more numerous.

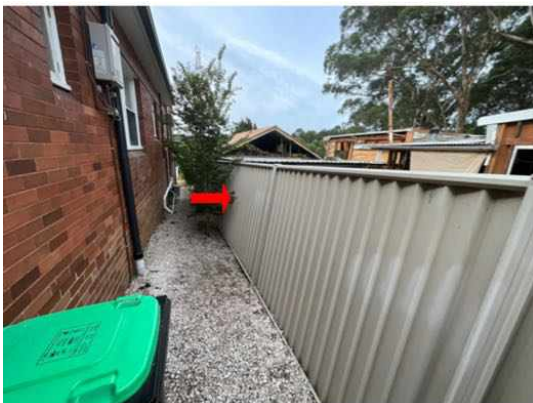
Finding 3.04

Building:	Yard
Location:	Fencing
Finding:	Fencing - Leaning
Information:	It was noted at the time of inspection that sections of the fencing in this area are leaning.

A licensed fencing contractor should be appointed to provide further advice and perform rectification works as necessary.

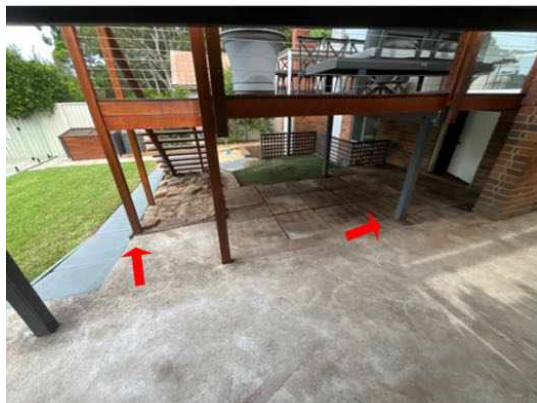
Finding 3.05

Building:	Yard
Location:	Deck
Finding:	In ground contact
Information:	Any timbers in direct ground contact provide opportunity for concealed termite entry and are likely to be subject to premature rot and decay as the soil retains moisture or damp conditions against the timbers.

Remove timber that is in direct contact with external grounds. Consider replacement

with more durable materials i.e. treated timber or non timber elements. Frequent pest inspections are advised to readily identify any termite activity in these areas.

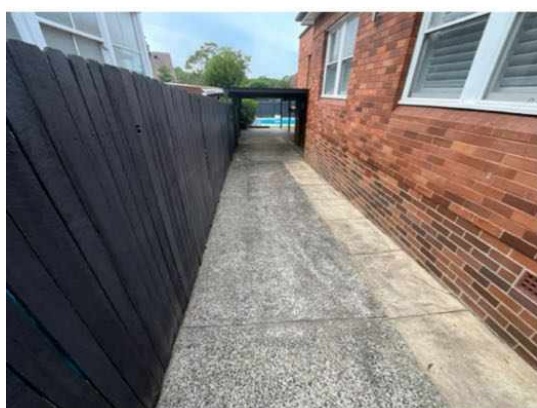
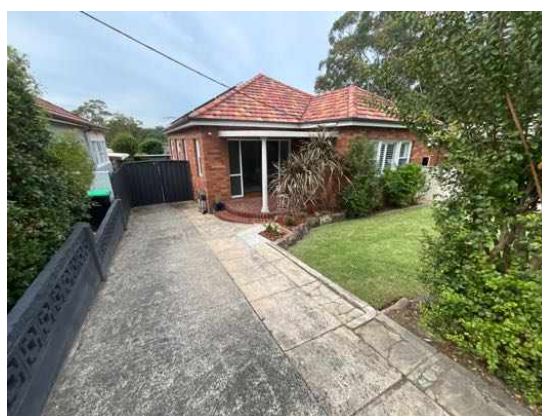
Finding 3.06

Building:	Yard
Location:	The Site
Finding:	Site drainage - Inadequate
Information:	The site drainage in this area was found to be inadequate at the time of inspection, creating potential for subsequent water damage to associated building elements.

It is important that water does not lie against the base of walls; surrounding paths and ground levels should be sloped to drain water away from walls.

Where site drainage is inadequate, installation of drains may be required. A qualified plumber should be appointed to further inspect the property and perform any remedial works as necessary. Water damage and secondary defects are likely to occur if left unmanaged.

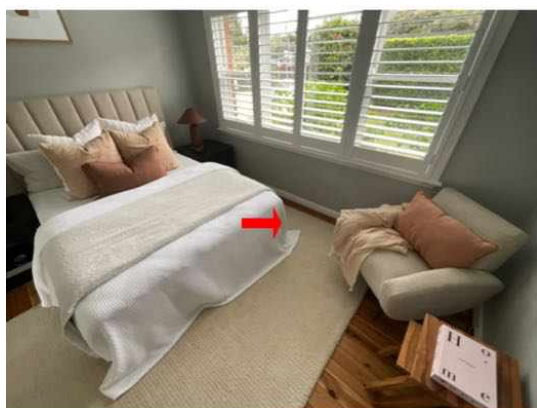
Finding 3.07

Building:	Main Building
Location:	Bedroom

Finding: Floors - bouncy
 Information: The internal flooring in this area was identified as being bouncy at the time of inspection. A bouncy floor surface generally presents as a discernible change in level as they are walked across, in noisy or creaking flooring, or in consequent movement of surrounding furniture and fixtures.

Bouncy floors generally indicate that the floorboards or the subfloor structures are coming loose from the joists that they are installed on. Bouncy flooring may also be the result of gaps between flooring and joist structures, which require packing.

The client is advised to seek quotations for required repairs from a Registered Builder.

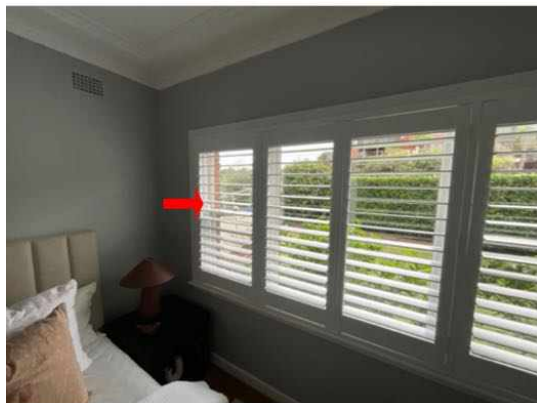
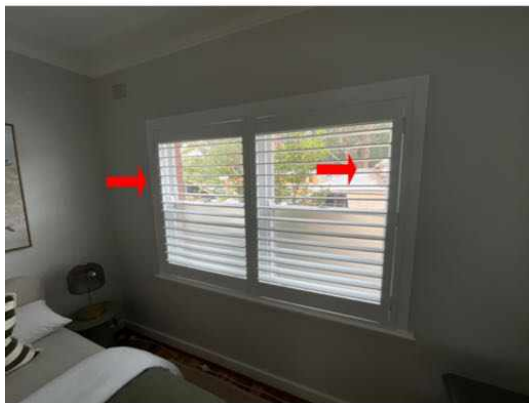
Finding 3.08

Building: Main Building
 Location: Window
 Finding: Windows - Sash cords missing
 Information: Sashes are the moveable panes of windows that primarily slide vertically over each other to expose one half of the window area. Each sash is provided with springs balances and/or compression weather-stripping, which act to hold the window in place in one position.

To facilitate this operation the weight of the glazed panel is usually balanced by steel weights or counterbalances. The sash weight is connected by a cord or chain that runs over a pulley at the top of the frame. These cords are prone to degradation over time and replacement is required.

Repairing or replacing sash cords involves some work and is often best completed by an experienced carpenter or specialist window restorer. It is advised that such works be completed to improve the operational state of the affected window.

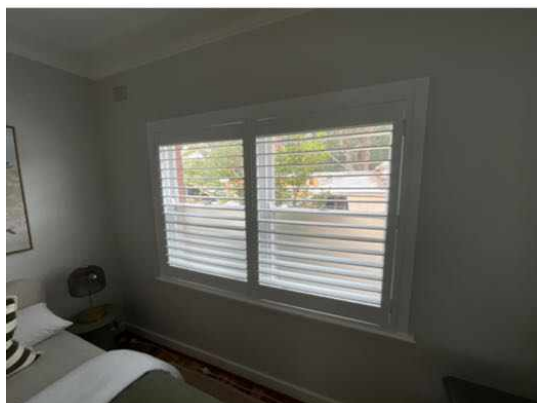
Finding 3.09

Building:	Main Building
Location:	Window
Finding:	Glass - Cracked
Information:	Cracks were identified in the glass in this area. Cracking in glass is generally the result of impact damage, and is likely to develop further when left unmanaged.

A qualified glazier is required to repair the glass.

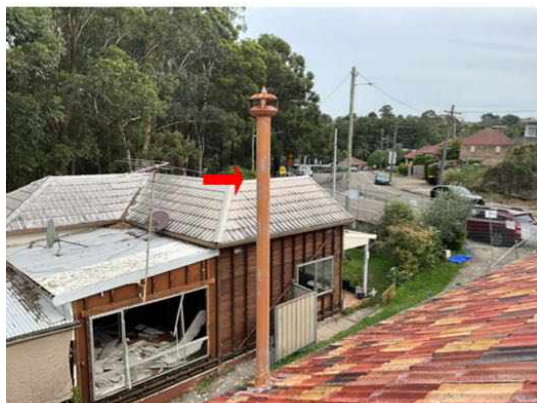
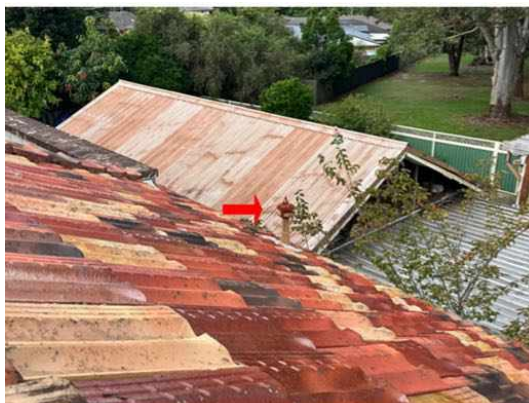
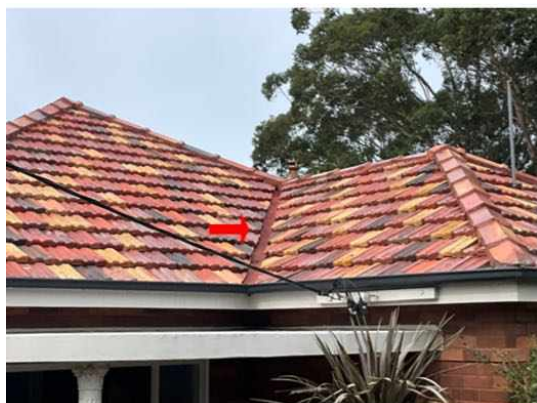
Finding 3.10

Building:	Main Building
Location:	Roof Exterior
Finding:	Building element - Rusted or corroded
Information:	This building element shows evidence of rusting and corrosion, which is likely to have developed as a result of excessive exposure to moisture and or inadequate coatings.

As surface rust provides no protection to the underlying iron, the deteriorating condition is likely to worsen if not addressed in the short-term future.

Where possible, the use of galvanized (treated) metals or aluminium coated metals aid in rust prevention, as does regular general maintenance. Rust formation can be controlled with coatings, such as paint, that isolate the iron from the environment.

Rusting and corrosion should be managed by ideally removing or limiting the affected surface from exposure to moisture.

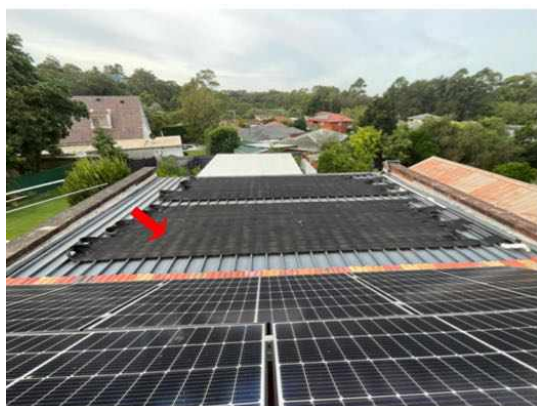
Finding 3.11

Building:	Main Building
Location:	Roof Exterior
Finding:	Roof sheets - Rusted
Information:	Metal roofs generally comprise numerous individual sheets, which join and overlap. These intersections are particularly prone to lift at the edge and consequently rust at these points.

Upon inspection of the exterior roofing structure, evidence of rust to these sections was identified.

A roofing contractor should be appointed to assess the damage to the roofing sheets and to perform remedial works as necessary.

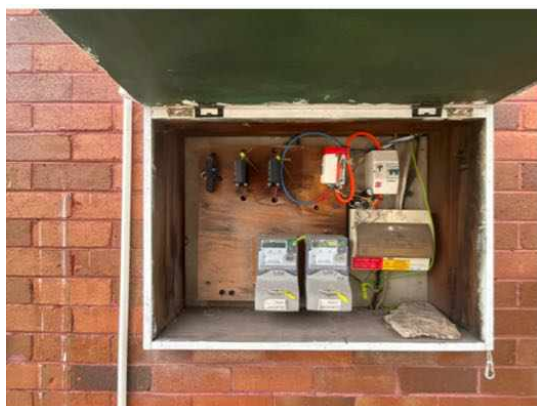
Finding 6.01

Building:	Main Building
Location:	All Areas
Finding:	Termite Management System - no evidence of a chemical installation
Information:	The application of a post-construction chemical termite barrier is highly recommended for all properties, particularly if live termite activity has been found on the site previously. Such barriers are highly effective in preventing termite attack on any timber building elements throughout the property.

A durable notice should be placed in the switchboard unit to indicate current termite barriers. At the time of inspection, it appeared as though no termite management system has been installed, with no evidence to suggest preventative works taking place.

The client may consider gaining further advice from a pest controller as to the costs and procedures involved with this application. It is recommended that obtaining such advice be a short-term priority.

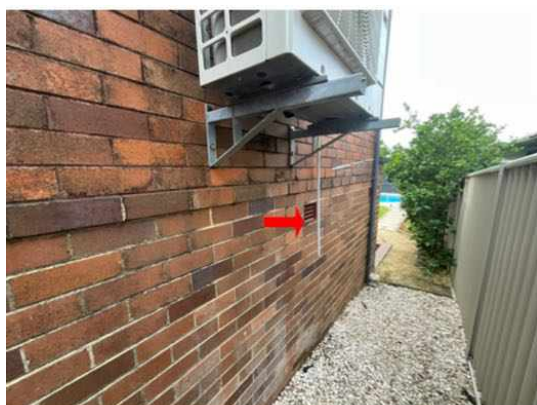
Finding 6.02

Building:	Yard
Location:	Exterior walls
Finding:	Air conditioner - Disconnected overflow
Information:	The Air Conditioner (A/C) overflow was found to be disconnected from storm water drainage and is creating excessive moisture in the surrounding area.

Such leaking creates an environment which is conducive to an array of defects, including water damage to associated building elements and the attraction of termite or timber pest infestation.

It is highly recommended that a licensed plumber be appointed to connect the A/C overflow in order to prevent such an environment from being created. These minor works should be carried out as soon as possible.

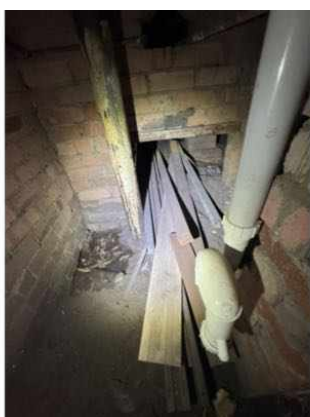
Finding 6.03

Building:	Main Building
Location:	Subfloor
Finding:	Subfloor - Debris
Information:	An array of debris was found in the subfloor area at the time of inspection. Debris in this area restricts subfloor ventilation and creates potential for concealed pest entry.

Stored timbers and other materials may also make the area susceptible to termite activity and wood rot.

A clear and empty subfloor will be better ventilated and easier to maintain in a dry condition. The removal of any timber debris is vital in minimising the risk of termite or wood borer activity.

Debris in the subfloor should be removed as soon as possible. Depending on the location and amount of debris and stored items, the homeowner may elect to undertake this task. Alternatively there are a large number of rubbish removal subcontractors that could undertake these works.

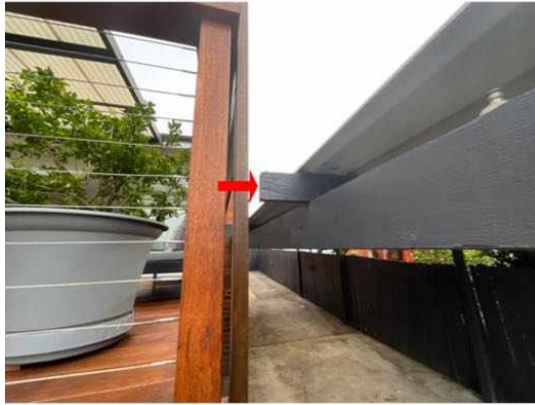
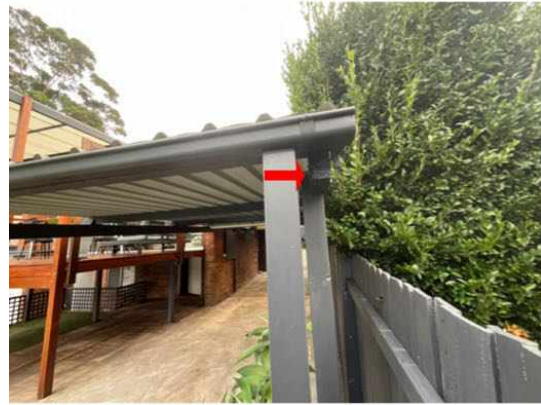
Finding 7.01

Building:	Main Building
Location:	External Areas
Finding:	Fungal decay - present (localised)
Information:	Fungal decay also known as wood decay or wood rot generally refers to the deterioration of timber elements when in contact with excessive levels of moisture for a prolonged period of time.

The development of fungal decay is accelerated by temperatures in the range of 5degreeC to 40degreeC as well as the presence of oxygen. Generally fungal decay develops on timber elements that are in use in an external environment which are exposed to rain penetration.

In this case although the affected timber element is in a decaying state the extent of any visible damage appears to be localised to a specific area and is yet to spread to other parts of the building element or affect adjoining structures. The fungal decay is therefore likely to be of a relatively superficial nature with minimal impact on the structural integrity or tensile strength of the timber element.
