Building and Timber Pest Inspection Report

Inspection Date: Tue, 27 Jan 2026

Property Address: 625 Browns Plains Rd, Crestmead QLD
4132, Australia

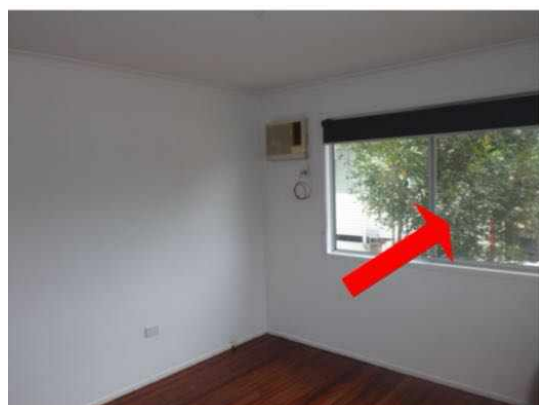
Building: Main Building
Location: Bedrooms > Existing
Finding: Window safety
Information: It was noted that the windows of the upper level bedrooms are less than 1.7m from the floor and have a fall greater than 2m on the exterior from the sill and as such are required to only open upto 125mm or have security grills fitted.

This is noted as a safety concern and this regulation may not have been in place at the time of construction.

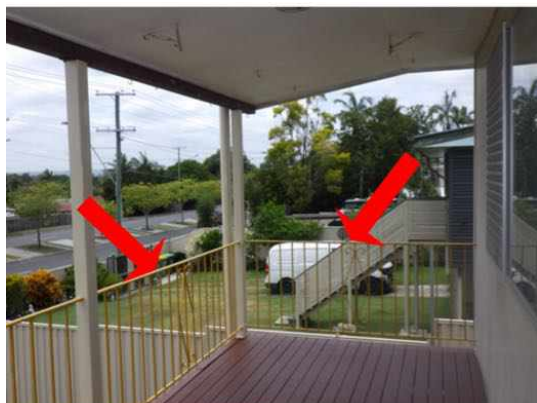
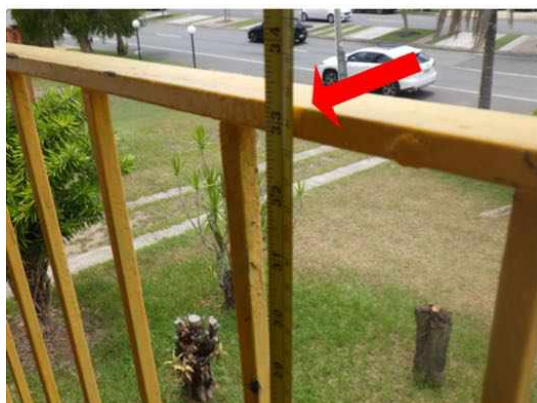
Finding 1.02

Building: Main Building
 Location: Balcony > Existing
 Finding: Balustrade - Suspected Non-Compliance
 Information: The balustrade to the front balcony was measured and found to be (.840mm high) less than the present building regulation requirement of 1000mm high.

This defect creates a potential safety hazard and should be rectified to ensure the safety of the area and to meet present building standards and regulations.

A registered builder should be contacted to discuss possible rectification solutions.

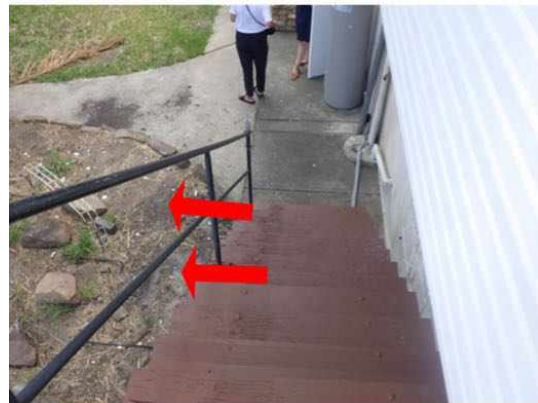
Finding 1.03

| Information: | The balustrade to the rear stair area landing was measured and found to be (.840mm high) less than the present building regulation requirement of 1000mm high. Additionally the gaps between the balustrade railing were found to be (.370mm wide) greater than the present building regulation requirement of 125mm. |

This defect creates a potential safety hazard and should be rectified as soon as possible to ensure the safety of the area and to meet present building standards and regulations.

A registered builder should be contacted to discuss possible rectification solutions.

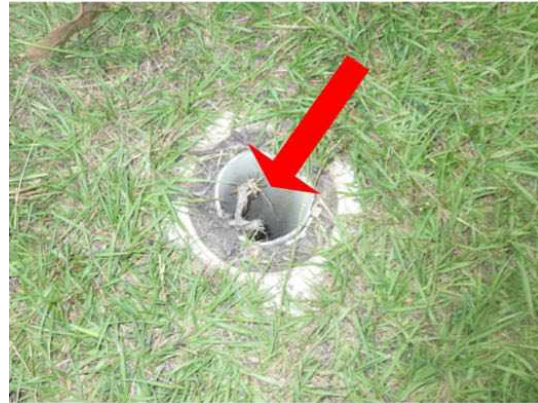
Building: Main Building
 Location: Yard - Front > Front Right
 Finding: Sewer line - Caps Missing
 Information: At the time of inspection it was noted the sewer line cap was missing on the front left side of the property.

It is assumed the caps have been previously removed.

A licensed plumber or general handyman could be engaged to replace the sewer line caps..

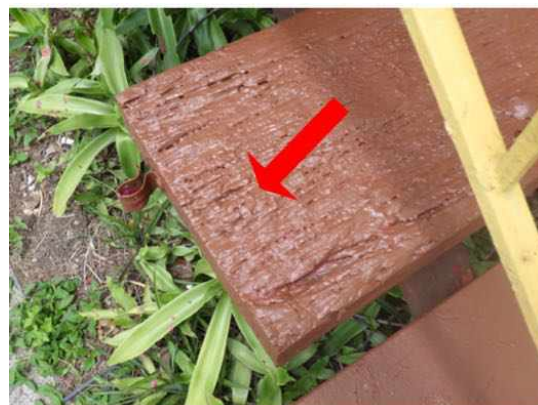
Finding: Stair treads - Deteriorated

Information: It was noted at the time of inspection that a number of the external timber stair treads to the front and rear of the property have deteriorated (as per example photos). Typically timber stair treads deteriorate due to age and or wear, rot and or rust which is generally expected for a structure of this age, due to prolonged exposure to weather conditions. Sometimes inadequate installation or maintenance can be to blame.

If left unattended, it is likely that further damage will occur. It is suspected that repair or replacement of several elements timber stair treads may be required.

A licensed carpenter could be appointed to provide further advice and perform rectification works as necessary.

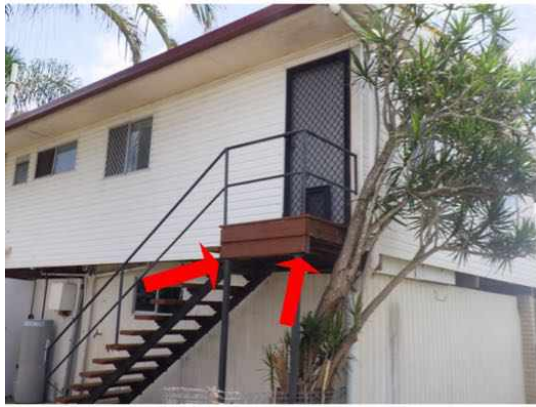
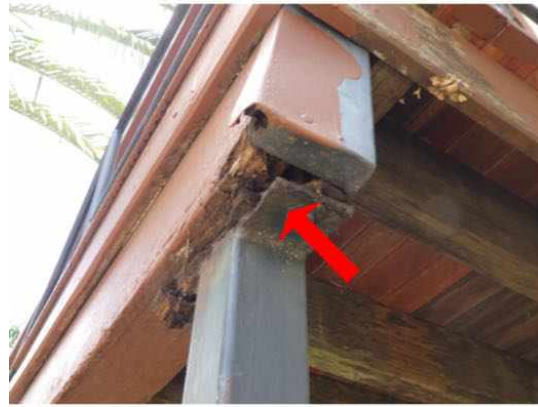
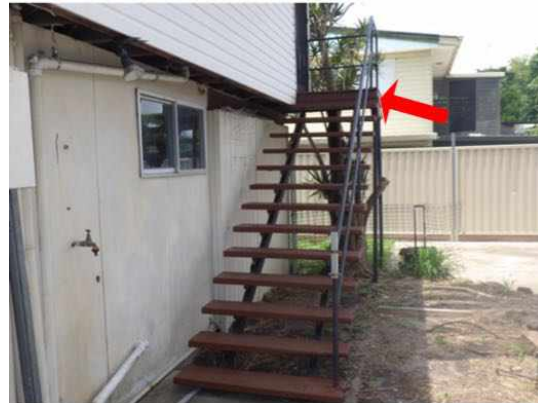
Finding 3.05

| Finding: | Steel posts- Rusted or corroded |
| Information: | The steel support posts to the rear stair landing area show evidence of rusting and corrosion, which is likely to have developed as a result of excessive exposure to moisture and or inadequate coatings. |

As surface rust provides no protection to the underlying iron, the deteriorating condition is likely to worsen if not addressed in the short-term future.

Where possible, the use of galvanized (treated) metals or aluminium coated metals aid in rust prevention, as does regular general maintenance. Rust formation can be controlled with coatings, such as paint, that isolate the iron from the environment.

Rusting and corrosion should be managed by ideally removing or limiting the affected surface from exposure to moisture. A registered builder should be appointed to replace the support posts that have been severely affected by rust or water damage.

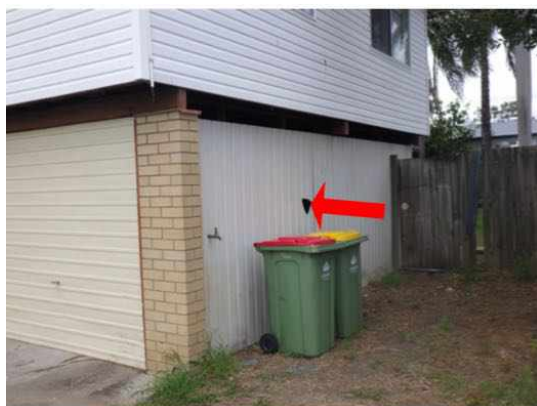
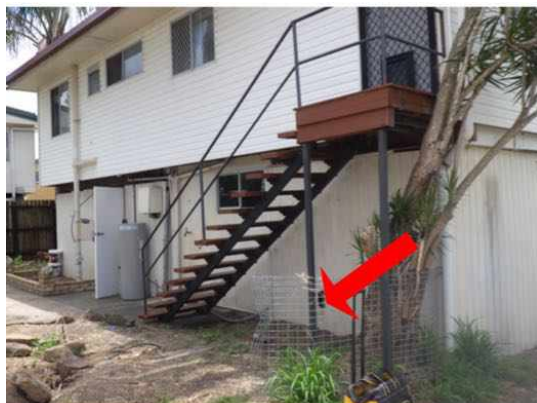
Finding 3.06

| Finding: | Walls - Damaged |
| Information: | At the time of inspection the wall cladding to the ground floor exterior of property were found to have suffered deterioration and damage in a number of areas (as per example photos). The damage may have been sustained as a result of a number of possible causes, including minor impact damage. |

The damage to the wall cladding in these areas detracts from the appearance of the structure.

NOTE - The lower area wall cladding maybe an asbestos containing materials.

A licensed carpenter or general handyman could be engaged to undertake repair work.

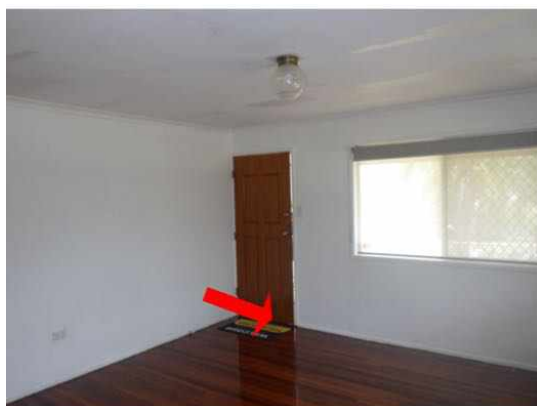
Finding 3.07

Building: Main Building
 Location: Entry > Front
 Finding: Door - Binding/Jamming
 Information: Binding and/or jamming of the entry door on the door sill was evident during standard operation. This defect inhibits the functionality of affected door as well as creating potential for secondary defects to associated building elements, such as damage to the door framing.

A door that binds to the associated door frame or sill may have several causes, such as poor installation of the door or deteriorated hinges.

A qualified carpenter or general handyperson could be appointed to perform minor rectification works at client discretion.

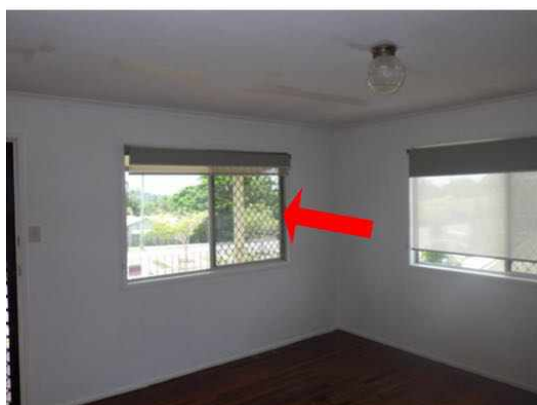
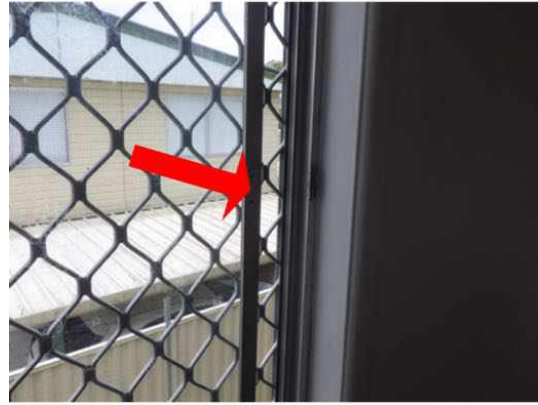
Finding 3.08

Building: Main Building
 Location: Living Room > Front Left, Centre Left
 Finding: Window - Broken latch
 Information: The window latches to the living room area sliding windows were found to be missing or broken at the time of inspection. Breakage occurs generally when the building materials have aged and decayed, but may be indicative of impact damage (accidental or deliberate).

Repair and/or replacement of the broken window catches is advised to improve the operational state of the associated windows.

An aluminium window service agent or general handyman should be appointed to repair/replace the window latch at the client's discretion.

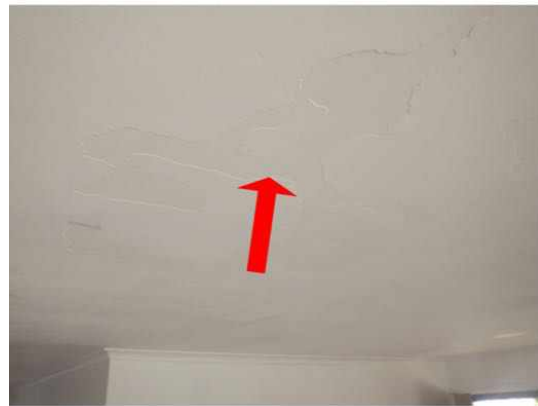
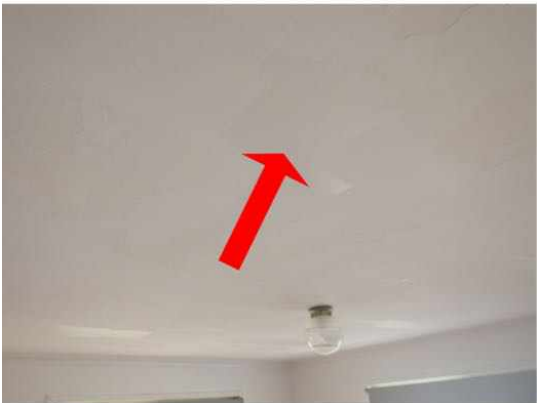
Finding 3.09

Building: Main Building
 Location: Living Room > Existing
 Finding: Ceiling Surface - Disfigurement
 Information: At the time of inspection the living room area ceiling surface showed evidence of significant surface disfigurement (cause unknown).

The level of damage may be the result of previous calcimine paint issues. In older homes original calcimine paint can become unstable, leading to severe peeling and flaking.

It is highly recommended a licensed painting contractor be engaged for further investigation and/or rectification options.

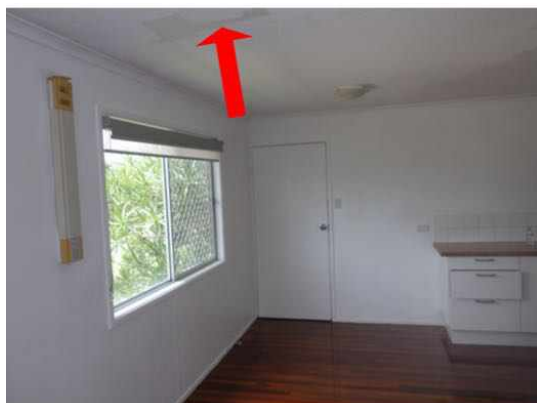
| Information: | At the time of inspection the dining room area ceiling surface showed evidence of significant surface disfigurement (cause unknown). |

The level of damage may be the result of previous calcimine paint issues. In older homes original calcimine paint can become unstable, leading to severe peeling and flaking.

It is highly recommended a licensed painting contractor be engaged for further investigation and/or rectification options.

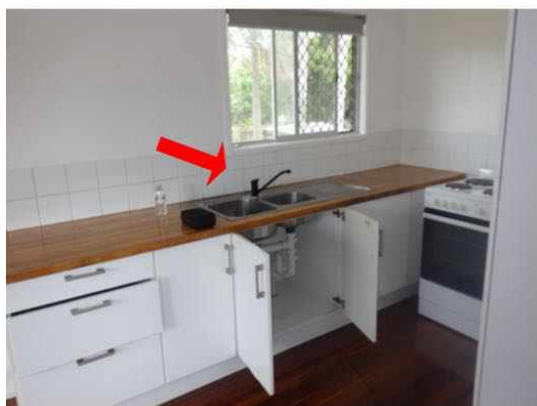
Finding 3.12

| Finding: | Tile - Cracked |
| Information: | Cracked tiles to the kitchen splash back area was identified at the time of inspection. Such defects are generally caused by impact. Cracked or broken tiled areas may also be a direct result of poor workmanship during the construction process. |

A tiling contractor could be appointed to perform repair works at the clients discretion.

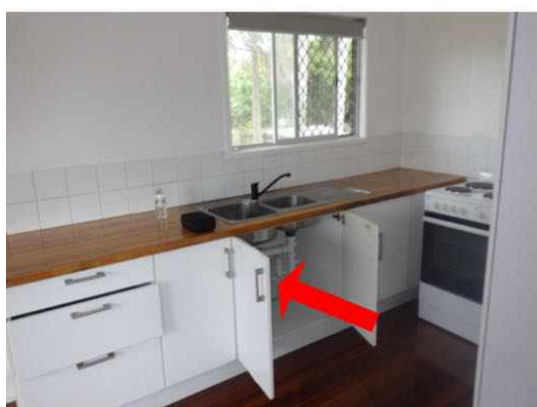
Finding 3.13

Building: Main Building
 Location: Kitchen > Centre Left
 Finding: Cabinetry - Deterioration
 Information: At the time of inspection the kitchen cabinetry showed signs of minor deterioration. The level of damage appears consistent with exposure to moisture or general wear and tear.

A qualified cabinet maker or general handyman could be engaged to undertake repair works at the clients discretion.

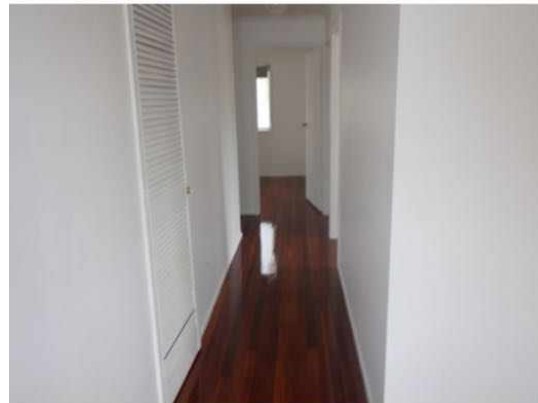
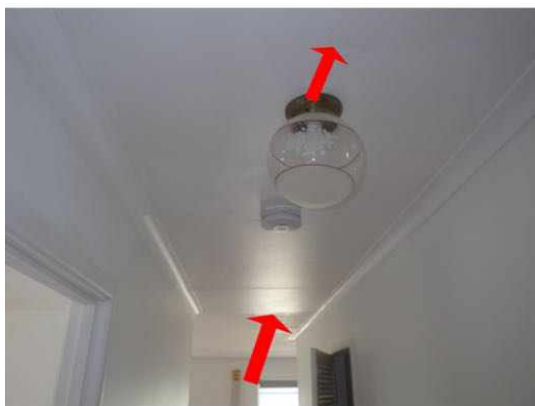
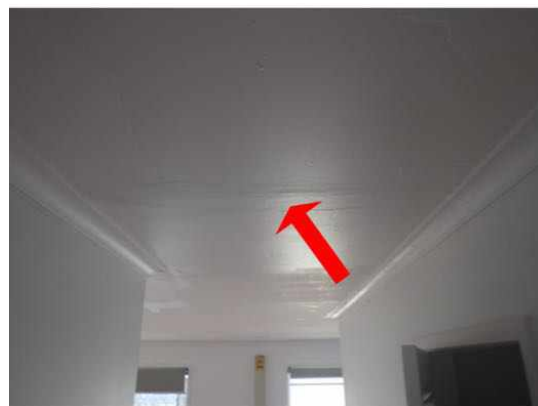
Finding 3.14

Building: Main Building
 Location: Hallway > Existing
 Finding: Ceiling Surface - Disfigurement
 Information: At the time of inspection the hallway area ceiling surface showed evidence of significant surface disfigurement (cause unknown).

The level of damage may be the result of previous calcimine paint issues. In older homes original calcimine paint can become unstable, leading to severe peeling and flaking.

It is highly recommended a licensed painting contractor be engaged for further investigation and/or rectification options.

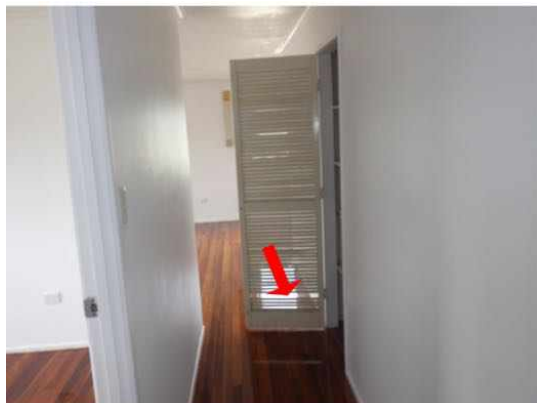
Finding 3.15

| Finding: | Damaged Door |
| Information: | The linen cupboard door in the hallway has suffered damage to the bottom louvres. |

Damage occurs generally when the building materials have aged and decayed, but in this instance the damage appears to be the result of impact.

A qualified carpenter or general handyman could be appointed to repair/replace the door at the clients discretion.

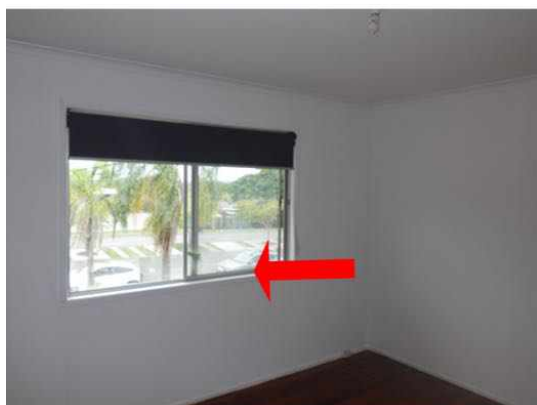
Generally, factors such as general age of the building element and a lack of maintenance are the usual causes for this type of defect.

An aluminium window service agent will be required to repair the affected windows.

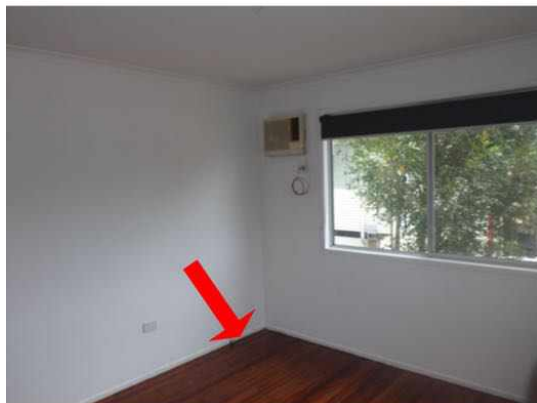
Finding 3.20

Building: Main Building
Location: Bedroom 2 > Front Left
Finding: Internal Floor - Holes
Information: Holes were identified in the bedroom 2 area timber floors. It is suspected that the holes are from a previously removed fixture or fittings.

Such works may be conducted by a general handy man.

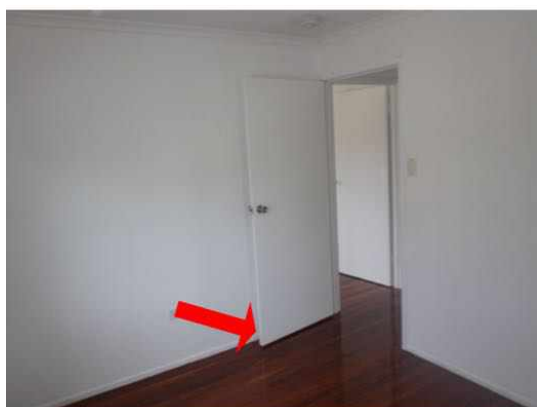
Finding 3.21

Building: Main Building
 Location: Bedroom 3 > Front
 Finding: Door stop - Missing
 Information: The bedroom 3 door stop is missing or is inadequate to stop the door handle from damaging the wall.

Re-installation or replacement of the door stop is advised to prevent any subsequent damage to the wall linings or associated structures.

A general handyman may be appointed to perform these works at client discretion.

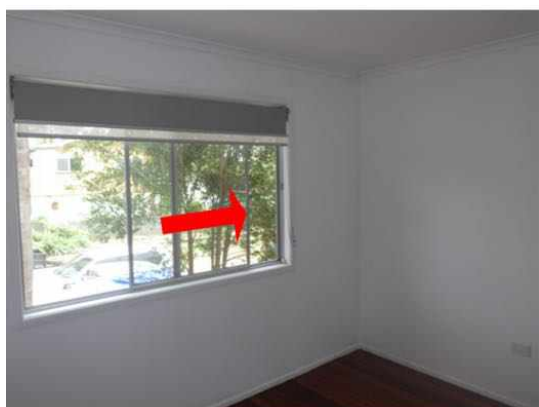
Finding 3.22

Building: Main Building
 Location: Bedroom 3 > Rear Right, Centre Left
 Finding: Window - Broken latch
 Information: The window latches to the bedroom 3 sliding windows were found to be missing or broken at the time of inspection. Breakage occurs generally when the building materials have aged and decayed, but may be indicative of impact damage (accidental or deliberate).

Repair and/or replacement of the broken window catch is advised to improve the

An aluminium window service agent or general handyman should be appointed to repair/replace the window latch at the client's discretion.

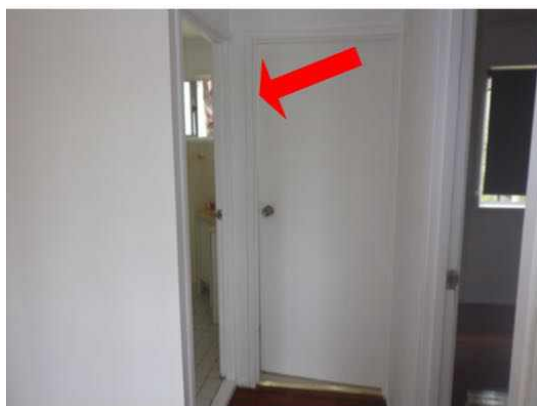
| Information: | Binding and/or jamming of the WC door on the door frame was evident during standard operation. This defect inhibits the functionality of affected door as well as creating potential for secondary defects to associated building elements, such as damage to the door framing. |

A door that binds to the associated door frame or sill may have several causes, such as poor installation of the door or deteriorated hinges.

A qualified carpenter or general handyperson could be appointed to perform minor rectification works at client discretion.

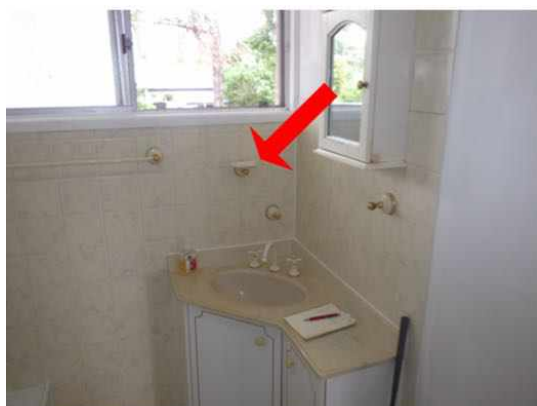
Finding 3.25

Building: Main Building
 Location: Bathroom > Rear Right
 Finding: Soap holder - Damaged
 Information: The bathroom area soap holder was found to be damaged at the time of inspection.

A general handyperson may be required to replace the damaged soap dish.

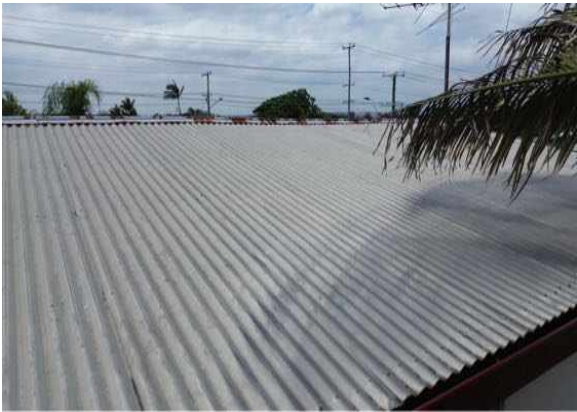
Finding 3.26

Building: Main Building
 Location: Roof Exterior > Existing
 Finding: Roof Photos
 Information: Roof area photos were taken with the DJI Mini 3 Drone flown over the roof at the time of inspection.

The metal ridge capping to the roof sheeting was found to be suffering from surface rust along the full length.

A qualified metal roofing contractor could be engaged to provide further advice and/or undertake rectification work.

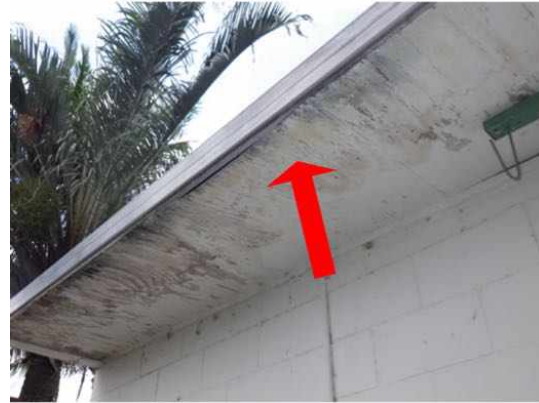
Finding 3.27

Building: Shed
 Location: Eaves > Centre Right
 Finding: Eaves - Damaged
 Information: At the time of inspection the eaves around the exterior of the shed area were found to have suffered deterioration and damage in a number of areas. The damage may have been sustained as a result of a number of possible causes, including poor roof drainage, leaking roof plumbing or minor impact damage.

The damage to the eave sheeting in these areas detracts from the appearance of the structure.

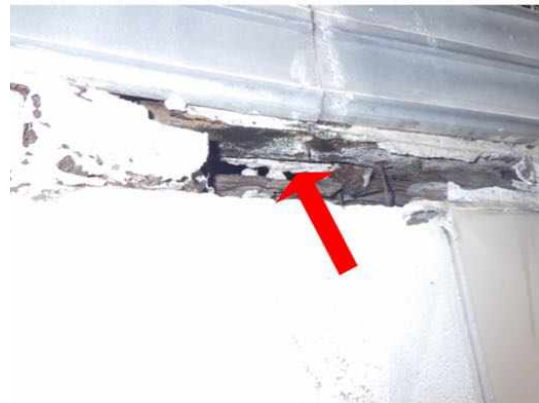
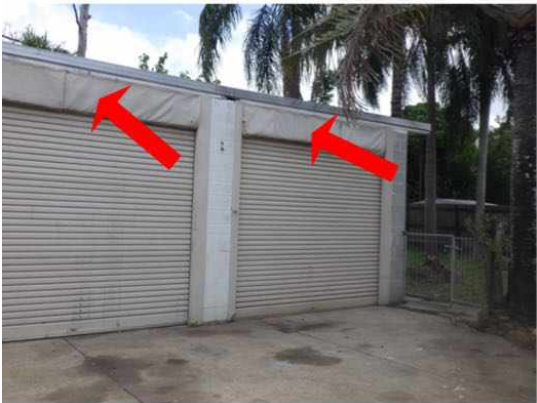
Finding 3.28

Building: Shed
 Location: Exterior walls - front > Centre
 Finding: Wood Rot
 Information: At the time of inspection an area of the timber facing board and/or cladding to the front of the shed showed signs of wood rot. The wood rot damage appears to be caused from excessive moisture in the area.

The client could engage a qualified carpenter to investigate further and undertake repair work as required.

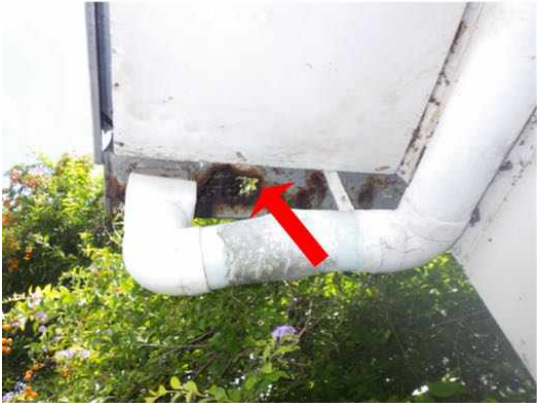
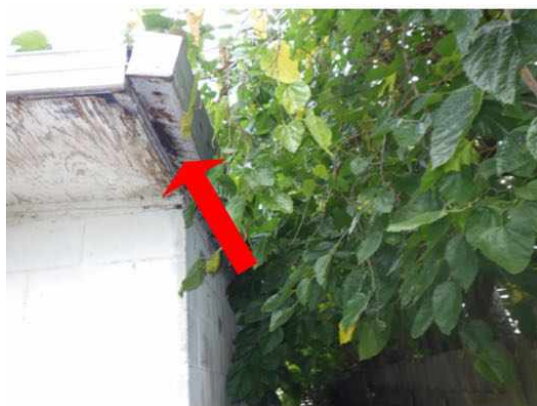
Finding 3.29

Building: Shed
Location: Roof Exterior > Rear
Finding: Gutter - Rusted
Information: Upon inspection of the shed area exterior guttering, evidence of significant rust or damage was identified.

A roofing contractor could be appointed to assess the damage to the roof guttering and to perform remedial works as necessary.

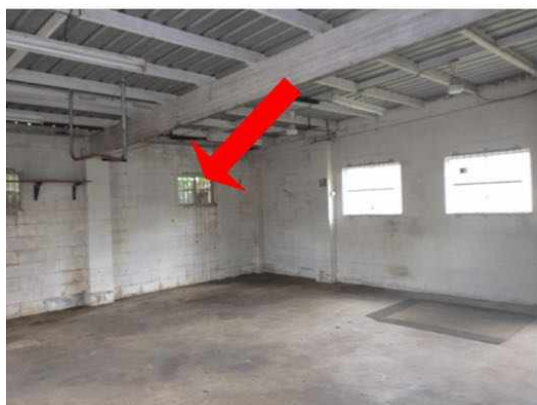
Finding 3.30

Building: Shed
 Location: Exterior walls - rear > Rear Right
 Finding: Window - missing
 Information: The window panel to the shed area rear right sliding window was found to be missing at the time of inspection. Breakage occurs generally when the building materials have aged and decayed.

An aluminium window service agent or general handyman should be appointed to replace the window panel at the client's discretion.

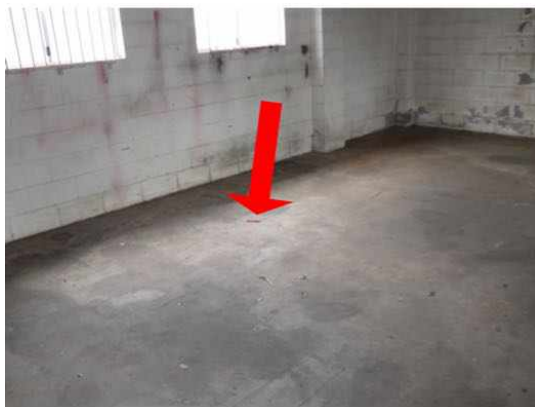
Finding 3.31

Building: Shed
 Location: Internal Areas > Ground Level
 Finding: Cracking in concrete slab - Category 1
 Information: Cracking coded as Category 1 was identified in the shed area concrete floor slab. A Category 1 crack is described as a fine but noticeable crack, with the slab at an otherwise reasonable level.

Category 1 cracks should be monitored for a period of 12 months. At the end of the monitoring period, identified cracks that are rated greater than Category 2 are considered defects, and require rectification.

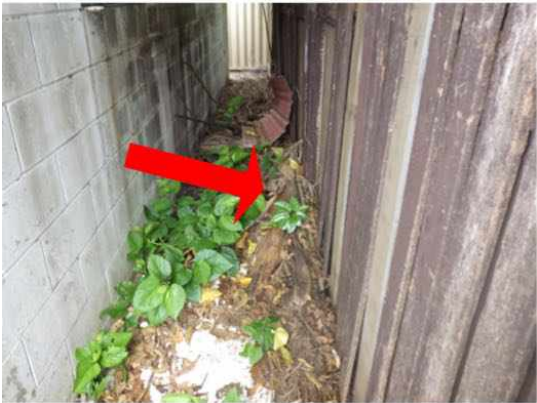
Finding 6.02

Building: Main Building
 Location: Yard - Back > Rear Left
 Finding: Garden Beds - Conditions Conducive to Termites
 Information: Garden beds and external landscape areas were found to contain tree stumps, debris and garden waste at the time of inspection (as per example photos). These garden beds can include untreated timber, and with a combination of moisture from watering hosing can make conditions conducive to termite activity and termite ingress. Removal of any garden debris or vegetation is advised. Frequent pest inspections are advised to readily identify any termite activity in these areas.
