Building Inspection Report

Inspection Date: Fri, 6 Mar 2026

Property Address: 24 Webster Ave, CROYDON, VIC, 3136,
Australia

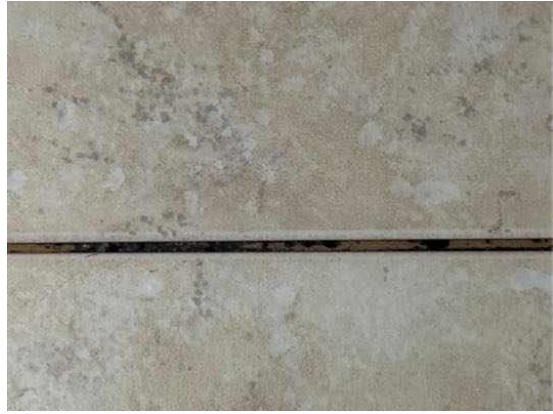
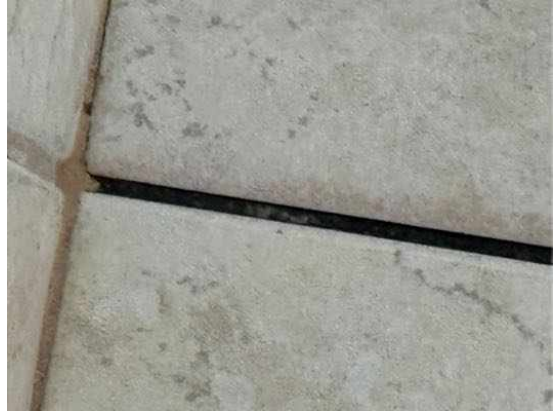
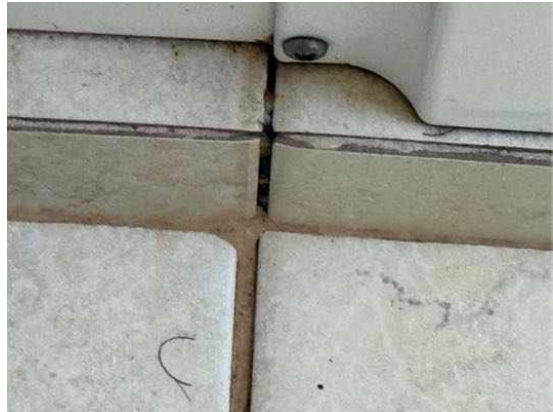
Defects 3.01

Building: Building 1
Location: All Areas > All Areas
Finding: Bathroom and en-suite shower cubical grout dislodged
Information: The bathroom and en-suite shower cubical grout was observed to have minor areas of grout that is missing or dislodged. Grout is used to protect gaps and crevices in building materials to ensure that they are water-tight and prevent water penetration to the associated floor and wall structures. The other side of the wall was test with a moisture meter at the time of the inspection showing a higher than normal moisture reading.

The shower alcove showed areas where the grout had been dislodged frame between the shower floor tiles. It is suspected that moisture has penetrated below the tiles. This defect needs to be rectified immediately or in the very short future. To prevent further secondary damage, the client should not use this shower before these defects are rectified.

Where the grout is found to be missing or dislodge from these shower base joins, a tiling contractor should be appointed immediately or in the short term future to re-apply grout and any sealants where deemed to be necessary. Failure to do so is highly likely to lead to further water damage and deterioration over time to the surrounding adjoining floor, wall structures and other building elements in the adjoining areas.

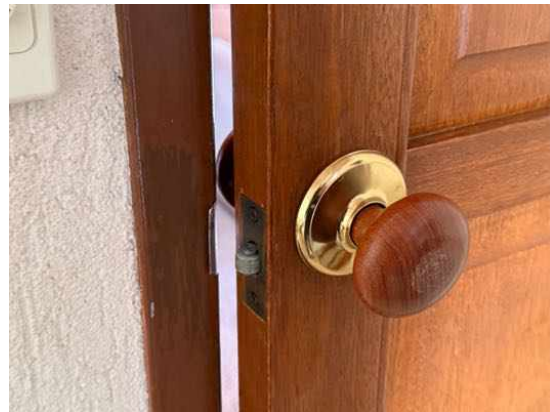
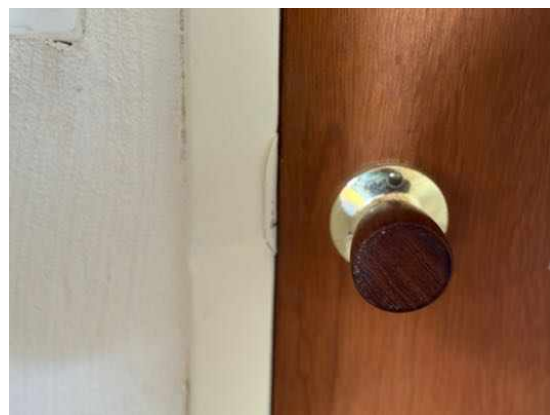
Defects 3.02

Building: Building 1
 Location: All Areas > All Areas
 Finding: Door adjustments
 Information: A couple of doors were observed to be binding and/or rubbing on the door frames during standard operation. This defect is suspected to inhibit the functionality of the affected door as well as creating potential for secondary defects to associated building elements, such as secondary damage and defects to the adjoining building elements. A door that binds to the associated door frame may have several causes, ranging from minor defects, such as poor installation of the door or deteriorated hinges.

Sliding door to top storey bathroom was observed to require some remedial work to replace or rectify the sliding door track or maintenance to make good. Generally, factors such as a lack of maintenance or general deterioration are the usual causes for this type of defect. Replacement of some door hardware may be required where deemed to be necessary, as well as minor repairs and cleaning. A qualified carpenter will be required to carry out remedial work on the affected doors.

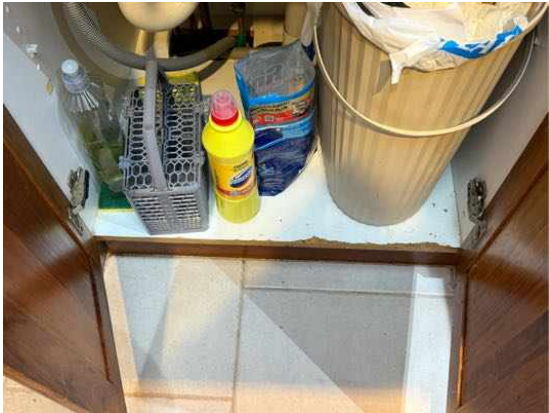
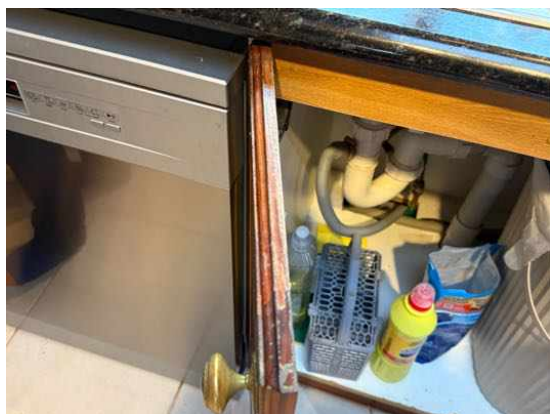
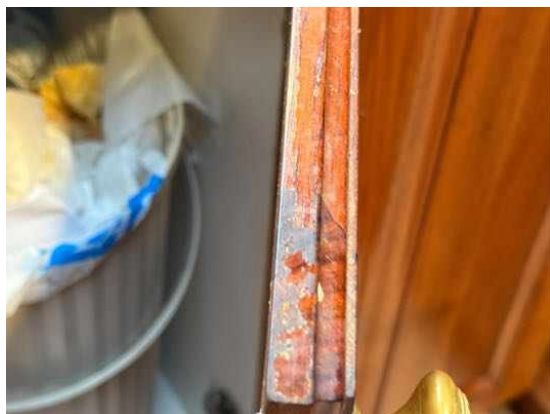
Defects 3.03

Building: Building 1
 Location: All Areas > All Areas
 Finding: Kitchen cabinetry

The kitchen cabinetry including cabinet doors and drawers showed signs of some moisture damage on the base of the sink cabinet carcasse and these two doors. Some maintenance, remedial work or repair is required to ensure further deterioration does not continue further. Although these defects may detract from the overall looks of the cabinetry, in most cases it does not necessarily affect the operational state of the cabinetry.

To improve the operation of these affected cabinets, cabinet doors or drawers, a qualified cabinet maker or carpenter may be appointed to rejuvenate rectify or repair any cabinetry as deemed to be necessary. Such works should be completed at discretion of the client.

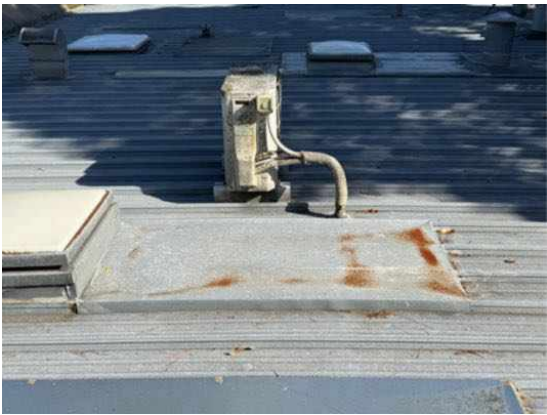
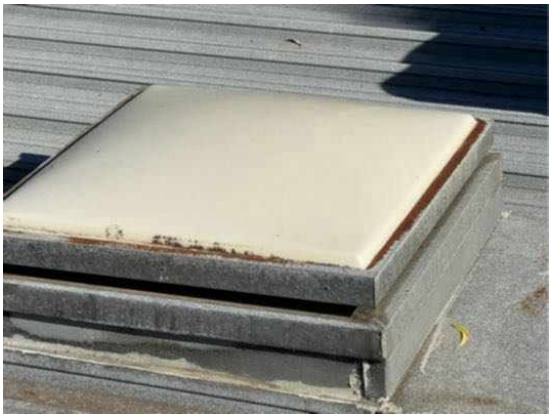
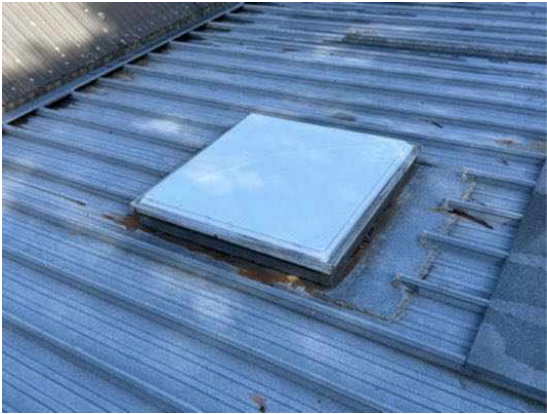
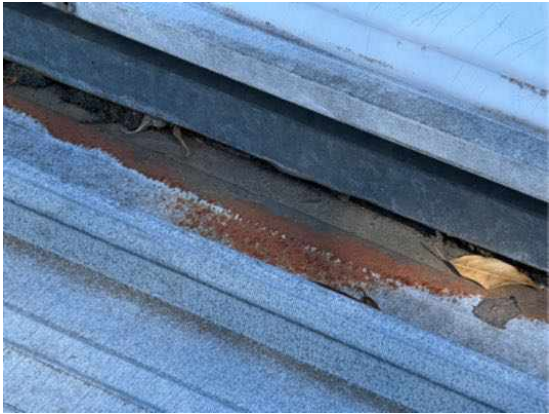
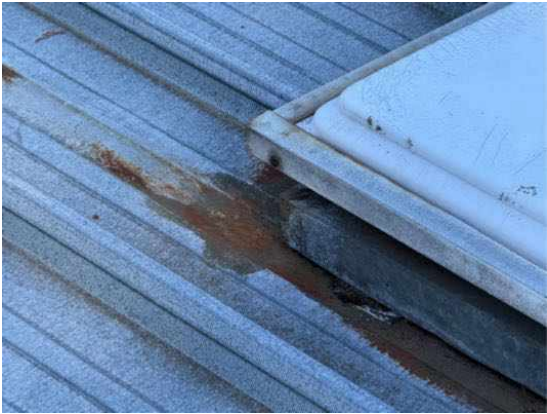
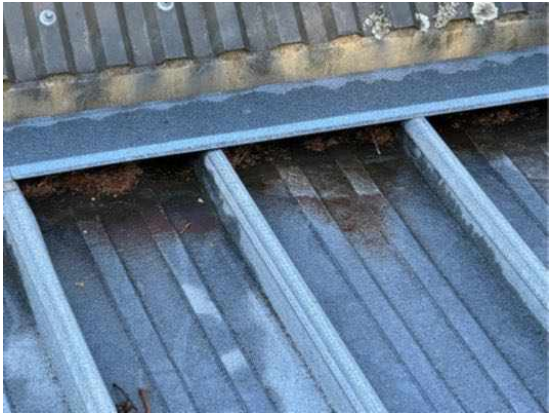
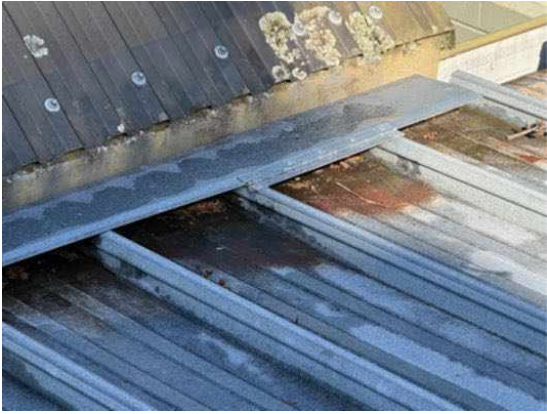
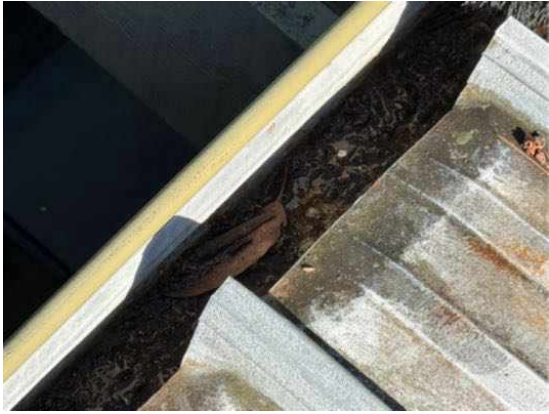
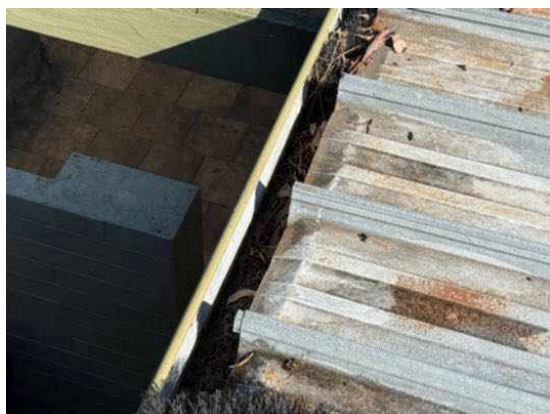
Defects 3.04

Building:	Building 1
Location:	All Areas > All Areas
Finding:	Roofing iron and roof flashings show rust and deterioration
Information:	At the time of the roof inspection it was observed that numerous areas of the rear exterior roofing iron was showing signs of rust and deterioration. It is highly recommended that the client appoint a registered roofing plumber to provide advice and the remedial work to either replace or the maintenance to neutralise rust to ensure the roofing iron and flashings remains weathertight and waterproof.

The rear exterior roofing iron was showing signs of rust and deterioration. It is highly recommended that the client appoint a registered roofing plumber to provide advice and the remedial work to either replace or the maintenance to neutralise rust to ensure the roofing iron and flashings remains weathertight and waterproof.

While the rust and weathering on the roofing iron is consistent with the age of the property, it is highly recommended that this remedial repair work and maintenance works are carried out in the short term future to maintain and prevent further rust, damage and deterioration. Where left unmanaged, deteriorating roofing is likely to lead to secondary defects over time, remedial works and maintenance of the roofing iron is suspected to increase in the future.

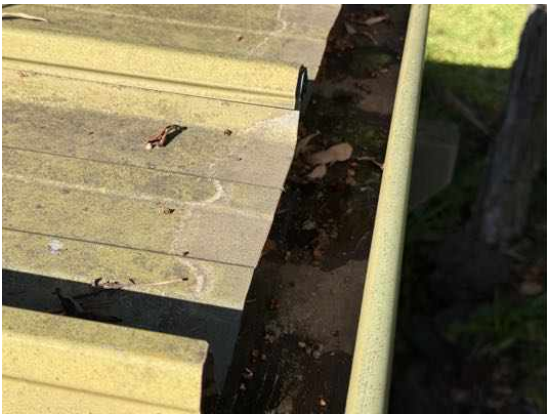
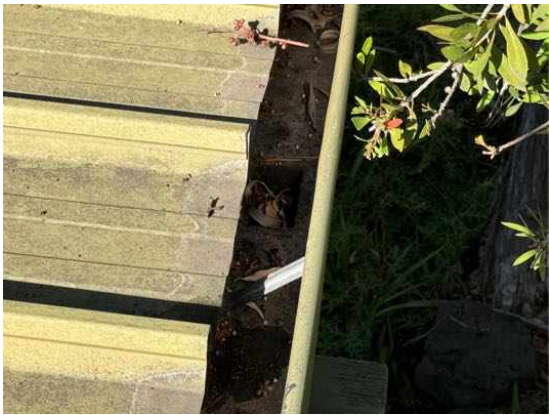
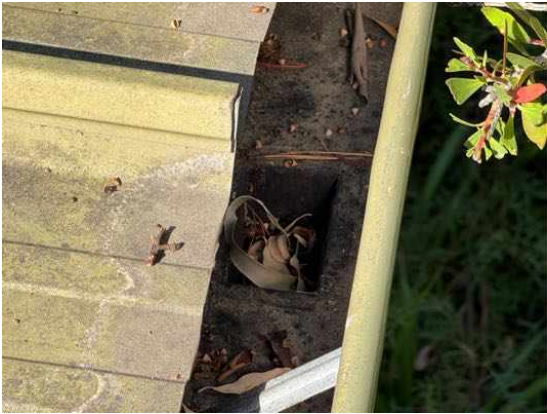
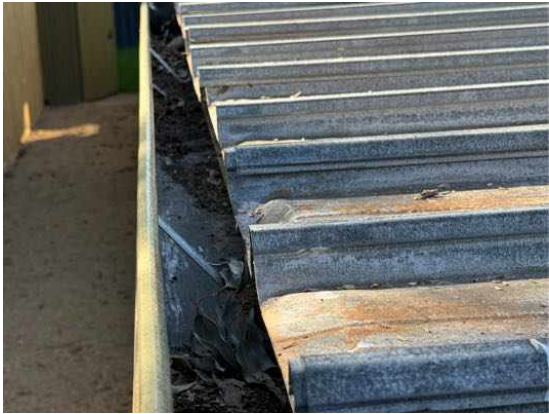
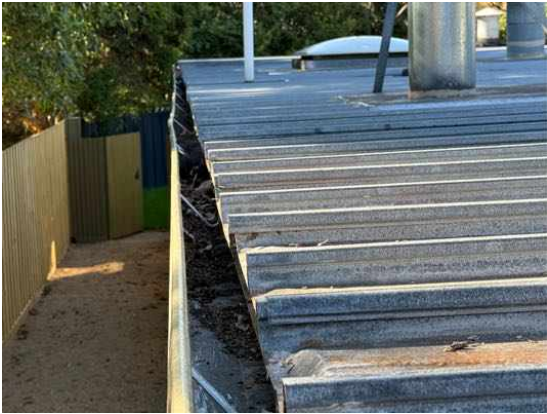
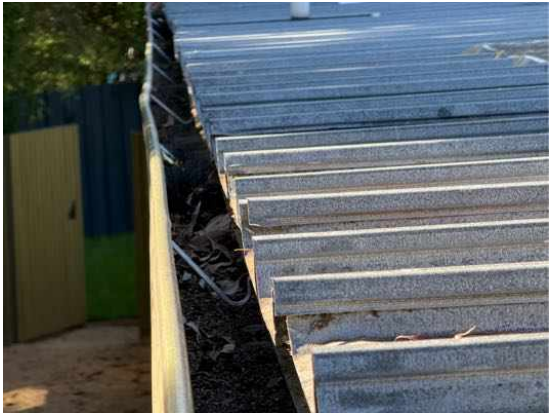
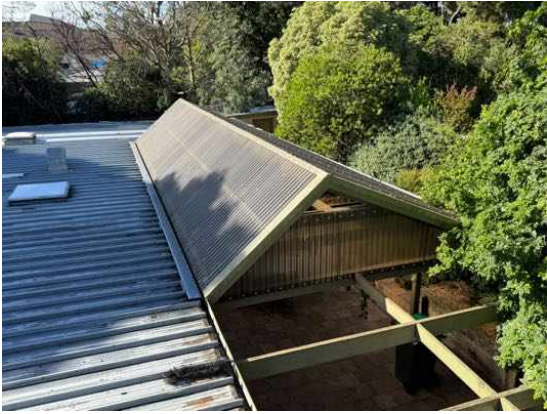
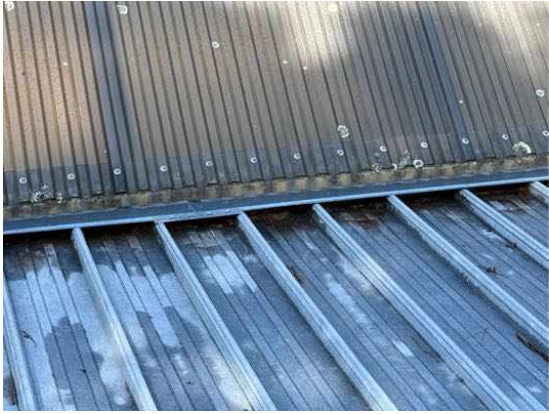
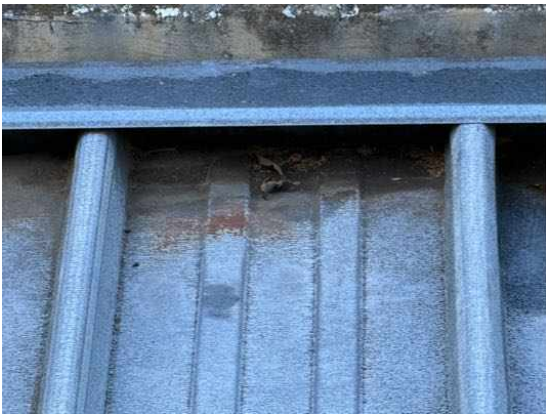
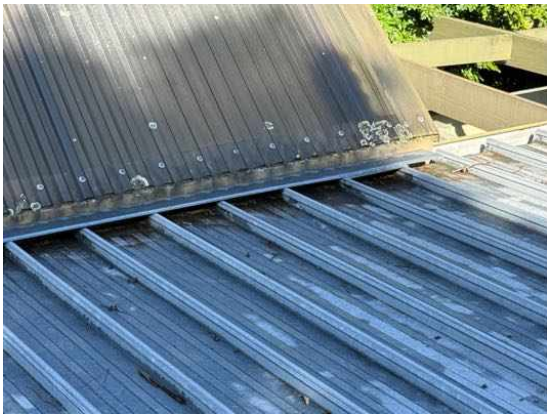
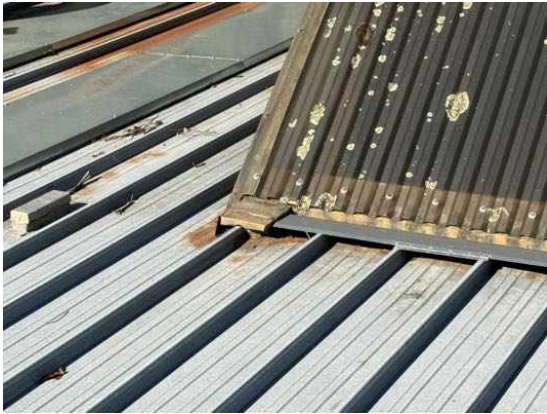
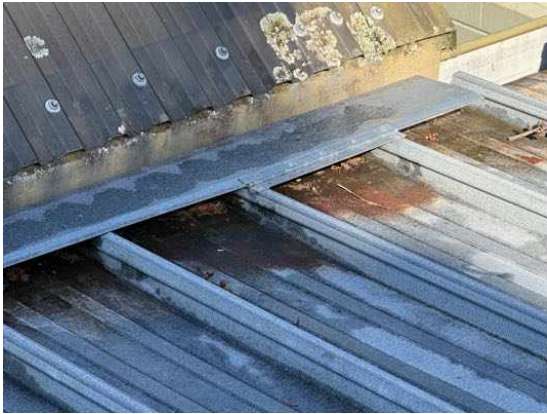
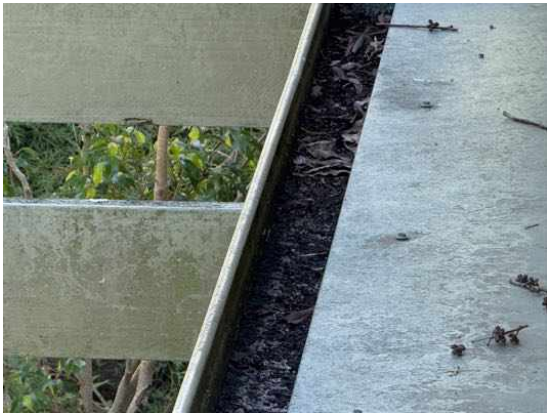
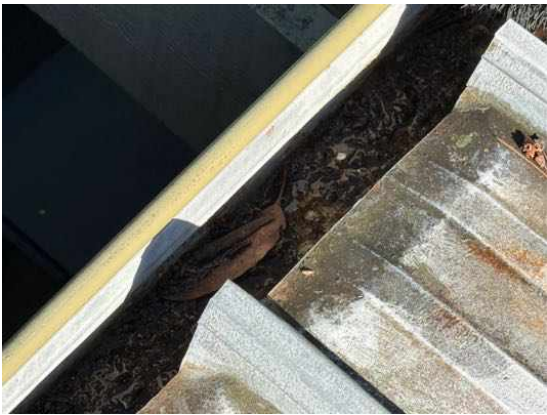
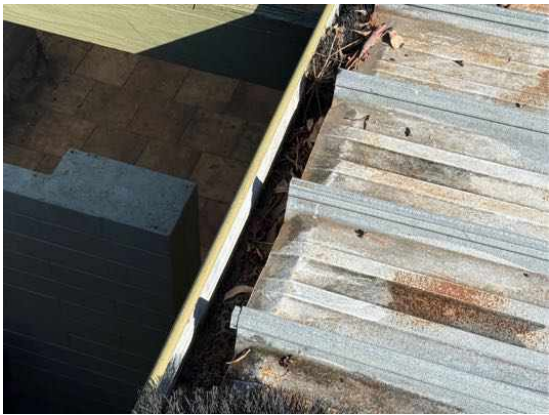
Defects 3.05

Building:	Building 1
Location:	All Areas > All Areas
Finding:	Gutters - minor blockages
Information:	Client should expect to clean out gutters regularly due to high standing trees around the perimeter of the property. This maintenance and the clearing out of the gutters is considered to be very important to prevent blockages of the guttering and downpipes which will lead to water pooling and accumulated water overflows, which is likely to subsequently flood exterior walls and enter internal areas and damage building structures and other building elements. Roof plumbing structures, such as guttering and downpipes, should be free of all debris to prevent blockages.

Blocked gutters are likely to lead to high levels of moisture in the affected areas. Such moisture will not only cause rust and decay of the associated building materials, but can also provide conditions that are conducive to termite and timber pest activity. Blockages in gutters should therefore be removed immediately to ensure dry conditions are maintained. It is recommended that blocked gutters be cleaned and leaf matter and debris be removed by a relevant tradespersons regularly, this may involve in the client appointing a gutter cleaning company regularly, periodically cleaning these gutters out.

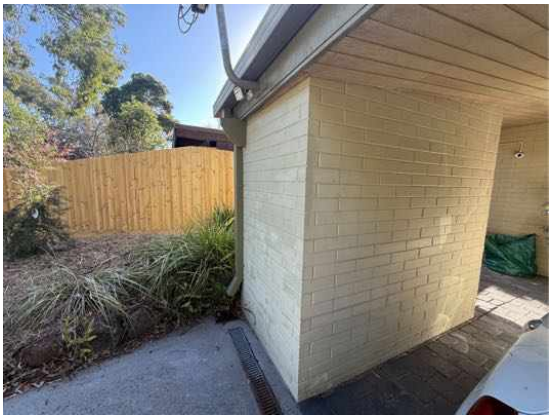
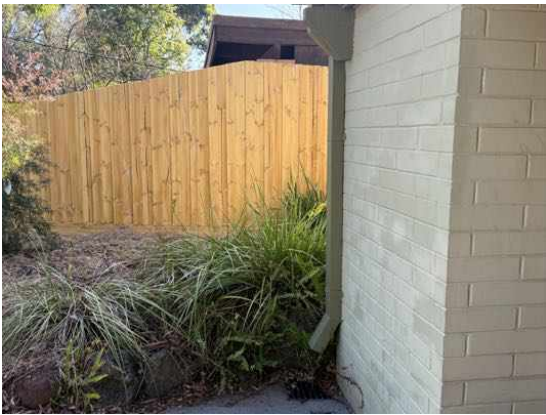
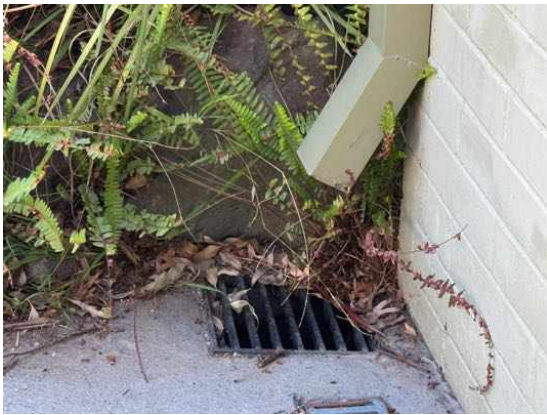
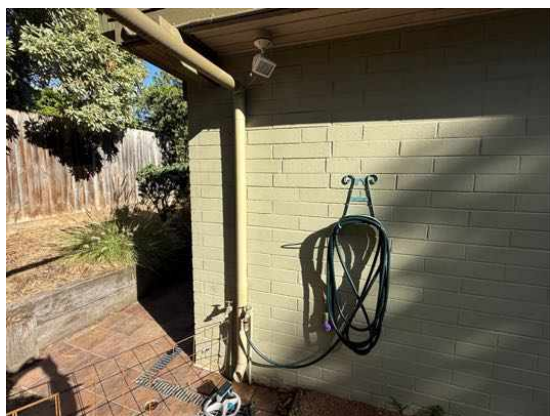
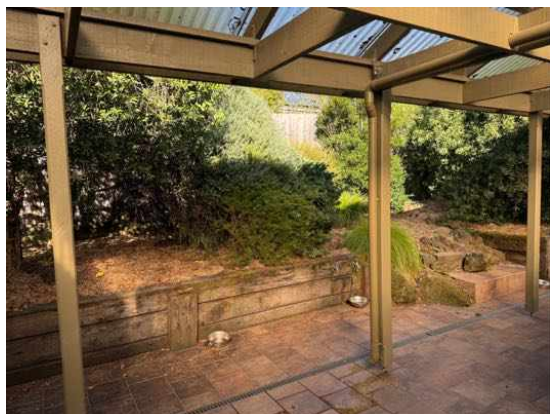
Defects 3.06

Building: Building 1
Location: All Areas > All Areas
Finding: Down-pipes not adequately connected to stormwater
Information: It was observed at the time of inspection that numerous of the down-pipes were not adequately connected or situated over stormwater point and not sealed adequately, these should be all connected properly into the stormwater drainage system and fully inserted into stormwater drainage point. Where these sit above the stormwater point, the surrounding areas are highly susceptible to excessive moisture from splashing out.

Where these are left unmanaged wood rot, rust, corrosion, termite and pest. If left unmanaged wood rot, rust and corrosion is likely to lead to secondary damage and defects to the surrounding building elements, adjoining these areas, this also makes these areas more susceptible to termite or timber pest activity. It is highly recommended that client appoint and seek advice and consultation with a licensed drainage plumber to gain advice and rectify affected down-pipes in the short term future.

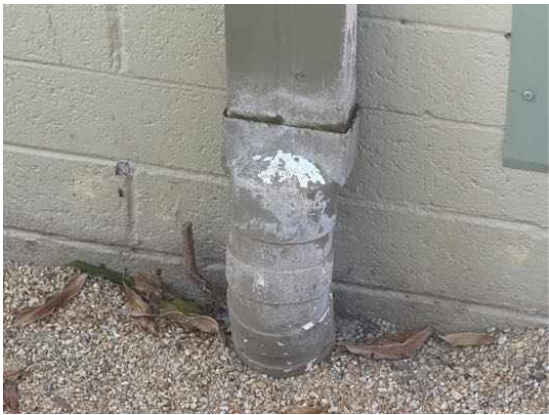
Defects 3.07

Building:	Building 1
Location:	All Areas > All Areas
Finding:	Downpipes rusted and deteriorated
Information:	It was observed at the time of inspection that some down-pipes were rusted and deteriorated beyond repair, making these areas susceptible to excessive water and moisture. This will therefore make these areas susceptible to excessive moisture, wood rot, rust, corrosion, termite and pest. If left unmanaged, moisture, wood rot, rust and corrosion is likely to lead to damage to adjoining areas and or other building elements, this also makes these areas more susceptible to termite or timber pest activity. It is recommended that client appoint, seek advice from a licensed roofing plumber to further investigate and where deemed to be necessary, rectify and repair all deteriorated downpipes and gutters that are deemed to be necessary.

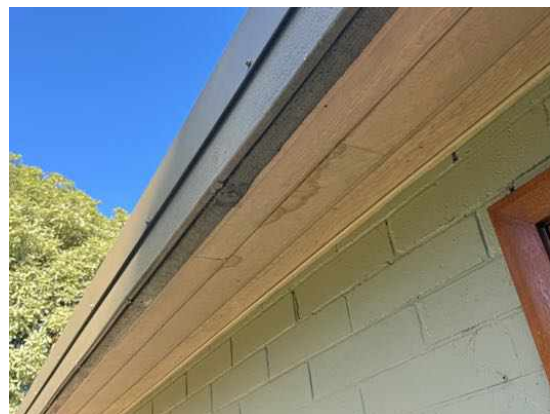
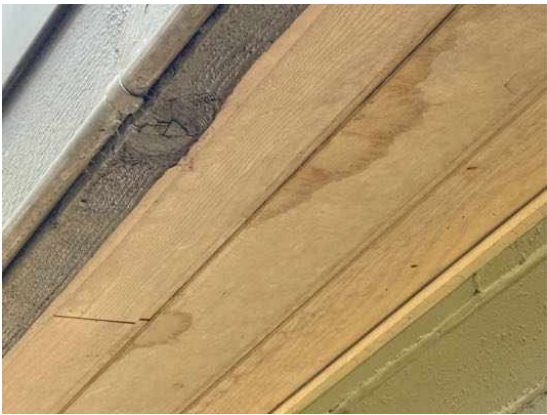
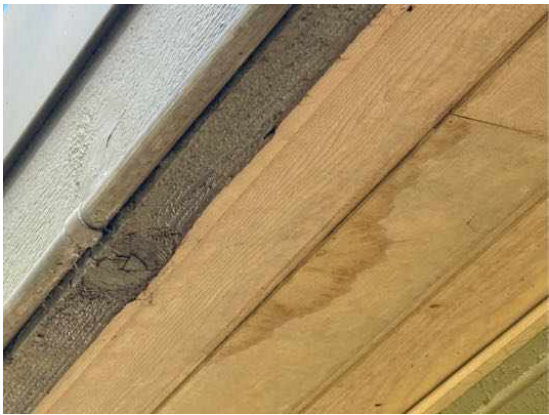
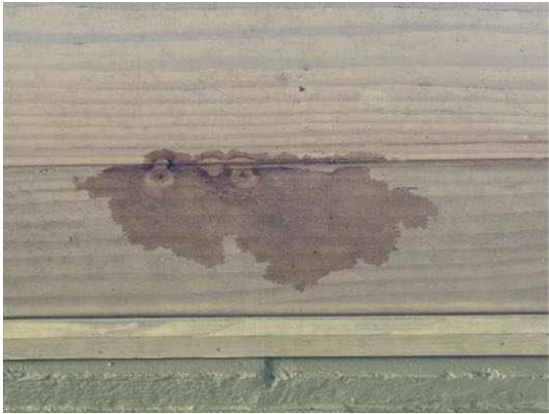
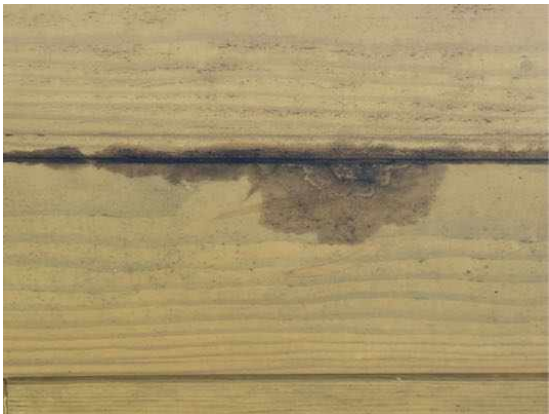
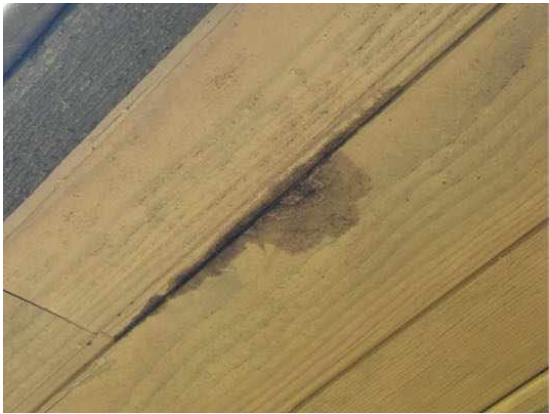
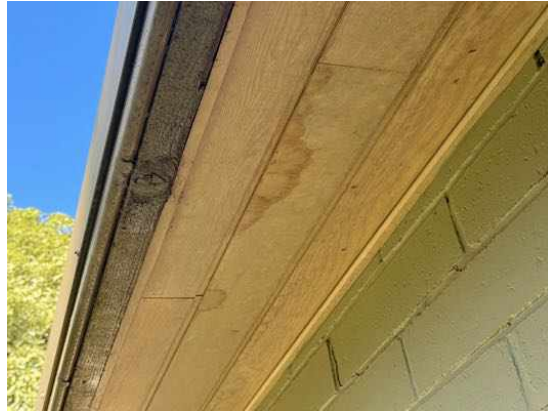
Defects 3.08

Building:	Building 1
Location:	Rear areas > All Areas
Finding:	Eaves - damage and deterioration from suspected water and moisture
Information:	The eaves to the rear areas of the home were observed to showing signs of suspected moisture. The damage is suspected to have been sustained as a result from overwhelmed roofing areas above. However this is not a conclusive answer, no definitive answer for the eaves suspected moisture was confirmed on the day of the inspection. Further investigation from a registered roofing plumber is recommended.

Where damage and deterioration from suspected moisture was observed, the primary requirement is to identify and rectify the source of the moisture and or roof leak. The damage to the eave in this area appeared to be minimal however it is unknown what it may have caused to the roof framing. It does detract from the appearance of the structure, as well as potentially compromising the structural integrity of the adjoining roofing area. Where eaves show suspected moisture damage and deterioration, remedial works are suspected to be required in the short term future. Where water damage is suspected as being the underlying cause, appointment of a licensed roofing plumber is recommended to identify any source of the water and moisture which is suspected to have affected the eaves.

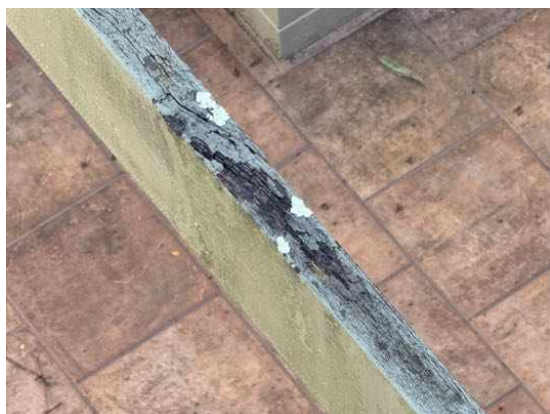
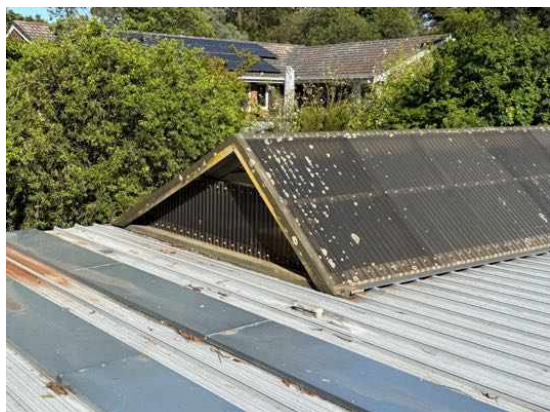
Defects 3.09

Building:	Building 1
Location:	All Areas > All Areas
Finding:	Wood rot
Information:	Wood rot was found to be affecting some pergola beams, protruding ends of beams, some retaining walls and other building elements and materials around the exterior and interior areas of the home. Wood rot, also known as Fungal Decay, occurs when timbers and other cellulose building materials are exposed to damp conditions on an ongoing basis.

Due to the pergolas not adequately protected against excessive water and moisture and frequent exposure to rain and other weather conditions it is highly likely making

these types of building elements susceptible to wood rot and accelerated deterioration. Early intervention and regular maintenance such as painting will prolong the useful life of these building elements. Prior to any works being performed, the cause of the moisture that has created the visible wood rot should be identified and addressed in a suitable manner.

It is advised that the relevant tradespersons be appointed to inspect and subsequently identify the cause of the numerous areas of wood rot. Replacement of affected building elements and materials may then be a necessary step in protecting surrounding areas from secondary damage and deterioration. A qualified carpenter should be appointed to assess the cause and to provide any remedial works as required to replace affected building materials.

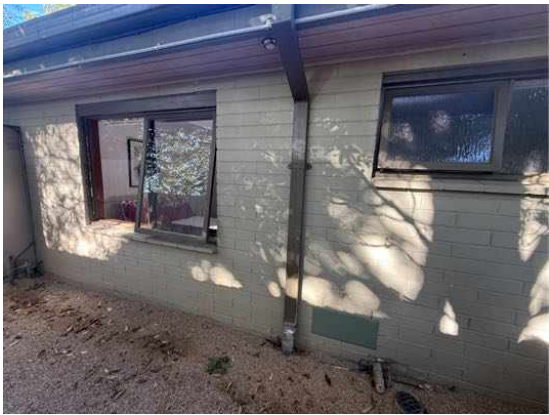
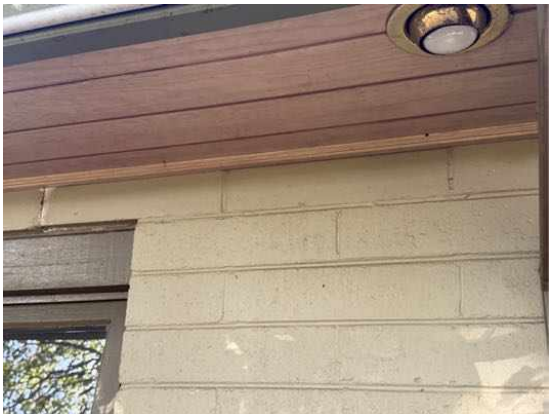
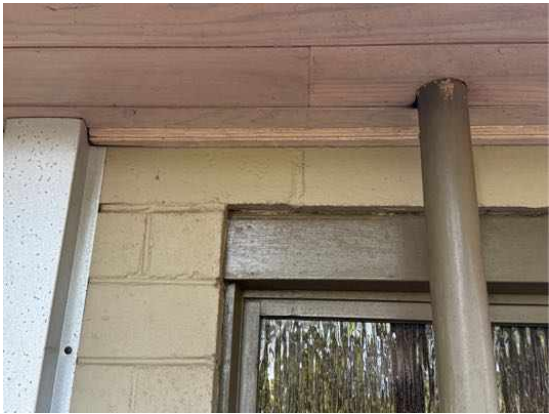
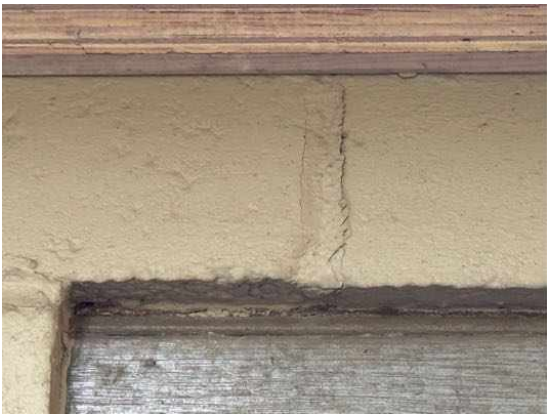
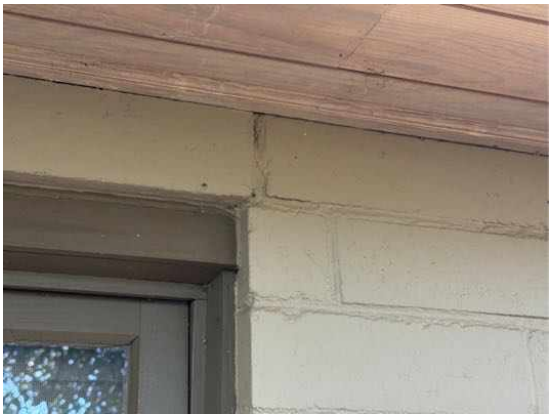
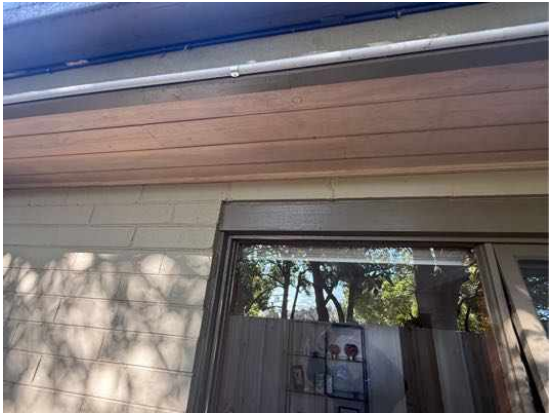
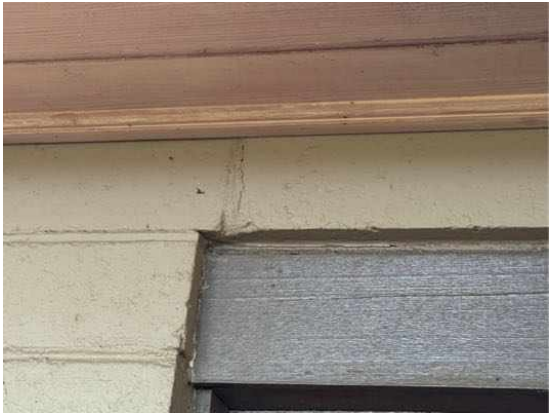
Defects 3.10

Building:	Building 1
Location:	All Areas > All Areas
Finding:	Brickwork - minor cracks
Information:	Although minor cracks are noticeable, they are often only considered to be an appearance defect and usually do not indicate any major structural damage. Generally, the cause of a minor cracks is indicative of some minor movement and expansion and contraction causing a minor separation between brickwork and mortar throughout the structure, single bricks may also show cracks of this nature.

All other areas of brickwork did not appear to show major damage or deterioration. These areas were considered to be structurally sound at the time of the inspection. Cracking of this nature can generally be repaired with minor filling and should be conducted by a qualified bricklayer. Always contact a builder or structural engineer should cracks widen lengthen or become more numerous.

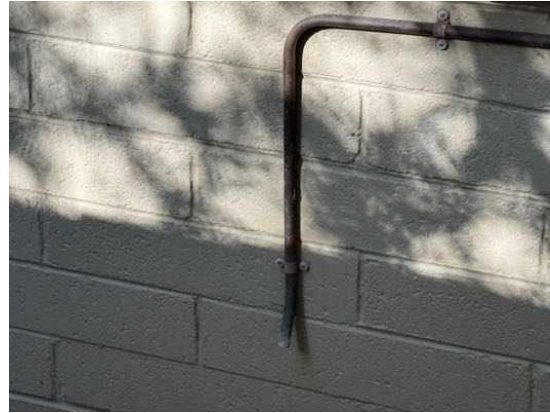
Defects 3.11

Building: Building 1
Location: All Areas > All Areas
Finding: HWS Overflow - Not Connected
Information: The Hot Water System (HWS) overflow was found to be disconnected from storm water drainage and may be or in the future create excessive moisture in the surrounding area.

These damp conditions can lead to secondary defects such as rot, rust or corrosion of associated building elements, the formation of fungal decay, or even the creation of potential slip hazards. When coupled with poor site drainage, pooling of water may also attract termite activity to this area.

It is highly recommended that a licensed plumber be appointed to connect the HWS overflow in order to prevent such an environment from being created. These minor works should be carried out as soon as possible.

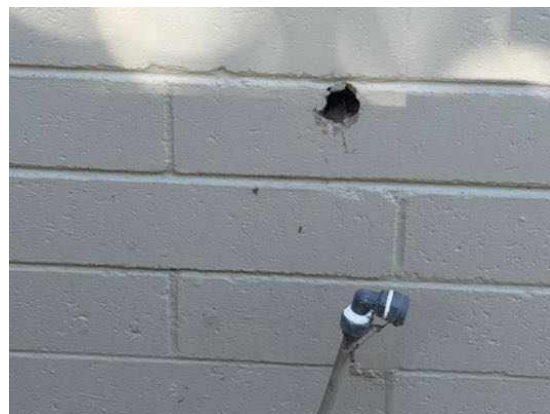
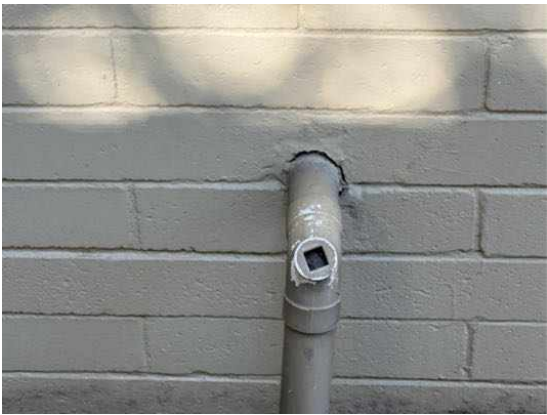
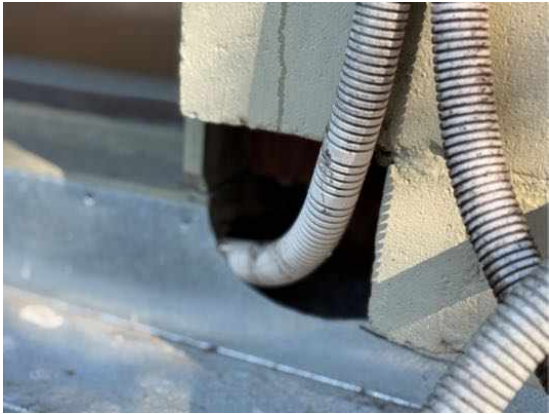
Defects 3.12

Building:	Building 1
Location:	All Areas > All Areas
Finding:	External roof and wall holes
Information:	Some holes were observed around the on the left hand side wall and roof. Gaps, cracks and holes around the home makes the area susceptible to pests, insect and vermin ingress, as well as allowing water penetration into these areas. As such, associated building elements are likely to deteriorate at an accelerated rate, due to weathering and other implications may be expected if these areas are not sealed off properly and left unmanaged. All excessive holes, gaps or cracks should be immediately and adequately filled by a suitable board, sealant or trimmings. Such works may be conducted by a qualified carpenter or licensed plumber.

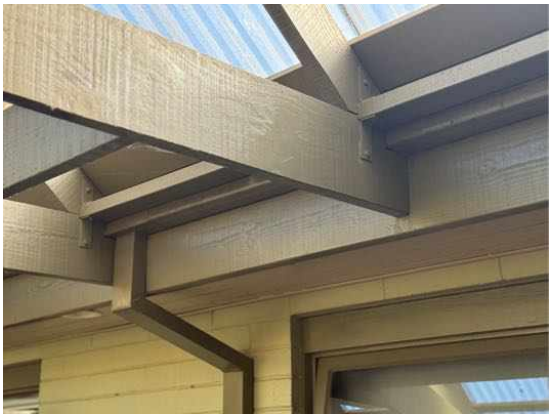
Noted Item

Building:	Building 1
Location:	All Areas > All Areas
Finding:	Back pergola roof brackets missing
Information:	Although some building elements may seem irrelevant or unnecessary at the time, all building elements play a key role in the operation and function of the overall structure and its performance. All the roof brackets that are missing to any of the roof structures should be installed to ensure that in the future as this structure ages and further deteriorates it will remain more stable over time. These types of structures are more susceptible to exposure from exterior weather conditions and are highly likely to become unstable if left unmanaged. The appropriate and relevant tradespersons should be appointed, to install, maintain or replace the missing building elements or materials deemed to be necessary.

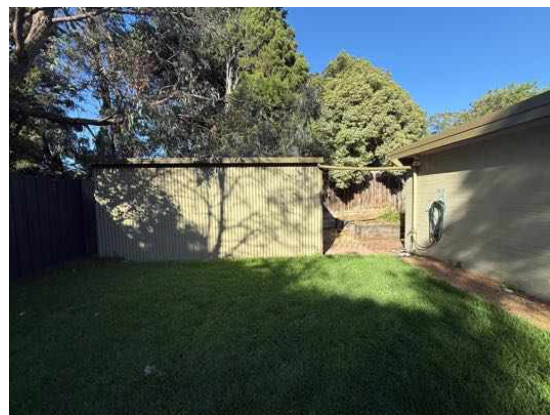
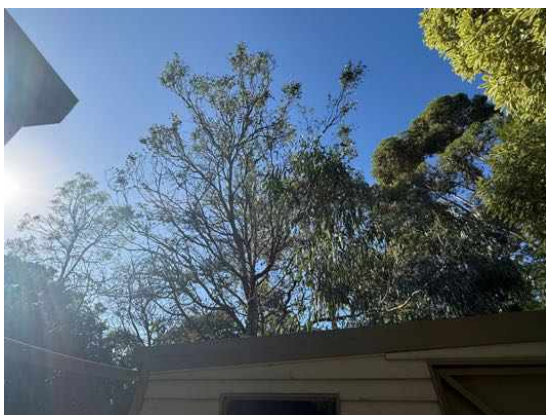
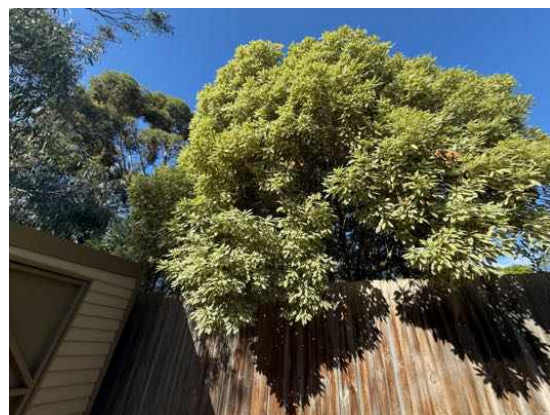
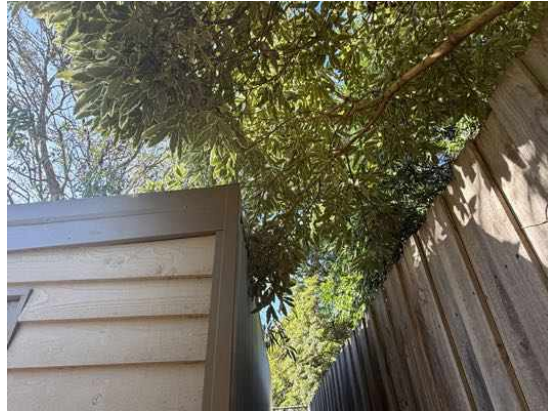
Noted Item

Building: Building 1
Location: All Areas > All Areas
Finding: Trees - Overhanging and filling gutters
Information: Overhanging trees often result in excessive amounts of leaf debris accumulating in gutters. Gutters are a critical part of the building's management of storm water and rain. It is therefore important that they be kept clear to prevent secondary damage to associated building elements, including exterior and interior walls, ceiling linings and any adjoining building elements. Where gutters get blocked from excessive leaf matter, water pooling is highly likely to occur more frequently, fast-tracking, rust and corrosion of the roof plumbing elements and making these areas even more susceptible to secondary defects

It is highly recommended that if at all possible, all overhanging tree branches be removed to prevent further damage. Such works can be performed by the homeowner; however, appointment of a landscape contractor or an arborist may be required. Consultation with a licensed roof plumber is required where guttering has been damaged.

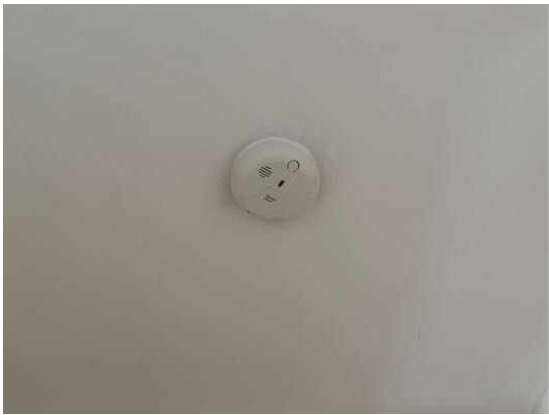
Noted Item

Building: Building 1
 Location: All Areas > All Areas
 Finding: Smoke detectors and alarms
 Information: Reporting on Smoke Detectors or Alarms, including hard wired smoke detection systems and their legislative requirements, is outside the Scope of this Report. Please note that this defect is highlighted as a caution only. We suspect, based on our experience in the building industry, that smoke detectors are sometimes get over looked, or they may be in a poor condition, so we recommend that they always should be addressed prior to occupation to improve occupant safety.

Always ensure sufficient working and suitable smoke detectors are installed prior and during to occupying any building. Additionally, it is advised that all smoke detectors be tested by the homeowner on a monthly basis.
