Building and Timber Pest Inspection Report

Inspection Date: Fri, 13 Feb 2026

Property Address: 63 Page Ave, North Nowra NSW 2541,
Australia

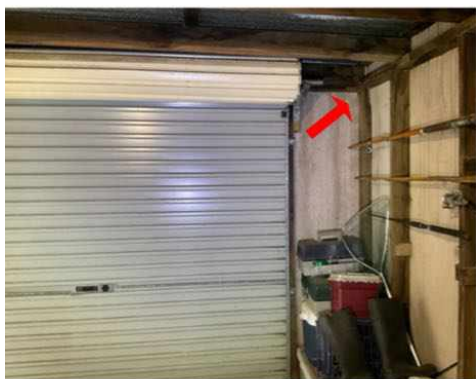
Building:	Building 2
Location:	Shed
Finding:	Wood rot to structural timbers.
Information:	The left front wall of the garage shows evidence of severe wood rot to wall studs and other nearby timbers and apparent termite damage. It appears the blocked or lack of working front drainage has lead to water damage to the lower areas. In high rain events front garage areas this appears to flood.

Replacement of the affected timbers is a necessary step in protecting surrounding building elements from such deterioration and supporting the roof.

A qualified plumber may be appointed to assess the cause of excessive moisture and to provide advice on any remedial works as required. A qualified carpenter or registered builder will be required to replace all the affected damaged building materials. Note - some garage areas particularly the rear cannot be accessed for inspection due to stored items and debris.

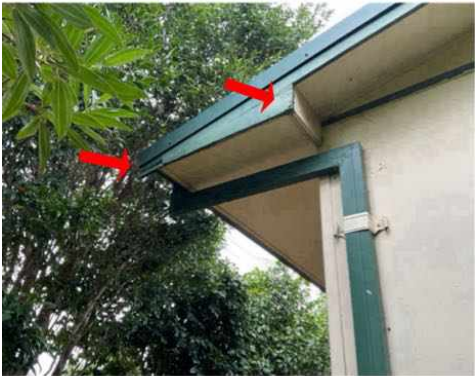
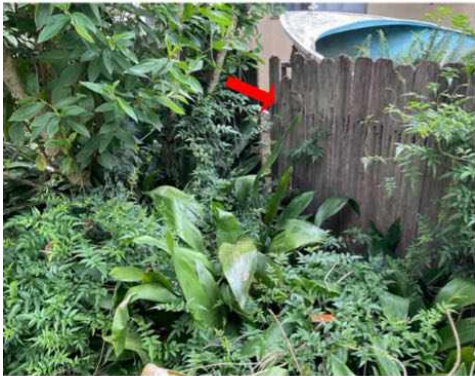
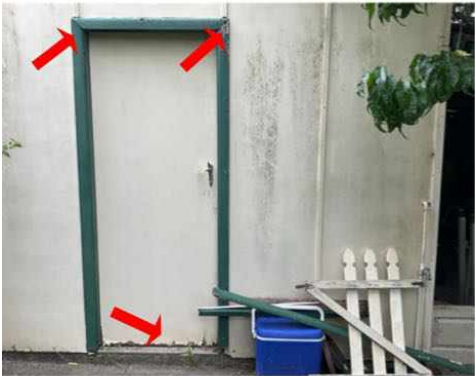
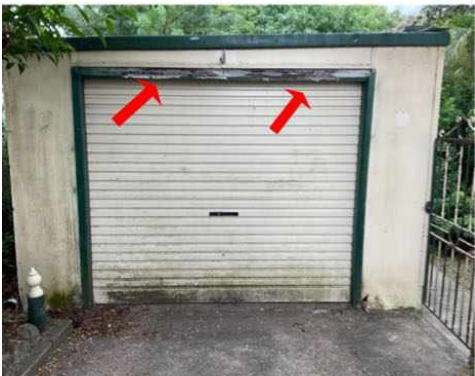
Finding 3.01

Building:	Building 1
Location:	Pictured exterior & interior areas
Finding:	Wood rot
Information:	These building areas on both buildings shows evidence of wood rot. Wood rot, also known as Fungal Decay, occurs when timbers and other cellulose building materials are exposed to damp conditions on an ongoing basis. This could be the result of exposure to weathering over a prolonged period of time, or the attraction of excessive moisture from other abutting building materials.

Early intervention and regular maintenance, particularly of exterior timbers, will prolong the useful life of these building elements. Prior to any works being performed, the cause of the moisture that has created the visible wood rot should be identified and addressed in a suitable manner. Replacement of affected timbers may then be a necessary step in protecting surrounding building elements from such deterioration.

A qualified carpenter or registered builder may also be required to replace affected building materials.

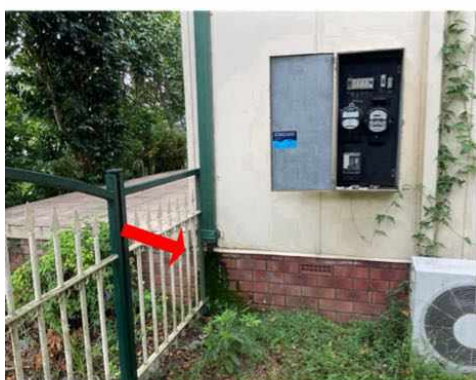
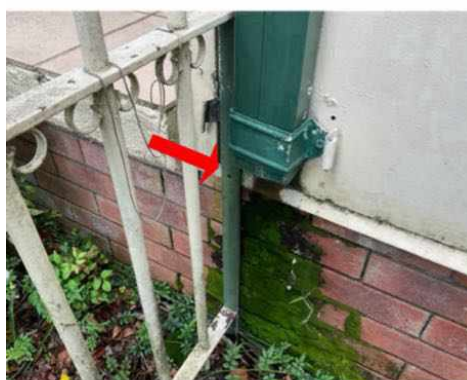
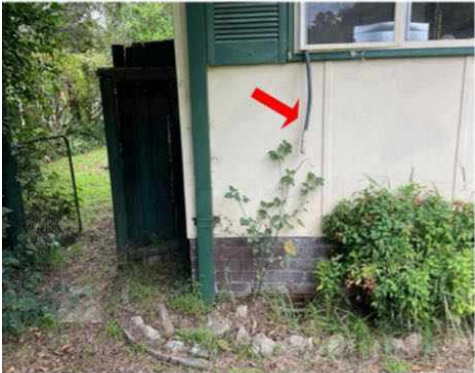
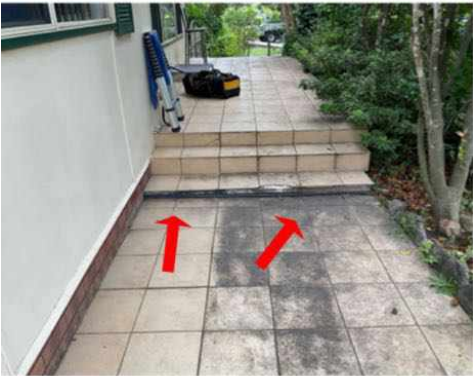
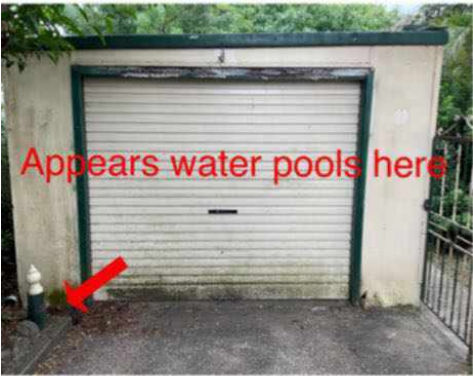
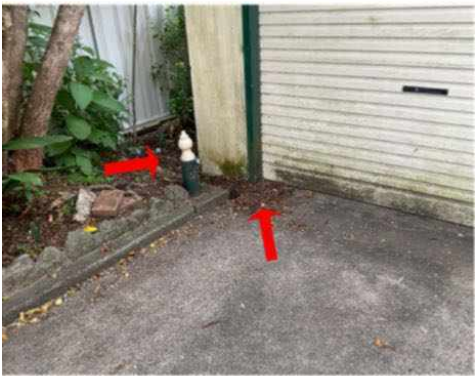
Finding 3.02

Building:	Building 1
Location:	Walls, verandah, garage
Finding:	Site drainage - Inadequate
Information:	The site drainage on both buildings was found to be inadequate at the time of inspection, creating potential for subsequent water damage to associated building elements.

The front downpipe run onto the wall causing further damage. The washing machine and bathroom floor waste overflows run against the rear house wall. The bathroom vanity is slow to drain and the tenant says blockages on the property occur and have been repaired a few times in approximately 15 months. The front garage drainage works appear to be substandard and blocked damaging many garage timbers. It appears water may also pool on the front steps.

It is important that water does not lie against the base of walls; surrounding paths and ground levels should be sloped to drain water away from walls. Downpipes should not discharge stormwater onto lower walls or plinths. Stormwater should be carried away by large, regularly cleaned drains. Ground levels may need to be lowered to expose a buried DPC.

Where site drainage is inadequate, installation of an Agricultural (Aggie) Drain may be required. A qualified plumber should be appointed to further inspect the property prior to purchase to quote and repair or replacement of damaged drainage areas. Secondary defects are likely to occur if left unmanaged.

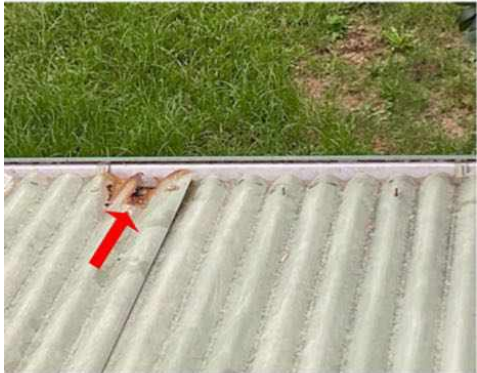
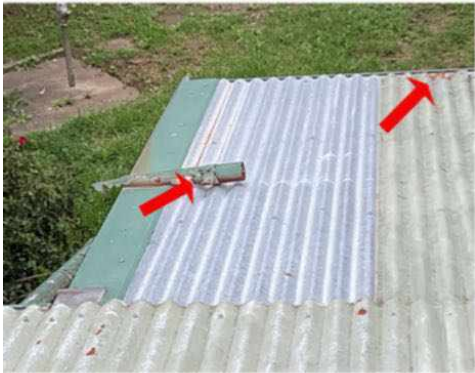
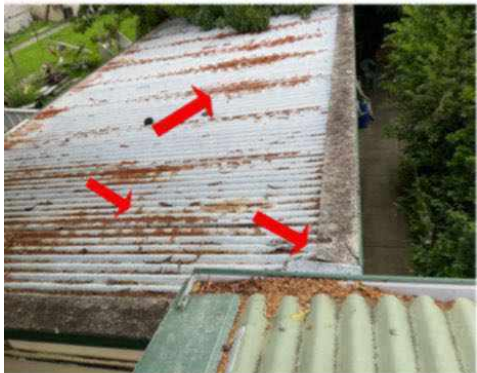
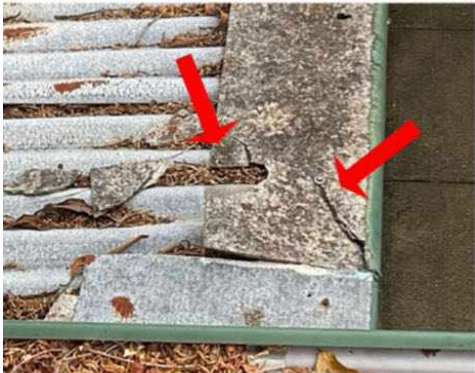
Finding 3.03

Building:	Building 1
Location:	Both External Roofs
Finding:	Roofing areas - Weathered
Information:	Upon inspection of the exterior roofing, the majority of the house roof areas were considered to be in fair condition and the garage roof in poor condition.

While weathering of these pictured areas is consistent with a the property where no maintenance has occurred. It appears some house roof areas need rust treatment or replacement and many garage areas need replacement due to severe rust. Numerous roof fixings are loose and also need repair/ replacement.

Re-sealing and replacing many areas of gaps, loose, rusted and damage sheets is required. Where left unmanaged, deteriorating roofing materials are likely to lead to a number of secondary defects, including minor water leaks and weather exposure to internal roofing structures.

Remedial works are likely to increase the longevity of the exterior roofing structure.

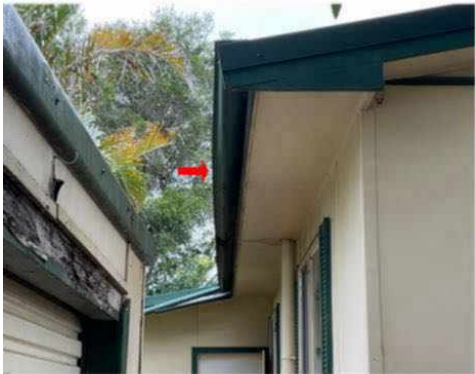
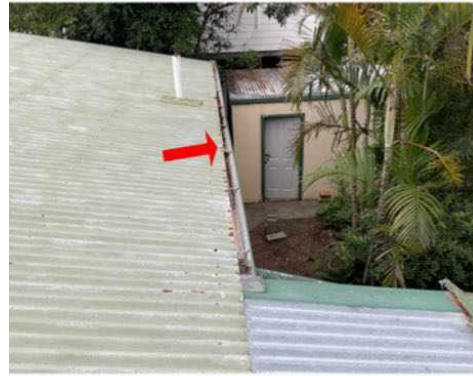
Finding 3.04

Building: Building 1
 Location: Most gutters on both buildings
 Finding: Gutters loose, damaged and insufficient fall
 Information: There is an insufficient fall and sagging in most of the garage and house gutters, which means that the angle of this gutter is inadequate for rainwater to drain away. This will result in pooling of water in these areas, creating the potential for water damage to nearby areas. This is likely to lead to further defects if not repaired. Adjustment by a roofing contractor is required as soon as possible to prevent any damage to this area.

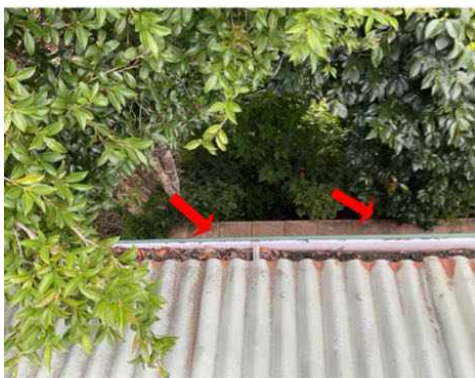
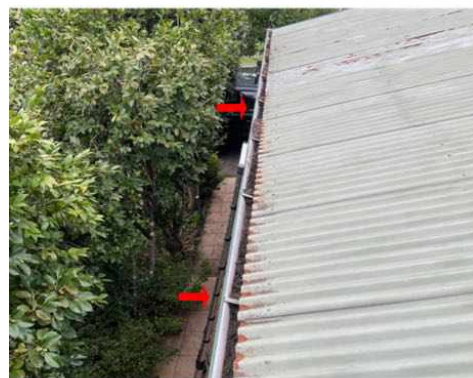
Finding 3.05

Building:	Building 1
Location:	Roof exterior
Finding:	Gutters - Full and blocked
Information:	The guttering on around the roof was found to be blocked and in poor condition at the time of the inspection. Roof plumbing structures, such as guttering and downpipes, should be free of all debris to prevent blockages. Blockages of the guttering and downpipes will lead to pooling and accumulated water overflows, which is likely to subsequently flood eaves and exterior walls.

Blocked gutters are likely to lead to high levels of moisture in the affected areas which can cause rust and decay of the gutters and downpipes and wood rot to adjoining timber areas. Blockages in gutters should therefore be removed immediately to ensure dry conditions are maintained.

It is highly advised that gutters be repaired and cleaned by a skilled handyperson as a matter of urgency.

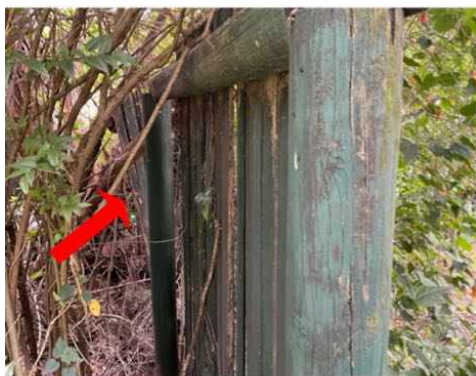
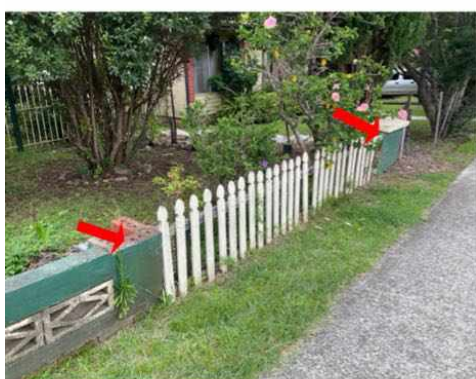
Finding 3.06

Building:	Building 1
Location:	Pictured fences

Finding: Fences damaged - leaning
 Information: Evidence of damage to the pictured front and other fences was identified at the time of the inspection. The likely cause of many of these fences leaning is not enough concrete used in the post footings, wood rot and bora damage. If left unmanaged these fences may deteriorate further. It is suggest a fencing contractor be engaged for rectification when convenient.

Note - many rear fences are covered in overgrowth and cannot be seen.

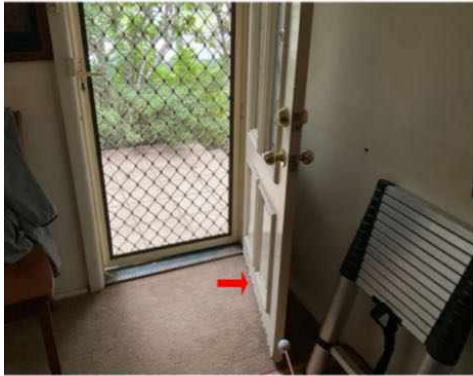
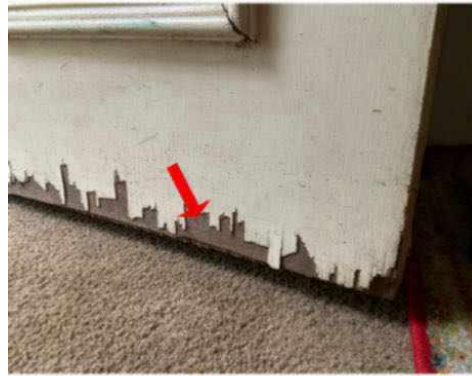
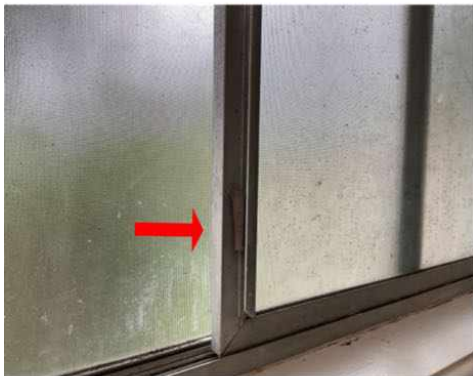
Finding 3.07

Building: Building 1
 Location: Pictured areas
 Finding: Building elements - Damaged
 Information: Evidence of minor missing or damaged areas was identified at the time of the inspection. These include -

1. The pictured front door and laundry cupboard doors are delaminating requiring replacement in the future.
2. The bathroom window latch is broken making the house not secure.
3. The laundry taps were missing and loose requiring repair.

A carpenter and plumber would be the trades responsible for rectification of these areas when convenient.

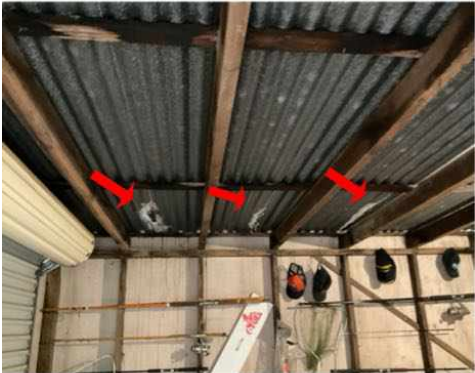
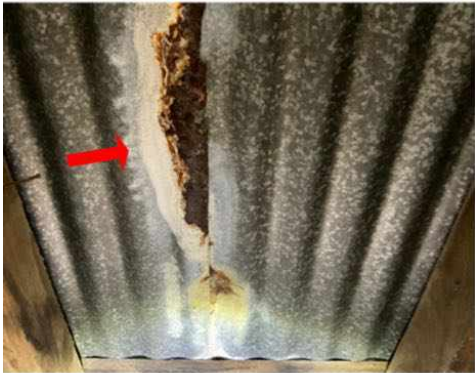
Finding 3.08

Building:	Main Building
Location:	Main building and shed
Finding:	Areas rusted or corroded
Information:	These roof areas shows evidence of rusting and corrosion, which is likely to have developed as a result of excessive exposure to moisture and or inadequate coatings.

As surface rust provides no protection to the underlying iron, the deteriorating condition is likely to worsen if not addressed in the short-term future.

Where possible, the use of galvanized (treated) metals or aluminium coated metals aid in rust prevention, as does regular general maintenance. Rust formation can be controlled with coatings, such as paint, that isolate the iron from the environment.

A roofing contractor should be consulted for quotes for repair/ replacement of these areas.

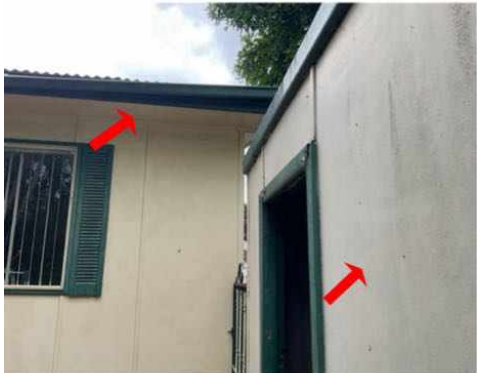
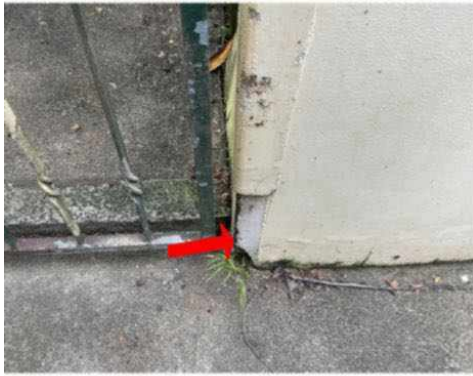
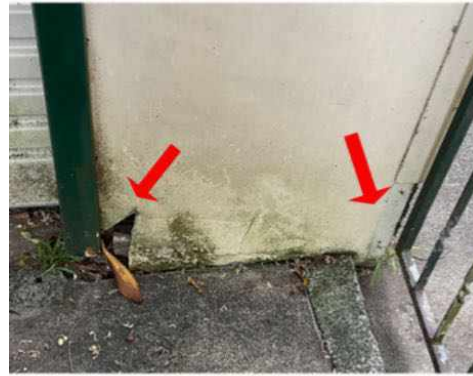
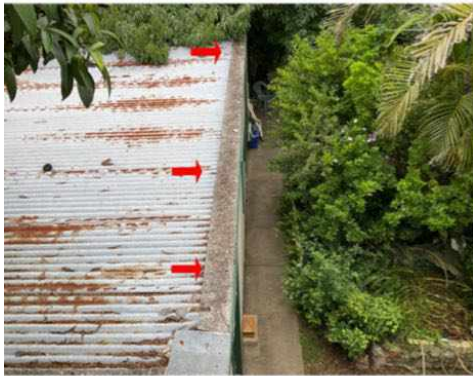
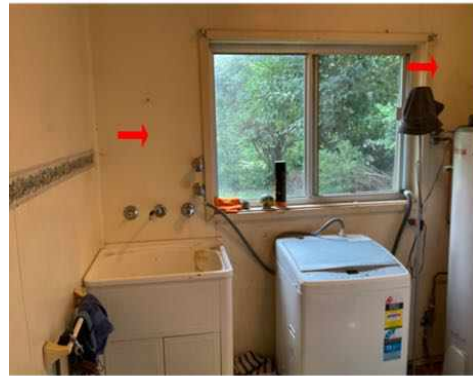
Building: Building 1
Location: Shed and house areas
Finding: Asbestos - Suspected ACM Identified on Site
Information: Reporting on Asbestos is outside the Scope of this Report. This suspected defect is highlighted as a caution only. We suspect, based on our experience in the building industry, that there is a higher risk of many building element containing asbestos. Many garage/ shed wall and roof areas are damaged.

As Asbestos Reporting is outside the scope of this report, we advise that you consider a separate Asbestos Inspection and Condition Audit, which can include the taking of samples for definitive confirmation of the presence of Asbestos.

In the interim, the client is advised to act with caution, especially when considering the damaged shed walls, general wear and tear and any renovations, extensions, demolition and general maintenance activities due to the suspected presence of Asbestos.

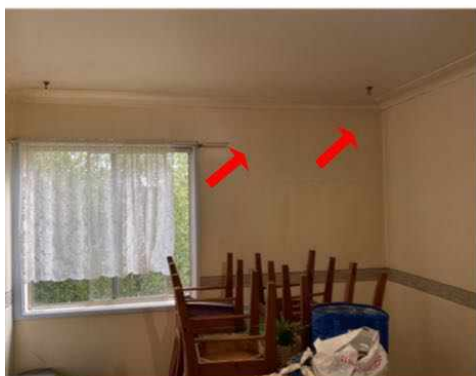
Finding 3.13

Information: Where evidence of mould growth was noted, there may be environmental, biological or health issues associated with the report. A specialist inspection by a suitably qualified environmental health inspector is warranted, where mould is extensive or where any queries regarding air quality spores or other related issues apply.

Generally, the client is advised to ensure that the general environment is free of moisture and humidity to aid in the prevention of mould formation and development.

Any mould found during the inspection should be cleaned immediately by a cleaning contractor or the homeowner as applicable.

Please - note that severely affected building elements may require replacement by a registered builder or qualified carpenter.

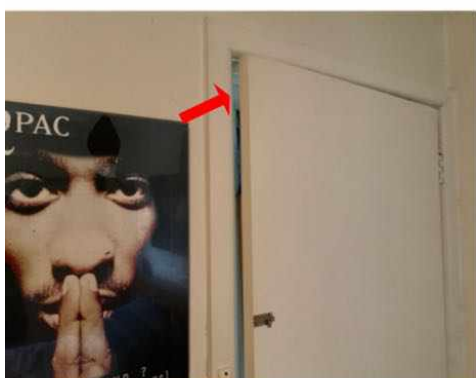
Finding 3.14

Building: Building 1
 Location: Pictured doors
 Finding: Doors - Binding/Jamming
 Information: Binding and/or jamming of several doors throughout the property were evident during

standard operation. This defect inhibits the functionality of affected doors as well as creating potential for secondary defects to associated building elements, such as damage to the floor covering.

A door that binds to flooring or to the associated door frame may have several causes, ranging from minor defects, such as poor installation of the door or deteriorated hinges, through to major structural issues, such as damage to subfloor structures.

Where door binding/jamming appears to indicate major structural issues, a registered builder specialising in re-stumping should be appointed to provide an estimate on the cost of rectification.

For minor causes, a qualified carpenter or general handyperson should be appointed to perform minor rectification works at client discretion.

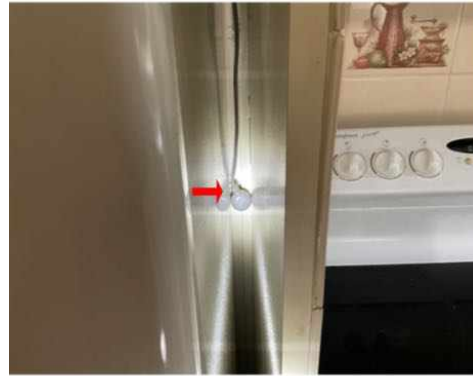
Without a functional fan, a build-up of grease and evaporative moisture is likely to accelerate deterioration of the range hood and associated flue. This potential build up may also create a minor fire hazard, particularly if left uncleaned.

A licensed electrician should be appointed to install PowerPoint to the fan on the range hood to restore it to a fully operational state.

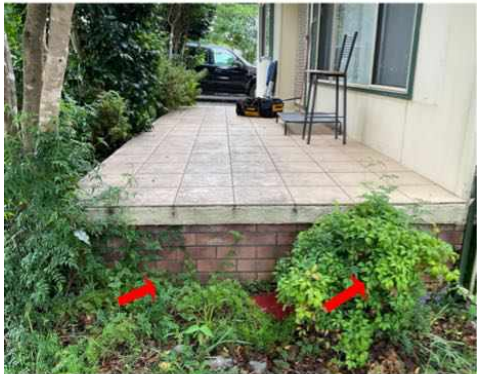
Building: Building 1
 Location: Many house and garage areas
 Finding: Bridging - Vegetation and decking
 Information: Where many areas of vegetation and decking obstructs inspection of building elements, also known as bridging as it provides a bridging point for the access of termites, full inspection can not be achieved. Consequently moisture or dampness may be present and the areas becomes conducive to termite activity. Plants and decks against or very close to buildings provide cover, shade and can provide an environment that is attractive to termite infestation.

Where the slab edge cannot be properly inspected, it is highly recommended that termite or timber pest inspections be carried out every 6-12 months to aid protection

of the property against infestation.

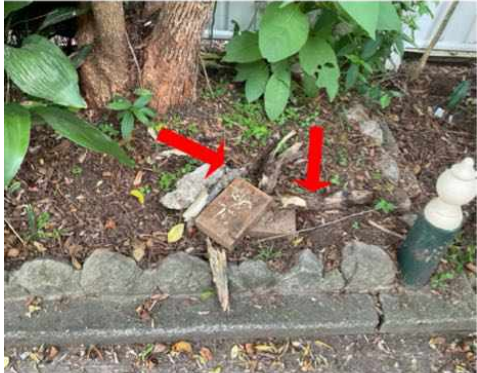
Finding 6.04

Building: Building 1
 Location: Yard and subfloor areas
 Finding: Timber in contact with the ground
 Information: Dozens of timbers/branches in direct ground contact provide opportunity for concealed termite entry and are likely to be subject to premature rot and decay as the soil retains moisture or damp conditions against the timbers.

Removal of all waste timber that is in direct contact with ground is highly advised. This timber is promoting mould and wood rot and is very attractive to termites.

Frequent pest inspections are advised to readily identify any termite activity in these areas.

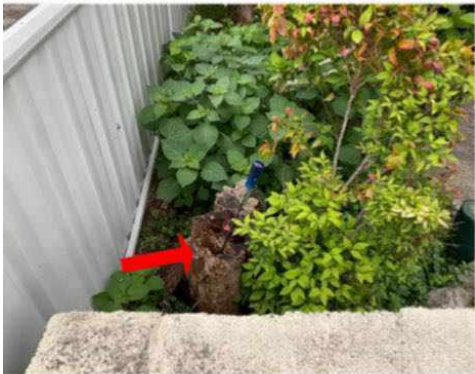
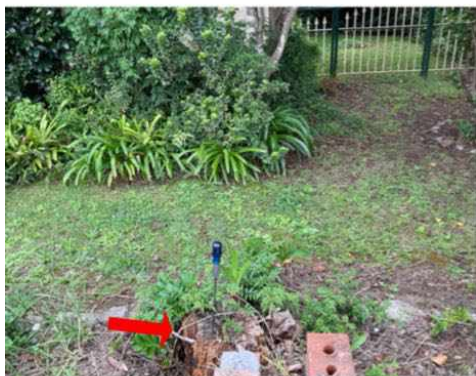
Finding 6.05

Building: Building 1
 Location: Yard areas
 Finding: Tree stumps - left in ground
 Information: Tree stumps left in ground provide opportunity for termite attack as they are likely to be subject to rot and decay providing an attractive food source. Treatment and/or Removal of the stump is highly recommended. A pest controller and tree removalist should be engaged to perform such works.

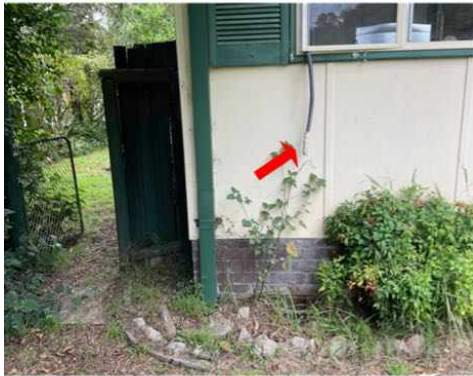
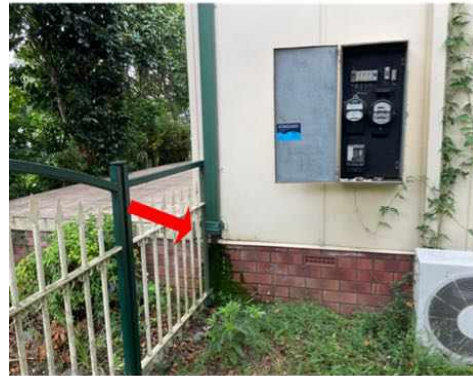
Building:	Building 1
Location:	Many external wall areas
Finding:	Overflows - Not plumbed for drainage
Information:	The pictured overflow pipes are not plumbed or connected to suitable drainage, which has resulted in the surrounding area becoming excessively damp.

These damp conditions can lead to secondary defects such as rot, rust or corrosion of associated building elements, the formation of fungal decay, or even the creation of potential slip hazards. When coupled with poor site drainage, pooling of water may also attract termite activity to this area. It is highly recommended that a qualified plumber be appointed to install adequate drainage to these areas. These works will ensure that the area remains dry and free of any secondary defects.

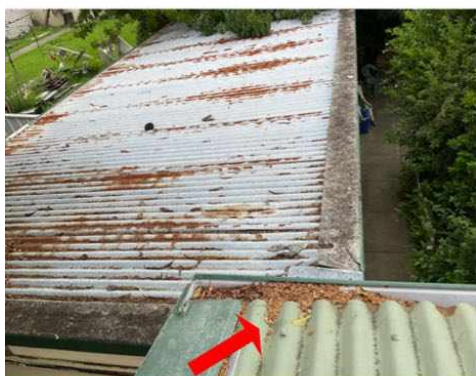
Finding 6.08

Blocked gutters are likely to lead to high levels of moisture in the affected areas. Such moisture will not only cause rust and decay of the associated building materials, but can also provide conditions that are conducive to termite and timber pest activity. Blockages in gutters should therefore be removed immediately to ensure dry conditions are maintained.

It is highly advised that gutters be cleaned by the homeowner or a general handyperson as a matter of urgency.

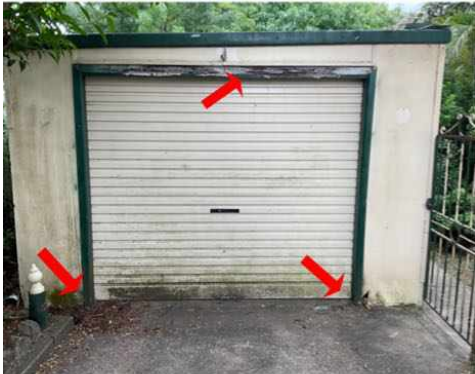
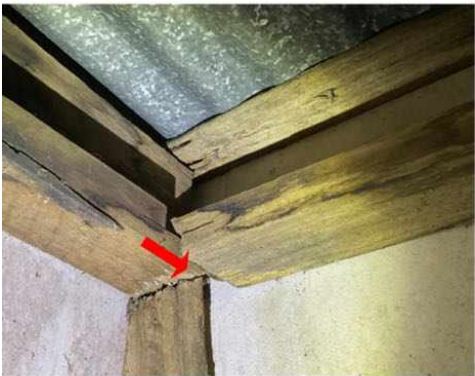
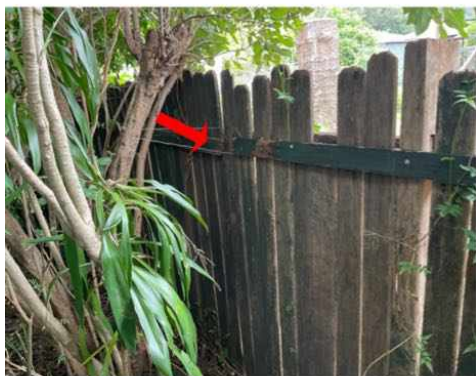
Finding 7.01

In this case, many of the affected timber elements are in a decaying state and will need replacement by a carpenter or licensed builder.

Note - See ALL wood rot photos, all these show fungal decay.
