Building Inspection Report

Inspection Date: Tue, 3 Feb 2026

Property Address: 13105/1 Cordelia St, South Brisbane QLD
4101, Australia

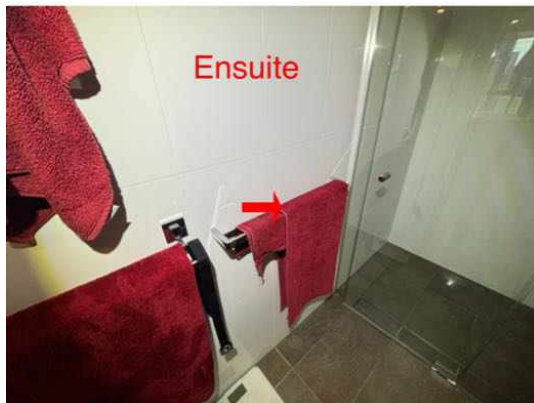
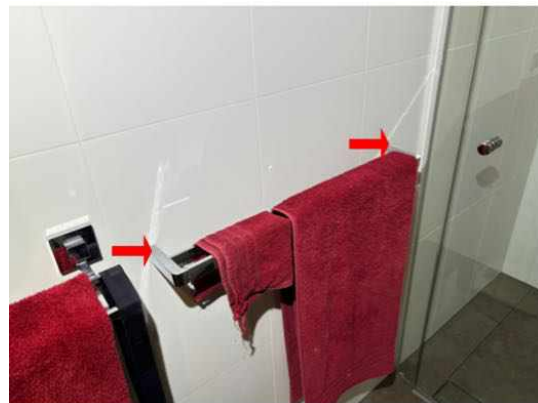
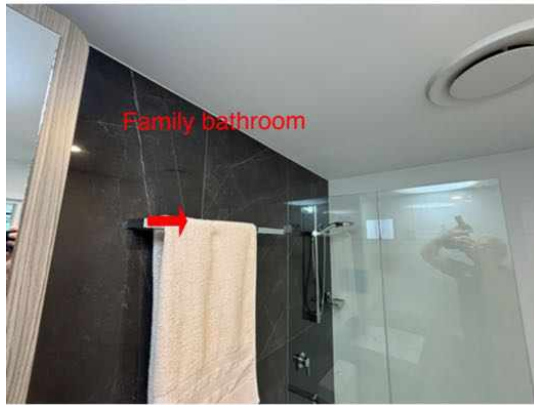
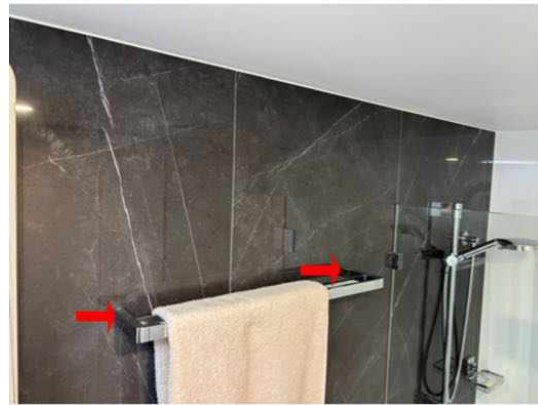
Defects 3.01

Building: Main Building
Location: Bathrooms
Finding: Bathrooms - towel rails loose
Information: At the time of the inspection, it was noted that the towel rails in the bathrooms were loose. This appears to be from general wear and tear. If not addressed, the towel rails may come away from the wall.

This may require simple adjustment of the fasteners attaching the towel rails. A building maintenance professional could be engaged to carry out this minor repair. This can be done at the clients discretion.

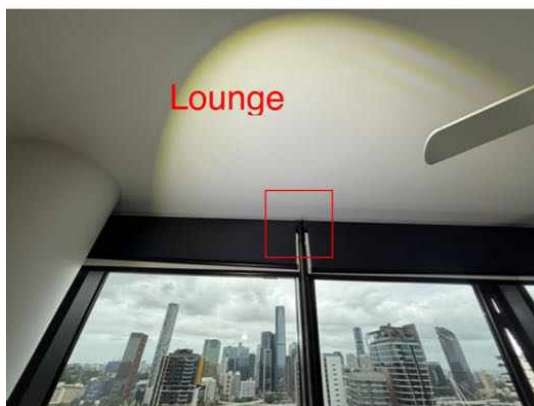
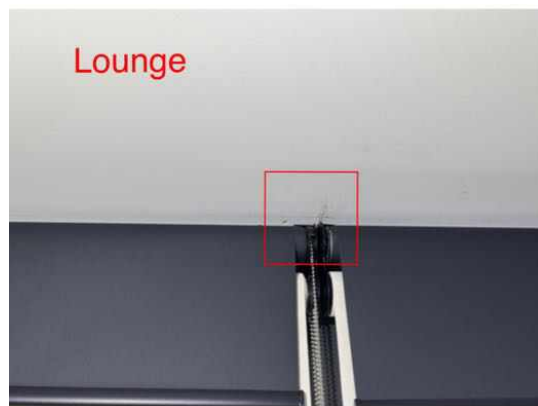
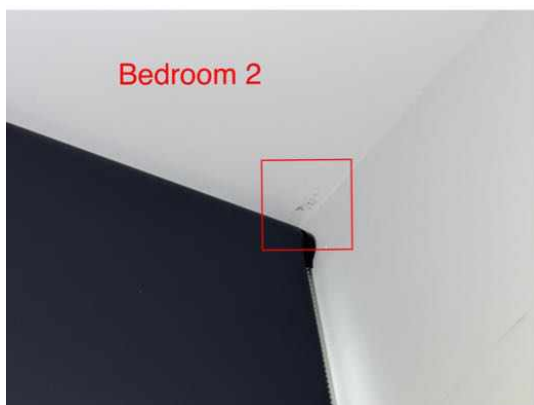
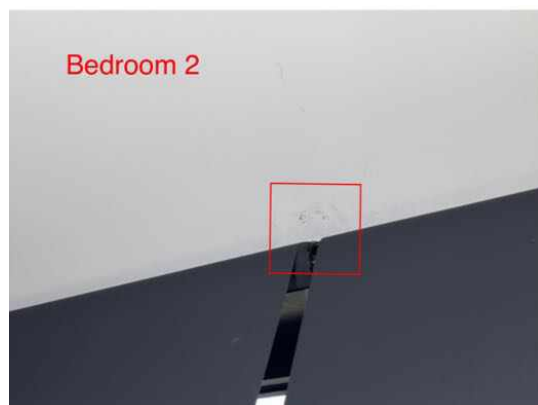
Defects 3.02

Finding: Ceilings - minor damage

Information: At the time of the inspection, it was noted that there was some minor damage to small sections of the ceiling in the lounge and bedroom 2. This appears to be where curtain rails have been removed and the holes have not been patched.

A building maintenance professional or painting contractor could be engaged to carry out these minor repairs. This can be done at the clients discretion.

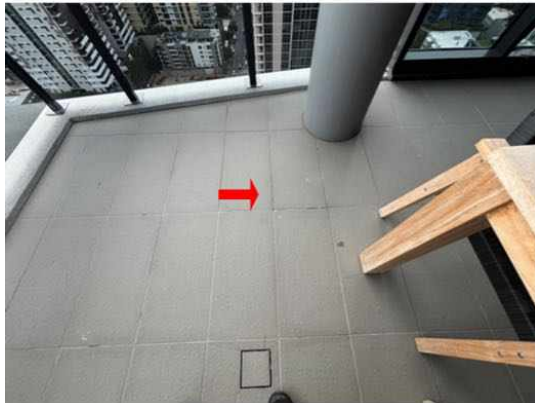
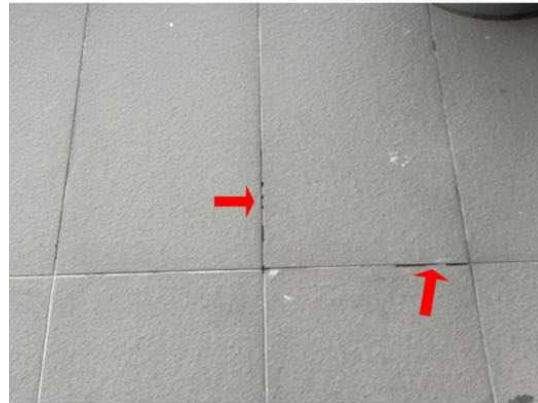
Defects 3.03

Finding: Balcony - grout missing

Information: At the time of the inspection, it was noted that a small section of grout was missing to the tiled balcony floor.

A building maintenance professional or tiler could be engaged to replace the missing grout. This can be done at the clients discretion.

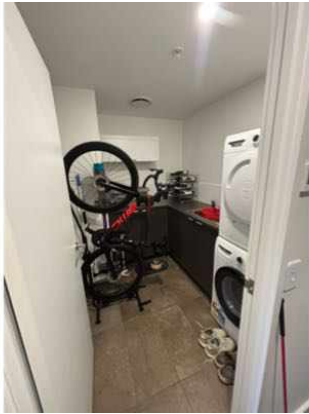
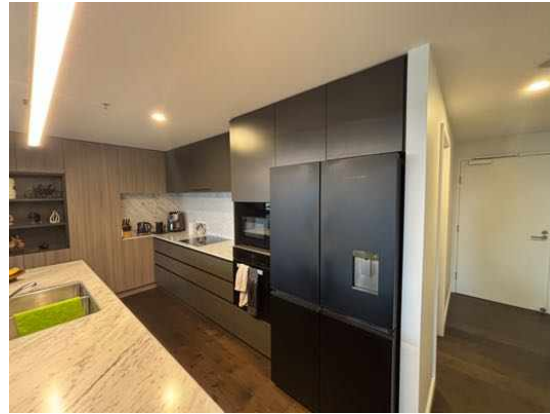
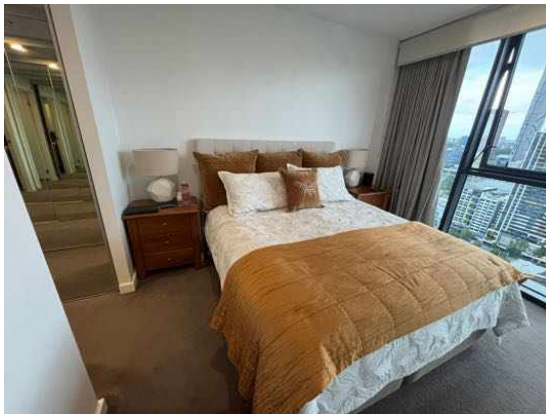
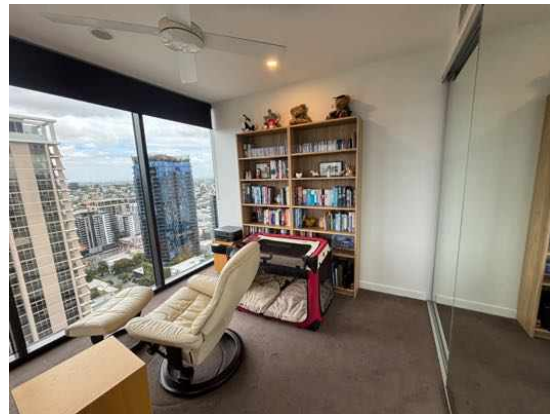
Building: Main Building
Location: All Internal Areas
Finding: Additional Photos - Obstructions and Limitations
Information: These photographs are an indication of the obstructions and limitations which impeded full inspection of the property at the time of inspection. These obstructions can hide an array of defects and should be removed to allow full inspection to be carried out. A re-inspection is recommended once the areas are made accessible.
