# Building and Timber Pest Inspection Report

Inspection Date: Mon, 2 Mar 2026

Property Address: 68 Olive Hill Dr, Cobbitty NSW 2570,  
Australia

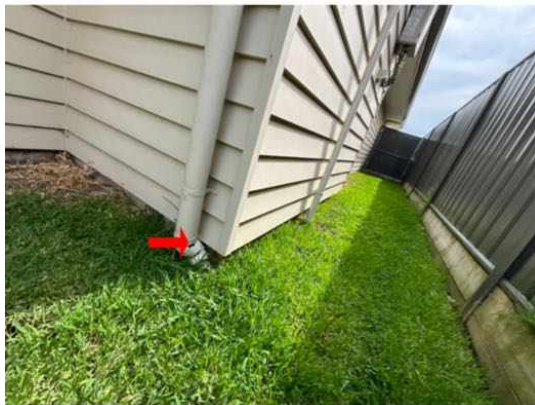
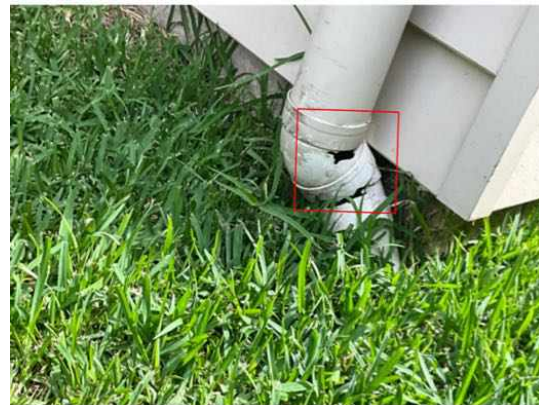
Building: Main Building  
 Location: Roof plumbing RHS  
 Finding: Stormwater drain - Damaged  
 Information: The roof plumbing is not adequately connected to stormwater drainage on the site. This disconnection negatively impacts the functional capacity of the roof plumbing.

Where roof plumbing doesn't drain adequately, the area at the base perimeter can become excessively damp, potentially creating an environment that is susceptible to rust and corrosion of surrounding building elements, as well as attracting termites and other pests.

It is highly recommended that a plumber be appointed to further inspect the area and to install adequate drainage equipment where necessary.

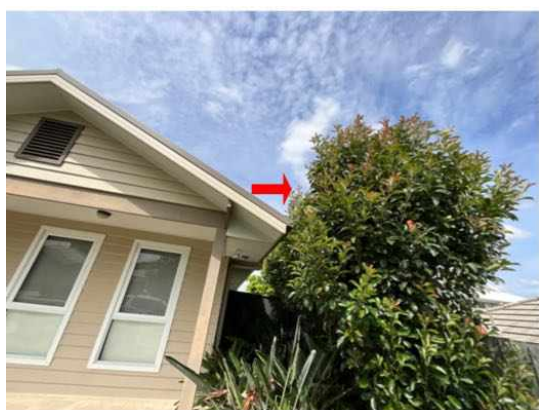
#### Finding 3.02

Building: Main Building  
 Location: Roof Exterior  
 Finding: Trees - Overhanging and filling gutters  
 Information: Overhanging trees often result in excessive amounts of leaf debris accumulating in

gutters.

Gutters are a critical part of the building's management of storm water and rain. It is therefore important that they be kept clear to prevent secondary damage to associated building elements, including exterior and interior walls, ceiling linings and any adjoining building elements. Where gutters are blocked, pooling of rainwater is likely to occur, fast-tracking rust and corrosion of the roof plumbing elements.

It is highly advised that all overhanging tree branches be removed as soon as possible to prevent any further damage. Repair and/or replacement of sections of damaged guttering may also be required where the extent of the damage necessitates.

Such works should be performed by the homeowner; however, appointment of a landscape contractor or an arborist may be required. Consultation with a licensed roof plumber is required where guttering has been damaged.

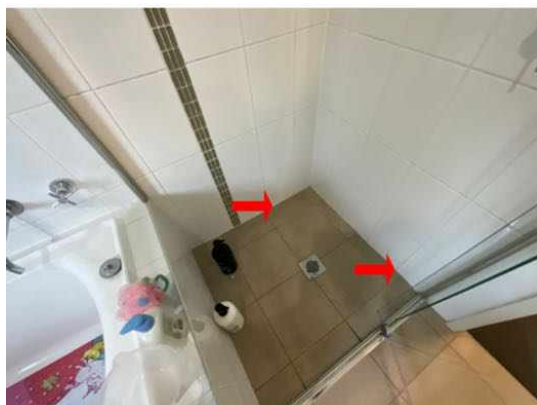
### Finding 3.03

Building:	Main Building
Location:	Bathroom
Finding:	Sealant and grouting - Missing or damaged
Information:

It was noted on inspection that sealant or grout is degraded to this area.

Different materials and floor areas move at different rates, generally causing cracking to grout or sealant at this point. A flexible sealant is required to allow for expected expansion and contraction, while keeping the joint water tight and protective of all associated building materials.

Flexible and mould resistant materials should be applied to affected areas to prevent any subsequent water damage that is likely to occur. Regular maintenance and replacement of damage or missing or damaged sealant and grout is highly recommended to the wet areas, as this is a regular wear and tear defect. Sealant and grouting in areas that come into regular contact with water should be maintained for the long term care of your property.

A sealant specialist should be appointed to complete these works as soon as possible.

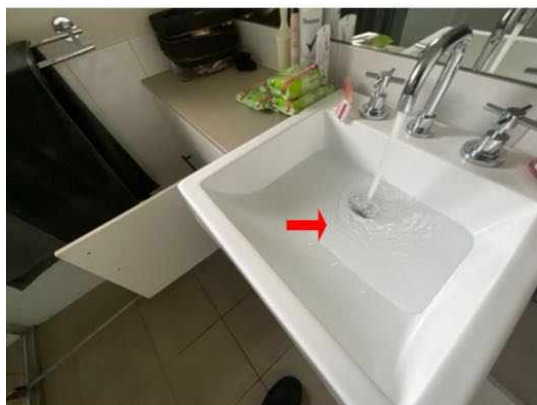
### Finding 3.04

Building: Main Building  
 Location: Ensuite, bathroom  
 Finding: Sink/basin - slow draining  
 Information:

The sink/basin drain appeared to be partially blocked at the time of inspection. Blockages here are usually caused by hair and other debris. If left unmanaged, a lack of general maintenance may lead to the development of more significant defects, such as water damage to surrounding building materials.

A licensed plumber should be appointed to remove the blockage at the client discretion.

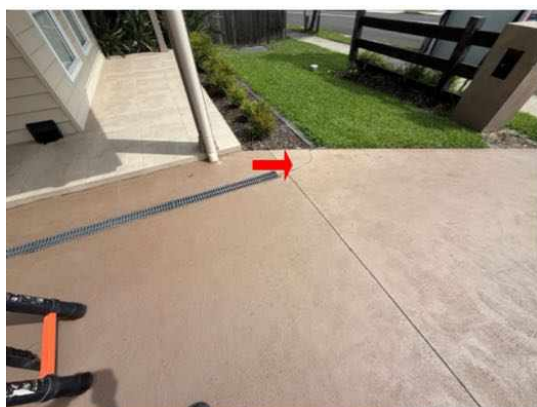
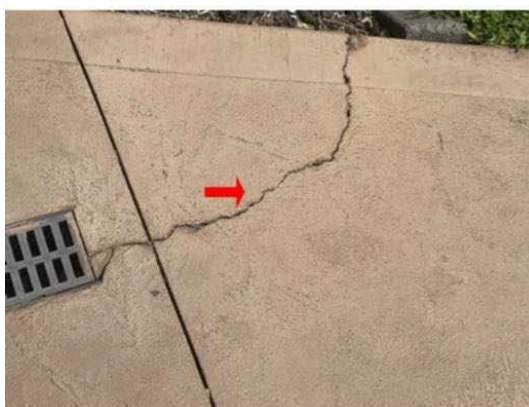
### Finding 3.05

Building: Main Building  
 Location: Driveway  
 Finding: Cracking - External Concrete Paving Damage Category 2 - Distinct (less than 3mm)  
 Information: Distinct cracks were identified in external concrete paving. Distinct cracks are

generally found in older concrete paving, and may also present as a trip hazard as consequence of an uneven or curved surface.

General age and expected deterioration of the paved areas is a common cause of this type of cracking. However, expansion and contraction of the slab may also have occurred due to environmental factors. Such factors include variable moisture and weather conditions, the presence of trees and their roots having a settling or lifting affect on the soil, or the effect of load bearing, e.g. heavy vehicles over a sustained period of time.

Cracking to this degree may also be due to poor original installation of the concrete. Factors such as poor compaction of the sub surface and/or inadequate reinforcing of the slab may create cracking and other secondary defects.

Repairs are likely to be required to prevent further cracking and to reduce hazards associated with cracking, such as tripping. Monitoring of all cracking should be conducted frequently. Always contact a building inspector should cracks widen, lengthen, or become more numerous.

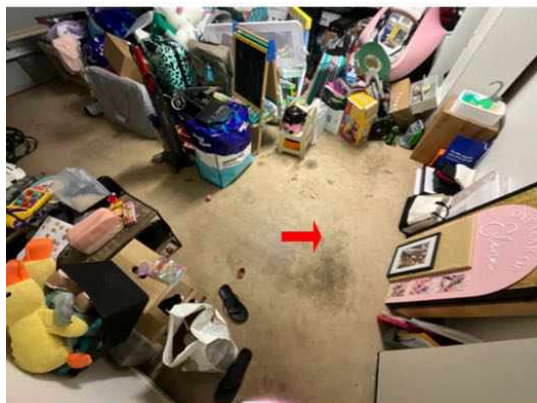
### Finding 3.06

Building:	Main Building
Location:	Garage
Finding:	Crack in concrete slab - Category 1
Information:	A crack coded as Category 1 was identified in the slab. A Category 1 crack is described as a fine but noticeable crack, with the slab at an otherwise reasonable level.

To be considered Category 1, the approximate width of the crack is less than 1.0mm, or a less than 10mm change in offset when a 3m straight edge is placed over the defect.

Category 1 cracks should be monitored for a period of 12 months. At the end of the monitoring period, identified cracks that are rated greater than Category 2 are considered defects, and require rectification.

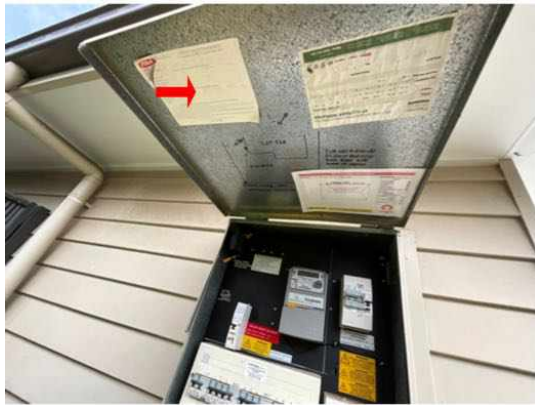
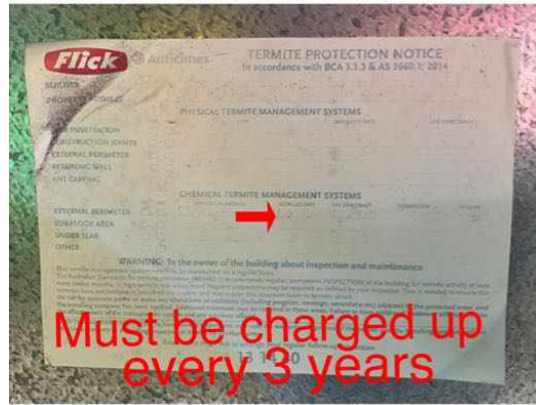
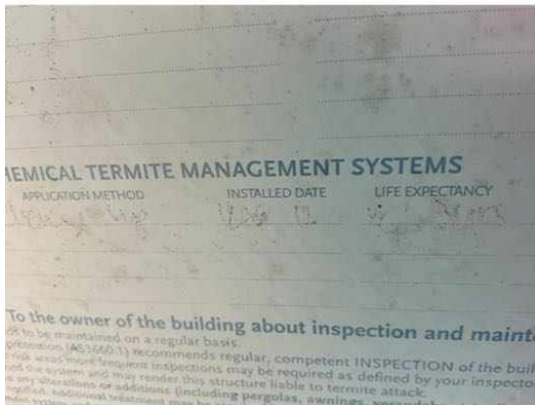
Building:	Main Building
Location:	All Areas
Finding:	Re-application of chemical termite barrier - required
Information:	Chemical treated barriers deteriorate over time necessitating the need for re-application of a barrier every 6-10 years depending on the product type environment etc. Due to this deterioration chemical barriers decline in their effectiveness exponentially if not replenished.

Consult the record of installation to identify the type of chemical and date of application. It is then advised to consult a licensed pest controller regarding reapplication intervals. Annual inspections are almost always required for all system types.

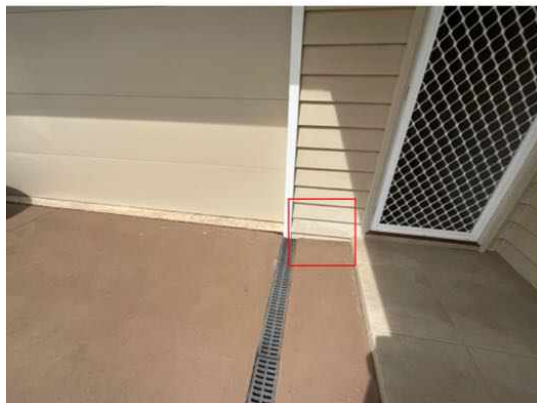
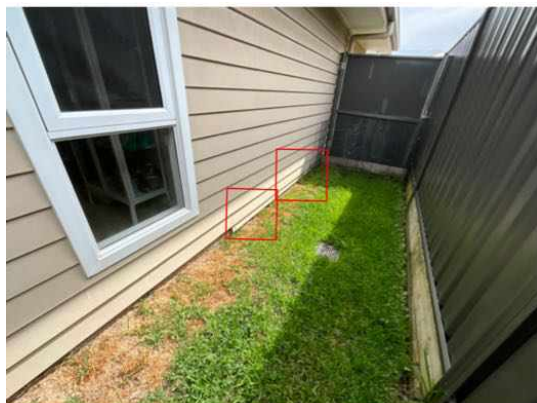
### Finding 6.02

Building: Main Building  
 Location: Multiple areas  
 Finding: Bridging of termite barrier  
 Information: Bridging of termite barriers occurs when termites bridge (usually by building a mud tunnel) a termite barrier or inspection zone or where termites have a passage allowing them to bridge the barrier.

Generally this takes the form of finished ground levels external paving or concrete being retrospectively installed above the damp course level the adjacent internal floor level or weep and ventilation holes.

Where bridging has occurred full inspection is prevented and termites may enter a property in a concealed or undetectable manner.

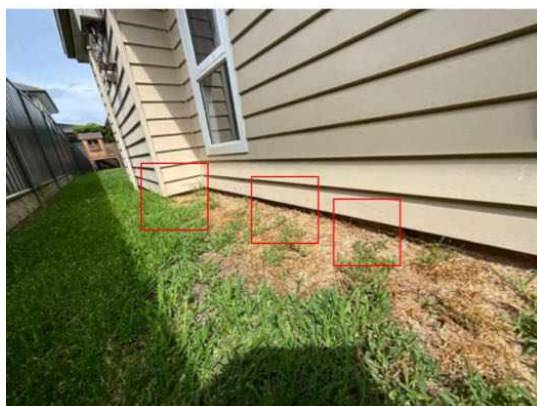
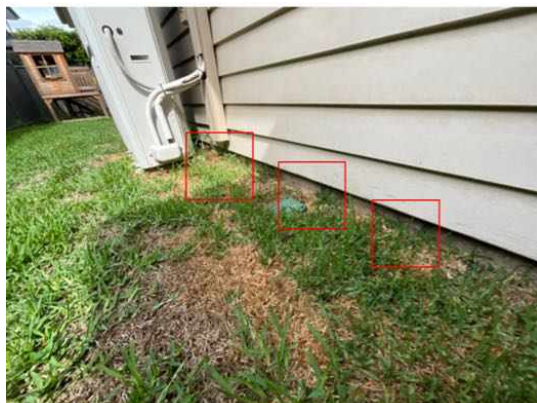
### Finding 6.03

Building: Main Building  
 Location: Exterior walls - right side  
 Finding: Bridging - Vegetation  
 Information: Where vegetation obstructs inspection of building elements, also known as bridging as it provides a bridging point for the access of termites, full inspection can not be achieved. Consequently moisture or dampness may be present and the areas becomes conducive to termite activity. Plants against or very close to buildings provide cover, shade and can provide an environment that is attractive to termite infestation.

The removal and replanting of species that do not provide "cover" or cutting back of existing vegetation will assist greatly in preventing Bridging from occurring.

The removal of any such materials that may be conducive to termite activity should be carried out as soon as possible and arrange re inspection to minimize the risk of termite attack.

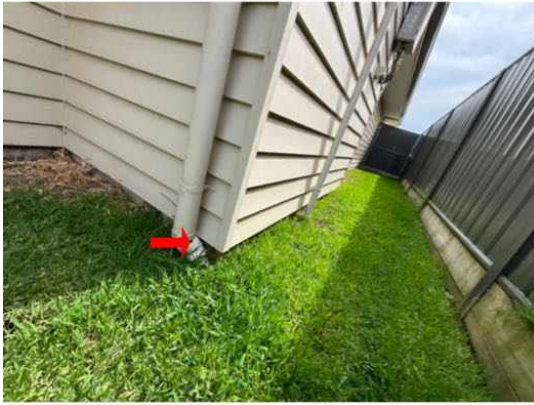
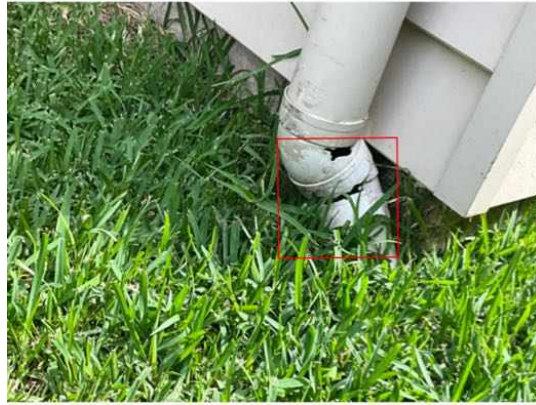
### Finding 6.04

Building:	Main Building
Location:	Roof plumbing RHS
Finding:	Stormwater drain - Damaged
Information:	The roof plumbing is not adequately connected to stormwater drainage on the site. This disconnection negatively impacts the functional capacity of the roof plumbing.

Where roof plumbing doesn't drain adequately, the area at the base perimeter can become excessively damp, potentially creating an environment that is susceptible to rust and corrosion of surrounding building elements, as well as attracting termites and other pests.

It is highly recommended that a plumber be appointed to further inspect the area and to install adequate drainage equipment where necessary.

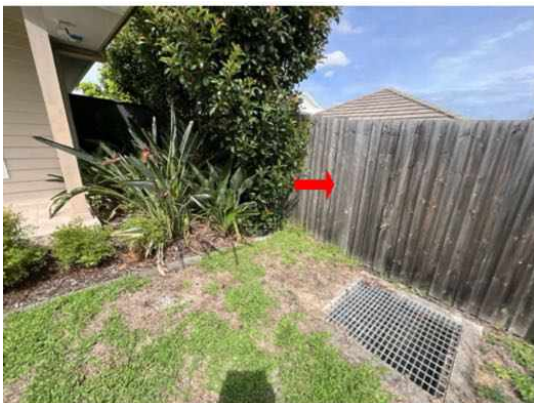
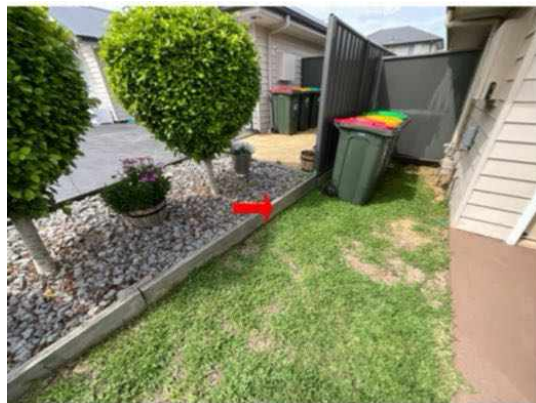
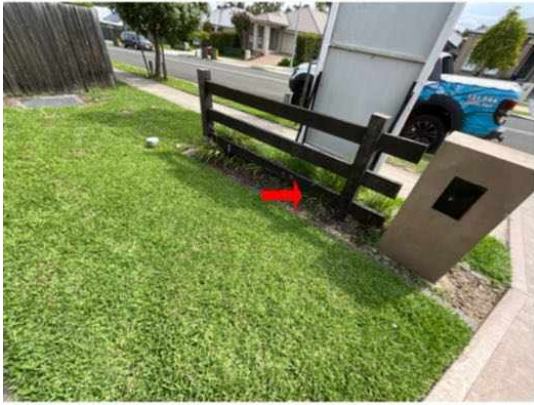
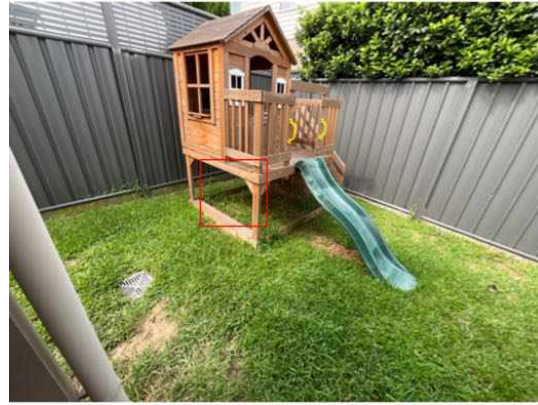
### Finding 6.05

Building:	Main Building
Location:	Fencing & Landscaping
Finding:	Building materials in direct ground contact - conducive to termites
Information:	Where timber elements are in direct contact with the ground and consequently moisture or dampness they become conducive to termite activity. Whether timber is used as a building element part of a fencing structure or stored as an unused item they can provide an environment that is attractive to termite infestation.

When met with excessive moisture timber begins to decay and develop wood rot. Any timbers that are in direct contact with external grounds especially if left untreated or non-durable also provide ingress for subterranean termites into that particular element.

The removal of any such materials that may be conducive to termite activity should be removed as soon as possible to minimise the risk of termite attack.

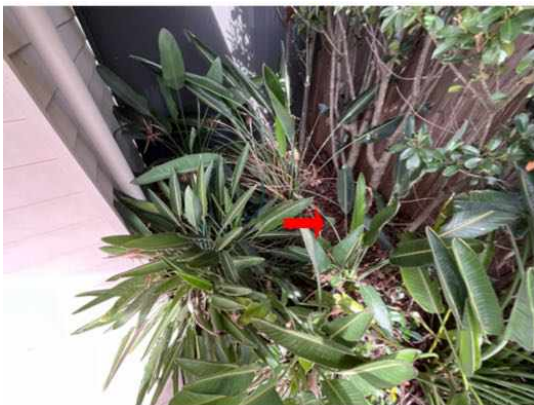
### Finding 6.06

Building:	Main Building
Location:	Garden beds
Finding:	Garden Beds
Information:	Garden beds were found to be evident in the garden area. These garden beds can include untreated timber, and with a combination of moisture from watering or hosing can make conditions conducive to termite activity and termite ingress.

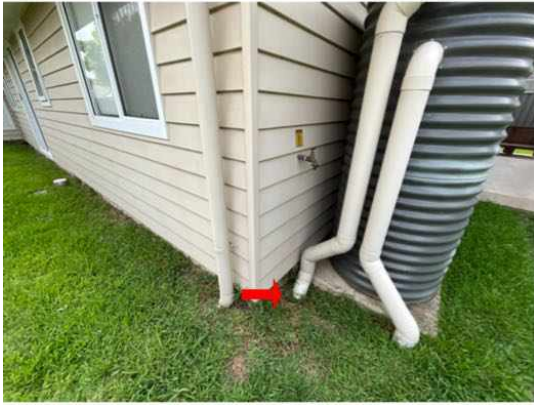
### Finding 6.07

Building:	Main Building
Location:	External tap
Finding:	Tap - No drain
Information:	The external tap in this area was noted to have no drain at the time of inspection.  This keeps the surrounding surfaces damp while using the tap, which becomes conducive to termite activity.  A licensed plumber must be appointed to ensure an appropriate drain is installed.
