## Building Inspection Report

Inspection Date: Mon, 23 Feb 2026

Property Address: 1008/2 Stockyard Bvd, Lidcombe NSW  
2141, Australia

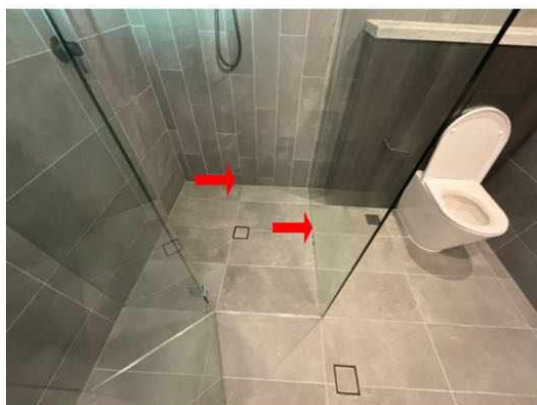
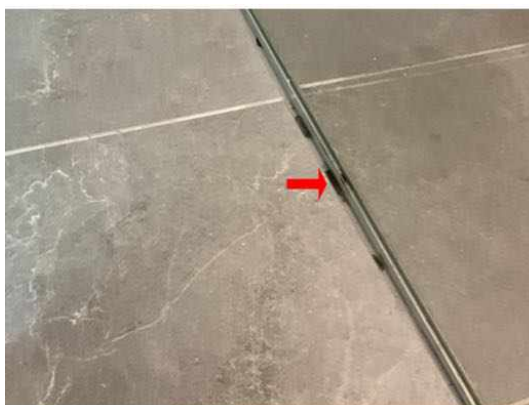
#### Defects 3.01

Building: Main Building  
Location: Bathroom  
Finding: Sealant and grouting - Missing or damaged  
Information:

It was noted on inspection that sealant or grout is degraded to this area.

Different materials and floor areas move at different rates, generally causing cracking to grout or sealant at this point. A flexible sealant is required to allow for expected expansion and contraction, while keeping the joint water tight and protective of all associated building materials.

Flexible and mould resistant materials should be applied to affected areas to prevent any subsequent water damage that is likely to occur. Regular maintenance and replacement of damage or missing or damaged sealant and grout is highly recommended to the wet areas, as this is a regular wear and tear defect. Sealant and grouting in areas that come into regular contact with water should be maintained for the long term care of your property.

A sealant specialist should be appointed to complete these works as soon as possible.
