# Building and Timber Pest Inspection Report

Inspection Date: Fri, 20 Mar 2026

Property Address: 17 Black Knight Street Mordialloc, Vic

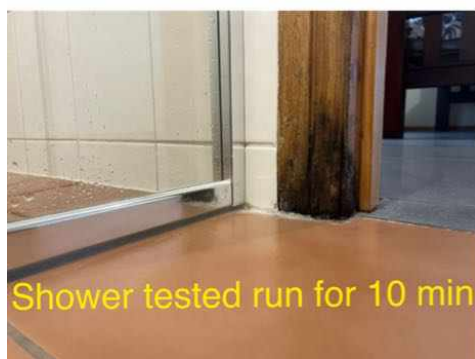
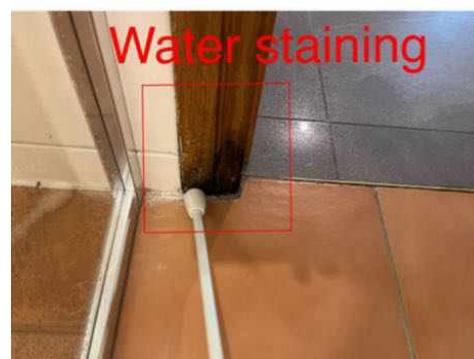
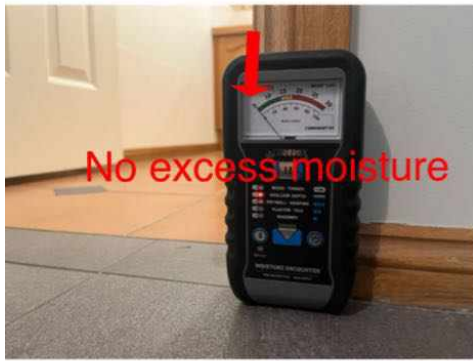
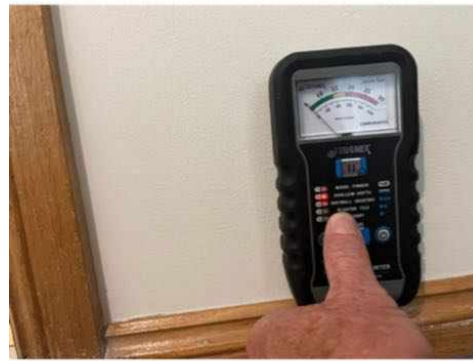
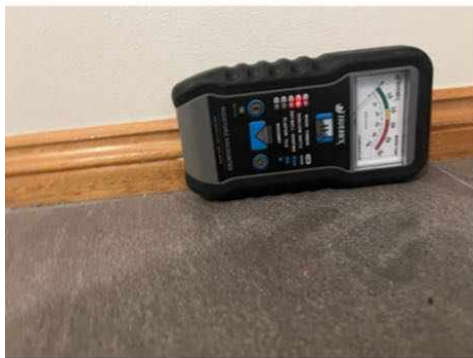
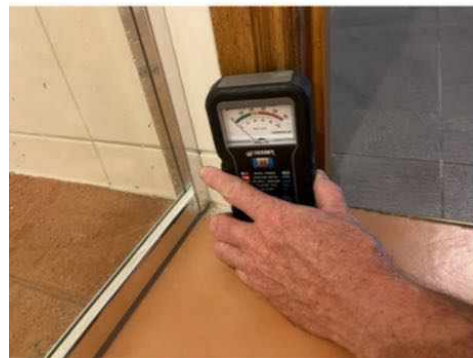
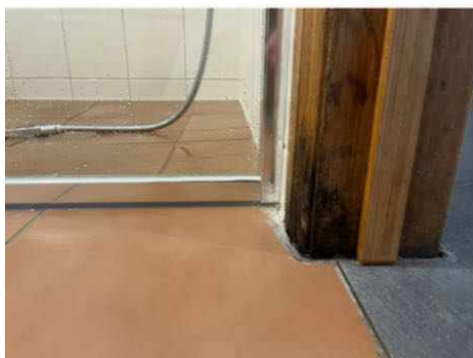
#### Finding 3.01

Building: Yard  
Location: Ensuite - Master  
Finding: Water damage - other  
Information: Evidence of moisture damage to the door architrave may be from slow seepage or poor seals to the shower in the past.

As the house may not have been occupied for many months, it was not surprising that the water stained area was dry.

Running the shower for 10min failed to identify any water / moisture escape.

It is possible that the moisture problem may be coming from where the shower screen, where it is screwed or fixed to the tiled wall - any screw hole can damage the water proof membrane. Testing at the time of the inspection could not confirm this is the cause of the problem.

Further testing by a licensed plumber is recommended.

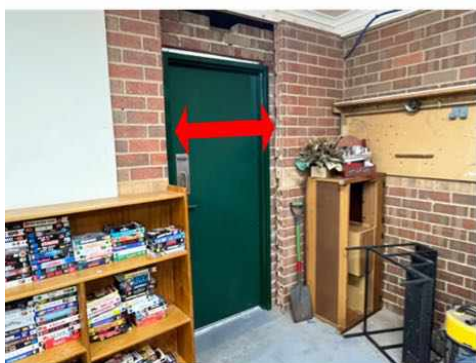
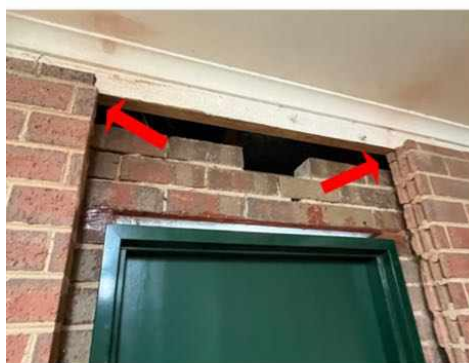
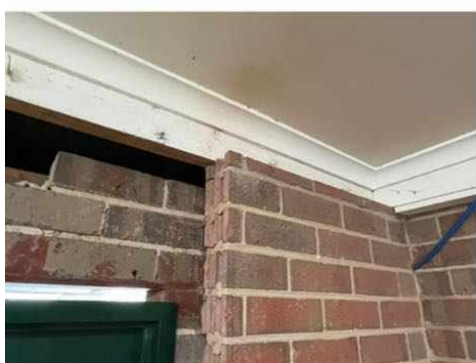
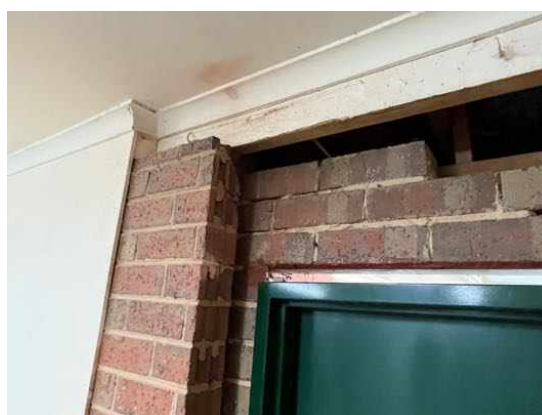
### Finding 3.02

Building: Garage  
 Location: Rear pedestrian door  
 Finding: Brickwork altered to accommodate a doorway  
 Information: At some point, the brick work at the back of the garage has been saw cut to create an opening for a door frame and rear pedestrian door.

The brickwork has never been completed and framed up however the opening has served its purpose.

We recommend that a licensed builder be engaged to finish off the alteration and to ensure the bricks at the top of the opening are completely stable.

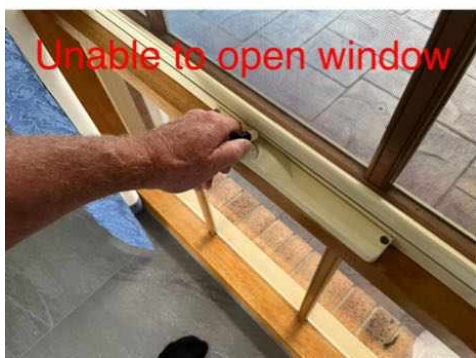
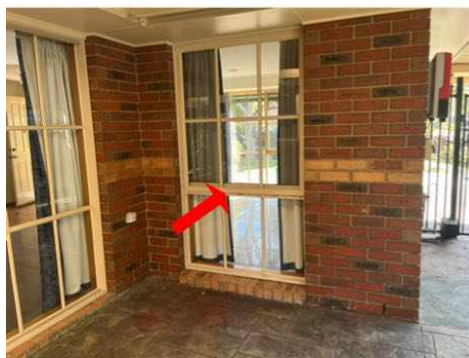
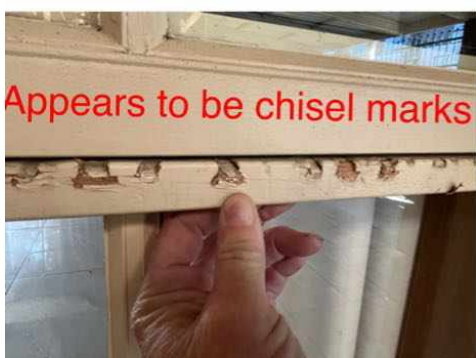
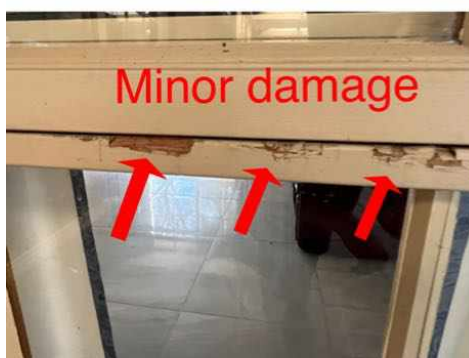
### Finding 3.03

Building:	Main Building
Location:	Lounge Room window
Finding:	Window - unable to open
Information:	The window in this area was jammed and not able to operate at the time of the inspection.

A check of the external of the Windows identified minor damage to the timber frame, suggesting a committed attempt has been made to free the window from the timber frame.

Sometimes when windows have not been opened for many years or even after painting, windows can become stuck.

Other, factors such as general age of the building element and a lack of maintenance are the usual causes for this type of defect.

It is likely that a carpenter or window supplier may be able to free the window from the frame.

In a worse case scenario, replacement of window or frame may be required.

A registered builder or general handy person will be required to repair the window.

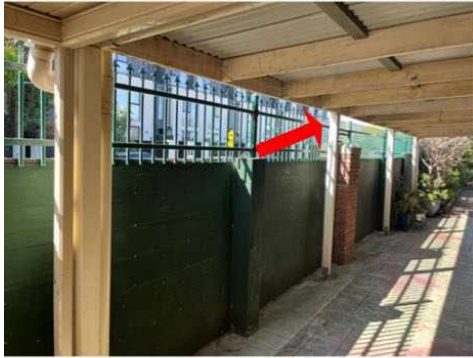
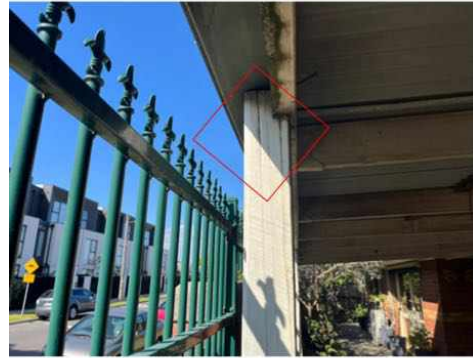
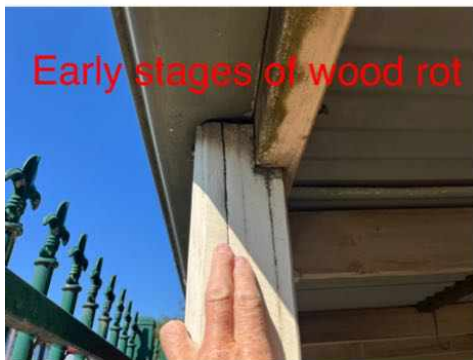
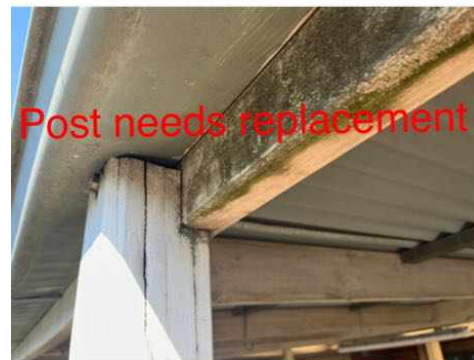
### Finding 3.04

Building:	Yard
Location:	Yard - pergola LH Side
Finding:	Wood rot - Pergola post (top)
Information:	This building element shows evidence of wood rot.

Wood rot, also known as Fungal Decay, occurs when timbers and other cellulose building materials are exposed to damp conditions on an ongoing basis. This could be the result of exposure to weathering over a prolonged period of time, or the attraction of excessive moisture from other abutting building materials.

Wood rot is often associated with general damp problems.

Early intervention and regular maintenance, particularly of exterior timbers, will prolong the useful life of these building elements.

Prior to any works being performed, the cause of the moisture that has created the visible wood rot should be identified and addressed in a suitable manner.

Replacement of affected timbers may then be a necessary step in protecting surrounding building elements from such deterioration.

A qualified plumber may be appointed to assess the cause of excessive moisture and to provide advice on any remedial works as required.

A qualified carpenter or registered builder may also be required to replace affected building materials.

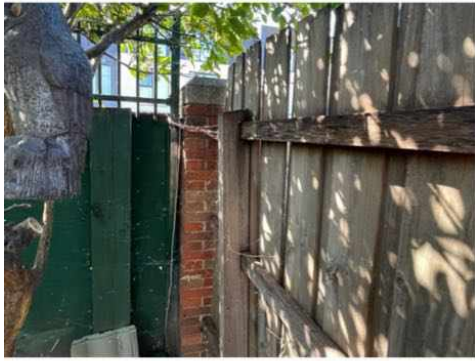
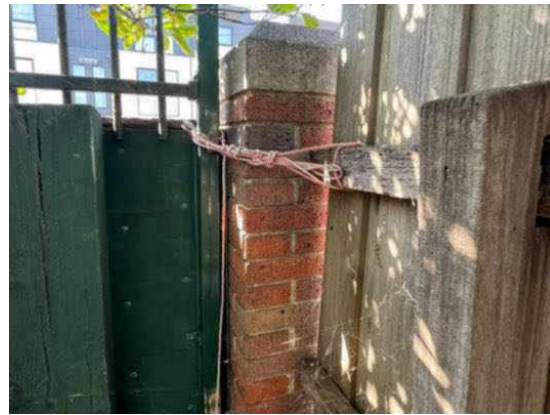
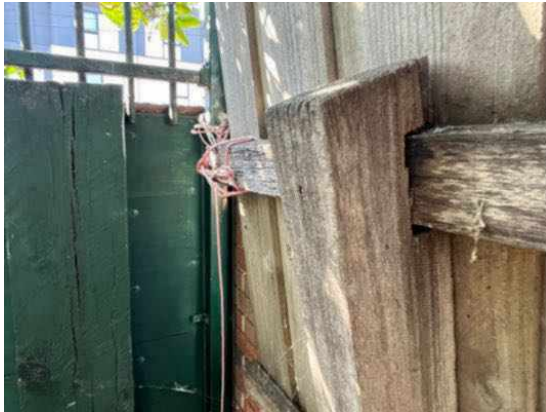
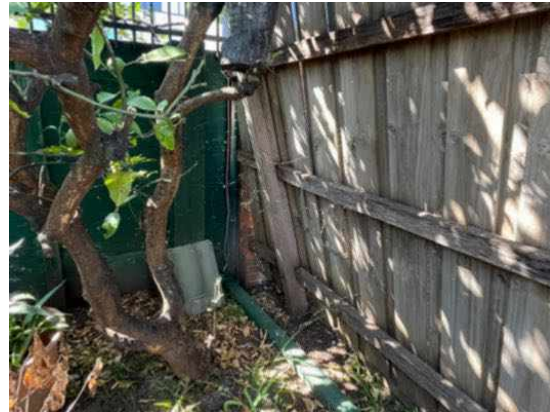
### Finding 3.05

Building:	Yard
Location:	Yard - Back
Finding:	Timber fence in poor condition - replacement likely to be needed.
Information:	The timber fence is in poor condition and is likely to need replacement in the near future. The purchaser should be prepared for the additional cost of replacing the fence in the near future.

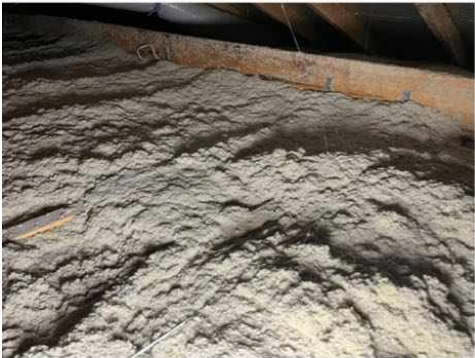
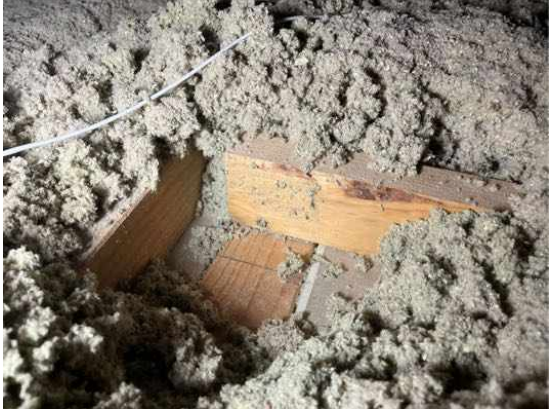
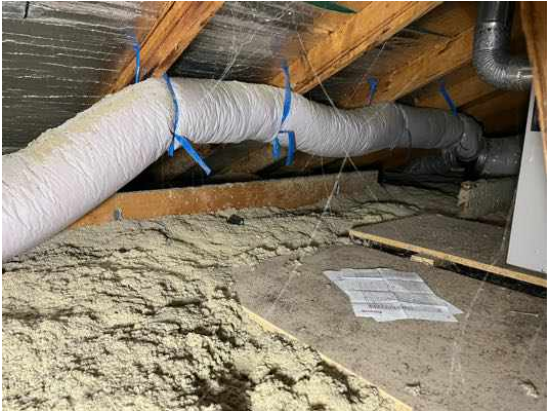
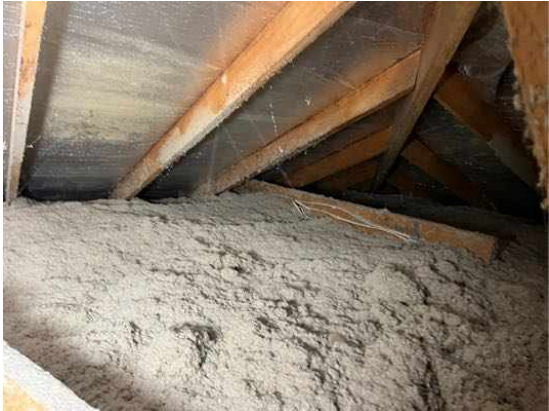
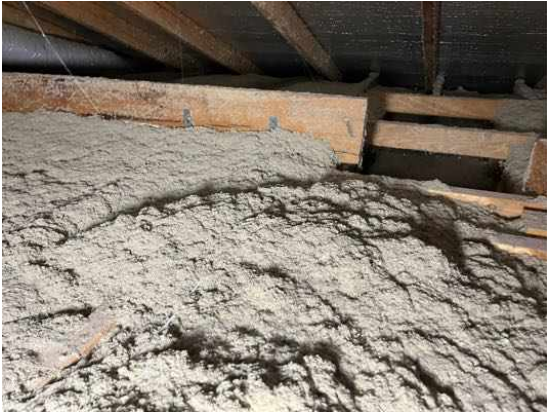
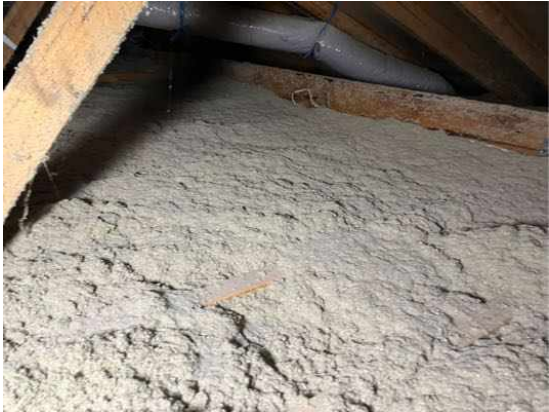
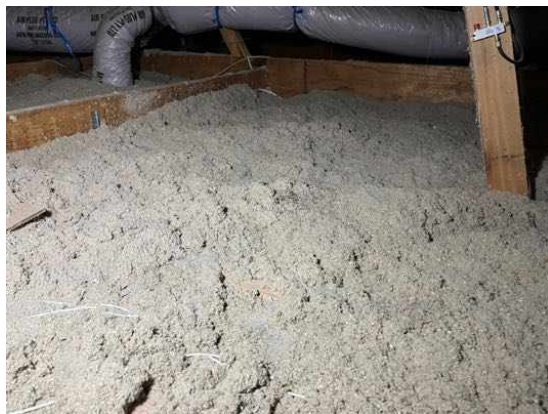
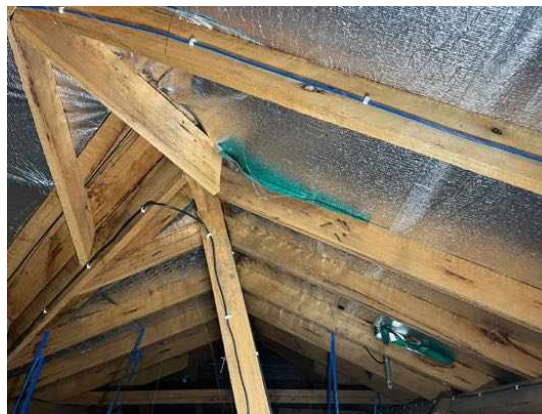
### Finding 6.01

Finding: Insulation in roof voids

Information: These photographs are an indication of the obstructions and limitations which impeded full inspection of the property at the time of inspection.

We were unable to gain access to inspect the timber components at risk of termite damage where insulation covers a large amount of timber.

These obstructions can hide an array of defects and a full inspection cannot be carried

A re-inspection is recommended once the areas are made accessible.

If the limitations are nor able to be reduced by removing areas or creating a manhole, a termite treatment is the next best option to protecting these timber elements.

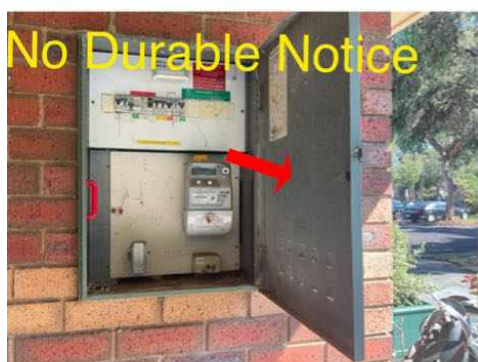
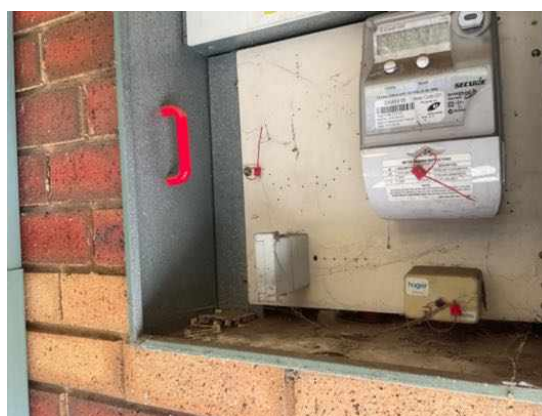
### Finding 6.02

Building:	Main Building
Location:	Meter Box
Finding:	Termite Management System - no evidence of a chemical installation
Information:	The application of a post-construction chemical termite barrier is highly recommended for all properties, particularly if live termite activity has been found on the site previously. Such barriers are highly effective in preventing termite attack on any timber building elements throughout the property.

A durable notice should be placed in the switchboard unit to indicate current termite barriers. At the time of inspection, it appeared as though no termite management system has been installed, with no evidence to suggest preventative works taking place.

The client may consider gaining further advice from a pest controller as to the costs and procedures involved with this application. It is recommended that obtaining such advice be a short-term priority.

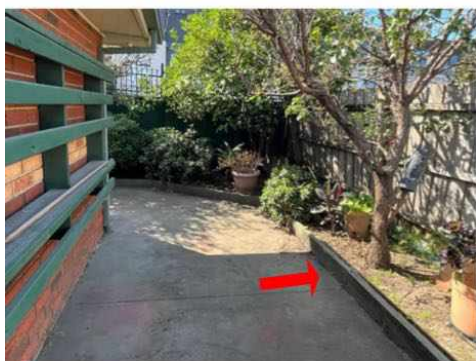
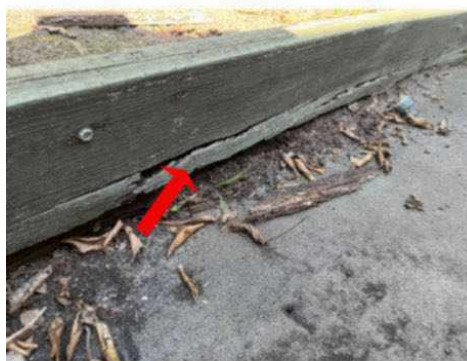
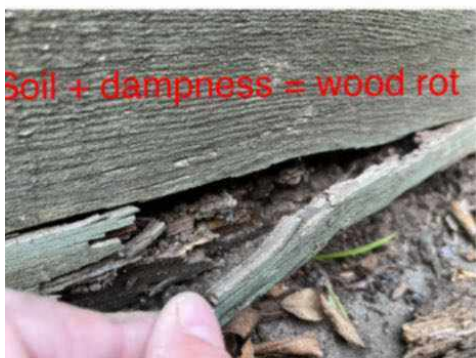
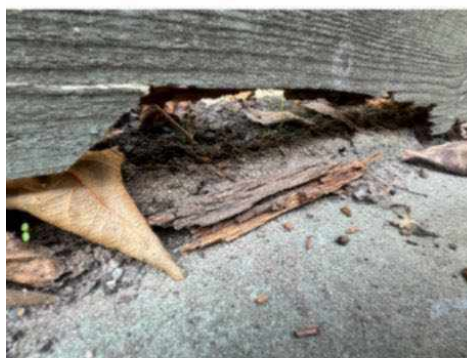
### Finding 6.03

Finding: Wood rot - Timber in contact with soil, Trees and external Timber  
Information: Wood rot, also known as Fungal Decay, occurs when timbers and other cellulose building materials are exposed to damp conditions on an ongoing basis.

This could be the result of exposure to weathering over a prolonged period of time, or the attraction of excessive moisture from other abutting building materials and soil. Contributing factors also include age of timber, decomposition, poor air ventilation and dampness.

Wood rot is often associated with general damp problems and is evidenced by a 'musty' smell or mould and mildew occurring on surfaces.

Timber in contact with the soil needs to be suitable rated (treated) dead or diseased trees should be removed.

Prior to any works being performed, the cause of the moisture that has created the visible wood rot should be identified and addressed in a suitable manner.

Replacement of affected timbers may then be a necessary step in protecting surrounding building elements from such deterioration.

A qualified Arborist can assist with trees and removal where appropriate.

A licensed plumber may be appointed to assess water related caused such as leaking gutters or the cause of excessive moisture and to provide advice on any remedial works as required.

A qualified carpenter or registered builder may also be required to replace affected building materials.

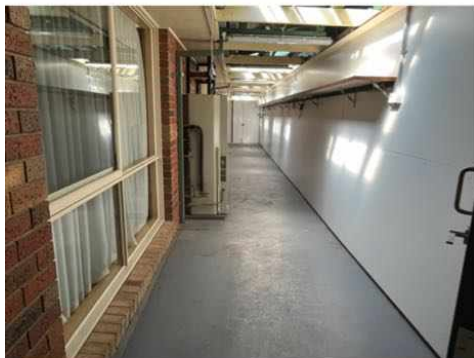
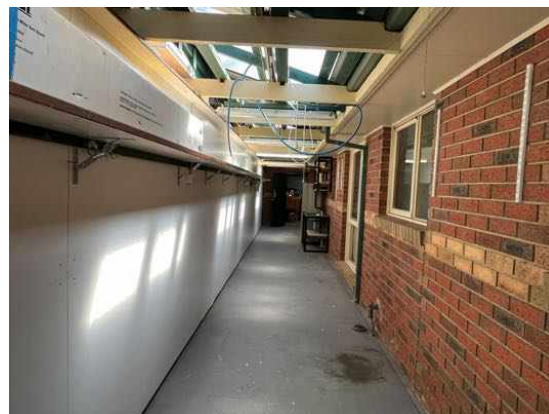
Building: Yard  
 Location: Pergola /Covered walkway  
 Finding: Unconventional handyman work  
 Information: This handyman work appears to have been completed to a reasonable standard of workmanship.

However, it is suspected the covered in walkway / storage area, does not comply with building regulations and may not have been constructed with a building permit.

Where handyman work is not completed satisfactorily, accelerated deterioration of the associated building elements is likely to occur and secondary defects to surrounding structures may develop.

It is highly recommended that the substandard work be rectified by professional services. Works to improve this area are likely to increase the safety and the operation of the associated building elements.

Rectification works are advised as soon as possible by the appropriate trades.
