Building and Timber Pest Inspection Report

Inspection Date: Wed, 25 Feb 2026

Property Address: 127 O'connell Street, Caddens NSW 2747

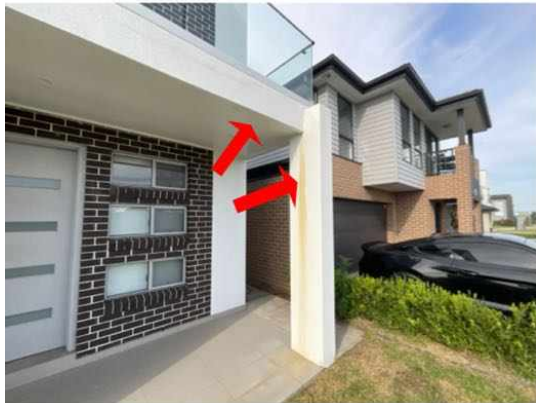
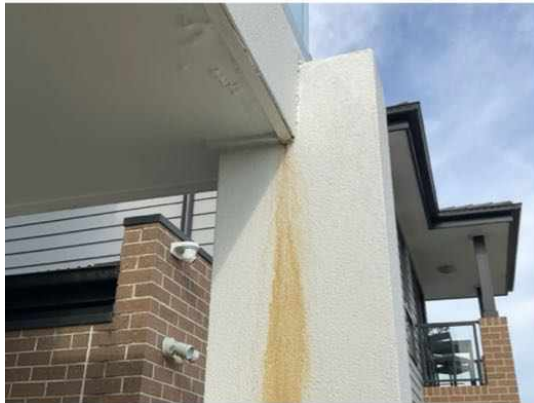
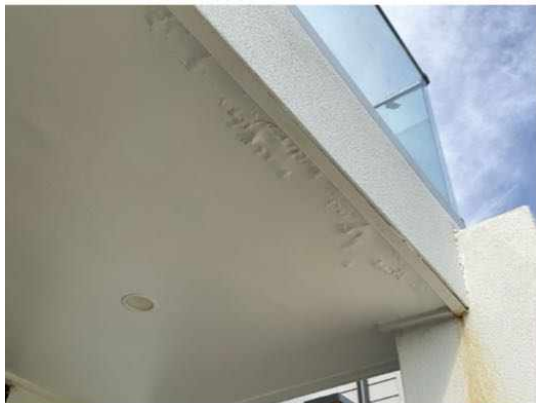
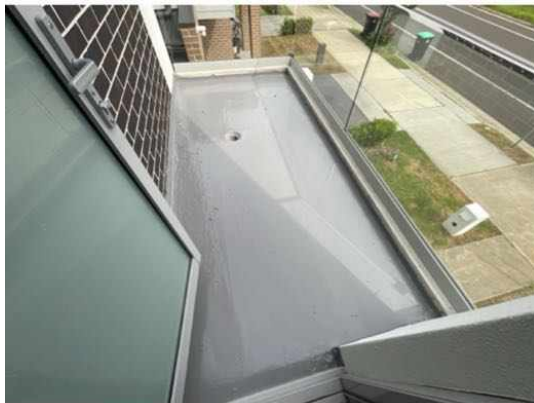
Building:	Main Building
Location:	Front Elevation
Finding:	Major Defect – Moisture Ingress Below Front Balcony
Information:	Observation:

Water staining was observed to sections of the external wall surfaces beneath the front balcony at the time of inspection. In addition, minor water-related damage was evident to the plasterboard ceiling lining directly below the balcony area.

Upon closer inspection of the balcony surface, it was noted that the original floor tiles and sand-and-cement screed have been removed. A new waterproofing membrane has recently applied and wet at the time of inspection. The balcony tiling remains incomplete at the time of inspection, leaving the membrane exposed.

The presence of water staining and ceiling lining damage indicates that moisture ingress has previously occurred from the balcony above. Incomplete reinstatement of the tiled surface exposes the newly applied waterproofing membrane to potential UV degradation, mechanical damage, and weathering. Prolonged exposure may compromise the integrity of the membrane system, increasing the risk of continued or recurrent water penetration into the structure below.

Ongoing moisture ingress can result in progressive deterioration of internal finishes, concealed structural timbers, fixings, and may promote mould growth if not adequately addressed. As the works are incomplete, the long-term effectiveness of the waterproofing system cannot be confirmed at this stage.

A suitably qualified and licensed tiling contractor should be engaged as a matter of priority to complete the balcony tiling works in accordance with relevant Australian Standards and manufacturer specifications. It is further recommended that documentary evidence be obtained confirming that the waterproofing system has been installed by a licensed applicator and complies with current waterproofing requirements, including provision of a waterproofing compliance certificate where

Following completion of the works, the affected areas should be monitored for any signs of continued moisture ingress. If staining persists or moisture levels remain elevated, further invasive investigation by a suitably qualified building or waterproofing specialist may be required.

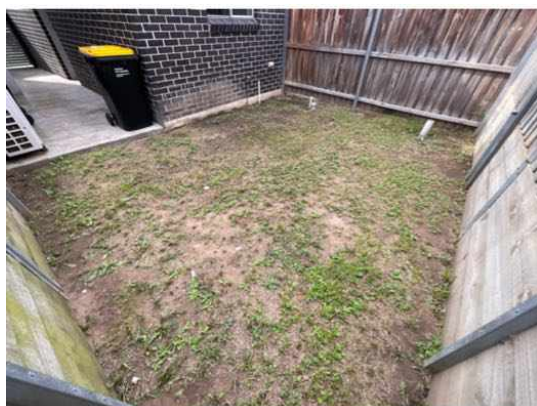
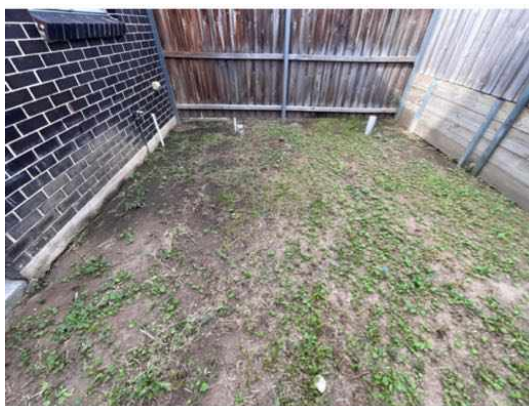
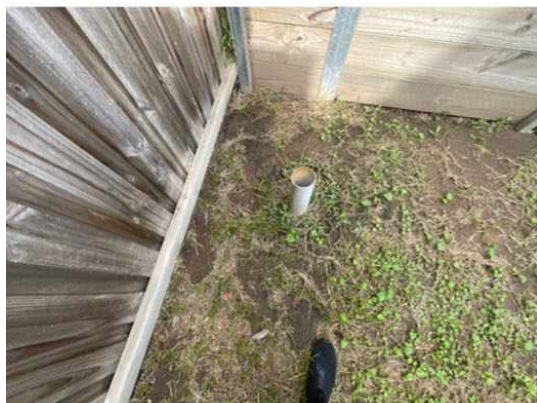
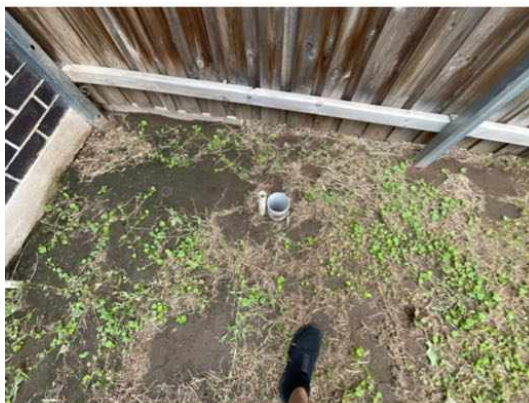
Finding 3.01

At the time of inspection, the site drainage in this area was found to be inadequate and incomplete, creating the potential for water pooling during periods of rainfall. Key

Inadequate drainage and poor drain installation can lead to:

- Water pooling near the structure or in pedestrian areas
- Soil saturation, which can impact footings, slab edges, or landscaping
- Increased risk of moisture ingress into subfloor areas or internal spaces
- Compromised termite management systems, particularly if water accumulates near concealed slab edges or weep holes

It is recommended that a qualified drainage plumber or landscaping contractor be appointed to:

- Assess the current drainage system and site levels
- Reconfigure or upgrade the surface drain to ensure it functions correctly
- Regrade surrounding areas if necessary to facilitate proper water runoff

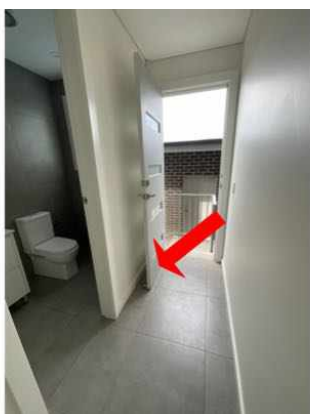
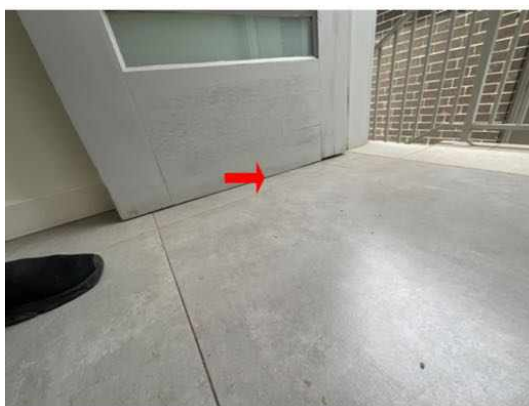
Finding 3.02

Building:	Main Building
Location:	Exterior door - rear
Finding:	Door - Binding on Floor Covering (insufficient clearance).
Information:	Observation:

Binding or rubbing was observed between the bottom edge of the door and the floor covering during normal operation. The door does not open or close freely due to insufficient clearance.

The bottom edge of the door should be trimmed or planed to provide adequate clearance, and the edge sealed appropriately after adjustment.

Rectification can be carried out by a qualified carpenter or general handyperson, depending on the extent of adjustment required and at the client's discretion.

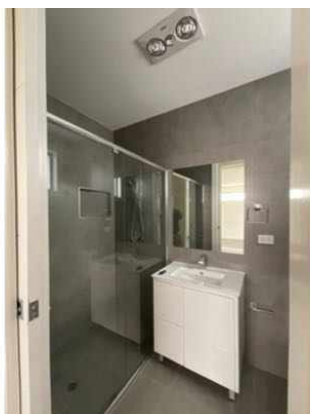
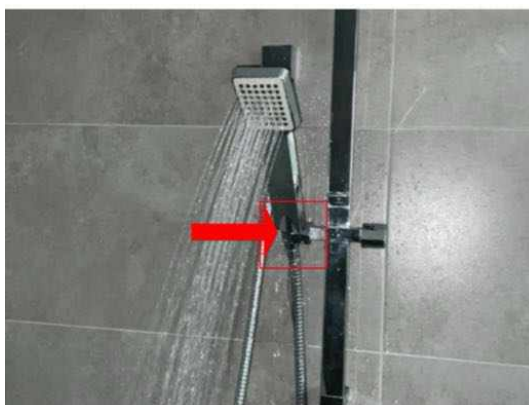
Finding 3.03

Building: Main Building
 Location: Ensuite
 Finding: Minor Defect – Leaking Shower Hose
 Information:

The flexible shower head hose within this bathroom was observed to be leaking at the time of inspection. The leakage appears to be associated with deterioration of the hose fitting and/or internal lining, consistent with general age-related wear and tear.

This condition is considered minor and typical of normal usage over time. While the defect is not structural in nature, ongoing leakage may contribute to unnecessary water wastage and, if left unaddressed, could lead to minor moisture accumulation within the shower recess or surrounding fixtures.

Repairs or replacement of the shower hose are recommended to prevent further

leakage. This work is relatively straightforward and may be carried out by a suitably experienced handyman or licensed plumber at the client's discretion.

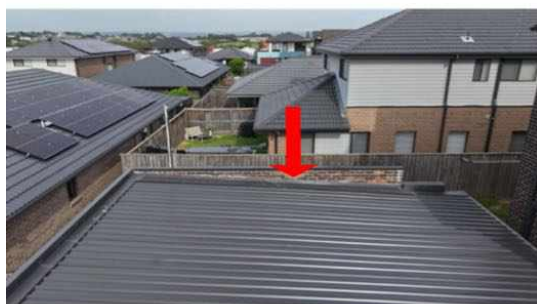
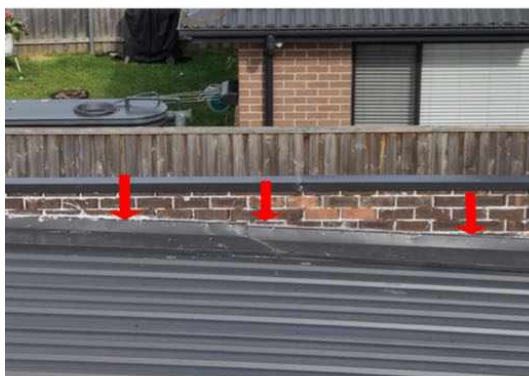
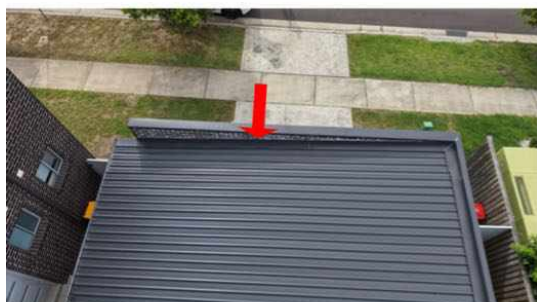
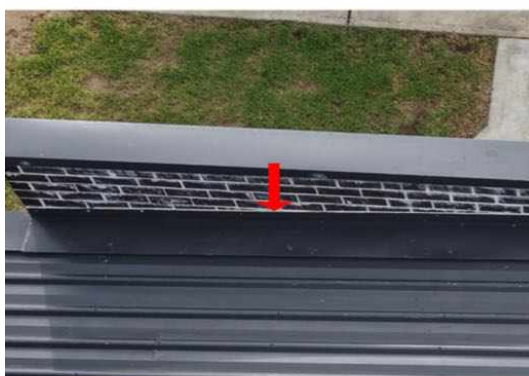
Finding 3.04

Building:	Garage
Location:	Roof Exterior
Finding:	Roof Flashing - Missing Over/Cover Flashings
Information:	Observation:

Sections of the roof were noted to be missing over/cover flashings at junctions where the roof covering abuts adjoining brickwork and structural elements. Over/cover flashings are typically installed over pressure or apron flashings to provide additional protection and weatherproofing at these critical junctions.

In the absence of correctly installed over/cover flashings, the reliance is placed solely on sealant and underlying flashing components to prevent water ingress. Sealant materials are subject to cracking, shrinkage, and separation over time due to thermal movement and weather exposure. Any failure at these junctions significantly increases the risk of moisture penetration into the roof space and adjoining wall cavities.

Flashings are specifically designed to weatherproof intersections between roof coverings and vertical building elements. Where flashings are inadequately installed or incomplete, there is an elevated risk of water ingress, which may result in internal damage, deterioration of structural timbers, corrosion of metal components, insulation damage, and potential mould growth. Prolonged exposure may lead to secondary building defects and premature ageing of associated materials.

A suitably qualified and licensed roofing contractor or builder should be engaged to install appropriate over/cover flashings in accordance with current building standards and good roofing practice. The rectification works should ensure that all roof-to-wall junctions are adequately protected and sealed to prevent future water penetration.

All works should be completed in a tradesman-like manner to ensure long-term weatherproofing performance. This assessment is based on visual inspection only, and no invasive inspection of concealed areas was undertaken at the time of assessment.

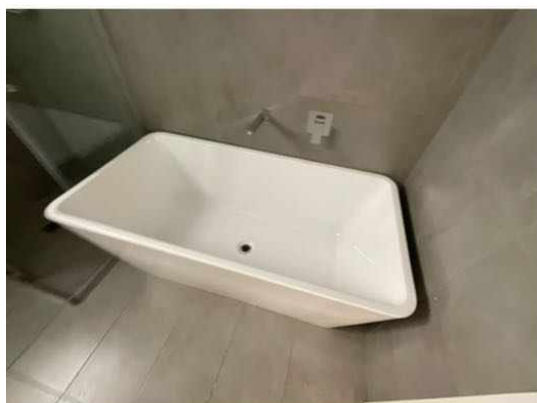
Finding 3.05

Building: Main Building
 Location: Bathroom
 Finding: Bathtub - Not secured.
 Information: Defect – Freestanding Bathtub Not Secured

The freestanding bathtub was found to be unsecured to the floor at the time of inspection. The tub is capable of movement when pressure is applied, indicating that it has not been mechanically or adhesively fixed. Freestanding baths require stabilisation and proper sealing to ensure safe and compliant use. Without adequate

An unsecured bathtub presents several functional and safety risks. Movement during use can cause shifting or tipping, creating a hazard for occupants. Ongoing movement may stress or partially dislodge the waste outlet or other plumbing connections, increasing the likelihood of concealed water leakage. Water escaping beneath the tub can lead to moisture accumulation, mould development, and deterioration of flooring or subfloor materials. Over time, this can escalate into significant repair costs and potential microbial health risks.

Engage a licensed plumber to secure the bathtub in accordance with manufacturer guidelines and relevant plumbing standards. Acceptable methods typically include mechanical fixing or the application of a flexible, mould-resistant adhesive sealant to stabilise the unit and ensure a watertight junction with the flooring. The plumber should also confirm that all waste and overflow connections are sound and compliant. Proper fixing and sealing will improve safety, protect plumbing integrity, and reduce the risk of moisture-related damage.

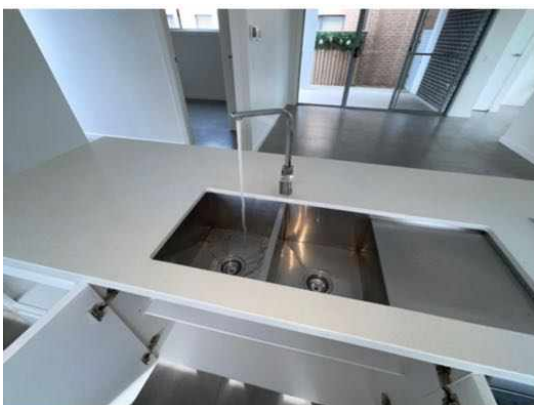
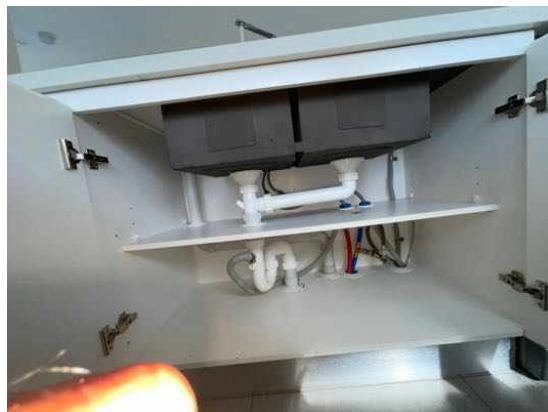
Building: Main Building
 Location: Kitchen
 Finding: Kitchen Sink – Overall Condition & Recommendations.
 Information: Observations:

- Further monitoring and testing are recommended once the tap(s) are in constant use, to identify any drainage issues or signs of slow leaks not evident during the limited inspection.

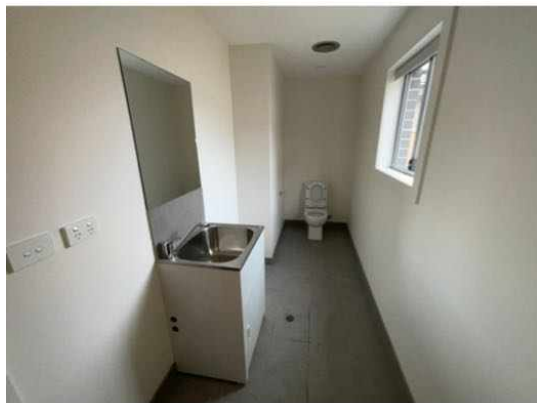
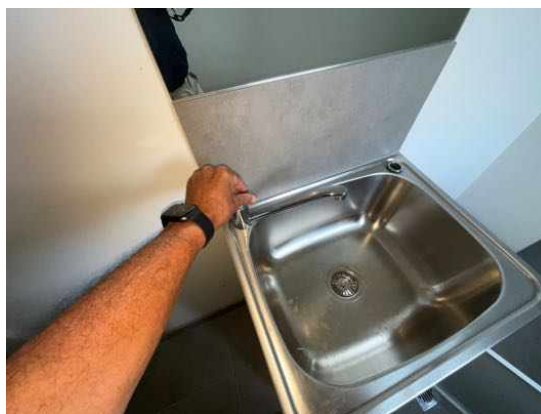
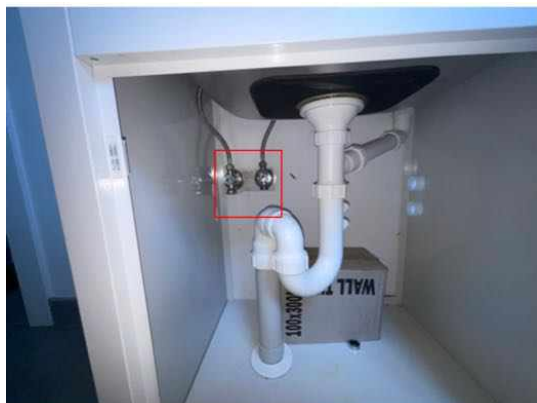
Building: Garage
 Location: Laundry
 Finding: Tap/s - Not Operational (2 way tap connection).
 Information: Tap Not Operational – Laundry

- Tap(s) should be checked for proper operation once the washing machine is connected.
- If issues persist, a licensed plumber should be engaged to assess and repair as required.
