Building and Timber Pest Inspection Report

Inspection Date: Wed, 28 Jan 2026

Property Address: 2/22 Stevens St, Sunshine Beach QLD 4567,
Australia

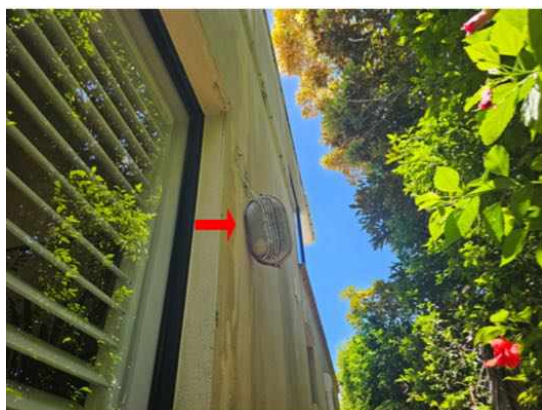
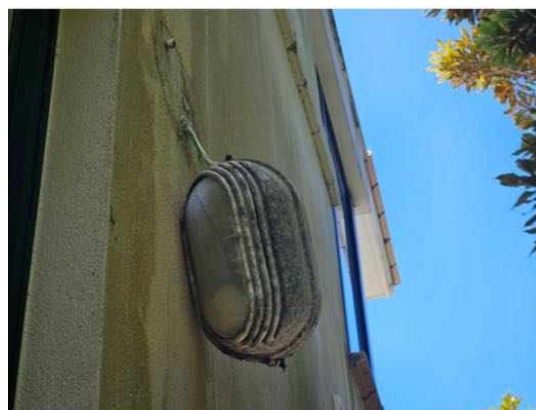
Finding 1.01

Building:	Main Building
Location:	Right side
Finding:	External light fitting damaged.
Information:	Note during the inspection, the right side external light fitting is damaged and will require replacement. As it is hanging by the cable from a height it is a safety / electrical hazard

The client should engage a licensed electrician to carry out the replacement.

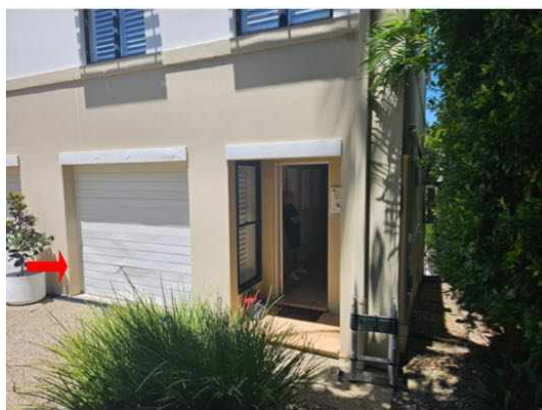
Finding 3.01

Building:	Main Building
Location:	Garage
Finding:	Garage door - dent
Information:	On the day of inspection the garage door panel at the lower left of the door was noted as being dented. The door could not operated on the day of inspection.

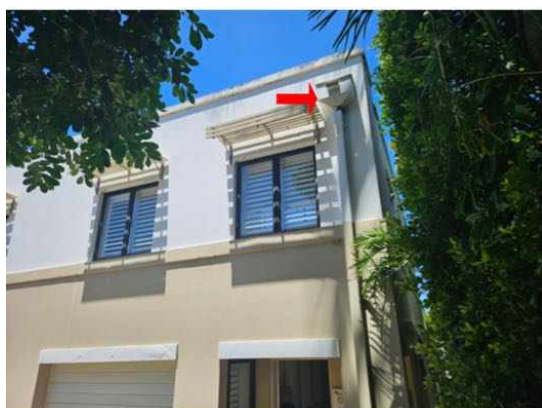
Finding 3.02

Building:	Main Building
Location:	Front elevation
Finding:	Downpipe dropper - rusting
Information:	On the day of inspection it was noted that the downpipe dropper / outlet of the front rain head was rusting.

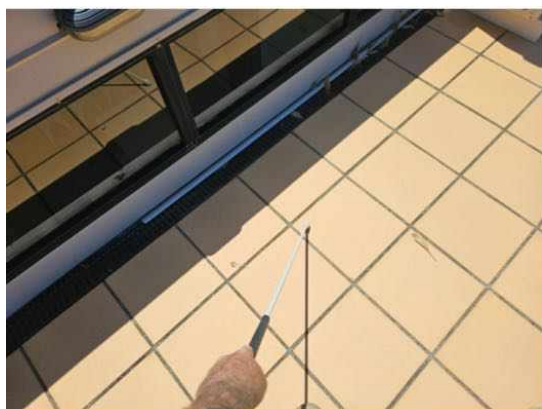
Finding 3.03

Building:	Main Building
Location:	Roof top terrace
Finding:	Tiles drummy - Category 1
Information:	Drummy tiles were identified in the roof top terrace at the time of inspection. These would be categorised as a category 1 type, meaning the tile is hollow underneath showing the adhesive has delaminated ; however the tile is not moving and the grout is intact. Please see the attached photos for locations.

The term 'drummy' refers to tiles that have become detached from their fixing, despite otherwise being in relatively good condition. Such defects are generally caused by physical or moisture damage to the area. Drummy tiled areas may also be a direct result of poor workmanship during the construction process.

Tiled areas may swell and shrink with changes in air humidity if the area has sustained moisture damage. Any exposure to moisture is capable of causing tiled areas to become drummy and/or cracked over a prolonged period of time. Drummy tiled areas generally require removal and replacement of affected tiles.

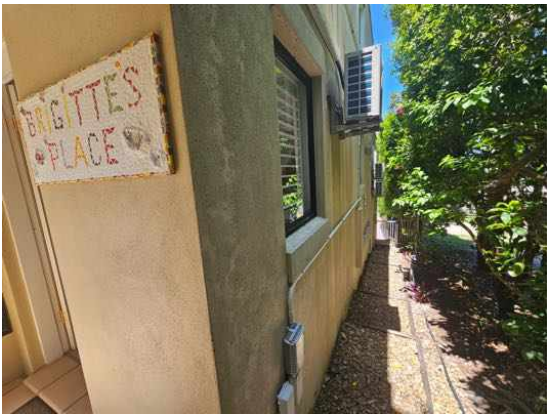
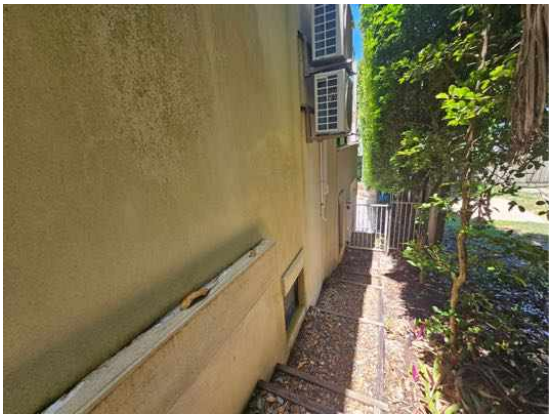
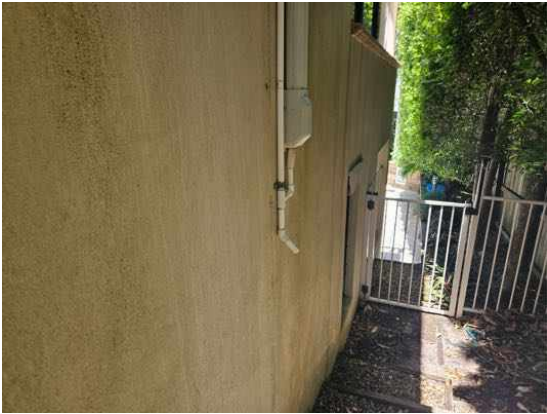
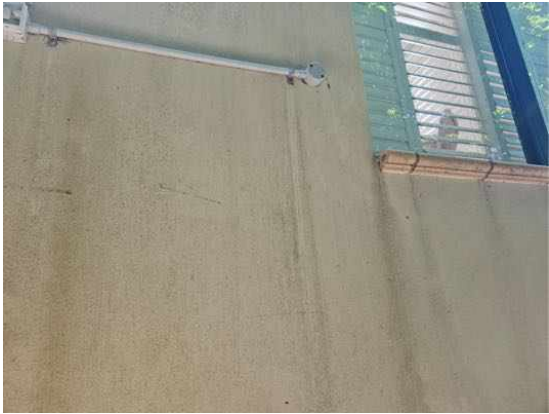
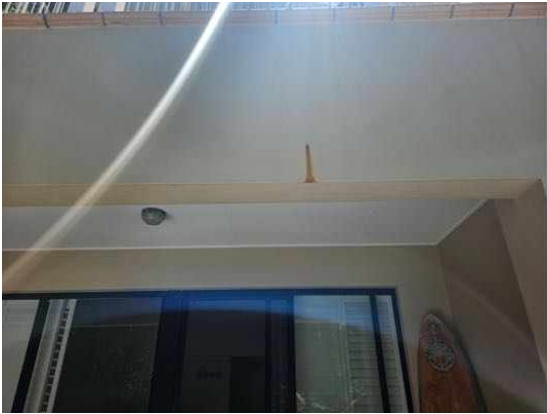
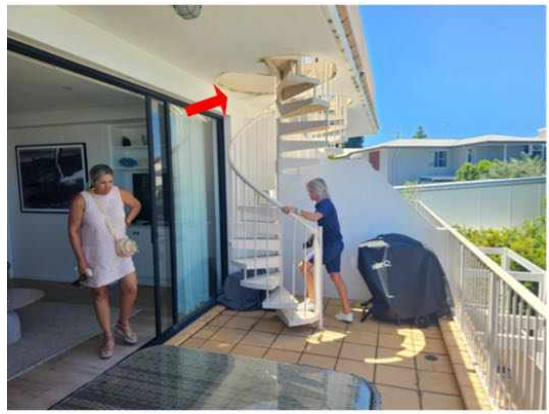
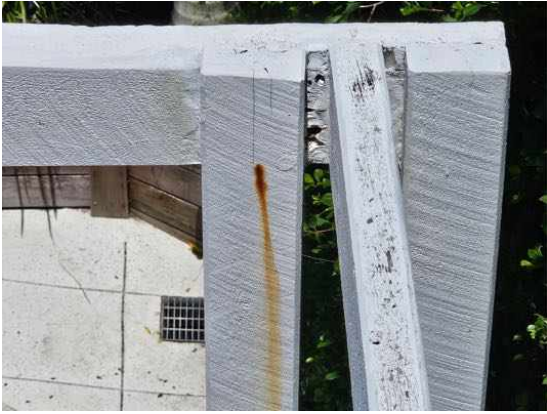
Finding 3.05

Building: Main Building
Location: All External Areas
Finding: External painting deteriorated
Information: The external paintwork in the areas shown requires attention to prepare and re-paint.

A painting contractor could be appointed to perform necessary works to aid the appearance of the affected area and to ensure the area is protected against further deterioration.

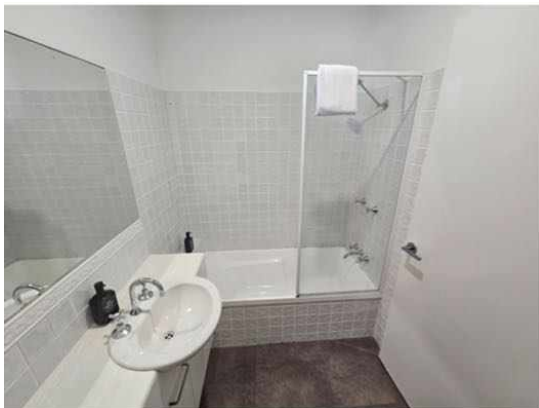
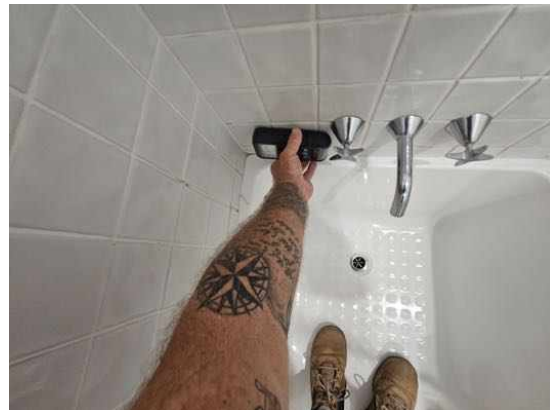
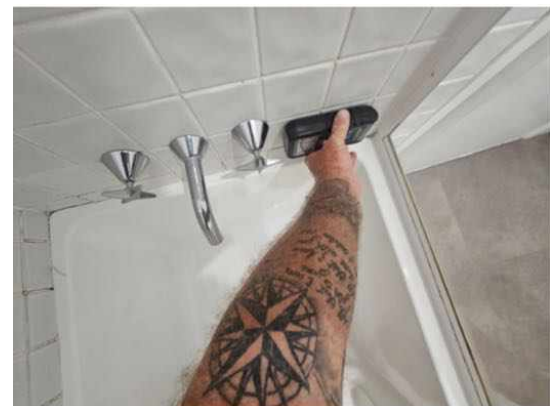
Finding 3.06

Building: Main Building
Location: Bathroom 2
Finding: Elevated moisture present at the time of inspection - bathroom 2
Information: Elevated moisture was noted in the lower tiled wall surfaces of the second bathroom shower.

This appears to be due to deteriorated grout and silicone sealants in the bottom two rows of tiles. These can break down over time and become porous, allowing moisture to enter the wall sheet surface behind the tiles.

Elevated moisture can attract timber pests and vermin, and produce conditions that promote timber pest attack, fungal growth and wood decay.

The moisture readings in the ground floor shower recess are limited to the lower 1-2 courses of tiles, which can usually indicate grout and silicone degradation.

It is recommended that the grout and silicone could be renewed to possibly eliminate any further moisture penetration.

A licensed tiler and / or sealant specialist could be engaged to renew these elements.

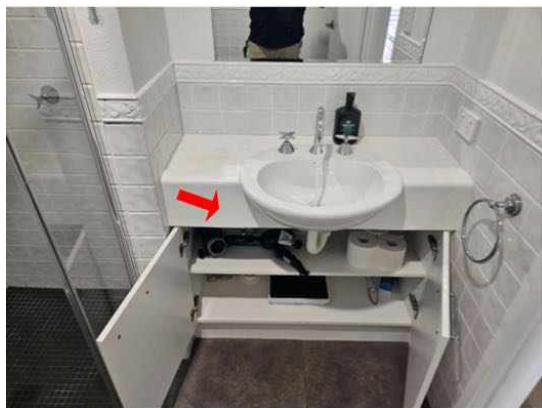
Finding 3.07

Building: Main Building
Location: Bathrooms
Finding: Bathroom cabinetry
Information: Whilst inspecting the bathrooms, minor moisture damage was noted in the vanities.

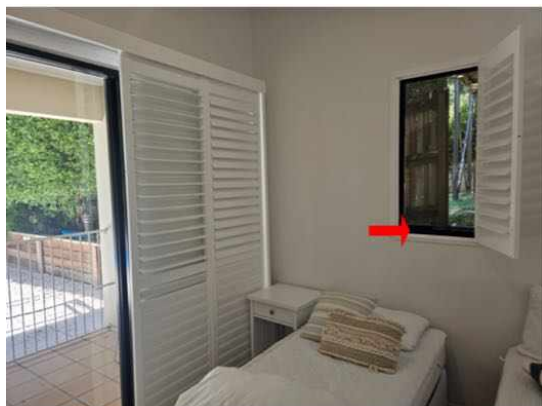
Finding 3.08

Building:	Main Building
Location:	Bedroom, ground floor
Finding:	Window lock - degraded
Information:	On the day of inspection the bedroom awning window latch mechanism was noted as corroded. This may require replacement by a suitably qualified technician in the short term.

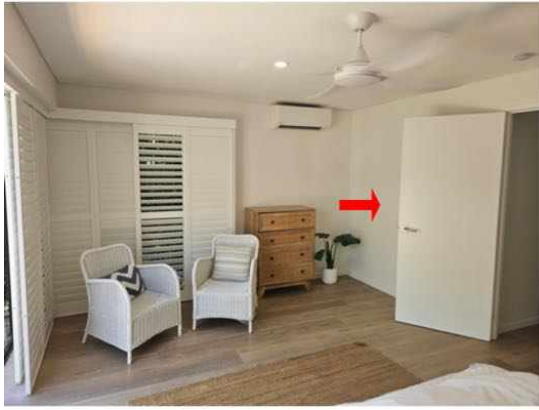
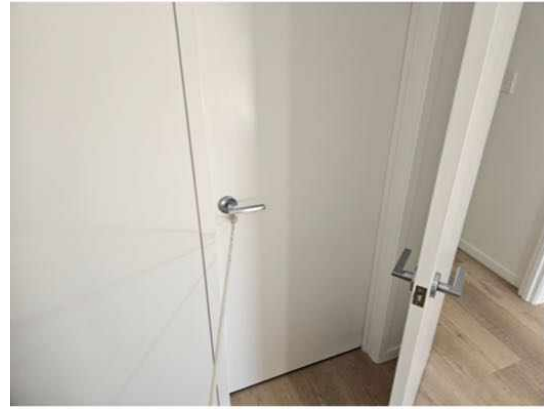
Finding 3.09

Building:	Main Building
Location:	Bedroom 2
Finding:	Door hardware faulty
Information:	At the time of inspection the door hardware to the entry door to the bathroom from the bedroom was faulty and is loose in the door.

A licensed carpenter or general handyman could be engaged to repair the door lock.

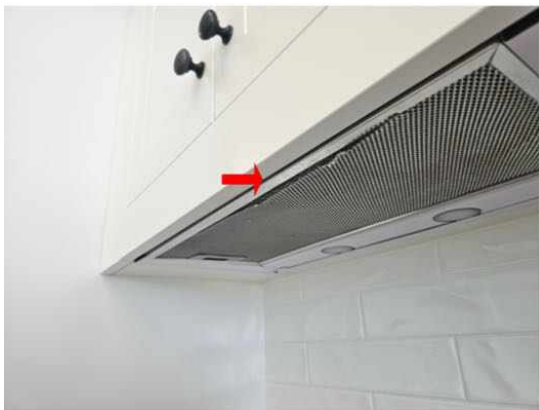
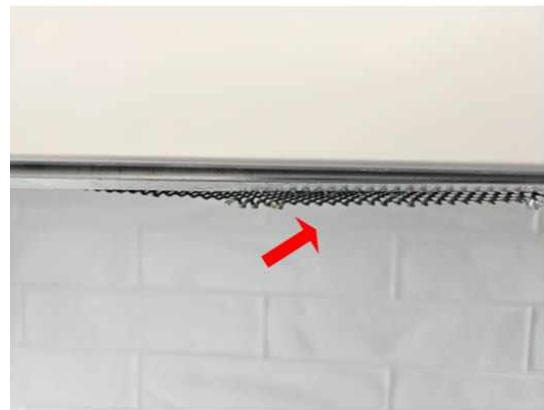
Finding 3.10

Building:	Main Building
Location:	Kitchen
Finding:	Rangehood - slide out filter misaligned
Information:	While the range hood appears to be working at a satisfactory level, the filter grill mesh is not faulty.

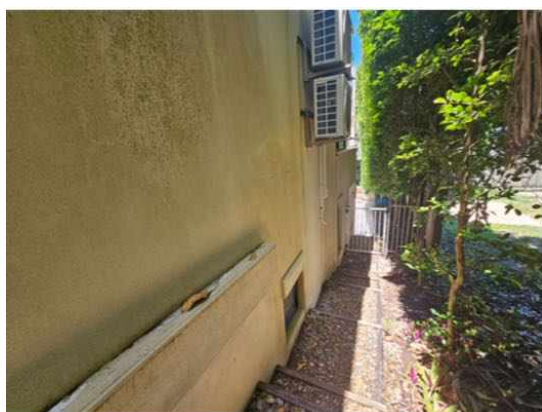
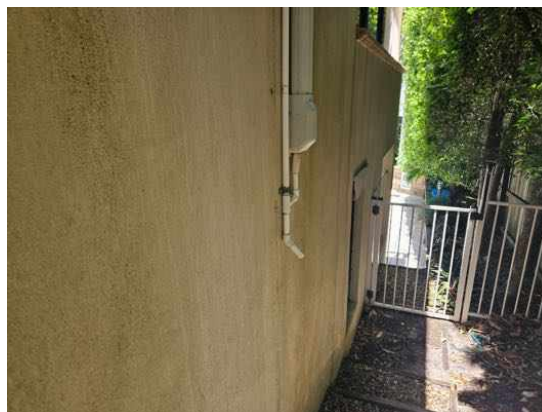
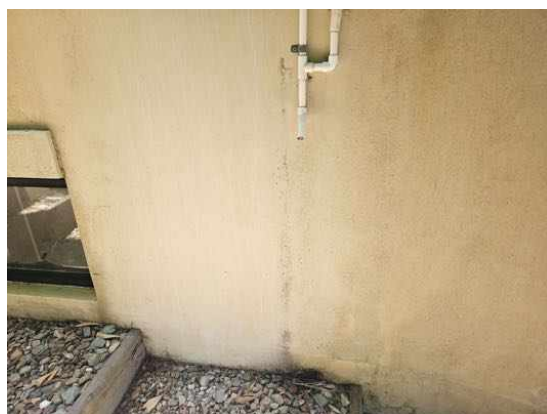
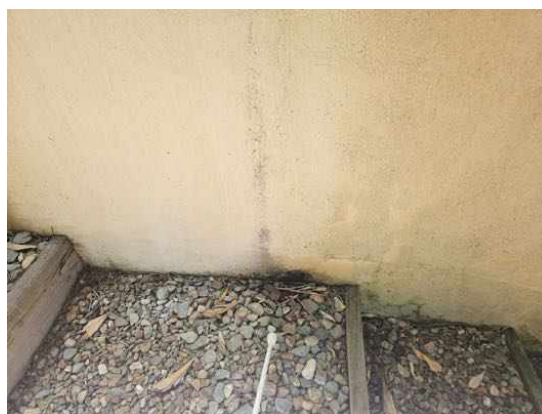
Finding 6.01

Finding: Air conditioner - Disconnected drain
 Information: The Air Conditioner (A/C) overflow was found to be disconnected from storm water drainage and could create excessive moisture in the surrounding area.

Such leaking creates an environment which is conducive to an array of defects, including water damage to associated building elements and the attraction of termite or timber pest infestation.

It is recommended that a licensed plumber be appointed to connect the A/C overflow to a drainage source in order to prevent such an environment from being created. An alternative is to extend the overflow further into the garden away from the building perimeter.

These minor works should be carried out in the short term.

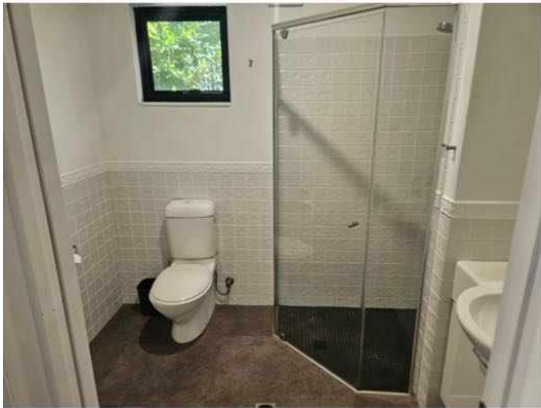
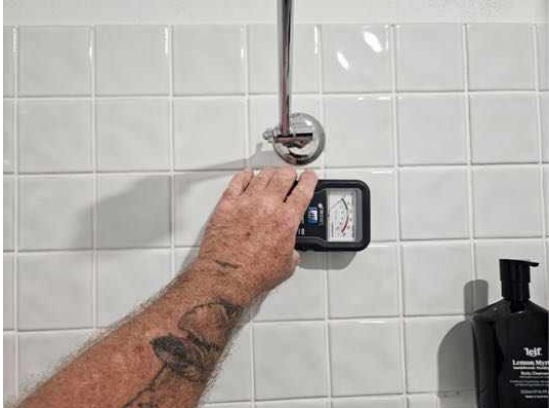
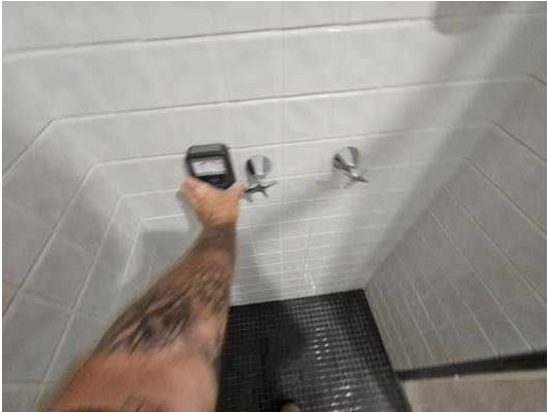
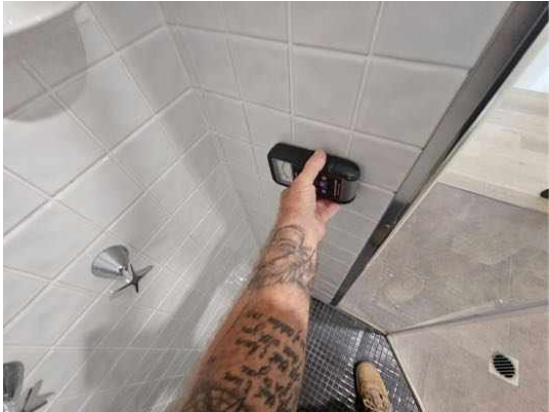
Building: Main Building
Location: Bathroom1, ensuite
Finding: No moisture detected in bathroom 1 / ensuite
Information: On the day of inspection the showers in the bathroom and ensuite are measure for moisture using a "Tramex" moisture meter. During this inspection no moisture was detected in these areas and the tiled / sheeted surfaces appear to be in good order.

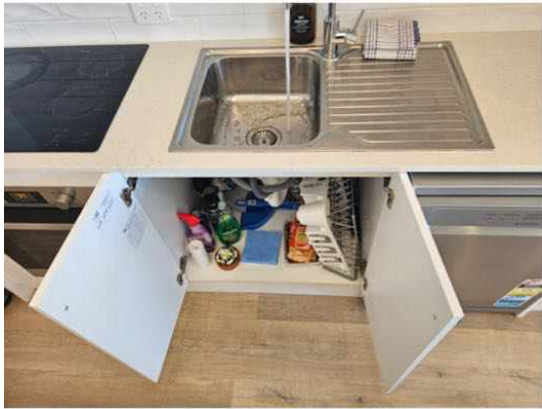
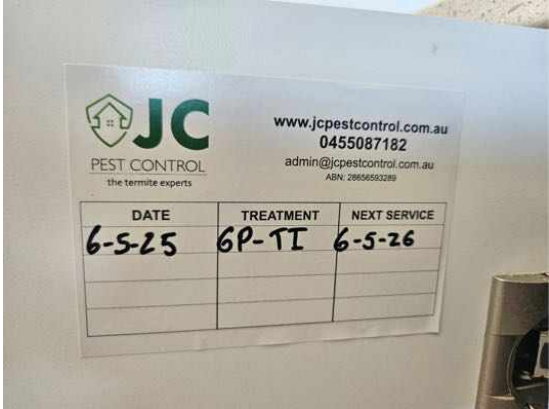
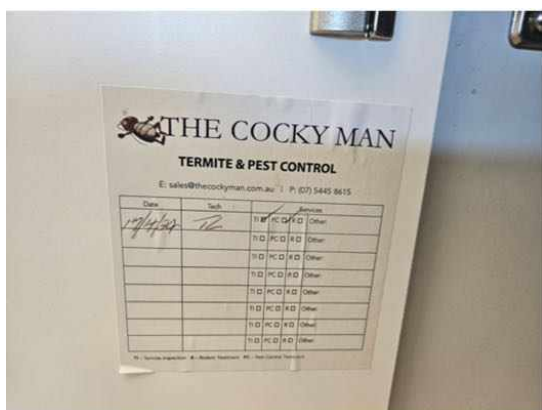
Building: Main Building
 Location: Meter box, kitchen cupboard
 Finding: Durable pest inspection notice
 Information: On the day of inspection it was noted that the durable timber pest inspection / treatment notice was in place and the most current inspection was notated and in date. These notices / stickers are to verify the timber pest inspection dates, the inspector, and, at times, the currency and type of timber pest system / barrier in place or being used in and around the property.

The client is advised to maintain annual inspections with the company listed or a company of their choosing.
