Building and Timber Pest Inspection Report

Inspection Date: Thu, 2 Apr 2026

Property Address: 13-10 Mickleham Dr, Cranbourne North VIC
3977, Australia

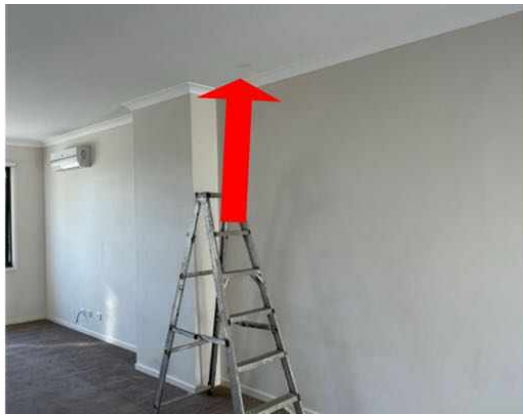
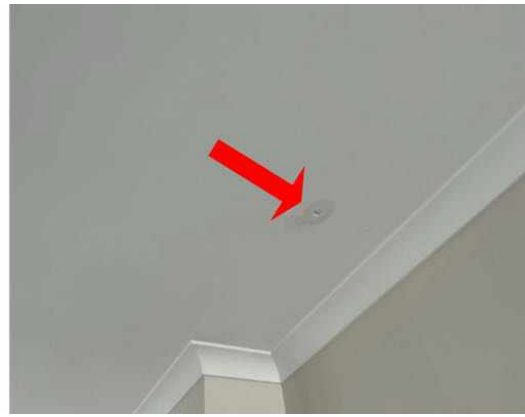
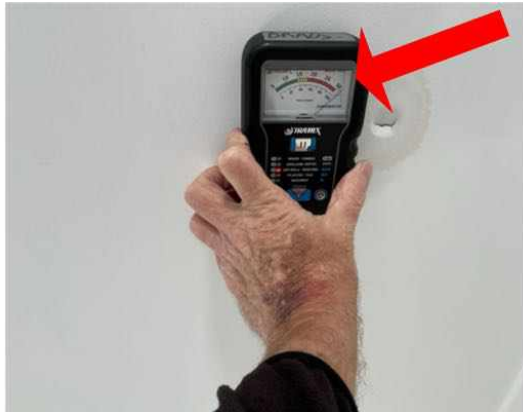
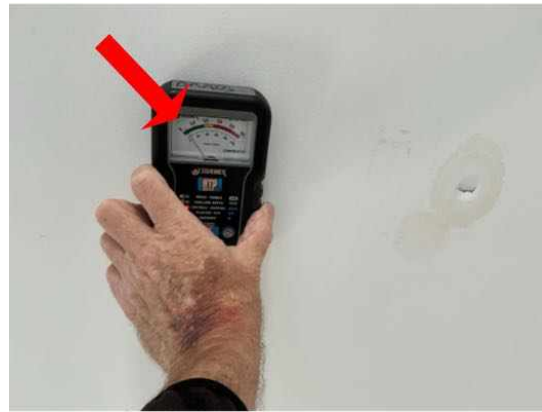
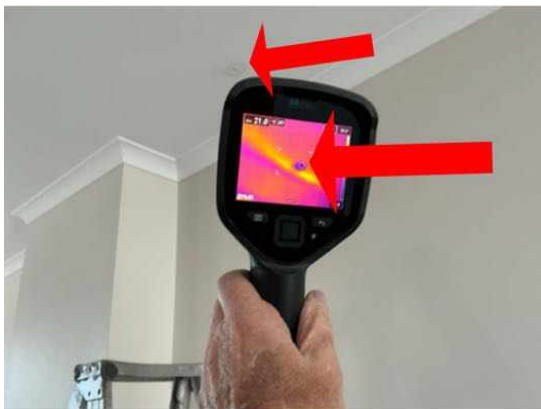
Building: Main Building
Location: Living Room
Finding: Suspected bath leak detected - elevated moisture readings identified
Information: During a non-invasive inspection of the living room area, moisture stains were noted and excessive moisture readings were recorded, to parts of the ceiling using a moisture meter and thermal camera.

These findings suggest the presence of abnormal moisture accumulation, consistent with a potential water leak within the ceiling cavity.

It is suspected these stains and high moisture readings are coming from a leaking plumbing pipe to the bath which is directly above this area.

This condition is assessed as a major structural defect until rectified.

As the defect is concealed and ongoing in nature, the full extent of damage cannot be determined without invasive investigation.

The presence of persistent moisture within wall or ceiling structures can lead to concealed water, damage, deterioration of internal building materials, and potential mould growth, which may compromise indoor air quality and structural integrity over time. Left unaddressed, such leaks can result in costly repairs and pose health and safety concerns for occupants.

It is strongly recommended that a licensed plumber be engaged as a matter of urgency to undertake a comprehensive invasive inspection. The purpose of this inspection is to determine the exact source of the water ingress, carry out any necessary repairs, and insure appropriate waterproofing measures are reinstated to prevent future recurrence. Prompt action will help mitigate further damage and preserve the condition of the property.

Once the leak has been repaired, a builder can arrange the appropriate trades to finish off cosmetic works.

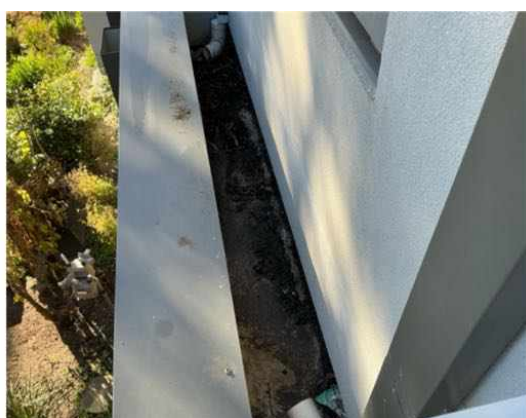
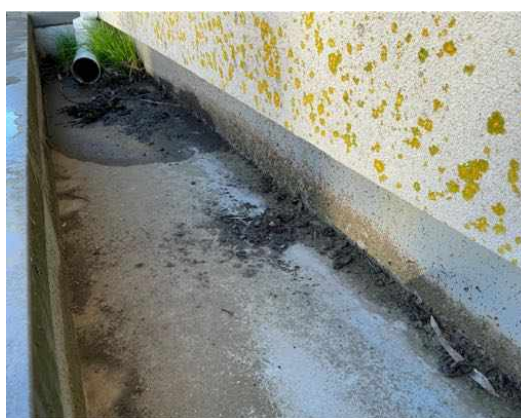
Finding 3.01

Blocked gutters are likely to lead to high levels of moisture in the affected areas. Such moisture will not only cause rust and decay of the associated building materials, but can also provide conditions that are conducive to termite and timber pest activity. Blockages in gutters should therefore be removed immediately to ensure dry conditions are maintained.

Consult a Licensed Plumber for further specific advice on remedial works that may be required. In the interim, it is highly advised that blocked gutters be removed by the homeowner or a general handyperson as a matter of urgency.

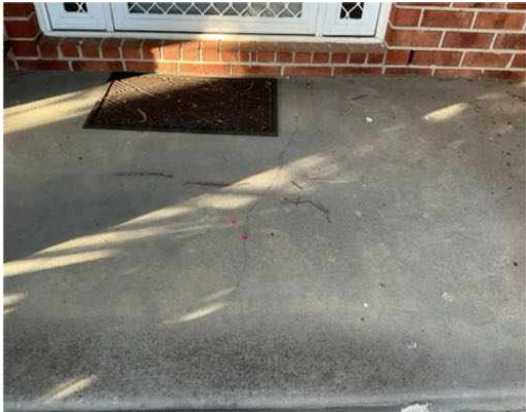
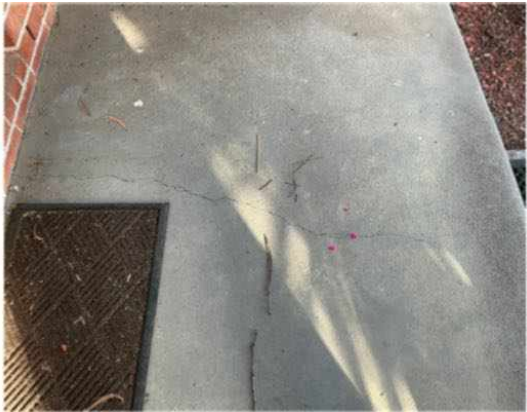
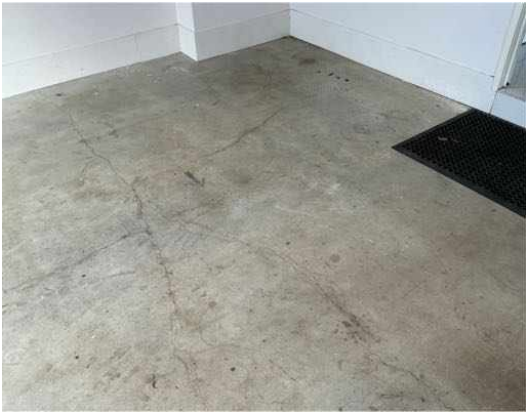
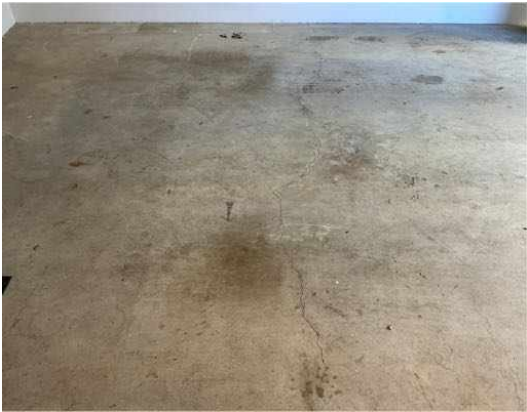
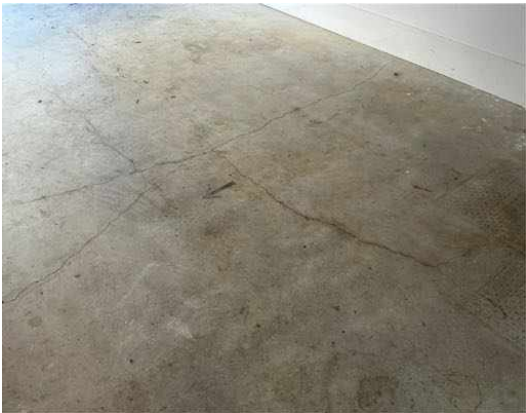
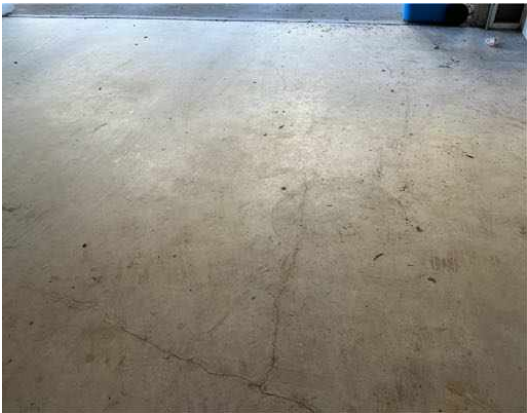
Finding 3.02

Building:	Main Building
Location:	Garage and front pathway
Finding:	Garage/pathway Cracking
Information:	Cracks were identified in the garage and front pathway concrete paving. Although cracks are quite noticeable, they are often only considered to be an appearance defect, and usually do not indicate any structural damage.

Generally the cause of the cracks in existing concrete paving such as driveways and pathways is indicative of the expansion and contraction of the concrete. Such causes are generally due to environmental factors, such as moisture levels, weather conditions, root systems of nearby trees or the soil types on which they are laid.

Cracks may also be due to poor original installation of the concrete. Factors such as poor compaction of the sub surface and/or inadequate reinforcing of the slab may create cracking and other secondary defects.

Monitoring of all cracking should be conducted frequently. Always contact a building inspector should cracks widen, lengthen, or become more numerous.

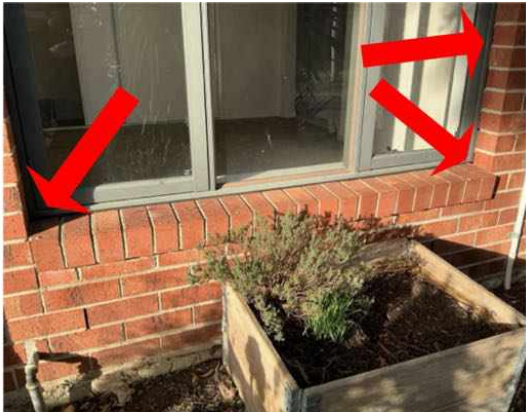
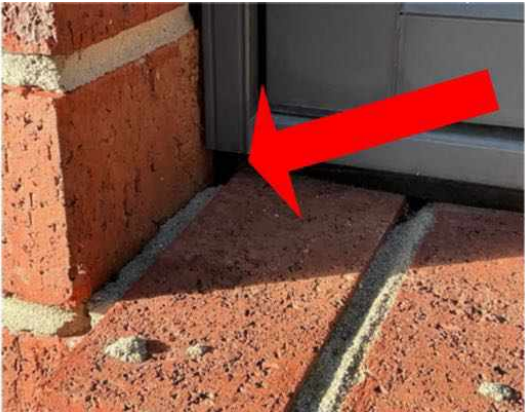
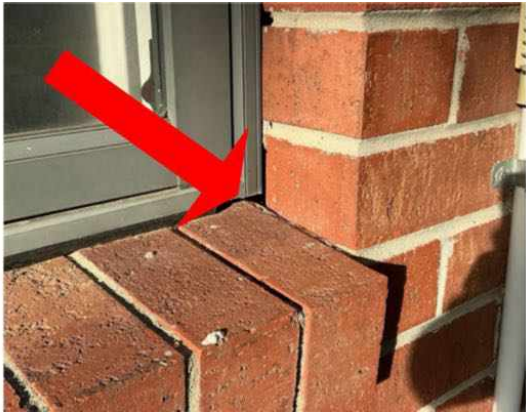
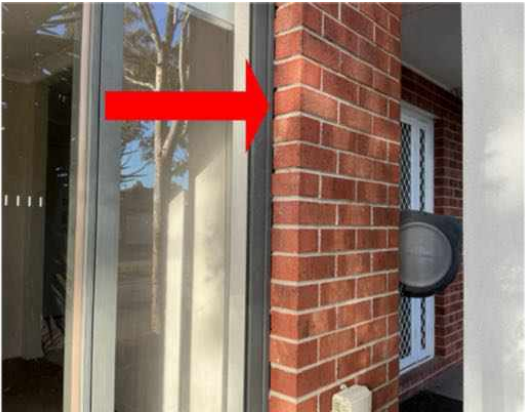
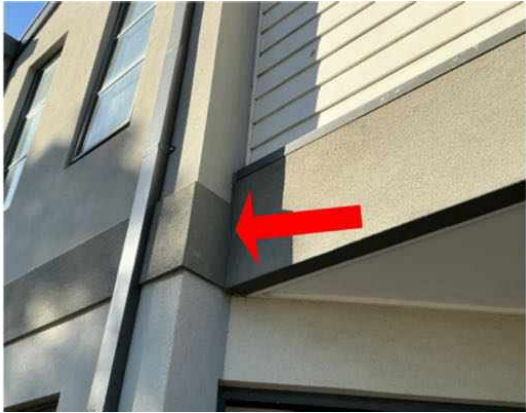
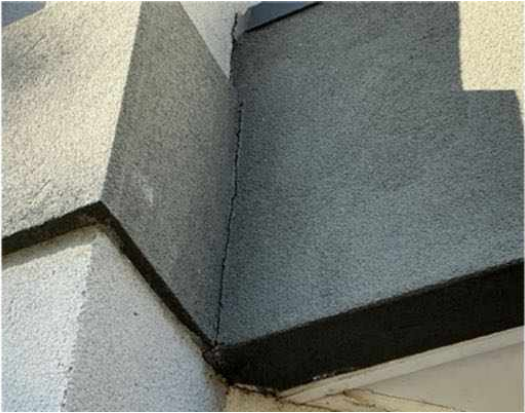
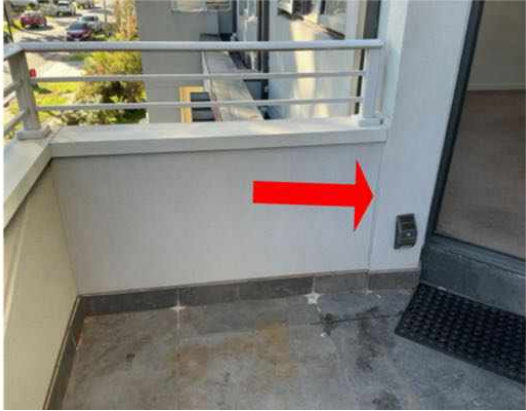
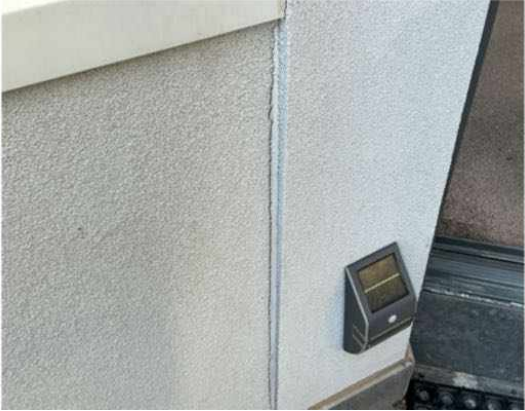
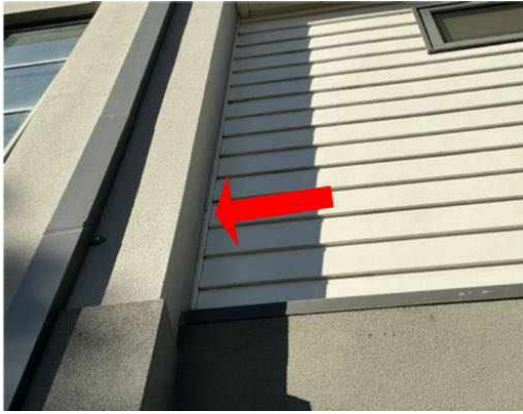
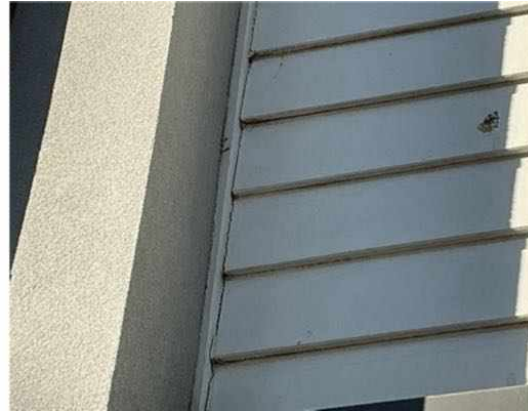
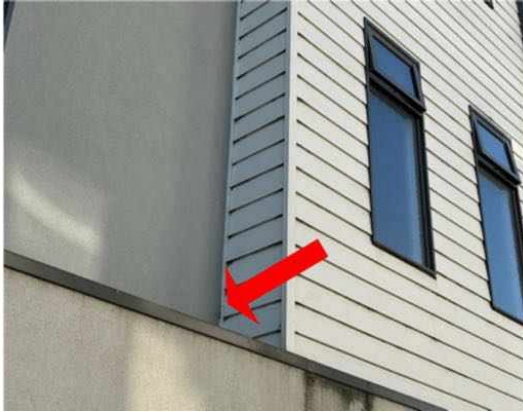
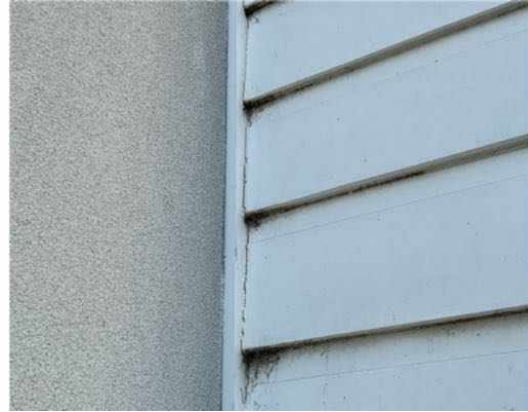
Finding 3.03

Building: Main Building
Location: Exterior walls
Finding: A few gaps to the exterior walls/windows
Information: A few gaps were noticed to some of the exterior walls/windows to the building. These gaps can let in water, drafts, and pests. Overtime moisture ingress may cause damage to internal walls, mould growth, or structural issues. Gaps also reduce the energy efficiency of the property. Recommend engaging a caulker to seal gaps with an exterior grade flexible sealant that is UV and weather resistant to reduce the risk of pest/water penetration to the building as soon as possible.

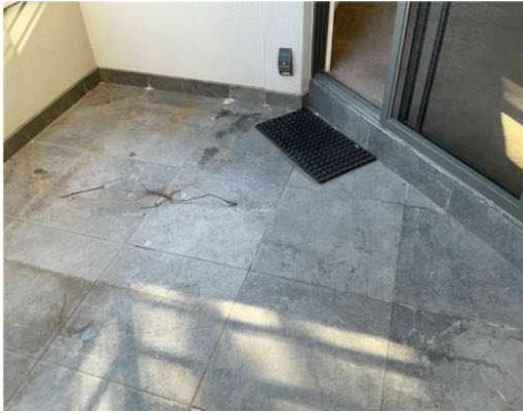
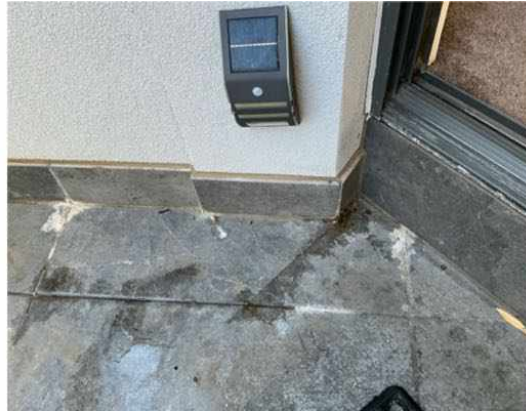
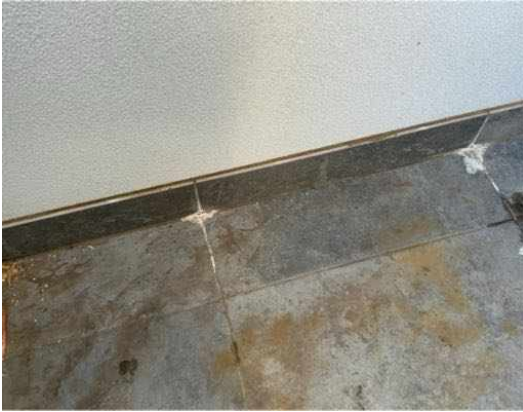
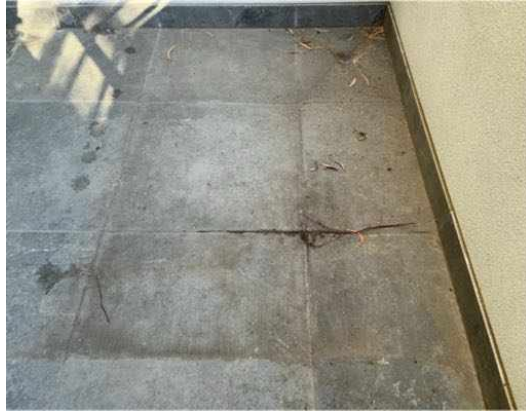
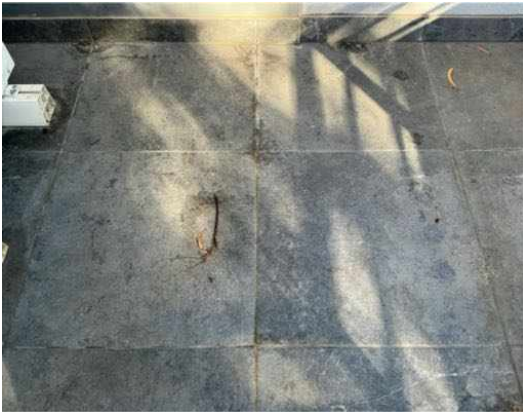
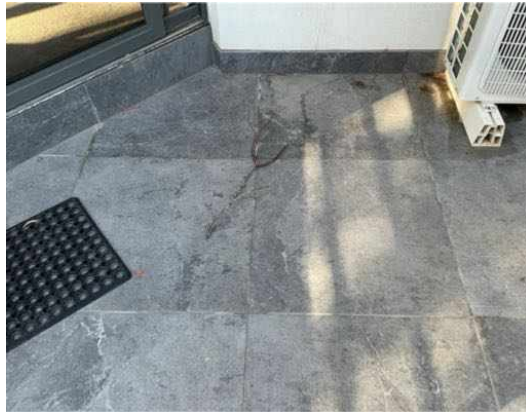
Finding 3.04

Building:	Main Building
Location:	Balcony
Finding:	Balcony grouting/sealant deterioration
Information:	The balcony grout/sealant is deteriorating and calcifying.

Deterioration of grout joints reduces the effectiveness of the tiled surface in preventing water ingress.

Damaged or missing grout allows moisture to penetrate below the tiled surface.

Prolonged moisture ingress can compromise the waterproofing membrane, lead to leaks into adjoining parts of the building and cause damage to the building structure.

The condition observed indicates that the balcony waterproofing system may be at risk of failure if not rectified.

Recommend engaging a licensed tiler or waterproofing contractor to remove and replace defective grout and sealants as soon as possible.

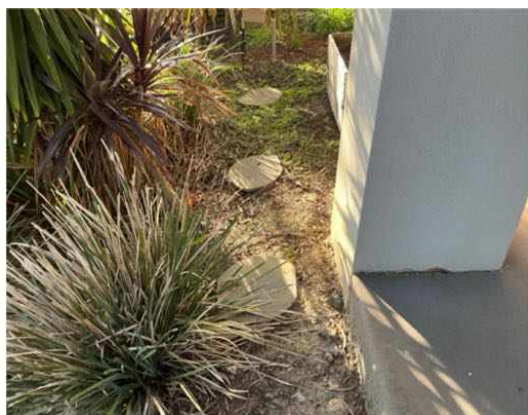
Finding 3.05

Information: Sections of the external paved area are uneven, creating a potential trip hazard. It appears as though the area has been subject to rough installation, or that paving sections have lifted due to movements in the foundation of the property.

Where paving creates a trip hazard, personal injury may ensue if due caution is not taken by all persons within this area.

Re-paving of the area is required as soon as possible to remedy this situation. Further

consultation with a specialist concreter is advised.

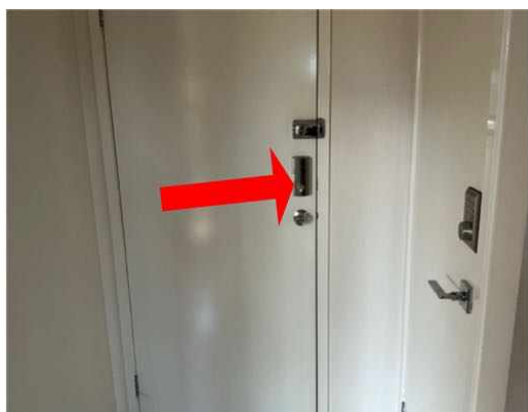
Finding 3.06

Building:	Main Building
Location:	Garage
Finding:	Door lock requires adjustment
Information:	The garage door lock is stiff to operate and requires adjustment to make it operate properly. This can happen overtime with deterioration or lack of maintenance. Recommend engaging a carpenter to repair/maintain at the owners discretion.

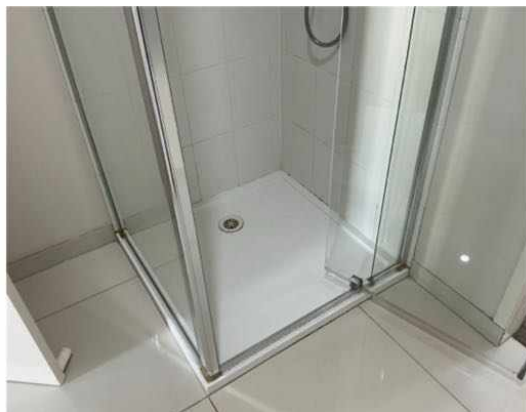
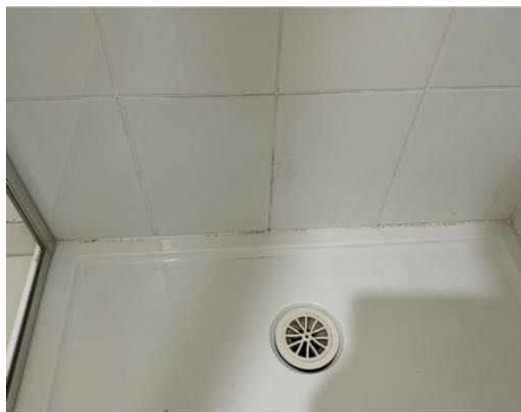
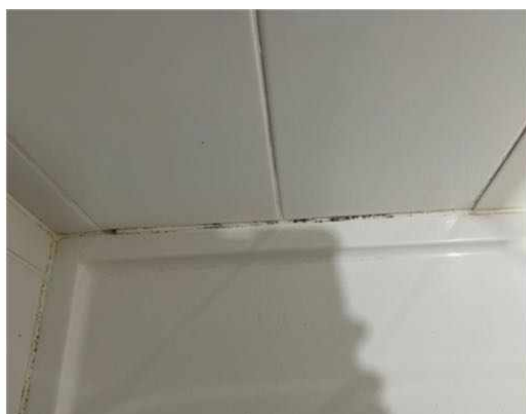
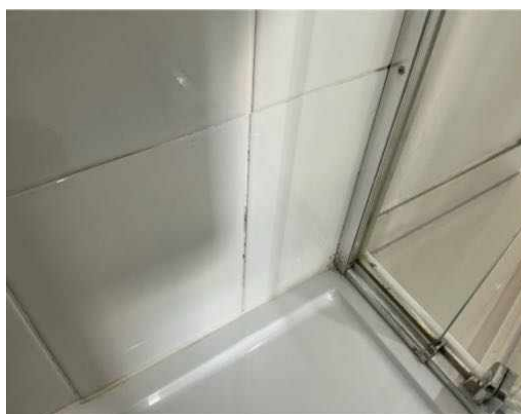
Finding 3.07

Building:	Main Building
Location:	Bathroom
Finding:	Bathroom Sealant and grouting - Missing or damaged
Information:	It was noted on inspection that sealant or grout is degraded to the tiled shower alcove and or other areas of the bathroom.

Different materials and floor areas move at different rates, generally causing cracking to grout or sealant at this point. A flexible sealant is required to allow for expected expansion and contraction, while keeping the joint water tight and protective of all associated building materials.

Flexible and mould resistant materials should be applied to affected areas to prevent any subsequent water damage that is likely to occur. Regular maintenance and replacement of damage or missing or damaged sealant and grout is highly recommended to the wet areas, as this is a regular wear and tear defect. Sealant and grouting in areas that come into regular contact with water should be maintained for the long term care of your property.

A sealant specialist or tiling contractor should be appointed to complete these works as soon as possible

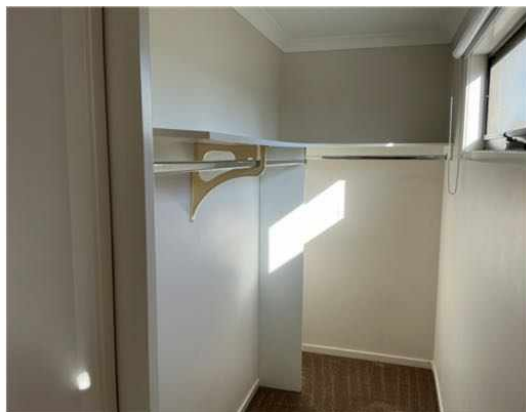
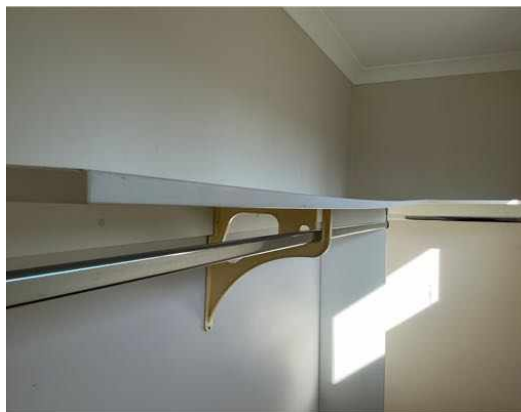
Finding 3.08

Building:	Main Building
Location:	Bedroom - Master
Finding:	Bowed shelves
Information:	The shelves to the master bedroom are bowed due to too much weight being stored. Recommend engaging a carpenter to repair/replace to reduce the risk of further deterioration at the owners discretion.

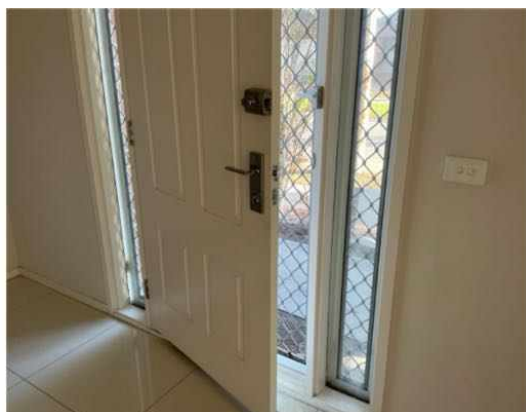
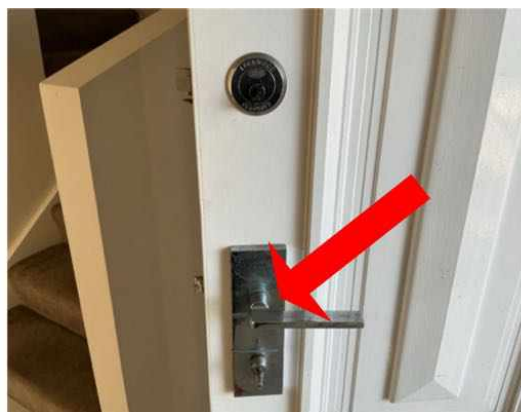
Finding 3.09

Building:	Main Building
Location:	Entry
Finding:	Door lock requires adjustment
Information:	The front door lock is stiff to operate and requires adjustment to make it operate properly. This can happen overtime with deterioration or lack of maintenance. Recommend engaging a carpenter to repair/maintain at the owners discretion.

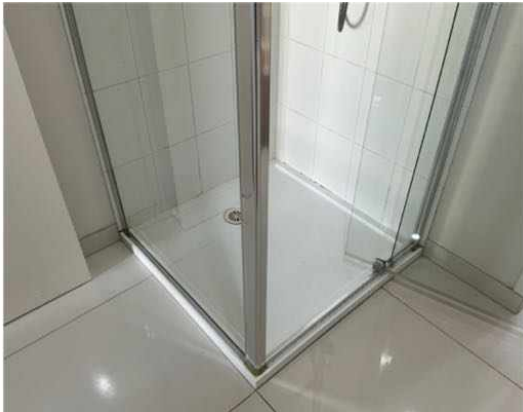
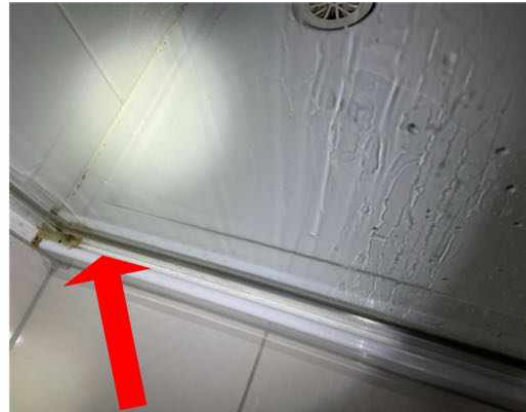
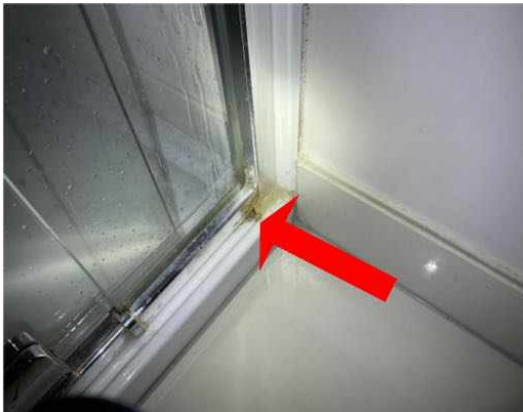
Finding 3.10

Building:	Main Building
Location:	Bathroom
Finding:	Bathroom-Shower screen leaking
Information:	Leaking was evident to the shower screen at the time of inspection. It is suspected that the leaking has occurred as a result of deteriorated or missing caulking to the shower or general ageing of the building elements.

Leaking from the shower where left unattended, is likely to lead to water damage to adjoining flooring and walls. Such damage can lead to water damage and necessitate extensive remedial works being required. Active water leaks may also create an environment that is susceptible to the formation and development of mould.

Appointment of a caulking contractor is required to repair or replace the caulking to the shower area. Such works should be performed as soon as possible to ensure that no further damage occurs.

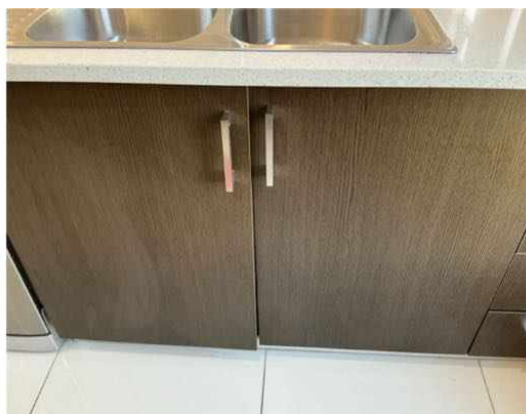
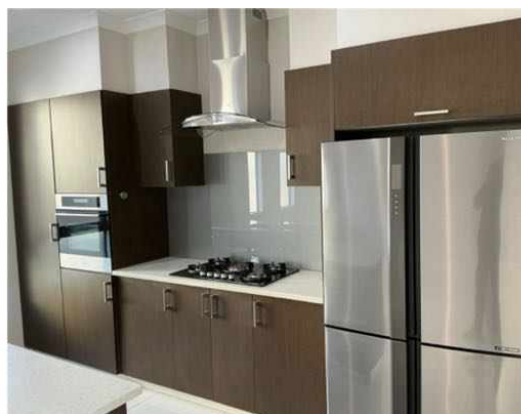
Finding 3.11

Building:	Main Building
Location:	Kitchen
Finding:	Cabinets need adjument
Information:	On inspection it was noticed that some of the kitchen cabinets do not shut correctly and require maintenance or adjustment. Recommend engaging a cabinet maker to adjust/maintain to reduce the risk of further deterioration at the owners discretion.

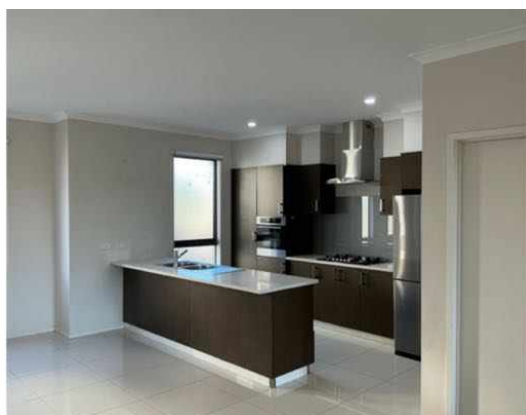
Finding 3.12

Building:	Main Building
Location:	Kitchen
Finding:	Kitchen Tap - Loose
Information:	The tap in the kitchen has not been installed correctly, or has deteriorated with age, and is consequently loose. This tap being loose creates potential for water leaks and subsequent water damage to the surrounding area.

Where taps or spouts are loose, a qualified plumber should be appointed to re-fix the plumbing fitting.

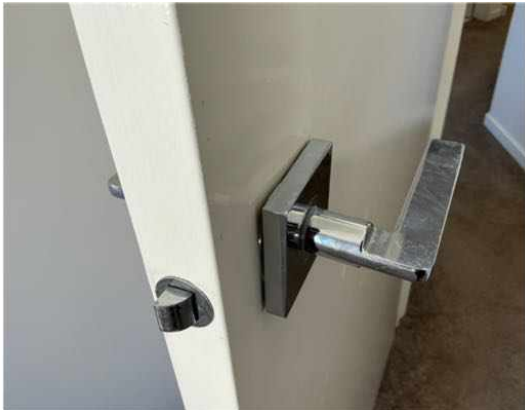
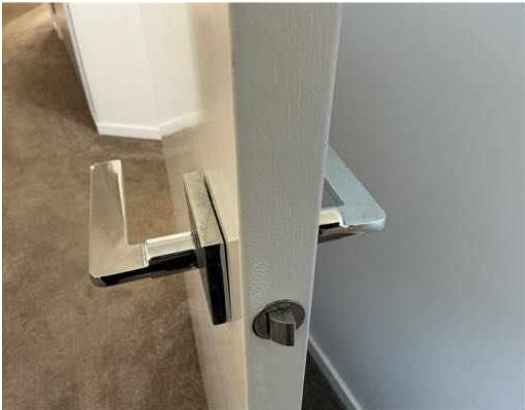
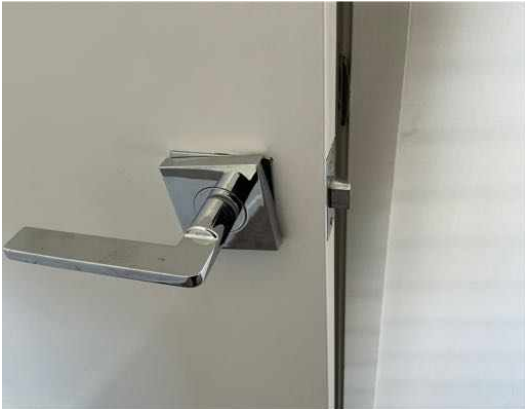
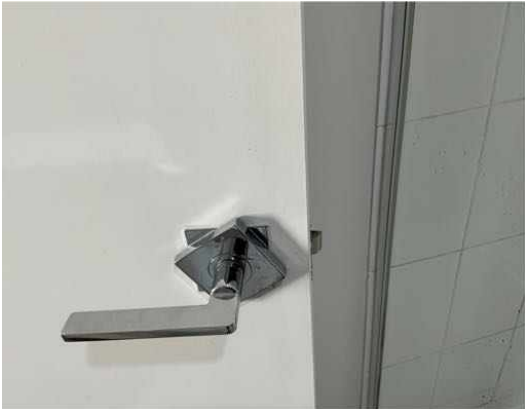
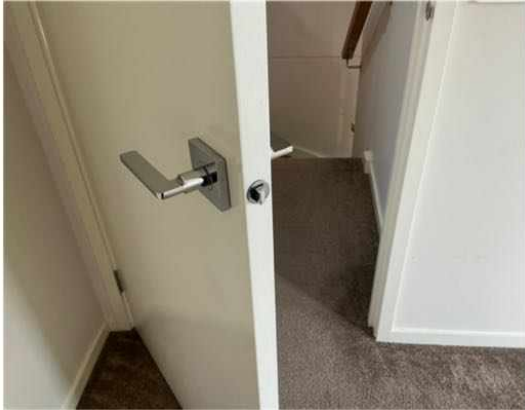
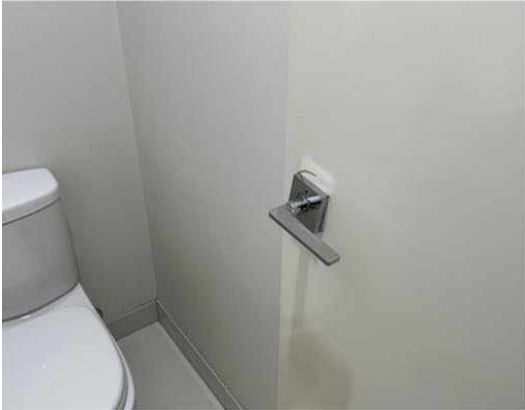
Finding 3.13

Building:	Main Building
Location:	Various parts of the building
Finding:	Door handles loose
Information:	Some of the door handles were found to be loose at the time of inspection.

Repair of the loose door handles is advised to improve the operational state of the associated doors.

A qualified carpenter or general handyman should be appointed to repair/replace the door handles at the client's discretion.

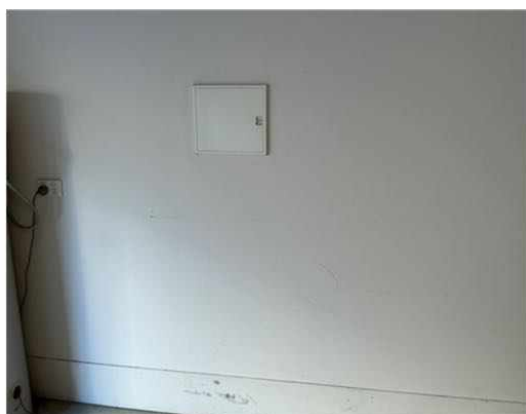
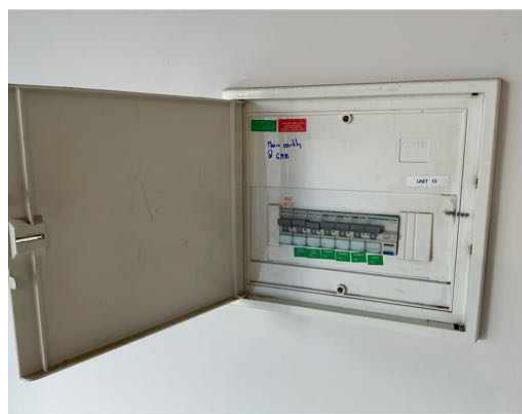
Building:	Main Building
Location:	All External Areas
Finding:	No Termite Management System - no evidence of a chemical installation
Information:	The application of a post-construction chemical termite barrier is highly recommended for all properties, particularly if live termite activity has been found on the site previously. Such barriers are highly effective in preventing termite attack on any timber building elements throughout the property.

A durable notice should be placed in the switchboard unit to indicate current termite barriers. At the time of inspection, it appeared as though no termite management system has been installed, with no evidence to suggest preventative works taking place.

The client may consider gaining further advice from a pest controller as to the costs and procedures involved with this application. It is recommended that obtaining such advice be a short-term priority.

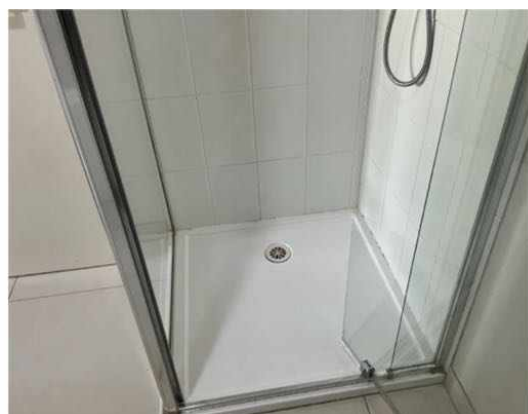
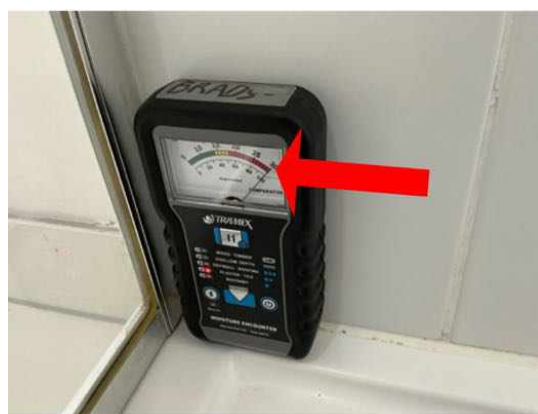
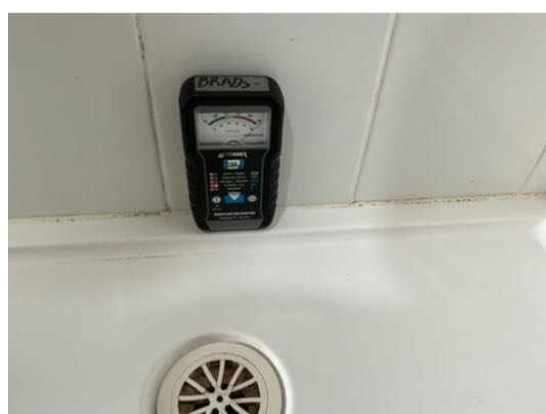
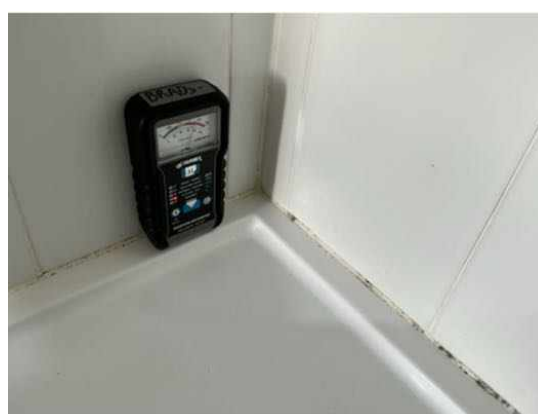
Finding 6.02

Building:	Main Building
Location:	Bathroom
Finding:	Shower - Damp
Information:	Damp is evident to parts of the bathroom shower alcove found using using a moisture meter. This defect is quite common, and is suspected to have been caused by moisture permeating through the grouting in this area, which shows evidence of deterioration creating moist conditions. Leaking pipes within the adjoining wall is also a possible cause. Excessive moisture can attract termites.

Damp (or structural damp) refers to the presence of unwanted moisture in the structure of a building, either as the result of intrusion from outside, or condensation from within the structure. In the shower area, internal water leaks or other sources of excessive moisture are generally the cause of damp.

Unmanaged damp in the shower recess is likely to facilitate the formation and development of mould and fungi growth, decaying associated building materials and compromising their structural integrity. It is important to address damp conditions, as the World Health Organisation notes that excess moisture leads - on almost all indoor materials - to growth of microbes such as moulds, fungi and bacteria, which subsequently emit spores and other matter into the indoor air. Exposure to these contaminants is associated with a wide range of respiratory and other health-related problems.

Consultation with a qualified plumber or bathroom specialist is advised immediately to identify the cause of damp and to perform remedial works as required. Where excessive mould growth is present, further inspection by a specialist environmental health inspector should also be considered.

Always ensure that sealant and grout is in good condition to prevent any moisture issues occurring in the future.

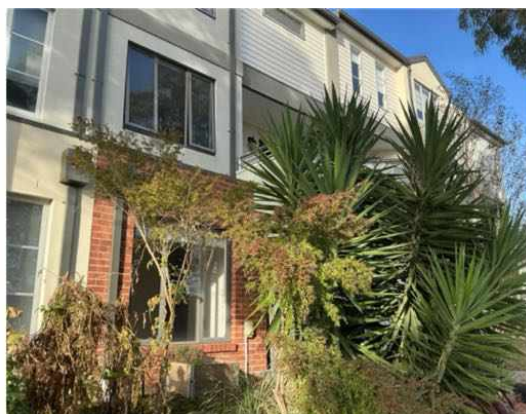
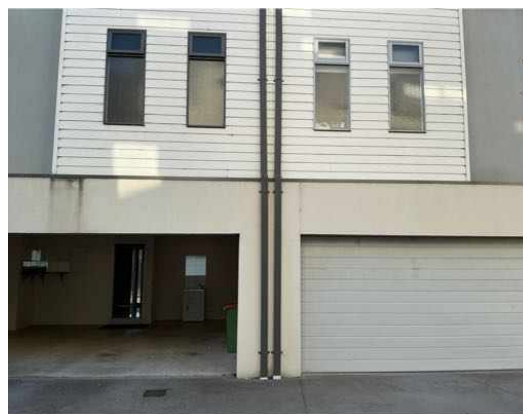
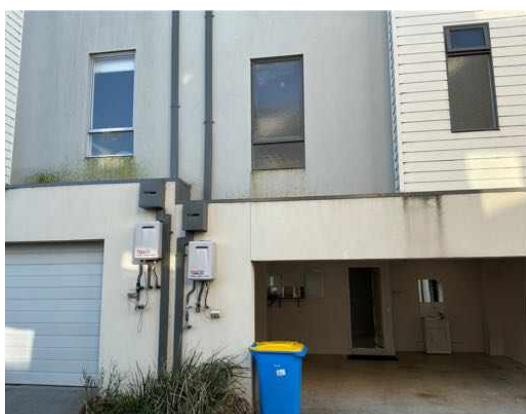
Finding 6.03

Building:	Main Building
Location:	Various parts of the building
Finding:	Bridging attachments to buildings
Information:	Bridging occurs when items against a building provide a concealed entry point for

Where any part of an attachment to a building is not isolated and is not provided with a clear gap of not less than 25mm from building, bridging occurs. Attachments to buildings such as hot water services, downpipes, verandahs, decks, steps, fences, service conduits and the like provide the opportunity for concealed entry.

Building attachments of this nature need to be frequently inspected for termite activity by a qualified inspector.

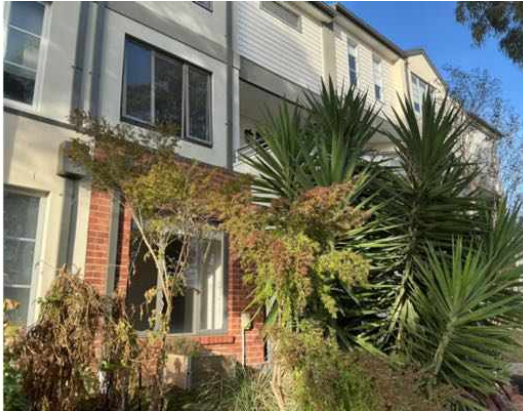
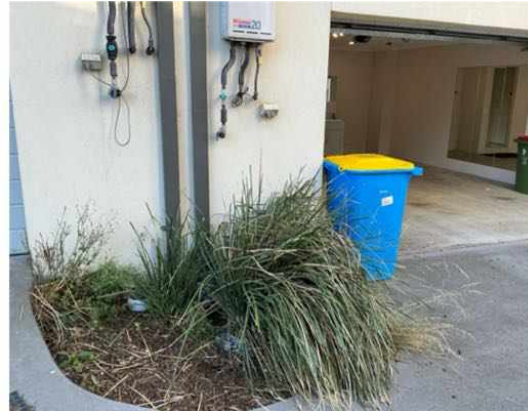
Finding 6.04

Building:	Main Building
Location:	Exterior walls
Finding:	Garden Beds Conditions Conducive to Termites
Information:	Garden beds were found to be evident in close proximity to the building. Garden beds immediately adjacent to the perimeter of the building block the visual inspection of these areas, providing a concealed termite entry point.

These garden beds can include untreated timber, and with a combination of moisture from watering hosing can make conditions conducive to termite activity and termite ingress.

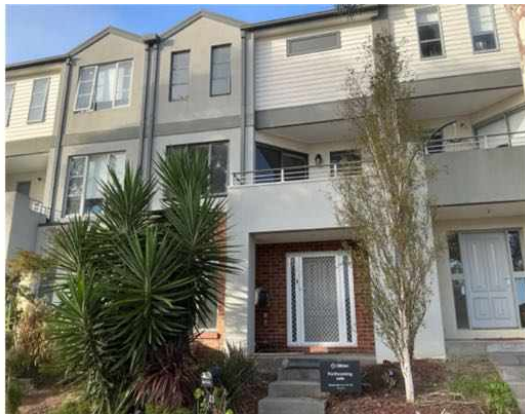
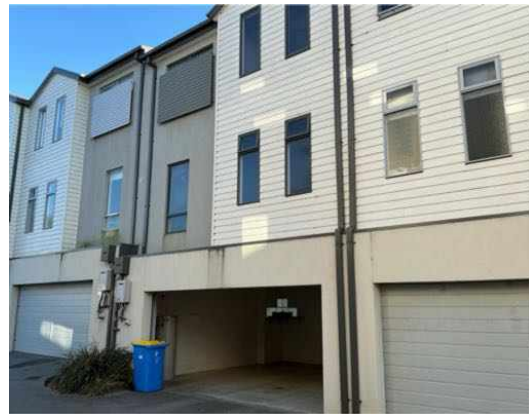
Building:	Main Building
Location:	All External Areas
Finding:	Additional Photos - Obstructions and Limitations
Information:	These photographs are an indication of the obstructions and limitations which impeded full inspection of the property at the time of inspection. These obstructions can hide an array of defects and should be removed to allow full inspection to be carried out. A re-inspection is recommended once the areas are made accessible.

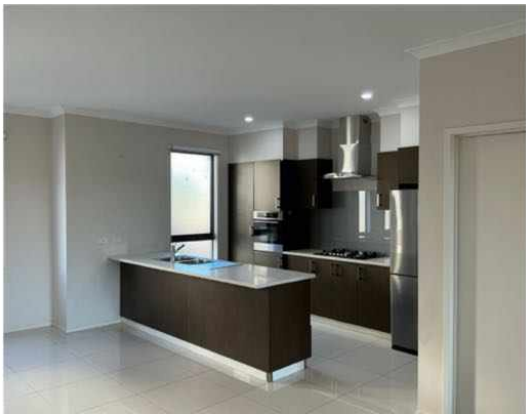
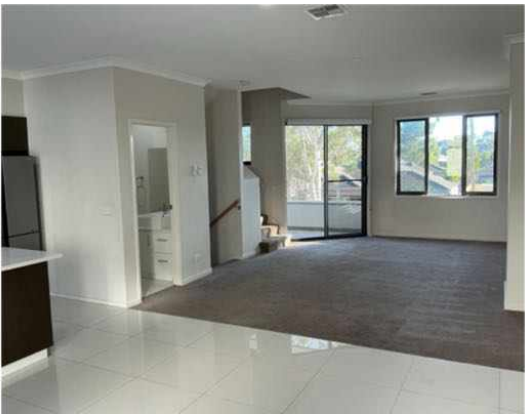
Building:	Main Building
Location:	All Internal Areas
Finding:	Additional Photos - Obstructions and Limitations
Information:	These photographs are an indication of the obstructions and limitations which impeded full inspection of the property at the time of inspection. These obstructions can hide an array of defects and should be removed to allow full inspection to be carried out. A re-inspection is recommended once the areas are made accessible.

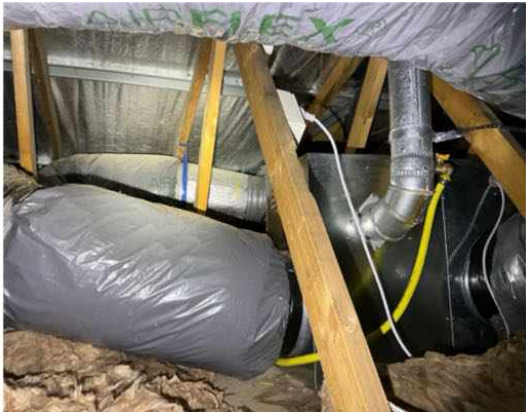
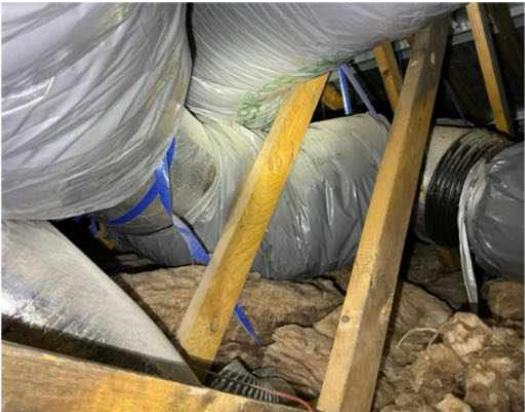
Building: Main Building
Location: Roof Void
Finding: Obstructions and Limitations -roof cavity
Information: These photographs are an indication of the obstructions and limitations which impeded full inspection of the roof cavity at the time of inspection. These obstructions can hide an array of defects and should be removed to allow full inspection to be carried out. A re-inspection is recommended once the areas are made accessible.
