Building Inspection Report

Inspection Date: Thu, 19 Mar 2026

Property Address: Unit 1/16 Starling St, MONTMORENCY,
VIC, 3094, Australia

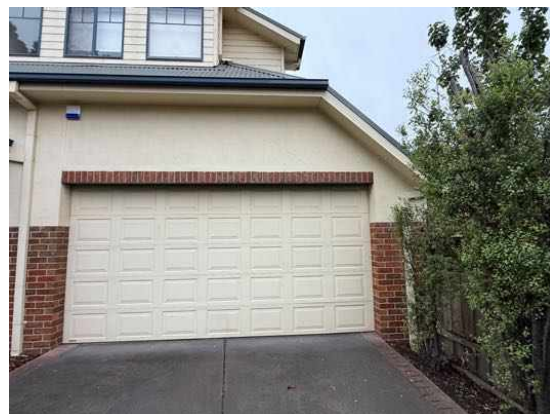
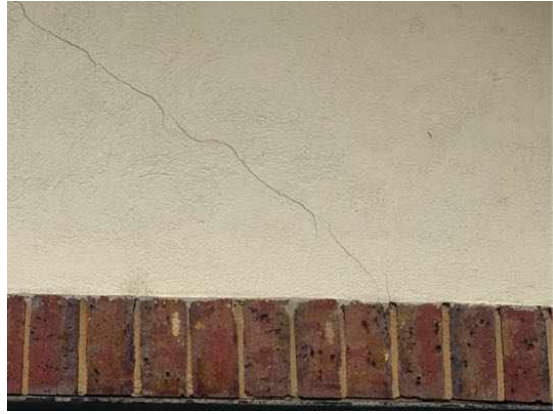
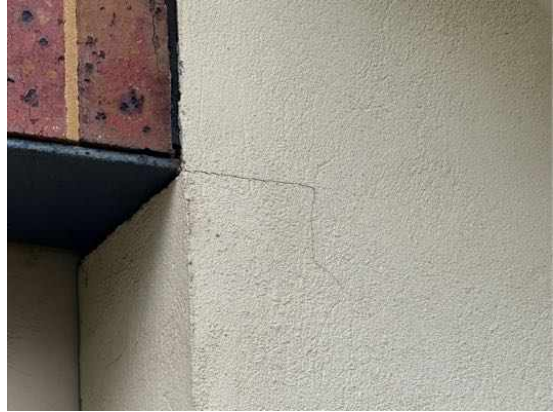
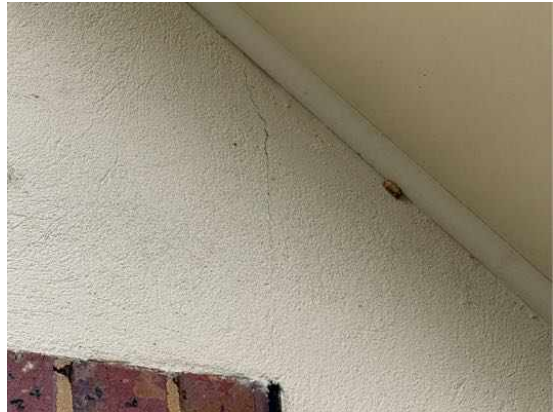
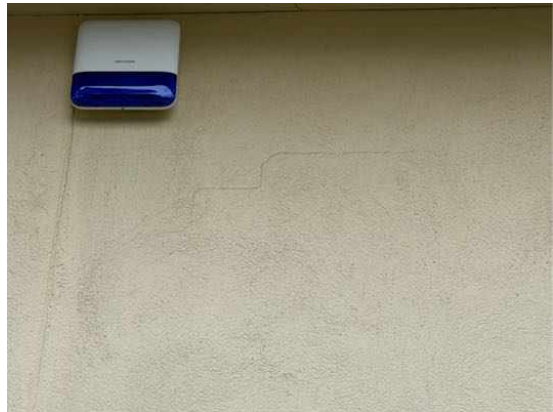
Defects 2.01

Building:	Building 1
Location:	All Areas > All Areas
Finding:	Brickwork rendered wall cracks and excessive movement
Information:	At the time of the inspection of the home, numerous cracks were observed to the exterior brickwork rendered walls. The front left hand side showed excessive movement where it is highly recommended to appoint a Structural Engineer to check these areas.

Structural issues are generally the underlying cause of these types of brickwork cracking and movement. The rendered brickwork wall cracks are suspected as a result of excessive movement within these foundations, or subsidence, and expansion and contraction of building materials in different weather conditions. These types of cracks may develop further if left unattended with potential for necessitating in some major remedial works.

The client should elect to appoint a structural engineer and a builder to inspect the structural integrity of these areas of affected brickwork, to assess the safety of the associated structures. The engineer can also nominate a scope of works required for the rectification. Always contact a Registered builder or engineer should cracks widen lengthen or become more numerous, even after repair works have been completed.

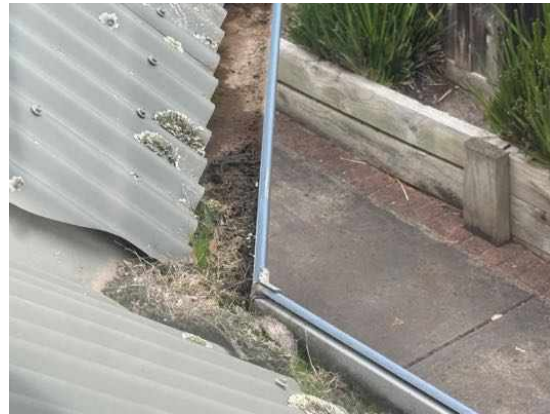
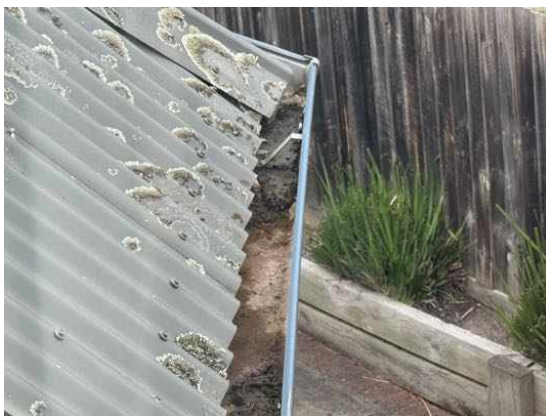
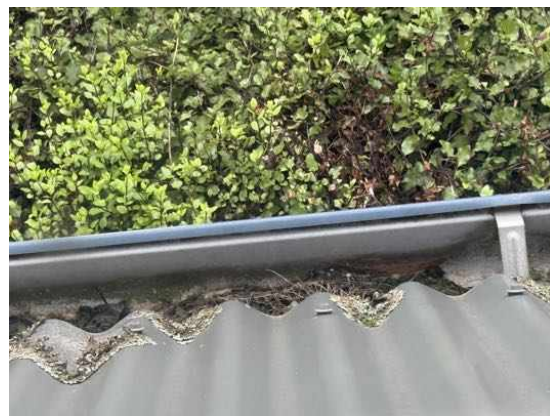
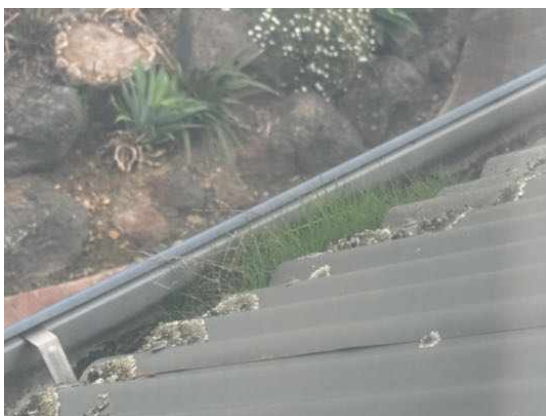
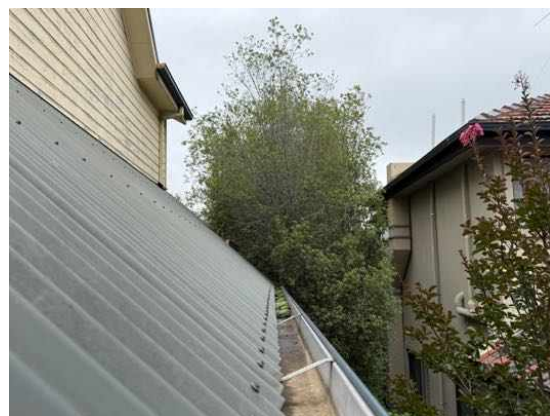
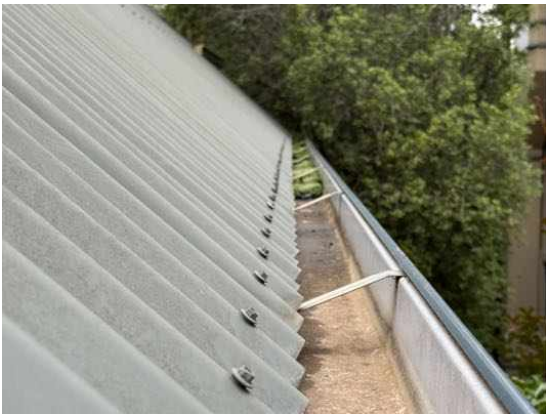
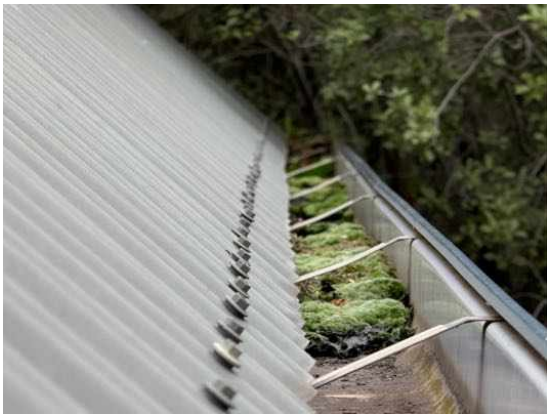
Defects 3.02

Building:	Building 1
Location:	All Areas > All Areas
Finding:	Gutters - Partially blocked
Information:	Roof plumbing structures, such as guttering and downpipes, should be free of all leaf matter and debris to prevent blockages. Blockages of the guttering and downpipes will lead to pooling and accumulated water overflows, which is likely to subsequently flood eaves and exterior walls. Blocked gutters are likely to lead to high levels of moisture in the affected areas. Such moisture will not only cause rust and decay of the associated building materials, but can also provide conditions that are conducive to termite and timber pest activity.

Blockages in gutters should therefore be removed immediately to ensure dry conditions are maintained. Client should consider the appointment of a gutter cleaning company to carry out these works or with a Licensed Plumber for further specific advice on remedial works that may be deemed to be required. In the interim, it is highly advised that blocked gutters be removed by the homeowner, gutter cleaning company or a general handy-person in the short term future.

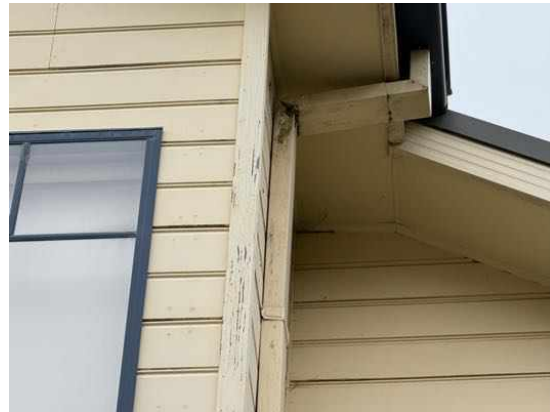
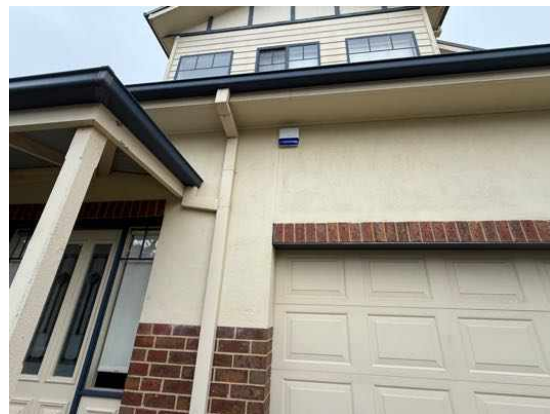
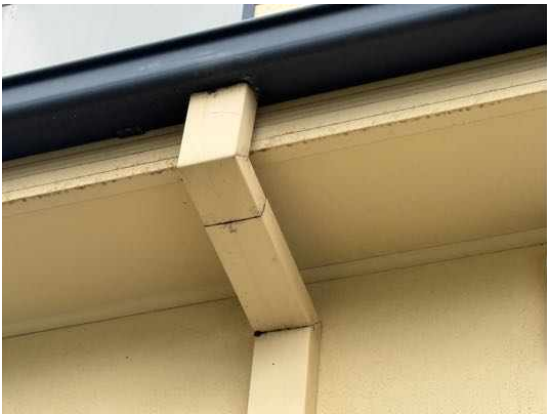
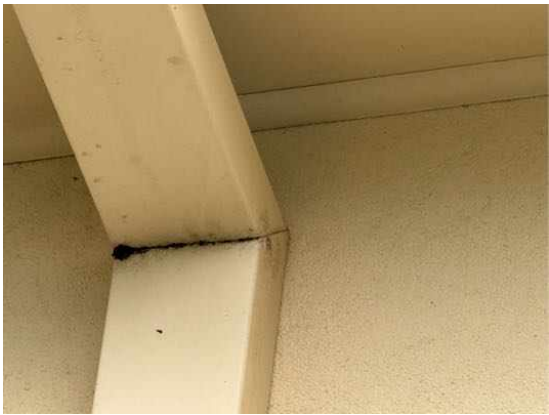
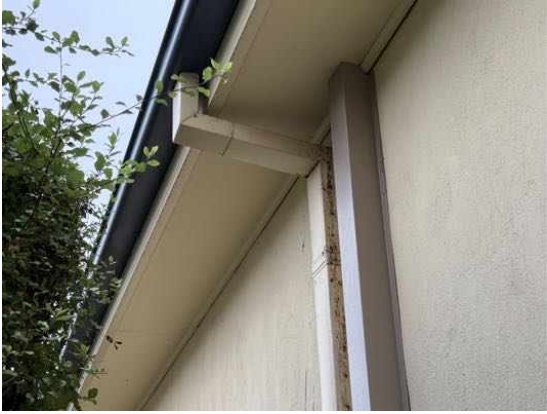
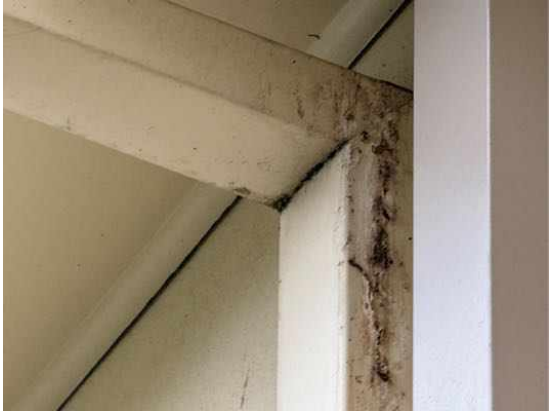
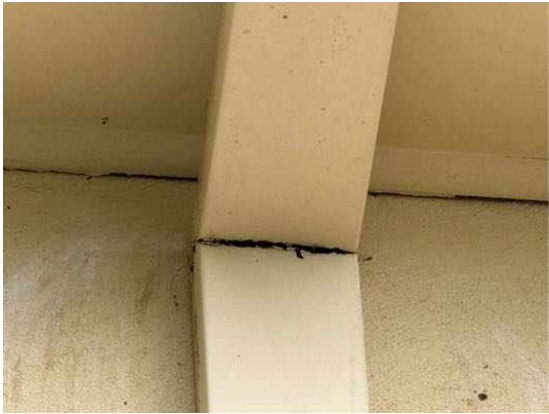
Defects 3.03

Building: Building 1
Location: All Areas > All Areas
Finding: Down-pipes weeping from joints
Information: It was observed at the time of inspection that some of the down-pipes were weeping from the joints and not sealed adequately, these should be all properly sealed to prevent down-pipes weeping from the joints. Where these down-pipes are not sealed or joined properly, the surrounding areas are highly susceptible to excessive moisture from splashing out and weeping joints.

If left unmanaged makes these areas highly susceptible to excessive water and moisture, wood rot, rust and corrosion is likely to lead to damage to adjoining areas, building structures and building elements, this also makes these areas more susceptible to termite or timber pest activity. It is recommended that the client appoint and seek advice from a licensed roof plumber to rectify any areas deemed to be necessary.

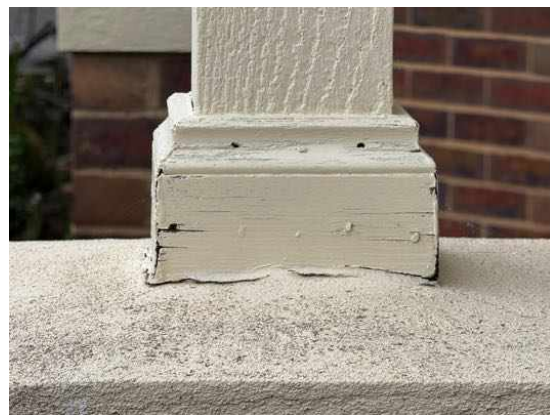
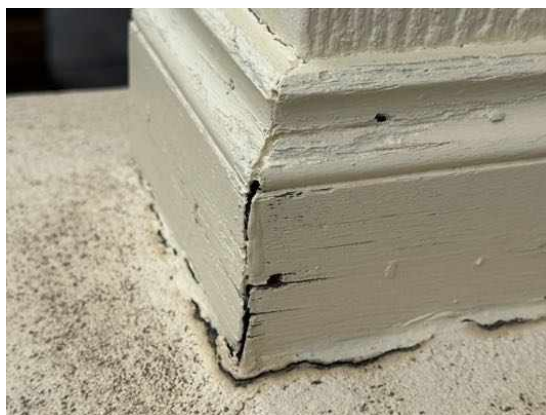
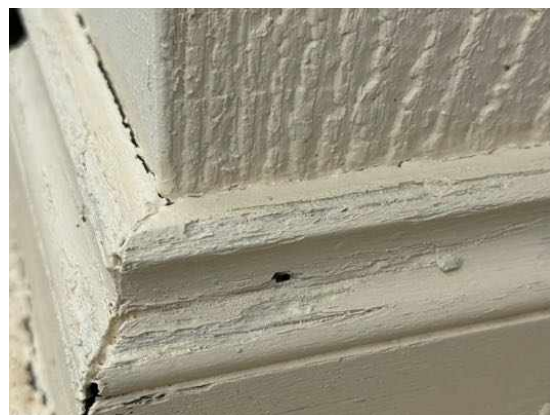
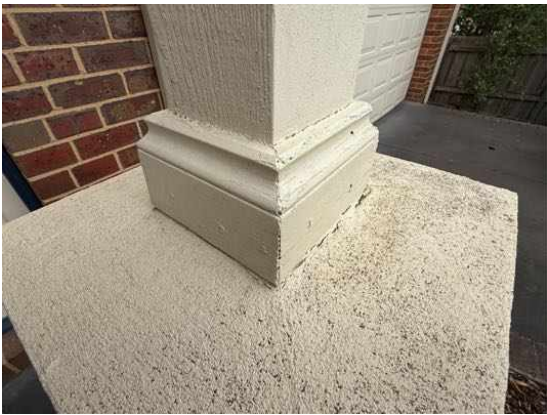
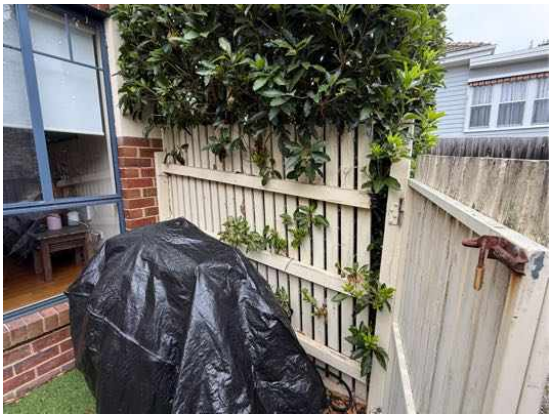
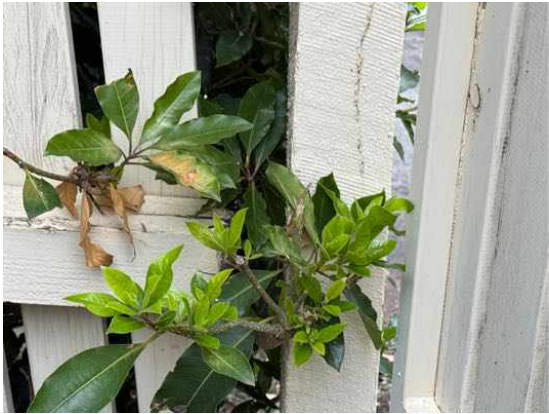
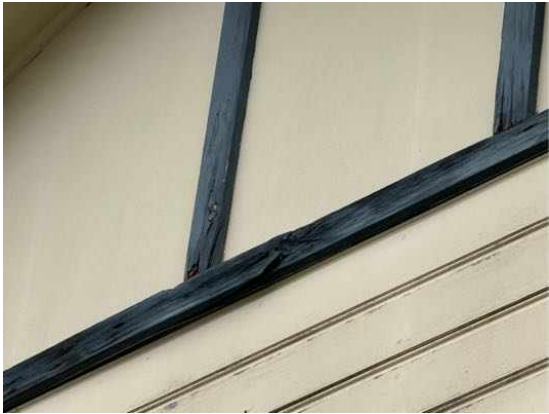
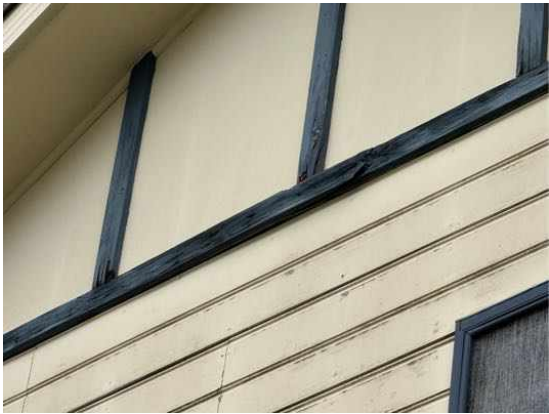
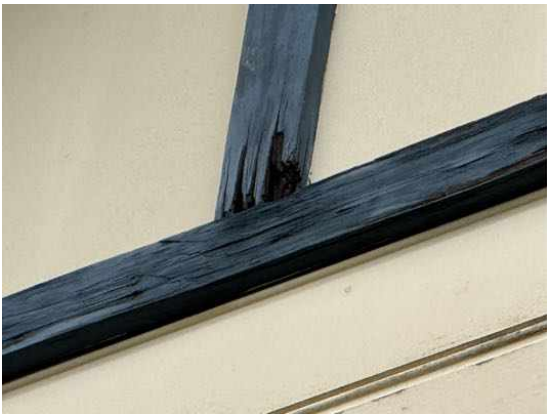
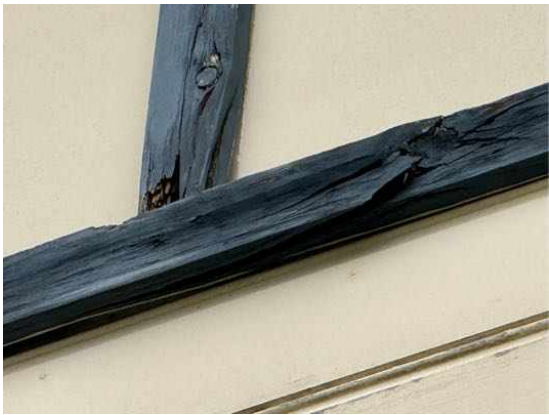
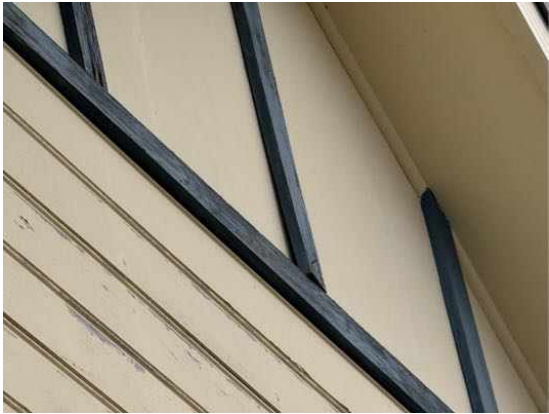
Defects 3.04

Building: Building 1
Location: All Areas > All Areas
Finding: Wood rot
Information: Some wood rot is suspected to be affecting some gable end roof slats. Wood rot, also known as Fungal Decay, occurs when timbers and other cellulose building materials are exposed to damp conditions on an ongoing basis. It is suspected to be due to frequent exposure to rain and other weather conditions also make building elements susceptible to accelerated deterioration.

Early intervention and regular maintenance such as painting will prolong the useful life of these building elements. Prior to any works being performed, the cause of the moisture that has created the visible wood rot should be identified and addressed in a suitable manner. Replacement of affected building elements may then be a necessary step in protecting surrounding areas from such deterioration. A qualified carpenter should be appointed to assess the cause of the moisture and to provide advice on any remedial works as required. A qualified carpenter or registered builder may also be required to replace affected building materials.

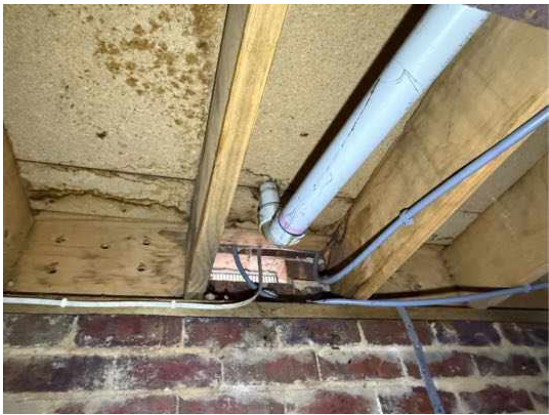
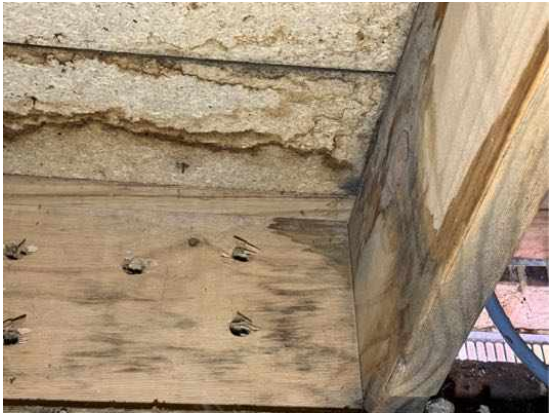
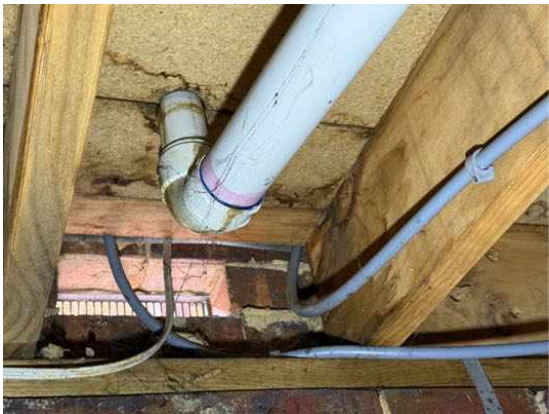
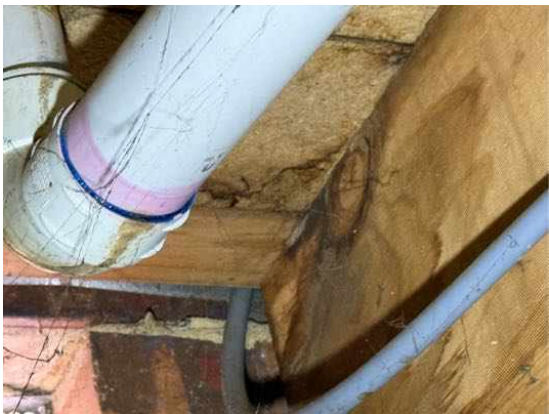
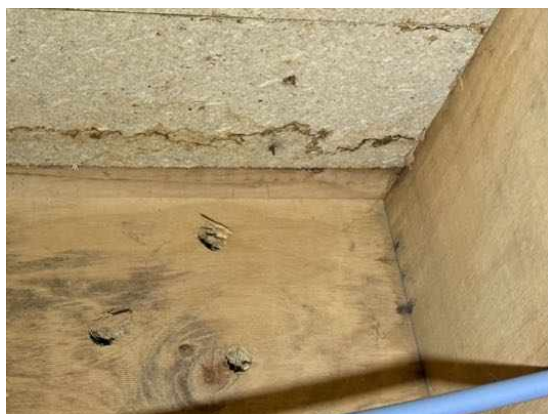
Defects 3.07

Building: Building 1
 Location: All Areas > All Areas
 Finding: Subfloor previous moisture stains observed under the Laundry and Kitchen areas

Some previous moisture stains were observed under the Laundry and Kitchen areas at the time of the subfloor inspection. The moisture stains did not appear to be active moisture and did not appear to have sustained moisture damage to the surrounding timber framing structures in this area. The client may appoint a relevant contractor carry out a further inspection of this area to check for further hidden damage. It is not suspected that any remedial work or repairs are expected to be required in these areas.

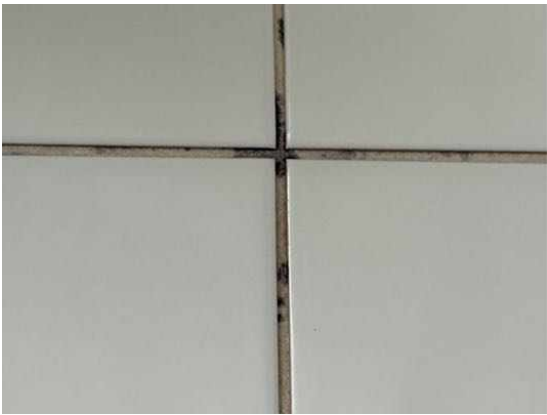
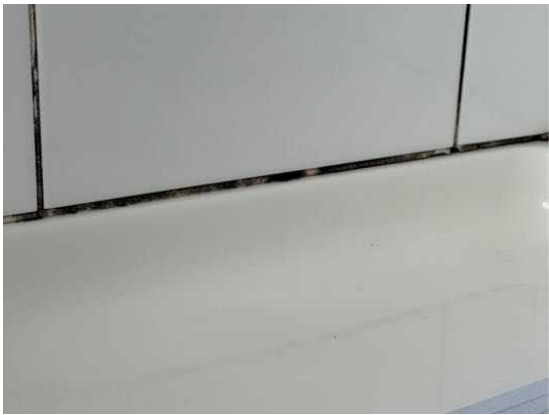
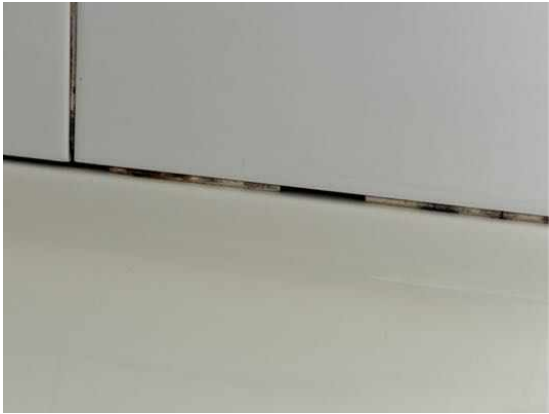
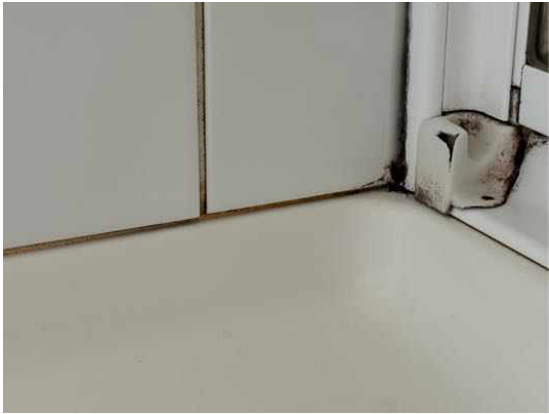
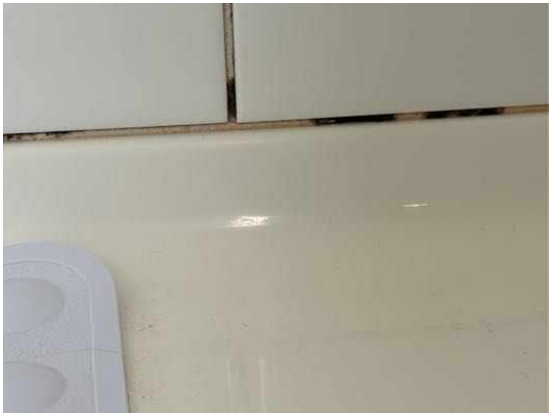
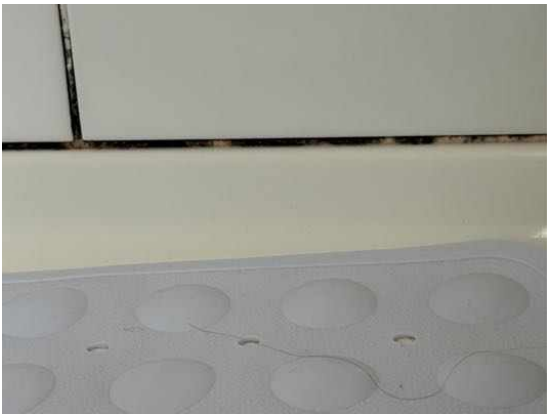
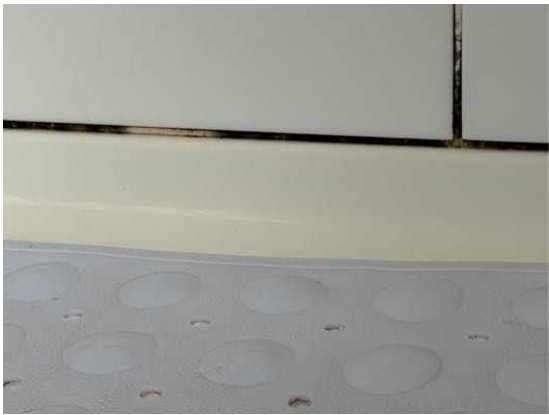
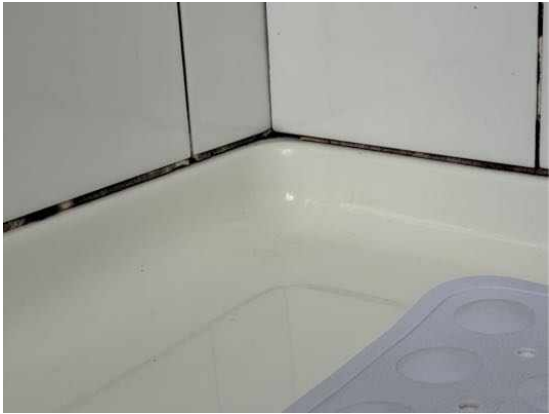
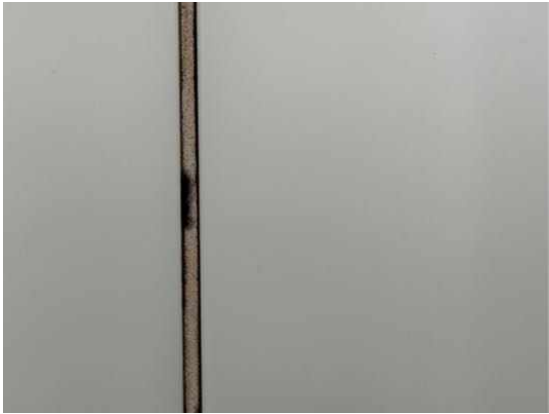
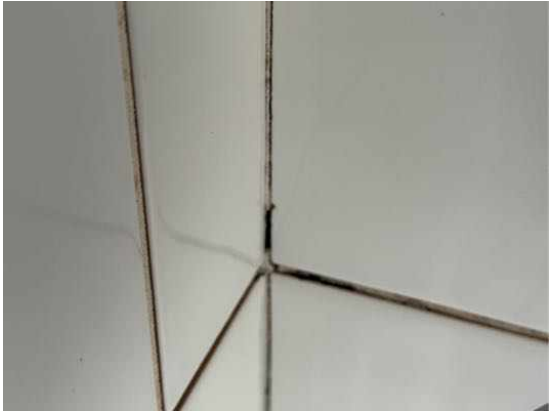
Defects 3.09

Building:	Building 1
Location:	All Areas > All Areas
Finding:	Grout and sealant in bathroom shower cubicle
Information:	<p>It was observed that grout and sealant in the shower alcove wall tiling had been dislodged in minor areas. It also shows excessive mould which should be removed immediately or in the short term future. Where grout or sealant is missing and or show excessive mould, accelerated damage and deterioration as well as more secondary defects to the adjoining structures is highly likely to occur.</p> <p>Regular maintenance and replacement of grout and sealants is highly recommended to all the wet areas. Grout and sealant is considered to be a regular wear and tear defect. Sealant and grouting in these types of wet areas will come into regular contact with water and moisture and should be maintained for the long term care of your property.</p>

Different materials on the walls and floor areas move at different rates, generally causing cracking to grout or sealant at these points. A flexible sealant is required to allow for expected expansion and contraction, while keeping the joint water tight and protective of all associated building structures and materials. Flexible and mould resistant materials should be applied to affected areas to prevent any subsequent water damage that is likely to occur if left unmanaged. Client should appoint a floor and wall tiler to complete these works as soon as possible.

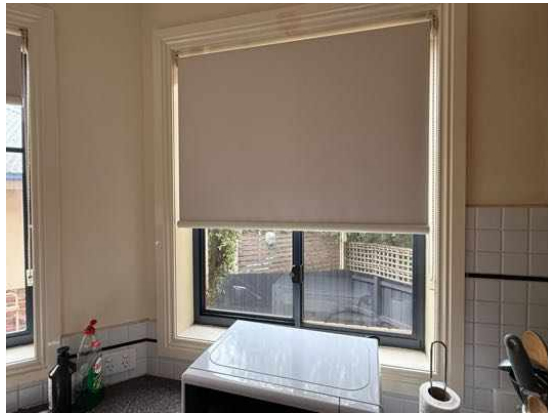
Defects 3.12

Building:	Building 1
Location:	All Areas > All Areas
Finding:	Flyscreens
Information:	Some flyscreens were found to be missing from the windows throughout the home at the time of inspection. Whether the flyscreens have not been installed or have been removed for maintenance and or painting purposes, this missing building element detracts from the operational state of the window. Where not replaced, missing flyscreens allow pest and insect ingress into the adjoining room/s. It is advised that all missing building elements be installed or replaced in order to ensure the full function of all building structures. A qualified carpenter may be appointed to replace flyscreens at the discretion of the client.

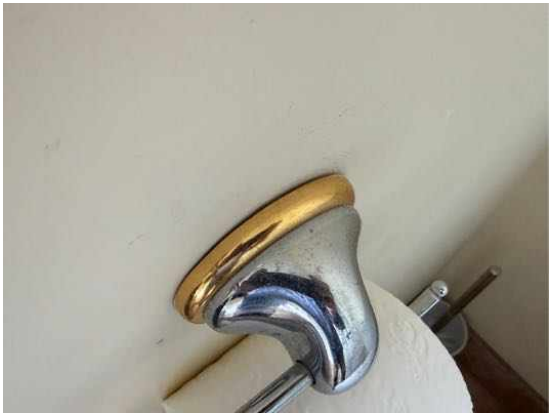
Defects 3.13

Building:	Building 1
Location:	Bottom storey toilet > All Areas
Finding:	Toilet roll holders - Loose
Information:	The toilet roll holders and towel rail were found to be loose at the time of inspection. While not a major operational defect, function can deteriorate if the problem is left unmanaged. It is recommended that some remedial works to rectify the loose toilet roll holders and towel rails to its original fixing. If these cannot be be rectified to function as intended, client is recommended to renew. A qualified carpenter may be required to perform these works.

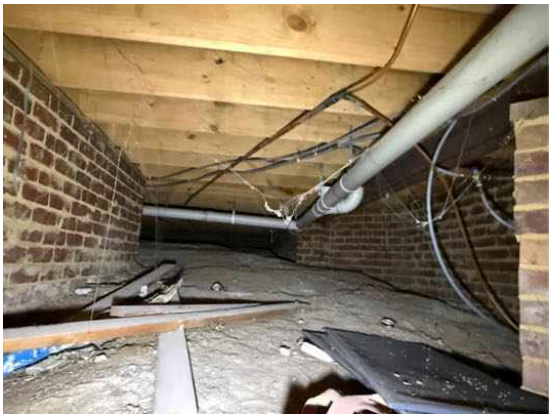
Building: Building 1
 Location: All Areas > All Areas
 Finding: Termite Management System - no evidence of a chemical installation or durable notice
 Information: At the time of the inspection no application of a chemical termite barrier or durable notice was observed. Such barriers are highly effective and highly recommended for all properties in preventing termite attack on any timber building elements throughout the property.

A durable notice should be placed in the switchboard unit or in the another accessible area to indicate current termite barriers. At the time of inspection, no evidence to suggest preventative works taking place. The client may consider gaining further advice from builders or a pest controller and as to the costs and procedures involved with this application. It is recommended that obtaining such advice be a short-term priority.

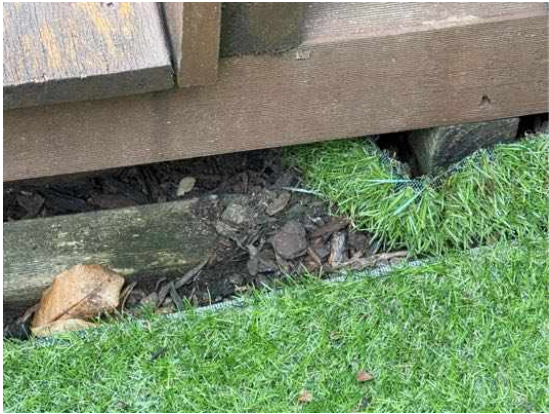
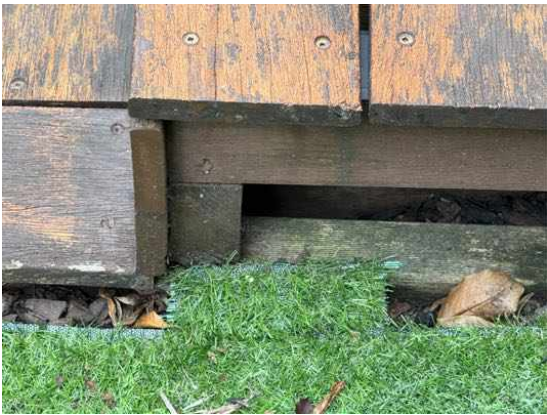
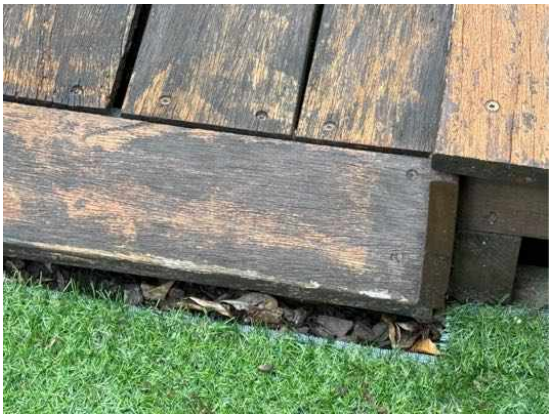
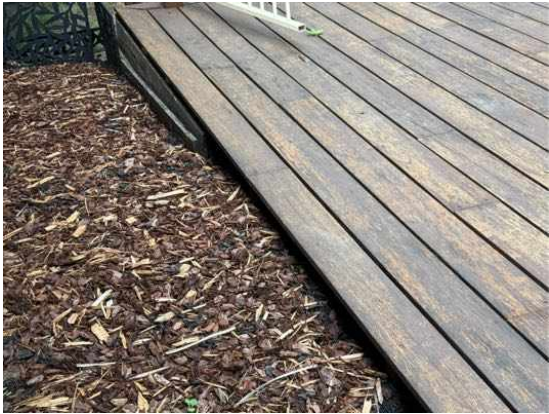
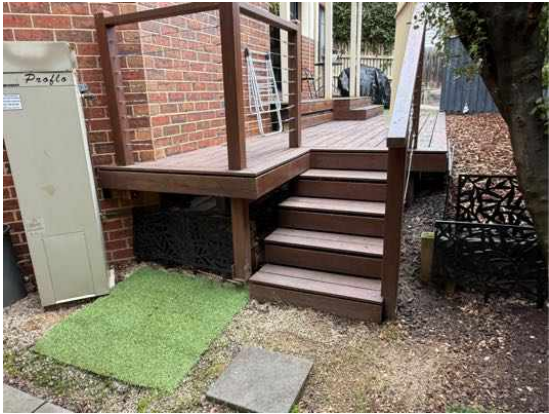
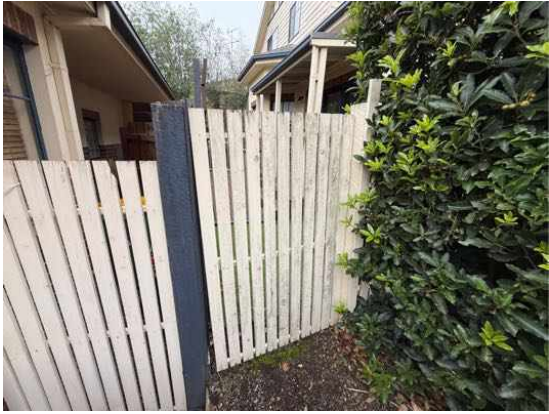
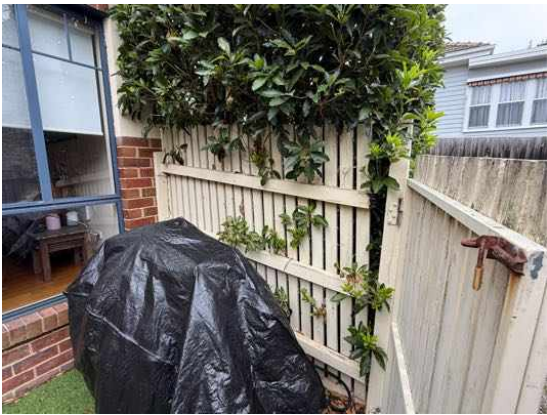
Building: Building 1
Location: Rear deck areas > All Areas
Finding: Timber in the ground and exposed to excessive weather conditions
Information: External timbers in the ground and are frequently exposed to harsh and extreme weather conditions, will require adequate protection and maintenance in order to maintain their condition. Other timbers are exposed to moisture from ground contact which exposes these areas to accelerated wood rot and decay, damage and deterioration. Where timbers have not been painted properly or treated adequately, general deterioration is likely to occur at an accelerated rate.

If left unattended, replacement of these timbers is likely to be necessary in the future. Adequate treatment of these timbers is required to ensure excessive weathering does not occur, painting of these areas may be carried out by the client or by a painting contractor or general handyman.
