Building and Timber Pest Inspection Report

Inspection Date: Mon, 9 Feb 2026

Property Address: 8 Sellwood Ct, Mooroopna VIC 3629,
Australia

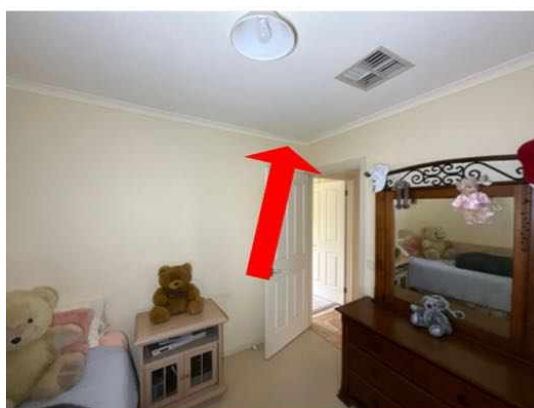
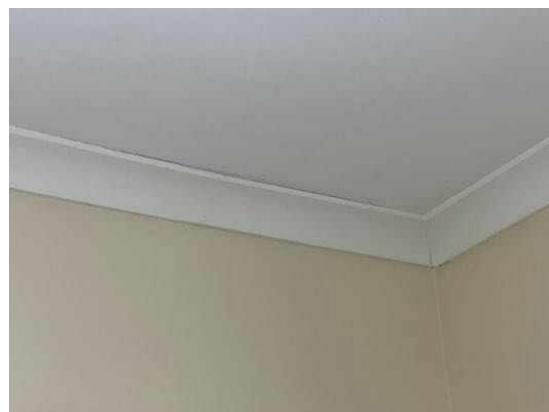
Finding 3.01

Building:	Building 1
Location:	Bedroom 2
Finding:	Cracking - Damage Category 1 - Fine (up to 1mm)
Information:	Although fine cracks are quite noticeable, they are often only considered to be an appearance defect, and usually do not indicate any structural damage. Generally, the cause of a fine crack is indicative of a separation between building materials and finishes (e.g. paint, plaster, etc.) along joins.

Monitoring of all cracking should be conducted frequently. Always contact a building inspector should cracks widen, lengthen, or become more numerous.

Cracking of this nature can generally be repaired with minor sanding, filling and/or repainting. Such works should be performed by a qualified painter or a general handyman.

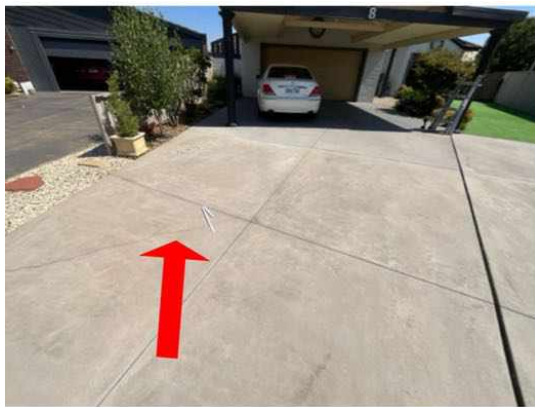
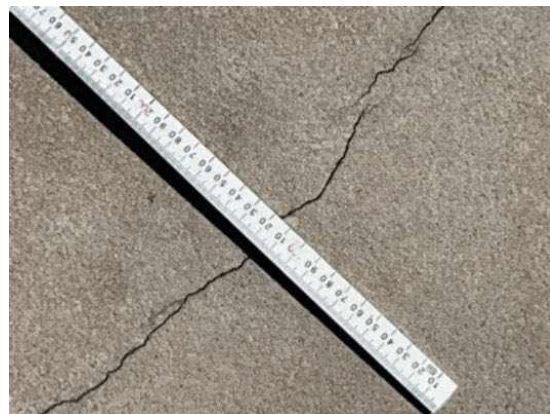
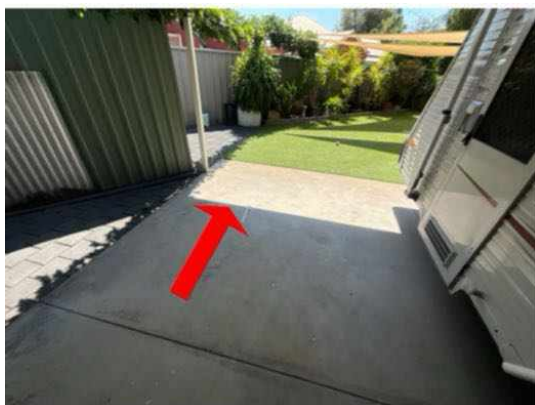
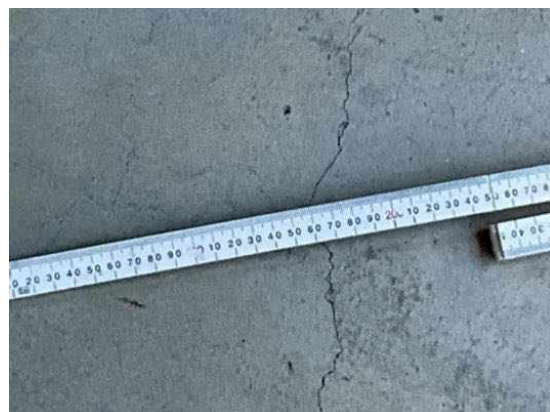
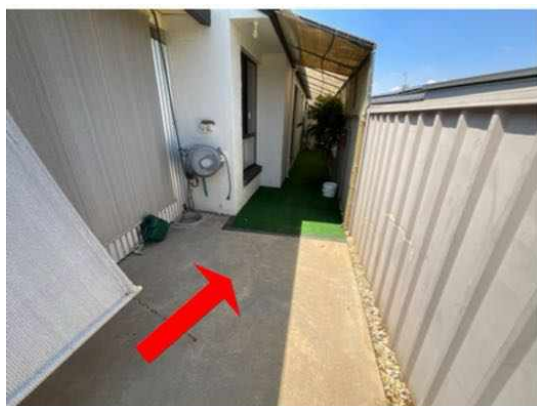
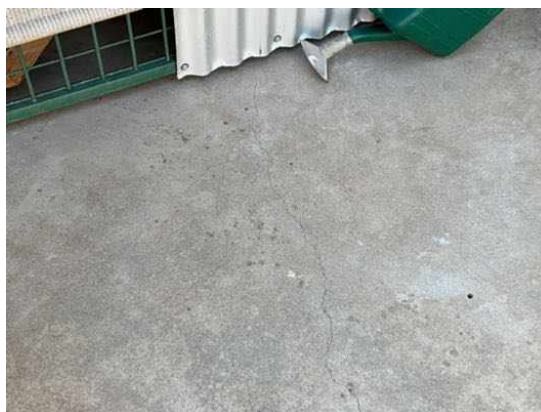
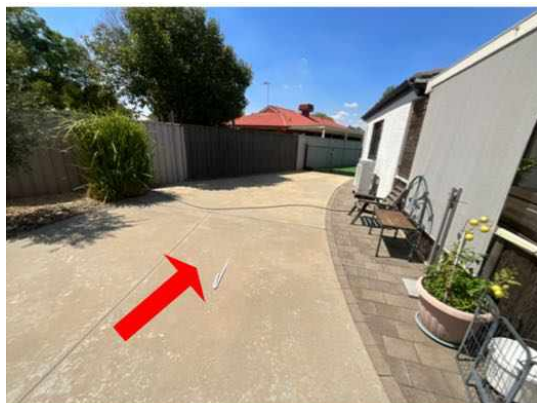
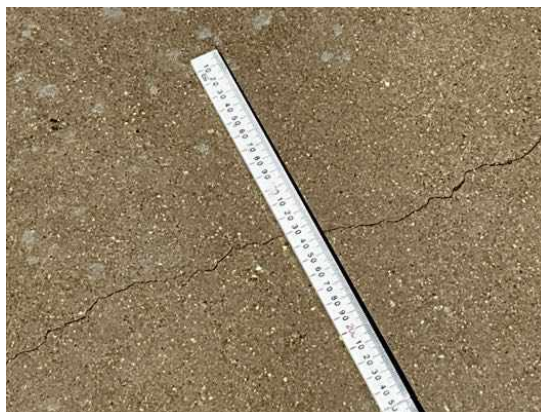
Finding 3.02

Building:	Building 1
Location:	Driveway, carport, yard- side
Finding:	Cracking - External Concrete Paving Damage Category 1 - Fine (less than 2mm)

Information: Fine cracks were identified in external concrete paving. Although fine cracks are quite noticeable, they are often only considered to be an appearance defect, and usually do not indicate any structural damage. To be considered a Category 1 or fine crack, the crack is found to be less than 2mm in width.

Generally the cause of a hairline crack in existing concrete paving such as driveways and pathways is indicative of the expansion and contraction of the concrete. Such causes are generally due to environmental factors, such as moisture levels, weather conditions, root systems of nearby trees or the soil types on which they are laid.

Fine cracks may also be due to poor original installation of the concrete. Factors such as poor compaction of the sub surface and/or inadequate reinforcing of the slab may create cracking and other secondary defects.

Monitoring of all cracking should be conducted frequently. Always contact a building inspector should cracks widen, lengthen, or become more numerous.

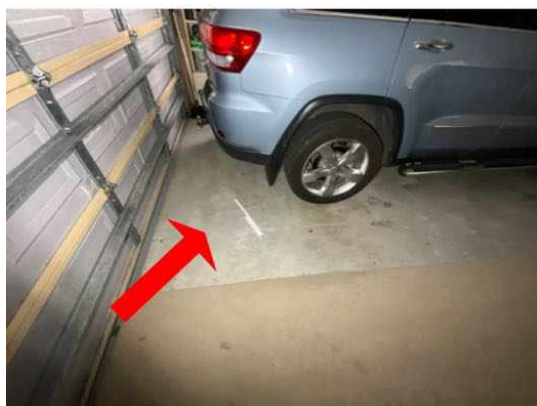
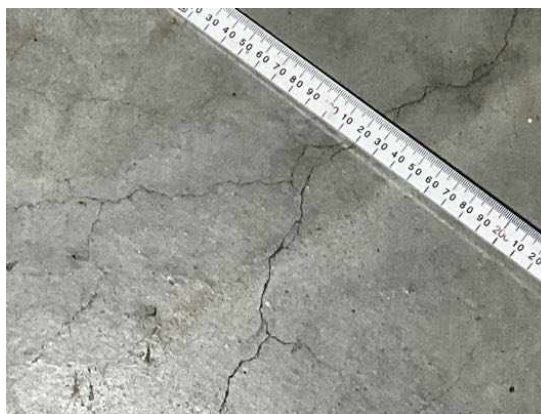
Finding 3.03

Building:	Building 1
Location:	Garage
Finding:	Crack in concrete slab - Category 1
Information:	A crack coded as Category 1 was identified in the slab. A Category 1 crack is described as a fine but noticeable crack, with the slab at an otherwise reasonable level.

To be considered Category 1, the approximate width of the crack is less than 1.0mm, or a less than 10mm change in offset when a 3m straight edge is placed over the defect.

Category 1 cracks should be monitored for a period of 12 months. At the end of the monitoring period, identified cracks that are rated greater than Category 2 are considered defects, and require rectification.

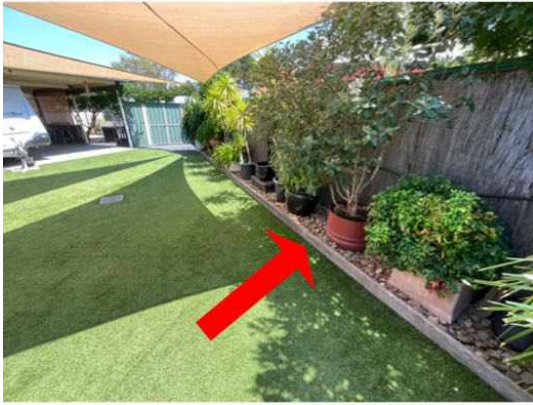
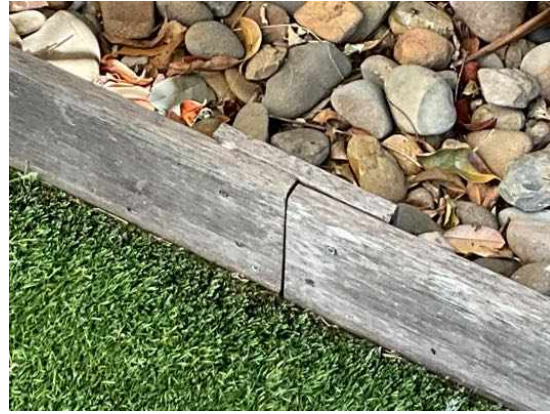
Finding 6.01

Building:	Building 1
Location:	Yard - Back
Finding:	Untreated or non-durable timbers in a hazardous environment
Information:	To reduce the risk of timber pest attack it is essential that timber used in a hazardous environment (e.g. in direct contact with the ground or frequently exposed to damp conditions) is of sufficient durability and/or is adequately preservative treated.

Untreated timbers in direct contact with the ground are likely to develop severe wood rot and/or fungal decay if left unattended creating attraction for subterranean termites to infest the timbers from surrounding areas.

If untreated or non-durable timbers are found to be in a hazardous environment it is highly advised that replacement of these building elements be performed as soon as possible to aid the protection of the property against termite / timber pest attack.

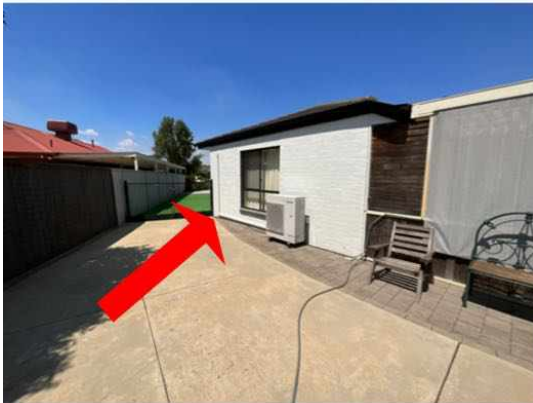
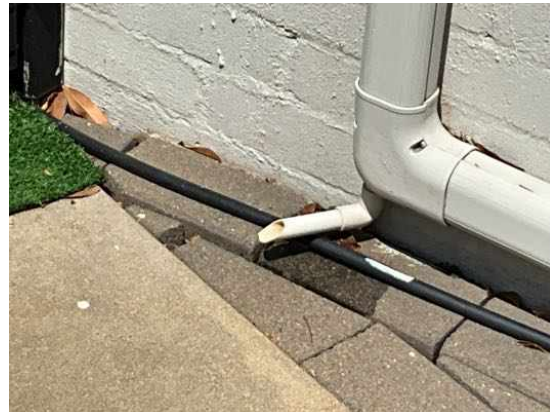
Finding 6.02

Building:	Building 1
Location:	Driveway
Finding:	Air conditioner - Disconnected overflow
Information:	The Air Conditioner (A/C) overflow was found to be disconnected from storm water drainage and is creating excessive moisture in the surrounding area.

Such leaking creates an environment which is conducive to an array of defects, including water damage to associated building elements and the attraction of termite or timber pest infestation.

It is highly recommended that a licensed plumber be appointed to connect the A/C overflow in order to prevent such an environment from being created. These minor works should be carried out as soon as possible.

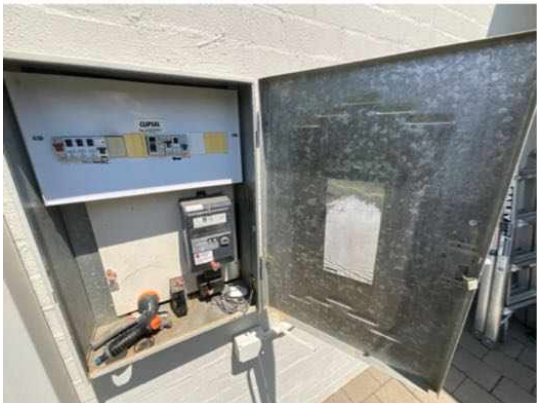
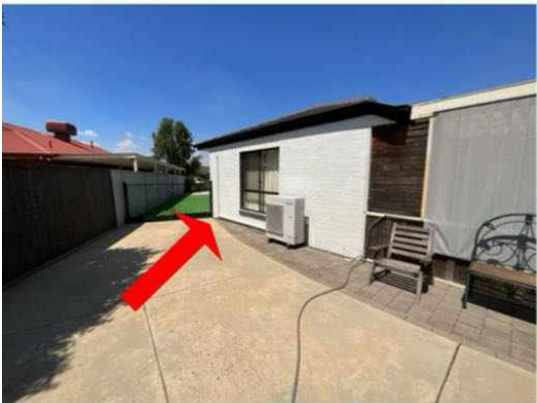
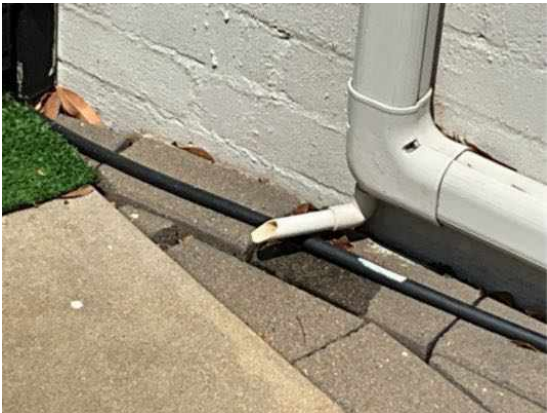
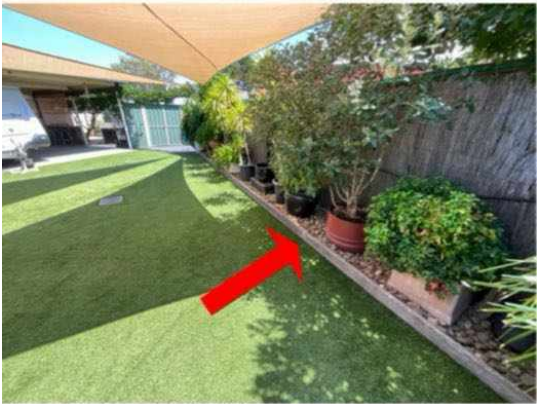
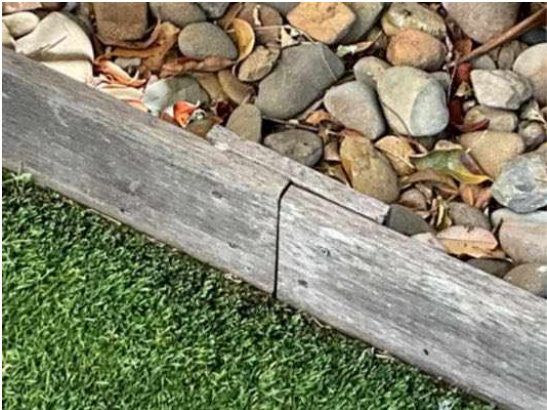
Finding 6.03

Building:	Building 1
Location:	All External Areas
Finding:	Termite Management System - no evidence of a chemical installation
Information:	The application of a post-construction chemical termite barrier is highly recommended for all properties, particularly if live termite activity has been found on the site

previously. Such barriers are highly effective in preventing termite attack on any timber building elements throughout the property.

A durable notice should be placed in the switchboard unit to indicate current termite barriers. At the time of inspection, it appeared as though no termite management system has been installed, with no evidence to suggest preventative works taking place.

The client may consider gaining further advice from a pest controller as to the costs and procedures involved with this application. It is recommended that obtaining such advice be a short-term priority.

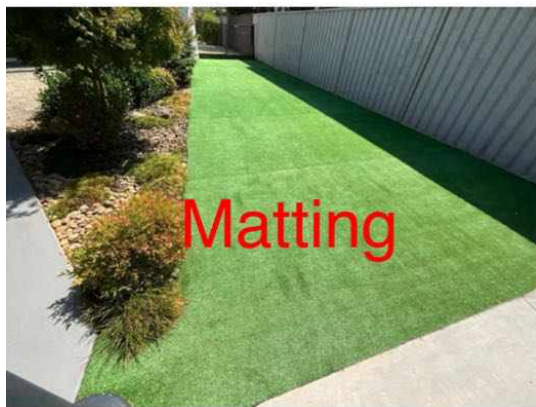
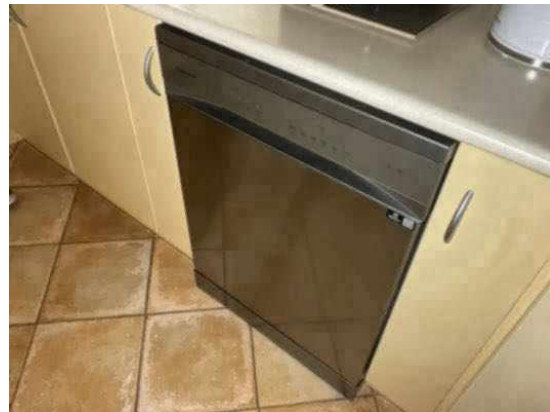
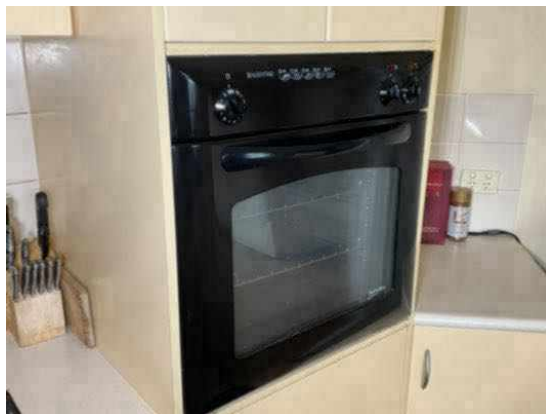
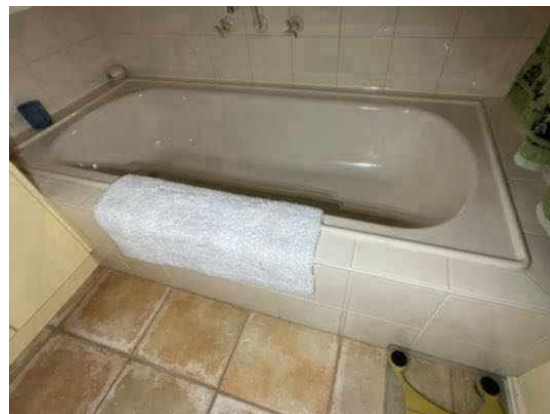
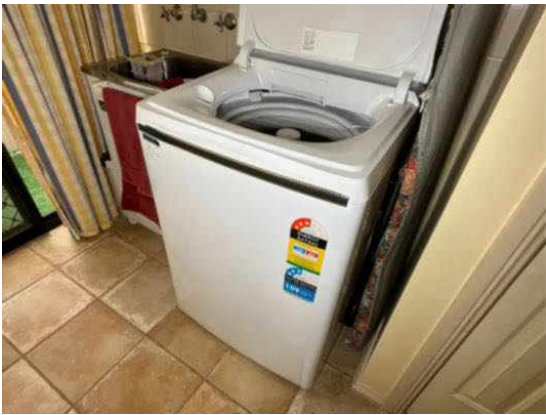
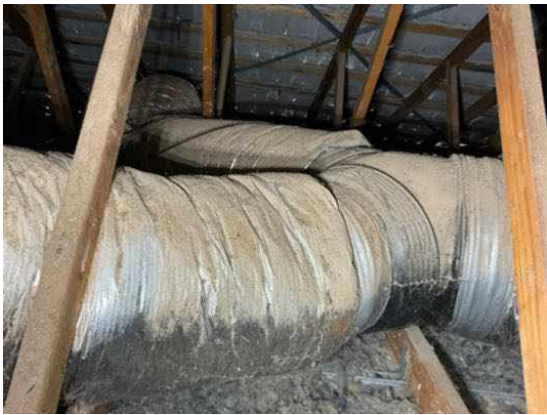
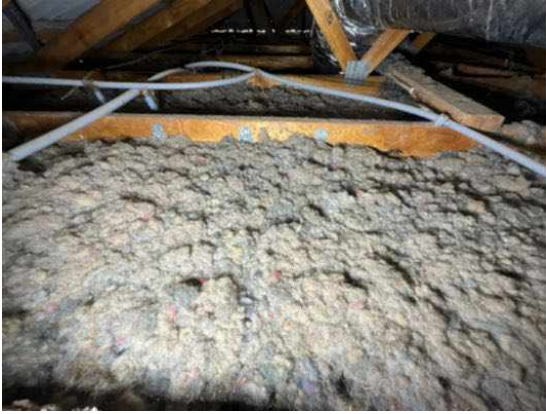
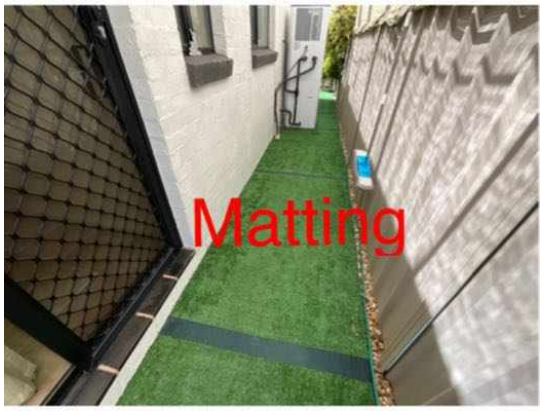
Noted Item

Building: Building 1
Location: All Areas
Finding: Additional Photos - Obstructions and Limitations
Information: These photographs are an indication of the obstructions and limitations which impeded full inspection of the property at the time of inspection. These obstructions can hide an array of defects and should be removed to allow full inspection to be carried out. A re-inspection is recommended once the areas are made accessible.
