Building and Timber Pest Inspection Report

Inspection Date: Wed, 7 Jan 2026

Property Address: 29/171-177 Moorefields Rd, Roselands
NSW 2196, Australia

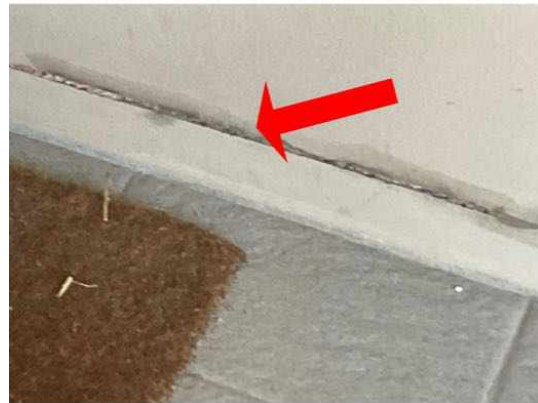
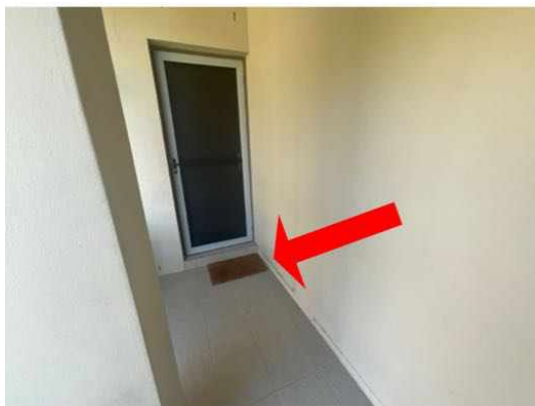
Building: Main Building
Location: Porch
Finding: Porch - Water Ingress and Staining
Information: Evidence of moisture staining and deterioration was observed to the porch area, consistent with suspected water ingress. This is likely associated with inadequate waterproofing, defective flashing, or moisture penetration from adjacent external elements.

Further investigation by a qualified building professional is recommended to identify the source of moisture and undertake rectification works to prevent ongoing damage.

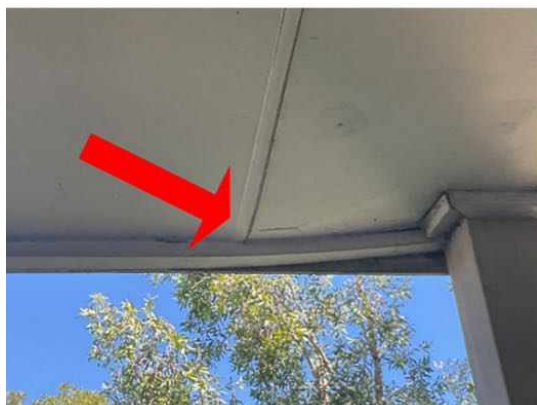
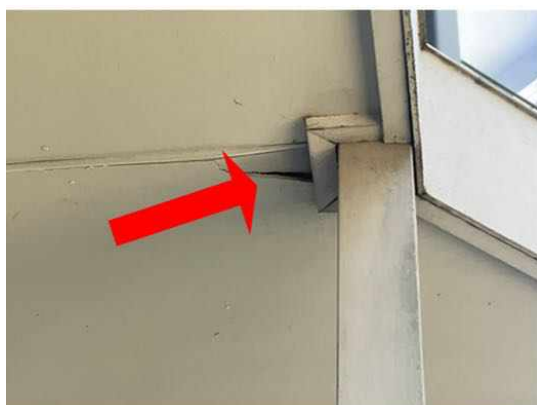
Finding 2.02

Finding: Eaves - Damaged

Information: The eaves around the external property were found to be in a visibly poor condition. The damage may have been sustained as a result of a number of possible causes, including poor roof drainage, leaking roof plumbing or minor impact damage.

The damage to the eave sheeting in this area detracts from the appearance of the structure, as well as potentially compromising the structural integrity of the roofing area.

Where eaves show moderate to severe damage, remedial works may be required. Where water damage is suspected as being the underlying cause, appointment of a licensed plumber is advised as a matter of urgency to identify the source of the water leak.

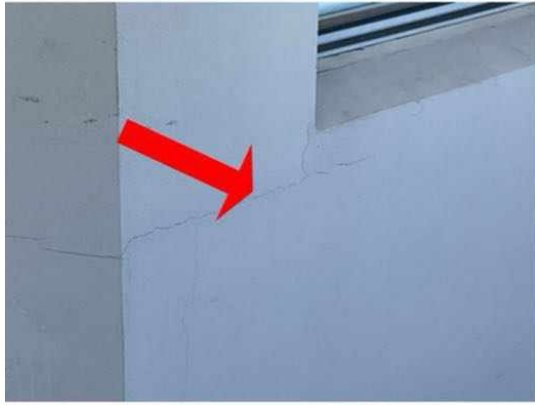
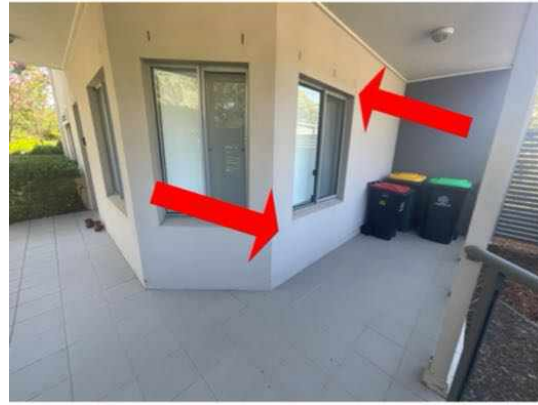
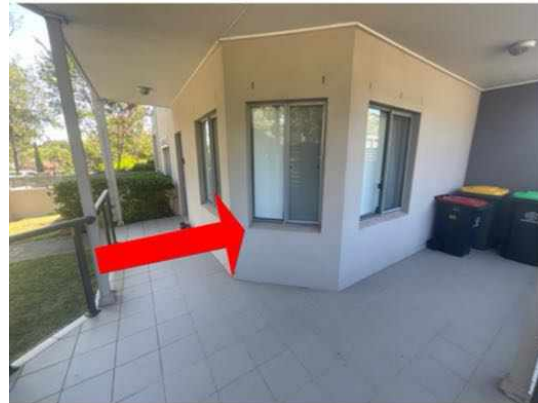
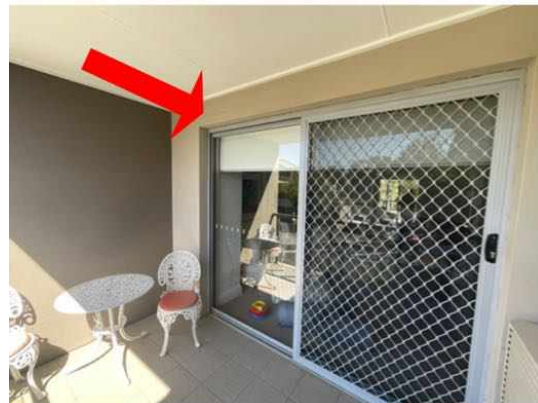
Finding 3.01

Finding: Cracks to external render - Category 1
Information: It has been observed that cracking to internal rendered surfaces has occurred. The degree of damage falls within Category 1, described as fine cracks that do not need repair and which are less than 1.0mm in width limit.

Damage of this category is not considered a defect for rectification. Always contact your building inspector should cracks widen, lengthen, or become more numerous.

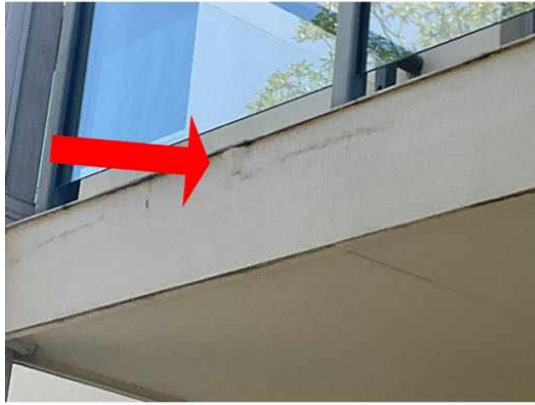
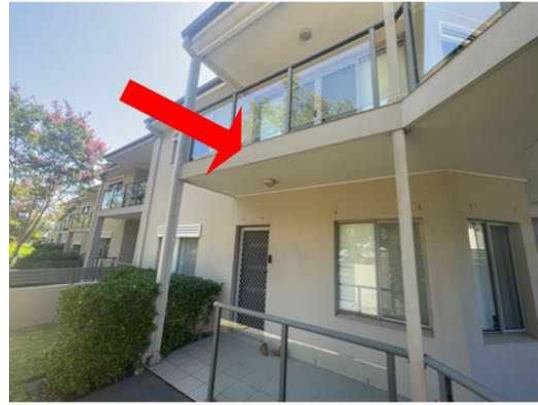
Finding 3.02

Building:	Main Building
Location:	All External Areas
Finding:	External Cladding - Damaged
Information:	At the time of inspection, the external cladding at the front elevation was found to be damaged. Further inspection by Licensed Building or Qualified Carpenter is highly recommended to ensure its safety and structural integrity of the area. If left unmanaged, the area is likely to deteriorate further, potentially creating not weather tight.

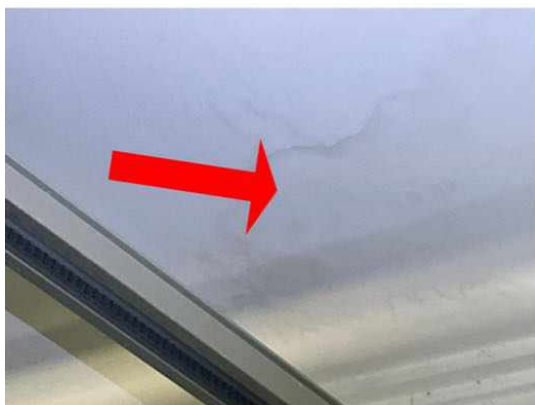
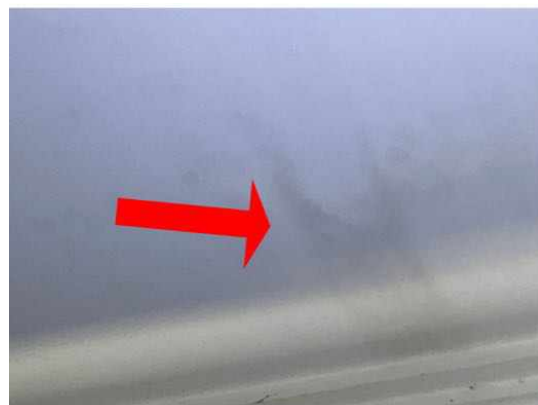
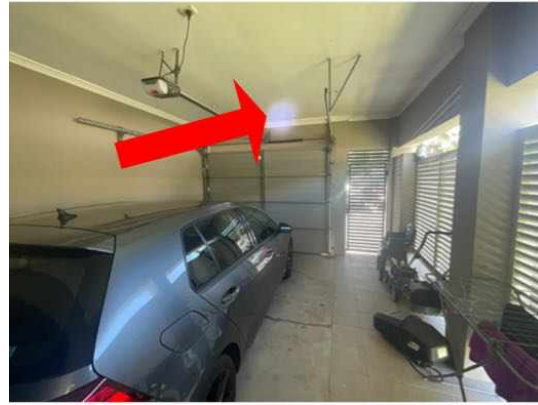
Finding 3.03

Finding: Ceiling - Water stained

Information: Water staining to ceiling linings in this area was evident at the time of inspection. Water staining indicates that surfaces have been exposed to excessive moisture over time. The minerals and other elements in the water lead to staining, which may graduate to corrosion and deterioration if left unmanaged.

While mostly an appearance defect, water staining can be indicative of more serious defects, which may be currently concealed by interior ceilings.

Where water staining is active, a licensed plumber must be consulted to identify the cause of the staining and to provide advice on any reparation works that may be required. Replacement of any damaged structures is advised.

Conversely, where water staining is old and inactive, affected building materials may be repaired or replaced at client discretion.

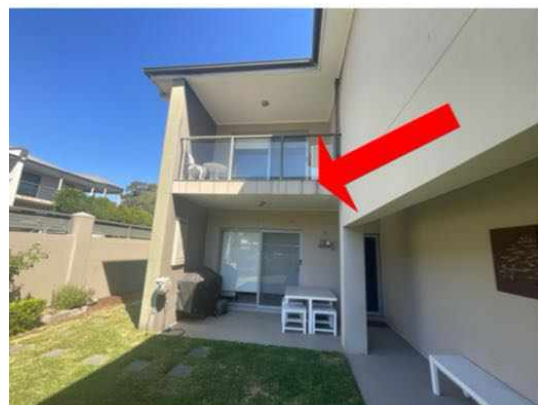
Finding 3.04

Finding: Walls - Water stained

Information: Water staining to sections of the walls in this area was evident at the time of inspection. Water staining indicates that surfaces have been exposed to excessive moisture over time. The minerals and other elements in the water lead to staining, which may graduate to corrosion and deterioration if left unmanaged.

While mostly an appearance defect, water staining can be indicative of more serious defects, which may be currently concealed by wall linings.

Where water staining is active, a licensed plumber must be consulted to identify the cause of the staining and to provide advice on any reparation works that may be required. Replacement of any broken or damaged structures is advised.

Conversely, where water staining is old and inactive, affected building materials may be repaired or replaced at client discretion.

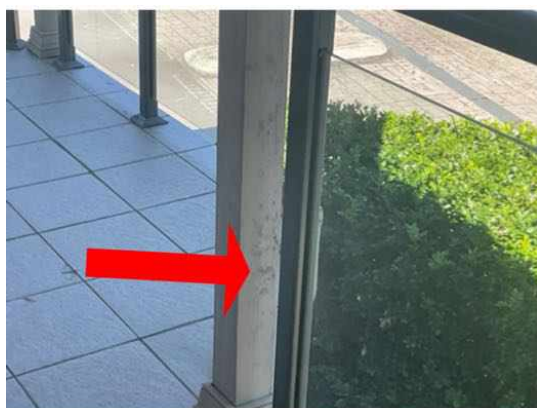
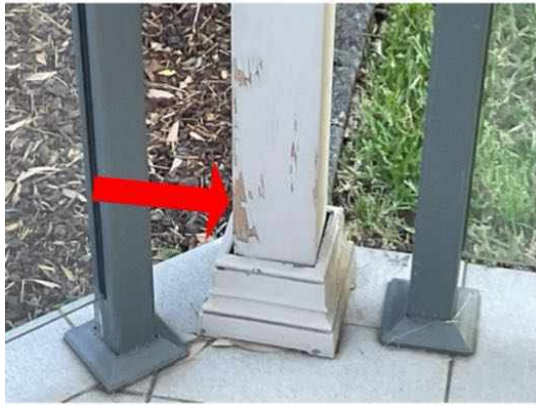
Finding 3.05

Building:	Main Building
Location:	All External Areas
Finding:	External painting deteriorated
Information:	Much of the external paintwork including but not limited to windows, fascias, guttering, veranda and other external fitments have been neglected and require attention to prepare and re-paint.

Whilst incomplete or missing paint finish is generally an appearance defect, it can also lead to the development of secondary building defects over time. Incomplete areas of paint finish expose the area to moisture, potentially accelerating the deterioration of underlying building materials.

Degraded paint finishes should be sanded back, filled, leveled and painted, as applicable. Where inadequate or missing paint protection has led to the deterioration of the associated building element, repair and/or replacement of this building element may be required.

A painting contractor should be appointed as soon as possible to perform necessary works to aid the appearance of the affected area and to ensure the area is protected against further deterioration. Alternatively, the homeowner following manufacturer instructions may perform these works.

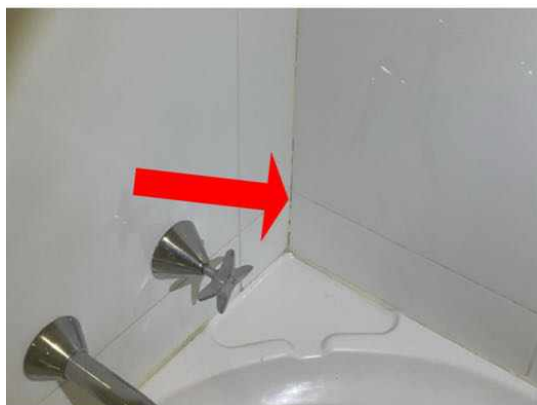
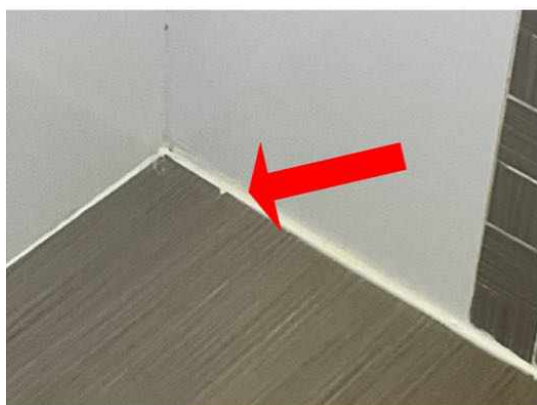
Building:	Main Building
Location:	Bathroom
Finding:	Sealant and grouting - Missing or damaged
Information:	It was noted on inspection that sealant or grout is degraded to the tiled shower alcove and or other areas of the bathroom.

Different materials and floor areas move at different rates, generally causing cracking to grout or sealant at this point. A flexible sealant is required to allow for expected expansion and contraction, while keeping the joint water tight and protective of all associated building materials.

There appears to be excessive mould to the sealant and grout which will likely require scraping out and replacement.

Flexible and mould resistant materials should be applied to affected areas to prevent any subsequent water damage that is likely to occur. Regular maintenance and replacement of damage or missing or damaged sealant and grout is highly recommended to the wet areas, as this is a regular wear and tear defect. Sealant and grouting in areas that come into regular contact with water should be maintained for the long term care of your property.

A sealant specialist or tiling contractor should be appointed to complete these works

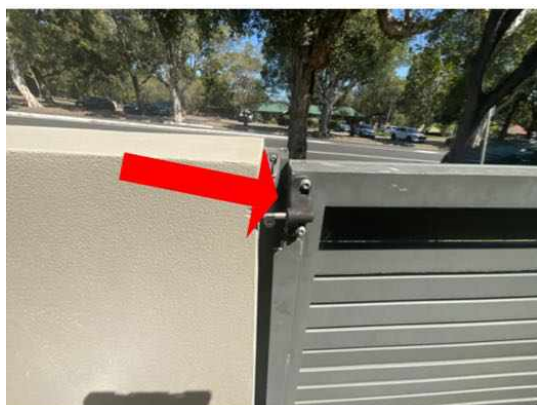
Finding 3.11

Building:	Main Building
Location:	All External Areas
Finding:	Gate - Binding / Jamming
Information:	Binding and/or jamming of this gate is evident during standard operation. This defect inhibits the functionality of the affected gate as well as creating potential for secondary defects to associated building elements, such as damage to the walls. A gate that binds to gate frame may have several causes, ranging from minor defects, such as poor installation of the gate or deteriorated hinges, through to major structural issues, such as damage to post or wall structures. For minor causes, a qualified carpenter or general handyman should be appointed to perform minor rectification works at client discretion.

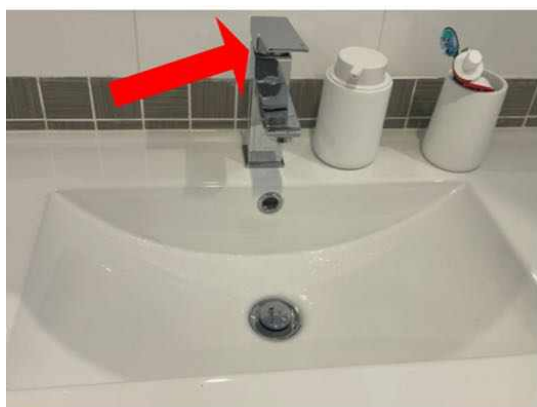
Building:	Main Building
Location:	Ensuite
Finding:	Fitting (tap ware) - Loose
Information:	The fitting in this area is loose and requires adjustment to tighten.

If left unmanaged, the fitting may further deteriorate, causing potential for the development of other minor secondary defects.

A relevant tradesperson should be appointed to perform these rectification works at discretion of the client.

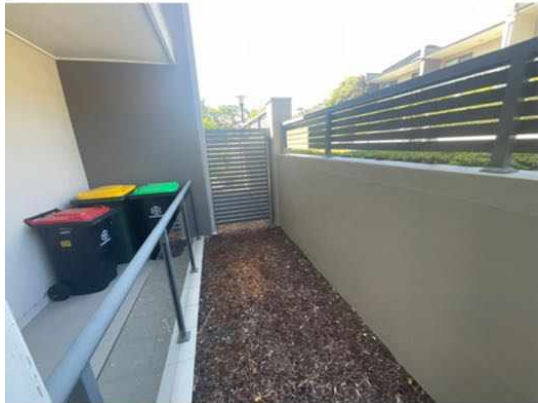
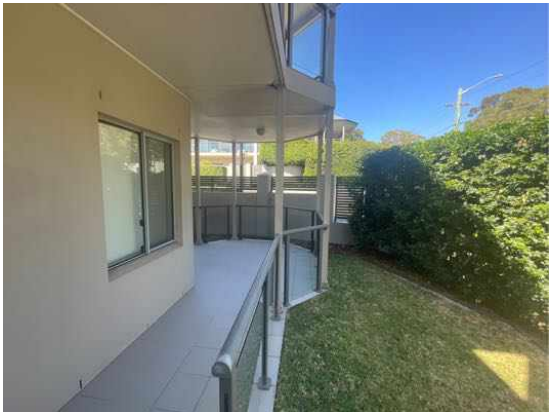
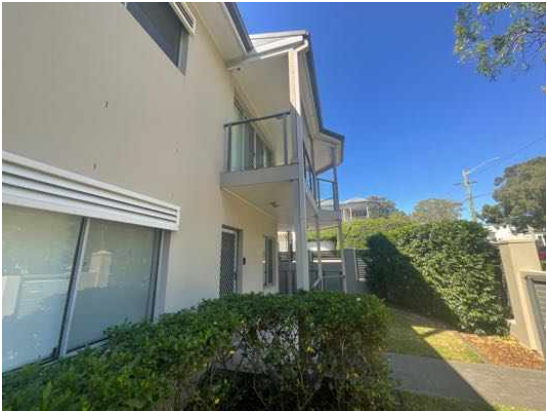
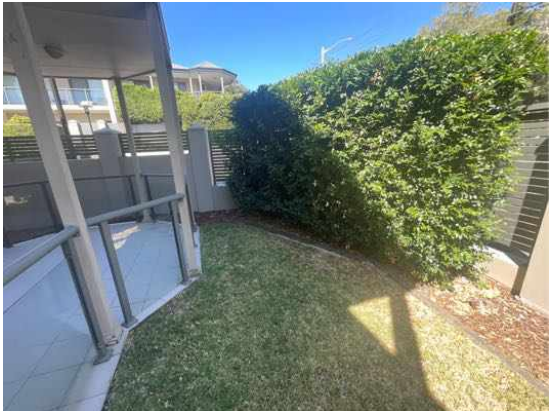
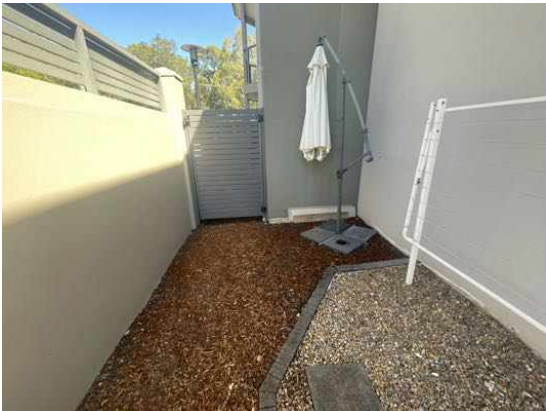
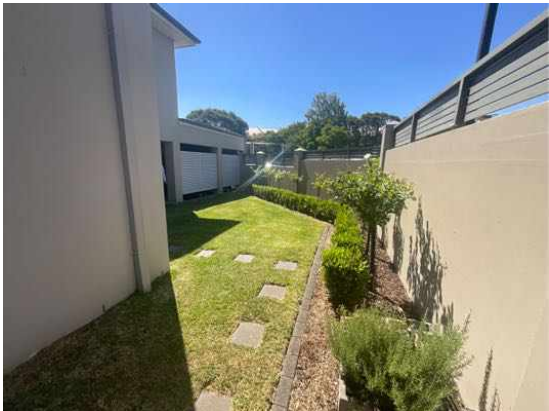
Finding 6.01

Building: Main Building
Location: All Areas
Finding: Garden Beds - Conditions Conducive to Termites
Information: Garden beds were found to be evident in the garden area. These garden beds can include untreated timber, and with a combination of moisture from watering hosing can make conditions conducive to termite activity and termite ingress.

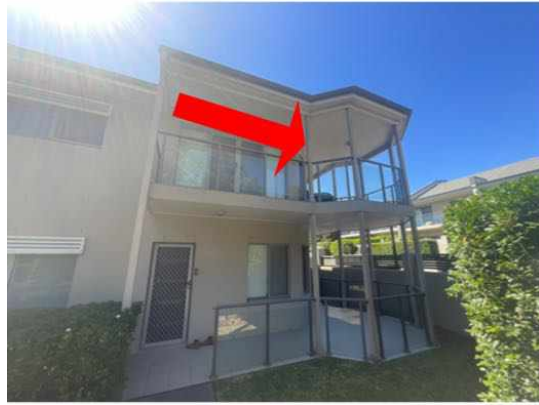
Building: Main Building
Location: All Areas
Finding: Timber - exposed to weather
Information: External timbers that are frequently exposed to harsh weather conditions require adequate protection in order to maintain their condition. Where timbers have not been painted or treated adequately, general deterioration is likely to occur at an accelerated rate.

If left unattended, replacement of these timbers is likely to be necessary in the short-term future. Adequate treatment of these timbers is required as soon as possible by a painting contractor or general handyman.

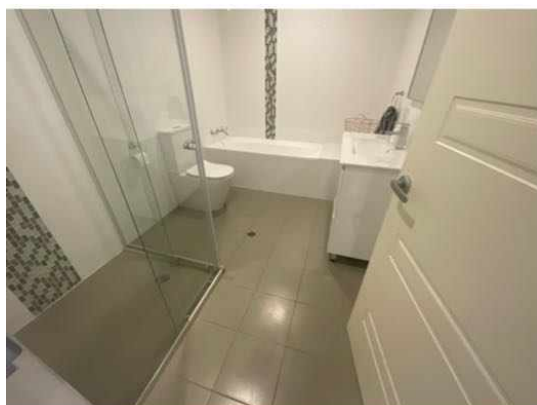
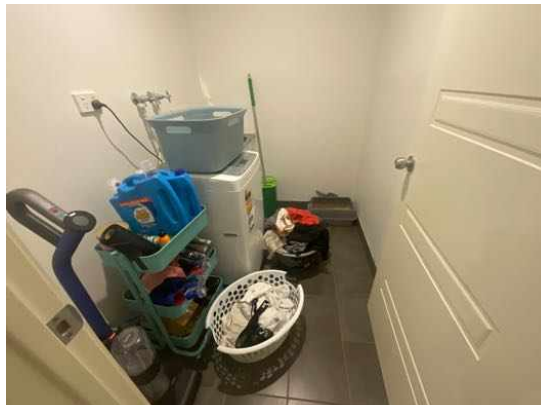
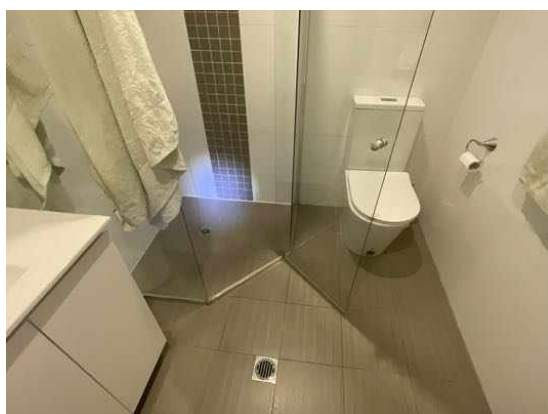
Building: Main Building
 Location: All Areas
 Finding: Water Proofing Membranes - Information Only
 Information: Internal Water Proofing Membranes, are crucial in preventing water ingress into the property is important to know that the Membrane System used is to Australian Standards and has been installed correctly. Please refer to the original Building Documents or Maintenance Schedule for the relevant information including; - Membrane used and Manufacturers Specifications. - The Installer and Installation Certification. Especially with older property's where this information is unavailable, all wet areas should be monitored. Generally new waterproofing with a certificate may

only have a guarantee of 8yrs. If any leaks, water staining, peeling or bubbling of the paint become evident to any adjacent walls or ceilings below a licensed builder or waterproofing specialist is recommended to investigate further.

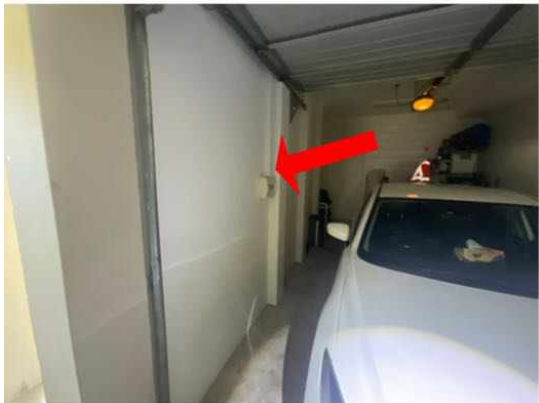
Building:	Main Building
Location:	All Areas
Finding:	Termite Management System - no evidence of a chemical installation
Information:	The application of a post-construction chemical termite barrier is highly recommended for all properties, particularly if live termite activity has been found on the site previously. Such barriers are highly effective in preventing termite attack on any timber building elements throughout the property.

A durable notice should be placed in the switchboard unit to indicate current termite barriers. At the time of inspection, it appeared as though no termite management system has been installed, with no evidence to suggest preventative works taking place.

The client may consider gaining further advice from a pest controller as to the costs and procedures involved with this application. It is recommended that obtaining such advice be a short-term priority.
