Building and Timber Pest Inspection Report

Inspection Date: Sat, 7 Feb 2026

Property Address: 15/49 Maranda St, Shailer Park QLD 4128,
Australia

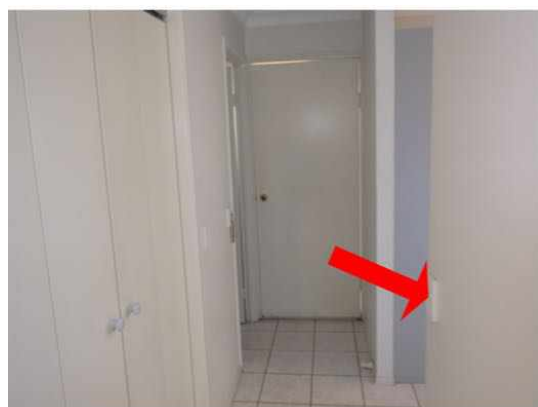
Building:	Main Building
Location:	Hallway > Front Right
Finding:	Light Switch
Information:	At the time of inspection the light switch activator in the hallway area was loose in the cover panel.

A licensed electrician should be engaged to repair or replace the light switch fitting.

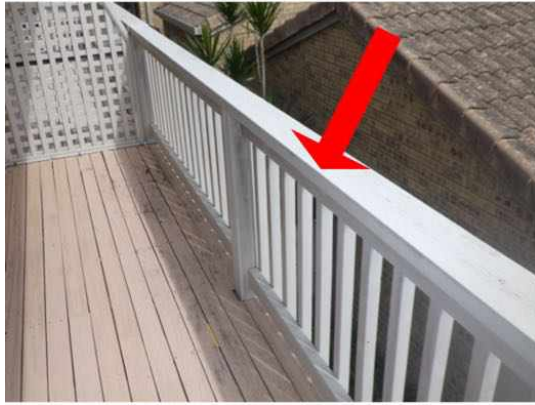
Finding 1.02

Building:	Main Building
Location:	Balcony > Existing
Finding:	Balustrade - Suspected Non-Compliance
Information:	The upper level balcony area balustrade was measured and found to be (.950mm high) less than the present building regulation requirement of 1000mm high.

A registered builder should be contacted to discuss possible rectification solutions.

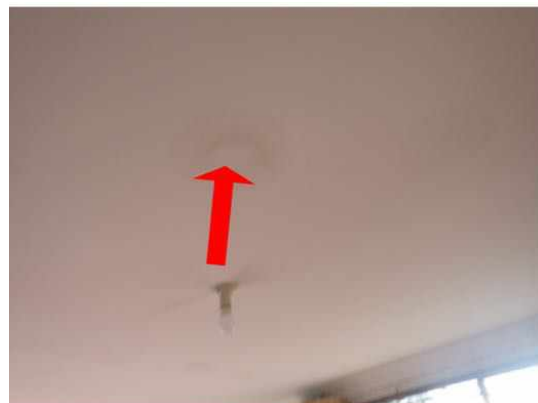
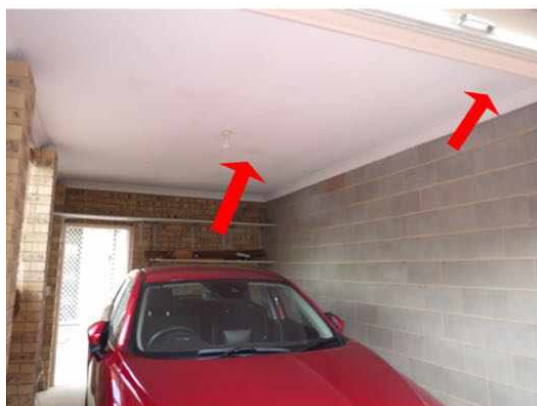
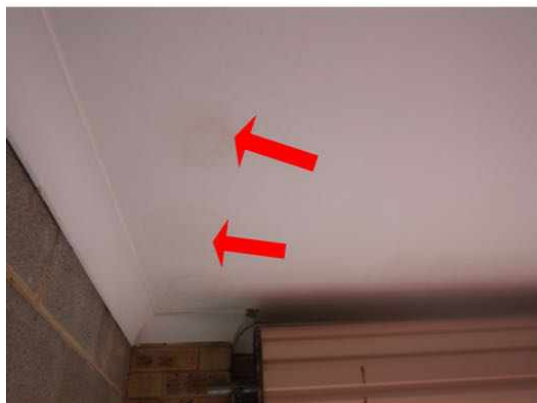
Building: Garage
 Location: Garage > Centre
 Finding: Ceiling - Water stained
 Information: Water staining to ceiling linings in the garage area was evident at the time of inspection. Water staining indicates that surfaces have been exposed to excessive moisture over time. The minerals and other elements in the water lead to staining, which may graduate to corrosion and deterioration if left unmanaged.

While mostly an appearance defect, water staining can be indicative of more serious defects, which may be currently concealed by interior ceilings.

Where water staining is old and inactive, affected building materials may be repaired or replaced at client discretion.

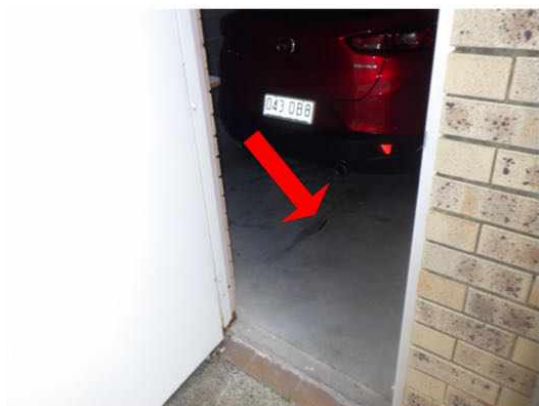
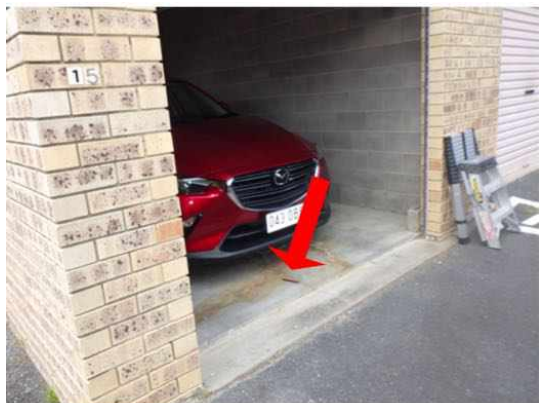
Finding 3.02

Building:	Garage
Location:	Garage > Ground Level
Finding:	Cracking in concrete slab - Category 1
Information:	Cracking coded as Category 1 was identified in the garage floor concrete slab. A Category 1 crack is described as a fine but noticeable crack, with the slab at an otherwise reasonable level.

To be considered Category 1, the approximate width of the crack is less than 1.0mm, or a less than 10mm change in offset when a 3m straight edge is placed over the defect.

Category 1 cracks should be monitored for a period of 12 months. At the end of the monitoring period, identified cracks that are rated greater than Category 2 are considered defects, and require rectification.

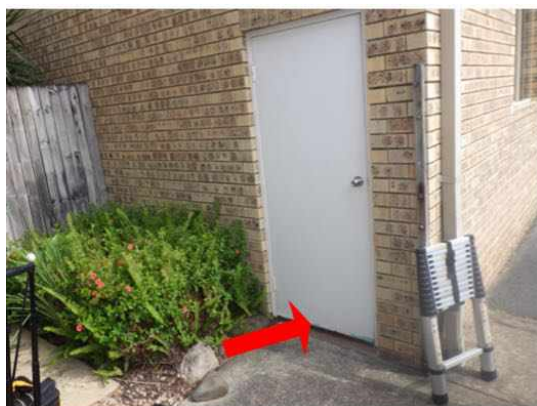
Finding 3.03

Building:	Garage
Location:	External Areas > Rear Left
Finding:	Damaged Door
Information:	The garage area exterior door has suffered damage to the bottom edge.

Damage occurs generally when the building materials have aged and decayed, but in this instance the damage appears to be the result of exposure to moisture, possibly from the bottom edge of the door not being sealed with a suitable paint or sealant at the time of construction.

A qualified carpenter or general handyman could be appointed to repair/replace the door at the clients discretion.

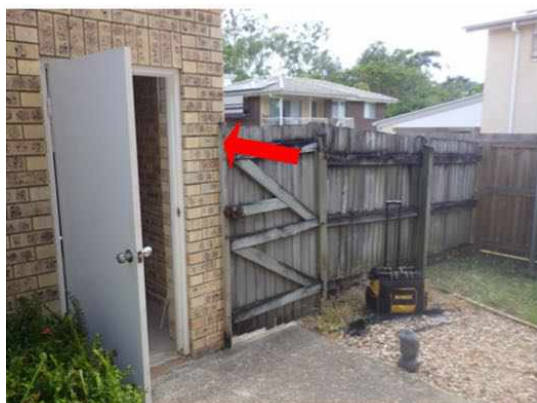
Finding 3.04

Building: Yard
 Location: Yard - Front > Front Left
 Finding: Gate - Sticking/ jamming
 Information: At the time of inspection the gate to the left side of the property was sticking or jamming during standard operation.

A fencing contractor or general handyman could be engaged to adjust or repair the gate as required.

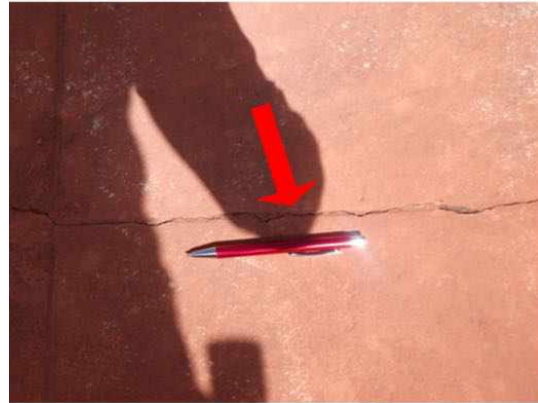
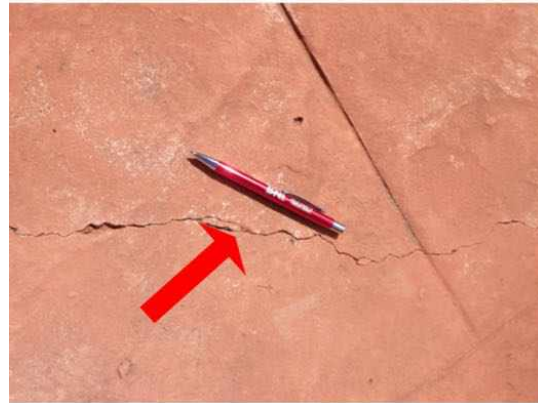
Finding 3.05

Building: Main Building
 Location: Yard - Back > Existing, Ground Level
 Finding: Cracking in concrete slab - Category 1
 Information: Cracking coded as Category 1 was identified in the footpaths concrete slab. A Category 1 crack is described as a fine but noticeable crack, with the slab at an otherwise reasonable level.

To be considered Category 1, the approximate width of the crack is less than 1.0mm, or a less than 10mm change in offset when a 3m straight edge is placed over the defect.

Category 1 cracks should be monitored for a period of 12 months. At the end of the monitoring period, identified cracks that are rated greater than Category 2 are considered defects, and require rectification.

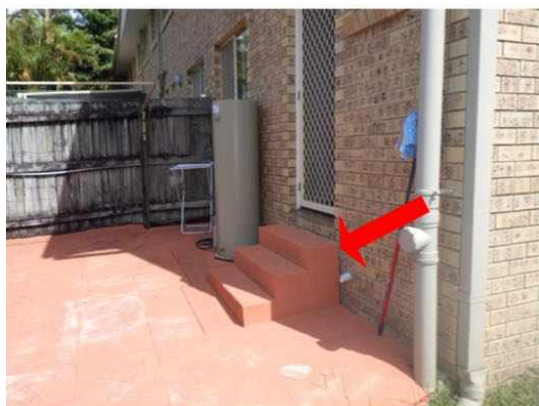
Finding 3.06

Building:	Main Building
Location:	Yard - Back > Existing
Finding:	Concrete Slab - Movement
Information:	The concrete slab/ steps to the rear of the property appears to have moved significantly away from the building exterior wall. The concrete slab or steps movement is assumed to be the result of ground subsidence or ground movement in the area.

Always contact a building inspector should gaps or cracks widen, lengthen or become more numerous.

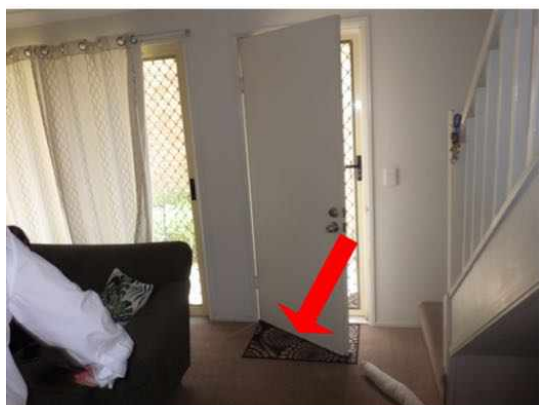
Finding 3.07

Building:	Main Building
Location:	Entry > Front
Finding:	Damaged Door
Information:	The entry door has suffered damage to the bottom edge.

Damage occurs generally when the building materials have aged and decayed, but in this instance the damage appears to be the result of exposure to moisture, possibly from the bottom edges of the door not being sealed with a suitable paint or sealant at the time of construction.

A qualified carpenter or general handyman could be appointed to repair/replace the door at the clients discretion.

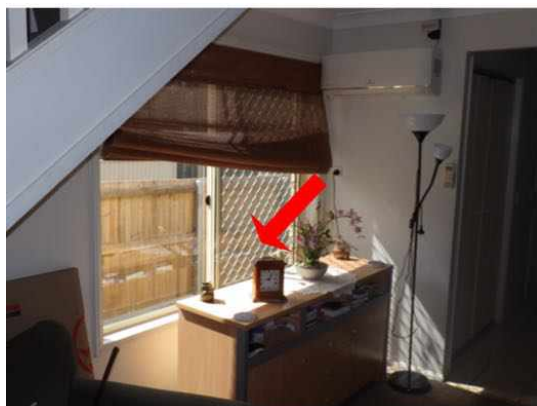
Finding 3.08

Building:	Main Building
Location:	Living/Dining Room > Centre Left
Finding:	Window - Stiff to Slide
Information:	The aluminium sliding window in the living room area was stiff to operate at the time of the inspection. Windows provide ventilation to the adjoining area and should be at a fully operational level to ensure user comfort. Restricted function of the window may

also pose as a potential safety hazard if required for emergency egress from the building.

Generally, factors such as general age of the building element and a lack of maintenance are the usual causes for this type of defect.

An aluminium window service agent will be required to repair the affected windows.

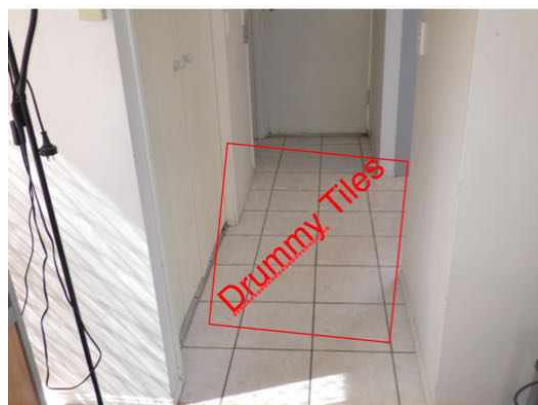
Building:	Main Building
Location:	Hallway > Existing
Finding:	Tiles - Drummy
Information:	Drummy tiles were identified in the hallway area floor at the time of inspection. The term 'drummy' refers to tiles that despite being in relatively good condition have a hollow sound when tapped on and may be inclined to crack from heavy impact whether accidental or deliberate. Drummy tiled areas may be a direct result of moisture exposure or poor workmanship during the construction process.

A tiling contractor could be appointed to perform works if necessary.

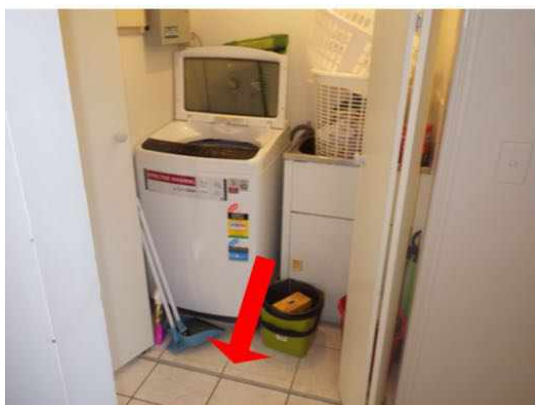
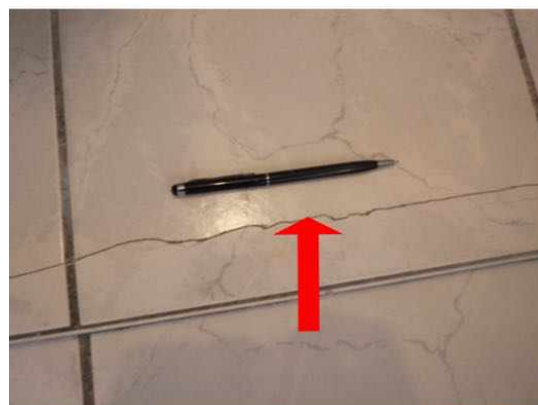
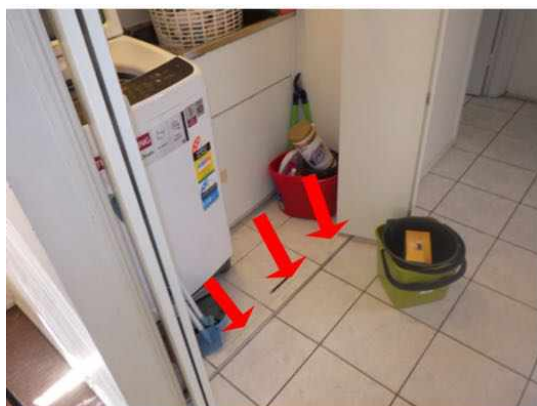
Finding: Tile - Cracked

Information: Cracked tiles to the laundry floor area were identified at the time of inspection. Such defects are generally caused by impact. Cracked or broken tiled areas may also be a direct result of moisture exposure or poor workmanship during the construction process.

A tiling contractor could be appointed to perform repair works at the clients discretion.

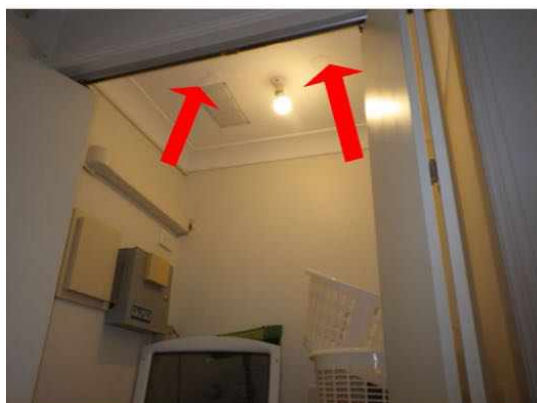
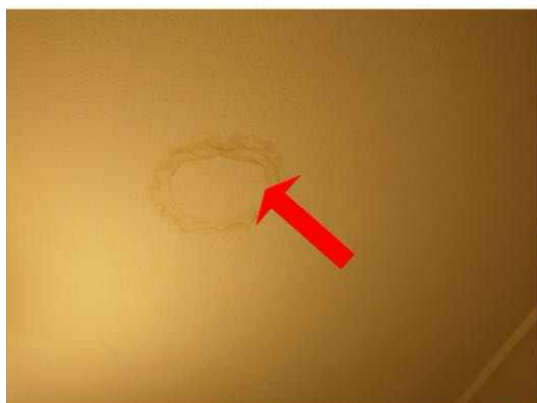
Finding 3.13

Building:	Main Building
Location:	Laundry > Centre
Finding:	Ceiling - Water stained
Information:	Water staining and/or damage to ceiling linings in the laundry area was evident at the time of inspection. Water staining indicates that surfaces have been exposed to excessive moisture at some time. The minerals and other elements in the water lead to staining, which may graduate to corrosion and deterioration if left unmanaged. The damaged or water stained ceiling linings returned low - normal moisture level readings at the time of inspection.

While mostly an appearance defect, water staining can be indicative of more serious defects, which may be currently concealed by interior ceilings.

Where water staining is old and inactive, affected building materials may be repaired or replaced at client discretion.

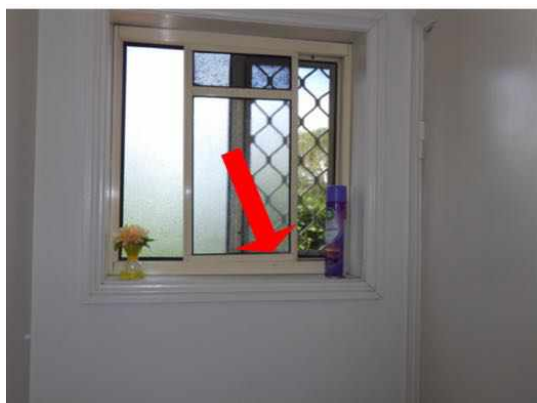
Finding 3.14

Building: Main Building
 Location: Toilet (WC) > Front Right
 Finding: Window - Stiff to Slide
 Information:

The aluminium sliding window in the WC area was stiff to operate at the time of the inspection. Windows provide ventilation to the adjoining area and should be at a fully operational level to ensure user comfort. Restricted function of the window may also pose as a potential safety hazard if required for emergency egress from the building.

Generally, factors such as general age of the building element and a lack of maintenance are the usual causes for this type of defect.

An aluminium window service agent will be required to repair the affected windows.

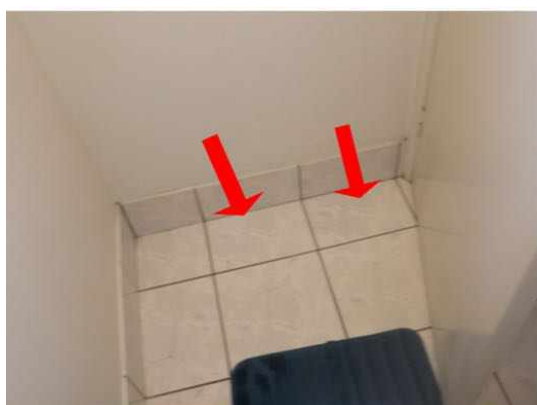
Finding 3.15

Building:	Main Building
Location:	Toilet (WC) > Front Right
Finding:	Tile - Cracked
Information:	Cracked tiles to the WC floor area were identified at the time of inspection. Such defects are generally caused by impact. Cracked or broken tiled areas may also be a direct result of poor workmanship during the construction process.

A tiling contractor could be appointed to perform repair works at the clients discretion.

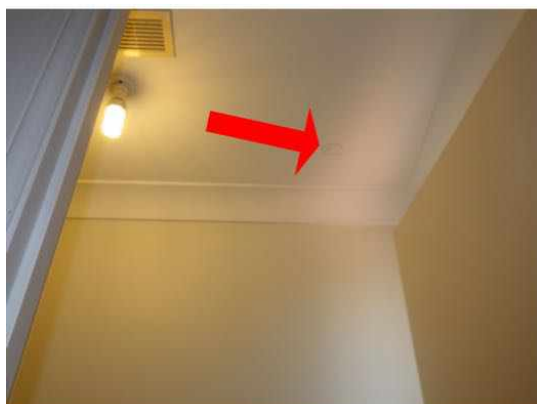
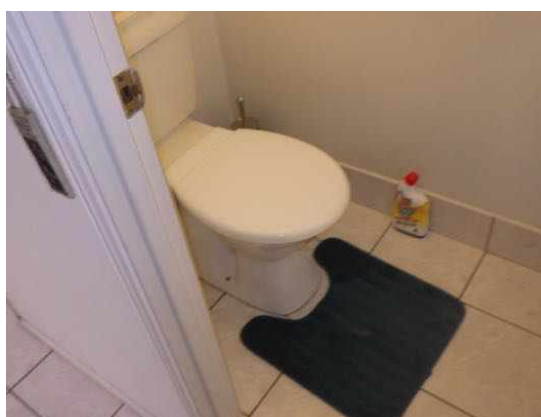
Finding 3.16

Building:	Main Building
Location:	Toilet (WC) > Centre
Finding:	Ceiling - Water stained
Information:	Water staining to ceiling linings in the WC area was evident at the time of inspection. Water staining indicates that surfaces have been exposed to excessive moisture over time. The minerals and other elements in the water lead to staining, which may graduate to corrosion and deterioration if left unmanaged. The water stained ceiling linings returned low - normal moisture level readings at the time of inspection.

While mostly an appearance defect, water staining can be indicative of more serious

defects, which may be currently concealed by interior ceilings.

Where water staining is old and inactive, affected building materials may be repaired or replaced at client discretion.

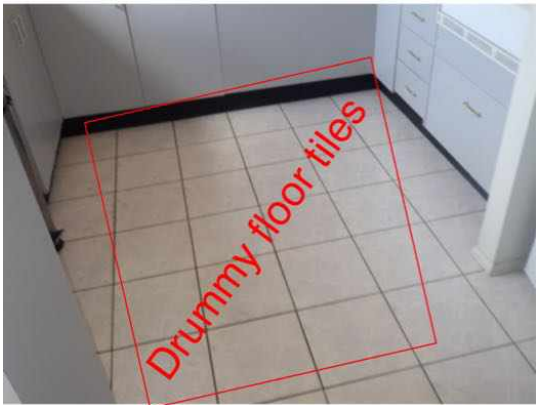
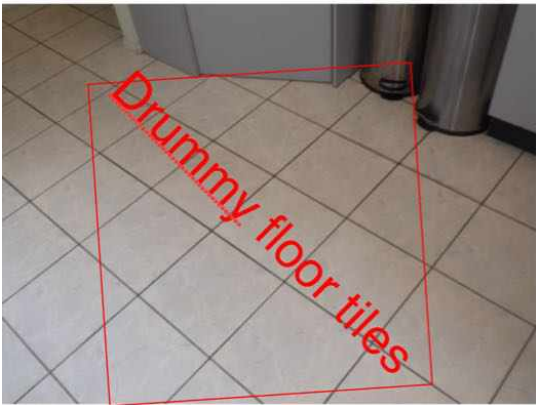
Finding 3.17

Information: Drummy tiled areas were identified in the kitchen area floor at the time of inspection. The term 'drummy' refers to tiles that despite being in relatively good condition have a hollow sound when tapped on and may be inclined to crack from heavy impact whether accidental or deliberate. Drummy tiled areas may be a direct result of moisture exposure or poor workmanship during the construction process.

A tiling contractor could be appointed to perform works if necessary.

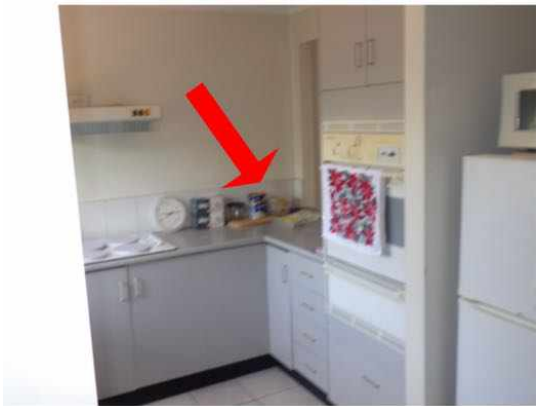
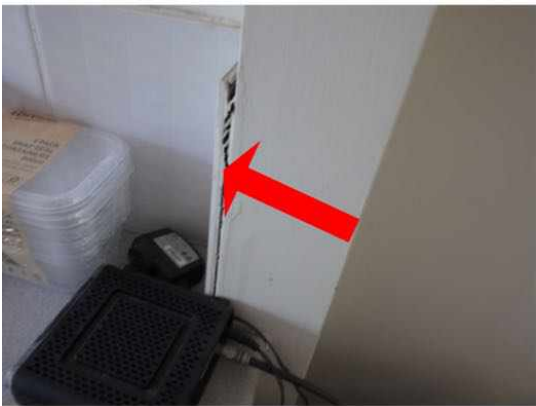
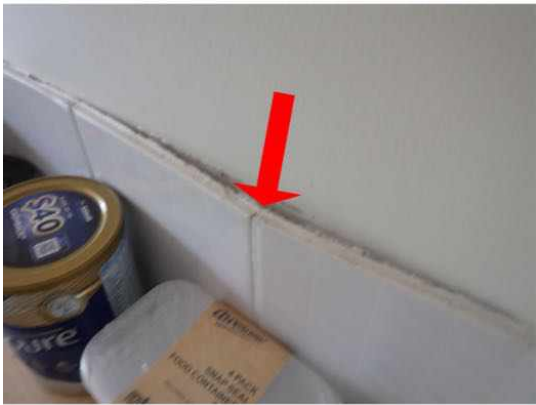
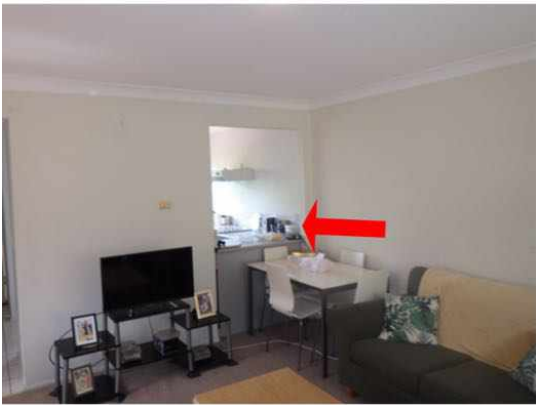
Finding 3.18

Building: Main Building
Location: Kitchen > Rear Right
Finding: Tiles - Loose
Information: Loose wall splashback tiles were identified in the kitchen at the time of inspection. The tiles show signs of separation from the internal wall linings. Such defects are generally caused by impact, exposure to moisture or may be a direct result of poor workmanship during the construction process.

It is advised that a tiling contractor be appointed to perform repair works as necessary.

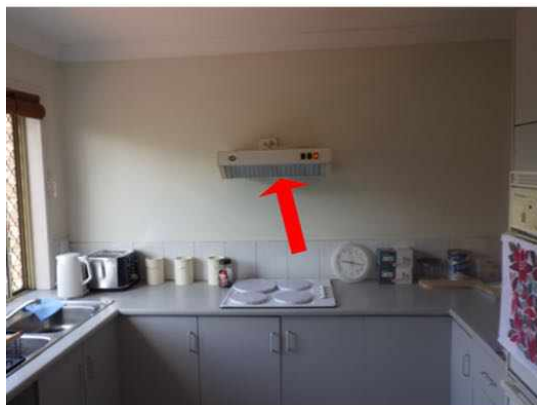
Finding 3.19

Building:	Main Building
Location:	Kitchen > Centre,Rear
Finding:	Rangehood - Light
Information:	The range hood light was not working at the time of inspection. It is advised to replace the bulb first - if still not functioning, a licensed electrician could be appointed to repair or replace the range hood to restore it to a fully operational state.

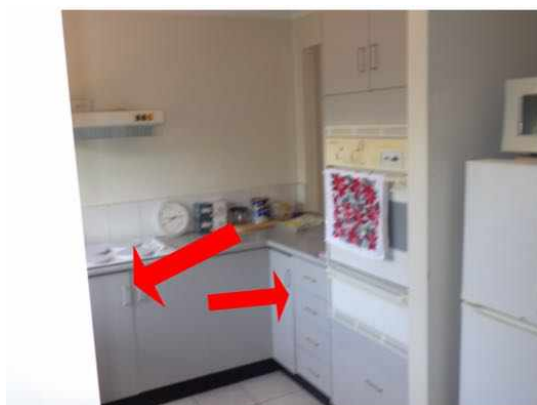
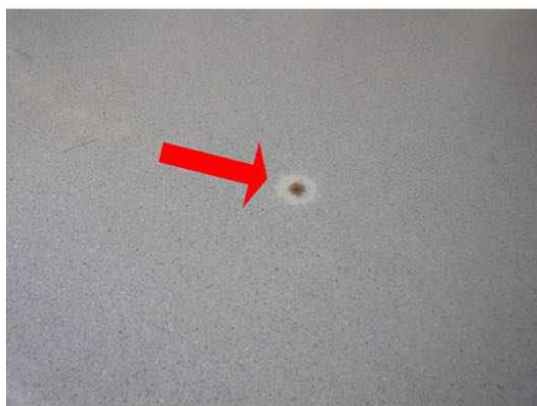
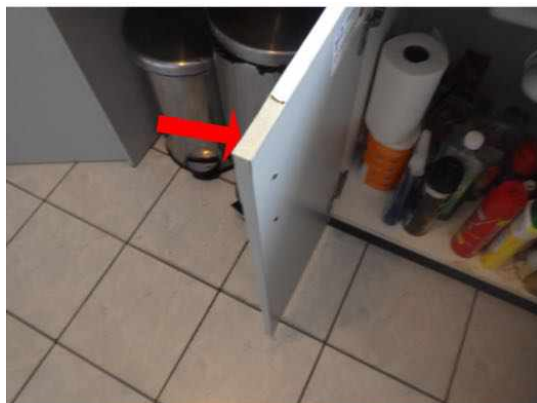
Finding 3.20

Building:	Main Building
Location:	Kitchen > Existing
Finding:	Cabinetry - Deterioration
Information:	At the time of inspection the kitchen cabinetry showed signs of minor deterioration (as per example photos). The level of damage appears consistent with exposure to moisture or general wear and tear.

A qualified cabinet maker or general handyman could be engaged to undertake repair works at the clients discretion.

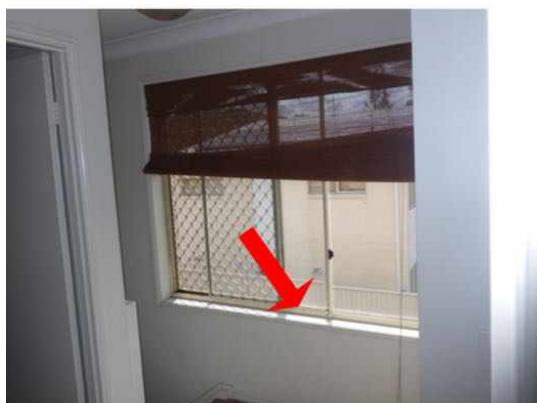
Finding 3.21

Building: Main Building
 Location: Stair Landing > Centre Left
 Finding: Window - Stiff to Slide
 Information: The aluminium sliding window in the upper level stair landing area was stiff to operate at the time of the inspection. Windows provide ventilation to the adjoining area and should be at a fully operational level to ensure user comfort. Restricted function of the window may also pose as a potential safety hazard if required for emergency egress from the building.

Generally, factors such as general age of the building element and a lack of maintenance are the usual causes for this type of defect.

An aluminium window service agent will be required to repair the affected windows.

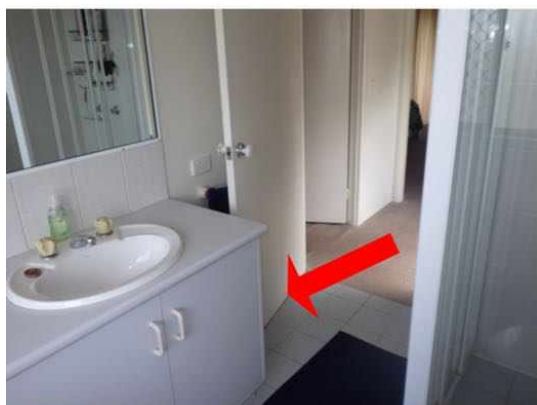
Finding 3.22

Building:	Main Building
Location:	Bathroom > Front
Finding:	Damaged Door
Information:	The door leading into the bathroom has suffered damage to the bottom edge.

Damage occurs generally when the building materials have aged and decayed, but in this instance the damage appears to be the result of exposure to moisture, possibly from the bottom edges of the door not being sealed with a suitable paint or sealant at the time of construction.

A qualified carpenter or general handyman could be appointed to repair/replace the door at the clients discretion.

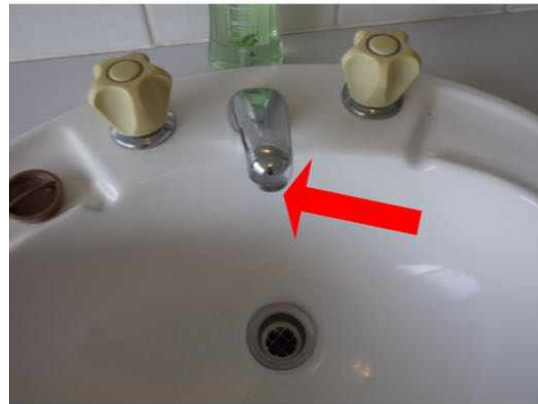
Finding 3.23

Building:	Main Building
Location:	Bathroom > Centre Right
Finding:	Tap - Leaking
Information:	The basin tap in the bathroom was found to be leaking at the time of inspection. This is a common defect that is consistent with general ageing of the building element.

While this defect only seems minor, if left unmanaged, it is likely to result in the

development of rust, and/or extensive water usage.

It is advised that a handyman or licensed plumber be appointed to perform remedial works on the affected tap.

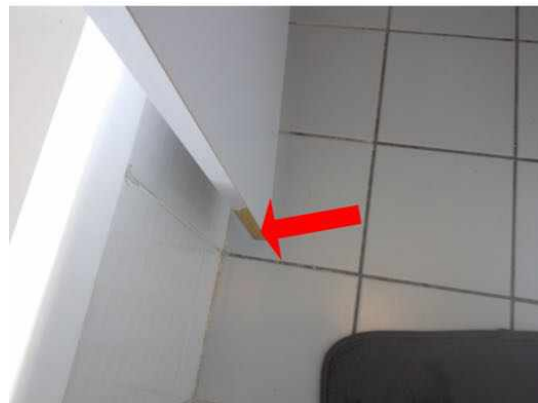
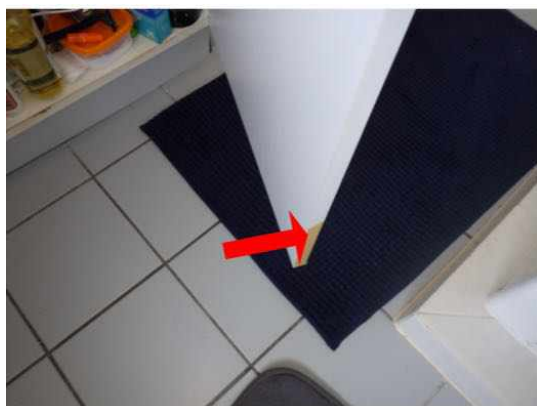
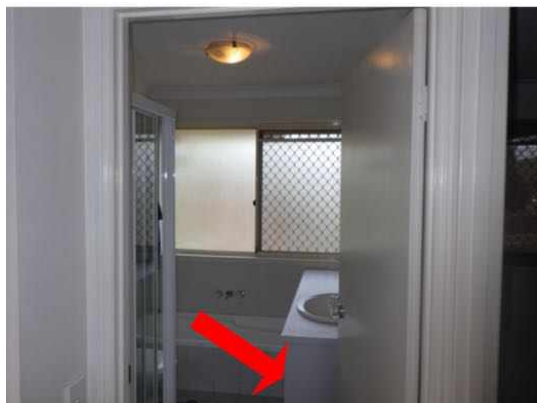
Finding 3.24

Building: Main Building
 Location: Bathroom > Centre Right
 Finding: Cabinetry - Deterioration
 Information: At the time of inspection the bathroom cabinetry showed signs of minor deterioration. The level of damage appears consistent with exposure to moisture or general wear and tear.

A qualified cabinet maker or general handyman could be engaged to undertake repair works at the clients discretion.

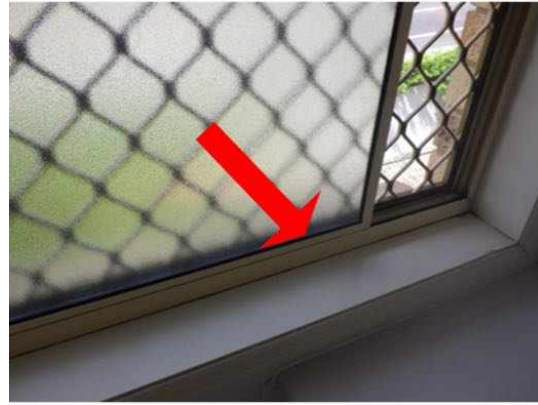
Finding 3.25

Building:	Main Building
Location:	Bathroom > Centre,Rear
Finding:	Window - Stiff to Slide
Information:	The aluminium sliding window in the bathroom area was stiff to operate at the time of the inspection. Windows provide ventilation to the adjoining area and should be at a fully operational level to ensure user comfort. Restricted function of the window may also pose as a potential safety hazard if required for emergency egress from the building.

Generally, factors such as general age of the building element and a lack of maintenance are the usual causes for this type of defect.

An aluminium window service agent will be required to repair the affected windows.

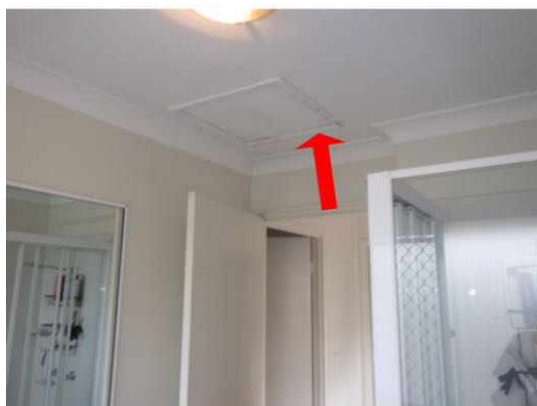
Finding 3.26

Building: Main Building
 Location: Bathroom > Centre
 Finding: Painted surface - Ceiling
 Information: Sections of paint in the upper level bathroom ceiling area were found to have bubbled and deteriorated. Paint bubbling or deterioration is generally an indication of excessive moisture in the area generally caused by a lack of natural or mechanical ventilation.

The presence of excessive moisture can have major implications on associated building elements if left unattended. While only seemingly minor at this stage, the damage cannot be fully determined.

It is advised that the affected ceiling area be further Inspected and/or repaired by a licensed painter.

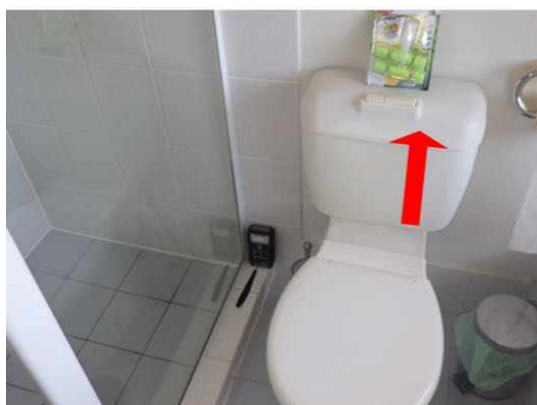
Finding 3.27

Building: Main Building
 Location: Bathroom > Centre Left
 Finding: Toilet Cistern
 Information: At the time of inspection the bathroom toilet cistern showed evidence of deterioration.

While generally considered a visual defect only, a qualified plumber could be engaged to replace the toilet cistern at the clients discretion.

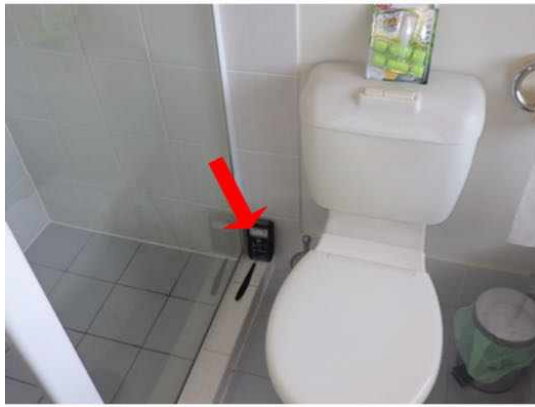
Finding 3.28

Building: Main Building
 Location: Bathroom > Front Left
 Finding: Shower - Monitor
 Information: Elevated moisture level readings were recorded to the lower 200mm of wall to the bathroom shower alcove at the time of inspection. There was no elevated moisture level readings around the tap area, and no elevated readings transferring outside the shower cubicle or to the other side of the wall in the areas where moisture readings were able to be obtained. Both sealant and grout appear in good condition at present.

This defect is quite common, and is suspected to have been caused by moisture permeating or leaching through the grouting and perhaps gaps in the sealant.

Monitoring the area is advised and if any visual signs of excessive moisture appear (peeling paint, mould) then consultation with a qualified plumber or bathroom specialist would be advised to identify the cause of damp and to perform remedial works as required.

Always ensure that sealant and grout is in good condition to prevent any moisture issues occurring in the future.

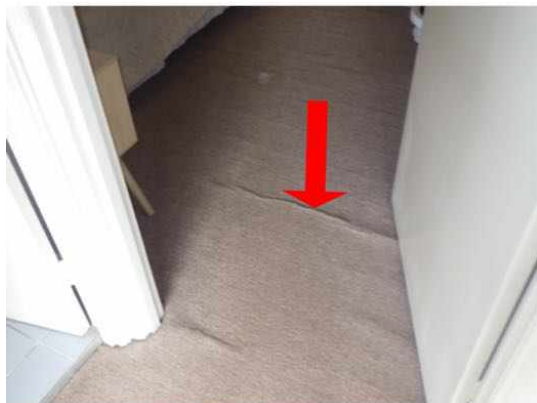
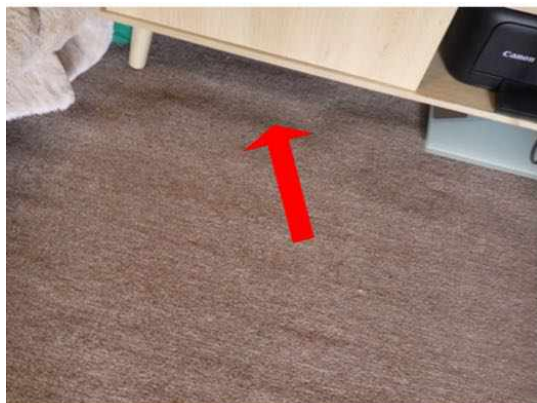
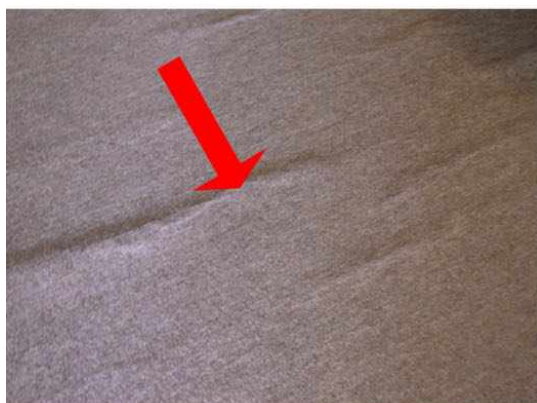
Finding 3.29

Building: Main Building
 Location: Bedrooms > Existing
 Finding: Carpet - Deteriorated
 Information: At the time of inspection it was noted sections of the carpet floor covering in the upper level bedrooms area appeared to have rippled and/or deteriorated. Deteriorated or rippled floor coverings create the potential for trip hazards to occupants.

Repair or replacement of the affected carpet may be required to ensure the safety of occupants or foot traffic in the area.

A qualified carpet layer could be engaged to undertake repair work.

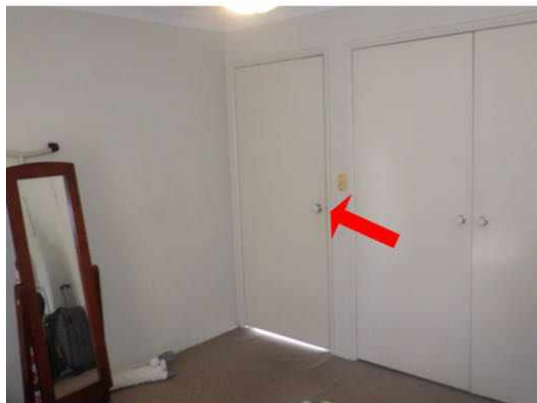
Finding 3.30

Building: Main Building
 Location: Bedroom 1 > Front
 Finding: Door - Not latching
 Information: The door to the main bedroom was found to be not latching at the time of inspection. Breakage occurs generally when the building materials have aged and decayed.

A qualified carpenter or general handyman could be appointed to adjust the door handle striker plate at the client's discretion.

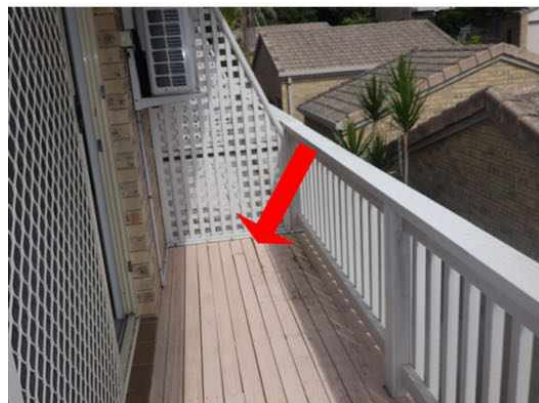
Building:	Main Building
Location:	Balcony > Centre Left
Finding:	Decking - Deteriorated
Information:	It was noted at the time of inspection that sections of the timber decking to the upper level balcony show evidence of minor deterioration. Typically decking deteriorates due

to age and or wear, rot and or rust which is generally expected for a structure of this age, due to prolonged exposure to weather conditions. Sometimes inadequate installation or maintenance can be to blame.

A licensed carpenter or general handyman could be appointed to perform rectification works as necessary.

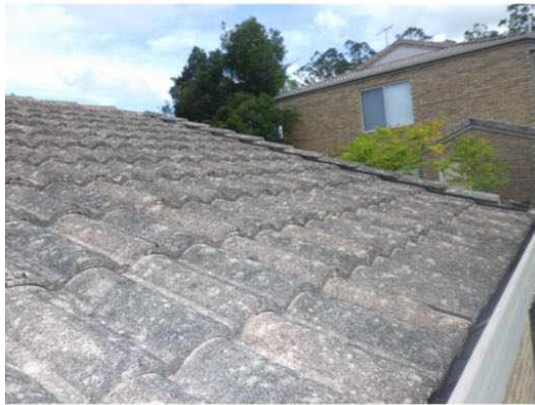
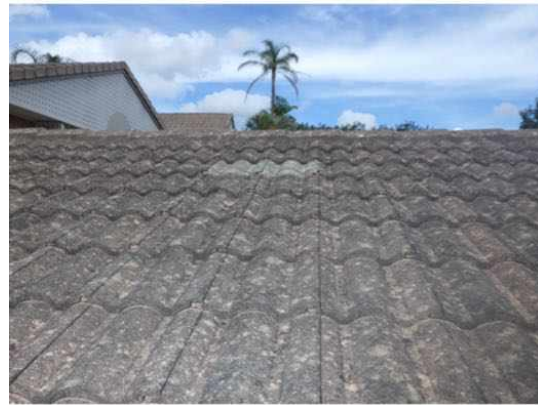
Finding 3.33

Building:	Main Building
Location:	Roof Exterior > Existing
Finding:	Roof tiles - Weathered
Information:	Upon inspection of the exterior roofing, the majority of roof tiles were considered to be in a fair condition. While weathering of the tiles is consistent with the age of the property, maintenance works will be required.

NOTE _ Roof exterior repair and maintenance works may be the responsibility of the buildings body corporate managers.

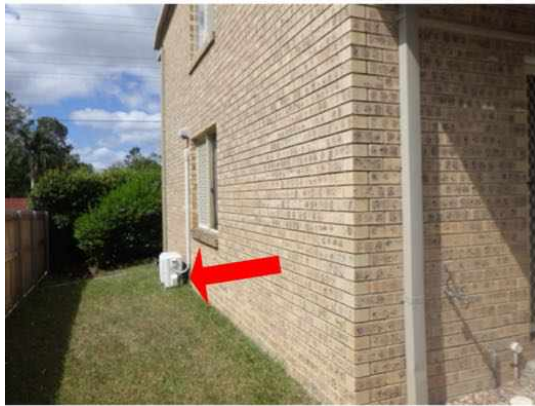
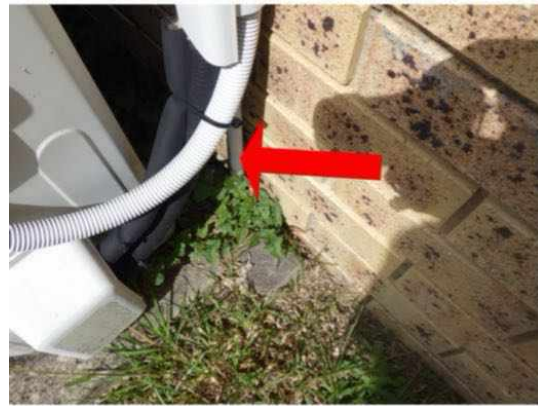
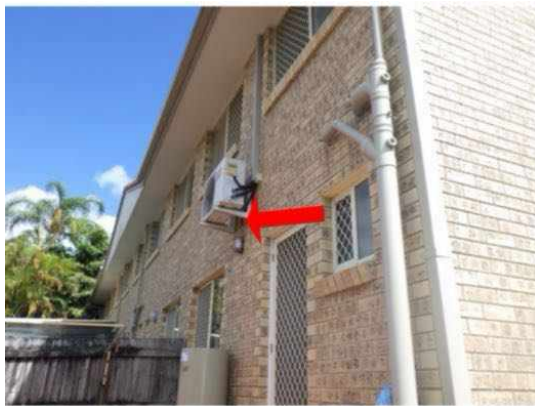
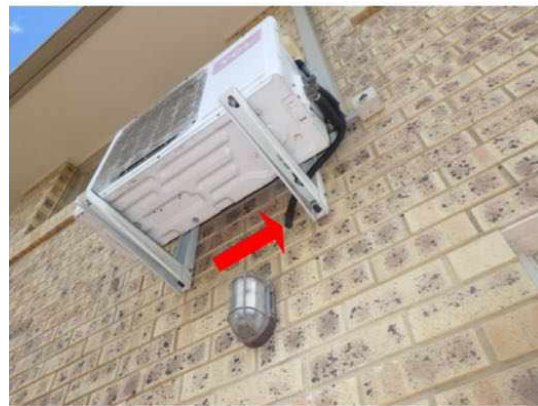
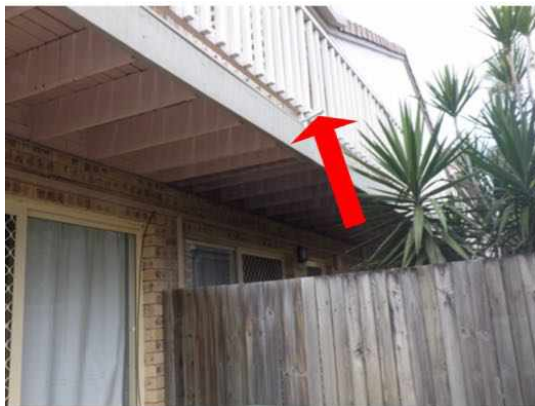
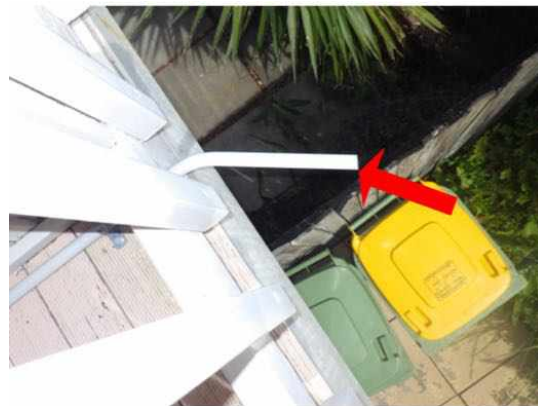
Finding 6.04

Building: Main Building
 Location: Exterior walls - front, left side & rear > Existing
 Finding: Overflow - Not plumbed for drainage
 Information: The air conditioning unit overflows are not plumbed or connected to suitable drainage, which can result in the surrounding areas becoming excessively damp. These damp conditions can lead to secondary defects such as rot, rust or corrosion of associated building elements, the formation of fungal decay, or even the creation of potential slip hazards. When coupled with poor site drainage, pooling of water may also attract termite activity to this area. It is highly recommended that a qualified plumber be appointed to install adequate drainage to the overflows. These works will ensure that

the area remains dry and free of any secondary defects.
