Building Inspection Report

Inspection Date: Thu, 12 Feb 2026

Property Address: 1 Taylor St, Brighton East VIC 3187,
Australia

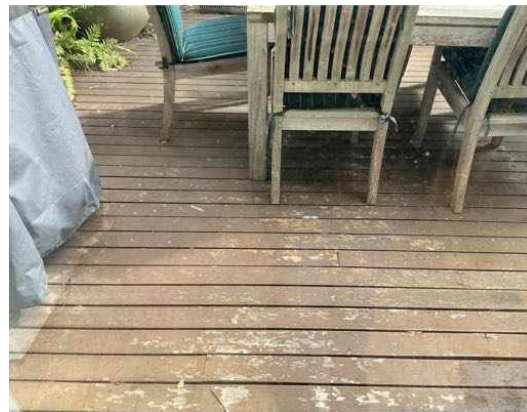
Defects 1.01

External timber structures are also constantly exposed to weather elements and can deteriorate in an accelerated manner, ongoing assessments are required.

It is highly recommended that a Structural Engineer further assess the external timber balcony or deck to inform the client of its load capacity. Regular maintenance inspections by competent practitioners is needed.

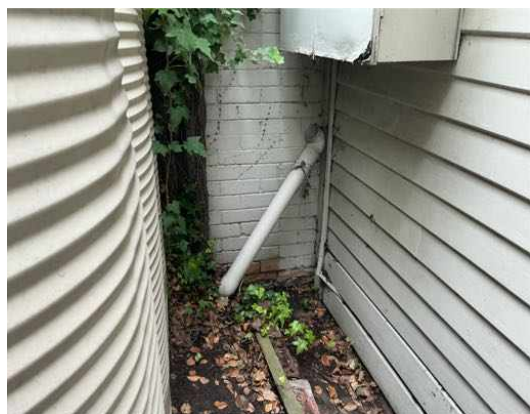
Defects 2.01

Where roof plumbing doesn't drain adequately, the area at the base perimeter can become excessively damp, potentially creating an environment that is susceptible to rust and corrosion of surrounding building elements, as well as attracting termites and other pests.

It is highly recommended that a plumber be appointed to further inspect the area and to install adequate drainage equipment where necessary.

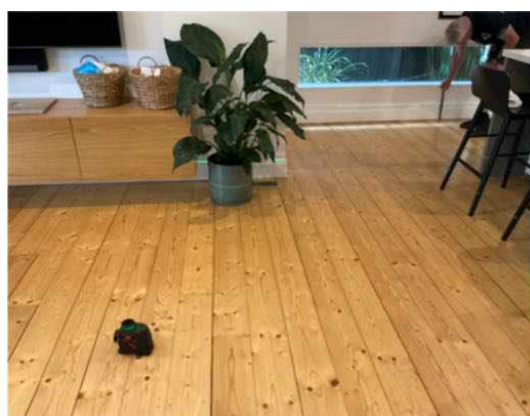
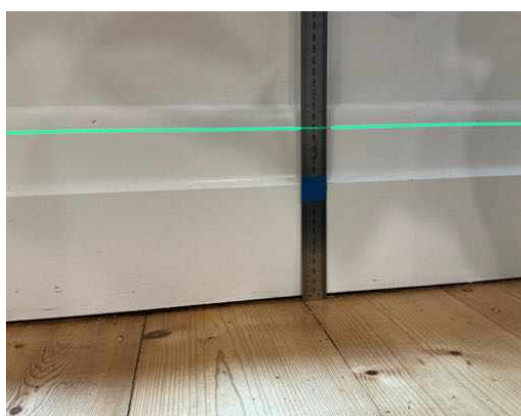
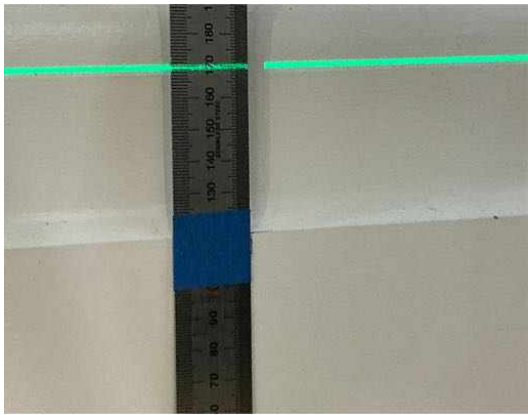
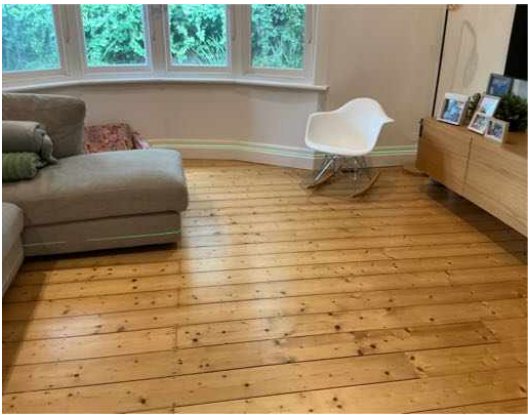
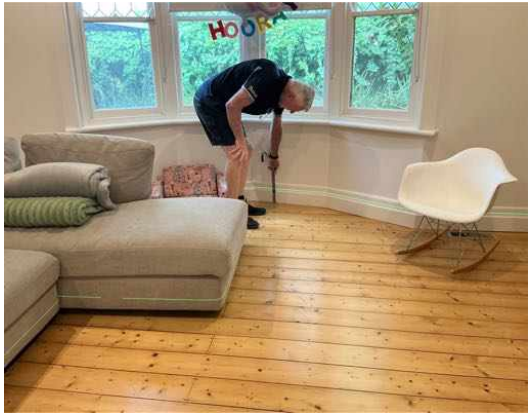
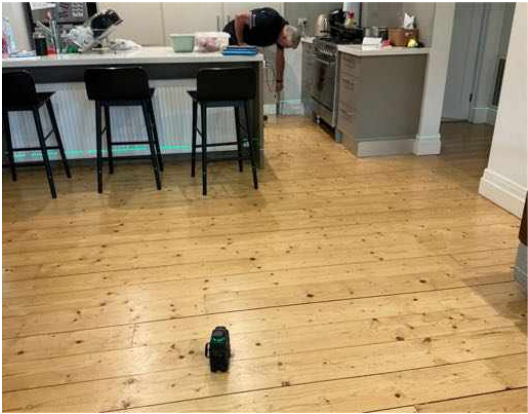
Defects 2.02

| Information: | The internal flooring in this area is out of level and uneven. Uneven flooring is likely to indicate minor defects such as expected movement of the foundations of the property, but may also indicate subsidence of the associated subfloor stumps. |

It is advised that the flooring be closely monitored to identify any further movement. Where flooring remains relatively unchanged for an extended period of time (i.e. several months), it is likely that this defect has been caused by expected movement of the foundations of the property.

However, where flooring is uneven further, potentially invasive inspection of the subfloor structures and stumps in this area is required. In this case, works to repair are likely to be required, and would be carried out by a registered builder specialising in re-stumping.

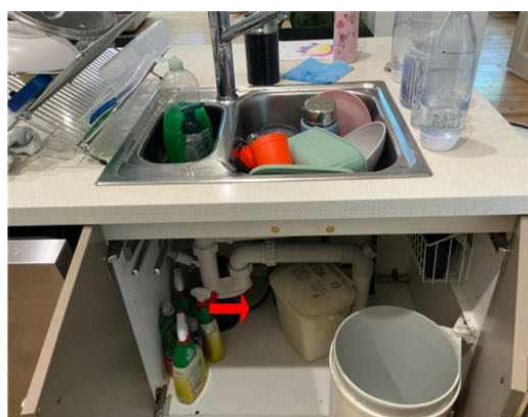
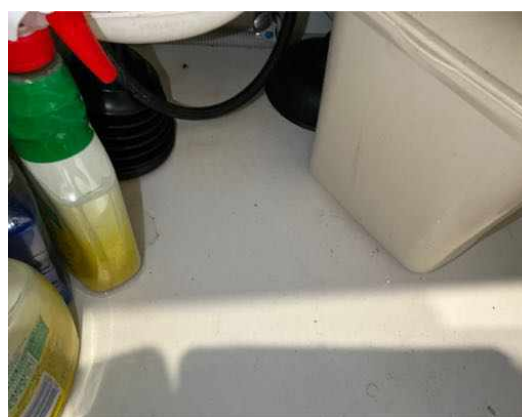
Defects 2.03

Building: Main Building
 Location: Kitchen
 Finding: Tap - Leaking
 Information: The tap in this area was found to be leaking at the time of inspection. This is a common defect that is consistent with general ageing of the building element. However, it may be indicative of substandard plumbing workmanship if the tap is relatively new.

While this defect only seems minor, if left unmanaged, it is likely to result in the development of rust, water damage and/or extensive water usage.

It is advised that a handyman or licensed plumber be appointed to perform remedial works on the affected tap. Such works should be performed prior to the development of secondary defects to ensure adequate functionality of all associated building elements.

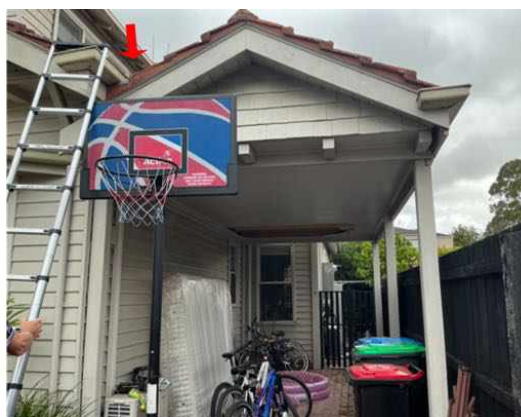
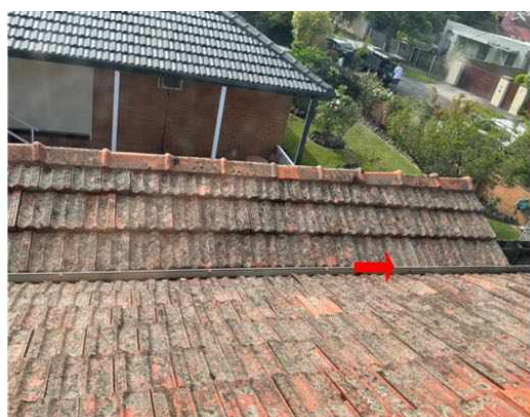
Defects 2.04

Building: Carport
 Location: Side elevation
 Finding: Roof plumbing - Flashing inadequate
 Information: Some sections of the roof are missing or have inadequate roof flashings. Flashings are metal and other materials which are applied to seals and intersections between roof coverings and building elements. They are designed to aid in weatherproofing of roof joins.

Flashings that are not installed adequately or are missing are likely to result in water penetration to the interior of the property, as well as creating excessively damp conditions against the exterior surfaces and around the base perimeter of the building.

Premature ageing and secondary building defects are imminent where roof plumbing is missing or inadequately installed. Additionally, water pooling also creates an environment that is susceptible to termite and pest infestation.

A roofing plumber should be appointed as soon as possible to install relevant roof

plumbing materials, ensuring that no further damage is sustained.

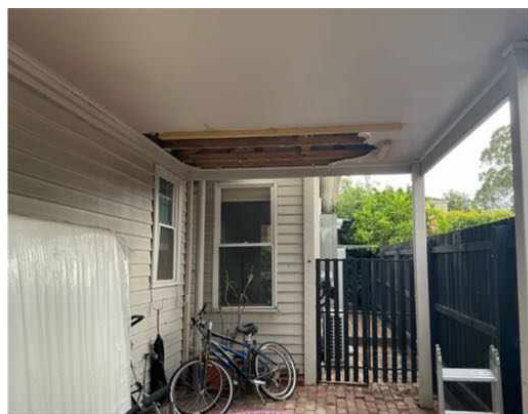
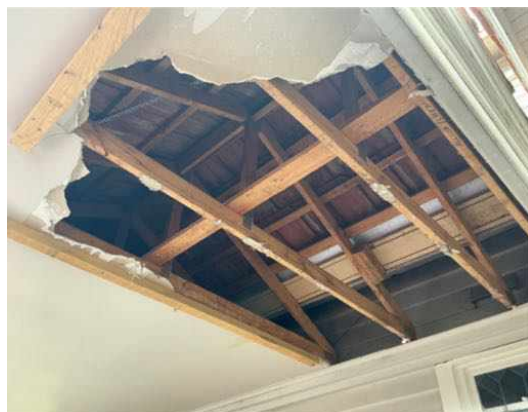
Defects 3.01

| Finding: | Ceiling - Water damaged |
| Information: | Water damage to the ceiling lining is generally an indication of excessive moisture being present in the roof void, usually via a leak to the roof covering. |

Where water damage is evident to the ceiling, the primary requirement is to identify and rectify the source of the leak. A roofing plumber should be appointed as soon as possible to identify the leak and perform rectification works as necessary, ensuring the water damage is restricted.

Once the leak is repaired, consultation with relevant tradespeople, including plasterers and painters, is advised. Rectification works may include replacement of ceiling lining or minor repainting, depending on the extent of the damage.

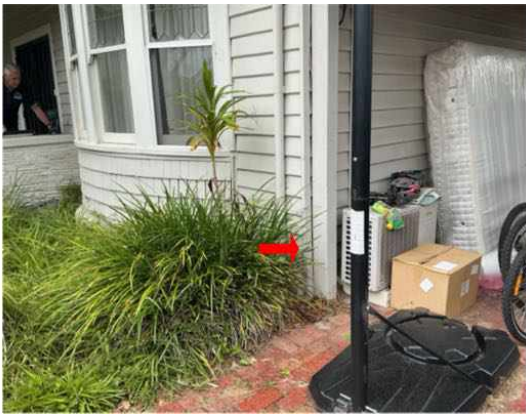
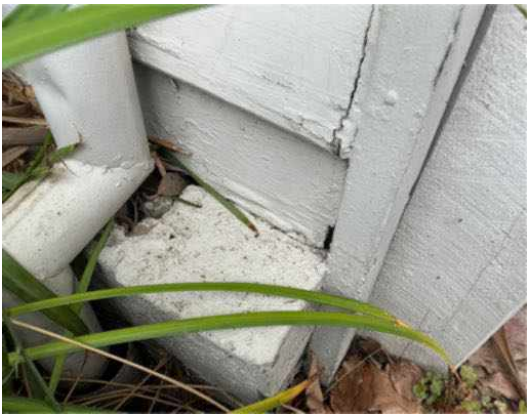
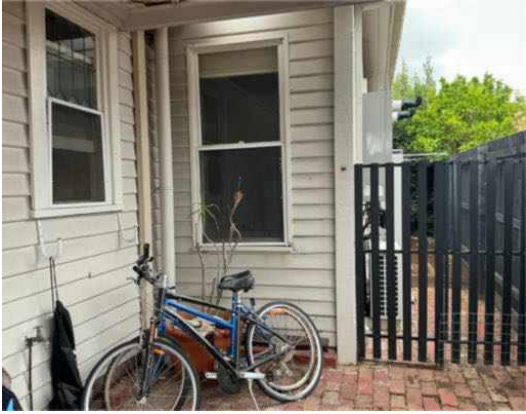
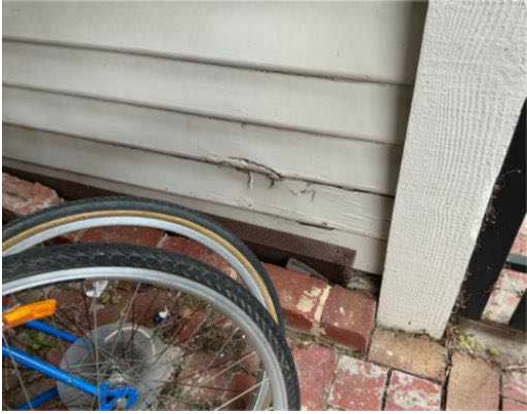
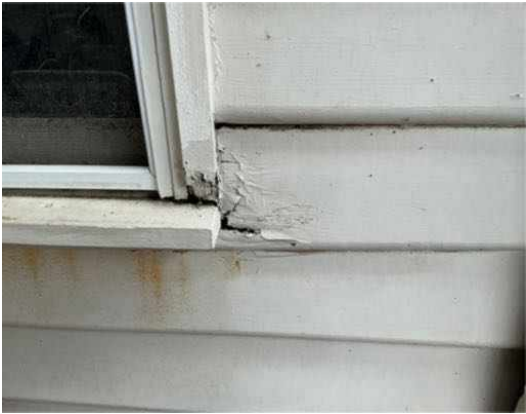
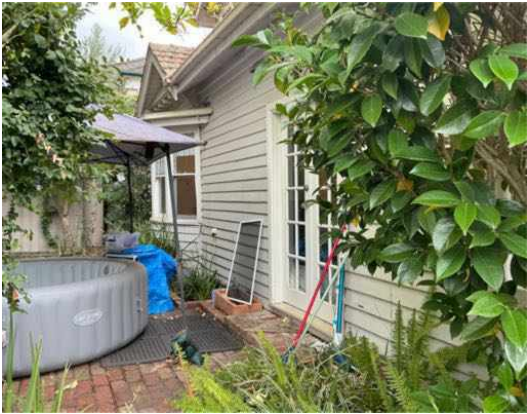
Defects 3.02

| Information: | The external weatherboards show signs of fungal decay (wood rot) in several sections. This wood rot is suspected to have developed over a prolonged period of time due to frequent weather exposure, which is expected in a property of this age and condition |

Weatherboards are sealed and protected by paint and other sealants. When these sealants deteriorate over time, they allow water penetration to the weatherboards, causing wood rot. If left unmanaged, the wood rot is likely to develop further, possibly necessitating major repair or replacement works in the long-term future.

To maintain the condition of the external wall cladding, any severely affected weatherboards should be substituted as soon as possible with pre-treated replacements. Where weatherboards have rotted due to excessive moisture other than rain penetration, the cause of the moisture should be identified immediately by a licensed plumber. A qualified carpenter should be appointed to repair and replace rotting weatherboards.

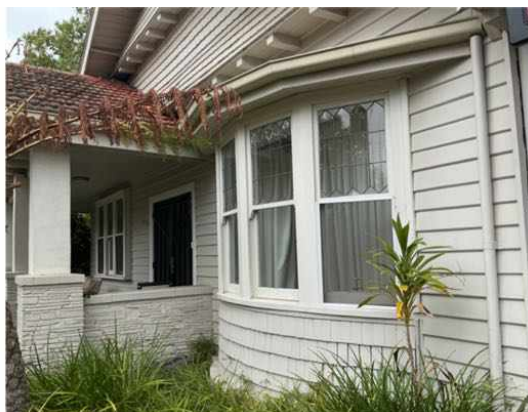
Defects 3.03

Windows provide ventilation to the adjoining area and should be at a fully operational level to ensure user comfort. Restricted function of the window may also pose as a potential safety hazard if required for emergency egress from the building.

Where windows have been painted shut the seal of the paint needs to be broken. This is generally done by breaking the seal of the paint and then maintaining the sash tracks clearing and lubricating them with silicone. Remedial paint work will likely be required and can be completed along with the rest of the remedial works necessary by a general handyman.

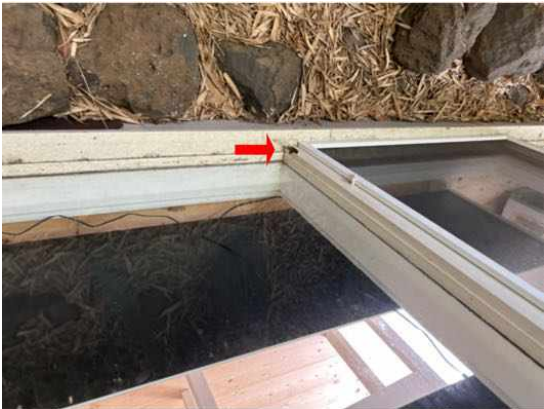
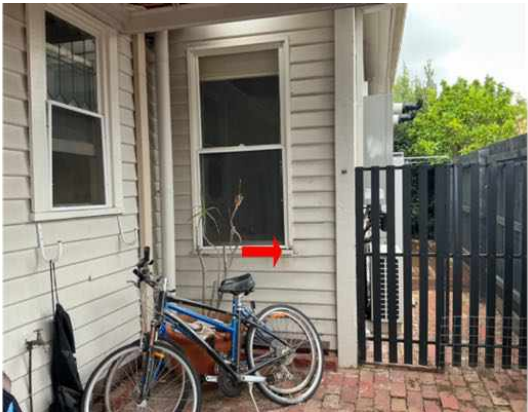
Defects 3.04

| Finding: | Windows - Wood rot |
| Information: | Wood rot was found to be affecting external windows. Wood rot, also known as Fungal Decay, occurs when timbers and other cellulose building materials are exposed to damp conditions on an ongoing basis. |

It is likely that this wood rot has developed as a result of frequent exposure to rain and other weather conditions. It is suspected that failure to maintain the window frames over a prolonged period has resulted in them deteriorating at an accelerated rate, increasing their susceptibility to the development of wood rot. Leaks in roof plumbing or associated pipework may have also contributed to the formation of the wood rot in this area.

elements. Prior to any works being performed, any associated pipework or roof plumbing should be inspected by a licensed plumber for faults or leaks.

Repair and/or replacement of affected window frames may be a necessary step in protecting surrounding building elements from such deterioration. Remedial works should be performed by a qualified carpenter or registered builder as soon as possible to prevent any further damage.

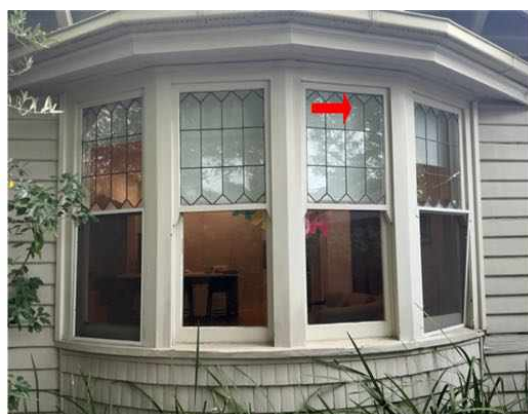
Defects 3.05

Finding: Window - Cracked
 Information: Cracks were identified in the window in this area. Cracking in windows is generally the result of impact damage, and is likely to develop further when left unmanaged.

The likelihood of this windowpane further cracking and shattering is increased exponentially, providing a safety hazard in the area. The cracked window also impairs the weather tightness of the building, creating potential for minor water leaks.

A qualified glazier is required to repair the window as soon as possible. Depending on the extent of the cracking, replacement of the window may be required. Please be advised that any persons coming into contact with the cracked window should do so with due caution to avoid any personal injury that may ensue.

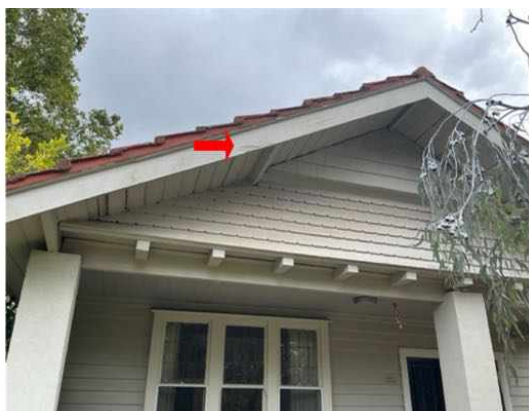
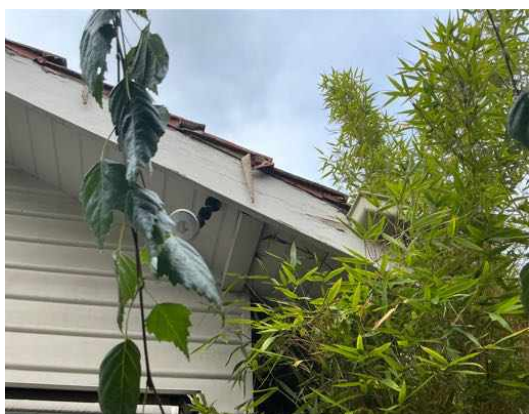
Defects 3.06

Building: Main Building
 Location: Fascias
 Finding: Fascias - Wood rot
 Information: Wood rot was found to be affecting fascias and barges in this area, evidenced by the presence of mould on the surface in some areas. Wood rot, also known as Fungal Decay, occurs when timbers and other cellulose building materials are exposed to damp conditions on an ongoing basis.

It is likely that this wood rot has developed as a result of faults in the roof plumbing, creating excessive moisture in this areas. Frequent exposure to rain and other weather conditions also make fascias and barges susceptible to accelerated deterioration.

Early intervention and regular maintenance will prolong the useful life of these building elements. Prior to any works being performed, the cause of the moisture that has created the visible wood rot should be identified and addressed in a suitable manner.

It is advised that a roof plumber be appointed to inspect all roof plumbing and subsequently identify the cause of the wood rot. Replacement of affected fascias and barges may then be a necessary step in protecting surrounding building elements from such deterioration.

A qualified plumber may be appointed to assess the cause of excessive moisture and to provide advice on any remedial works as required. A qualified carpenter or registered builder may also be required to replace affected building materials.

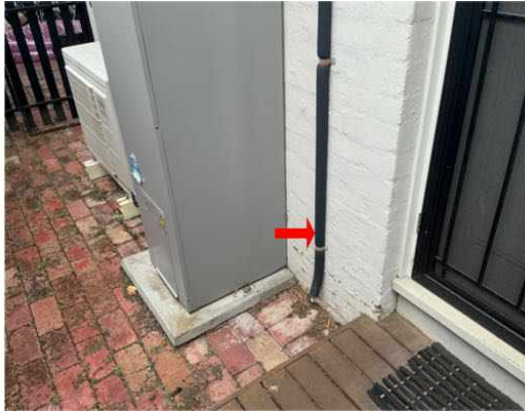
Defects 3.07

| Information: | The Hot Water System (HWS) overflow was found to be disconnected from storm water drainage and is creating excessive moisture in the surrounding area. |

These damp conditions can lead to secondary defects such as rot, rust or corrosion of associated building elements, the formation of fungal decay, or even the creation of potential slip hazards. When coupled with poor site drainage, pooling of water may also attract termite activity to this area.

It is highly recommended that a licensed plumber be appointed to connect the HWS overflow in order to prevent such an environment from being created. These minor works should be carried out as soon as possible.

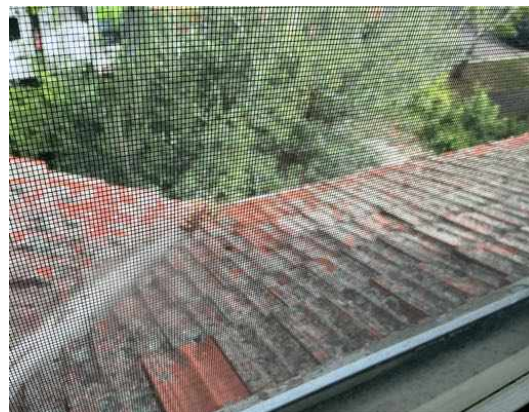
Defects 3.08

| Information: | Upon inspection of the exterior roofing, the majority of roof tiles were considered to be in a fair condition. While weathering of the tiles is consistent with the age of the property, maintenance works are required. |

Isolated areas of mortar have come loose in the valleys and minor cracking is also present. Re-pointing and re-sealing the may be considered as an interim solution by the client to help preserve and extend the life span of the tiles.

Where left unmanaged, deteriorating roof tiles are likely to lead to a number of secondary defects, including minor water leaks and weather exposure to internal roofing structures.

Consultation with a roofing contractor is highly advised to gain advice on cost of remedial works that may be required in the short to medium term. Remedial works are likely to increase the longevity of the exterior roofing structure.

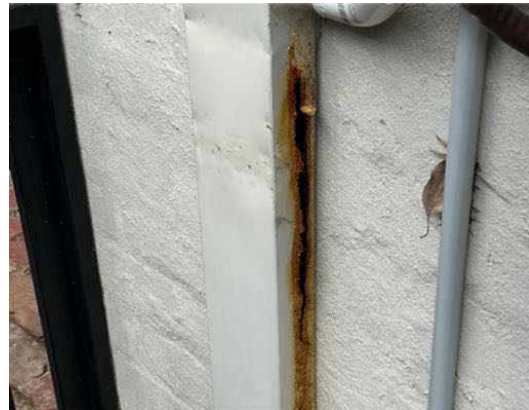
Defects 3.09

| Finding: | Roof plumbing - Rusted or corroded |
| Information: | The roof plumbing has areas of rust and corrosion. It is suspected that this has been caused by blockages, resulting in pooling or standing water, that have prematurely rusted elements of the roof plumbing. |

Rusted roof plumbing will generally develop holes and leaks that can affect other building elements with poor drainage of storm water. Poorly drained roof areas will also lead to damp conditions surrounding the base perimeter of the building which, if left unmanaged, can lead to a range of secondary building defects.

Repair and/or replacement of rusted roof plumbing is highly required in order to reinstate the roof drainage system to a fully operational level. To further maintain these areas, gutters should be cleaned frequently, allowing the avoidance of any partial blockages.

A licensed plumber or specialist roof restoration company should be appointed to undertake these works. It is advised that such works be completed as soon as possible to prevent any further damage and deterioration.

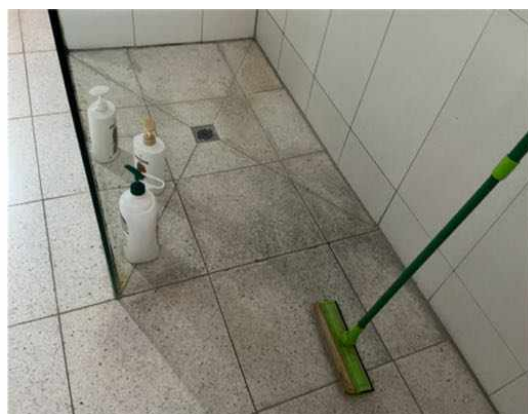
Defects 3.10

| Information: | Regular cleaning and maintenance improves the longevity of all building elements. A build up of dirt and debris can reduce the useful life of building materials and may result in earlier replacement of items being required. |

Excessive dirt is also likely to lead to secondary hazards, including potential health hazards, as the building elements begin to harbour bacteria and/or mould.

Remedial cleaning is recommended in order to improve the appearance of this area as well as to counteract the development of bacteria. Such works can be performed by a cleaning contractor and should be completed at the discretion of the client.

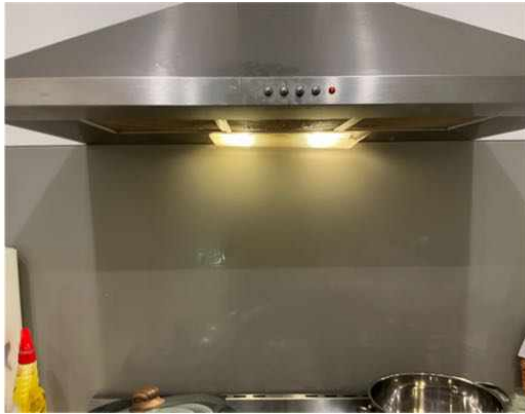
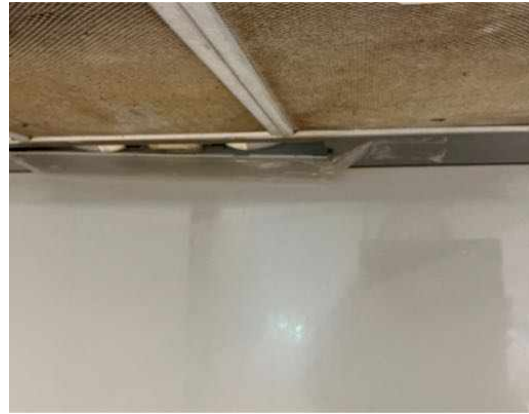
Defects 3.11

| Finding: | Building element - Damaged |
| Information: | Evidence of damage was identified to the Rangehood light, this may be repaired or replaced at your convenience. |

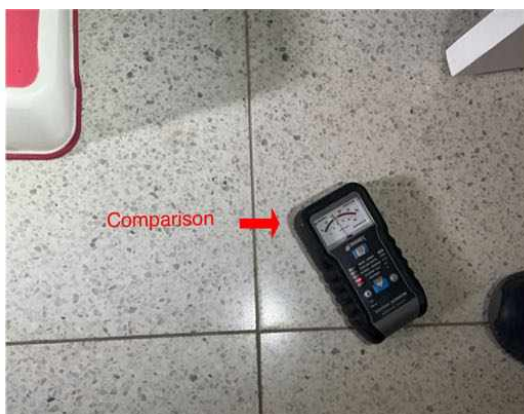
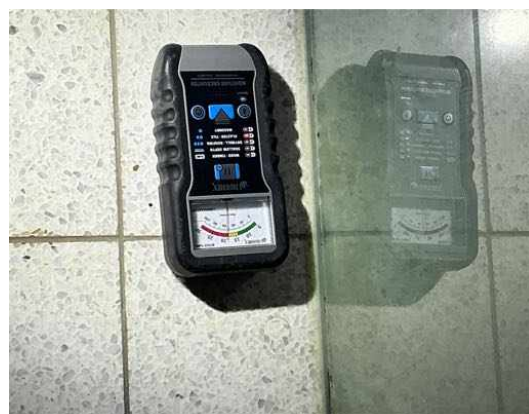
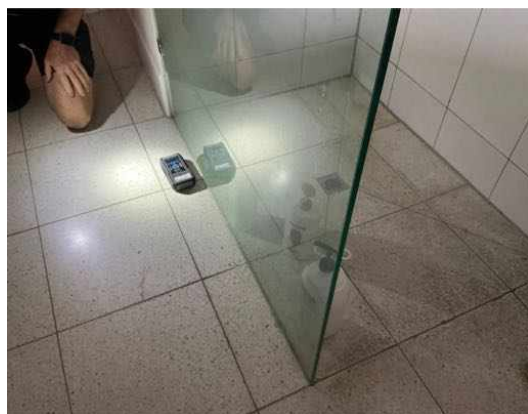
Defects 3.12

Finding: Shower - Leaking

Information: Leaking was evident to the shower area at the time of inspection as shown in photos with the moisture meter. It is suspected that the leaking has occurred as a result of general ageing of the building elements.

Leaking from the shower base, where left unattended, is likely to lead to water damage to adjoining flooring and walls. Leaking can lead to water damage and necessitate extensive remedial works being required. Active water leaks may also create an environment that is susceptible to the formation and development of mould.

Appointment of a tiling contractor is required to replace the shower the bathroom waterproofing and tiling. Such works should be performed as soon as possible to ensure that no further damage occurs.

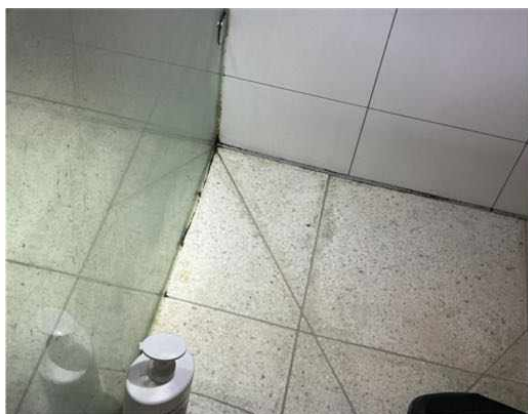
Defects 3.13

| Finding: | Sealant and grouting - Missing or damaged |
| Information: | It was noted on inspection that sealant or grout is degraded to the tiled shower alcove and or other areas of the bathroom. |

Different materials and floor areas move at different rates, generally causing cracking to grout or sealant at this point. A flexible sealant is required to allow for expected expansion and contraction, while keeping the joint water tight and protective of all associated building materials.

There appears to be excessive mould to the sealant and grout which will likely require scraping out and replacement.

Flexible and mould resistant materials should be applied to affected areas to prevent any subsequent water damage that is likely to occur. Regular maintenance and replacement of damage or missing or damaged sealant and grout is highly recommended to the wet areas, as this is a regular wear and tear defect. Sealant and grouting in areas that come into regular contact with water should be maintained for the long term care of your property.

A sealant specialist or tiling contractor should be appointed to complete these works as soon as possible

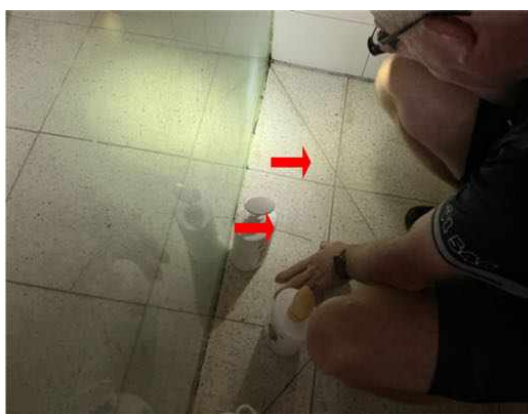
Defects 3.14

| Finding: | Tiles - Cracked or damaged |
| Information: | Cracking was evident to the tiling in this area at the time of inspection. While the cracking appears to be minor, this area is frequently exposed to water, allowing potential for water penetration into adjoining sections of walls or flooring. |

If left unmanaged, water penetration to these areas may lead to subsequent water damage, which is likely necessitate repair work to affected building elements.

A tiling contractor should be appointed to ensure that no further water damage occurs. The re-application of silicone and grouting throughout remaining tile work is also advised, to further protect the area against water penetration.

Where water penetration has led to water damage, appointment of a relevant tradesperson may be required to repair damaged building elements.

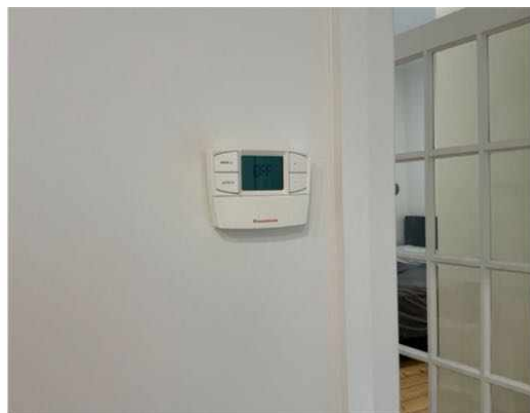
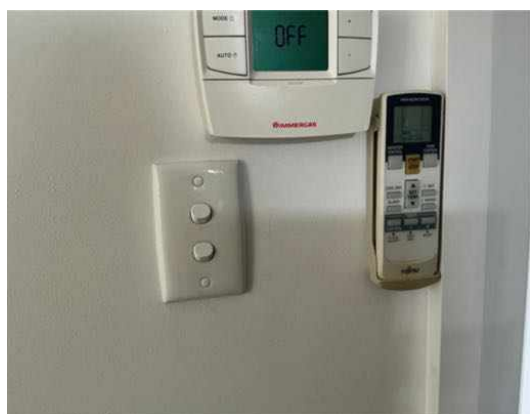
Defects 3.15

| Finding: | Warranty - Expired |

Information: Where appliances are beyond their warranty period, the owner should be prepared to meet the cost of replacement or repair of the item at any time. The operation of the appliance can not be guaranteed and further inspection by an appropriately qualified tradesperson may be required.

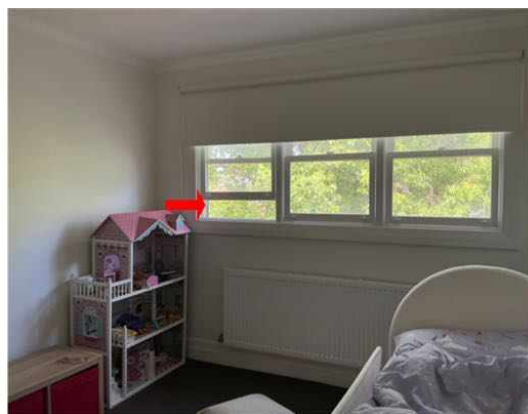
Defects 3.16

Finding: Windows - Sash balances broken

Information: Sashes are the moveable panes of windows that primarily slide vertically over each other to expose one half of the window area. Each sash is provided with springs balances and/or compression weather-stripping, which act to hold the window in place in one position.

The sash balance mechanism will need replacement to allow the window to function as intended. Such works may be completed by a qualified carpenter or registered builder.

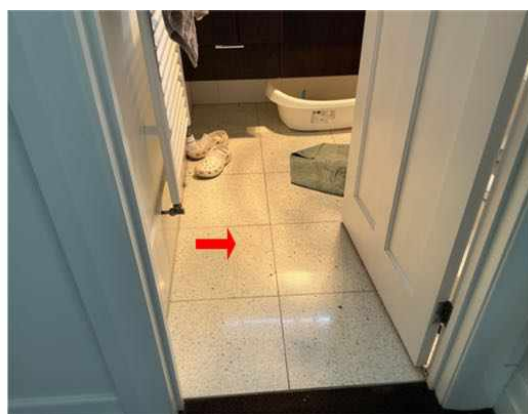
Defects 3.17

| Finding: | Floor tiles - Cracked |
| Information: | Cracking in the floor tiles was evident in this area at the time of inspection. It is suspected that this cracking has occurred as a result of the floor being uneven and lacking a solid or suitable foundation for the tiles to be laid on. Settlement in the floor foundations may also have caused movement and resulted in the cracking of tiles in this area. |

Cracked tiles throughout the household detract from the overall appearance of the affected areas, as well as creating potential for water penetration to adjoining building elements. If left unmanaged, water damage may occur as a result of constant water penetration over a prolonged period of time.

While not considered a matter of urgency, replacement of cracked floor tiles is advised as a solution. A tiling contractor or general handyperson may be appointed to perform these works at client discretion. Where cracks become more numerous, consultation with a registered builder specialising in re-stumping may be required.

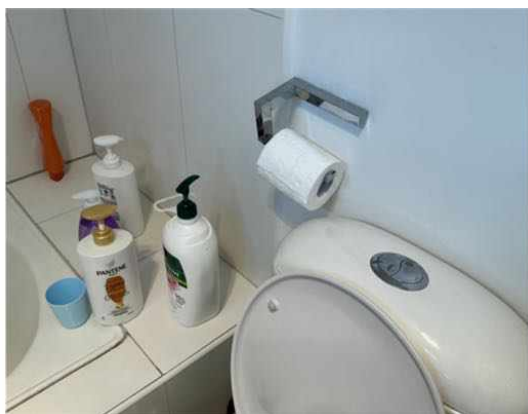
Defects 3.18

| Finding: | Toilet roll holder - Loose |
| Information: | The toilet roll holder was found to be loose at the time of inspection. While not a major operational defect, function can deteriorate if the problem is left unmanaged. |

It is advised that the homeowner performs remedial works to re-attach the toilet roll holder to its original fixing. A general handyperson may be required to perform these works.

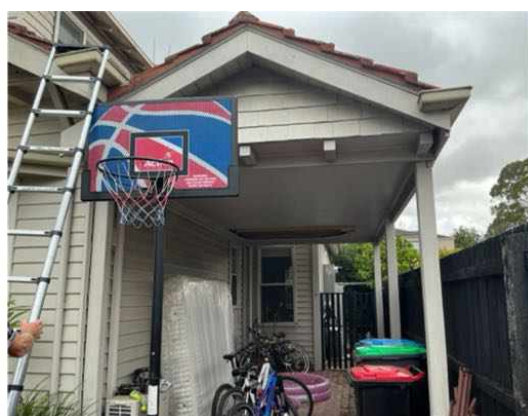
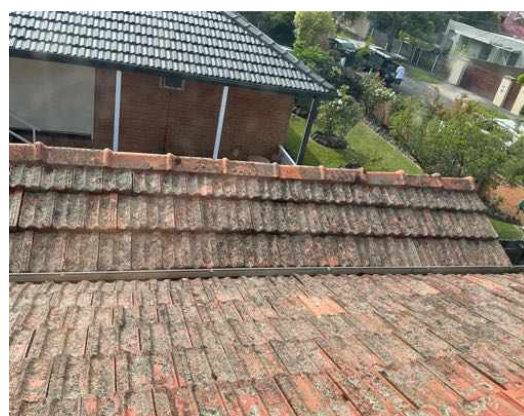
Noted Item

As building standards have not been followed, this area provides a heightened risk of the development of building defects. The structural integrity of the area may have been compromised, which creates potential for the development or presence of major safety issues.

It is highly recommended that any planned repair, remodeling or demolition works be carried out by registered builders. Such works may be necessary in the short-term future to ensure the safety and functionality of the area.
