Building and Timber Pest Inspection Report

Inspection Date: Tue, 10 Mar 2026

Property Address: 64 Heidelberg St, Mambourin VIC 3024,
Australia

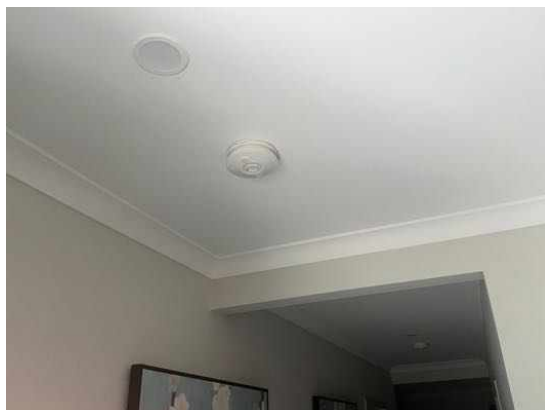
Please note that this defect is highlighted as a caution only. We suspect, based on our experience in the building industry, that the absence of smoke detectors, or their poor condition, should be addressed as a matter of urgency to improve occupant safety.

Further Inspection and/or advisory services is necessary to provide advice on the sufficiency, type and location of smoke detectors, and to test the functionality of all devices including battery replacement. Greater requirements for fire safety and detection exist for commercial buildings.

Always ensure sufficient working and suitable smoke detectors are installed prior to occupying any building. Additionally, it is advised that all smoke detectors be tested by the homeowner on a monthly basis.

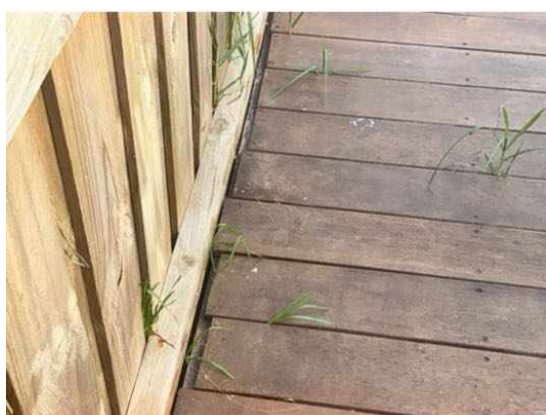
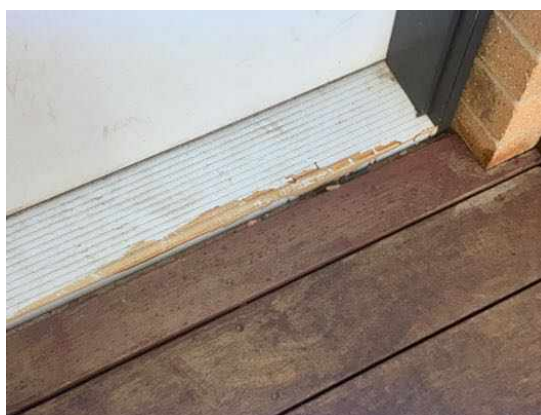
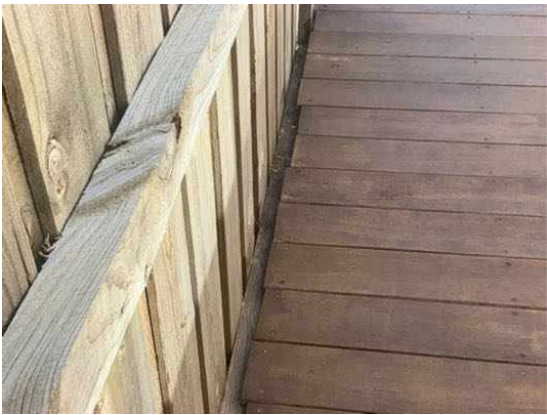
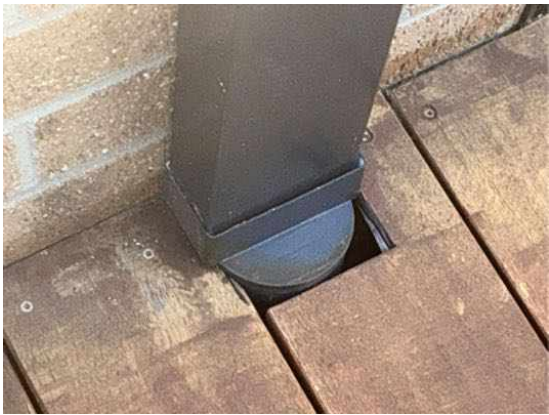
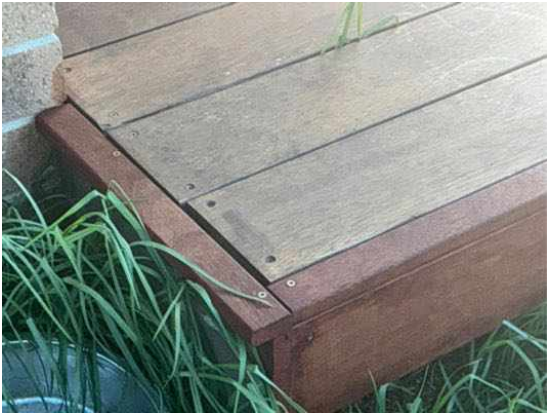
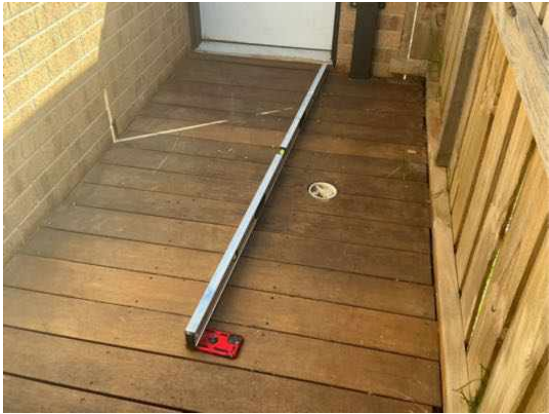
Finding 2.01

- 1/ Non-compliant decking. Suspected.
- 2/ Major leak to laundry tub cabinet plumbing.

It is highly advised to request that the current owner provide a Defect report (Owner Builder/Section 137b) for this structure. This would involve a structural engineer or a licenced building surveyor conducting an inspection of the structure and advising of any defects and/or areas of non-compliance in accordance with the current building codes. The current owner should then attend to any issues on this report prior to settlement.

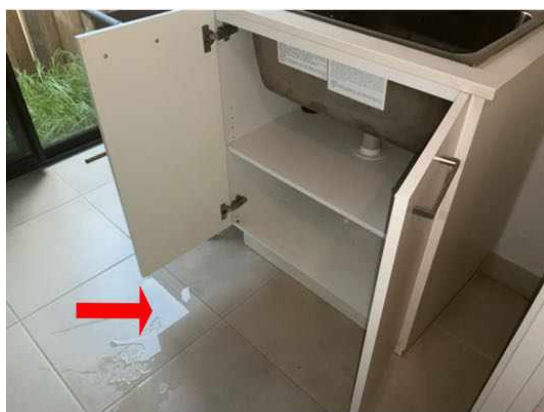
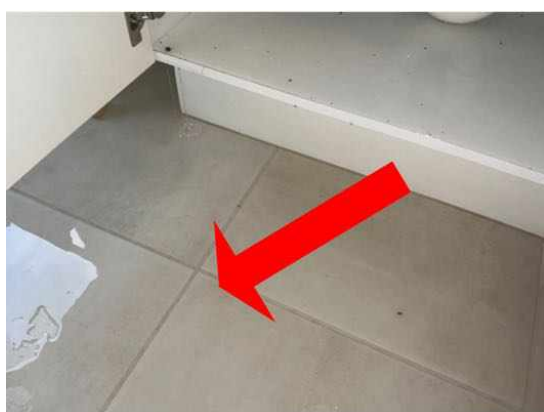
Finding 2.02

Building: Main Building
 Location: Laundry
 Finding: Plumbing to laundry tub leak
 Information: It was observed at the time of the inspection that there was a significant water leak in the plumbing to the laundry tub and cabinet. The leak was causing flooding to the laundry floor.

A licensed plumber should be engaged to review immediately.

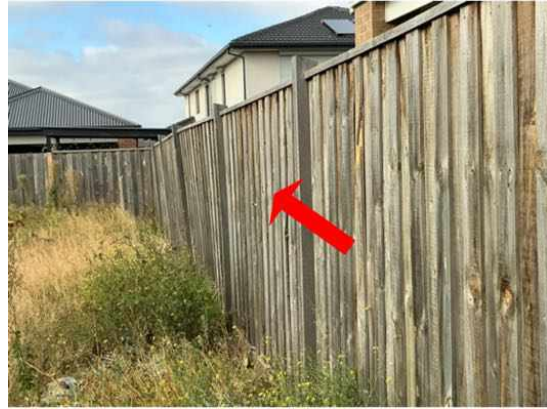
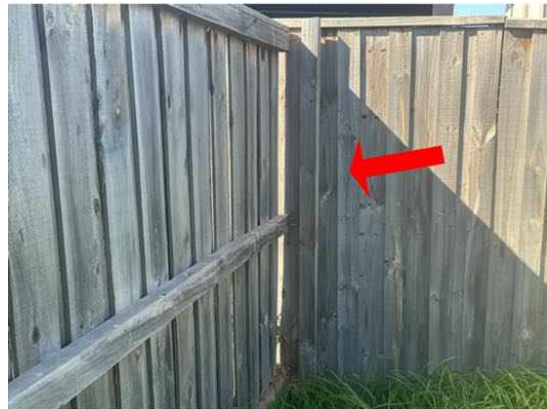
Finding 3.01

Building: Main Building
 Location: All External Areas
 Finding: Fencing - Deteriorated
 Information: It was noted at the time of inspection that sections of the fencing throughout the property have deteriorated. Typically fencing deteriorates due to age and or wear, rot and or rust which is generally expected for a structure of this age, due to prolonged exposure to weather conditions. Sometimes inadequate installation or maintenance can be to blame.

If left unattended, it is likely that further damage will occur. It is suspected that repair of several elements of the fencing may be required however replacement may be a consideration of the client also.

A licensed fencing contractor should be appointed to provide further advice and perform rectification works as necessary.

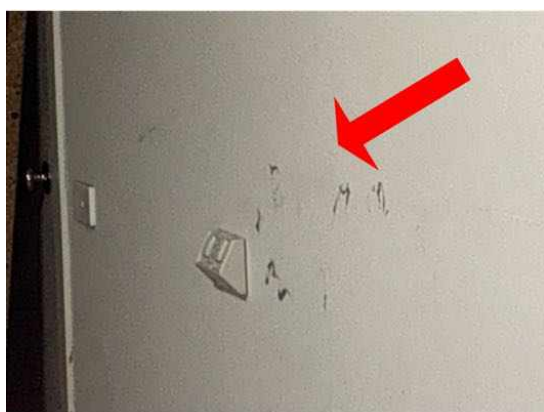
Building:	Main Building
Location:	Garage
Finding:	Garage wall damaged
Information:	It was noted at the time of the inspection that the garage wall was damaged and marked to the rear of the garage

Although this is anaesthetic detracts from the overall appearance of the building.

A general handyman should be engaged to review at the owners discretion

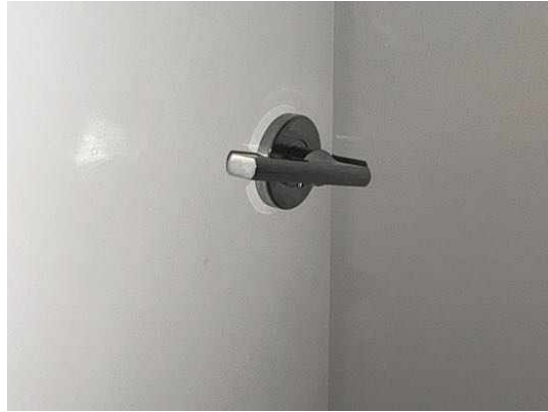
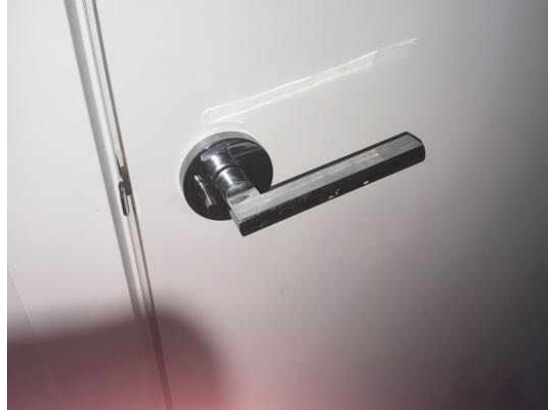
Finding 3.05

Building:	Main Building
Location:	All Internal Areas
Finding:	Door handle required adjustment
Information:	It was observed that many internal door handles required adjustment the levers were pointing in an upward direction. Correctly fitted door levers are horizontal. The door leaves may have been incorrectly fitted at the time of construction.

Although one aesthetic defect general handyman should be engaged to reviewer at the owners discretion

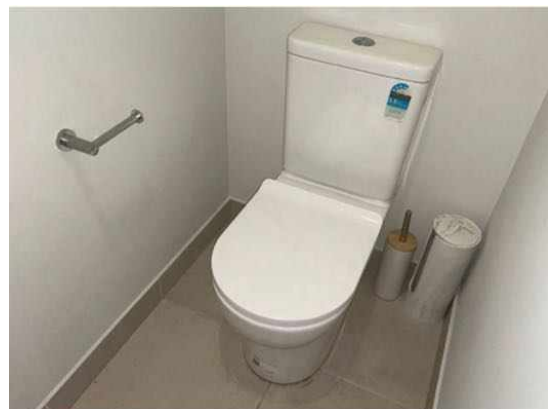
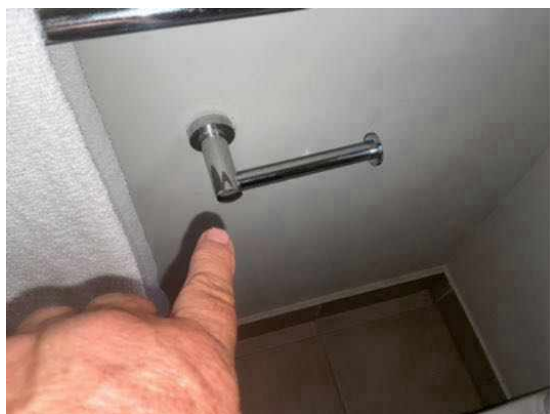
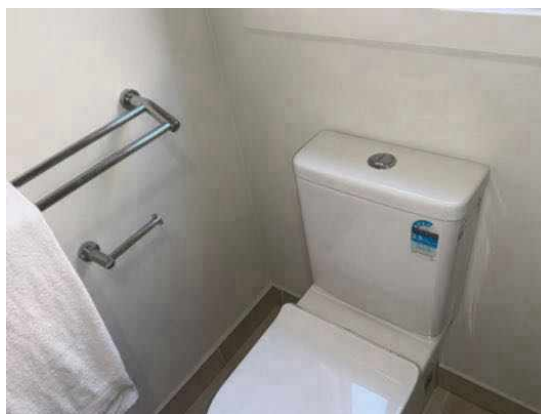
Finding 3.06

Building:	Main Building
Location:	WC and ensuite bathroom
Finding:	Toilet roll holder - Loose
Information:	The toilet roll holder was found to be loose at the time of inspection. While not a major operational defect, function can deteriorate if the problem is left unmanaged.

It is advised that the homeowner performs remedial works to re-attach the toilet roll holder to its original fixing. A general handyperson may be required to perform these works.

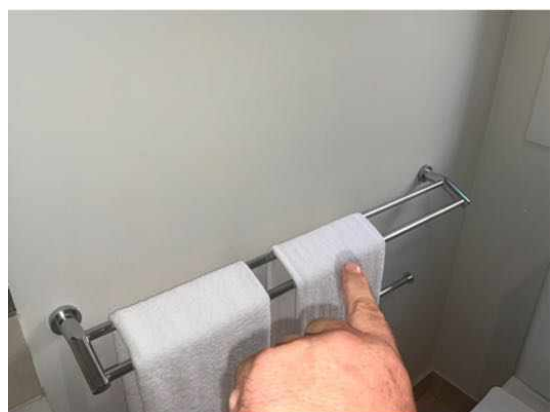
Finding 3.07

Building:	Main Building
Location:	Ensuite
Finding:	Towel rail - Loose
Information:	The towel rails were found to be loose at the time of inspection. While not a major operational defect, function can deteriorate if the problem is left unmanaged.

It is advised that the homeowner performs remedial works to re-attach the towel rail to its original fixing. A general handyperson may be required to perform these works.

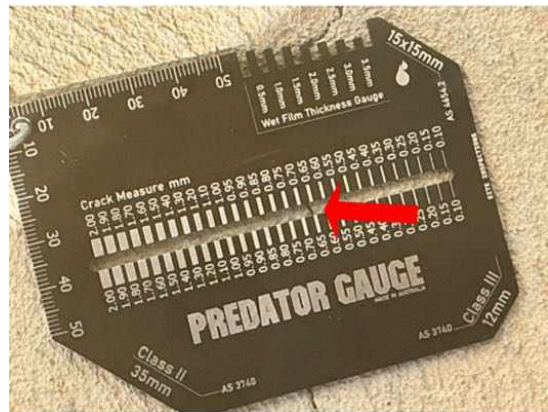
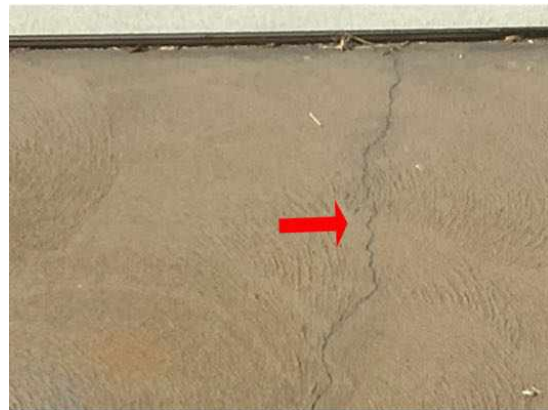
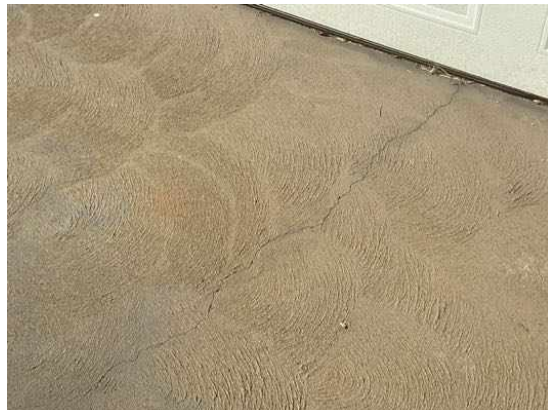
Finding 3.08

Building:	Main Building
Location:	Driveway
Finding:	Crack in concrete slab - Category 1
Information:	A crack coded as Category 1 was identified in the slab. A Category 1 crack is described as a fine but noticeable crack, with the slab at an otherwise reasonable level.

To be considered Category 1, the approximate width of the crack is less than 1.0mm, or a less than 10mm change in offset when a 3m straight edge is placed over the defect.

Category 1 cracks should be monitored for a period of 12 months. At the end of the monitoring period, identified cracks that are rated greater than Category 2 are considered defects, and require rectification.

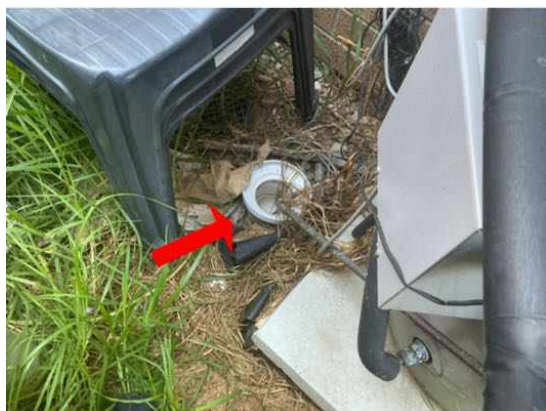
Finding 3.09

Building: Main Building
 Location: Exterior walls - right side
 Finding: Drainage grate cap missing
 Information: It was noted at the time of the inspection that the stormwater grate cap adjacent to the hot water service was missing

These cups are provided to prevent debris falling into the stormwater drain system and causing blockages.

A general handyman or licensed plumber should review as soon as possible

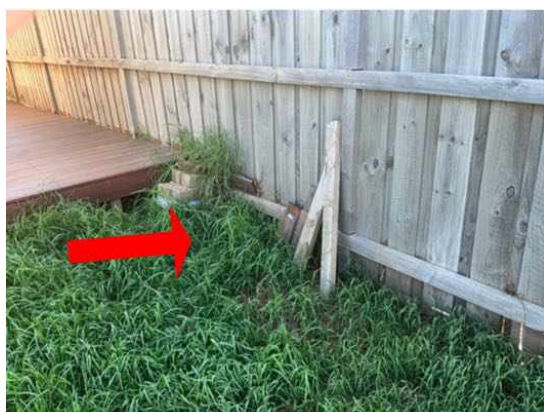
Building:	Main Building
Location:	Yard - Back
Finding:	Stored timbers - subfloor space or external area
Information:	The storing of timbers in the subfloor space or around the external property increases the risk of termite activity being present. As they are likely to come into contact with weather conditions or excessive moisture wood rot is likely to develop on timbers that are not treated.

It is highly recommended that any stored timbers be immediately removed from areas in which they may attract any termite / timber pest attack. Minimisation of risk / prevention of termite attack is far more adequate than dealing with the presence of termite activity.

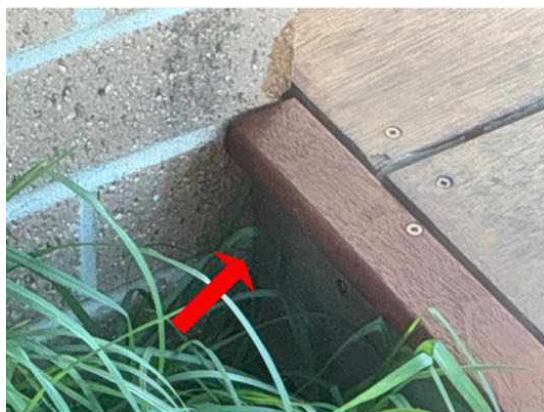
Finding 6.03

Building:	Main Building
Location:	All External Areas
Finding:	Bridging or breaching of termite barriers - adjacent internal flooring
Information:	Bridging is the spanning of a termite barrier or inspection zone so that subterranean termites are provided with passage over or around that barrier.

It is highly advised that a landscaper or paver be appointed to lower external grounds that are raised above adjacent internal flooring. Alternatively if external grounds and internal flooring is level installation of a raised door sill may be appropriate in preventing any water pooling in the area.

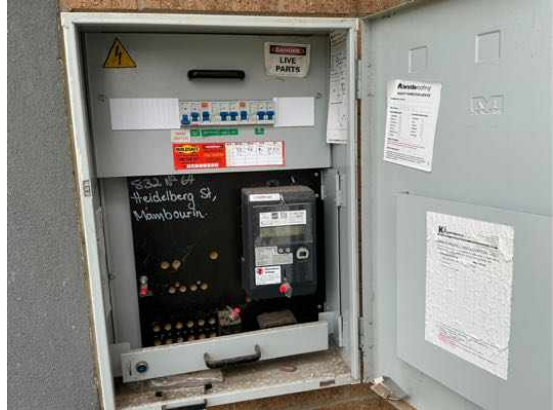
Building:	Main Building
Location:	All External Areas
Finding:	Evidence of a chemical treated zone barrier was identified
Information:	During inspection of the property, it was noted that works to install a chemical treated zone barrier had previously been completed. A chemical treated zone barrier is likely to ensure effective protection against termites.

However, we strongly recommend annual inspections of the barrier and surrounding areas as there are several factors that can lead to deterioration of the barrier and decrease its effectiveness.

Where a Termite Management System has been identified, the client should identify to the type of barrier, date of installation, warranty conditions and any documentation provided by a builder or past owner. Consult the company who installed the barrier to confirm whether the system is still under warranty.
