# Building and Timber Pest Inspection Report

Inspection Date: Wed, 21 Jan 2026

Property Address: 16 Clearwater Cct, Bli Bli QLD 4560,  
Australia

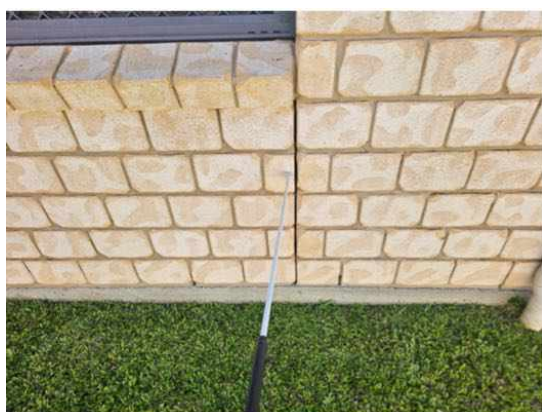
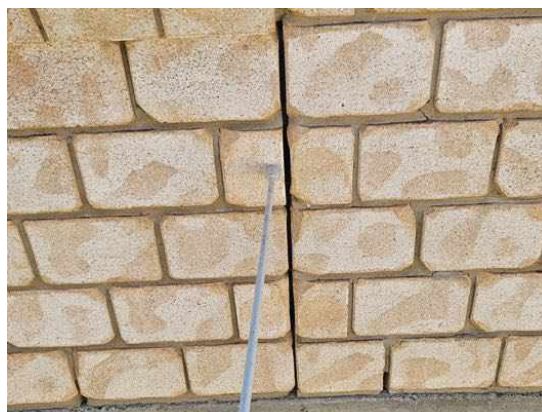
#### Finding 3.01

Building:	Main Building
Location:	Right side
Finding:	Expansion / Control joints - degraded.
Information:	In the location around the building as shown in the photos, the control / expansion joint in the brick work is degraded and the brickwork is not completely sealed. This joint requires renewal with correct sealant to prevent moisture and vermin from entering the building via this joint.

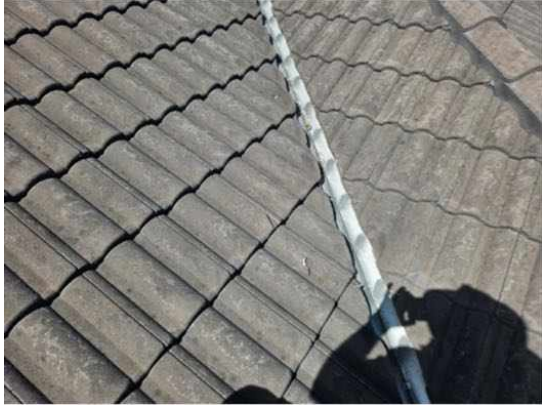
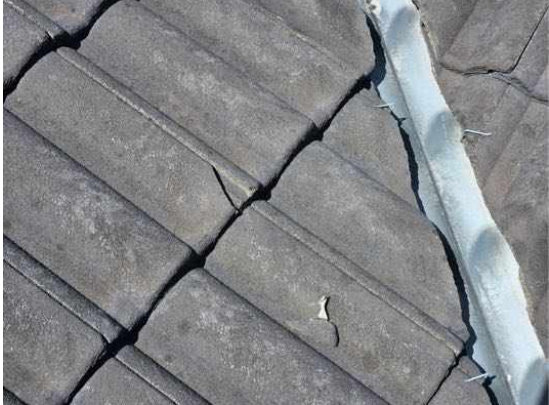
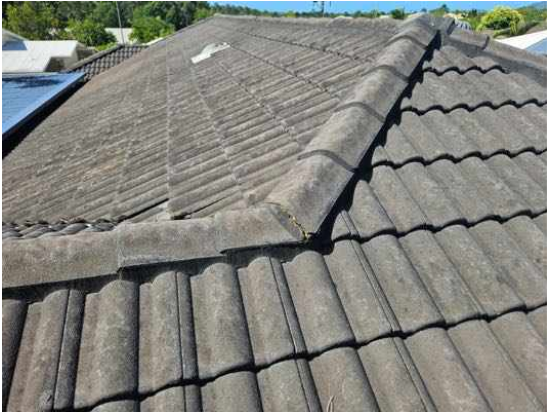
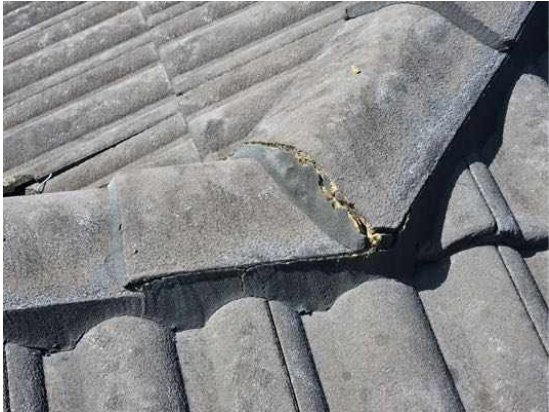
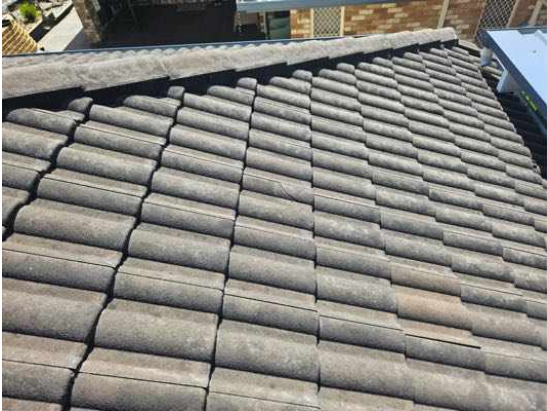
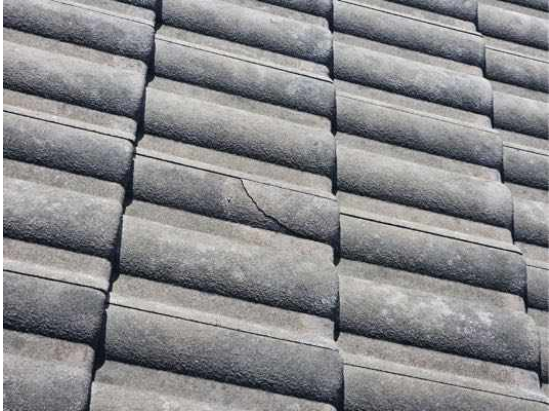
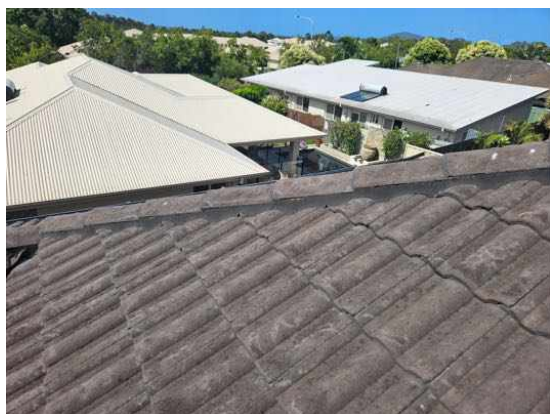
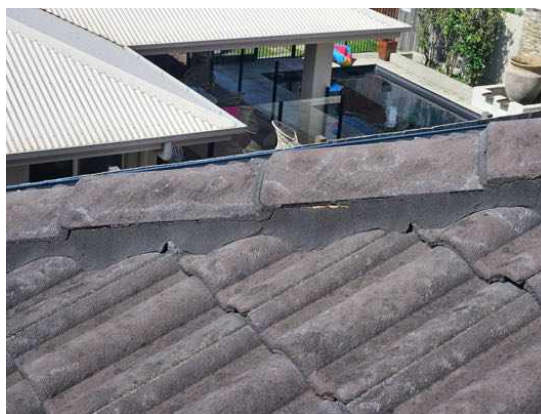
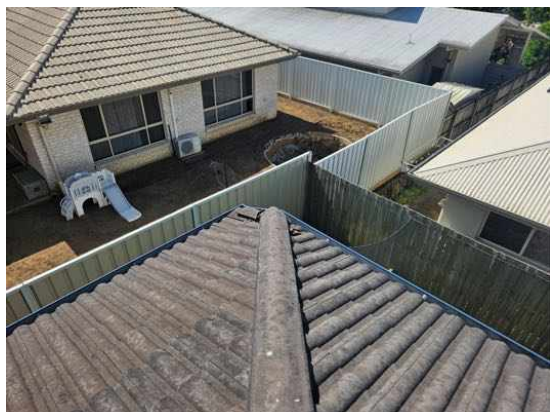
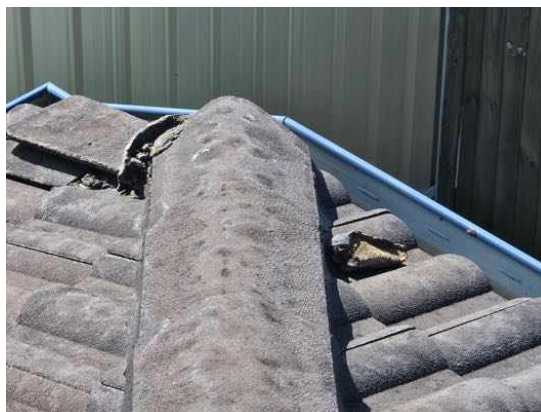
#### Finding 3.02

Building:	Main Building
Location:	As shown
Finding:	Roof tiles - miscellaneous defects
Information:	Upon inspection of the exterior roofing, the majority of roof tiles were considered to be in a good condition. While minor weathering of the tiles is consistent with the age of the property, minor maintenance works are required. Isolated areas of tiles and the bed and pointing appear to be faulty. Areas of wear and deterioration were evident. Some cracked / chipped tiles were identified.

Where left unmanaged, deteriorating roof tiles are likely to lead to a number of

secondary defects, including minor water leaks and weather exposure to internal roofing structures. The underside of the tiles is not sealed with sislation; therefore, it is more important to attend to defects with haste to continue the roof surfaces water resistance.

The roof condition is noted as a minor defect ; however it should be made a priority to maintain the surface condition and prevent possible leaks and further deterioration. Giving consideration to the lack of sialtion fixed under the tiles, considered attention should be given to maintaining a waterproof roof surface.

Consultation with a roofing contractor could be sought to carry out these minor repairs.

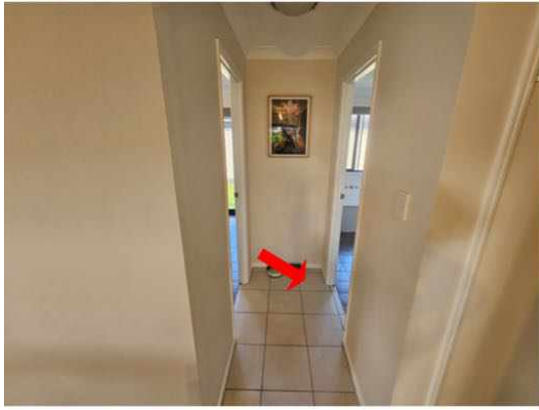
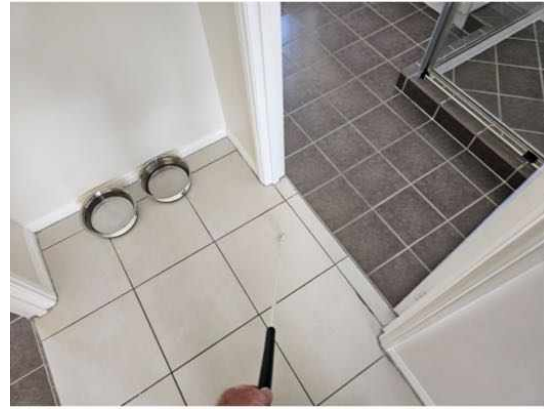
### Finding 3.03

Building:	Main Building
Location:	Hallway
Finding:	Tiles - Drummy
Information:	A drummy tile was identified at the time of inspection. Please see the attached photos for location.

The term 'drummy' refers to tiles that have become detached from their fixing, despite otherwise being in relatively good condition. Such defects are generally caused by physical or moisture damage to the area. Drummy tiled areas may also be a direct result of poor workmanship during the construction process.

Tiled areas may swell and shrink with changes in air humidity if the area has sustained moisture damage. Any exposure to moisture is capable of causing tiled areas to become drummy and/or cracked over a prolonged period of time. Drummy tiled areas generally require removal and replacement of affected tiles.

Specialist trades are available for these types of services. A licensed builder may be required to undertake works if damage is extensive or if secondary building defects have resulted. Otherwise, it is advised that a tiling contractor or a tile adhesive injection service may be appointed to perform works as necessary.

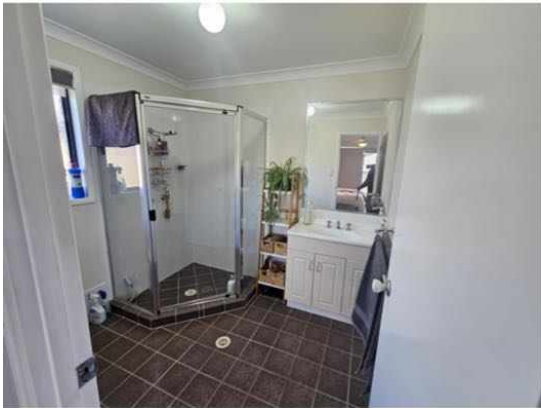
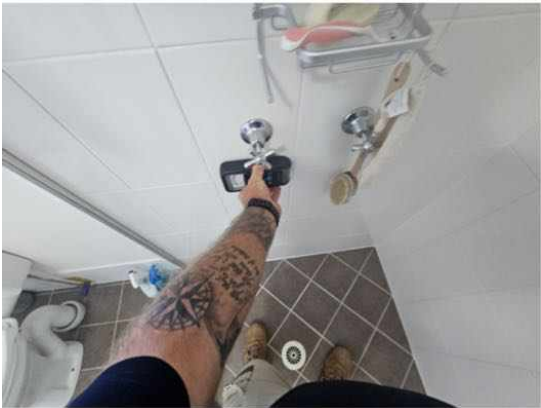
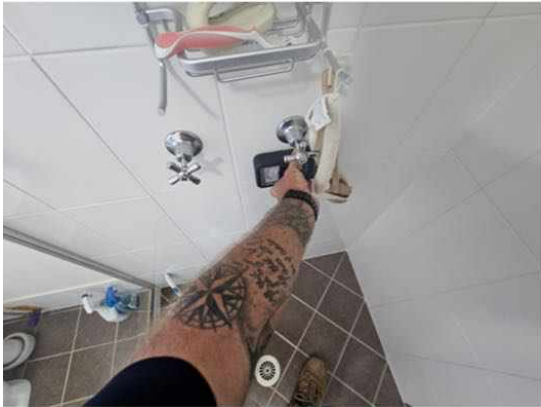
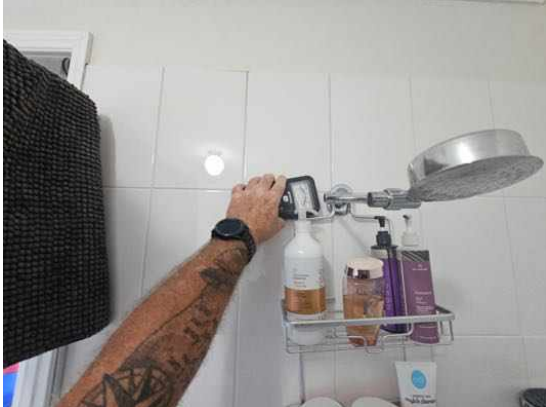
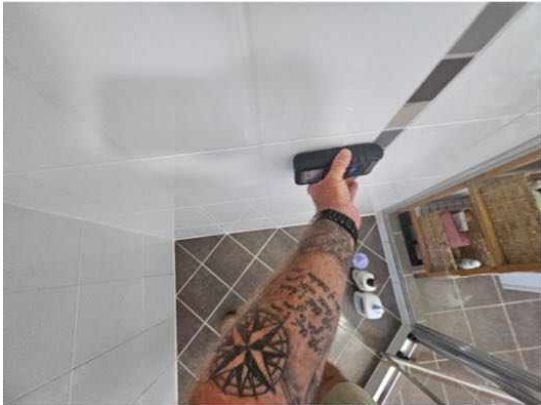
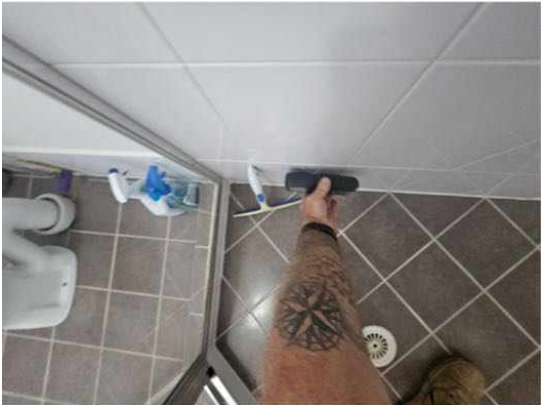
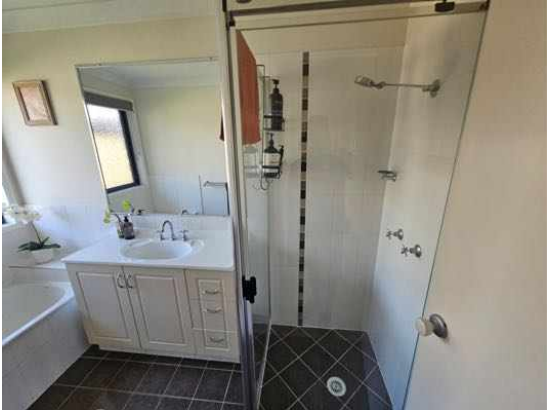
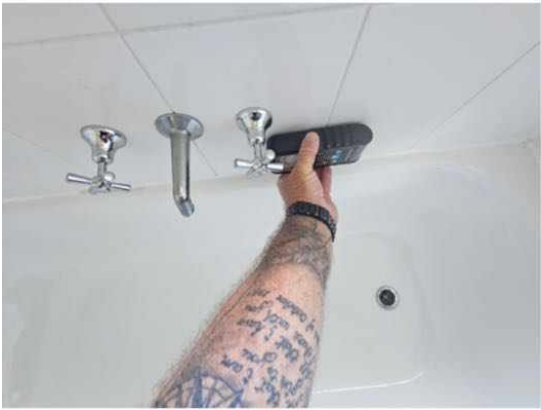
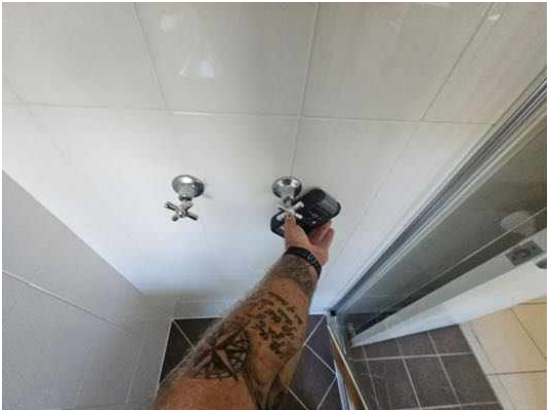
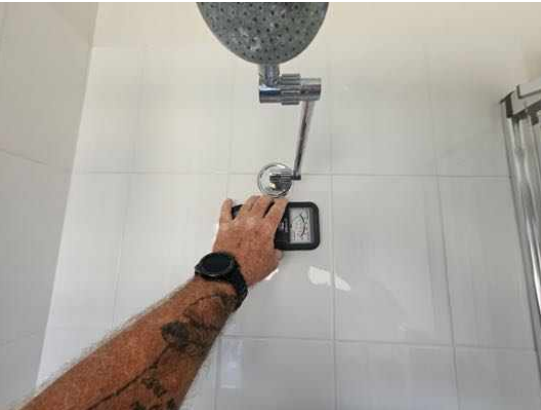
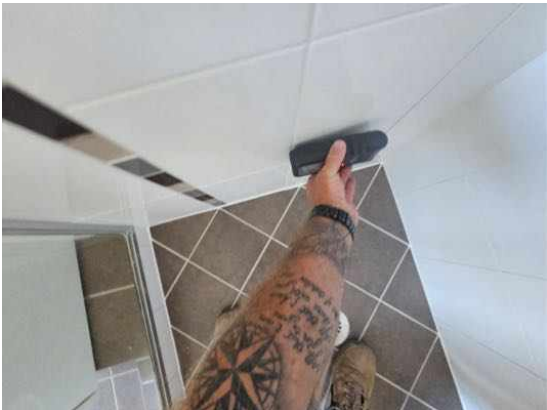
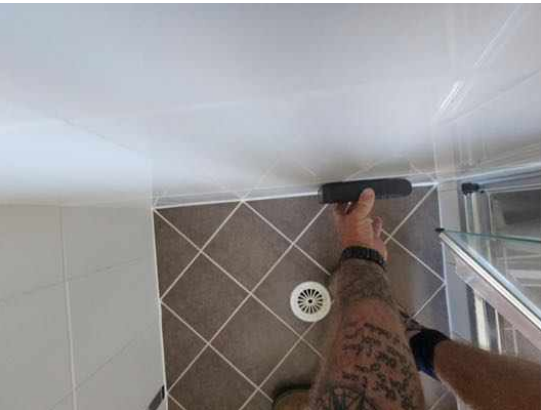
#### Noted Item

Building: Main Building  
Location: Bathroom, ensuite  
Finding: No moisture detected in bathroom / ensuite  
Information: On the day of inspection the showers in the bathroom/s and ensuite are measure for moisture using a "Tramex" moisture meter. During this inspection no moisture was detected in these areas and the tiled / sheeted surfaces appear to be in good order.

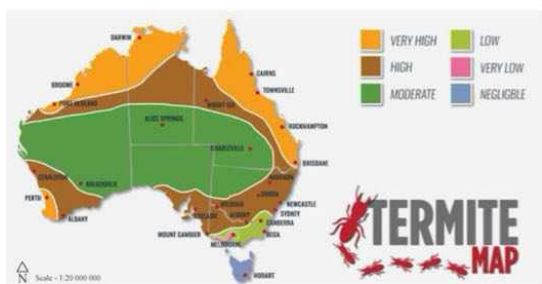
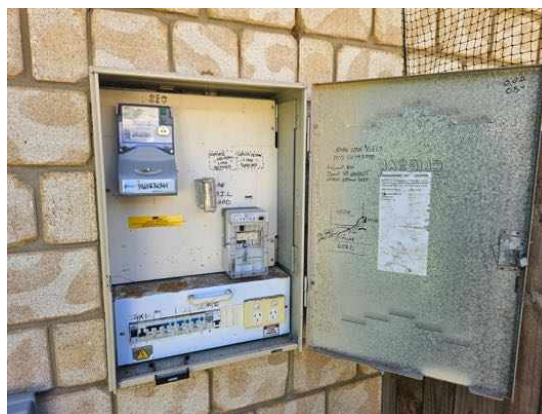
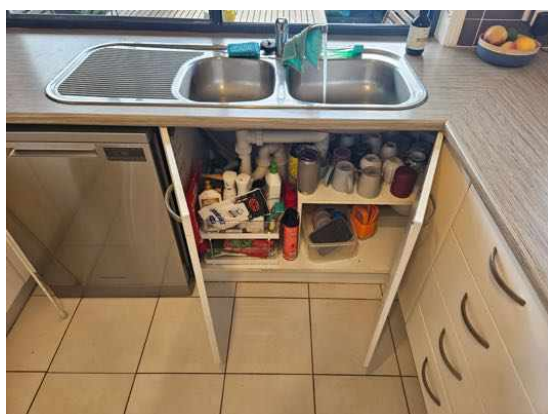
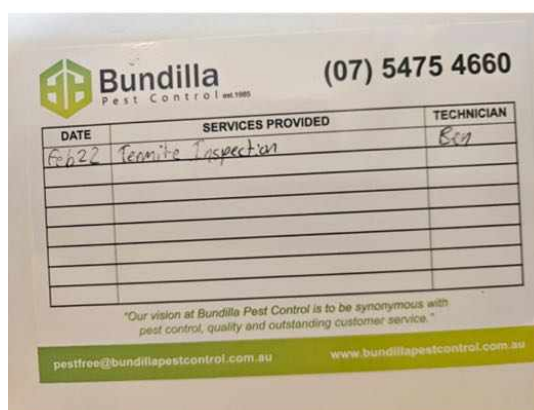
Building: Main Building  
 Location: Meter box, kitchen cupboard  
 Finding: Durable pest inspection notice - out of date  
 Information: On the day of inspection it was noted that the durable pest inspection / treatment notice was missing, not visible or out of date. These notices / stickers are to verify the

There has been an annual inspection programme is in place previously. It was out of date on the day of inspection and will fall due 12 months from this inspection.

It is recommend that the inspector of the day or a licensed timber pest controller be contacted to assess the properties needs and provide costings for an annual inspection programme.

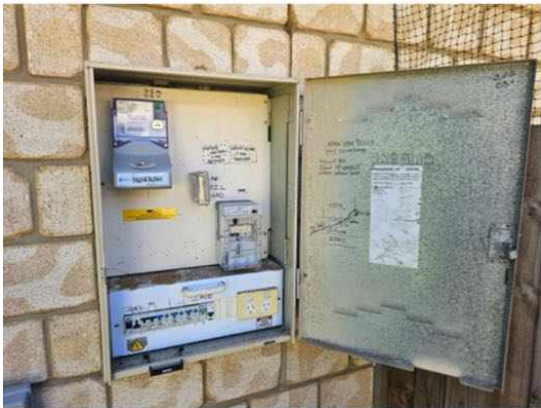
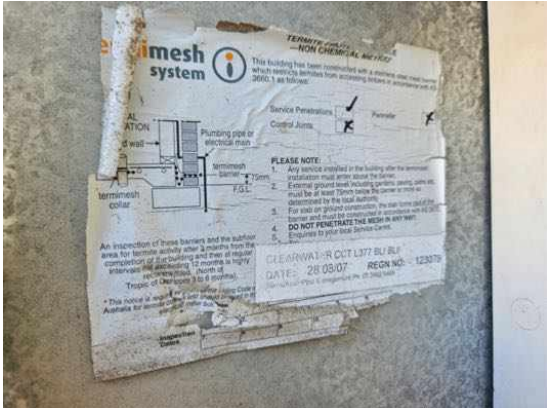
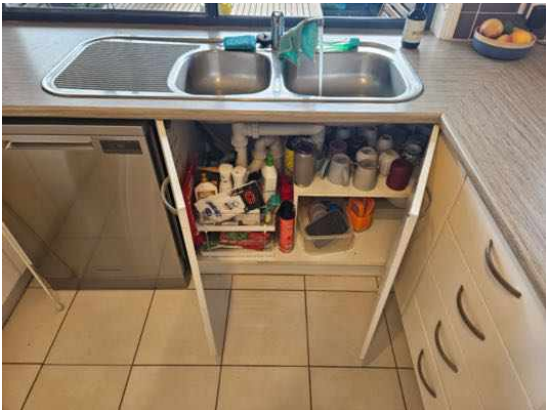
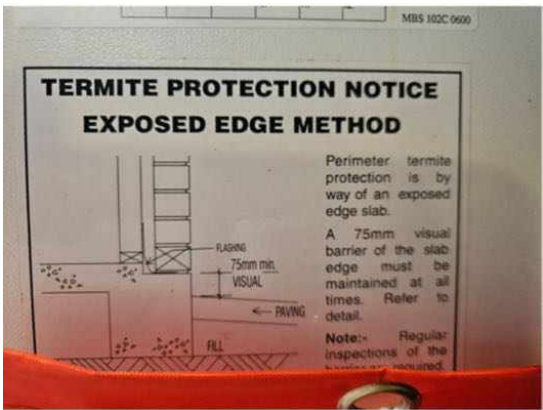
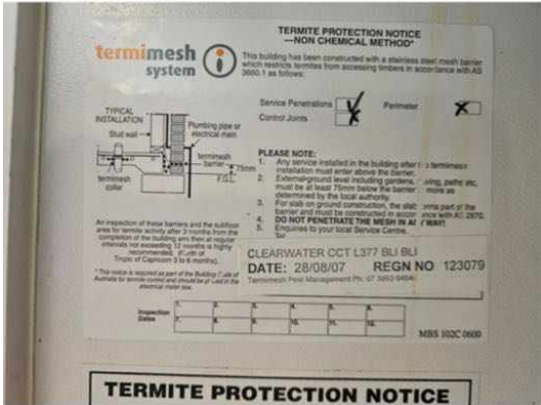
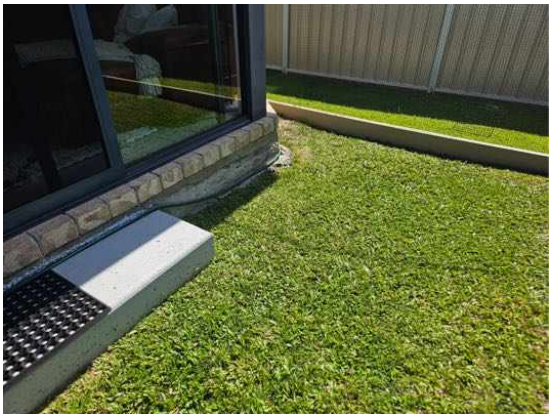
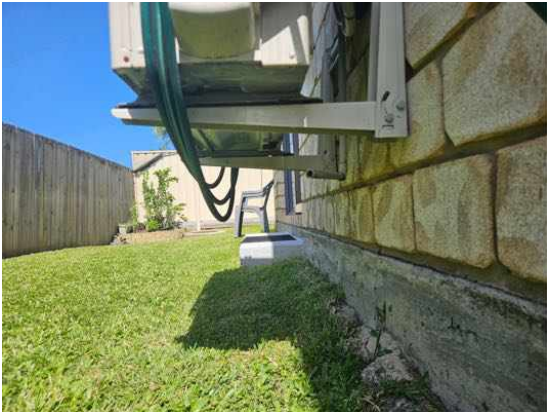
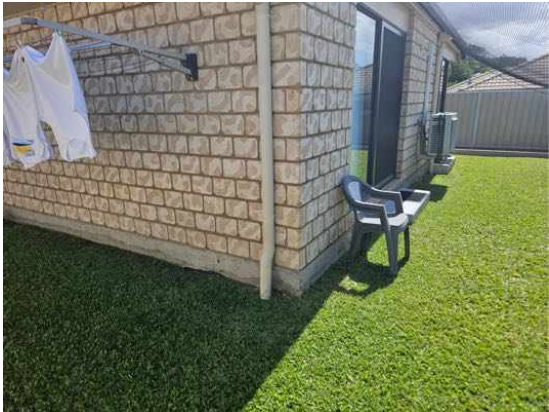
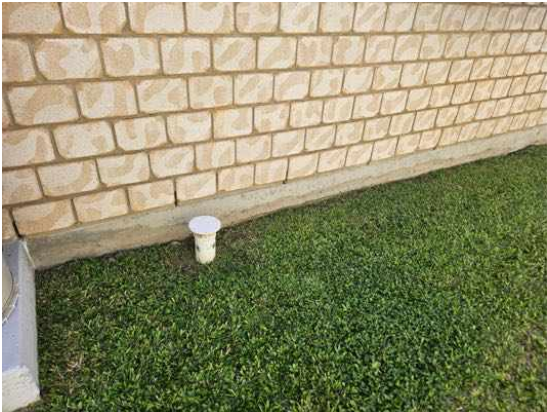
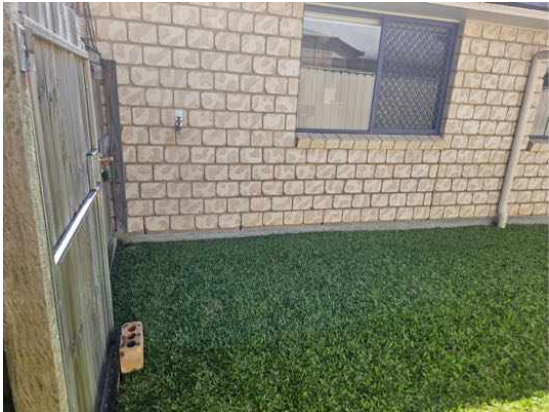
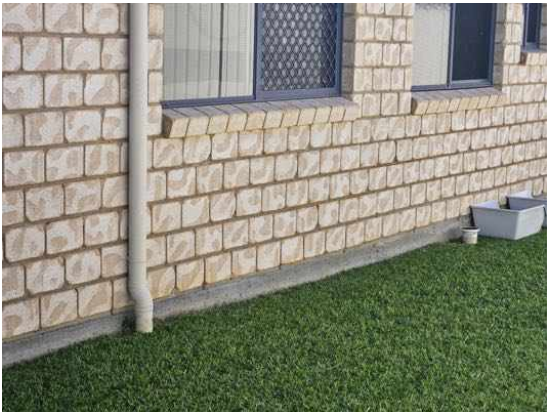
The building employs a "Termimesh" physical barrier system to the perimeter and slab penetrations in combination with an exposed slab edge visual barrier.

In order for a barrier system to be effective, the property must have regular inspections at intervals of not greater than 12 months. Depending on the risk profile attributed to the property, these inspections may be recommended at lesser time periods.
