Building Inspection Report

Inspection Date: Wed, 18 Mar 2026

Property Address: unit 2/4 Prokuda Cl, Goodna QLD 4300,
Australia

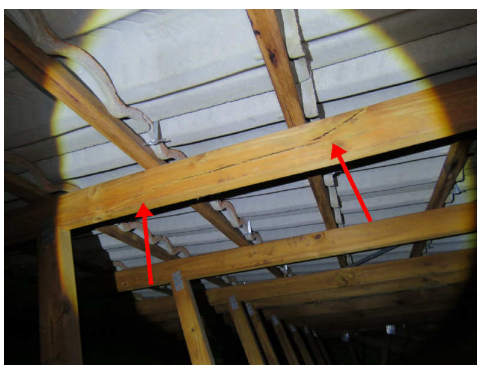
Defects 2.01

Location: Roof Void Centre Right

Finding: Cracked Top Chord of Roof Truss

Information: At the time of inspection, the top chord of a roof truss was observed to be cracked through its full depth. This represents a significant structural defect, as the top chord is a primary load-bearing component of the roof framing system. Such damage may compromise the structural integrity and load bearing capacity of the truss.

It is recommended that a suitably qualified structural engineer be engaged as a matter of priority to assess the extent of the damage and provide recommendations for immediate repair or rectification.

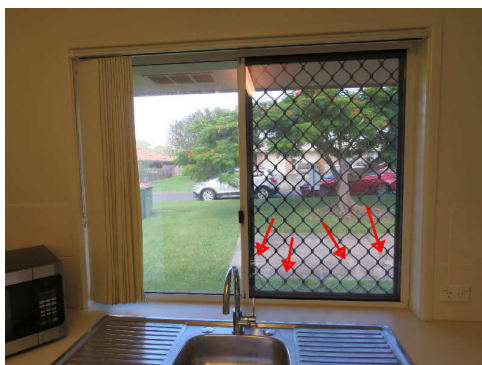
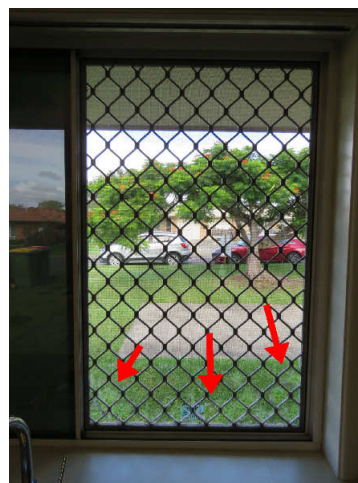
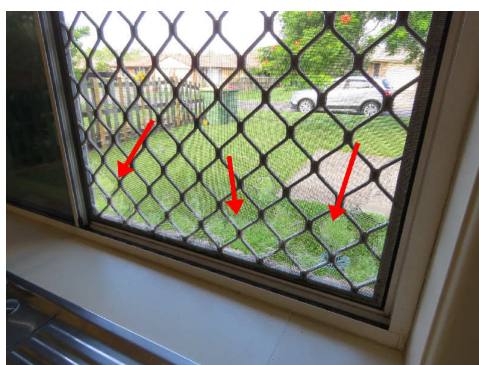
Defects 3.01

Location: Kitchen Rear Right

Finding: Damaged Insect Screen – Kitchen Window

Information: At the time of inspection, the insect screen to the kitchen window was observed to be torn with multiple large holes. This condition reduces the effectiveness of the screen in preventing the entry of insects and impacts its intended function.

It is recommended that the damaged screen be repaired or replaced by a flyscreen contractor to restore its functionality.

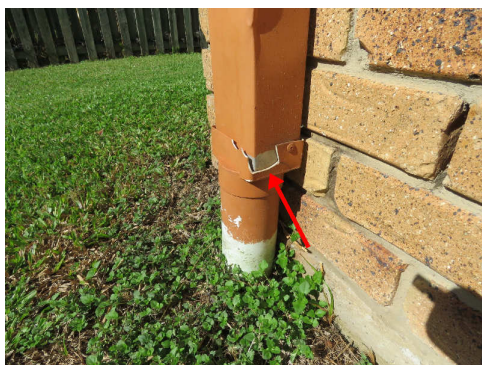
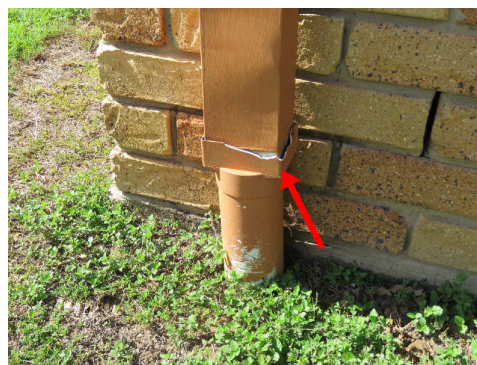
Defects 3.02

Location: Rear Elevation Rear, Rear Right

Finding: Cracked Downpipe Adapters (Rectangular to Circular)

Information: At the time of inspection, the adapters connecting the rectangular downpipes to the circular drainage pipes were observed to be slightly cracked in couple of downpipes.

While these components may still be functioning, the cracks may allow water leakage, particularly during periods of heavy rainfall.

It is recommended that the affected connections be checked for leaks and repaired or replaced (if leaking) by a licensed plumber to ensure effective stormwater discharge and prevent potential water-related issues.

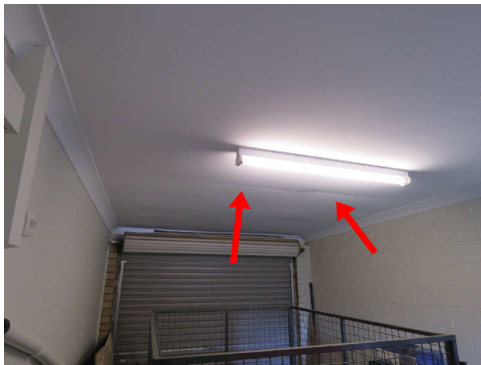
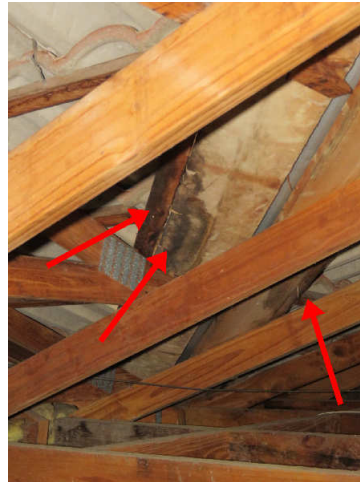
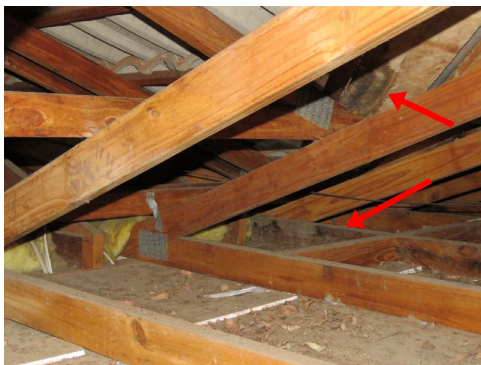
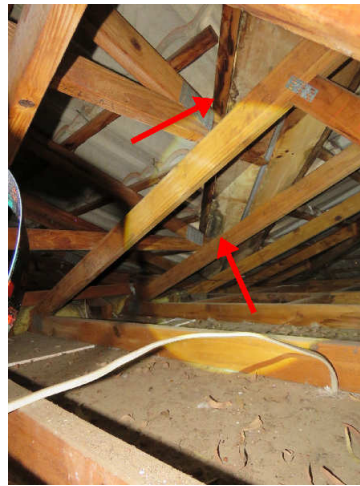
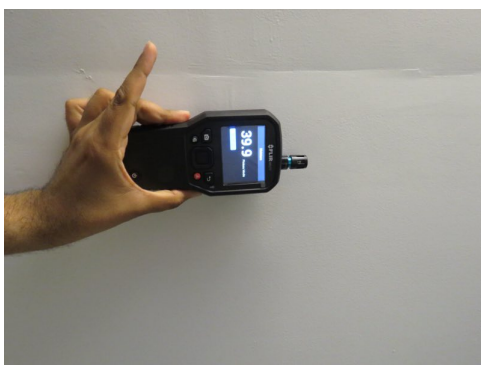
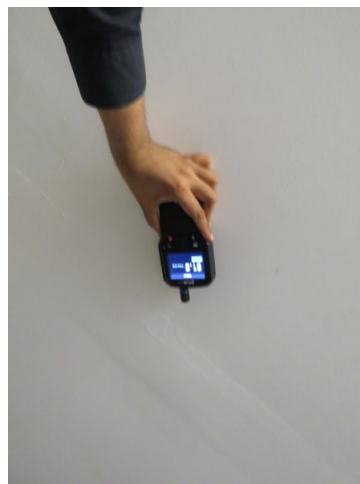
Defects 3.03

Location: Roof Front Left

Finding: Water Staining to Garage Ceiling

Information: At the time of inspection, signs of sagging were observed to the garage ceiling, and water stains were observed on the ridge board above. Moisture meter readings were taken on the garage ceiling and were found to be within normal range at the time of inspection. The staining may indicate a past moisture event; however, no active moisture ingress was detected during the inspection.

It is recommended that a suitably qualified roof tiler be engaged to inspect and assess the condition of the roof tiles and carry out any necessary repairs (if required).

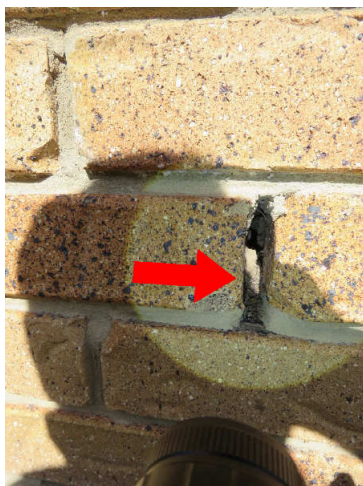
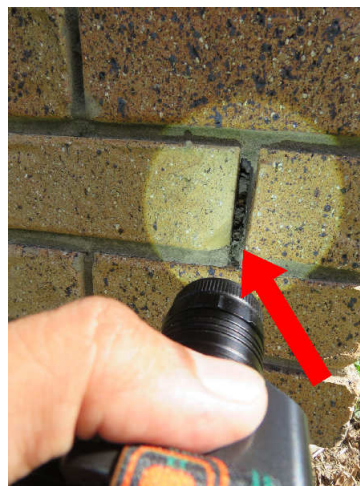
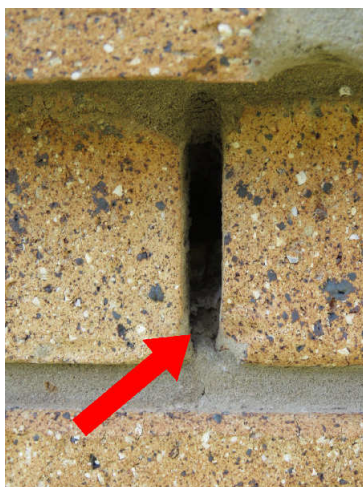
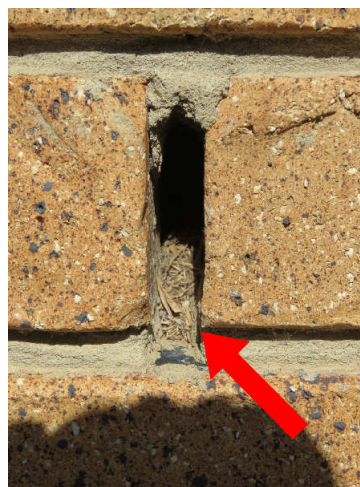
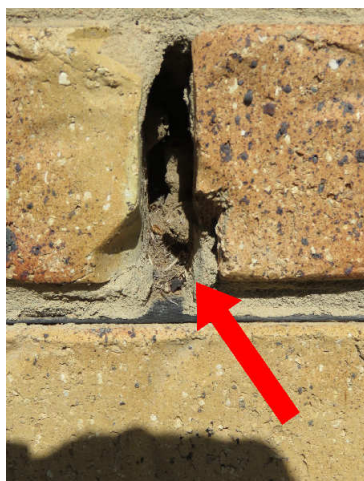
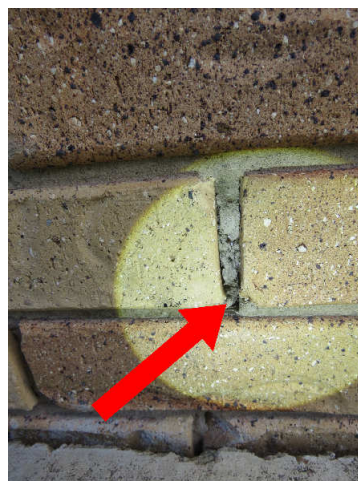
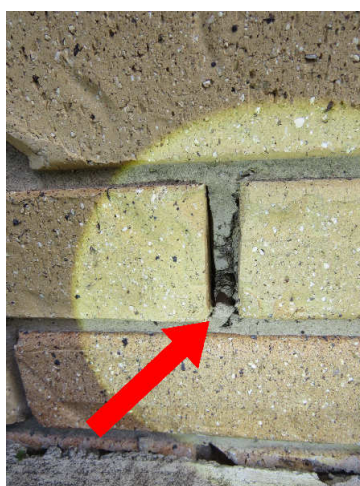
Defects 3.04

Location: Weepholes Front Right,Rear,Rear Left,Rear Right

Finding: Blocked Weepholes

Information: At the time of inspection, several weepholes were observed to be blocked by sand. Blocked weepholes may restrict drainage and ventilation of the wall cavity, potentially leading to moisture-related issues.

It is recommended that a licensed builder be engaged to clear the weepholes and ensure proper functionality of the roof cavity.

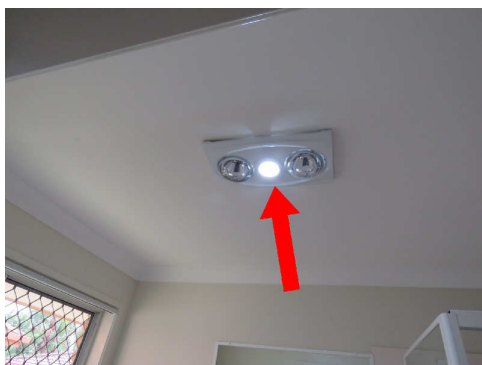
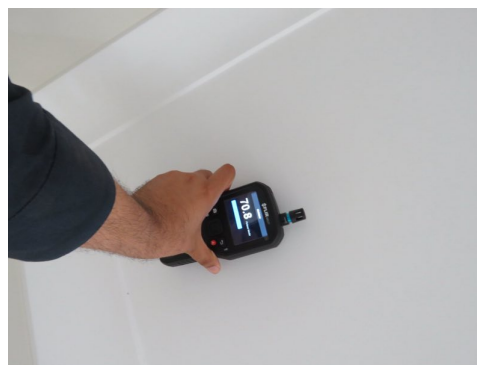
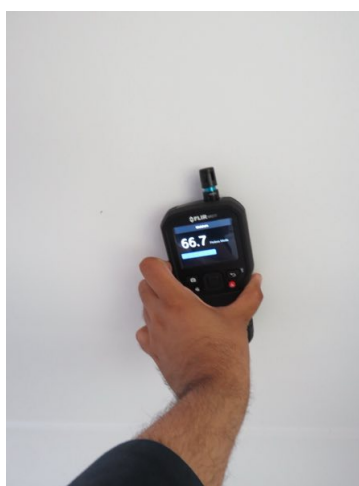
Defects 3.05

Location: Bathroom Centre Left

Finding: Bathroom Exhaust Not Operational & Elevated Moisture to Ceiling

Information: At the time of inspection, the bathroom exhaust fan was not operational. In addition, elevated moisture readings were recorded to the bathroom ceiling. The lack of mechanical ventilation may contribute to the build-up of moisture within the area, which can lead to deterioration of finishes over time.

It is recommended that the exhaust fan be inspected and repaired or replaced by a licensed electrician, and moisture readings on the bathroom ceiling to be observed.

If the elevated moisture is still present, a registered builder should be engaged to identify the source of moisture and rectify the defect.

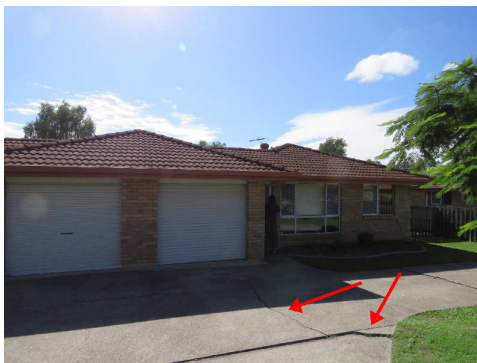
Defects 3.06

Location: Driveway Front

Finding: Cracking and Minor Settlement – Driveway Slab

Information: At the time of inspection, cracking and minor settlement were observed to the driveway slab. This condition is likely associated with ground movement or material behaviour over time. At present, the defect does not appear to impact the serviceability of the driveway.

It is recommended that the area be monitored for any further movement or deterioration. If the condition worsens, further assessment and rectification by a suitably qualified concreter may be required.

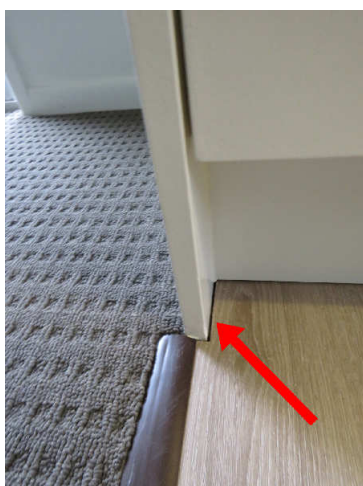
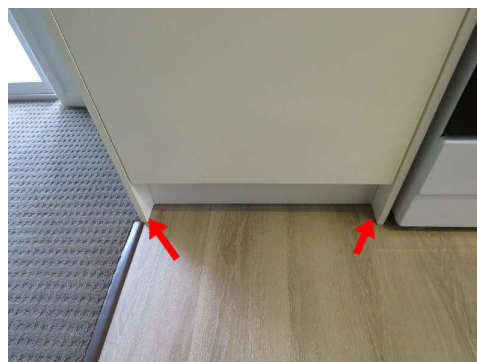
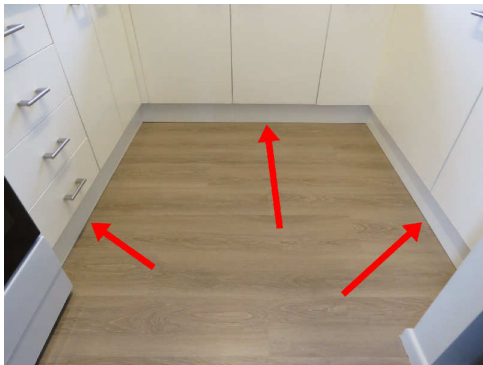
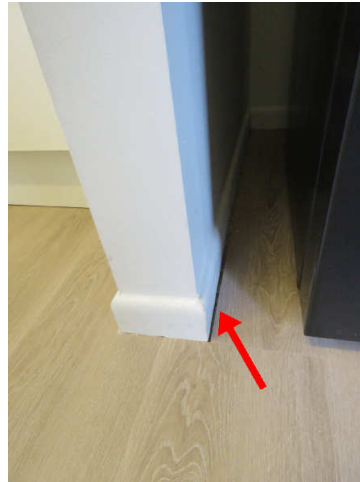
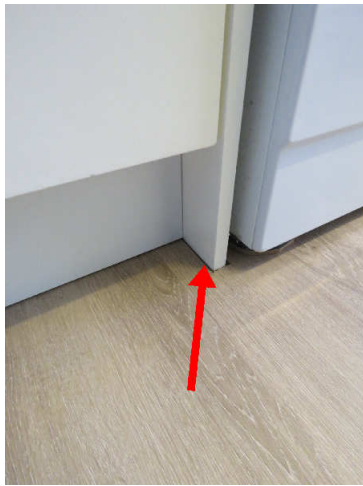
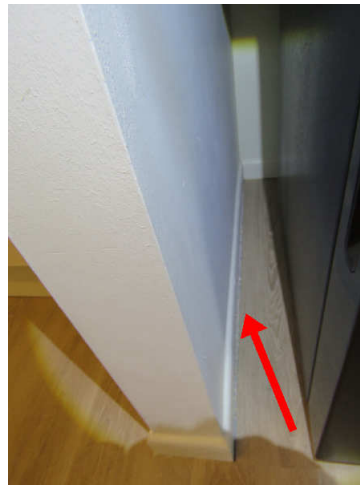
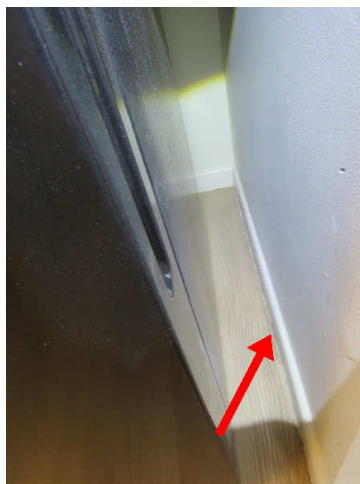
Defects 3.07

Location: Kitchen Front Right

Finding: Missing Sealant to Floorboard Edges – Kitchen

Information: At the time of inspection, sealant was observed to be missing along the edges of the floorboards in the kitchen area. The absence of sealant may allow moisture ingress at the edges, which can lead to deterioration or movement of the flooring over time.

It is recommended that appropriate sealant be applied to the affected areas by a caulking contractor to protect the floorboards.

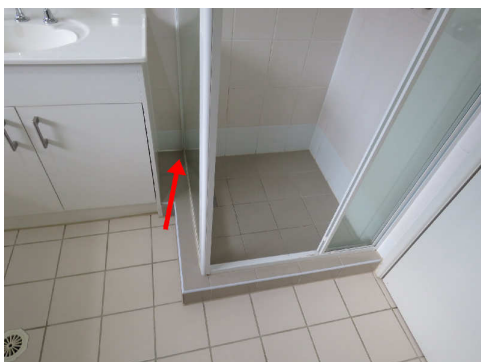
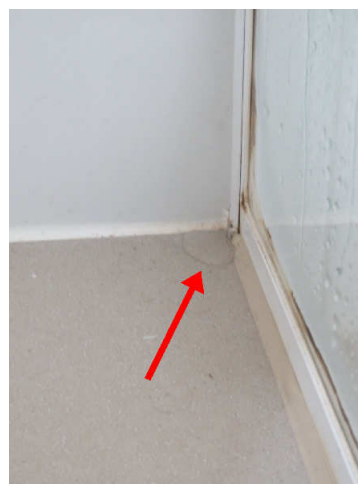
Defects 3.08

Building: Main Building
Location: Bathroom Centre Left

Finding: Leakage at Shower Screen Junction

Information: At the time of inspection, when water was applied to the edges of the shower area, water was observed escaping at the junction between the tiles and the shower screen. This indicates failure or absence of sealant at this junction, which may allow ongoing water leakage.

It is recommended that the affected junction be properly cleaned and resealed by a suitably qualified caulking contractor to prevent water ingress and maintain the integrity of the shower area.

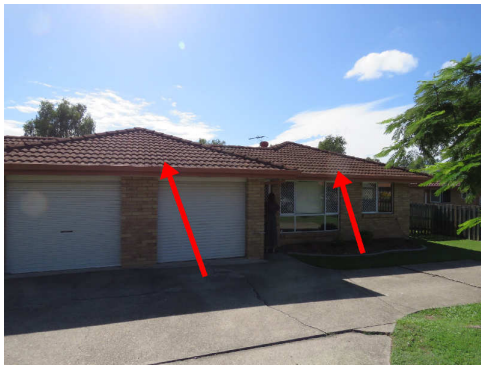
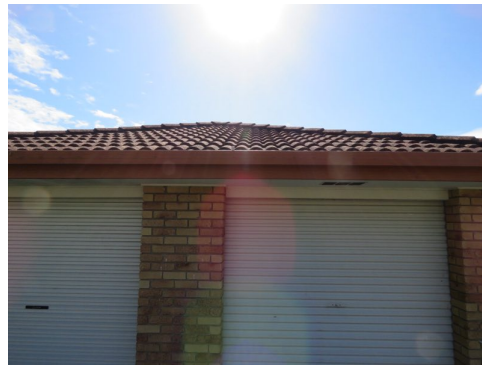
Defects 3.09

Location: Roof Exterior

Finding: Roof tiles - Weathered

Information: Upon inspection of the exterior roofing, the majority of roof tiles were considered to be in a fair condition. While weathering of the tiles is consistent with the age of the property, maintenance works are required.

Isolated areas of mortar have come loose in the valleys and minor cracking is also present.

Where left unmanaged, deteriorating roof tiles are likely to lead to a number of secondary defects, including minor water leaks and weather exposure to internal roofing structures.

Re-pointing and re-sealing the may be considered as an interim solution by the client to help preserve and extend the life span of the tiles.

Consultation with a roofing contractor is highly advised to gain advice on cost of remedial works that may be required in the short to medium term. Remedial works are likely to increase the longevity of the exterior roofing structure.

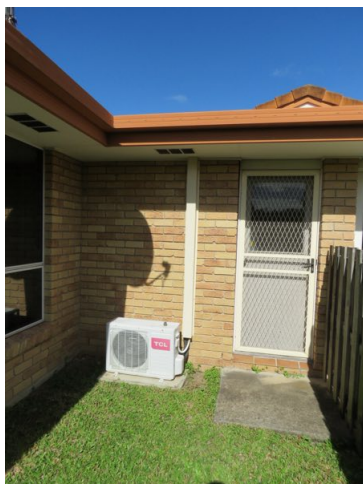
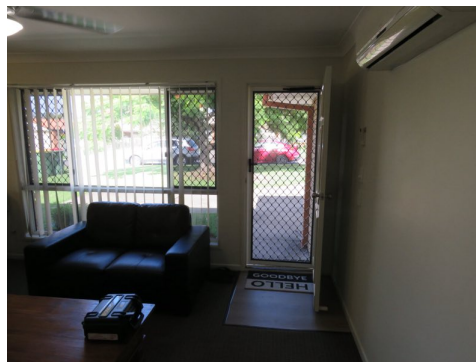
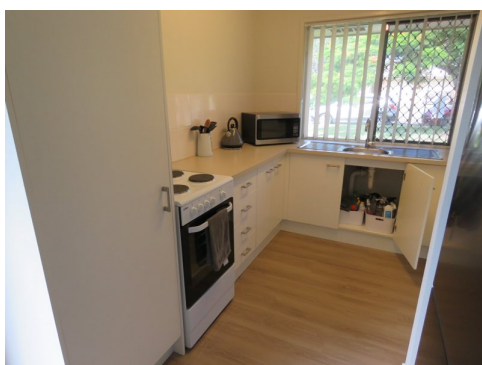
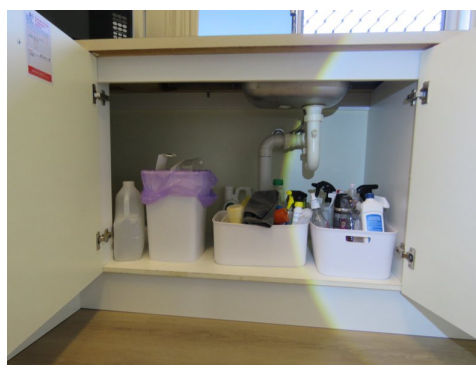
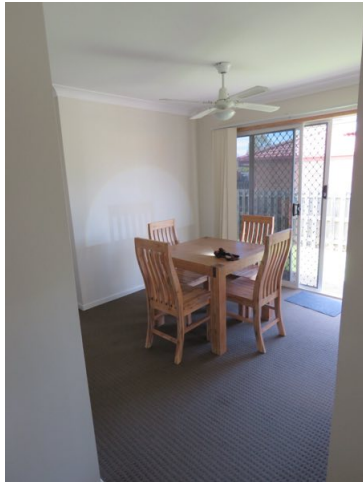
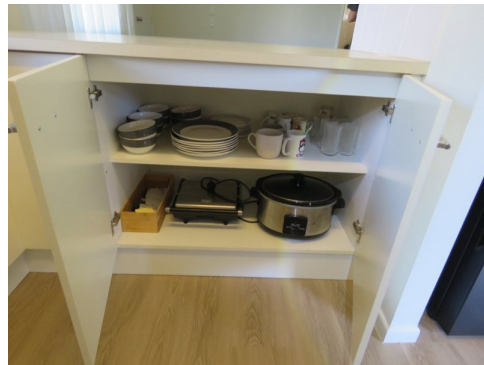
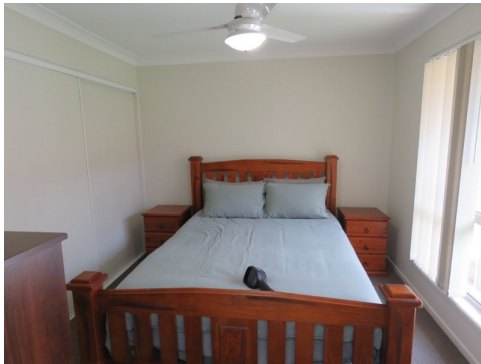
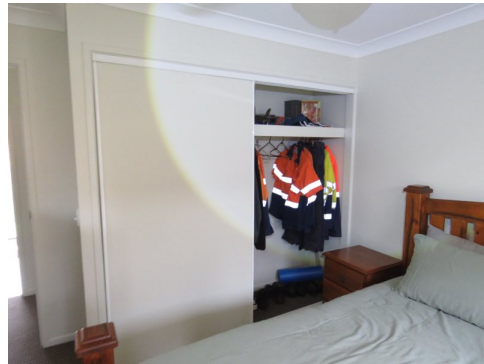
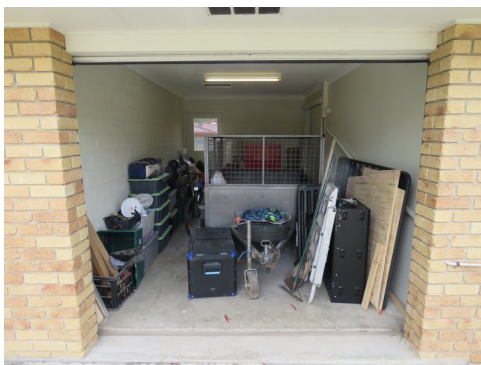
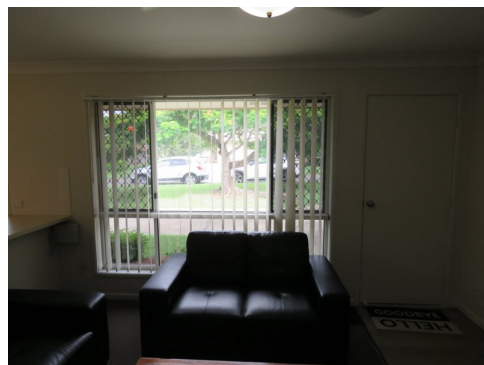
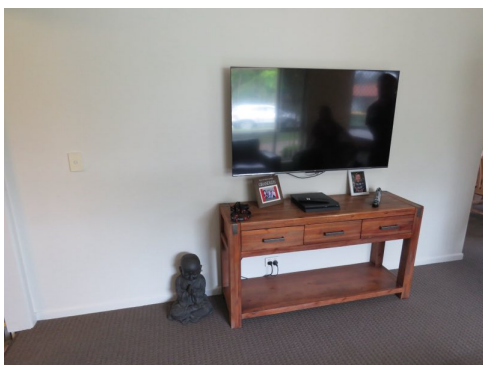
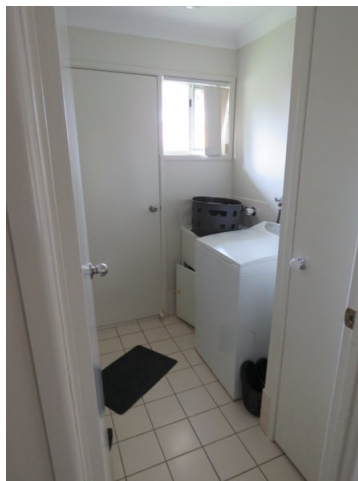
Location: All Areas All Areas

Finding: Additional Photos - Obstructions and Limitations

Information: These photographs are an indication of the obstructions and limitations which impeded full inspection of the property at the time of inspection. These obstructions can hide an array of defects and should be removed to allow full inspection to be carried out. A re-inspection is recommended once the areas are made accessible.

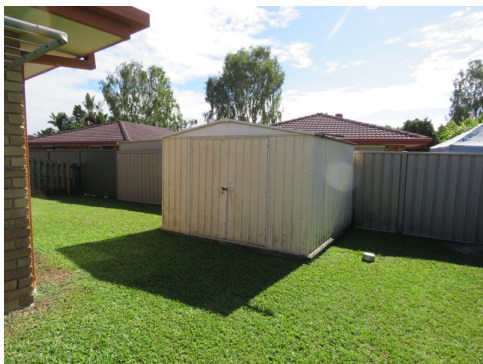
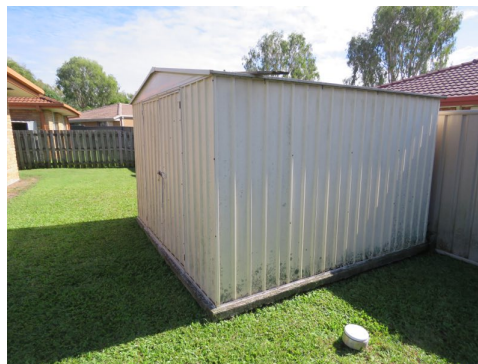
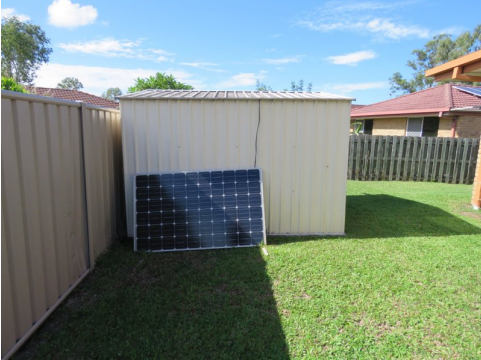
Location: Shed Rear

Finding: Rear Shed – Inaccessible

Information: At the time of inspection, the rear shed was locked and inaccessible. As a result, the internal condition and any potential defects within this structure could not be assessed.
