# Building and Timber Pest Inspection Report

Inspection Date: Wed, 18 Mar 2026

Property Address: 4/50 Eleanor St, Footscray VIC 3011,  
Australia

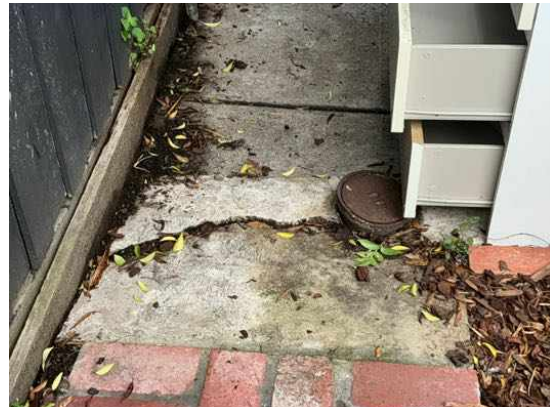
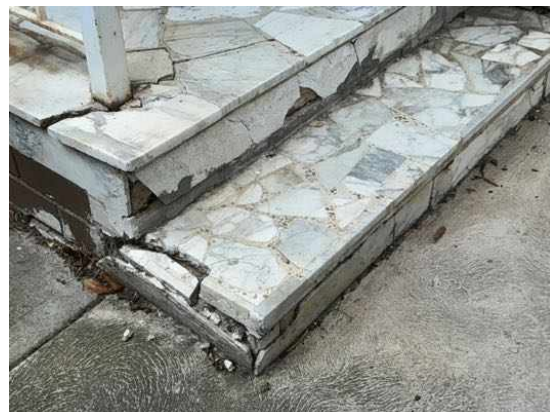
Building: Main Building  
Location: All Internal Areas  
Finding: Paving - Uneven  
Information: Sections of the external paved area are uneven, creating a potential trip hazard. It appears as though the area has been subject to rough installation, or that paving sections have lifted due to movements in the foundation of the property.

Where paving creates a trip hazard, personal injury may ensue if due caution is not taken by all persons within this area.

Re-paving of the area is required as soon as possible to remedy this situation. Further consultation with a specialist concreter is advised.

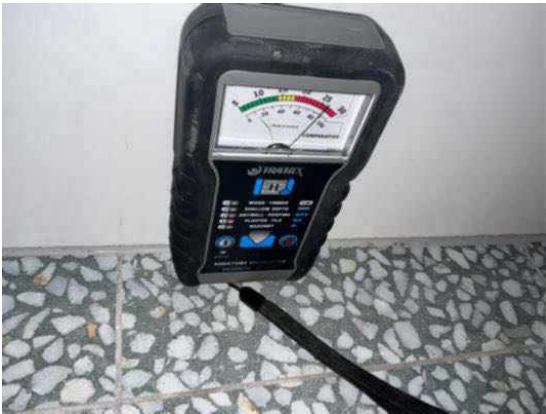
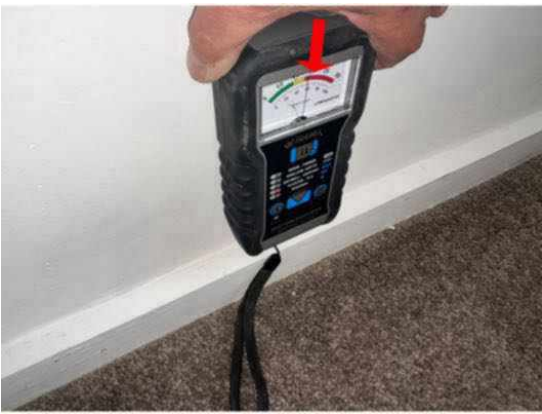
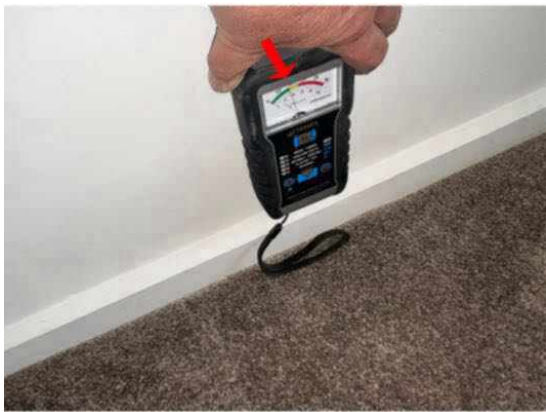
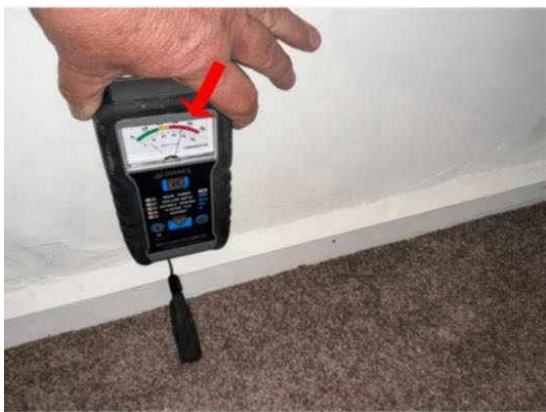
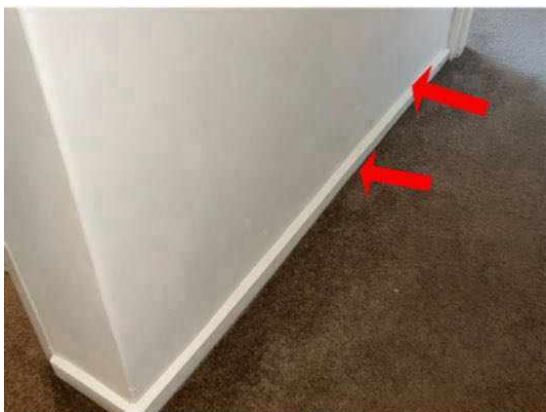
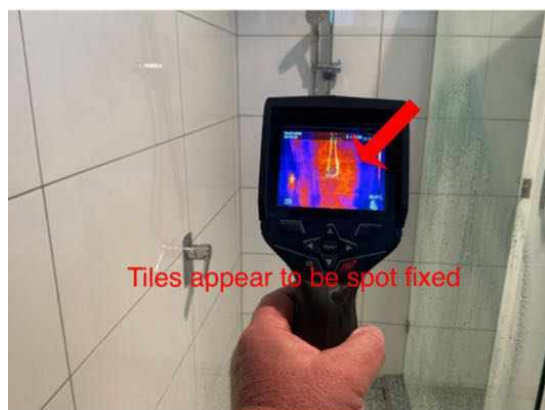
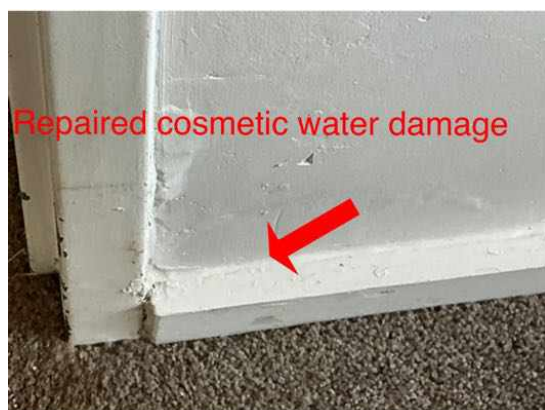
Building:	Main Building
Location:	Bathroom
Finding:	Shower base - suspected Leaking
Information:	Leaking was evident to the shower base at the time of inspection. It is suspected that the leaking has occurred as a result of minor impact damage to the shower base or general ageing of the building elements.

Leaking from the shower base, where left unattended, is likely to lead to water damage to adjoining flooring and walls. Such damage can lead to water damage and necessitate extensive remedial works being required. Active water leaks may also create an environment that is susceptible to the formation and development of mould.

A moisture meter and thermal camera were used and high readings were obtained from the bottom 400 mm of the shower base both inside the shower closet and the adjacent internal walls. The shower closet appears to have been a recent renovation and the tiles appear to be adhesive spot fixed without a full coverage of adhesive endearing the title to the substrate. Shower leaks can be caused by numerous reasons for example plumbing leaks, poor waterproofing techniques and poor tile installation. Spot fixing can allow the transfer of moisture between the tile and the substrate.

Appointment of a tiling and waterproofing contractor is required to review as soon as possible and prior to further use of the shower.

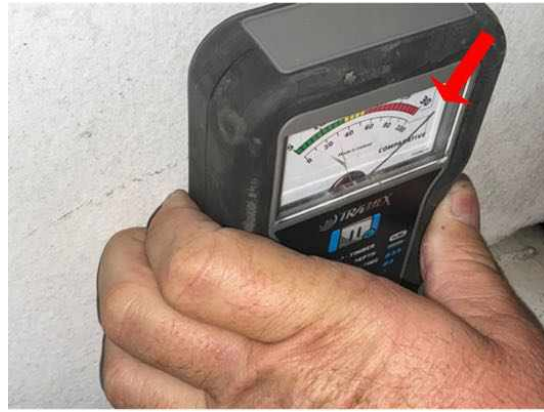
Building: Main Building  
 Location: Roof Exterior  
 Finding: Exterior roof - Leaking- minor  
 Information: Active roof leaks were evident at the time of inspection. Roof leaks can have a number of causes, including damage to roof coverings, deterioration of roof fixtures and fittings, or loosely associated materials (fascias etc.).

Where water leaks are active, rain penetration is likely to cause water damage to associated structures and building elements in this area, which can have a range of implications. If left unmanaged, the development of major structural damage to the roofing and associated structures may occur.

A roof plumber should be appointed as soon as possible to primarily identify the cause of the leak, and to provide subsequent repair works as necessary. Depending on the extent of the damage, replacement of sections of the roof covering and/or roofing structures may be required, and may be performed by a registered builder or qualified carpenter.

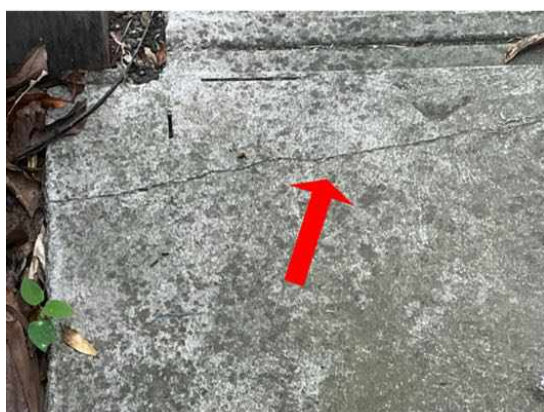
Building: Main Building  
 Location: All External Areas  
 Finding: Crack in concrete slab - Category 1  
 Information: A crack coded as Category 1 was identified in the slab. A Category 1 crack is described as a fine but noticeable crack, with the slab at an otherwise reasonable level.

To be considered Category 1, the approximate width of the crack is less than 1.0mm, or a less than 10mm change in offset when a 3m straight edge is placed over the defect.

Category 1 cracks should be monitored for a period of 12 months. At the end of the monitoring period, identified cracks that are rated greater than Category 2 are considered defects, and require rectification.

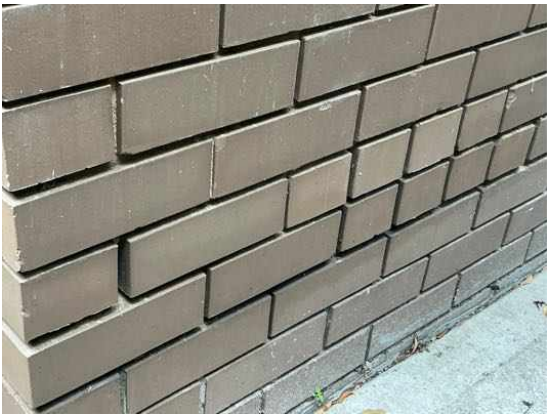
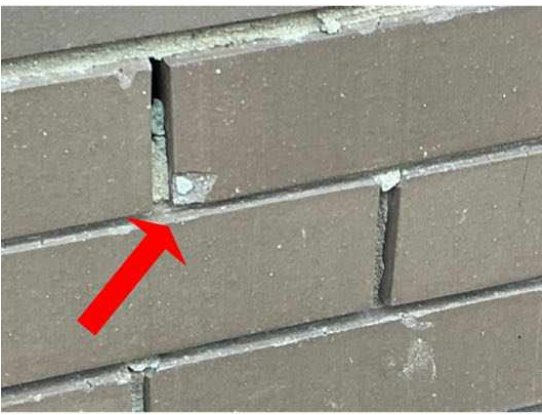
Building:	Main Building
Location:	All External Areas
Finding:	Brickwork - Deteriorated mortar
Information:	Mortar, or 'bedding', is the material which fills joins and intersections between bricks in masonry walls and structures. Sections of mortar in this brickwork were identified as having deteriorated, which is generally expected for a property of this age and condition.

Mortar may deteriorate as a result of age of building materials, minor movement of bricks, or frequent exposure to weathering. Mortar should be replaced to ensure that bricks remain in their intended location and to prevent gaps, which would allow water or moisture ingress and secondary damage as a result.

Mortar deterioration can be addressed by a bricklayer where areas of deterioration are localised and easily accessible. Alternatively, appointment of a registered builder is advised, to repoint large areas of decaying mortar. Where secondary structural defects have become evident, consultation with a structural engineer may be required.

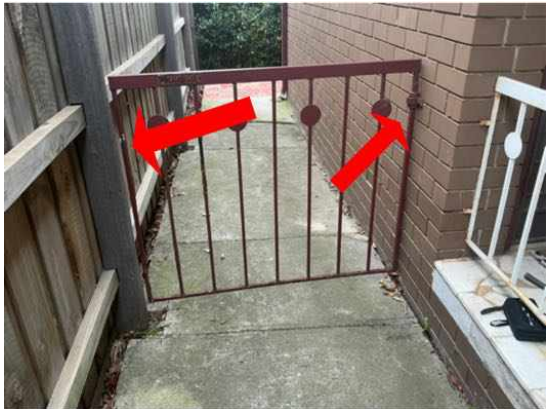
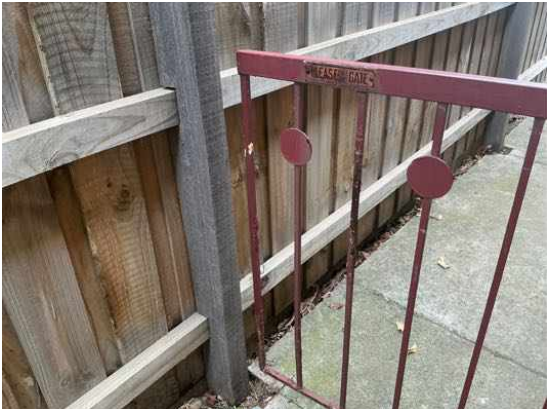
**Finding 3.07**

Information: It's was observed at the time of the inspection that the gate was in need of adjustment. The hinges appeared to be deteriorated and there was no catch holding the gate closed. There were also signs of corrosion to the metal.

A general handyman should be engaged to review at the owners discretion.

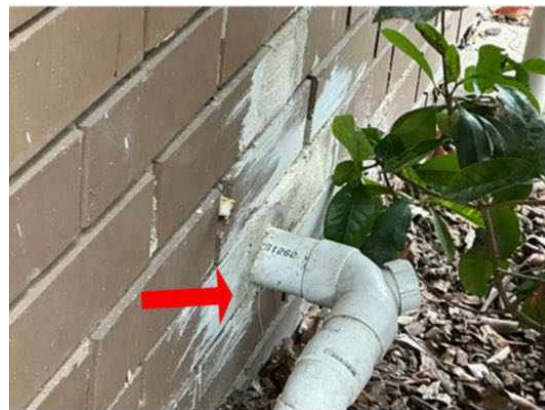
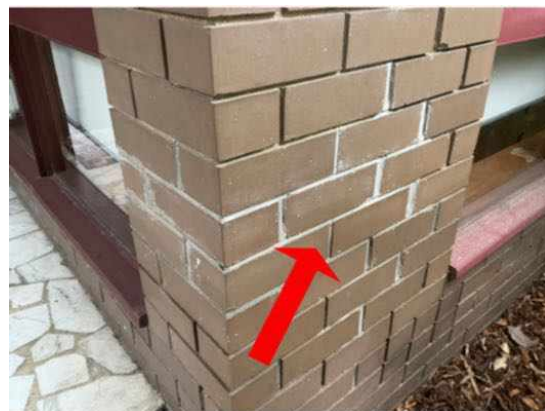
**Finding 3.08**

Building:	Main Building
Location:	All Areas
Finding:	Poor quality repair work
Information:	It was observed at the time of the inspection that repairs has been undertaken to the external brickwork. The repairs are demonstrating poor workmanship and appears to be incomplete. Recent plumbing repairs were also observed.

Although anaesthetic defect it detracts from the overall appearance of the building.

The owners should engage a general handyman or experienced an bricklayer to review at their discretion

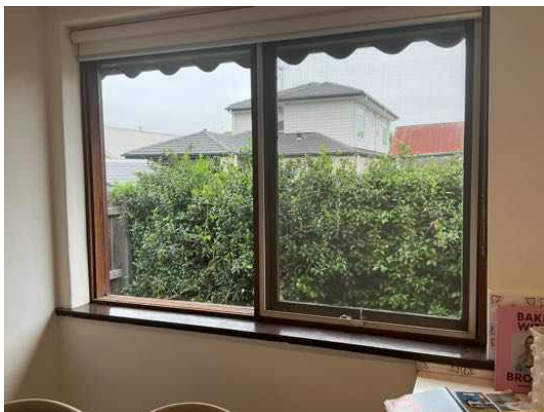
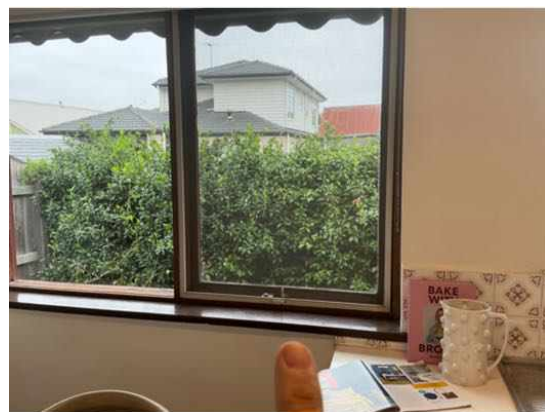
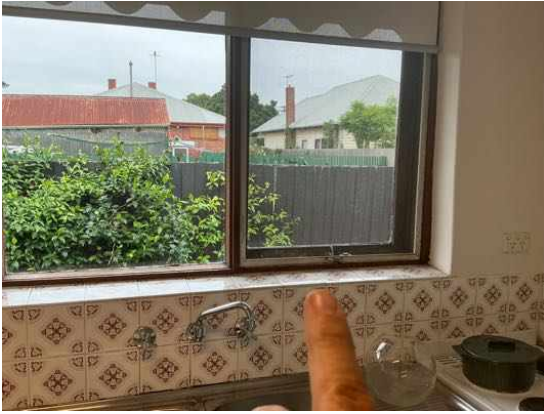
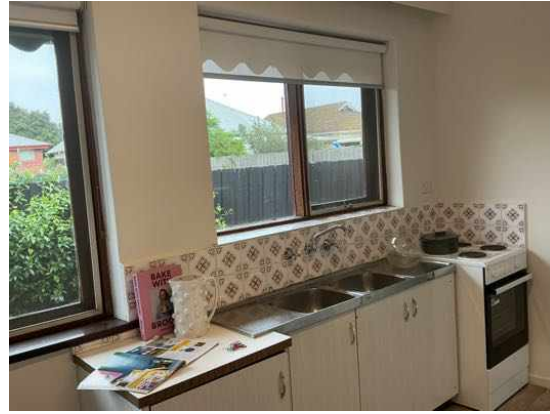
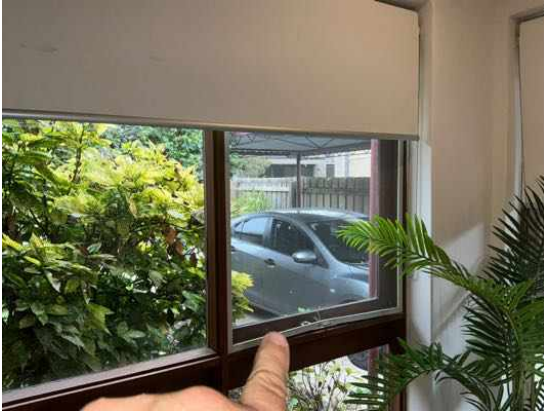
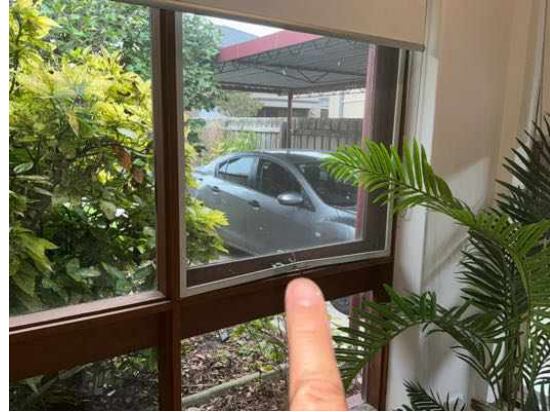
Information: Several awning windows throughout the building were jammed and inoperable at the time of the inspection. Windows provide ventilation to the adjoining area and should be at a fully operational level to ensure user comfort. Restricted function of the window may also pose as a potential safety hazard if required for emergency egress from the building.

Generally, factors such as general age of the building element and a lack of maintenance are the usual causes for this type of defect.

Replacement of window hardware or frame may be required, as well as minor repairs and cleaning. A registered builder or general handy person will be required to repair the window.

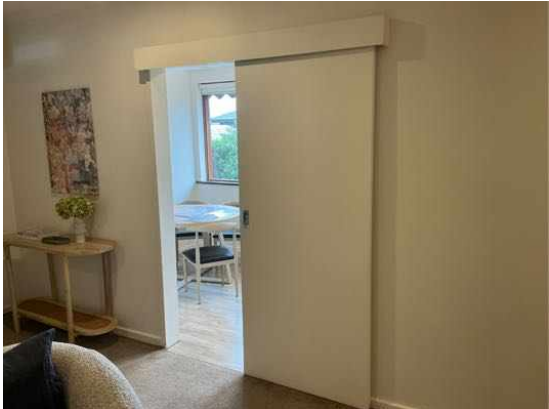
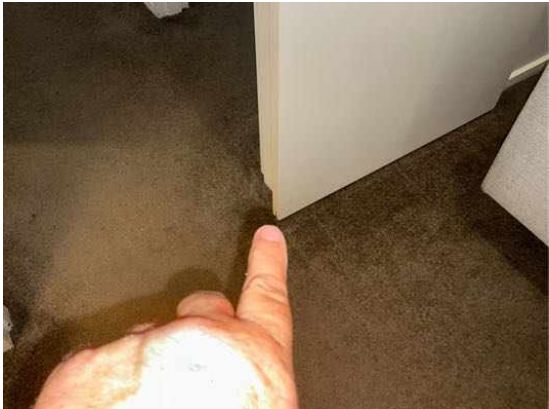
### Finding 3.11

Building:	Main Building
Location:	All Internal Areas
Finding:	Sliding door guides missing/not working
Information:	The door guides for the sliding doors throughout the building are missing.

Doors without the correct guides will cause damage to the paint finishes to the door.

A general handyman or carpenter should be engaged to review at the owners discretion

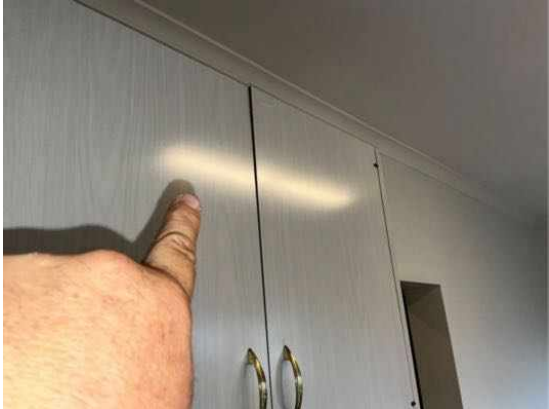
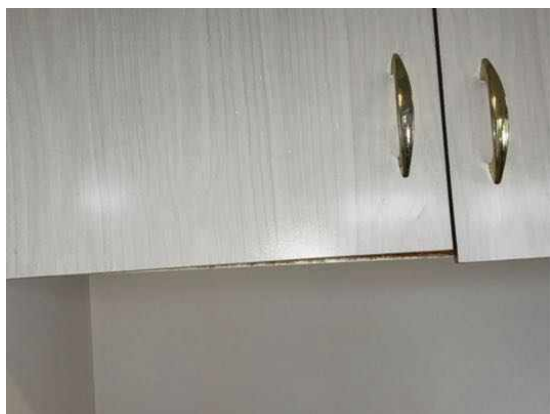
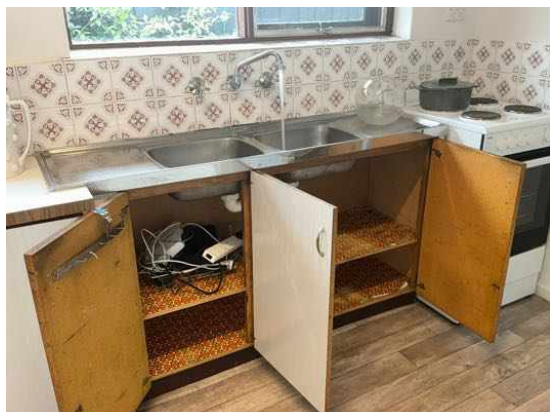
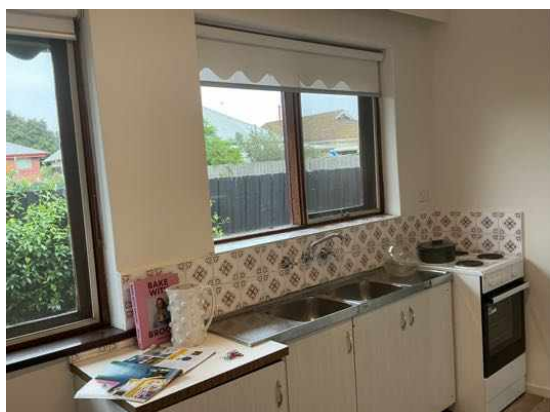
**Finding 3.12**

Building: Main Building  
 Location: Kitchen  
 Finding: Kitchen cabinets deteriorated  
 Information: It was observed at the time of the inspection that several cabinet doors require required adjustment. Some cabinet doors had damaged melamine laminate surfaces. Which unattended to will deteriorate further overtime.

An experienced cabinet maker should be engaged to review as their owners disc

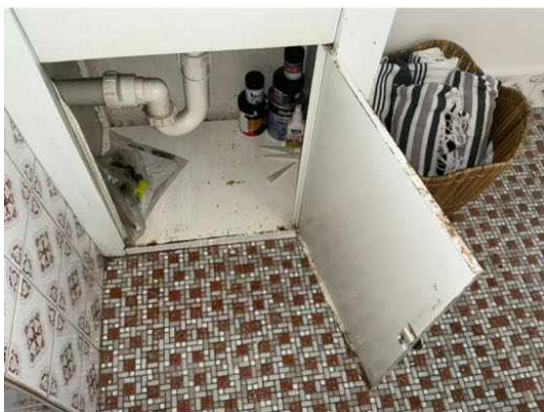
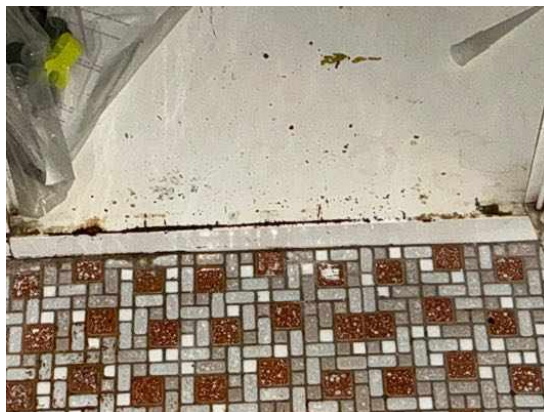
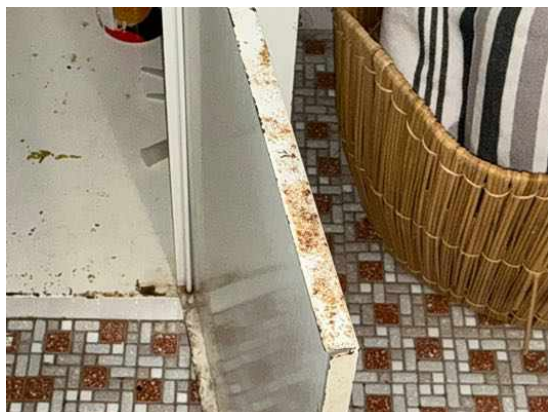
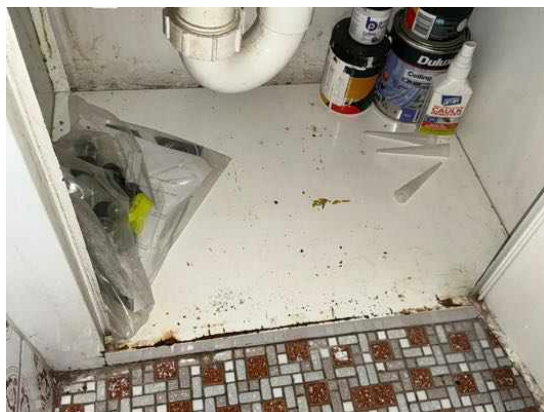
### Finding 3.13

Building: Main Building  
 Location: Laundry  
 Finding: Laundry tub cabinet rusted  
 Information: It was observed that the laundry tub cabinet was rusted.

In time if left untreated the rust could get worse and the cabinet could become structurally compromised.

A general handy man should review at the owners discretion.

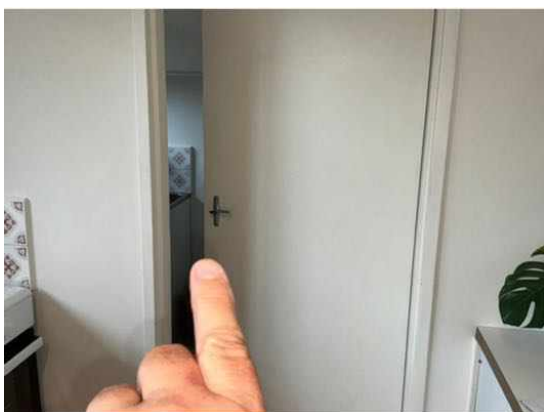
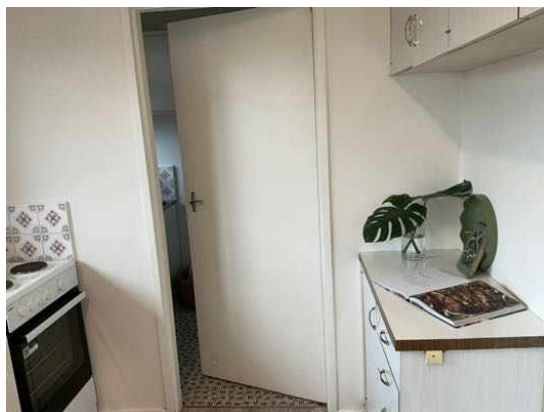
### Finding 3.14

Information: It was observed that the laundry internal door is rattling when closed at the latch.

Unadjusted, the rattling should can be noisy and irritating. Door movement also can cause cracking paintwork to the door frame and architraves.

A qualified carpenter or handyman should be engaged to adjust at the owners convenience

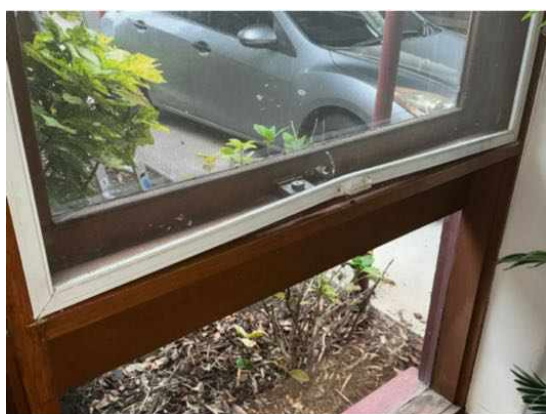
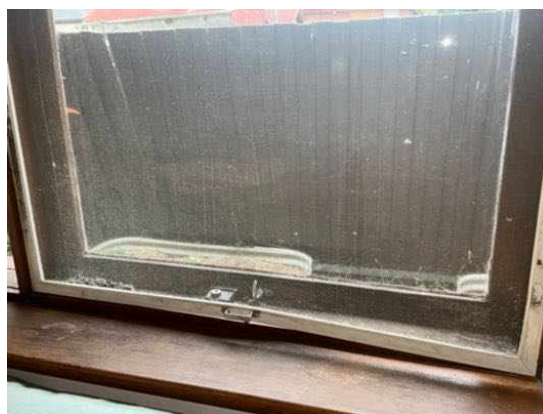
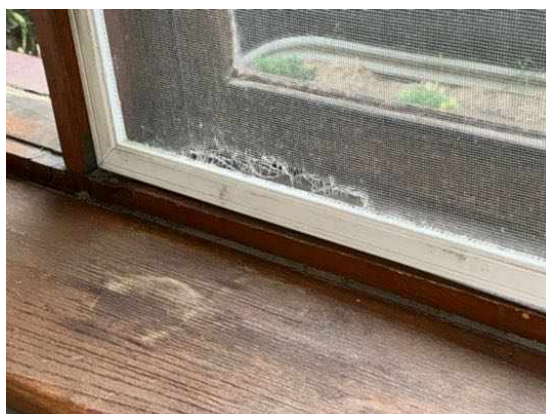
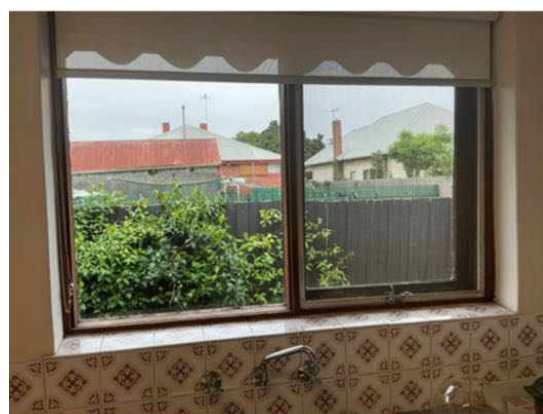
### Finding 3.15

Building:	Main Building
Location:	All Internal Areas
Finding:	Fly screens damaged
Information:	It was observed that several fly wire screens throughout the building at the time of the inspection showing deterioration and mesh tear damage

Fly wires are required to prevent the invasion of mosquitoes and other airborne insect pests

A general handyman should be engaged to review at the owners discretion

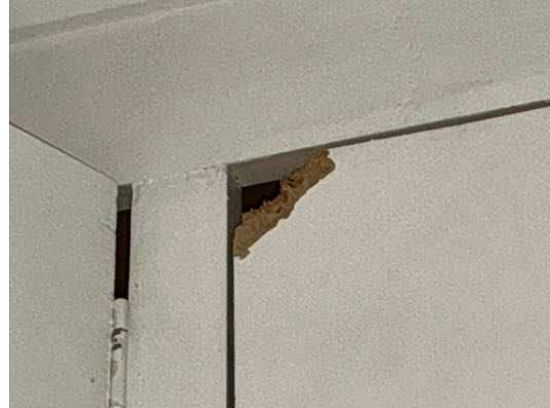
### Finding 3.16

Building:	Main Building
Location:	Bedroom - Master
Finding:	Damaged wardrobe door
Information:	It was observed at the time of the inspection that the small wardrobe door two bedroom two has been chipped and damaged. Although an anaesthetic defect it detracts from the overall appearance of the building.

A general handyman should be engaged to review at their owners discretion.

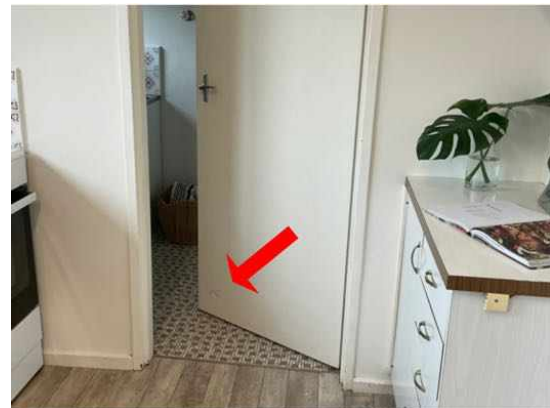
### Finding 3.17

Finding: Laundry door damaged

Information: It was observed at the time of the inspection that the laundry door appears to have suffered some impact damage which is evident in the face of the door

A qualified carpenter or general handyman should be engaged to review at their owners discretion

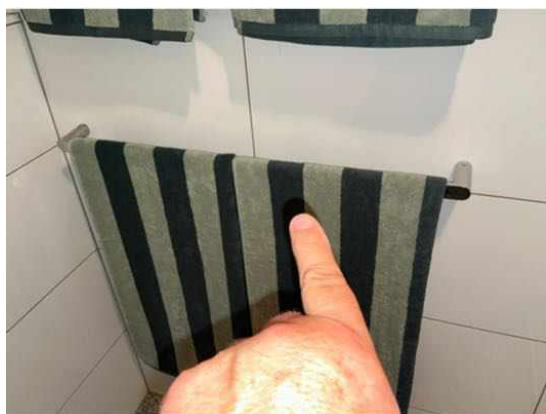
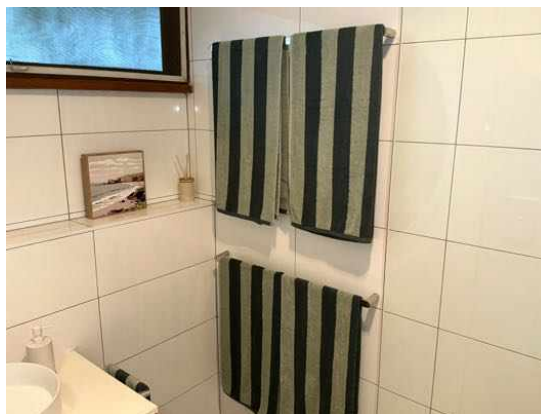
### Finding 3.18

Finding: Towel rail - Loose

Information: The towel rails were found to be loose at the time of inspection. While not a major operational defect, function can deteriorate if the problem is left unmanaged.

It is advised that the homeowner performs remedial works to re-attach the towel rail to its original fixing. A general handyperson may be required to perform these works.

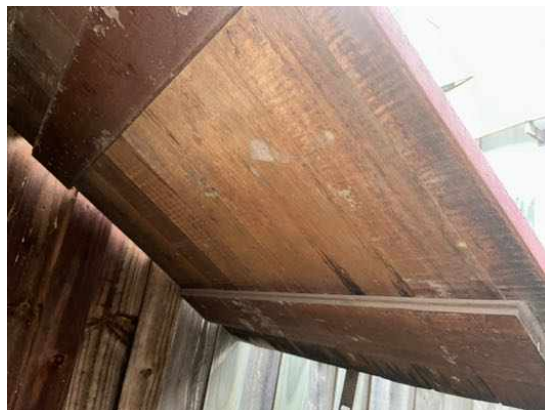
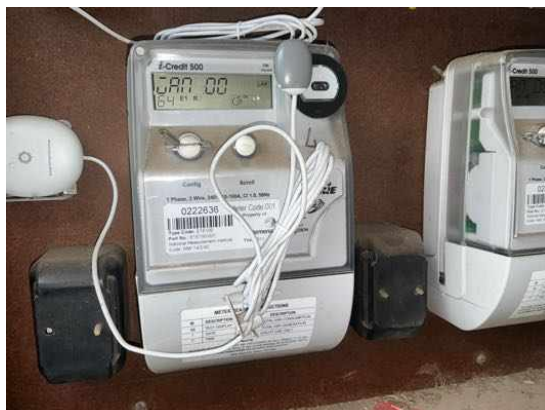
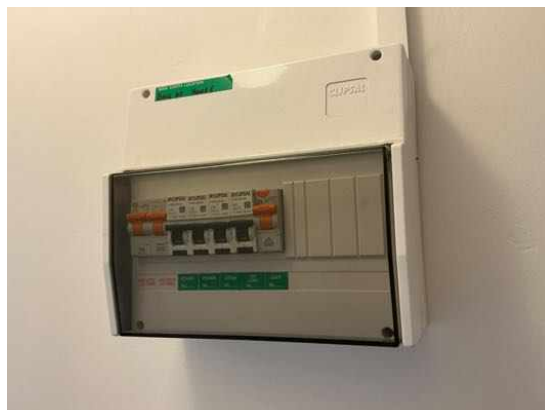
Building:	Main Building
Location:	Meter Box
Finding:	Termite Management System - no evidence of a chemical installation
Information:	The application of a post-construction chemical termite barrier is highly recommended for all properties, particularly if live termite activity has been found on the site previously. Such barriers are highly effective in preventing termite attack on any timber building elements throughout the property.

A durable notice should be placed in the switchboard unit to indicate current termite barriers. At the time of inspection, it appeared as though no termite management system has been installed, with no evidence to suggest preventative works taking place.

The client may consider gaining further advice from a pest controller as to the costs and procedures involved with this application. It is recommended that obtaining such advice be a short-term priority.

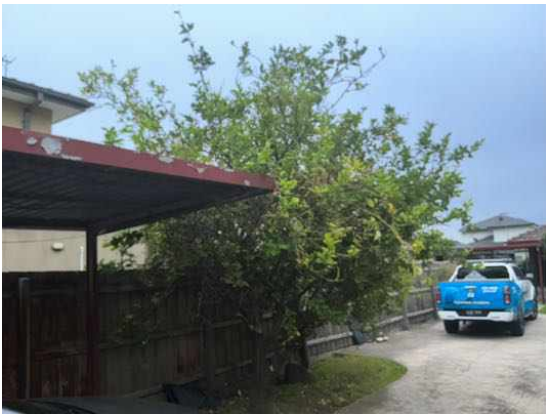
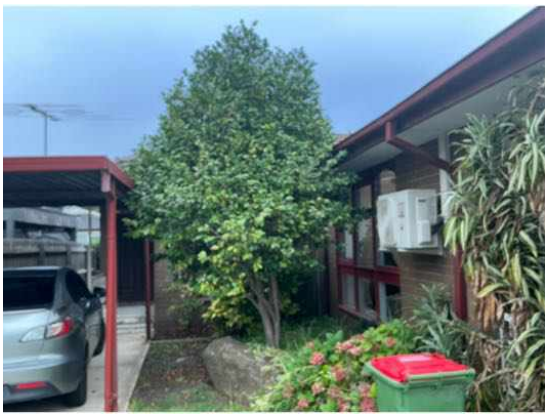
## Finding 6.02

Building:	Main Building
Location:	All External Areas
Finding:	Trees on the property TP
Information:	During the inspection, it was observed that significant trees are located within the property perimeter which poses a potential risk for termites infestation. The proximity of the trees to the structure increases the likelihood of subterranean termites using the root system as pathways to access the building compromising its integrity.

Given the propensity for such trees to harbour and facilitate the spread of termites, it is strongly recommended that a comprehensive termite protection plan be implemented to mitigate this risk.

As an initial remedial action consultation with a qualified arborist and pest control specialist is advised to assess the health and species of the trees in question, as well as explore options for creating a barrier or modifying the landscape to deter termite access.

Regular monitoring and maintenance should be prioritised to ensure the ongoing protection of the property from potential termite activity.

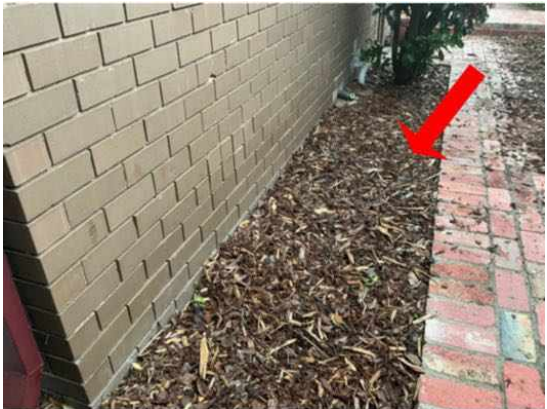
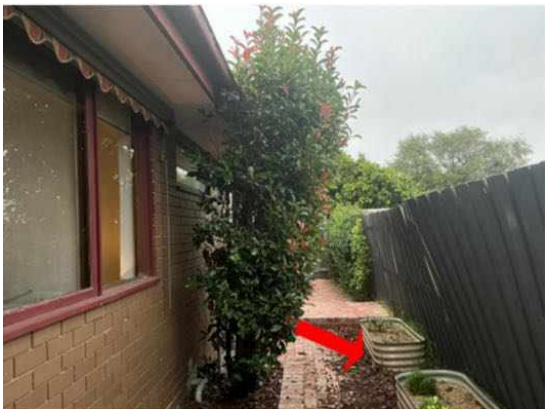
**Finding 6.03**

Building: Main Building  
 Location: All External Areas  
 Finding: Garden Beds - Conditions Conducive to Termites  
 Information: Garden beds were found to be evident in the garden area. These garden beds can include untreated timber, and with a combination of moisture from watering hosing can make conditions conducive to termite activity and termite ingress.

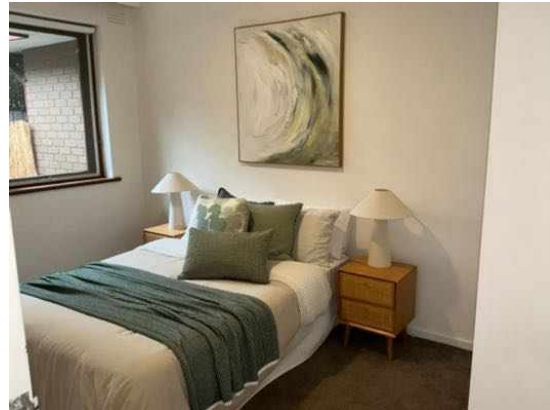
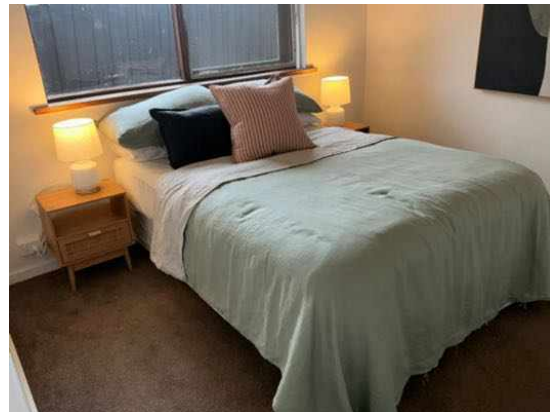
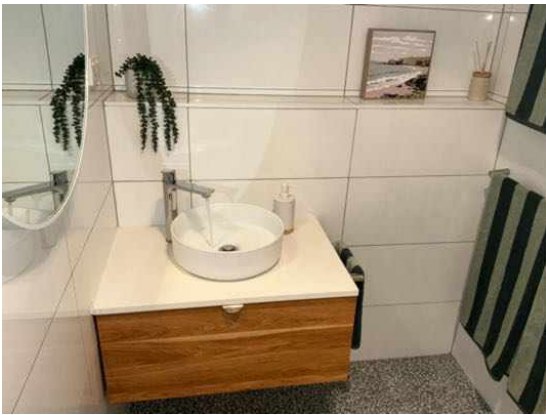
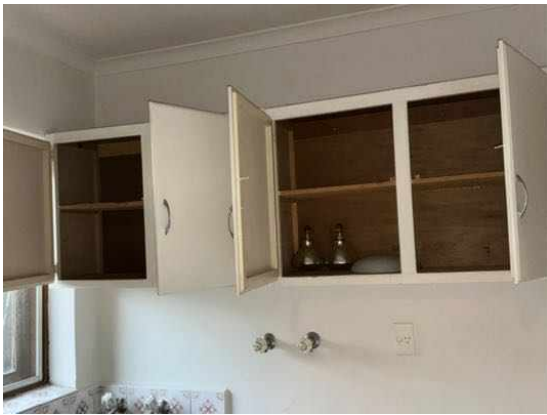
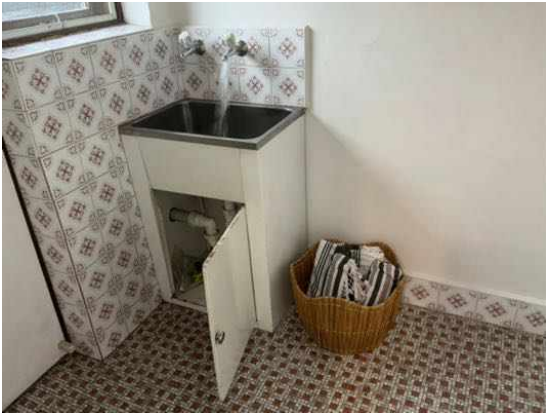
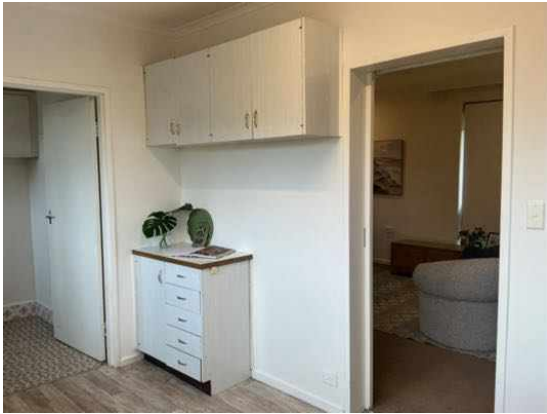
Building: Main Building  
Location: All Areas  
Finding: Additional Photos - Obstructions and Limitations  
Information: These photographs are an indication of the obstructions and limitations which impeded full inspection of the property at the time of inspection. These obstructions can hide an array of defects and should be removed to allow full inspection to be carried out. A re-inspection is recommended once the areas are made accessible.
