Building and Timber Pest Inspection Report

Inspection Date: Thu, 12 Feb 2026

Property Address: 37 Doe St, Rye VIC 3941, Australia

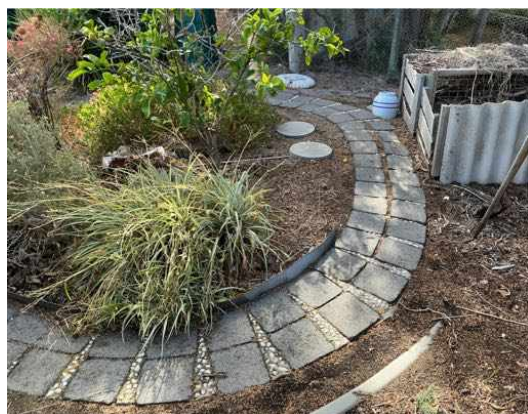
Information: Sections of the external paved areas are uneven, creating a potential trip hazard. It appears as though the area has been subject to rough installation, or that paving sections have lifted due to movements in the foundation of the property.

Where paving creates a trip hazard, personal injury may ensue if due caution is not taken by all persons within this area.

Re-paving of the area is required as soon as possible to remedy this situation. Further consultation with a specialist concreter is advised.

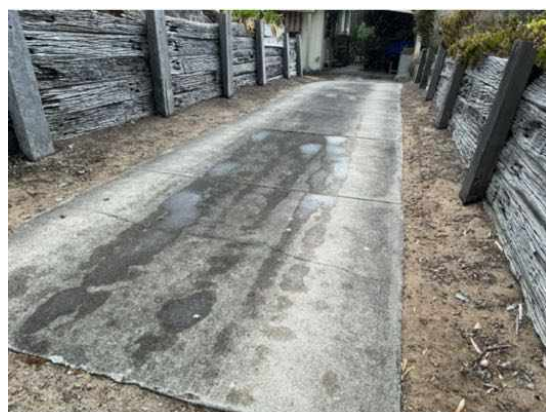
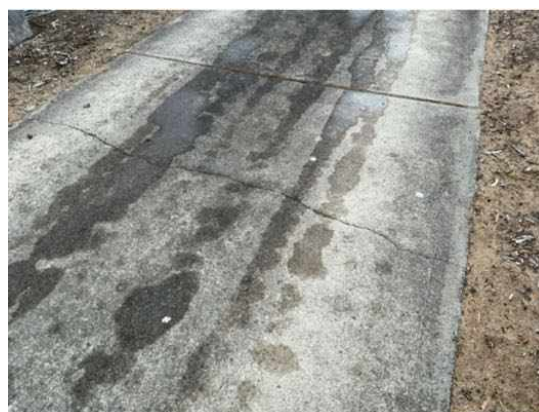
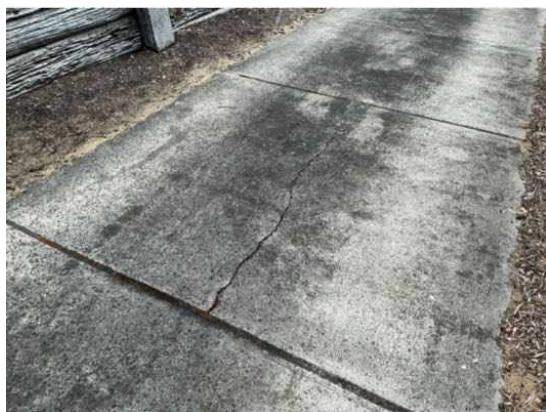
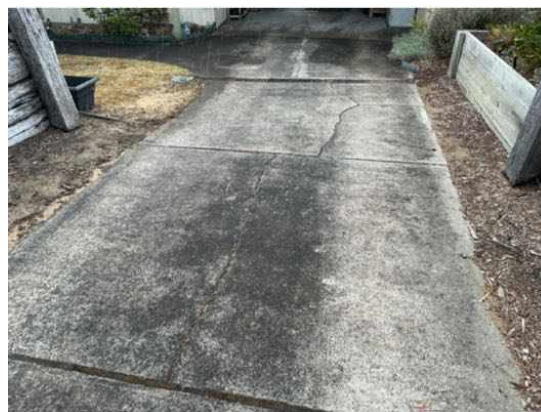
Finding 3.02

Building:	Main Building
Location:	Driveway
Finding:	Driveway Cracking
Information:	Cracks were identified in the driveway external concrete paving. Although cracks are quite noticeable, they are often only considered to be an appearance defect, and usually do not indicate any structural damage.

Generally the cause of the cracks in existing concrete paving such as driveways and pathways is indicative of the expansion and contraction of the concrete. Such causes are generally due to environmental factors, such as moisture levels, weather conditions, root systems of nearby trees or the soil types on which they are laid.

Cracks may also be due to poor original installation of the concrete. Factors such as poor compaction of the sub surface and/or inadequate reinforcing of the slab may create cracking and other secondary defects.

Monitoring of all cracking should be conducted frequently. Always contact a building inspector should cracks widen, lengthen, or become more numerous.

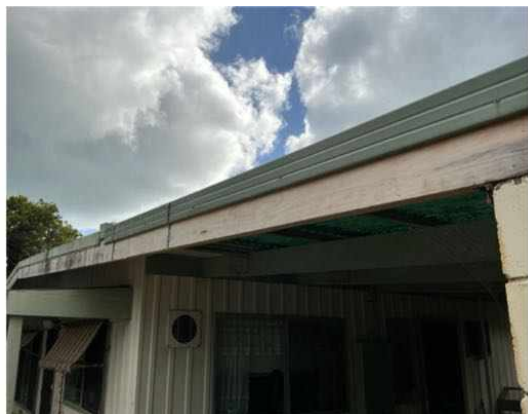
Finding 3.03

Building:	Main Building
Location:	Exterior
Finding:	External painting deteriorated
Information:	Much of the external paintwork has been neglected and requires attention to prepare and re-paint.

Whilst incomplete or missing paint finish is generally an appearance defect, it can also lead to the development of secondary building defects over time. Incomplete areas of paint finish expose the area to moisture, potentially accelerating the deterioration of underlying building materials.

Degraded paint finishes should be sanded back, filled, leveled and painted, as applicable. Where inadequate or missing paint protection has led to the deterioration of the associated building element, repair and/or replacement of this building element may be required.

A painting contractor should be appointed as soon as possible to perform necessary works to aid the appearance of the affected area and to ensure the area is protected against further deterioration. Alternatively, the homeowner following manufacturer instructions may perform these works.

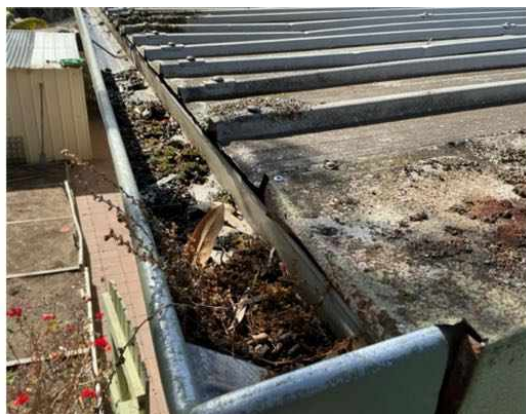
Finding 3.04

Blocked gutters are likely to lead to high levels of moisture in the affected areas. Such moisture will not only cause rust and decay of the associated building materials, but can also provide conditions that are conducive to termite and timber pest activity. Blockages in gutters should therefore be removed immediately to ensure dry conditions are maintained.

Consult a Licensed Plumber for further specific advice on remedial works that may be required. In the interim, it is highly advised that blocked gutters be removed by the homeowner or a general handyperson as a matter of urgency.

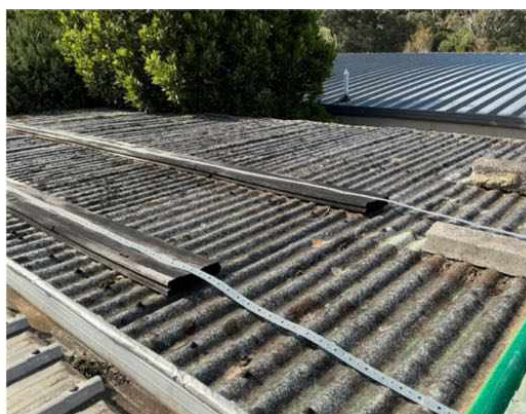
Finding 3.05

Building:	Main Building
Location:	Carport
Finding:	Roof sheets deteriorated and fixings loose and rusted
Information:	Upon inspection of the exterior carport roof covering, it was noted that the fibreglass roof sheets have deteriorated and numerous roof fixings have become loose from their original fixings or are rusted. It is suspected that this defect has developed as a result of a lack of adequate maintenance, but may also have been caused by inappropriate fixings being used in the construction process.

Loose roof sheeting detracts from the weather tightness of the roof covering, making the internal roofing structure susceptible to water penetration and subsequent damage. If left unaddressed, it is likely that secondary damage to associated building elements will develop, potentially necessitating remedial works to these structures.

A roofing restoration contractor should be appointed to advise on rectification options and on the cost of repair. It is advised that remedial works be performed as soon as possible to prevent any further damage.

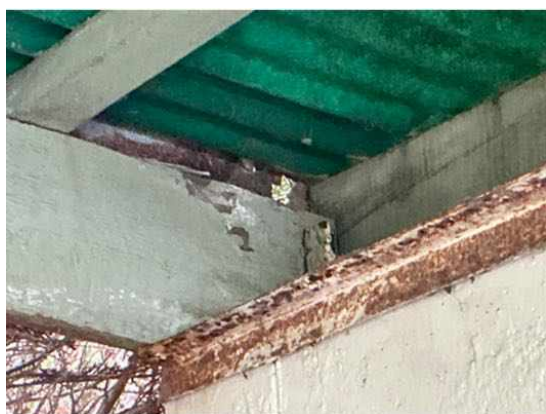
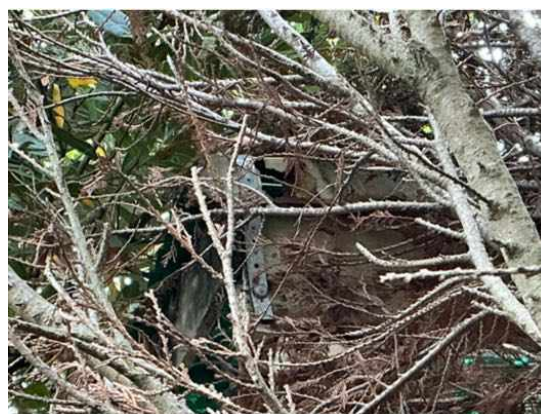
Finding 3.06

Location: Carport
 Finding: Flashings - Rusted or corroded
 Information: The carport flashing to the roof shows evidence of rusting and corrosion, which is likely to have developed as a result of excessive exposure to moisture and or inadequate coatings.

As surface rust provides no protection to the underlying iron, the deteriorating condition is likely to worsen if not addressed in the short-term future.

Where possible, the use of galvanized (treated) metals or aluminium coated metals aid in rust prevention, as does regular general maintenance. Rust formation can be controlled with coatings, such as paint, that isolate the iron from the environment.

Rusting and corrosion should be managed by ideally removing or limiting the affected surface from exposure to moisture. A registered builder may be appointed to replace any building elements that have been severely affected by rust or water damage.

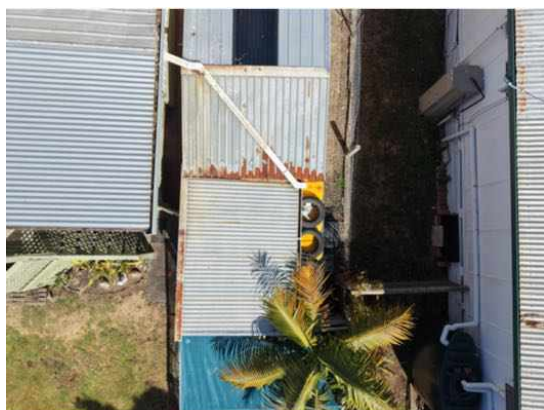
Finding 3.07

Building: Main Building
 Location: Yard - Back
 Finding: Rust and damage to shed
 Information: Rust and damage to parts of the shed. Recommend repair/replacement by a handyman or carpenter to reduce the risk of future deterioration at the owners discretion.

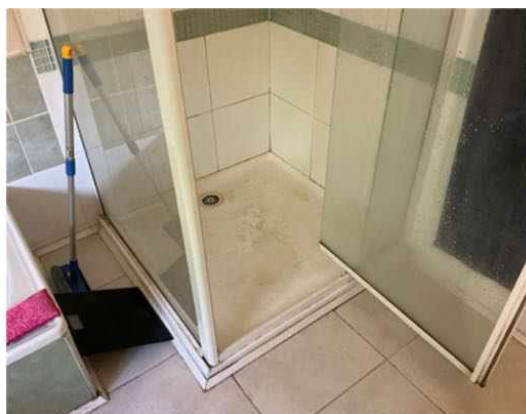
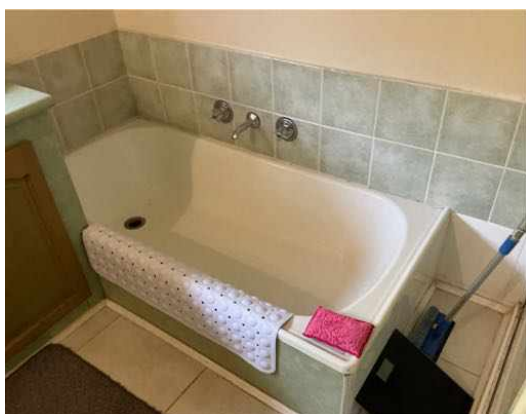
Finding 3.08

Building:	Main Building
Location:	Bathroom
Finding:	Bathroom Sealant grouting - Missing or damaged degraded
Information:	It was noted on inspection that sealant or grout is degraded/missing or damaged to the tiled shower alcoves and or other areas of the bathrooms.

Different materials and floor areas move at different rates, generally causing cracking to grout or sealant at this point. A flexible sealant is required to allow for expected expansion and contraction, while keeping the joint water tight and protective of all associated building materials.

Flexible and mould resistant materials should be applied to affected areas to prevent any subsequent water damage that is likely to occur. Regular maintenance and replacement of damage or missing or damaged sealant and grout is highly recommended to the wet areas, as this is a regular wear and tear defect. Sealant and grouting in areas that come into regular contact with water should be maintained for the long term care of your property.

A sealant specialist or tiling contractor should be appointed to complete these works as soon as possible

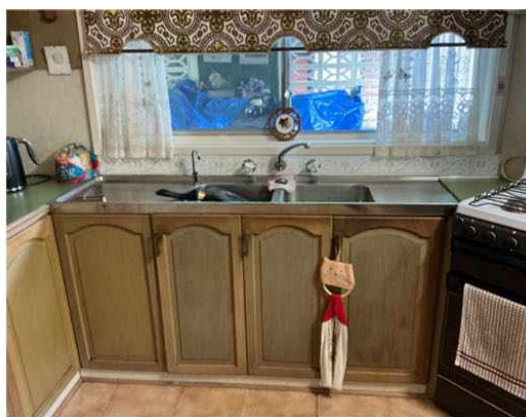
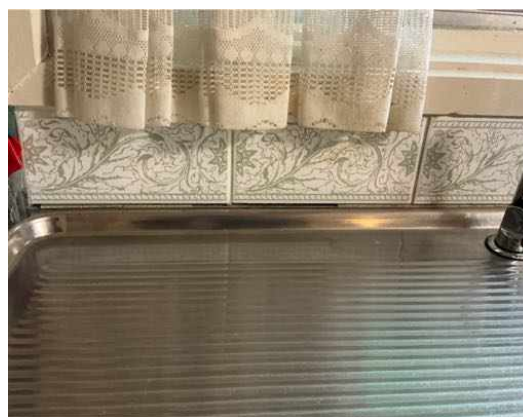
Finding 3.09

Building: Main Building
 Location: Kitchen
 Finding: Kitchen Sealant and grouting - Missing or damaged
 Information: It was noted on inspection that sealant or grout is degraded to the kitchen splash back and or other areas of the kitchen.

Different materials and floor areas move at different rates, generally causing cracking to grout or sealant at this point. A flexible sealant is required to allow for expected expansion and contraction, while keeping the joint water tight and protective of all associated building materials.

scraping out and replacement.

Flexible and mould resistant materials should be applied to affected areas to prevent any subsequent water damage that is likely to occur. Regular maintenance and replacement of damage or missing or damaged sealant and grout is highly recommended to the wet areas, as this is a regular wear and tear defect. Sealant and grouting in areas that come into regular contact with water should be maintained for the long term care of your property.

A sealant specialist or tiling contractor should be appointed to complete these works as soon as possible

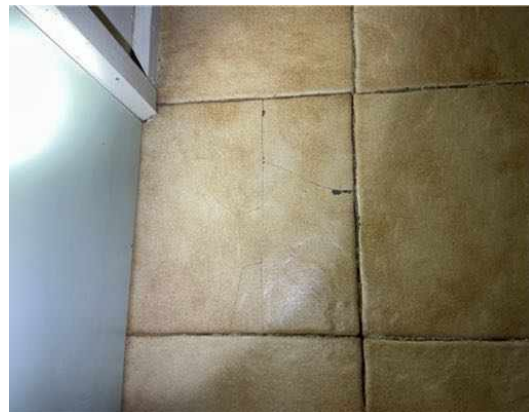
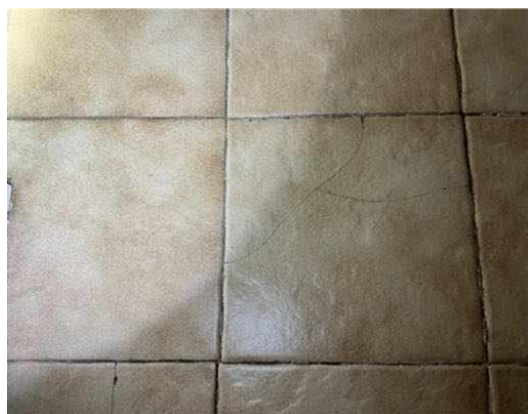
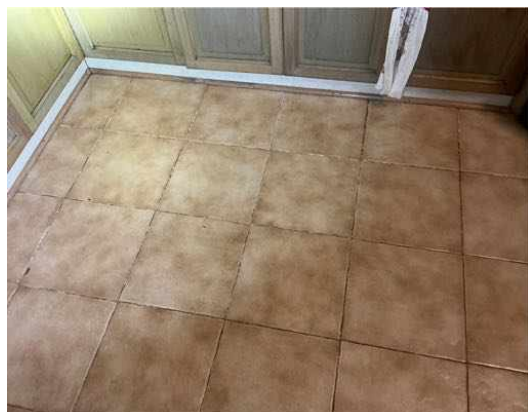
Building: Main Building
 Location: Laundry and kitchen
 Finding: Cracked tiles-laundry
 Information: Cracking/damage to the tiles was evident to the laundry and kitchen areas at the time of inspection. It is suspected that this cracking has occurred as a result of minor settlement/shrinkage or impact damage.

Cracked tiles to the household detract from the overall appearance of the affected areas however it is unlikely to create or lead to any secondary defects.

While not considered a matter of urgency, replacement of cracked tiles is recommended at the clients discretion. A tiling contractor may be appointed to perform these works. Where cracks become more numerous, contact a licensed building inspector for further investigation.

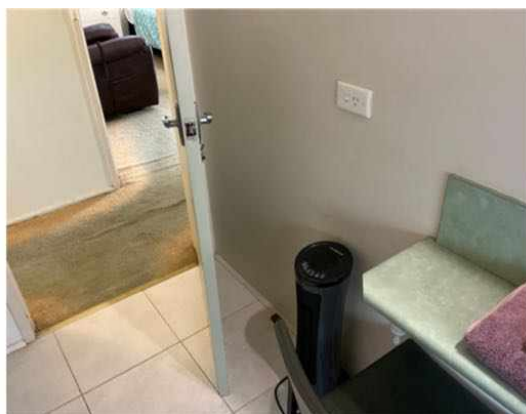
Finding 3.12

Building:	Main Building
Location:	Bathroom
Finding:	Door stop missing
Information:	The door stop to the bathroom is missing and is unable to stop the door furniture from damaging the wall. Although some building elements may seem irrelevant or unnecessary, all building elements play a key role in the operation and function of the overall structure and its performance.

Re-installation or replacement of the door stop is advised as soon as possible to prevent any subsequent damage to the door or associated structures. A general handyman may be appointed to perform these works at client discretion.

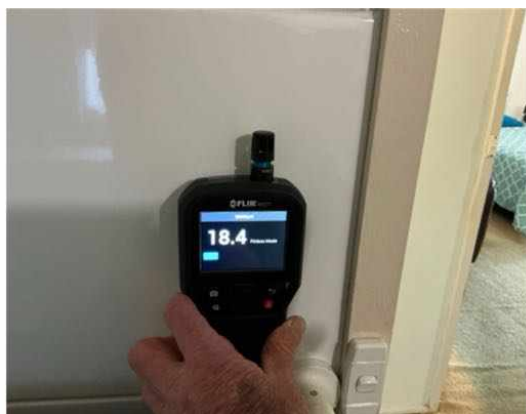
Finding 6.02

Building:	Main Building
Location:	Bathroom
Finding:	Shower - Damp
Information:	Damp is evident to parts of the bathroom shower alcove found using using a moisture meter. This defect is quite common, and is suspected to have been caused by moisture permeating through the grouting in this area, which shows evidence of deterioration creating moist conditions. Leaking pipes within the adjoining wall is also a possible cause. Excessive moisture can attract termites.

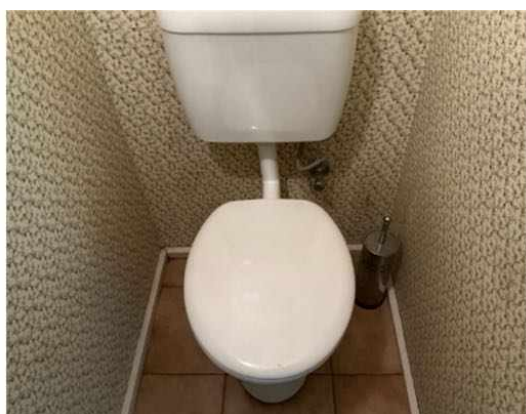
Finding 6.03

Building:	Main Building
Location:	Toilet (WC)
Finding:	Toilet - Leaking
Information:	At the time of inspection, the toilet showed evidence of leaking during operation.

It is highly advised that internal water leak be addressed by a licensed plumber as soon as possible. Use of the leaking toilet should be minimised until such time.

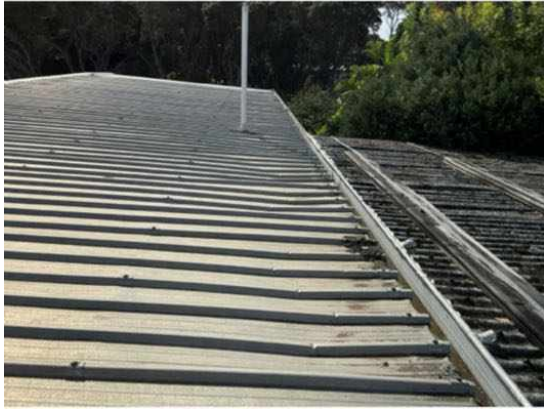
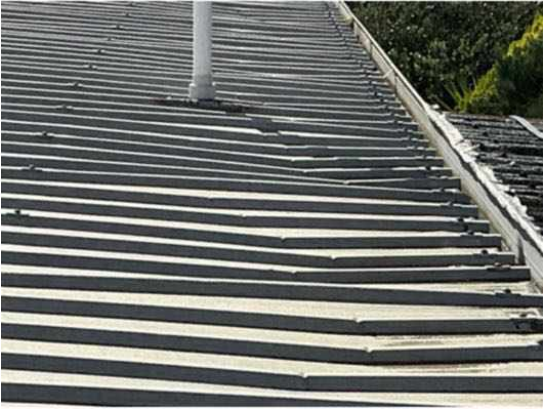
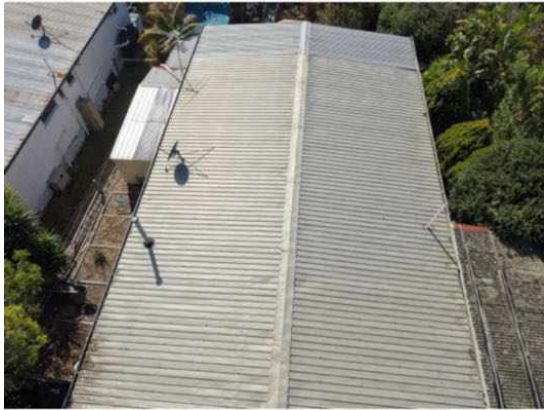
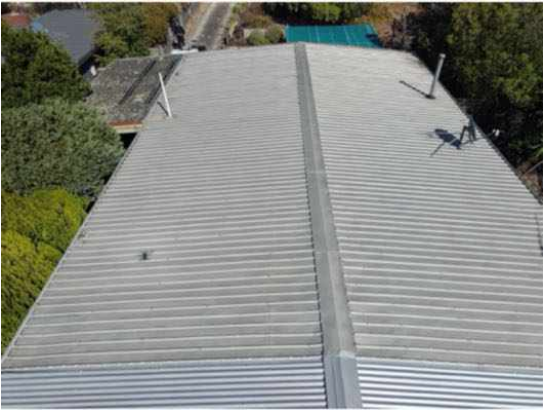
Finding 6.04

Building:	Main Building
Location:	Roof Exterior
Finding:	Roof dented
Information:	On inspection it was noticed that parts of the roof is dented down and could hold

Rectification by a qualified roofing contractor is recommended as soon as possible to prevent potential structural damage, internal water ingress, and conditions conducive to timber pest activity.

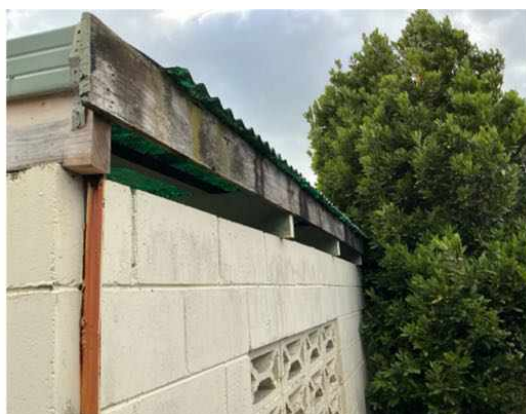
Finding 6.05

Building:	Main Building
Location:	Carport and front patio
Finding:	No gutters or down pipes installed
Information:	No gutters or down pipes installed to the carport and front patio roof. Where plumbing doesn't drain adequately, the area at the apse perimeter can become excessively damp, potentially creating an environment that is susceptible to rust and corrosion of surrounding building elements as well as attracting termites and other pests. Recommend engaging a plumber to install gutters and down pipes to reduce the risk of footing movement and other moisture related issues as soon as possible.

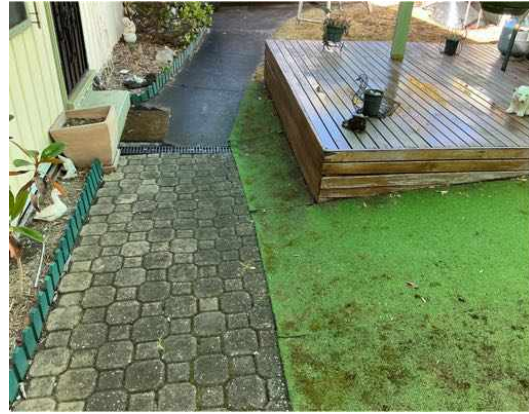
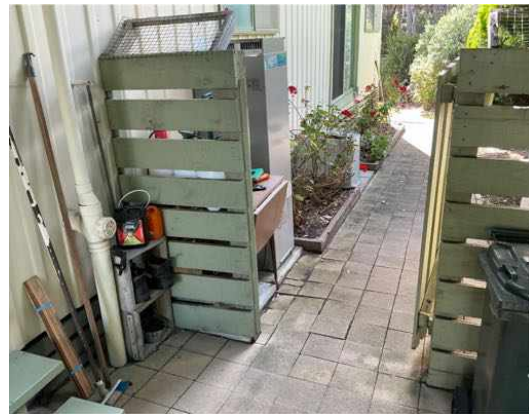
Finding 6.06

Building:	Main Building
Location:	Yards
Finding:	Stored timbers/stumps - external area
Information:	The storing of timbers or tree stumps to the external property increases the risk of termite activity being present. As they are likely to come into contact with weather conditions or excessive moisture wood rot is likely to develop on timbers that are not treated. It is highly recommended that any stored timbers or stumps be immediately removed from areas in which they may attract any termite / timber pest attack. Minimisation of risk / prevention of termite attack is far more adequate than dealing with the presence of termite activity.

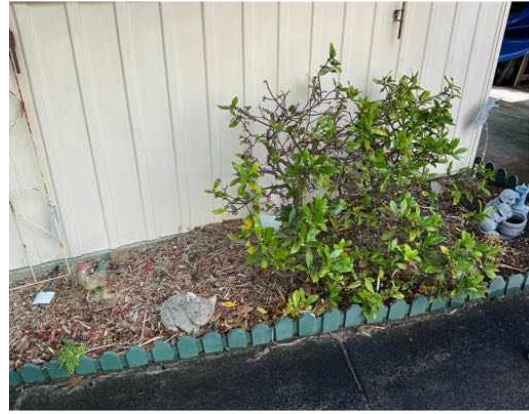
Finding 6.08

Building:	Main Building
Location:	Yards
Finding:	Garden Beds Conditions Conducive to Termites
Information:	Garden beds were found to be evident in close proximity to the building. Garden beds immediately adjacent to the perimeter of the building block the visual inspection of these areas, providing a concealed termite entry point.

These garden beds can include untreated timber, and with a combination of moisture from watering hosing can make conditions conducive to termite activity and termite ingress.

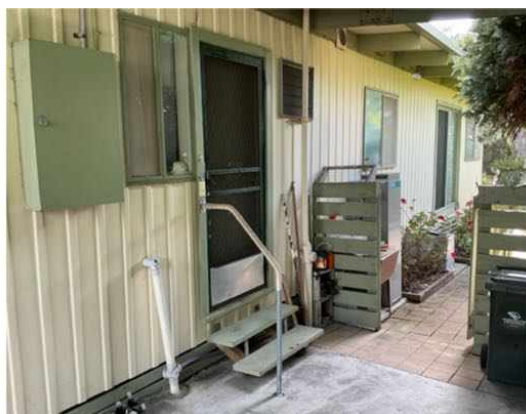
Finding 6.09

Building:	Main Building
Location:	Various parts of the building
Finding:	Bridging attachments to buildings
Information:	Bridging occurs when items against a building provide a concealed entry point for termites into the building or by passing around a termite management system.

Building attachments of this nature need to be frequently inspected for termite activity by a qualified inspector.

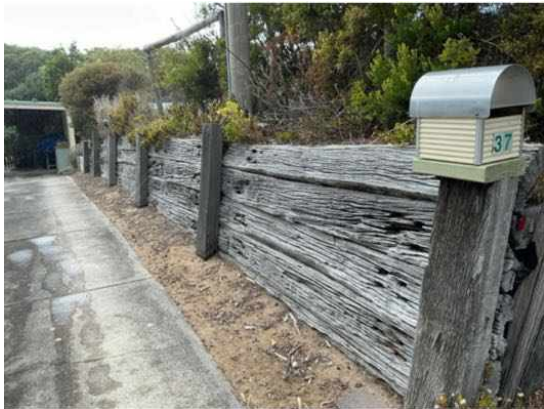
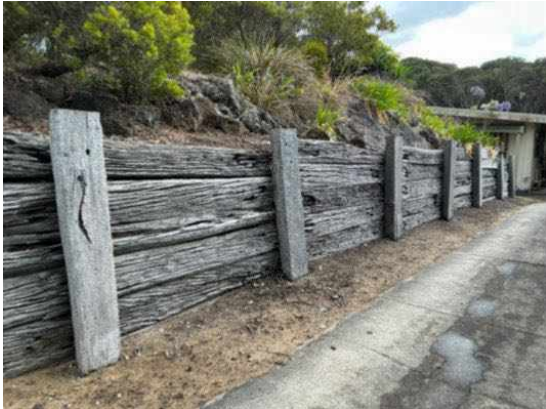
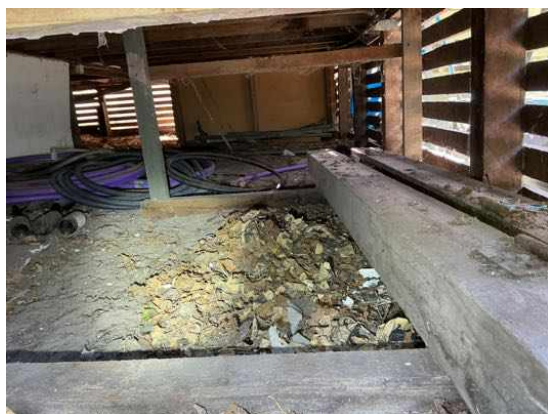
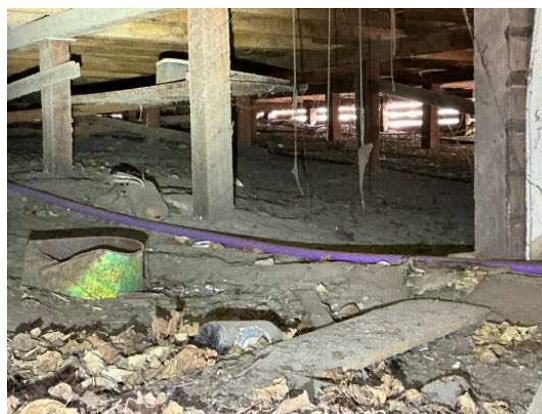
Finding 6.10

Building:	Main Building
Location:	Various parts of the building
Finding:	In ground contact
Information:	Any timbers in direct ground contact provide opportunity for concealed termite entry and are likely to be subject to premature rot and decay as the soil retains moisture or damp conditions against the timbers.

Remove untreated timber that is in direct contact with external grounds. Consider replacement with more durable materials i.e. treated timber or non timber elements. Frequent pest inspections are advised to readily identify any termite activity in these areas.

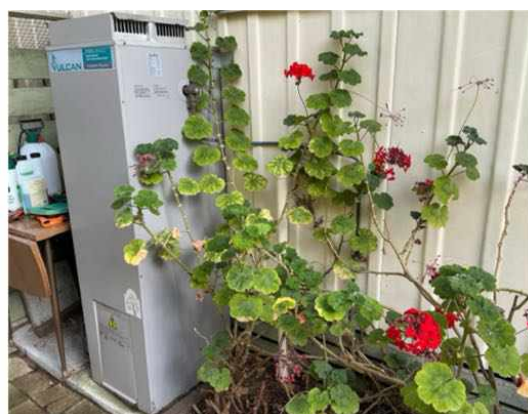
Finding 6.11

Building:	Main Building
Location:	Yard - Back
Finding:	HWS Overflow - Not Connected
Information:	The Hot Water System (HWS) overflow was found to be disconnected from storm water drainage and is creating excessive moisture in the surrounding area.

It is highly recommended that a licensed plumber be appointed to connect the HWS overflow in order to prevent such an environment from being created. These minor works should be carried out as soon as possible.

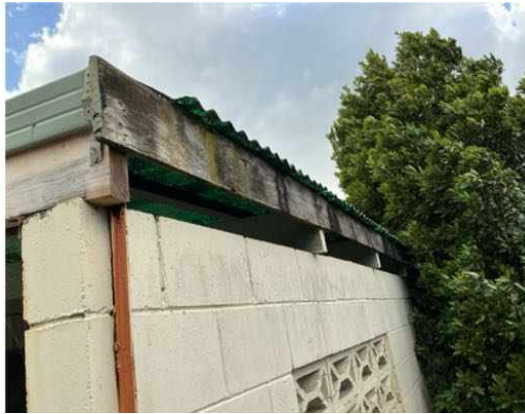
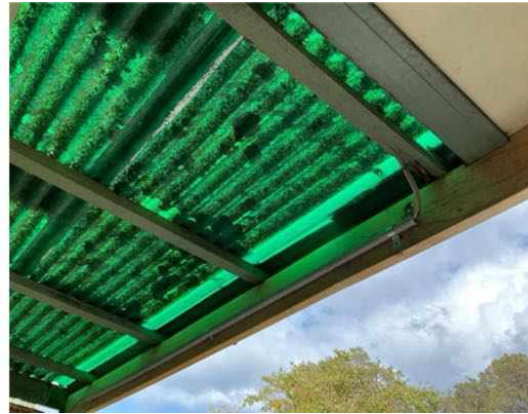
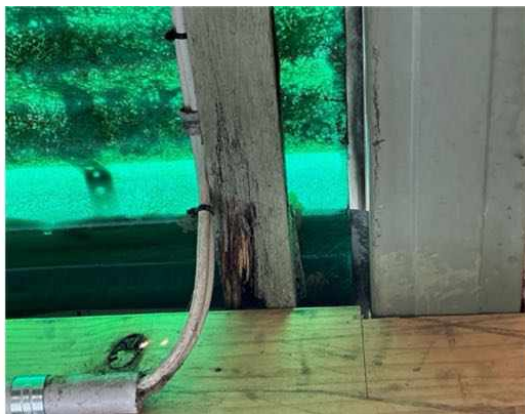
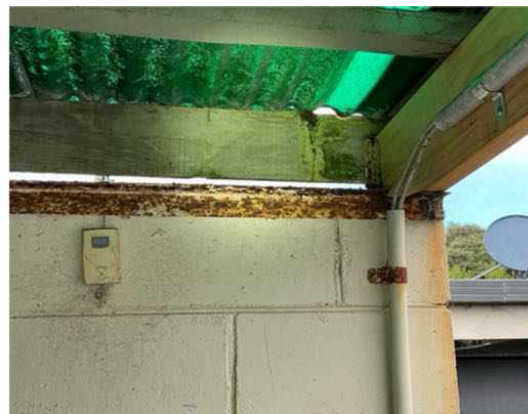
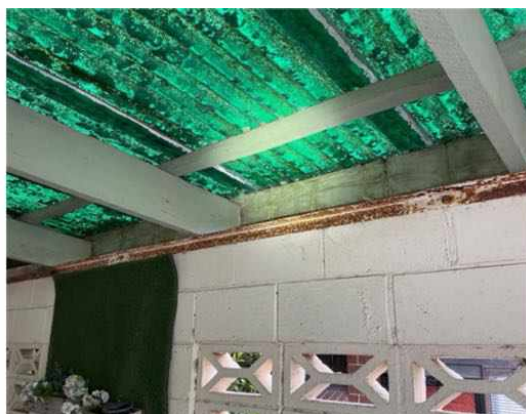
Finding 7.02

Finding: Wood rot to carport

A qualified plumber may be appointed to assess the cause of excessive moisture and to provide advice on any remedial works as required. A qualified carpenter or registered builder may also be required to replace affected building materials.

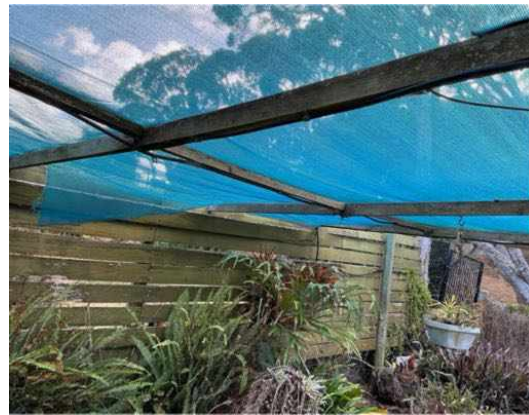
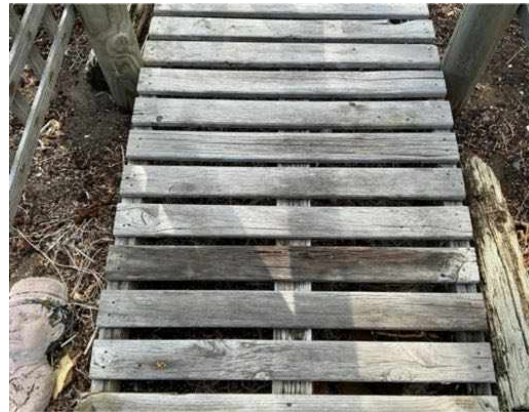
Finding 7.04

Finding: Wood rot

A qualified plumber may be appointed to assess the cause of excessive moisture and to provide advice on any remedial works as required. A qualified carpenter or registered builder may also be required to replace affected building materials.

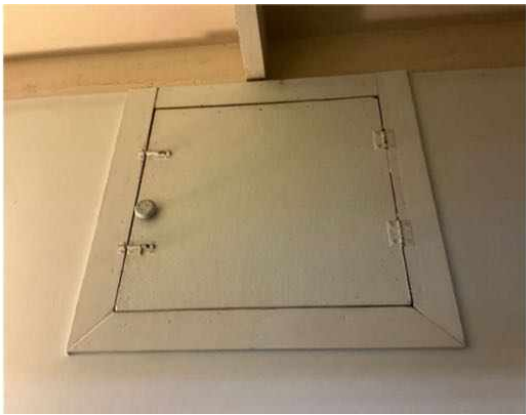
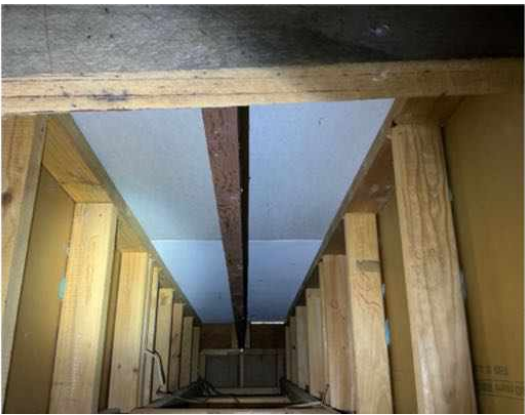
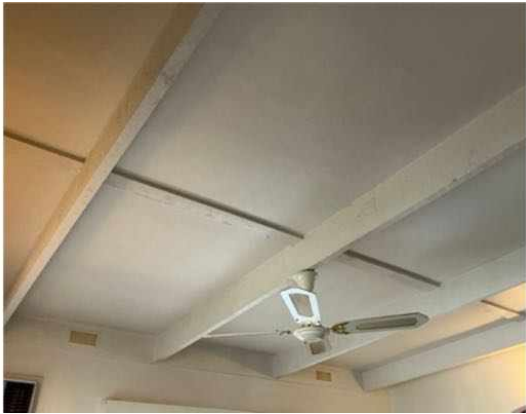
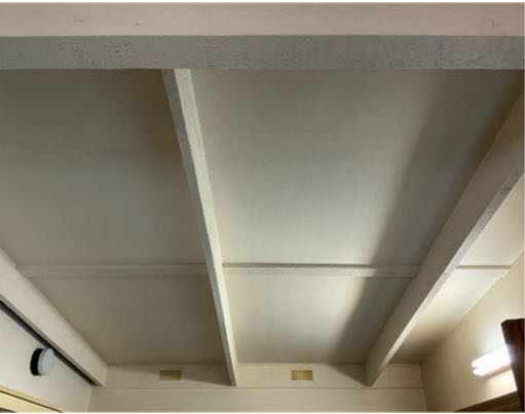
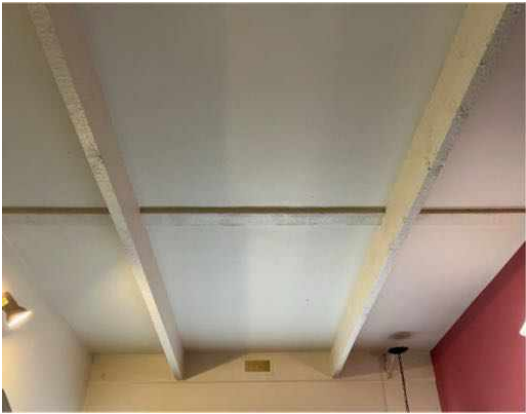
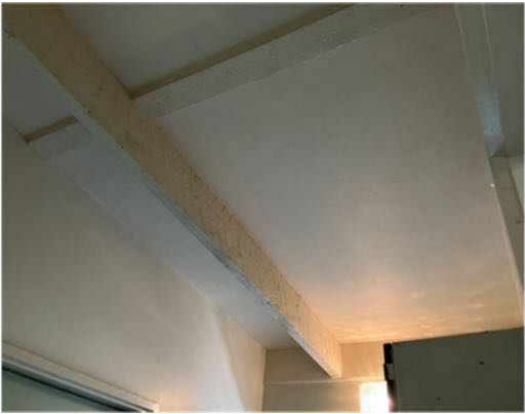
Building:	Main Building
Location:	Various parts of the building
Finding:	Asbestos - Suspected ACM Identified on Site
Information:	It is suspected that the ceiling linings to the building and cement sheet cladding to parts of the bathroom, laundry, kitchen and ceiling space contain asbestos. Reporting on Asbestos is outside the Scope of this Report. This suspected defect is highlighted as a caution only. We suspect, based on our experience in the building industry, that there is a higher risk of the identified building element containing asbestos.

In the interim, the client is advised to act with caution, especially when considering any damage to building materials, general wear and tear, renovations, extensions, demolition and general maintenance activities due to the suspected presence of Asbestos.
