Building and Timber Pest Inspection Report

Inspection Date: Mon, 2 Feb 2026

Property Address: 1/63 Carr St, Coogee NSW 2034, Australia

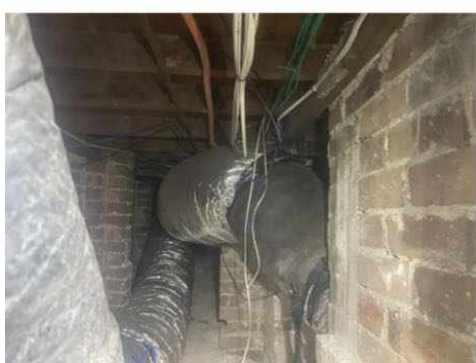
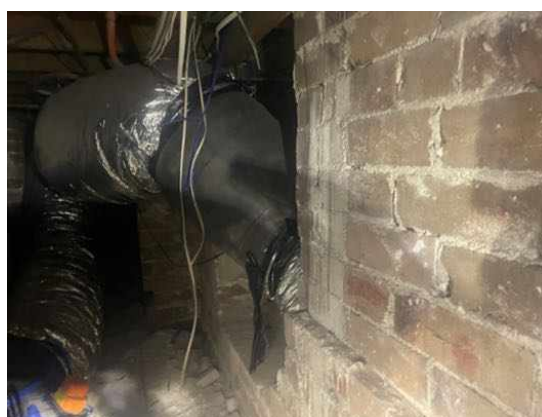
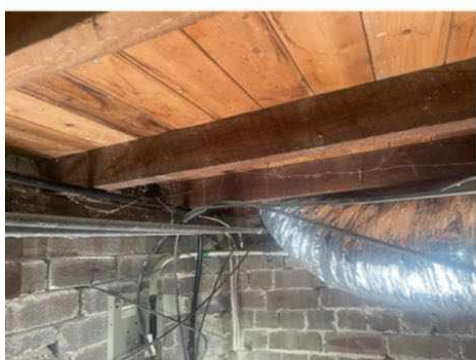
Finding 1.01

Building:	Main Building
Location:	Subfloor
Finding:	Electrical wires exposed
Information:	Exposed electrical wiring was identified. Exposed electrical wiring represents a potential safety hazard including for fire and personal contact. Contact a licensed electrician urgently for further inspection investigation and rectification.

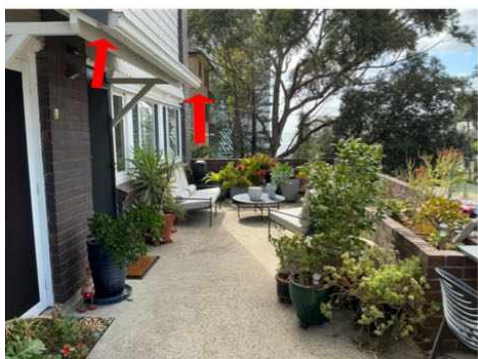
Finding 1.02

Building:	Main Building
Location:	Front porch- main entrance
Finding:	Guttering and/or Downpipes - Not plumbed for drainage
Information:	The guttering or downpipes are not plumbed or connected to suitable drainage, which can result in the surrounding area becoming excessively damp. These damp conditions can lead to secondary defects such as rot, rust or corrosion of associated building elements, the formation of fungal decay, or even the creation of potential slip

hazards.

When coupled with poor site drainage, pooling of water may also attract termite activity to this area.

It is highly recommended that a qualified plumber be appointed to install adequate drainage to the overflow. These works will ensure that the area remains dry and free of any secondary defects.

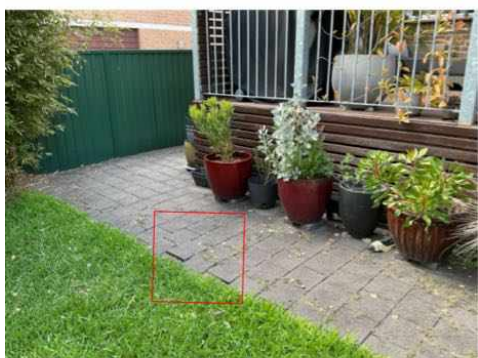
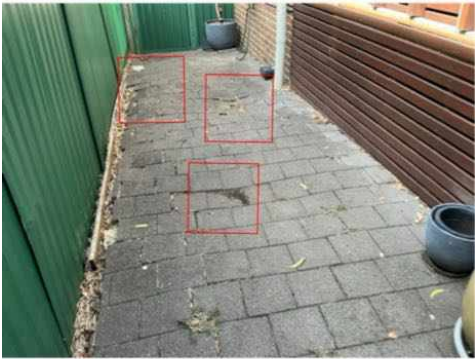
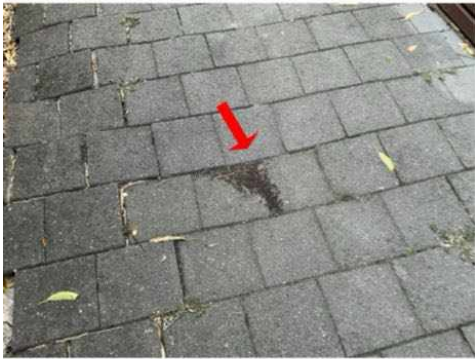
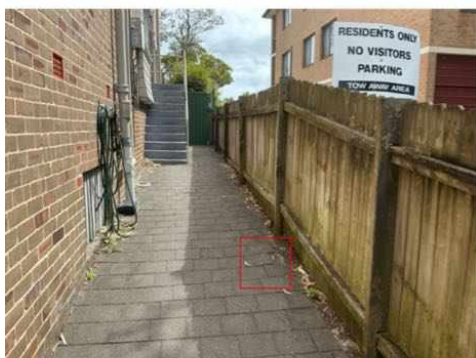
Finding 1.03

Building: Main Building
Location: Back yard, side passage
Finding: Paving uneven
Information: Sections of the external paved area are uneven, creating a potential trip hazard. It appears as though the area has been subject to rough installation, or that paving sections have lifted due to movements in the foundation of the property.

Where paving creates a trip hazard, personal injury may ensue if due caution is not taken by all persons within this area.

Re-paving of the area is required as soon as possible to remedy this situation. Further consultation with a specialist concreter is advised.

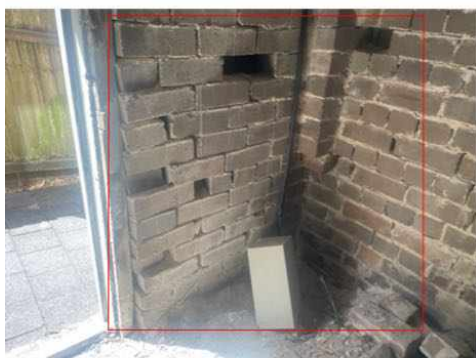
Finding 2.01

Building:	Main Building
Location:	Subfloor
Finding:	Brickwork - Deteriorated mortar throughout subfloor
Information:	Mortar, or 'bedding', is the material which fills joints and intersections between bricks in masonry walls and structures. Sections of mortar in this brickwork were identified as having deteriorated, which is generally expected for a property of this age and condition.

Mortar may deteriorate as a result of age of building materials, minor movement of bricks, or frequent exposure to weathering. Mortar should be replaced to ensure that bricks remain in their intended location and to prevent gaps, which would allow water or moisture ingress and secondary damage as a result.

Mortar deterioration can be addressed by a bricklayer where areas of deterioration are localised and easily accessible. Alternatively, appointment of a registered builder is advised, to repoint large areas of decaying mortar. Where secondary structural defects have become evident, consultation with a structural engineer may be required.

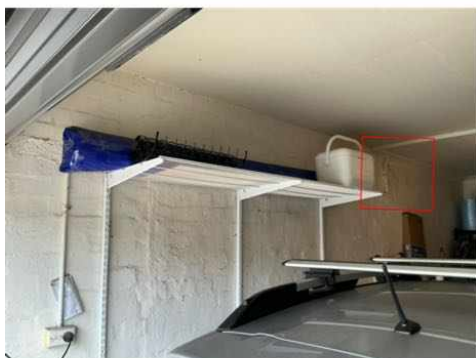
Building:	Main Building
Location:	Garage wall
Finding:	Brickwork - Step cracking
Information:	Step cracking was identified to the brickwork in this area at the time of inspection. Step cracking, which is similar to other forms of cracking, has a variety of possible causes. However, the most common is the subsidence of adjacent footings.

Step cracking is a relatively common defect, and is most likely to occur adjacent to windows, doors and other openings. Mortar failure in the gaps between affected bricks indicates the stresses and tensions affecting the wall.

Where step cracking is extensive or severe, the client is advised to consult a structural engineer. Minor step cracking can be used as a warning sign to address factors causing stress to the wall, which can include the effect of surrounding trees, water leaks, soil erosion, or even the presence of reactive soils in the surrounding area.

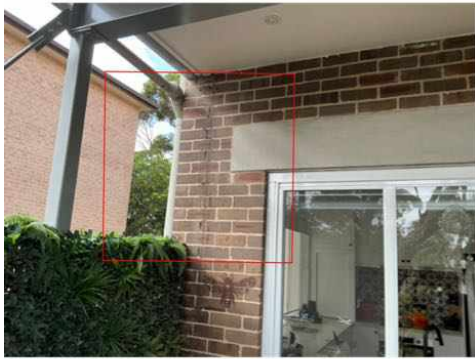
Finding 3.02

Building:	Main Building
Location:	Rear balcony wall
Finding:	Brickwork - Deteriorated mortar
Information:	Mortar, or 'bedding', is the material which fills joins and intersections between bricks in masonry walls and structures. Sections of mortar in this brickwork were identified as having deteriorated, which is generally expected for a property of this age and condition.

Mortar may deteriorate as a result of age of building materials, minor movement of bricks, or frequent exposure to weathering. Mortar should be replaced to ensure that bricks remain in their intended location and to prevent gaps, which would allow water or moisture ingress and secondary damage as a result.

Mortar deterioration can be addressed by a bricklayer where areas of deterioration are localised and easily accessible. Alternatively, appointment of a registered builder is advised, to repoint large areas of decaying mortar. Where secondary structural defects have become evident, consultation with a structural engineer may be required.

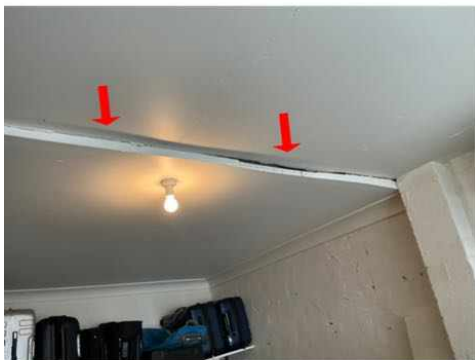
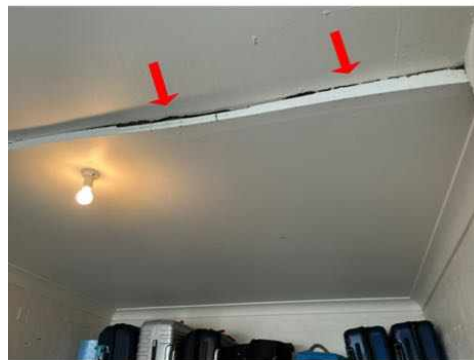
Finding 3.03

Building:	Main Building
Location:	Garage ceiling
Finding:	Incomplete or substandard works
Information:	The works to this area appear to be incomplete or have been completed to a substandard level.

Works that have not been completed to a satisfactory level create potential for the development of building defects and may impede on the safety and integrity of the overall structure.

It is highly recommended that the relevant trades be appointed to complete these works and ensure the safety of the area and the longevity of all associated building elements.

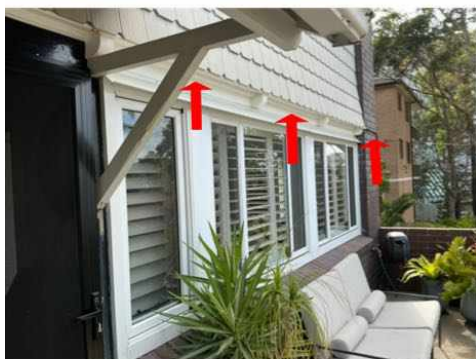
Finding 3.04

Building:	Main Building
Location:	Front balcony
Finding:	Building element - Rusted or corroded. Brackets and steel tubing
Information:	This building element shows evidence of rusting and corrosion, which is likely to have developed as a result of excessive exposure to moisture and or inadequate coatings.

As surface rust provides no protection to the underlying iron, the deteriorating condition is likely to worsen if not addressed in the short-term future.

Where possible, the use of galvanized (treated) metals or aluminium coated metals aid in rust prevention, as does regular general maintenance. Rust formation can be controlled with coatings, such as paint, that isolate the iron from the environment.

Rusting and corrosion should be managed by ideally removing or limiting the affected surface from exposure to moisture. A registered builder may be appointed to replace any building elements that have been severely affected by rust or water damage.

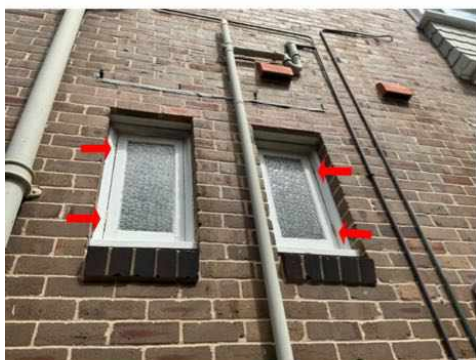
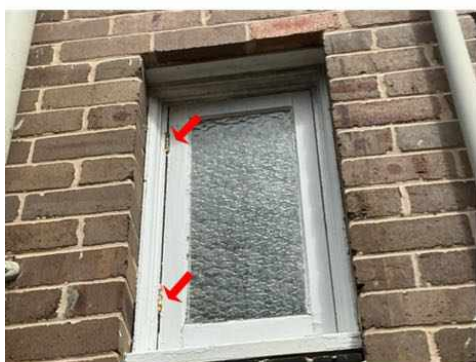
Finding 3.05

Building:	Main Building
Location:	Side passage
Finding:	Building element - Rusted or corroded- window hinges
Information:	This building element shows evidence of rusting and corrosion, which is likely to have developed as a result of excessive exposure to moisture and or inadequate coatings.

As surface rust provides no protection to the underlying iron, the deteriorating condition is likely to worsen if not addressed in the short-term future.

Where possible, the use of galvanized (treated) metals or aluminium coated metals aid in rust prevention, as does regular general maintenance. Rust formation can be controlled with coatings, such as paint, that isolate the iron from the environment.

Rusting and corrosion should be managed by ideally removing or limiting the affected surface from exposure to moisture. A registered builder may be appointed to replace any building elements that have been severely affected by rust or water damage.

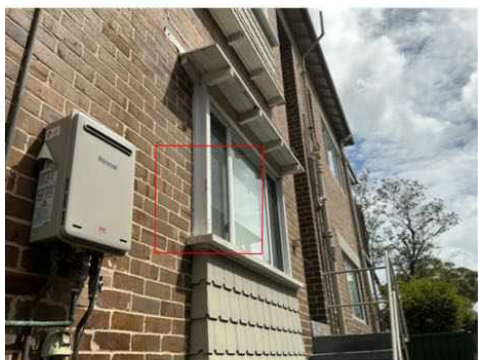
Finding 3.06

Building:	Main Building
Location:	Side passage- window frames
Finding:	External painting deteriorated
Information:	Much of the external paintwork including but not limited to windows, fascias, guttering, veranda and other external fitments have been neglected and require attention to prepare and re-paint.

Whilst incomplete or missing paint finish is generally an appearance defect, it can also lead to the development of secondary building defects over time. Incomplete areas of paint finish expose the area to moisture, potentially accelerating the deterioration of underlying building materials.

Degraded paint finishes should be sanded back, filled, leveled and painted, as applicable. Where inadequate or missing paint protection has led to the deterioration of the associated building element, repair and/or replacement of this building element may be required.

A painting contractor should be appointed as soon as possible to perform necessary works to aid the appearance of the affected area and to ensure the area is protected against further deterioration. Alternatively, the homeowner following manufacturer instructions may perform these works.

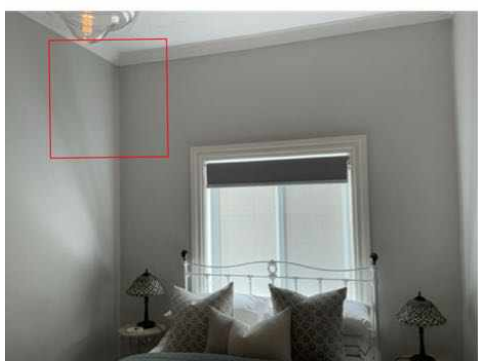
Finding 3.07

Building: Main Building
 Location: Third bedroom - nearest kitchen
 Finding: Painted surface - Bubbling
 Information: Sections of paint in this area were found to have bubbled and deteriorated. Paint bubbling is generally an indication of excessive moisture in the area, that is currently hidden by the painted surface.

The presence of excessive moisture can have major implications on associated building elements if left unattended. While only seemingly minor at this stage, the damage cannot be determined due to the paint obstructing any further inspection of the damage.

It is highly advised that the affected paint be cleaned to allow a further, more invasive inspection by a licensed plumber. Failure to act on this defect may necessitate major works in the future.

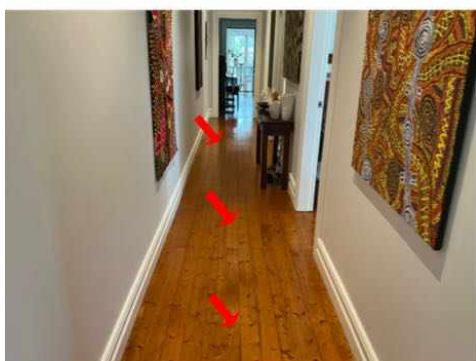
Finding 3.08

Building: Main Building
 Location: Hallway
 Finding: Floors - bouncy

Bouncy floors generally indicate that the floorboards or the subfloor structures are coming loose from the joists that they are installed on. Bouncy flooring may also be the result of gaps between flooring and stumps or joist structures, which require packing.

The client is advised to seek quotations for required repairs from a Registered Builder specialising in re-stumping. The potential resolution may range from packing gaps in subfloor structures through to replacement of subfloors stumps and refixing of flooring.

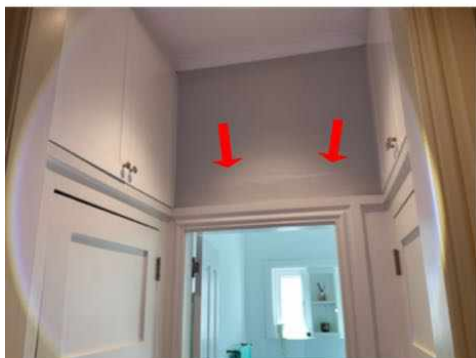
Finding 3.09

Building: Main Building
Location: Entrance to main bathroom
Finding: Cracks to internal render - Category 1
Information: It has been observed that cracking to internal rendered surfaces has occurred. The degree of damage falls within Category 1, described as fine cracks that do not need repair and which are less than 1.0mm in width limit.

Damage of this category is not considered a defect for rectification. Always contact your building inspector should cracks widen, lengthen, or become more numerous.

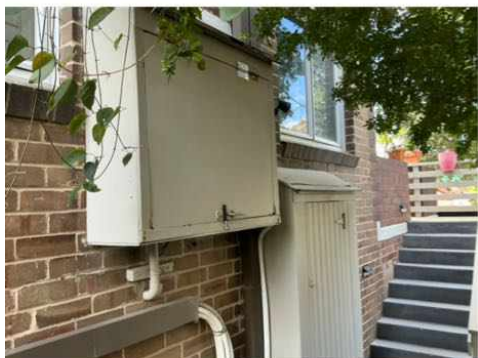
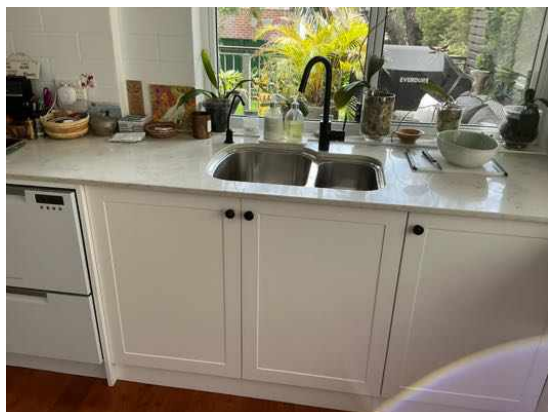
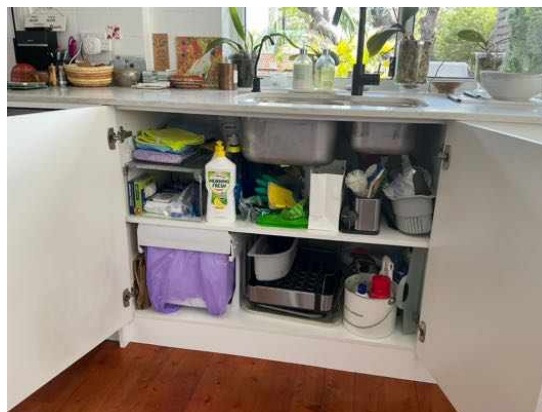
Building:	Main Building
Location:	Meter box and kitchen sink
Finding:	Termite Management System - no evidence of a chemical installation
Information:	The application of a post-construction chemical termite barrier is highly recommended for all properties, particularly if live termite activity has been found on the site previously. Such barriers are highly effective in preventing termite attack on any timber building elements throughout the property.

A durable notice should be placed in the switchboard unit to indicate current termite barriers. At the time of inspection, it appeared as though no termite management system has been installed, with no evidence to suggest preventative works taking place.

The client may consider gaining further advice from a pest controller as to the costs and procedures involved with this application. It is recommended that obtaining such advice be a short-term priority.

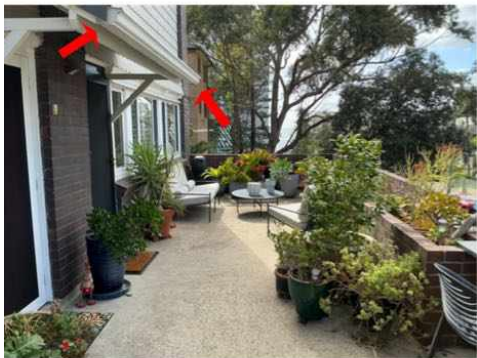
Finding 6.02

Building:	Main Building
Location:	Front balcony- main entrance
Finding:	Overflow - Not plumbed for drainage (Excessive Moisture)
Information:	The overflow is not plumbed or connected to suitable drainage, which has resulted in the surrounding area becoming excessively damp. These damp conditions can lead to secondary defects such as rot, rust or corrosion of associated building elements, the formation of fungal decay, or even the creation of potential slip hazards.

When coupled with poor site drainage, pooling of water may also attract termite activity to this area. It is highly recommended that a qualified plumber be appointed to install adequate drainage to the overflow. These works will ensure that the area remains dry and free of any secondary defects.

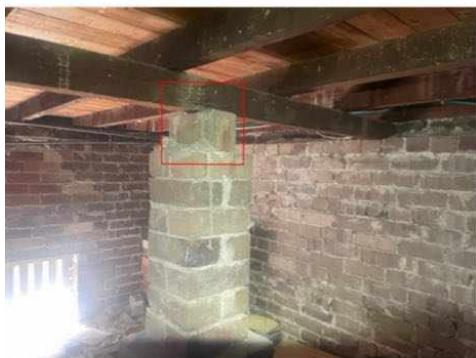
Finding 6.03

Building: Main Building
Location: Back yard, side passage
Finding: Ant caps - Not installed, subfloor
Information: Ant caps have not been installed to the subfloor structure at the time of inspection. Generally, ant caps are installed to the intersection between the top of the stumps (or piers) and the subfloor structures.

Where ant caps have not been installed, frequent monitoring of these areas should be carried out in order to identify any signs of termite or timber pest workings.

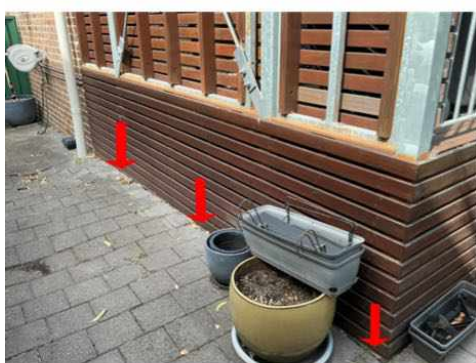
Finding 6.04

Building: Main Building
 Location: Side and rear balcony perimeter
 Finding: Untreated or non-durable timbers in a hazardous environment (Timbers in ground contact)
 Information: To reduce the risk of timber pest attack it is essential that timber used in a hazardous environment (e.g. in direct contact with the ground or frequently exposed to damp conditions) is of sufficient durability and/or is adequately preservative treated.

Untreated timbers in direct contact with the ground are likely to develop severe wood rot and/or fungal decay if left unattended creating attraction for subterranean termites to infest the timbers from surrounding areas.

If untreated or non-durable timbers are found to be in a hazardous environment it is highly advised that replacement of these building elements be performed as soon as possible to aid the protection of the property against termite / timber pest attack.

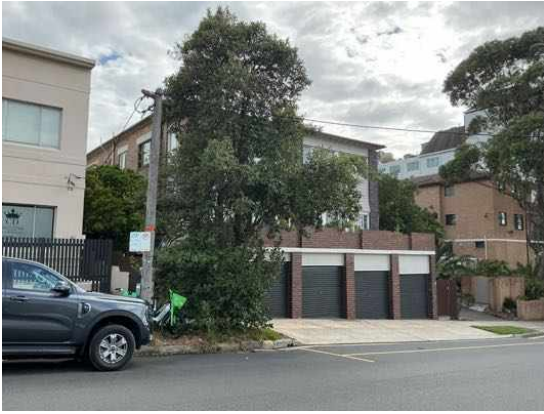
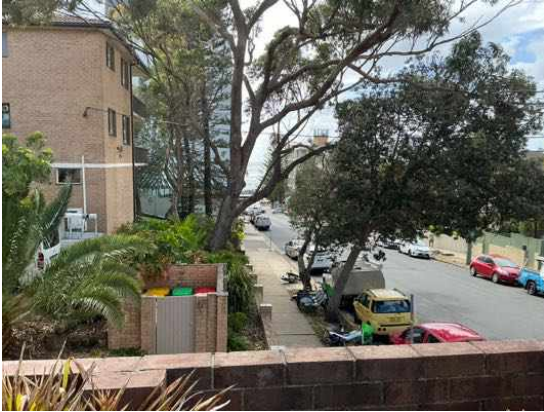
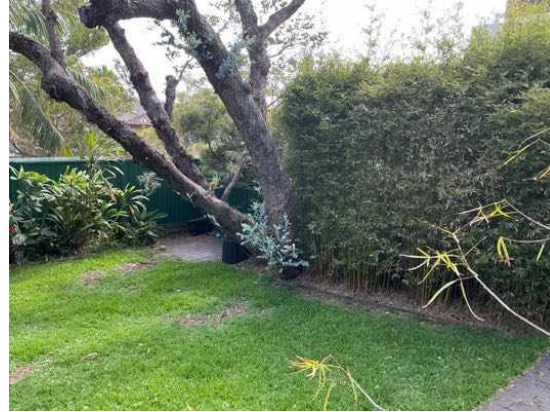
Building: Main Building
 Location: All Areas
 Finding: Trees to be inspected within the property.
 Information: Trees can be conducive to termite activity and nesting. Trees over 100mm on the property, should be drilled and tested for termite activity.

Regular inspections every 6-12 months- or advised by the termite management system installer.
