Building and Timber Pest Inspection Report

Inspection Date: Thu, 22 Jan 2026

Property Address: 11/37 Shedworth St, Marayong NSW 2148,
Australia

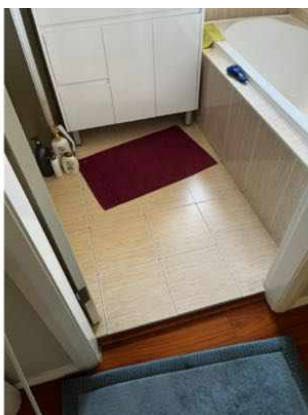
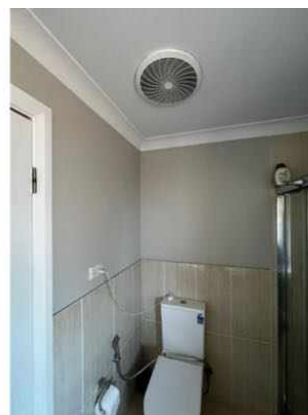
Building: Main Building
Location: Main Bathroom
Finding: Sealant and grouting - Missing or damaged
Information: It was noted on inspection that sealant or grout is degraded to the tiled shower alcove and or other areas of the bathroom.

Different materials and floor areas move at different rates, generally causing cracking to grout or sealant at this point. A flexible sealant is required to allow for expected expansion and contraction, while keeping the joint water tight and protective of all associated building materials.

There appears to be excessive mould to the sealant and grout which will likely require scraping out and replacement.

Flexible and mould resistant materials should be applied to affected areas to prevent any subsequent water damage that is likely to occur. Regular maintenance and replacement of damage or missing or damaged sealant and grout is highly recommended to the wet areas, as this is a regular wear and tear defect. Sealant and grouting in areas that come into regular contact with water should be maintained for the long term care of your property.

A sealant specialist or tiling contractor should be appointed to complete these works as soon as possible

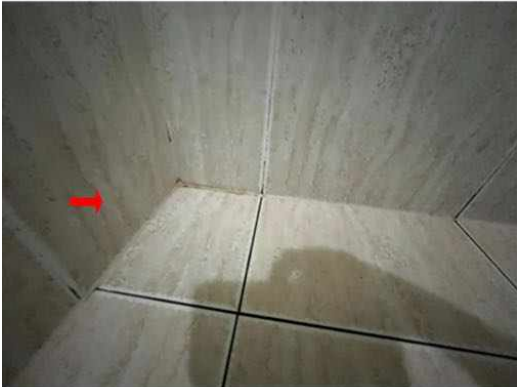
Building:	Main Building
Location:	Ensuite
Finding:	Sealant and grouting - Missing or damaged
Information:	It was noted on inspection that sealant or grout is degraded to the tiled shower alcove and or other areas of the bathroom.

Different materials and floor areas move at different rates, generally causing cracking to grout or sealant at this point. A flexible sealant is required to allow for expected expansion and contraction, while keeping the joint water tight and protective of all associated building materials.

There appears to be excessive mould to the sealant and grout which will likely require scraping out and replacement.

Flexible and mould resistant materials should be applied to affected areas to prevent any subsequent water damage that is likely to occur. Regular maintenance and replacement of damage or missing or damaged sealant and grout is highly recommended to the wet areas, as this is a regular wear and tear defect. Sealant and grouting in areas that come into regular contact with water should be maintained for the long term care of your property.

A sealant specialist or tiling contractor should be appointed to complete these works as soon as possible to prevent any further damage.

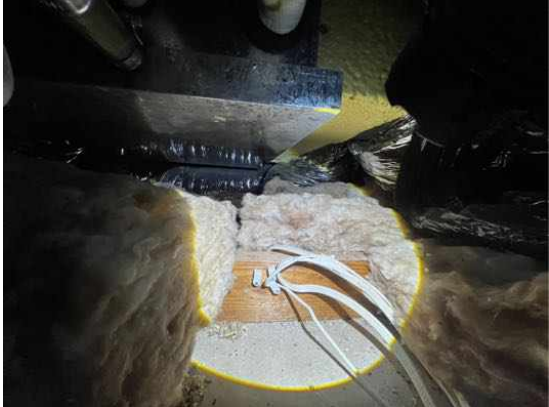
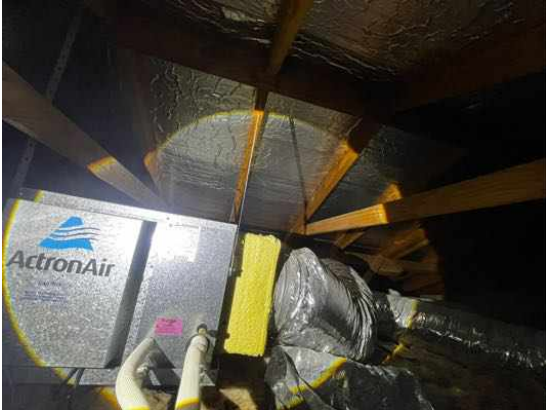
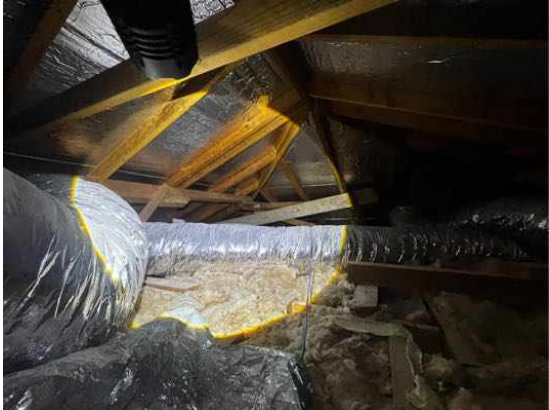
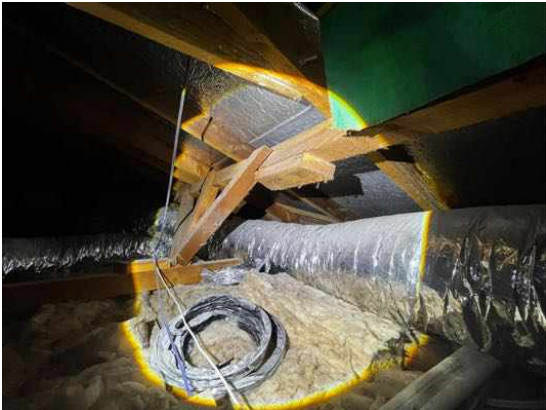
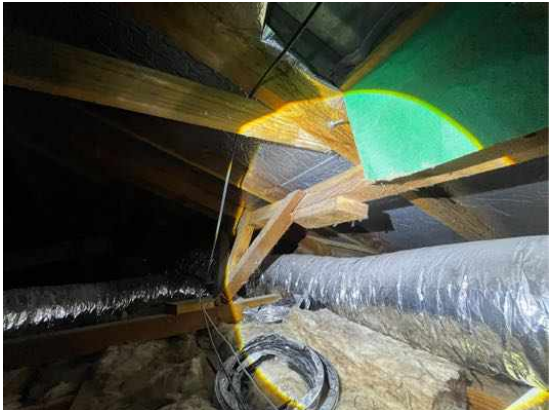
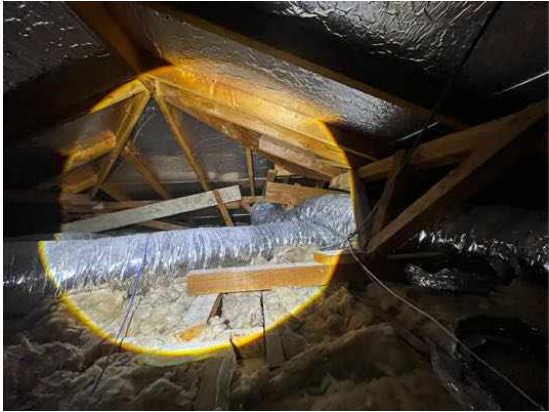
Finding 3.01

Roof Space/Void at the time of inspection such as Electrical wires and cross beams, rafters, low clearance as of the pitch in the roof. These obstructions can hide an array of defects and should be removed to allow full inspection to be carried out.

A re-inspection is recommended once the areas are made accessible.

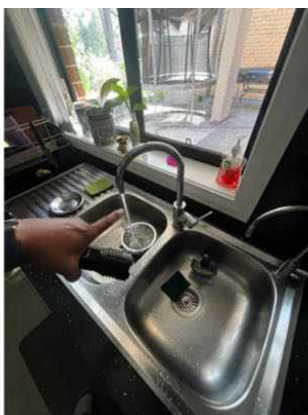
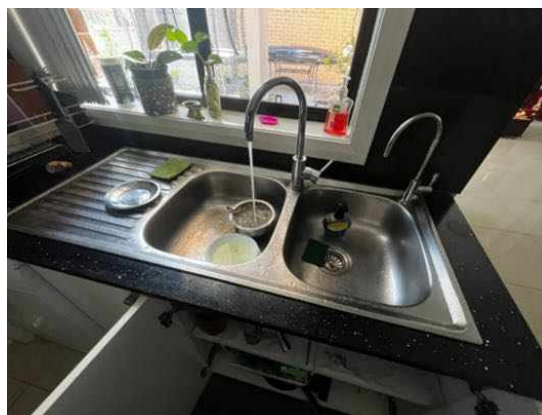
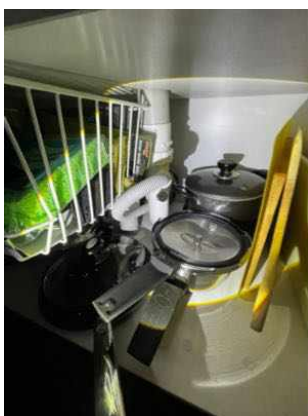
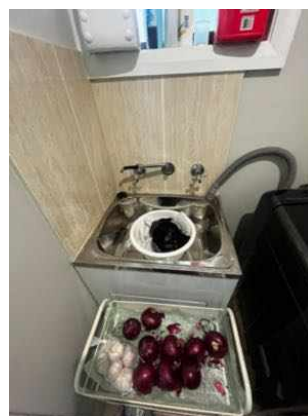
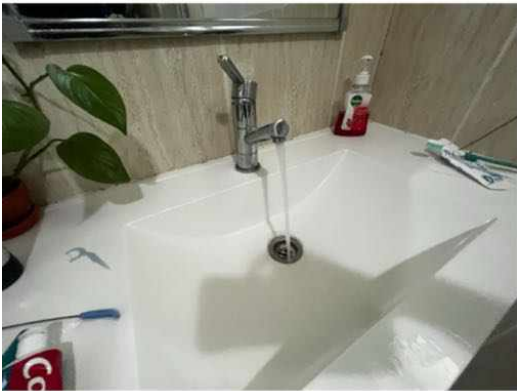
Finding 3.02

Building: Main Building
 Location: Kitchen/ Laundry/ Ensuite/ Bathroom
 Finding: Cabinetry Plumbing - Kitchen/ Laundry/Powder
 Information: All cupboards where sinks and basins with drainage plumbing were inspected and no evidence of leaks were present at the time of inspection.

Upon Inspection in the Laundry the sink was not to be found, only the Hot and cold water taps were installed in the wall. This is non compliant .

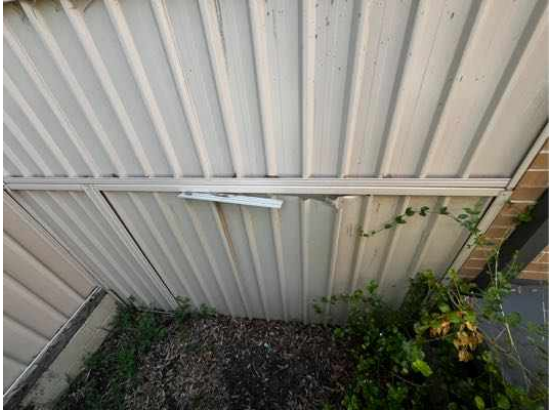
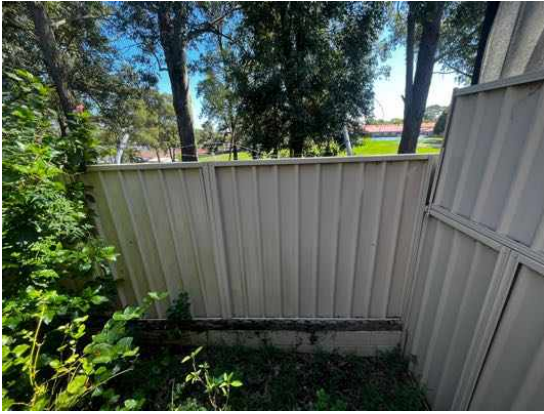
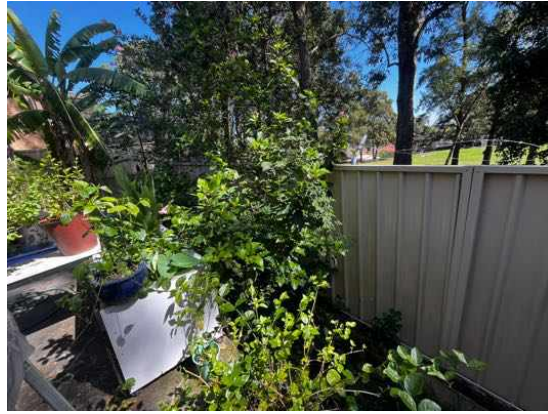
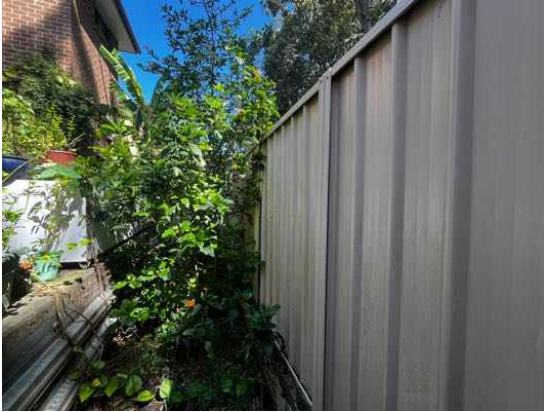
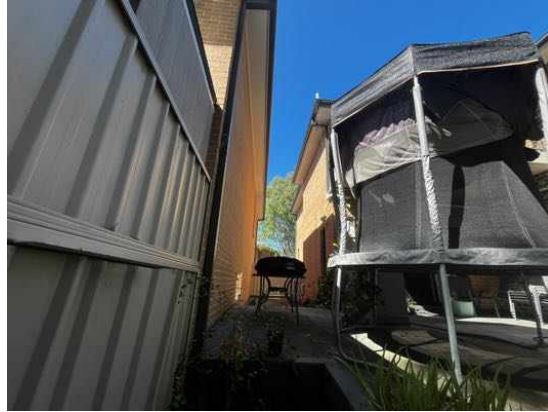
Finding 3.03

Building: Main Building
Location: Yard
Finding: Perimeter Fencing -
Information: For your information photos taken at the time of inspection.

Some parts of the fence needs attention and looks deteriorated.

It is best to consult a fencing professional to take advise and fix the fence in good condition.

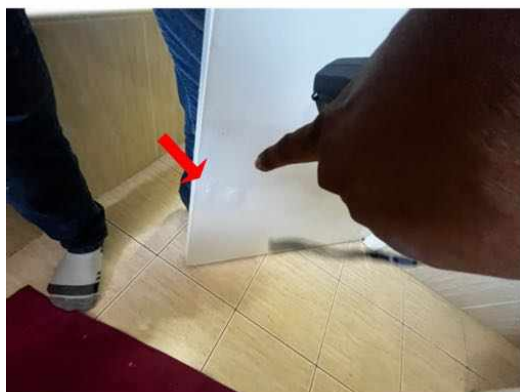
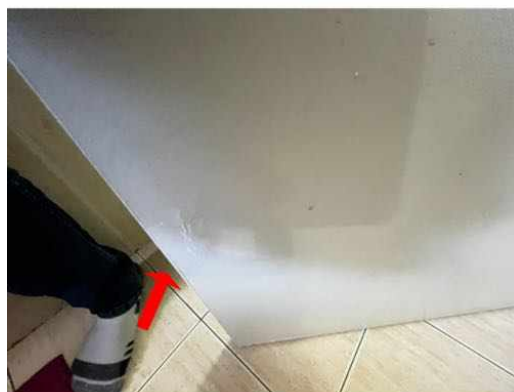
Finding 3.04

Building:	Main Building
Location:	Bedroom Door
Finding:	Door - Damaged.
Information:	At the time of inspection, it was noted that the Bedroom door had damages in few spots and broken.

Restricted function of the affected door may pose as a potential hazard if required to operate for daily needs.

Generally, factors such as general age of the building element and a lack of maintenance are the usual causes for this type of defect.

Replacement of door hardware or tracks may be required, as well as minor repairs and cleaning. A general handy Man will be required to repair the affected doors.

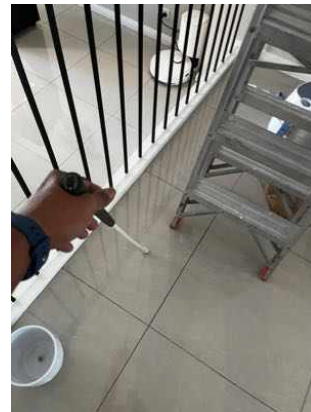
Finding 3.05

Building: Main Building
 Location: Lounge
 Finding: Tiles - Drummy
 Information:

Drummy tiled areas were identified at the time of inspection. The term 'drummy' refers to tiles that have become detached from their fixing, despite otherwise being in relatively good condition. Such defects are generally caused by physical or moisture damage to the area. Drummy tiled areas may also be a direct result of poor workmanship during the construction process.

Tiled areas may swell and shrink with changes in air humidity if the area has sustained moisture damage. Any exposure to moisture is capable of causing tiled areas to

become drummy and/or cracked over a prolonged period of time. Drummy tiled areas generally require removal and replacement of affected tiles, with adequate sealant and grouting.

Specialist trades are available for these types of services. A registered builder may be required to undertake works if damage is extensive or if secondary building defects have resulted. Otherwise, it is advised that a tiling contractor be appointed to perform works as necessary. Immediate action is recommended to ensure that no further damage is sustained in the affected area.

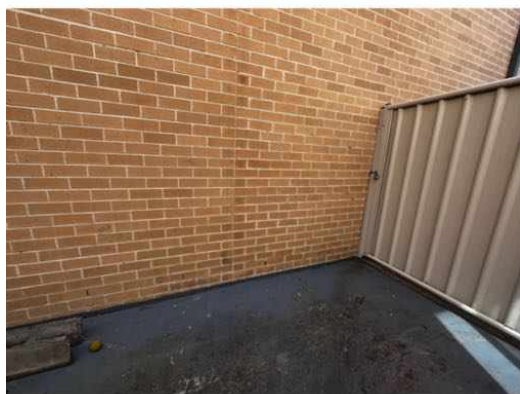
Finding 6.03

Building:	Main Building
Location:	All External Areas
Finding:	Slab Edge - Exposure

If the slab edge is not properly exposed there is a high risk of termite attack. Sometimes, in order to determine the type of slab, a suitably qualified person such as an architect or builder may be required to consult the construction plans.

Where the slab edge cannot be properly inspected, it is highly recommended that termite or timber pest inspections be carried out every 6-12 months to aid protection of the property against infestation.

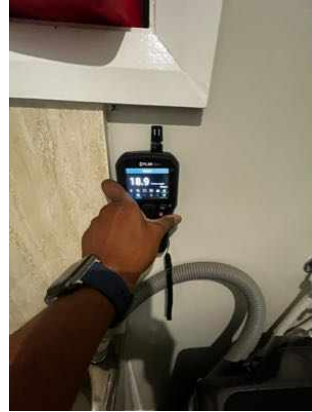
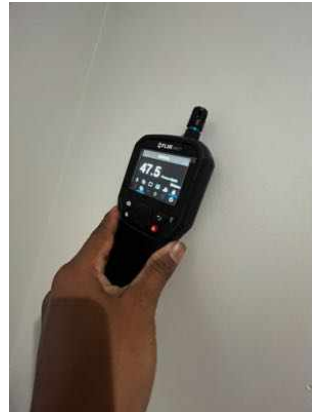
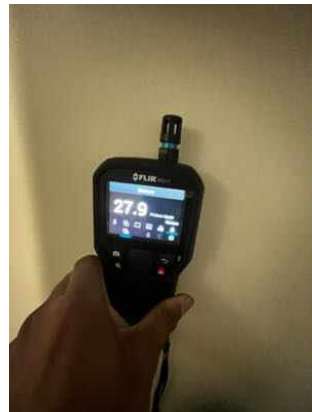
Finding 6.04

Building: Main Building
Location: Laundry
Finding: High Moisture Readings
Information: All areas of dwellings are checked with particular attention paid to wet areas which were closely assessed to check for moisture levels of moisture and temperature anomalies.

Some readings for moisture were found in the walls adjacent the showers at the time of inspection.

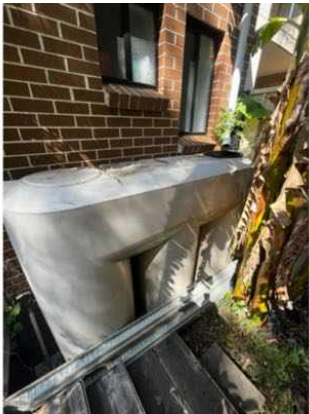
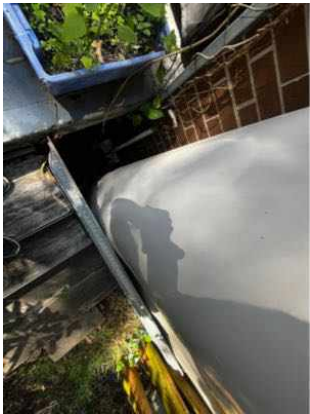
Building: Main Building
Location: Yard - Side
Finding: Storm Water Tank
Information: Storm Water Tank photos taken at the time of inspection.

Please consult a licensed Plumber to check the Connections/ pressure/ pumps/ flow of water and functionality.
