# Building and Timber Pest Inspection Report

Inspection Date: Fri, 30 Jan 2026

Property Address: 67 Clare St, Blacktown NSW 2148, Australia

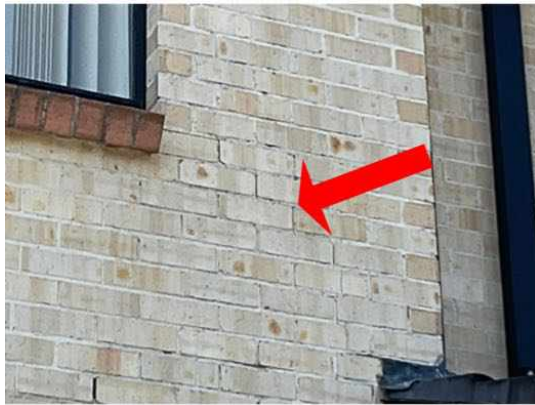
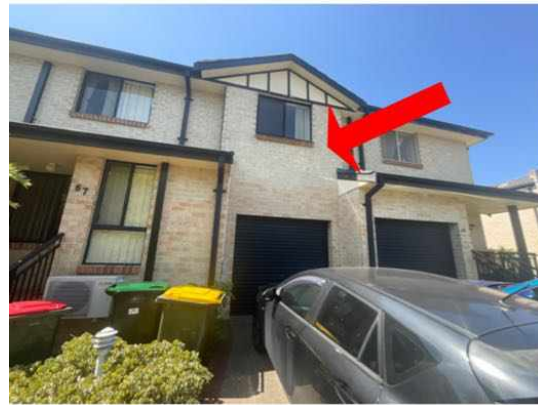
### Finding 3.01

Building:	Main Building
Location:	Exterior walls - front
Finding:	Brickwork - Step cracking
Information:	Step cracking was identified to the brickwork in this area at the time of inspection. Step cracking, which is similar to other forms of cracking, has a variety of possible causes. However, the most common is the subsidence of adjacent footings.

Step cracking is a relatively common defect, and is most likely to occur adjacent to windows, doors and other openings. Mortar failure in the gaps between affected bricks indicates the stresses and tensions affecting the wall.

Where step cracking is extensive or severe, the client is advised to consult a structural engineer. Minor step cracking can be used as a warning sign to address factors causing stress to the wall, which can include the effect of surrounding trees, water leaks, soil erosion, or even the presence of reactive soils in the surrounding area.

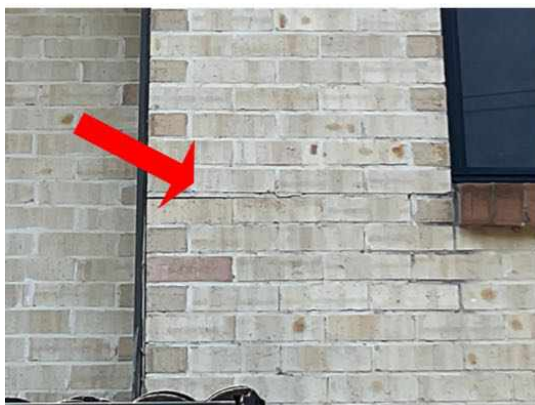
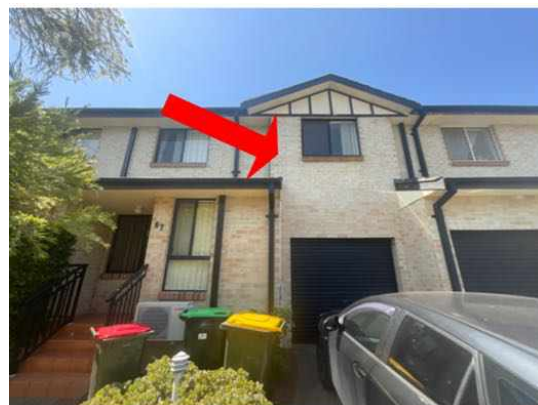
### Finding 3.02

Building:	Main Building
Location:	Exterior walls - front
Finding:	Brickwork - Deteriorated mortar
Information:	Mortar, or 'bedding', is the material which fills joints and intersections between bricks in masonry walls and structures. Sections of mortar in this brickwork were identified as having deteriorated, which is generally expected for a property of this age and condition.

Mortar may deteriorate as a result of age of building materials, minor movement of bricks, or frequent exposure to weathering. Mortar should be replaced to ensure that bricks remain in their intended location and to prevent gaps, which would allow water or moisture ingress and secondary damage as a result.

Mortar deterioration can be addressed by a bricklayer where areas of deterioration are localised and easily accessible. Alternatively, appointment of a registered builder is advised, to repoint large areas of decaying mortar. Where secondary structural defects have become evident, consultation with a structural engineer may be required.

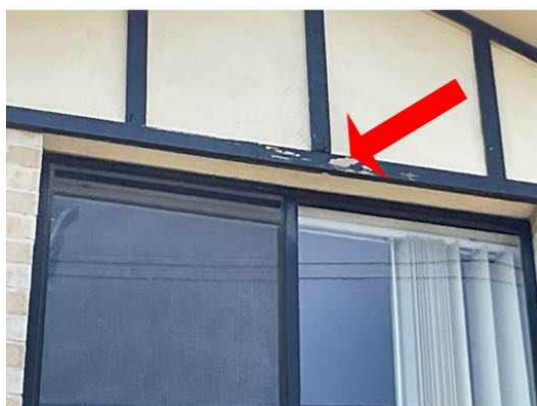
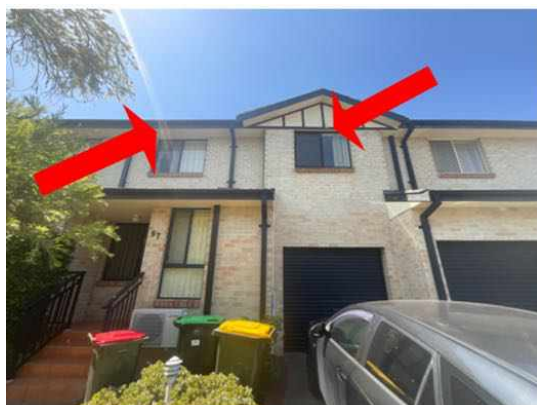
### Finding 3.03

Building:	Main Building
Location:	All External Areas

Finding: External painting deteriorated  
Information: Much of the external paintwork including but not limited to windows, fascias, guttering, veranda and other external fitments have been neglected and require attention to prepare and re-paint.

Whilst incomplete or missing paint finish is generally an appearance defect, it can also lead to the development of secondary building defects over time. Incomplete areas of paint finish expose the area to moisture, potentially accelerating the deterioration of underlying building materials.

Degraded paint finishes should be sanded back, filled, leveled and painted, as applicable. Where inadequate or missing paint protection has led to the deterioration of the associated building element, repair and/or replacement of this building element may be required.

A painting contractor should be appointed as soon as possible to perform necessary works to aid the appearance of the affected area and to ensure the area is protected against further deterioration. Alternatively, the homeowner following manufacturer instructions may perform these works.

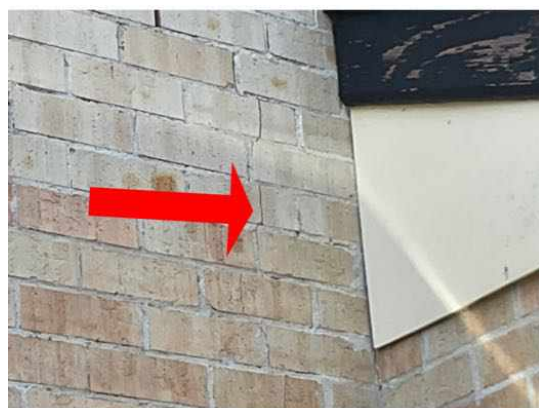
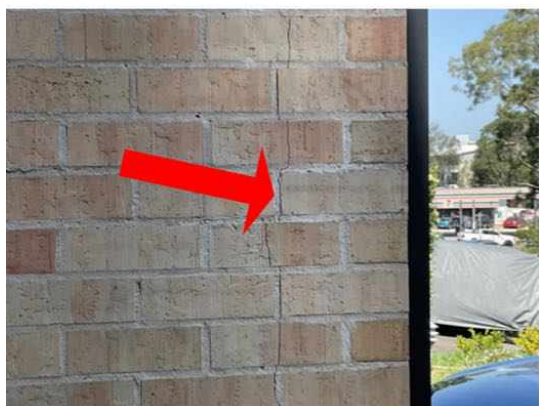
### Finding 3.04

Building: Main Building

Location:	Exterior walls - front
Finding:	Cracking - Articulation joints absent
Information:	The articulation or control joints throughout the exterior cladding were absent at the time of inspection.

When render cracking occurs due to the absence of expansion joints between external claddings at the junction, it's primarily a consequence of inadequate allowance for the natural movement of materials. Here's a detailed look at this defect:

To rectify this defect, it's essential to retroactively introduce expansion joints between the external claddings at the junction. This may involve carefully cutting and retrofitting expansion joint materials or implementing alternative solutions, depending on the specific requirements of the building. Additionally, addressing any underlying structural issues and ensuring proper surface preparation before repairing the render can help prevent recurrence of cracking. Regular maintenance and monitoring are also necessary to identify and address any emerging issues promptly.

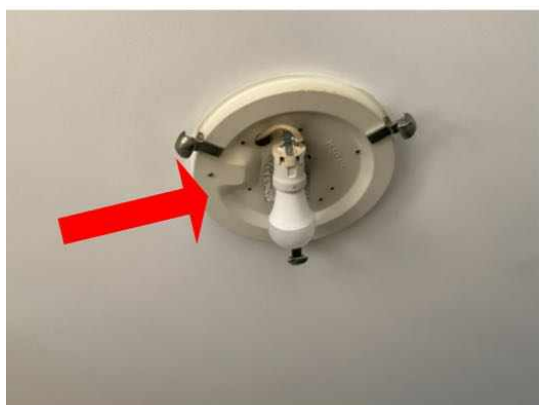
### Finding 3.05

Building:	Main Building
Location:	Kitchen
Finding:	Light fitting - Missing
Information:	The light cover in the area has been missing. An electrician should be appointed as soon as possible to replace the light and to provide any remedial works as required.

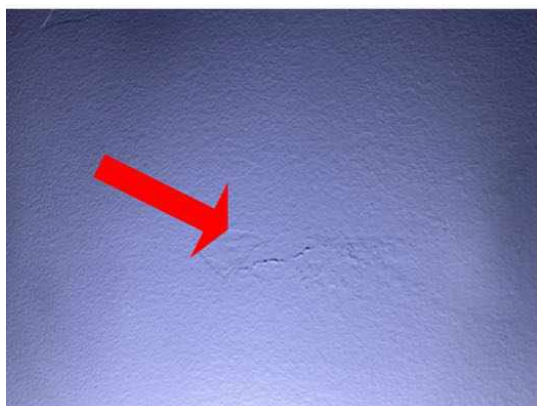
Building:	Main Building
Location:	All Internal Areas
Finding:	Paint finish - Substandard, Wear and Tear
Information:	The paint finish in this area was found to have been completed to a substandard level or wear and tear as the normal deterioration of a property from ordinary, everyday use. Exposure to the elements, time, as well as day to day living can cause fair wear and tear.

If this applies, further areas of poor and incomplete finishes could develop over time. Furthermore, substandard, wear and tear paint finishes in areas exposed to moisture, e.g. external areas or wet areas, could lead to deterioration of underlying building materials.

Substandard, wear and tear paint finishes should be sanded back, filled, leveled and repainted, as applicable. Where inadequate paint protection has led to the deterioration of the associated building element, repair and/or replacement of this building element may be required.

A painting contractor should be appointed as soon as possible to perform necessary works to aid the appearance of the affected area and to ensure that the area is protected against further deterioration. Alternatively, the homeowner following manufacturer instructions may be able to provide this service.

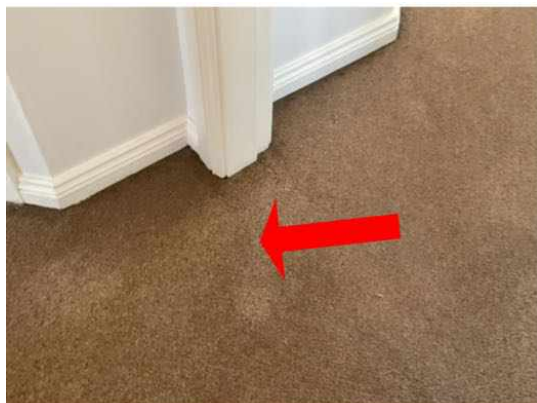
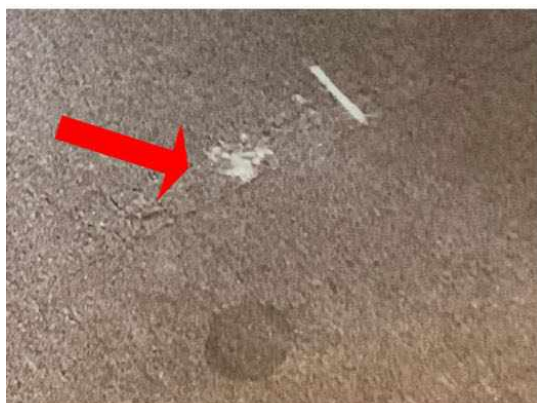
### Finding 3.08

Building:	Main Building
Location:	All Internal Areas
Finding:	Carpet - damaged / deteriorated
Information:	Static Damage

Replacement of the affected carpet is required as a matter of urgency to ensure the safety of the area. Where required, remedial works should be undertaken to any associated walls and flooring showing evidence of mould.

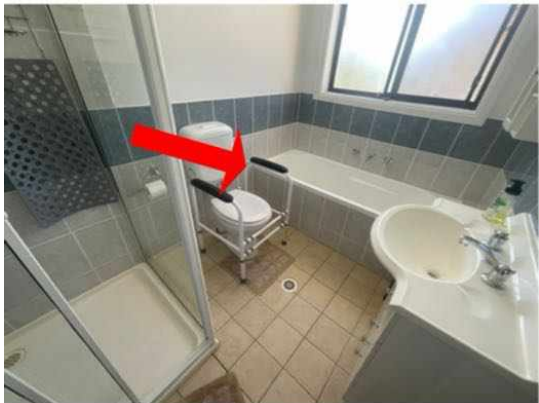
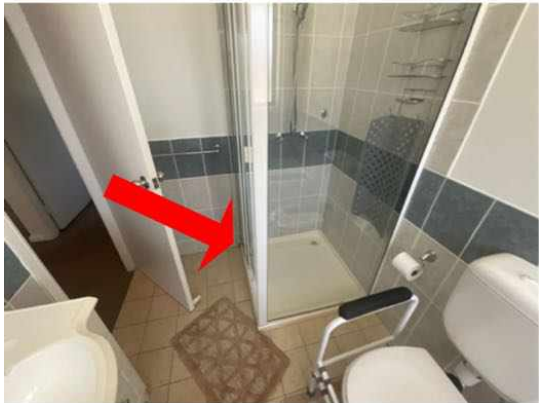
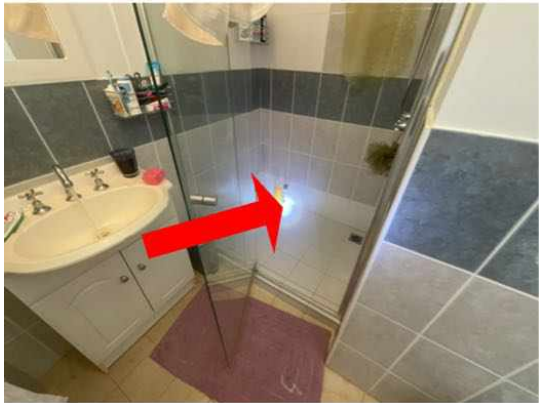
### Finding 3.09

Building:	Main Building
Location:	Bathroom
Finding:	Sealant and grouting - Missing or damaged
Information:	It was noted on inspection that sealant or grout is degraded to the tiled shower alcove and or other areas of the bathroom.

Different materials and floor areas move at different rates, generally causing cracking to grout or sealant at this point. A flexible sealant is required to allow for expected expansion and contraction, while keeping the joint water tight and protective of all associated building materials.

There appears to be excessive mould to the sealant and grout which will likely require scraping out and replacement.

Flexible and mould resistant materials should be applied to affected areas to prevent any subsequent water damage that is likely to occur. Regular maintenance and replacement of damage or missing or damaged sealant and grout is highly recommended to the wet areas, as this is a regular wear and tear defect. Sealant and grouting in areas that come into regular contact with water should be maintained for the long term care of your property.

A sealant specialist or tiling contractor should be appointed to complete these works as soon as possible

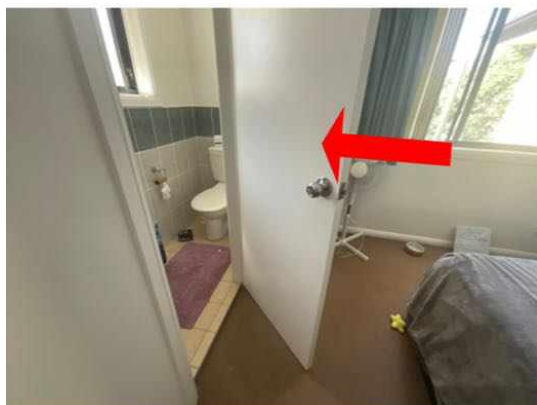
### Finding 3.10

Building:	Main Building
Location:	Ensuite
Finding:	Door frames - not square
Information:	It appears that one and / or more doors have been installed in a manner which is not consistent with acceptable standards of workmanship. The door frames are not square and or plumb and require rectification.

Deviation from the manufacturer's installation instructions is considered a defect with reference to Standards and Tolerances.

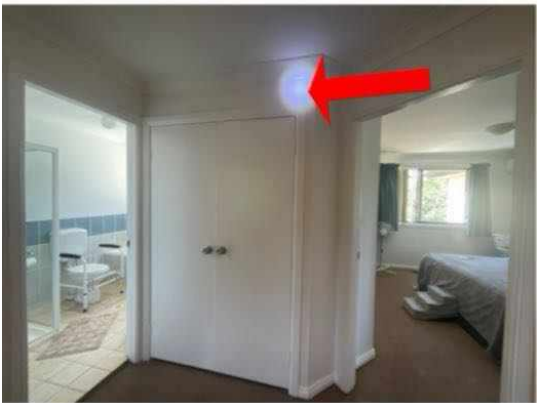
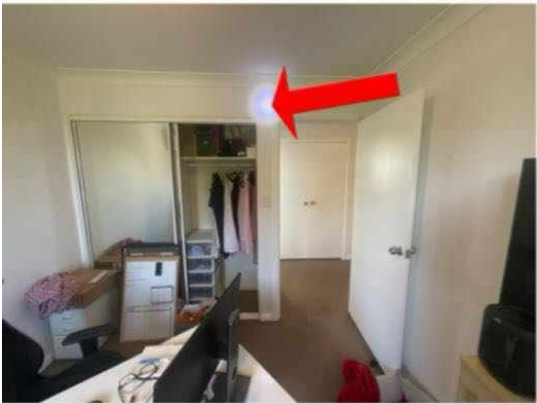
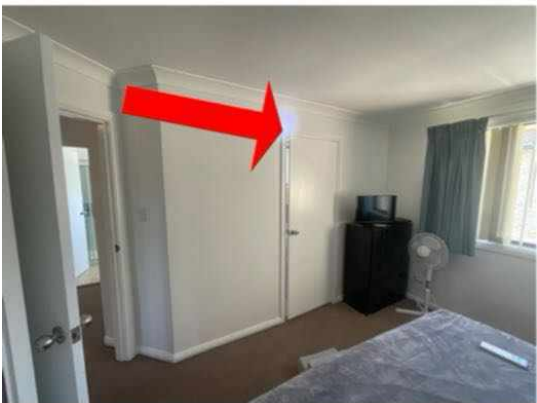
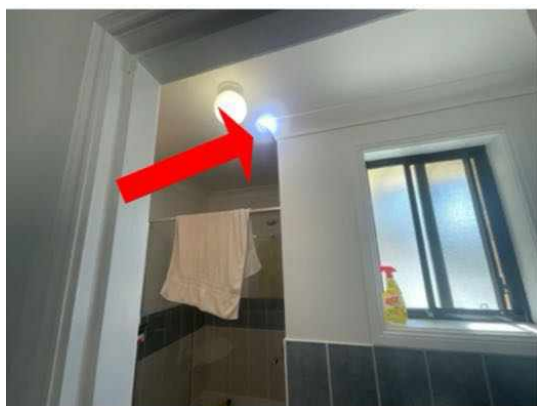
### Finding 3.11

Building:	Main Building
Location:	All Internal Areas
Finding:	Cracking - Damage Category 1 - Fine (up to 1mm)
Information:	Although fine cracks are quite noticeable, they are often only considered to be an appearance defect, and usually do not indicate any structural damage. Generally, the cause of a fine crack is indicative of a separation between building materials and finishes (e.g. paint, plaster, etc.) along joins.

Cracking of this nature can generally be repaired with minor sanding, filling and/or repainting. Such works should be performed by a qualified painter or a general handyman.

Monitoring of all cracking should be conducted frequently. Always contact a building inspector should cracks widen, lengthen, or become more numerous.

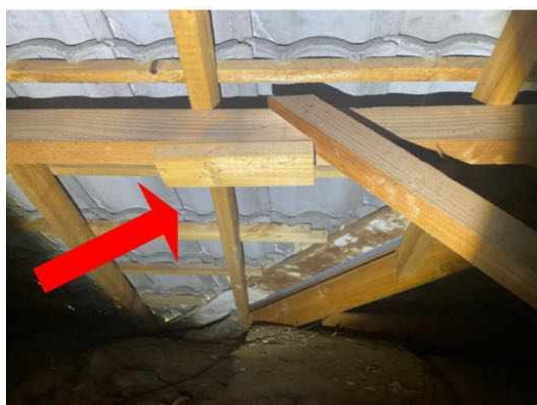
### Finding 3.12

Building:	Main Building
Location:	Roof Void
Finding:	Sarking - Missing
Information:	Sarking is missing under the roof sheeting. Sarking acts as an insulator that helps with noise reduction and protects against water penetration. Sarking plays a key role in the operation and function of the overall roofing structure and its performance.

Although not a requirement at the time of construction, replacement of any missing building element is advisable (although this can be quite expensive to do after the time of construction). Where sarking is missing, regular inspections of the roof tiles for cracking and potential moisture penetration is required.

Sarking may be retrospectively fitted by a registered builder at the discretion of the client.

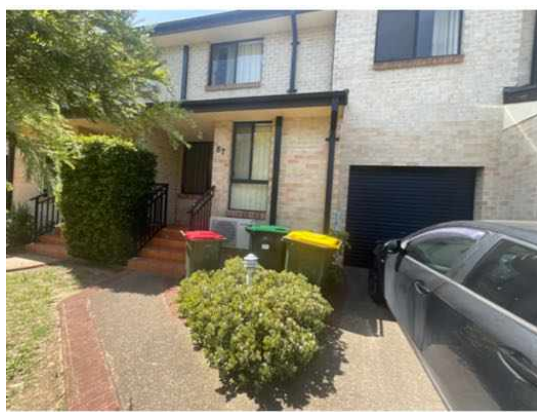
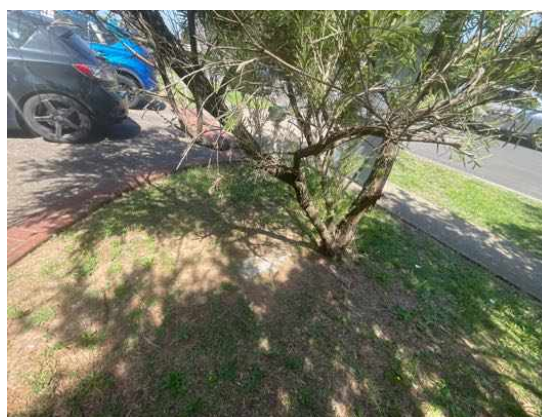
### Finding 6.01

Building:	Main Building
Location:	All Areas
Finding:	Garden Beds - Conditions Conducive to Termites
Information:	Garden beds were found to be evident in the garden area. These garden beds can include untreated timber, and with a combination of moisture from watering hosing can make conditions conducive to termite activity and termite ingress.

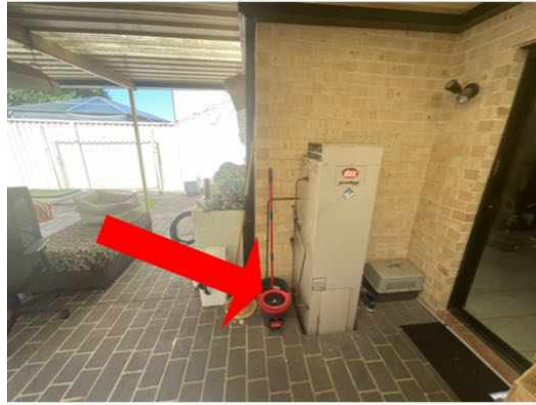
### Finding 6.02

Building:	Main Building
Location:	All Areas
Finding:	HWS Overflow - Not Connected
Information:	The Hot Water System (HWS) overflow was found to be disconnected from storm water drainage and is creating excessive moisture in the surrounding area.

These damp conditions can lead to secondary defects such as rot, rust or corrosion of associated building elements, the formation of fungal decay, or even the creation of potential slip hazards. When coupled with poor site drainage, pooling of water may also attract termite activity to this area.

It is highly recommended that a licensed plumber be appointed to connect the HWS overflow in order to prevent such an environment from being created. These minor works should be carried out as soon as possible.

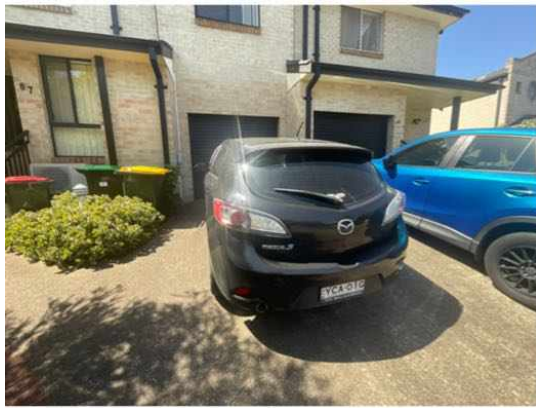
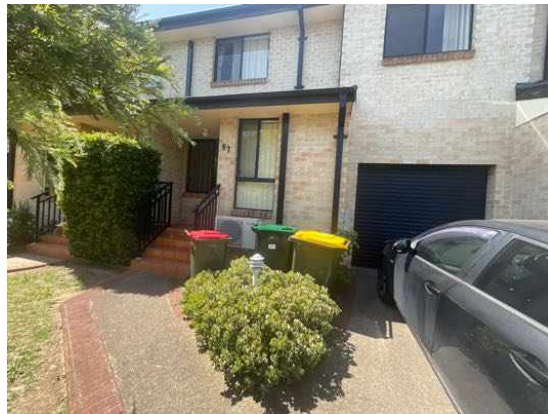
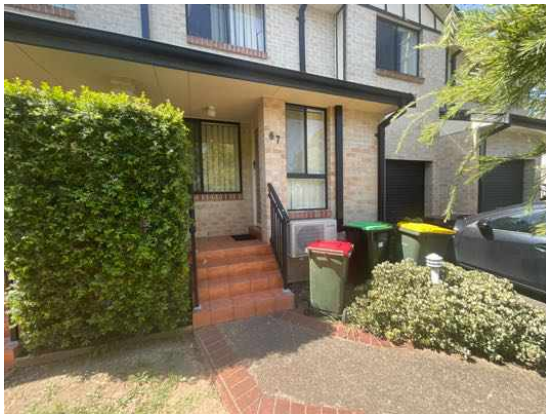
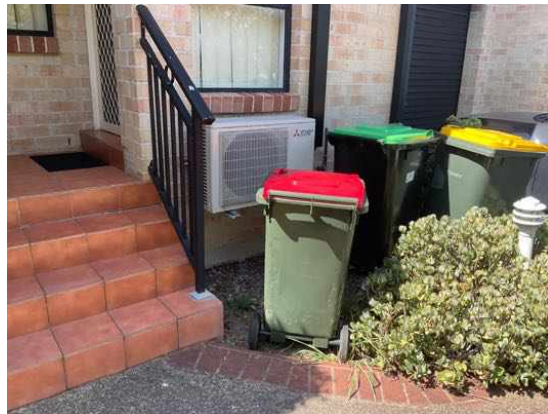
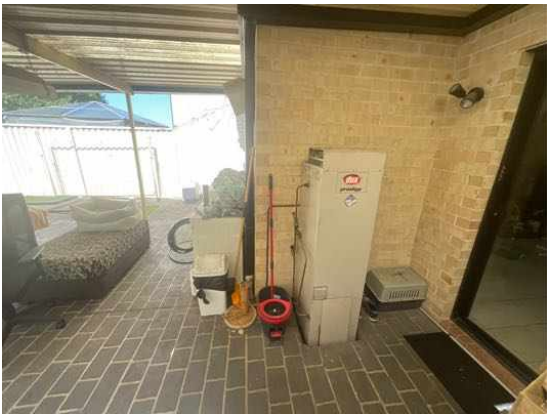
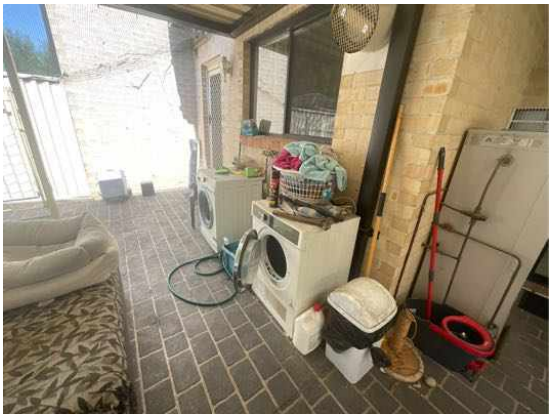
Building: Main Building  
Location: All Areas  
Finding: Additional Photos - Obstructions and Limitations  
Information: These photographs are an indication of the obstructions and limitations which impeded full inspection of the property at the time of inspection. These obstructions can hide an array of defects and should be removed to allow full inspection to be carried out. A re-inspection is recommended once the areas are made accessible.

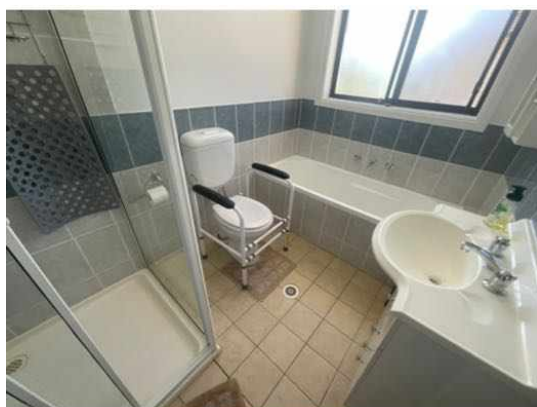
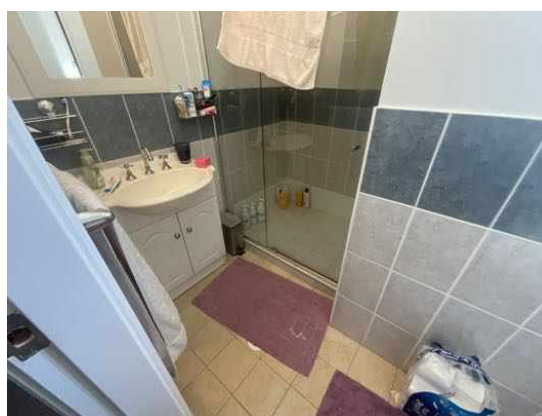
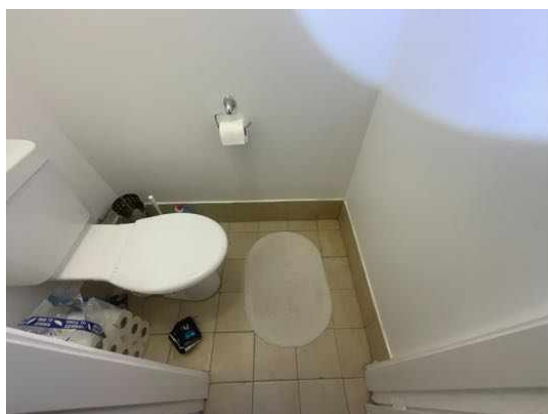
Building: Main Building  
 Location: All Areas  
 Finding: Water Proofing Membranes - Information Only  
 Information: Internal Water Proofing Membranes, are crucial in preventing water ingress into the property is important to know that the Membrane System used is to Australian Standards and has been installed correctly. Please refer to the original Building Documents or Maintenance Schedule for the relevant information including; - Membrane used and Manufacturers Specifications. - The Installer and Installation Certification. Especially with older property's where this information is unavailable, all wet areas should be monitored. Generally new waterproofing with a certificate may only have a guarantee of 8yrs. If any leaks, water staining, peeling or bubbling of the paint become evident to any adjacent walls or ceilings below a licensed builder or waterproofing specialist is recommended to investigate further.
