# Building and Timber Pest Inspection Report

Inspection Date: Thu, 26 Feb 2026

Property Address: 82 Jacaranda Cres, Casula NSW 2170,  
Australia

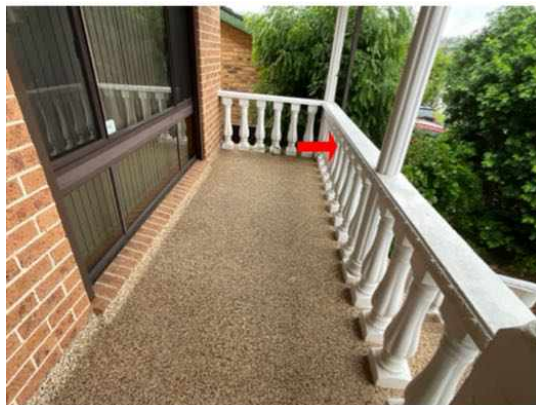
Building: Main Building  
Location: Balustrades  
Finding: Balustrade - Suspected Non-Compliance  
Information: The balustrade was measured and found to be less than the present building regulation requirement of 1000mm high. Additionally the gaps between the balustrade cladding were found to be greater than the present building regulation requirement of 125mm.

This defect creates a potential safety hazard and should be rectified as soon as possible to ensure the safety of the area and to meet present building standards and regulations.

A licensed builder should be contacted to discuss possible rectification solutions.

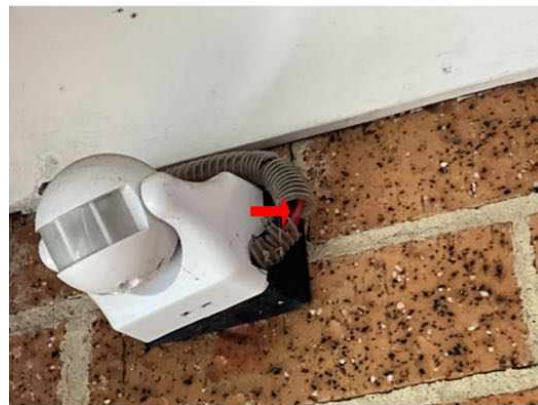
### Finding 1.02

Finding: Conduit - Damaged

Information: The conduit in this area was found to have been damaged at the time of inspection. This is a safety measure that is aimed at protecting the wires and preventing any personal injury that may result if wires are squashed or damaged.

Without a conduit providing adequate protection, external wiring is likely to become damaged and deteriorated over time, creating an electrical safety hazard. Damage to the wiring is also likely to result in the associated elements losing function.

A licensed electrician should be contacted immediately to install a conduit around the wires and provide any further advice on additional works that may be required to increase the safety of the wiring and its surrounding area.

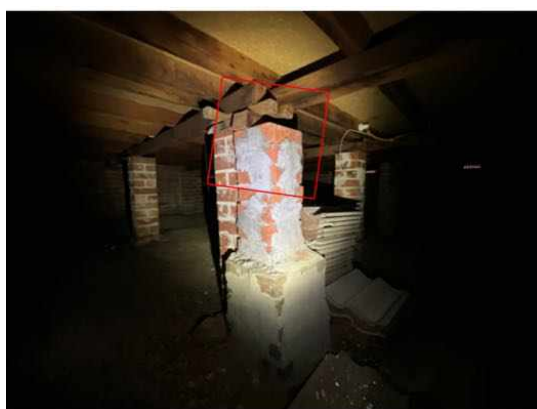
### Finding 2.01

**Information:** This handyman work appears to have been completed to a substandard level and does not comply with regular building practices. Where handyman work is not completed satisfactorily, accelerated deterioration of the associated building elements is likely to occur and secondary defects to surrounding structures may develop.

It is highly recommended that the substandard work be rectified by professional services. Works to improve this area are likely to increase the safety and the operation of the associated building elements.

The client should exercise care when coming into the immediate vicinity of the substandard works. Rectification works are advised as soon as possible by the appropriate trades.

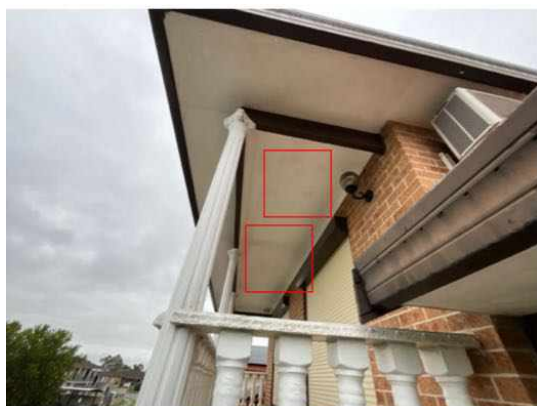
### Finding 3.01

**Finding:** Ceiling - Water damaged

**Information:** Water damage to the ceiling lining is generally an indication of excessive moisture being present in the roof void, usually via a leak to the roof covering.

Where water damage is evident to the ceiling, the primary requirement is to identify and rectify the source of the leak. A roofing plumber should be appointed as soon as possible to identify the leak and perform rectification works as necessary, ensuring the water damage is restricted.

Once the leak is repaired, consultation with relevant tradespeople, including plasterers and painters, is advised. Rectification works may include replacement of ceiling lining or minor repainting, depending on the extent of the damage.

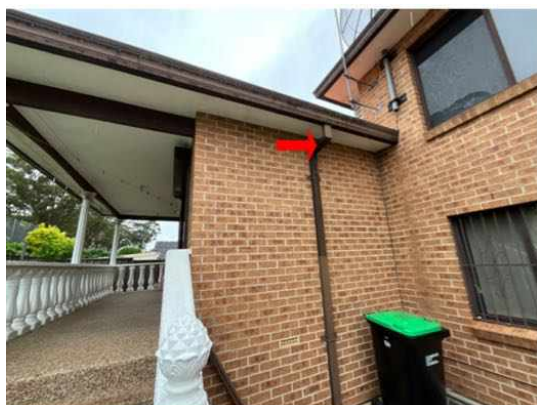
| Finding: | Water leak - External |
| Information: | Water leaks were found to be present to exterior plumbing work. Leaks are generally caused by deterioration of the plumbing elements over time, due to exposure to weather conditions, but may have also been caused by minor impact damage. |

Such leaking creates damp conditions in the affected area, causing potential for water pooling and subsequent water damage if left unattended. These conditions may also attract termite attack, particularly if the area is subject to minimal levels of sun throughout daylight hours.

It is highly advised that a licensed plumber be appointed to rectify any water leaks that may be present. Areas of repair and replacement of plumbing fittings and fixtures may be required and, as such, a quotation should be sought.

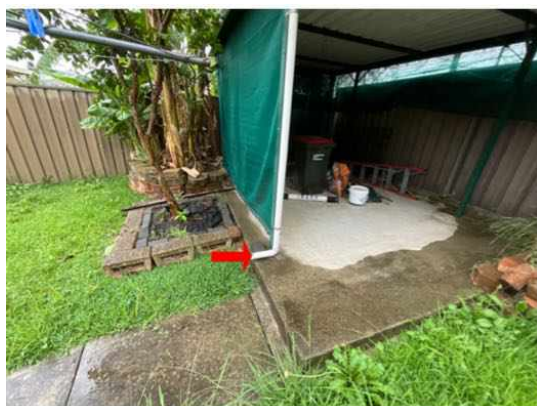
### Finding 3.04

Where roof plumbing doesn't drain adequately, the area at the base perimeter can become excessively damp, potentially creating an environment that is susceptible to rust and corrosion of surrounding building elements, as well as attracting termites and other pests.

It is highly recommended that a plumber be appointed to further inspect the area and to install adequate drainage equipment where necessary.

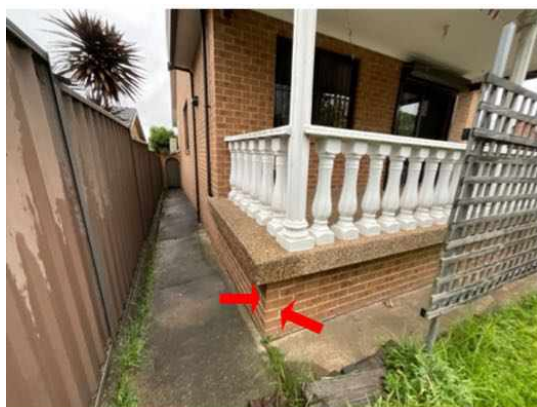
### Finding 3.05

| Finding: | Damage to Masonry Walls (Cracks) - Category 1 |
| Information: | It has been observed that damage to masonry walls caused by movement of slabs, footings, or other causes, has occurred. The degree of damage falls within Category 1, described as fine cracks, which are less than 1.0mm in width limit, and that do not need repair. |

Damage of this category is not considered a defect for rectification. Always contact your building inspector should cracks widen, lengthen, or become more numerous.

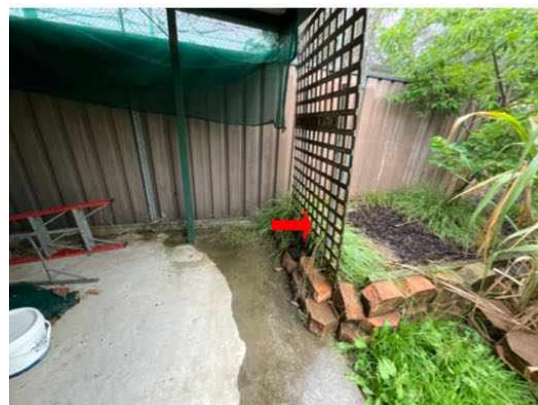
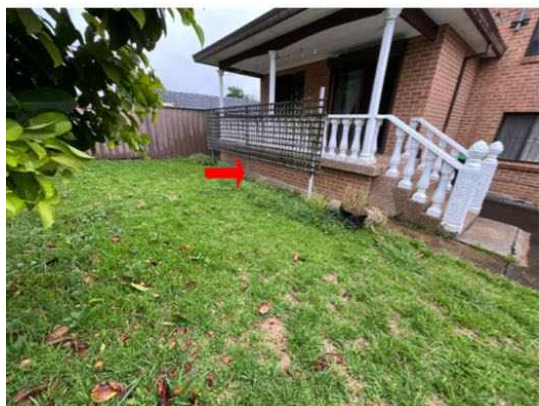
| Finding: | Untreated or non-durable timbers in a hazardous environment |
| Information: | To reduce the risk of timber pest attack it is essential that timber used in a hazardous environment (e.g. in direct contact with the ground or frequently exposed to damp conditions) is of sufficient durability and/or is adequately preservative treated. |

Untreated timbers in direct contact with the ground are likely to develop severe wood rot and/or fungal decay if left unattended creating attraction for subterranean termites to infest the timbers from surrounding areas.

If untreated or non-durable timbers are found to be in a hazardous environment it is highly advised that replacement of these building elements be performed as soon as possible to aid the protection of the property against termite / timber pest attack.

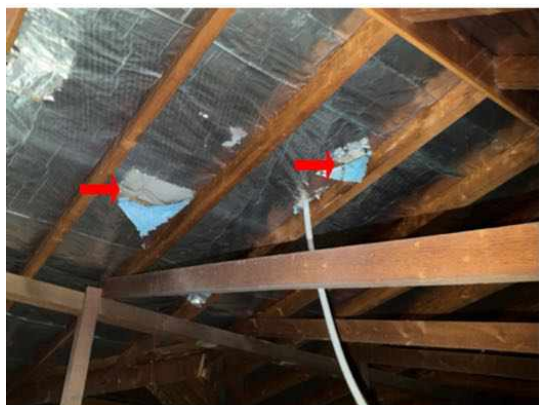
### Finding 3.08

| Finding: | Sarking - Damaged |

Where sarking is damaged, both insulation and moisture protection of the property are inhibited. This creates a loss of energy and thus negatively impacts the energy efficiency of the property, allowing potential for moisture ingress from condensation or leaking roof tiles.

It is important to repair any holes or damaged sections of sarking to ensure that the building material is fully functional. A registered builder or qualified carpenter should be consulted to provide further advice on this defect and to perform rectification works at client discretion.

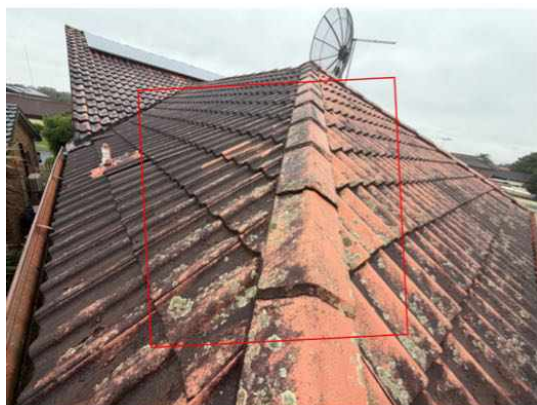
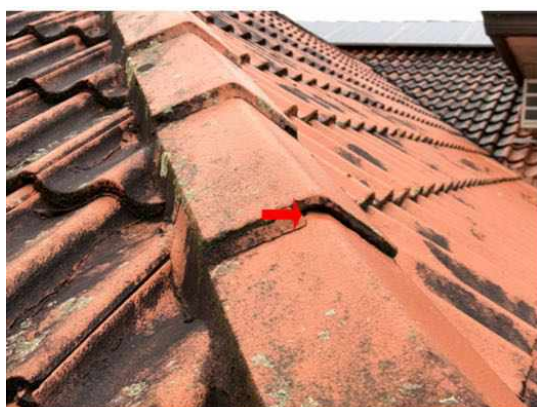
### Finding 3.09

Upon inspection of the exterior roofing, the majority of roof tiles were considered to be in a fair condition. While weathering of the tiles is consistent with the age of the property, maintenance works are required.

Isolated areas of mortar have come loose and minor cracking is also present. Re-pointing and re-sealing the may be considered as an interim solution by the client to help preserve and extend the life span of the tiles.

Where left unmanaged, deteriorating roof tiles are likely to lead to a number of secondary defects, including minor water leaks and weather exposure to internal roofing structures.

Consultation with a licensed roofing contractor is highly advised to gain advice on cost of remedial works that may be required in the short to medium term. Remedial works are likely to increase the longevity of the exterior roofing structure.

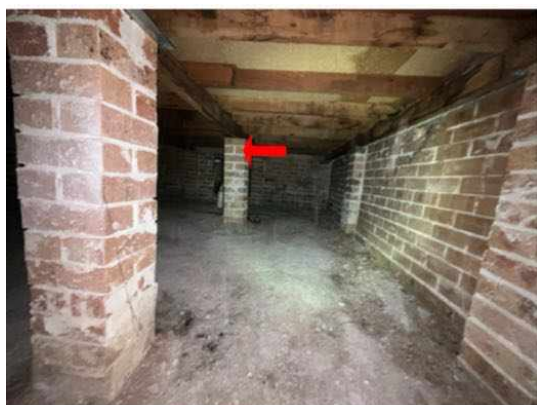
Location: Subfloor  
 Finding: Piers - Leaning  
 Information: Pier to the subfloor structure is leaning, indicating that its structural integrity may have been affected. The cause of this instability is likely to be caused by movement / minor subsidence of the pier due to moisture.

Although only minor the pier should be monitored to avoid potential structural damage, which is likely to lead to a range of major and minor defects. Improving site drainage is recommended to avoid further movement / subsidence of the affected pier.

If further movement is evident appointment of a structural engineer is advised to assess the condition of the piers and provide advice on remedial works that may be required.

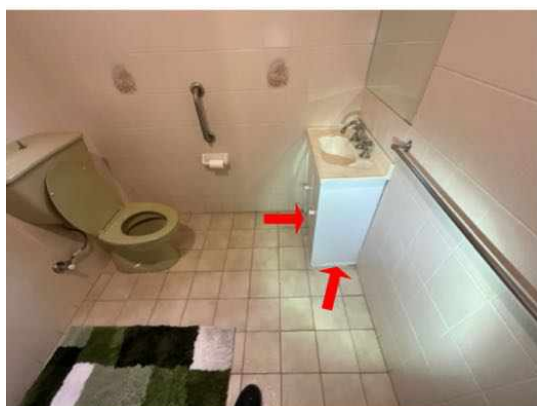
| Finding: | Cupboard/vanity - Swollen/Water Damaged |
| Information: | Water damage was identified inside the vanity/cupboards in this area and it was also found to be swollen. Water damaged/swollen building elements generally indicate that the building materials have been affected by excessive moisture over a prolonged period of time, and have swollen as a result. A licensed plumber should be engaged to assess where the moisture is coming from and carry out any rectification as soon as possible. Replacement of the vanity/cupboards is also advised by a licensed cabinetmaker. |

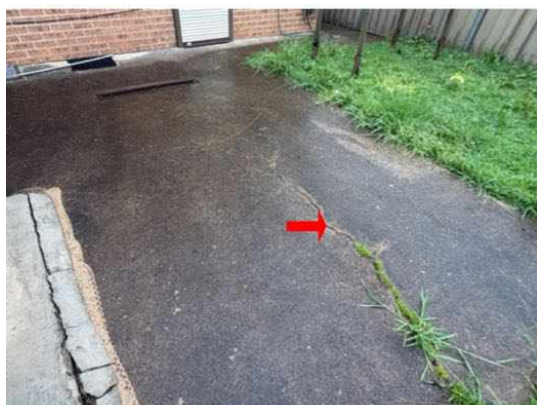
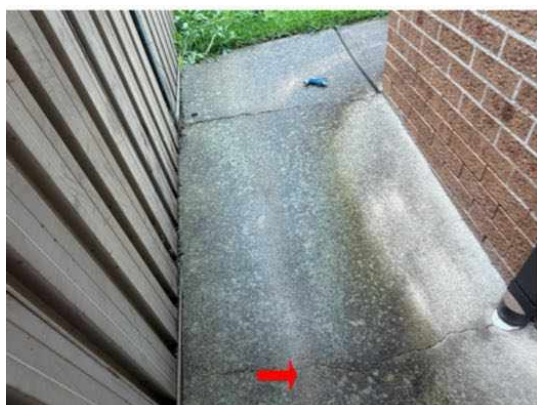
### Finding 3.15

| Finding: | Cracking - External Concrete Paving Damage Category 2 - Distinct (less than 3mm) |
| Information: | Distinct cracks were identified in external concrete paving. Distinct cracks are generally found in older concrete paving, and may also present as a trip hazard as consequence of an uneven or curved surface. |

General age and expected deterioration of the paved areas is a common cause of this type of cracking. However, expansion and contraction of the slab may also have occurred due to environmental factors. Such factors include variable moisture and weather conditions, the presence of trees and their roots having a settling or lifting affect on the soil, or the effect of load bearing, e.g. heavy vehicles over a sustained period of time.

Cracking to this degree may also be due to poor original installation of the concrete. Factors such as poor compaction of the sub surface and/or inadequate reinforcing of the slab may create cracking and other secondary defects.

Repairs are likely to be required to prevent further cracking and to reduce hazards associated with cracking, such as tripping. Monitoring of all cracking should be conducted frequently. Always contact a building inspector should cracks widen, lengthen, or become more numerous.

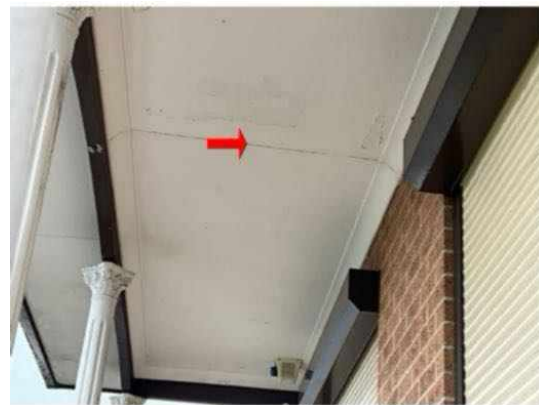
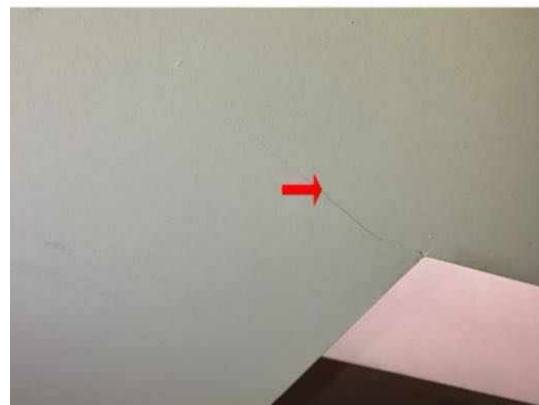
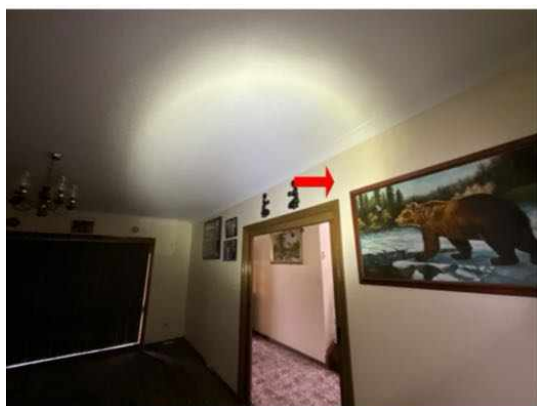
**Finding 3.16**

| Finding: | Cracking - Damage Category 1 - Fine (up to 1mm) |
| Information: | Although fine cracks are quite noticeable, they are often only considered to be an appearance defect, and usually do not indicate any structural damage. Generally, the cause of a fine crack is indicative of a separation between building materials and finishes (e.g. paint, plaster, etc.) along joins. |

Cracking of this nature can generally be repaired with minor sanding, filling and/or repainting. Such works should be performed by a qualified painter or a general handyman.

Monitoring of all cracking should be conducted frequently. Always contact a building inspector should cracks widen, lengthen, or become more numerous.

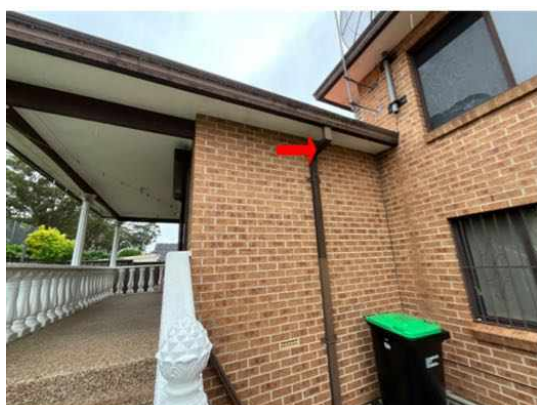
Such leaking creates damp conditions in the affected area, causing potential for water pooling and subsequent water damage if left unattended. These conditions may also attract termite attack, particularly if the area is subject to minimal levels of sun throughout daylight hours.

It is highly advised that a licensed plumber be appointed to rectify any water leaks that may be present. Areas of repair and replacement of plumbing fittings and fixtures may be required and, as such, a quotation should be sought.

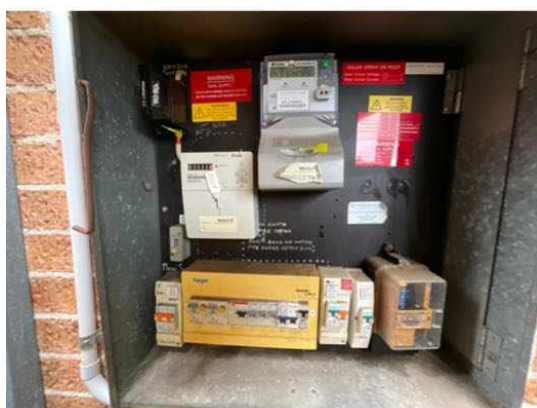
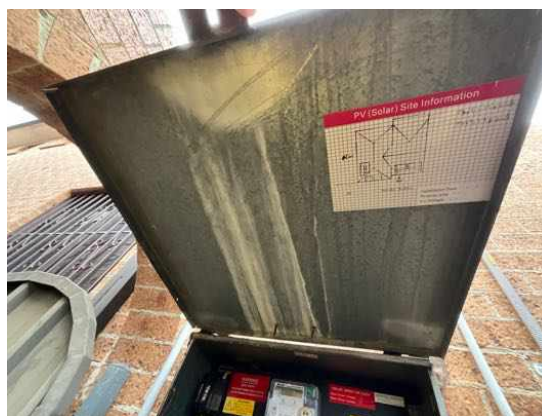
### Finding 6.03

A durable notice should be placed in the switchboard unit to indicate current termite barriers. At the time of inspection, it appeared as though no termite management system has been installed, with no evidence to suggest preventative works taking place.

The client may consider gaining further advice from a pest controller as to the costs and procedures involved with this application. It is recommended that obtaining such advice be a short-term priority.

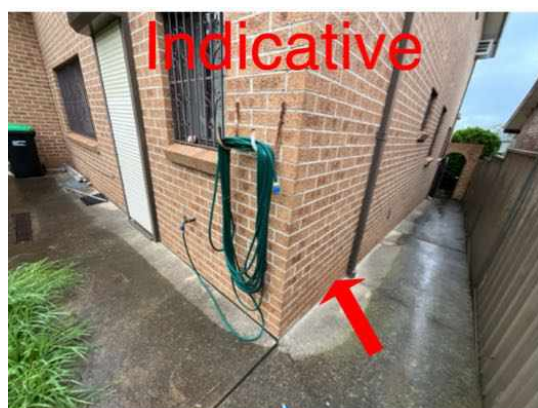
### Finding 6.04

| Information: | Slab Edge Exposure: Where external concrete slab edges are not exposed there is a high risk of concealed termite entry. In some buildings built since July 1995 the edge of the slab forms part of the termite shield system. In these buildings an inspection zone of at least 75mm should be maintained to permit detection of termite entry. The concrete edge should not be concealed by render, tiles, cladding, flashings, adjoining structures, paving, soil, turf or landscaping etc. Where this is the case you should arrange to have the slab edge exposed for inspection. Concealed termite entry may already be taking place but could not be detected at the time of the inspection. This may have resulted in concealed timber damage. Does the slab edge inspection zone fully comply? |

Not able to comment. A very high proportion of termite attacks are over the edge of both Infill and other concrete slabs types. Covering the edge of a concrete slab makes concealed termite entry easy. Infill slab type construction has an even higher risk of concealed termite ingress as the slab edge is concealed due to the construction design and cannot be exposed. The type of slab may only be determined by assessment of the construction plans by a qualified person e.g. Builder, Architect. Construction Plans may be obtainable by your local Council or Builder. Termite activity and or damage may be present in concealed timbers of the building. We strongly recommend frequent regular inspections in accordance with AS 3660.2. Where the slab edge is not fully exposed or the slab is an infill slab or the slab type cannot be determined then we strongly recommend inspections every 3 to 6 months in accordance with AS 3660.2 or AS 4349.3.

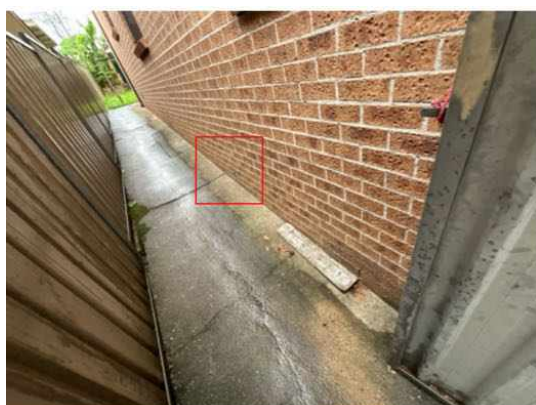
### Finding 6.05

Additionally build-up of moisture is likely to occur if weep holes are covered further attracting termite activity to these areas.

It is highly recommended that weep holes are left exposed in all areas throughout the external property. Therefore if any termite activity leading into weep holes becomes easily detectable during frequent pest inspections.

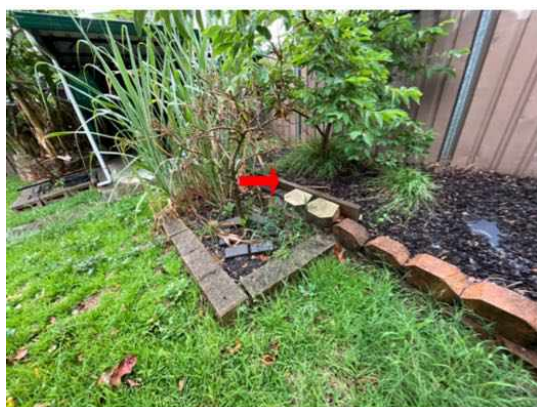
When met with excessive moisture timber begins to decay and develop wood rot. Any timbers that are in direct contact with external grounds especially if left untreated or non-durable also provide ingress for subterranean termites into that particular element.

The removal of any such materials that may be conducive to termite activity should be removed as soon as possible to minimise the risk of termite attack.

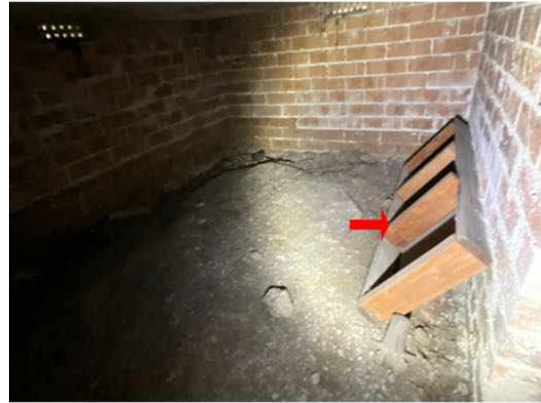
### Finding 6.10

the risk of termite activity being present. As they are likely to come into contact with weather conditions or excessive moisture wood rot is likely to develop on timbers that are not treated.

It is highly recommended that any stored timbers be immediately removed from areas in which they may attract any termite / timber pest attack. Minimisation of risk / prevention of termite attack is far more adequate than dealing with the presence of termite activity.

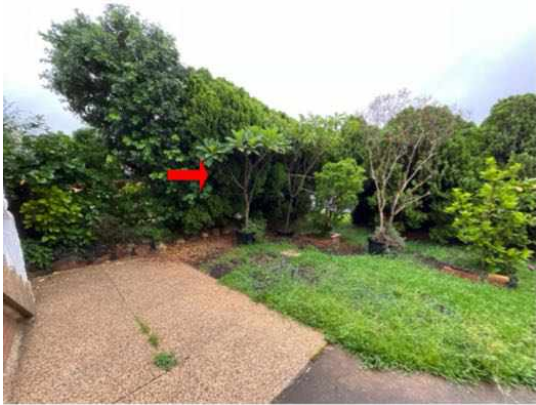
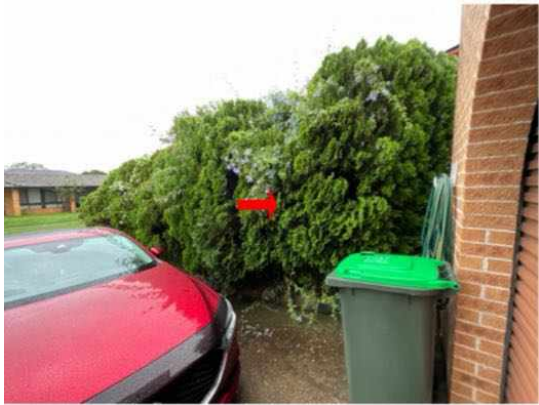
### Finding 6.11

| Finding: | Surrounding bushland - Conductive |
| Information: | Home and or building is situated in a high risk area for termite activity, due to close proximity to surrounding bushland. |

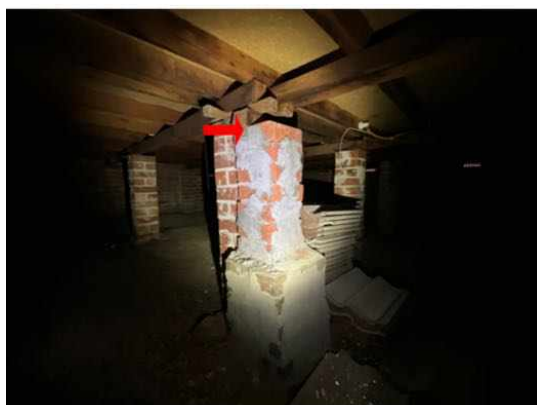
Where ant caps have not been installed, frequent monitoring of these areas should be carried out in order to identify any signs of termite or timber pest workings.

A licensed builder must be appointed urgently to replace any missing ant caps.
