Building and Timber Pest Inspection Report VR

Inspection Date: Fri, 9 Jan 2026

Property Address: 32 Warradale Road Silverdale NSW 2752

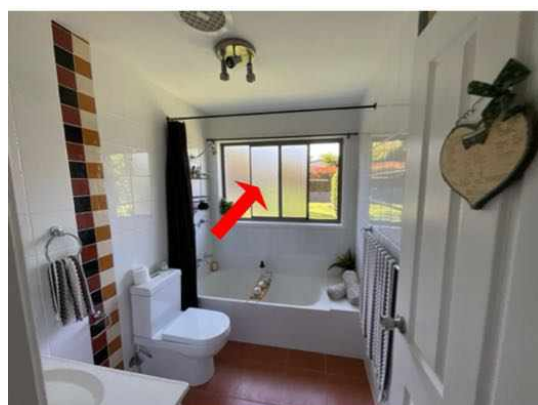
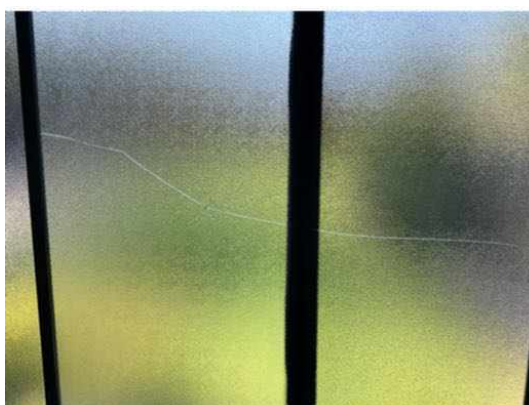
Building:	Main Building
Location:	Bathroom
Finding:	Window - Cracked Glazing.
Information:	Observation

Cracking was identified to the window glazing in this area at the time of inspection. The pattern and nature of the cracking is consistent with impact-related damage. No evidence was available to confirm the timing or cause of the damage; however, the defect is clearly visible and has not been rectified.

Cracked glazing is likely to continue to deteriorate over time, with an increased risk of the glass further cracking or shattering, particularly when exposed to vibration, wind loading, or temperature variation. This condition presents a potential safety hazard to occupants and visitors. In addition, the integrity of the window is compromised, reducing weather tightness and increasing the likelihood of minor water ingress and draughts, which may lead to secondary damage to internal finishes if left unmanaged.

A suitably qualified glazier should be engaged to repair or replace the damaged window glazing as soon as practicable. Until rectification is completed, caution should be exercised by any persons in proximity to the affected window to reduce the risk of personal injury.

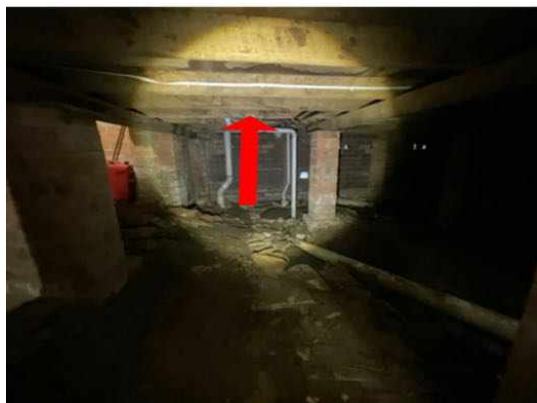
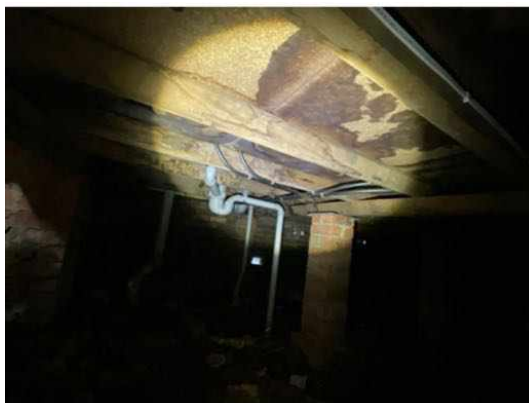
Finding 2.01

Building:	Main Building
Location:	Subfloor - Below Ensuite
Finding:	Subfloor – Observation - Water Staining & Minor Deterioration Below Bathroom.
Information:	Water staining and minor deterioration were noted on the flooring directly beneath the bathroom, indicating a possible previous leak from the shower base or plumbing. The area was dry at the time of inspection, including after a basic water test, suggesting that the issue may have been rectified.

- Minor water damage to the floor sheets was observed but did not appear structural at the time of inspection.
- The ensuite appears to have been renovated at some point.

- Previous leaks may have caused concealed damage or inadequate waterproofing, potentially leading to future leaks or subfloor deterioration.
- Dry conditions may indicate recent repairs; however, a visual inspection alone cannot confirm leak resolution.

- Monitor the area over time, especially after bathroom fixtures are in regular use.
- If moisture or leaking recurs, a licensed plumber or bathroom specialist should be engaged to locate and rectify the issue.
- For a more definitive assessment, a special purpose inspection is recommended. Alternatively, it should be assumed the shower or plumbing may still pose a leak risk.

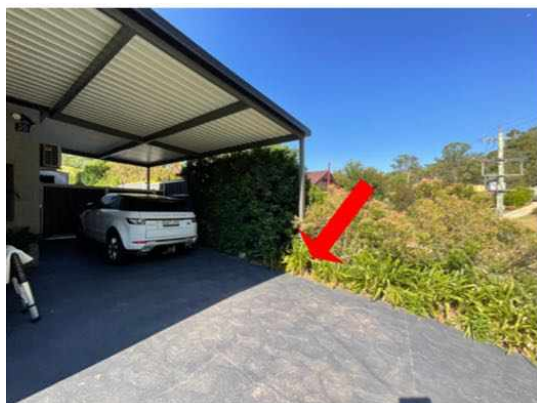
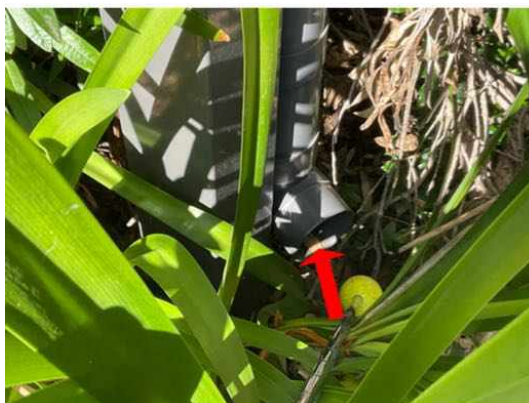
Finding 3.01

A section of roof plumbing was found where the downpipe is not connected to the stormwater drainage system.

It is advised that a licensed plumber be engaged to:

- Inspect the affected roof plumbing area, and
- Connect the downpipe to a compliant stormwater drainage system, or alternatively, install appropriate drainage measures to manage water flow and mitigate potential property damage or pest risks.

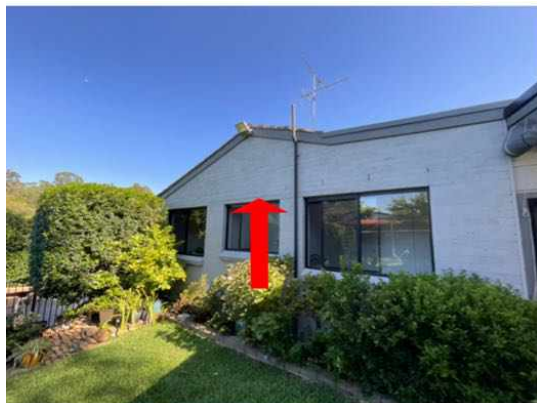
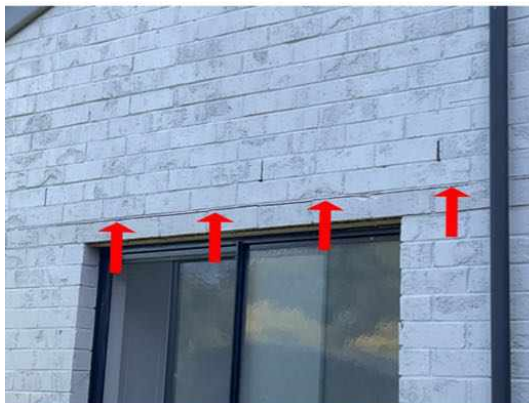
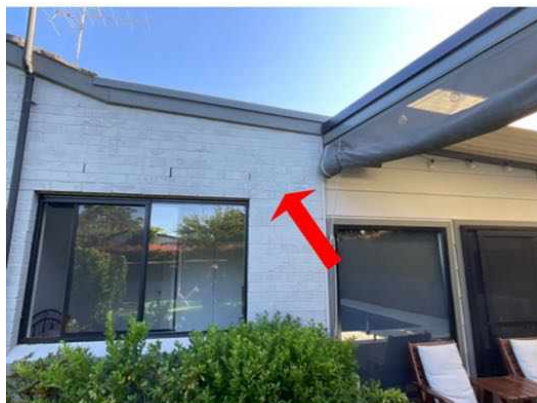
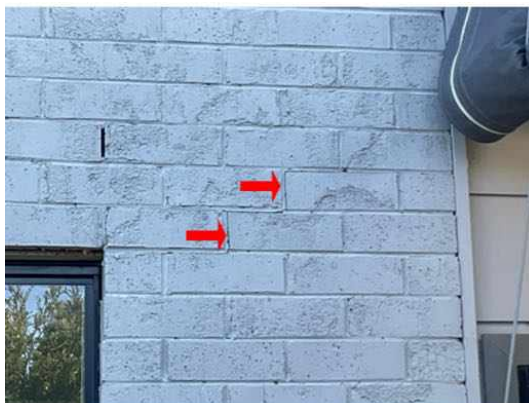
Finding 3.02

Building: Main Building
 Location: Exterior walls - rear
 Finding: Brickwork - Cracking.
 Information: Cracking – External Brickwork (Minor to Moderate)

Cracking was observed in the external brickwork in the noted location(s) and was considered minor at the time of inspection.

This type of cracking is relatively common in buildings of similar age and construction, and typically reflects stresses and movement affecting the wall over time.

- Subsidence or minor footing movement, often due to:
- Poor or inadequate site drainage
- Excessive subfloor moisture
- Soil erosion or moisture variations around footings
- Reactive clay soils subject to expansion and contraction
- Localised water leaks from plumbing or roof drainage

If left unaddressed, such cracking may lead to progressive movement or more significant structural issues over time.

It is strongly recommended that:

- The cracking be assessed by a qualified Structural Engineer to determine its cause and whether it is related to foundation movement
- Drainage improvements to the yard and/or subfloor be undertaken to manage moisture and prevent further movement

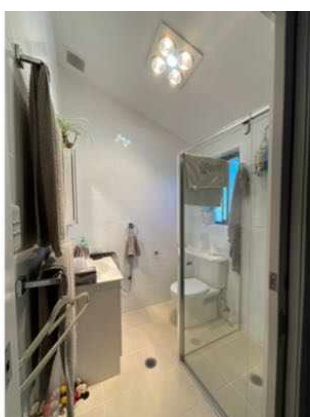
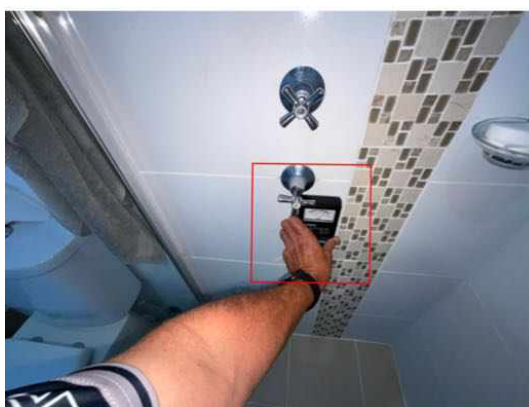
Finding 3.03

Building:	Main Building
Location:	Ensuite
Finding:	Shower - Evidence of Damp and Elevated Moisture Readings.
Information:	Damp was noted to the wall within the shower alcove, with elevated moisture readings detected below the tap fittings and lower wall tiles at the time of inspection. No visible evidence of moisture was detected below in the subfloor and no visible evidence of water damage or mould growth in adjacent areas.

The likely source of the dampness is water ingress around the unsealed tap fittings, allowing moisture to penetrate behind the tiles. While minor leaks to plumbing fittings within the wall cavity are a possibility, no elevated moisture was found behind the shower wall to confirm this at the time of inspection.

- Seal around tap fittings to prevent water ingress – this may be carried out by a licensed plumber or general handyman.
- Inspect and reseal grout and tile joints as required. A shower sealant specialist may be appointed at the client's discretion to undertake preventative sealing of tile surfaces and joints.
- Ensure that sealant around junctions, tap penetrations, and wall/floor joints is maintained in good condition to prevent future moisture issues.
- If moisture is noted behind walls in future, or if signs of damp or mould develop, an invasive inspection by a builder, plumber, or pest controller is recommended to assess the condition of concealed structural elements and identify any underlying water leaks.

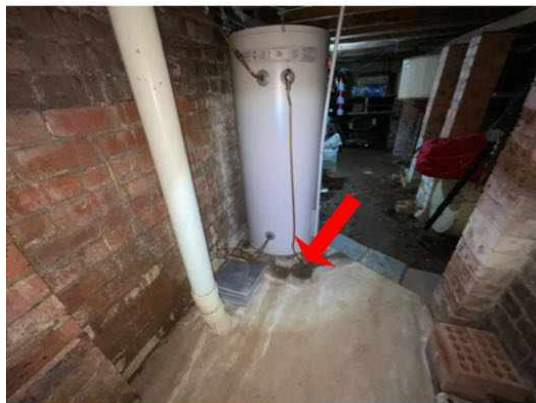
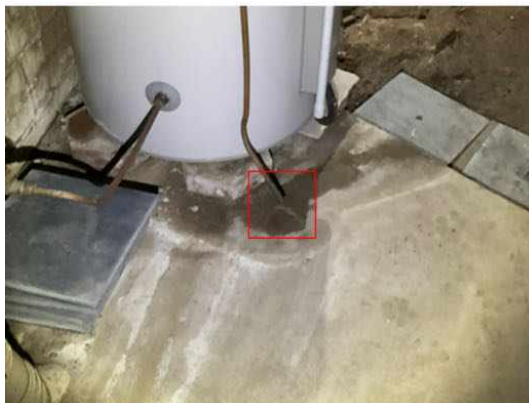
Building:	Main Building
Location:	Subfloor
Finding:	Overflow Management – Risk of Termite Activity..
Information:	Observation: Water Pooling from HWS and Air Conditioning Overflows

Water discharge from the Hot Water System (HWS) pressure relief valve and air conditioning unit overflows was observed discharging close to the base of the structure, contributing to water pooling around the building perimeter.

Persistent moisture near the foundation or subfloor area significantly increases the likelihood of termite activity. Termites are highly attracted to damp environments, and stagnant water near structural elements provides ideal conditions for foraging and infestation.

It is highly recommended that all overflows from the HWS and air conditioning units be redirected away from the building, preferably via fixed drainage or extension piping, to prevent water accumulation near the structure.

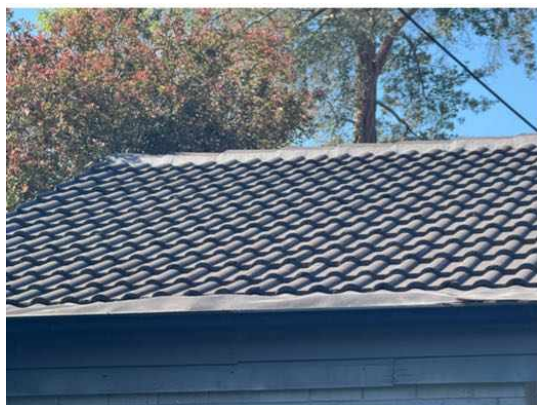
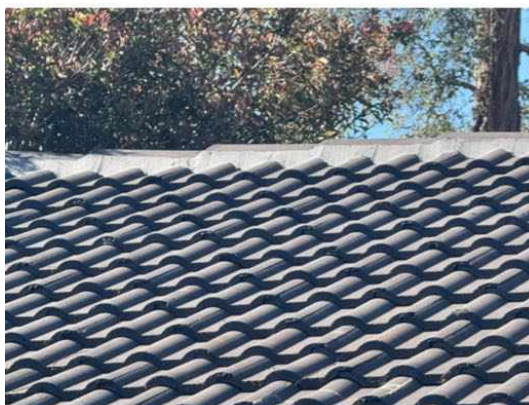
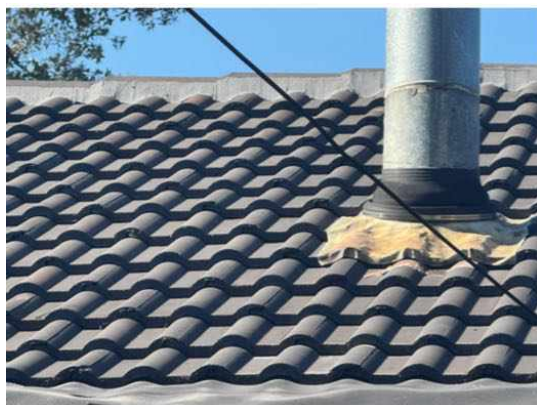
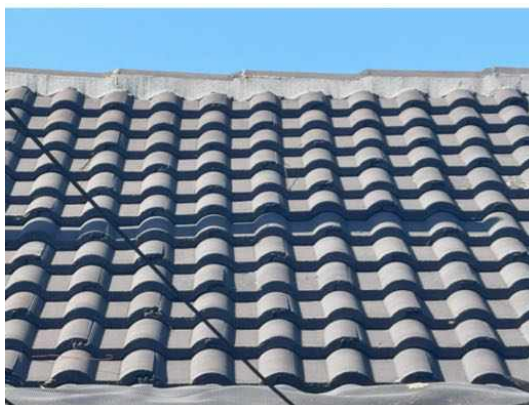
Building: Main Building
 Location: Roof Exterior
 Finding: Roof Tiles – General Condition.
 Information: Condition Overview:

Based on the limited visual inspection, the roof and guttering system appears to be in good condition generally and serviceable condition. A further investigation by a roofing specialist to ensure the integrity of non-visible areas and replaced silicone repaired tiles.

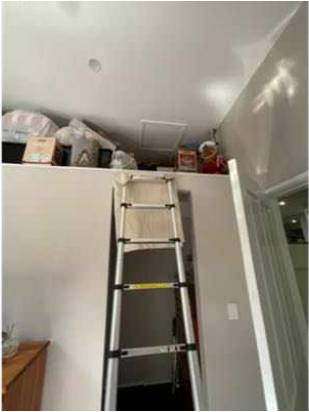
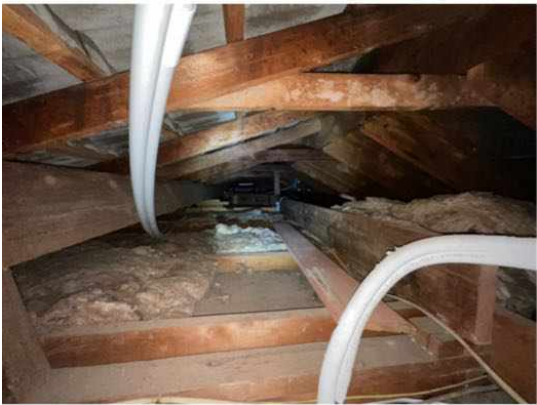
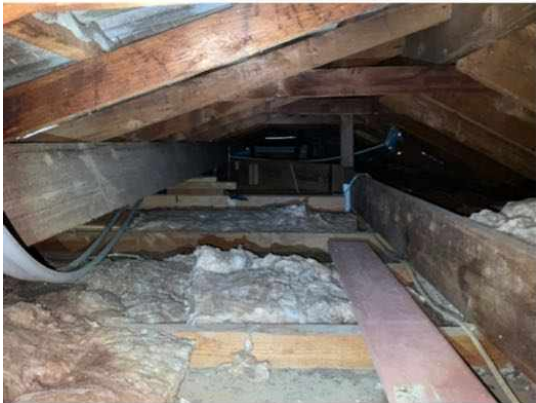
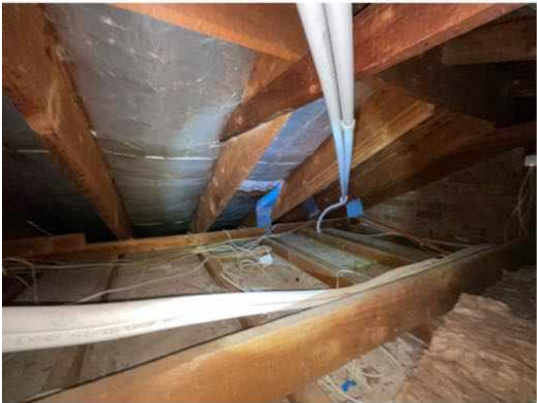
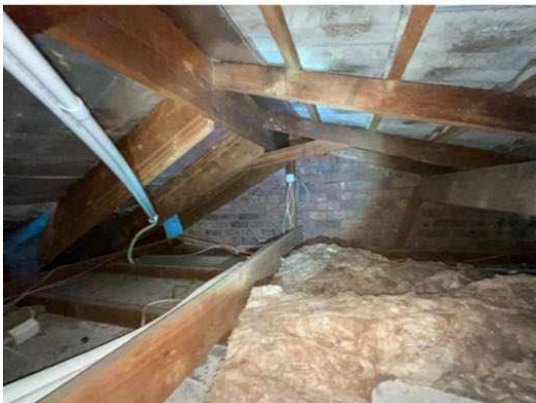
Building: Main Building
 Location: Roof Void
 Finding: Roof Void – Limited Accessibility..
 Information: Observation:

Installation of an additional manhole is recommended to facilitate a re-inspection and enable a more thorough assessment of the roof void in the future. This will help ensure that all structural elements and concealed areas are properly evaluated.

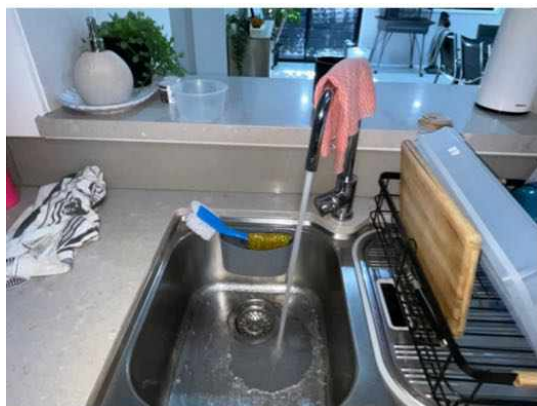
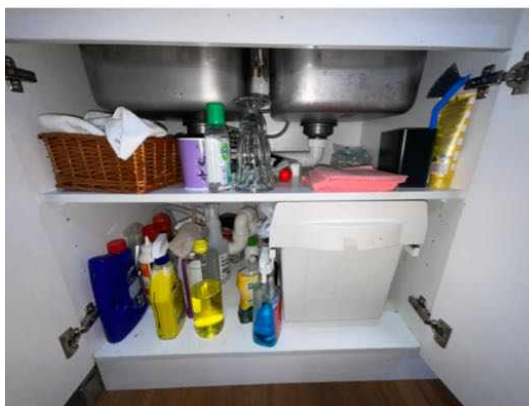
Building: Main Building
Location: Kitchen
Finding: Kitchen Sink – Overall Condition & Recommendations.
Information: Observations:

- Further monitoring and testing are recommended once the tap(s) are in constant use, to identify any drainage issues or signs of slow leaks not evident during the limited inspection.

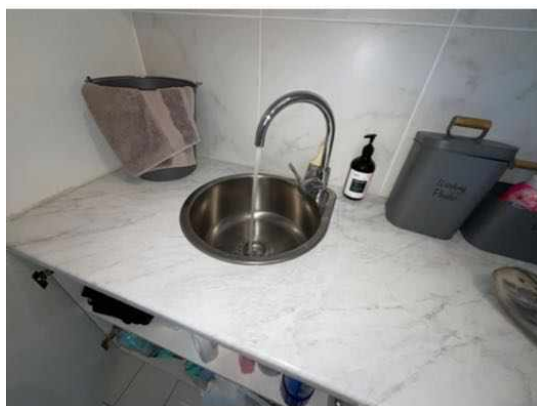
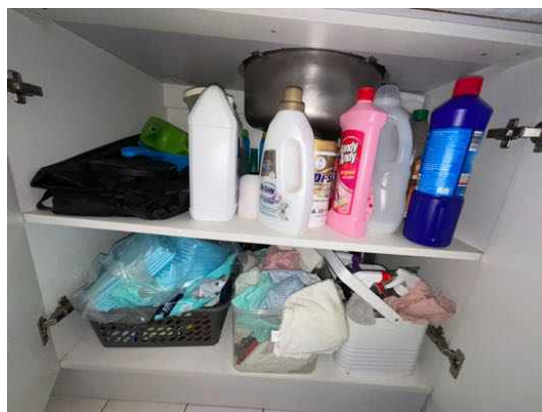
Building: Main Building
 Location: Laundry
 Finding: Laundry - Taps/Plumbing/Drainage.
 Information: Observation: Laundry Tub – Taps, Plumbing, and Cabinetry

- Further monitoring or testing is recommended once the taps are placed into regular use, to ensure no leaks develop over time and that the drainage system continues to perform adequately.
- Sealant and grouting in wet areas should be maintained as part of the long-term care and upkeep of the property.
