## Building Inspection Report VR

Inspection Date: Wed, 14 Jan 2026

Property Address: 14 Base St, Victoria Point QLD 4165,  
Australia

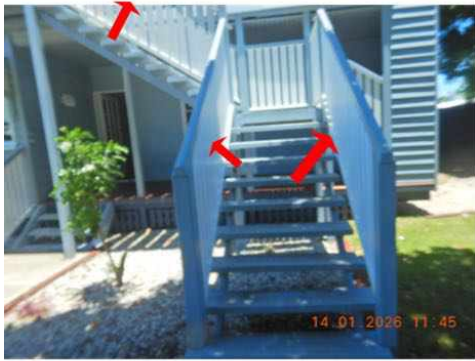
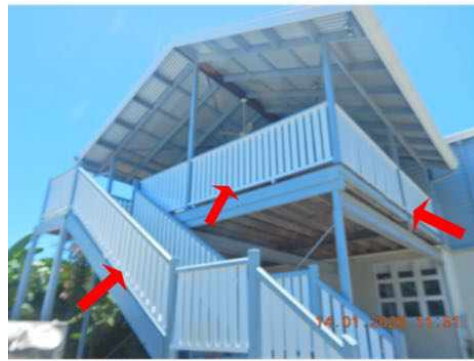
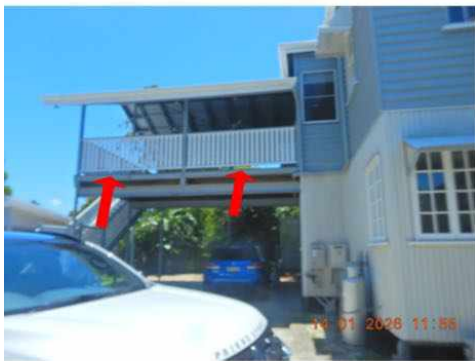
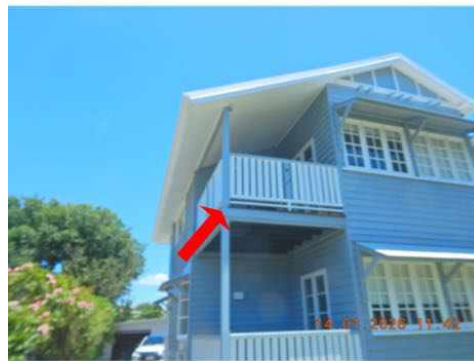
#### Defects 1.01

Building: Main Building  
Location: Patio/ Deck/Stairs > All Areas  
Finding: External Handrail's/ Balustrade  
Information: The external Front patio/stairs/deck areas and rear deck and stairs handrail / Balustrades on this building are showing signs of deterioration due to environmental and moisture damage. Commonly known as wood rot , the bottom edges of the timber slats have come loose from the bottom rail, and some handrails were found to be not adequately secured to the posts in areas. Repair work or replacement is recommended as a priority to assure the personnel safety of anyone using these areas to access the building. The service of a carpenter or registered builder could be engaged to carry out this task.

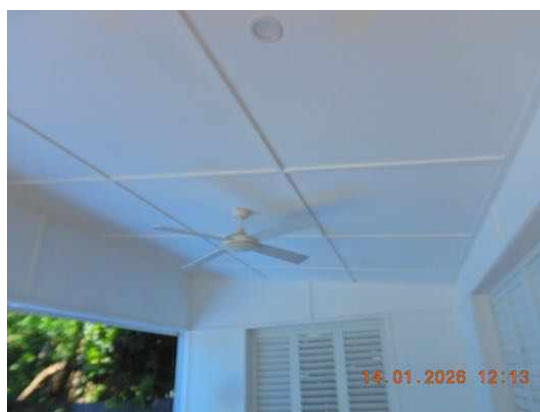
### Defects 1.03

Building: Main Building  
 Location: Pool Area > Rear Right  
 Finding: Electrical fitting - Broken  
 Information: The pool house electrical ceiling light and fan switch fitting in this area was found to be broken at the time of inspection. Breakage occurs generally when the building materials have aged and decayed, but may also be indicative of impact damage to the building element (accidental or deliberate).

Left unmanaged, the fitting is unlikely to cause further damage to surrounding building elements. However, the broken fitting does expose electrical works, and may create a safety hazard if there is potential contact with persons in the area.

Repair and/or replacement of the broken fitting is advised. A Licensed electrician should be appointed to repair/replace the fitting immediately.

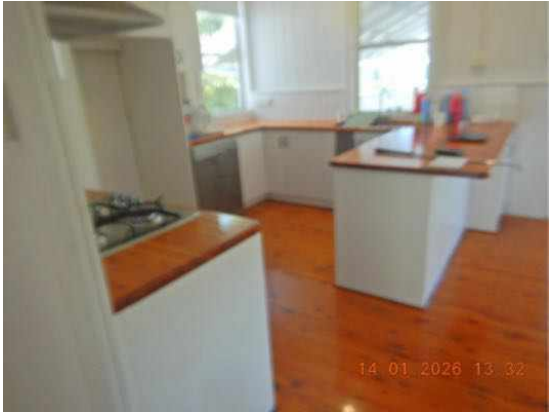
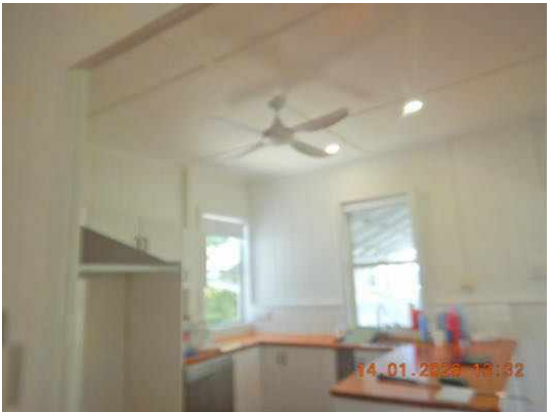
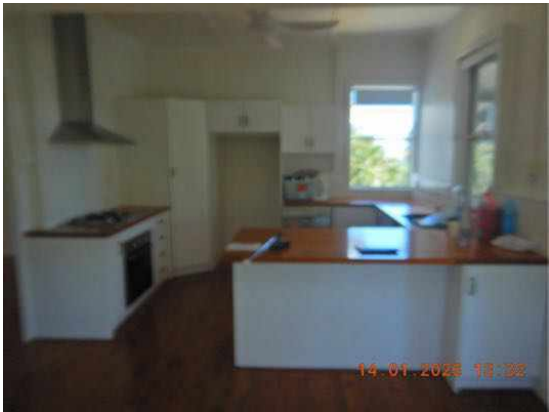
**Defects 1.04**

Building: Main Building  
Location: Kitchen/ Dining > Rear  
Finding: Oven Not secured correctly  
Information: The under bench oven was found to be loose in the opening and requires a couple of fixtures to secure it correctly.

At present this unit can be removed and may pose a safety hazard to anyone using this area.

The electrical contractor can complete the job.

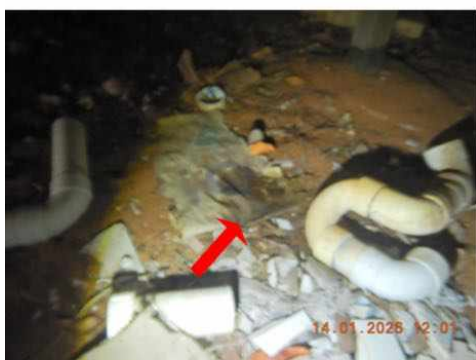
#### Defects 2.01

Building: Main Building  
Location: Bedroom 2 > Rear Left  
Finding: Shower base - Leaking  
Information: Leaking was evident to the lower level bedroom-2 ensuite shower base at the time of inspection. It is suspected that the leaking has occurred as a result of minor impact damage to the shower base or general ageing of the building elements.

Leaking from the shower base, where left unattended, is likely to lead to water damage to adjoining flooring and walls. Such damage can lead to water damage and necessitate extensive remedial works being required. Active water leaks may also create an environment that is susceptible to the formation and development of mould.

Appointment of a plumbing contractor is required to repair or replace the shower base. Such works should be performed as soon as possible to ensure that no further damage occurs.

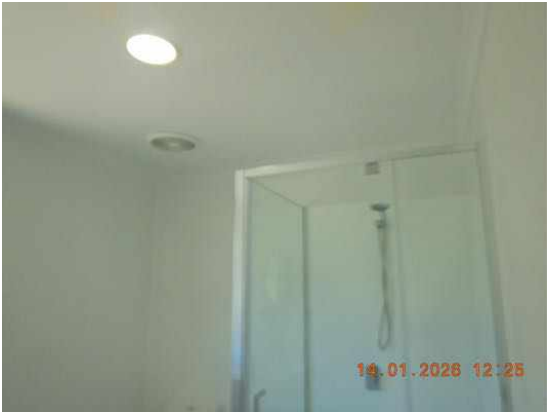
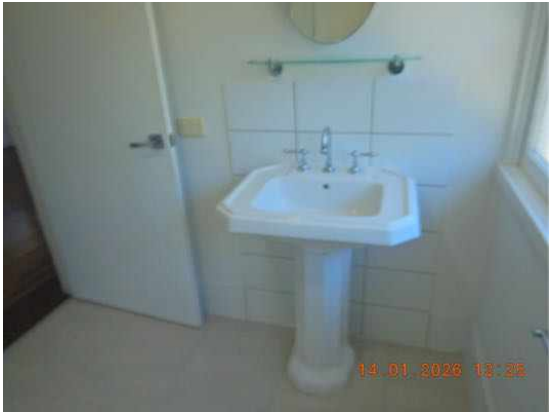
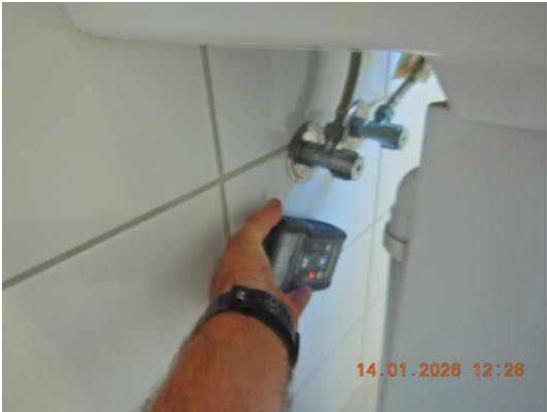
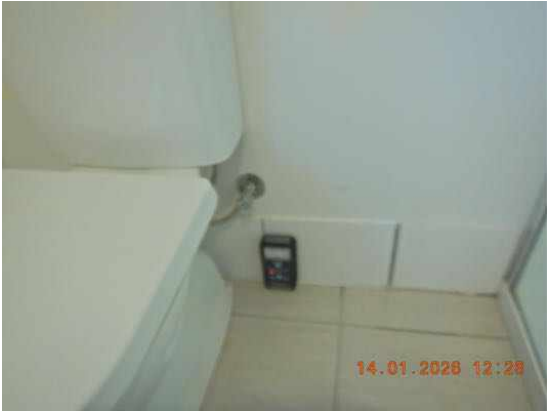
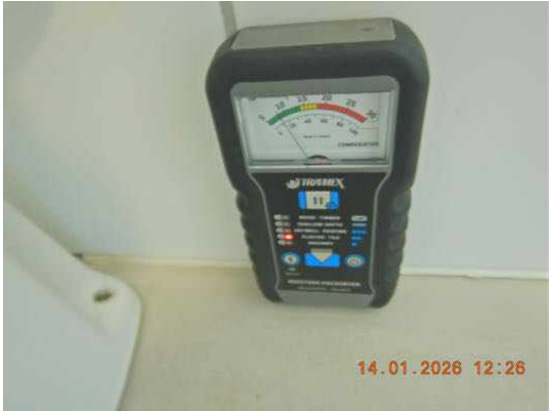
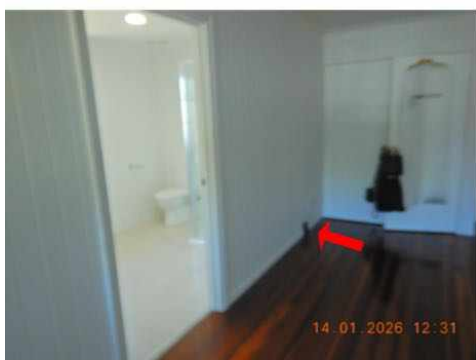
## Defects 2.02

Building:	Main Building
Location:	Bedroom - Master/ Ensuite > Rear
Finding:	moisture meter readings
Information:	There was a high moisture meter reading of 30 % in the master bedroom shower wall area at the time of this inspection. This can be caused by water ingress into the wall cavity from external sources or a possible plumbing leak . Wet areas can also have a potential failure to the water proofing membrane causing potential water issues. A licensed plumbing contractor or waterproofing contractor should inspect this area and report .

As the bedroom -2 shower that backs onto this wall was found to be leaking in the subfloor area, this MAY be the cause of the high moisture in this area.

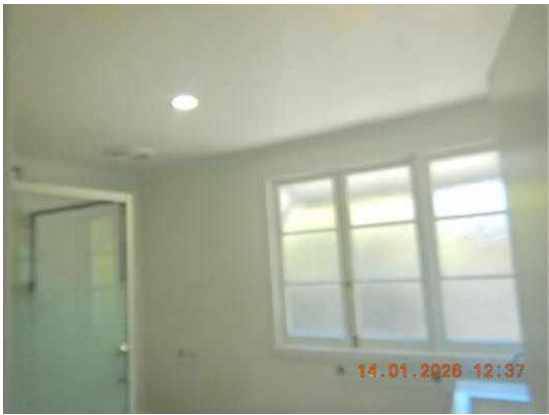
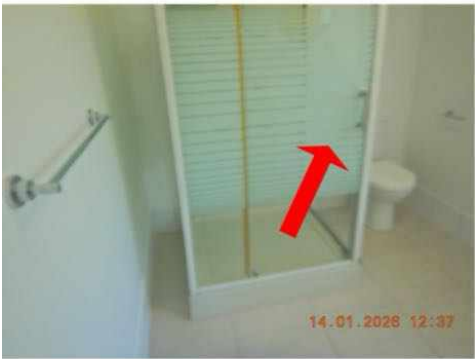
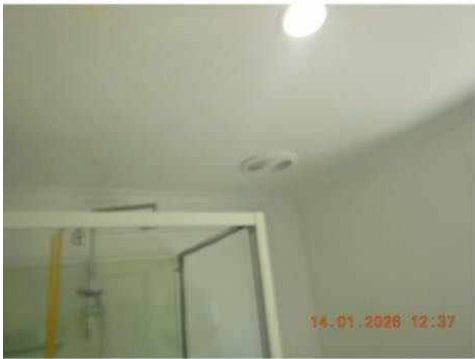
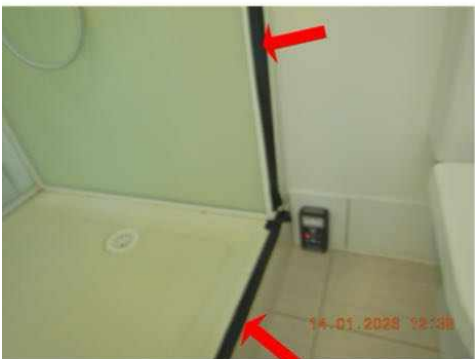
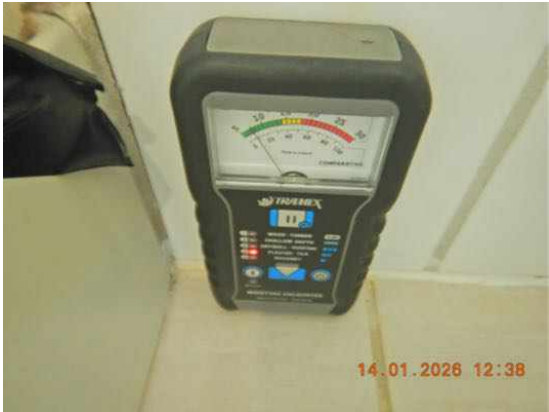
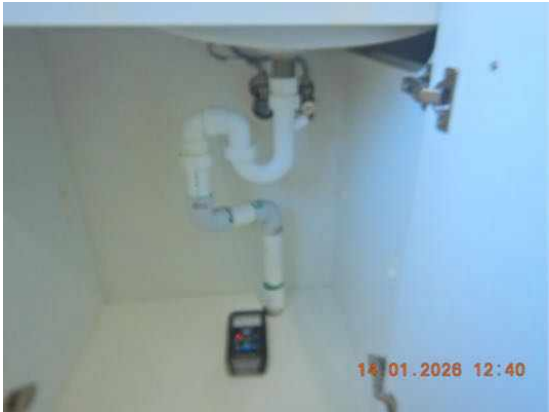
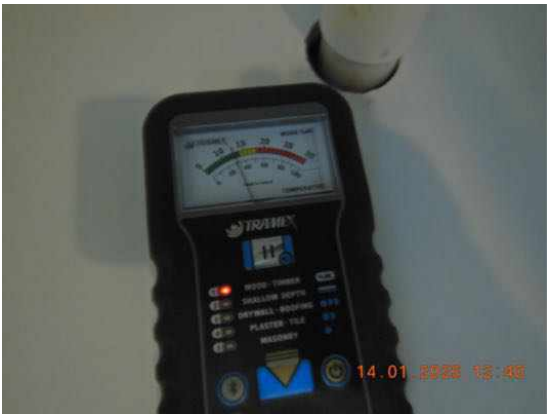
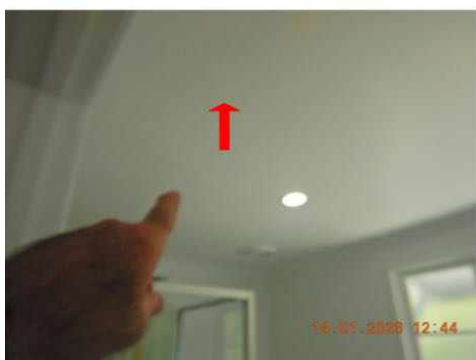
## Defects 2.03

Building: Main Building  
 Location: Bedroom 2/ Ensuite > Front Left  
 Finding: Bathroom in a deteriorated condition  
 Information: The bedroom -2 bathroom was found to be in a minor state of deterioration, with a glass panel missing in the shower screen and the shower unit detached of the rear wall.

This unit was found to be leaking into the subfloor area at the time of this inspection, and will require repairs.

The vanity unit top is not secured adequately to the unit and can be lifted up, this will require repairs secured.

There is minor movement cracking to the floor tiles in the centre of this room ,and repairs may be required if the movement cracking continues.

There appears to have been repairs to the ceiling area, and have been completed to a poor standard, and repairs will be required.

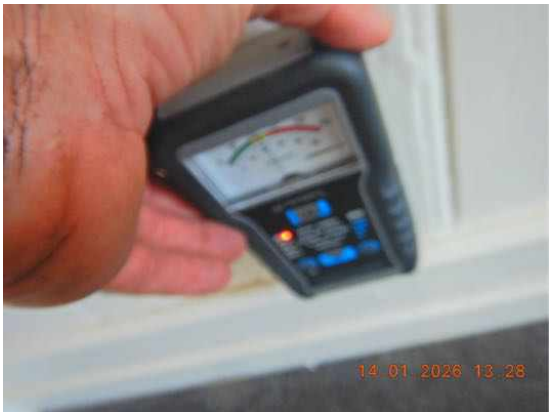
## Defects 2.04

Building: Main Building  
 Location: Bedroom 3/ Ensuite > All Areas  
 Finding: Waterproofing not installed  
 Information: The bedroom-3 ensuite floor area is suspected to not have a waterproof membrane installed as per Australian building code standards at the time of this inspection , no water stop angle or waterproofing was sighted at the door front to this room or other wet area.

There is a noticeable gap behind this ensuite doorway , and NO waterproof membrane was sighted, and may allow water into the floor cavity or ceilings below.

Monitoring of this area for any moisture deterioration occurring is recommended.

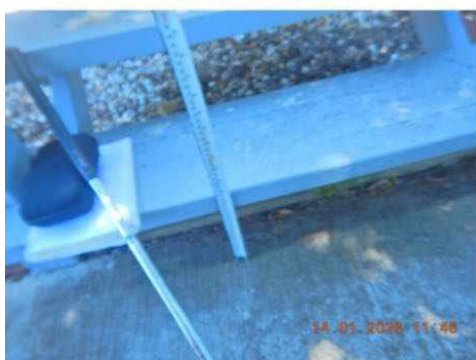
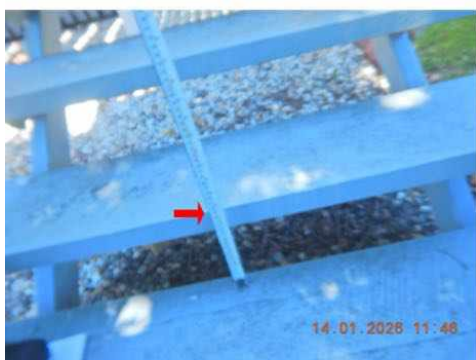
## Defects 3.02

Building:	Main Building
Location:	Stairs - External > Centre
Finding:	External stairs
Information:	main front stairs were found to have a bottom riser of 220 mm from the concrete to the first step and should not be greater than 190 mm.

The difference of 50 mm at the bottom step can cause some people to be unbalanced and there is a potential for a fall.

The installation of a 50 mm paver secured to the concrete should be considered.

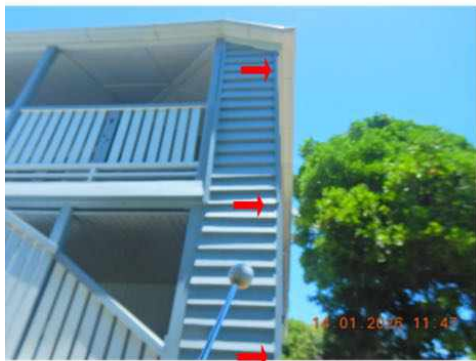
### Defects 3.03

Building:	Main Building
Location:	Exterior walls - front > Front Right
Finding:	Timber wall Framing ( As- 1684.2 )
Information:	The front right side external balcony wall and timber stop were noticeably leaning out off plumb.

As the original house is suspected to be 80 years old and has been lifted and built in underneath, this defect is considered a cosmetic defect only at this time.

New construction Timber wall framing is considered defective if it deviates from plane ( horizontal or vertical bow ) by more than 4 mm in any 2 meter length of wall framing.

Areas of wall framing in this area were found to be bowed / bent or out of horizontal or vertical tolerances by up to \_ mm over a 2 meter level.

This will require correction at the client's discretion.

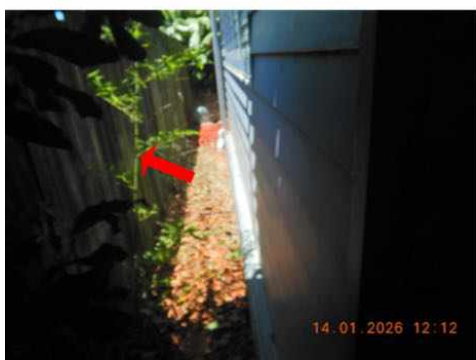
### Defects 3.04

Building:	Main Building
Location:	Yard > All Areas
Finding:	Fencing - Deteriorated
Information:	It was noted at the time of inspection that sections of the boundary timber fencing throughout the property have deteriorated. Typically fencing deteriorates due to age and or wear, rot and or rust which is generally expected for a structure of this age, due to prolonged exposure to weather conditions. Sometimes inadequate installation or maintenance can be to blame.

If left unattended, it is likely that further damage will occur. It is suspected that repair of several elements of the fencing may be required however replacement may be a consideration of the client also.

A licensed fencing contractor should be appointed to provide further advice and perform rectification works as necessary.

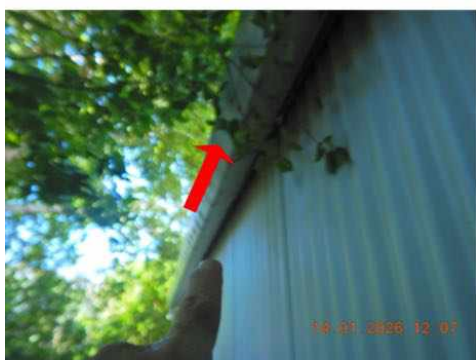
## Defects 3.08

Building:	Main Building
Location:	Shed > Centre Left
Finding:	Trees - Overhanging and filling gutters
Information:	The rear left side detached metal shed was found to have a large tree in direct contact with the roof and guttering on this building.

Gutters are a critical part of the building's management of storm water and rain. It is therefore important that they be kept clear to prevent secondary damage to associated building elements, including exterior and interior walls, ceiling linings and any adjoining building elements. Where gutters are blocked, pooling of rainwater is likely to occur, fast-tracking rust and corrosion of the roof plumbing elements.

It is highly advised that all overhanging tree branches be removed as soon as possible to prevent any further damage. Repair and/or replacement of sections of damaged guttering may also be required where the extent of the damage necessitates.

Such works should be performed by the homeowner; however, appointment of a landscape contractor or an arborist may be required. Consultation with a licensed roof plumber is required where guttering has been damaged.

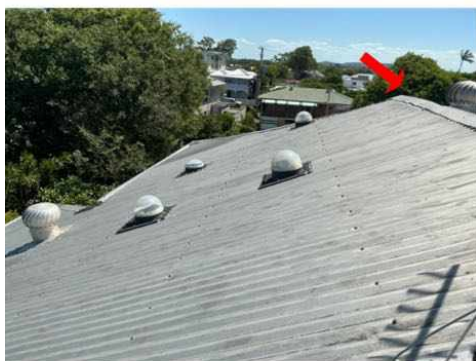
### Defects 3.12

Building:	Main Building
Location:	Roof Exterior > All Areas
Finding:	Roof plumbing - Loose flashing
Information:	Metal and other material flashings are applied to seals and intersections between roof coverings and building elements. They are designed to aid in weatherproofing of roof joins, and require regular inspection and maintenance as they are more subject to rust-related deterioration.

The flashing in this section of the exterior roofing appears to have come loose from its original fixing. It is suspected that this minor defect has occurred as a result of general deterioration over time.

Re-fixing and potential replacement of certain areas of flashing is advised to promote adequate roof drainage and protection from water penetration. Failure to perform these works may result in water damage and accelerated deterioration of associated building elements.

A roofing contractor or roofing plumber should be appointed as soon as possible to restore the flashing to a fully operational state.

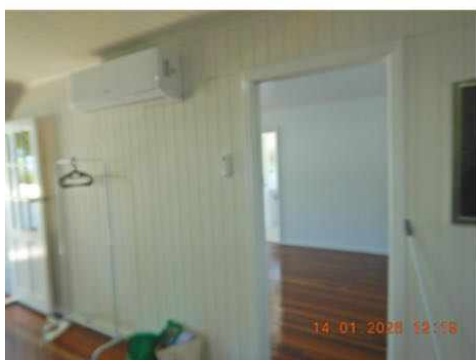
**Defects 3.13**

Building: Main Building  
Location: Living Room > Front Right  
Finding: Hopper Window springs broken  
Information: The downstairs front living room wall window was found to have the operating side spring damaged.

This will restrict the operational capacity of this window and will need to be replaced.

A windows service technician could complete the job.

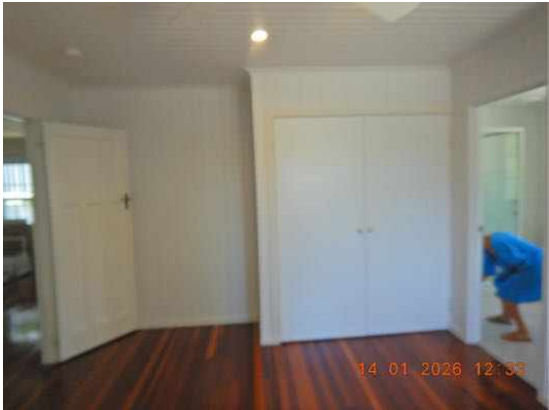
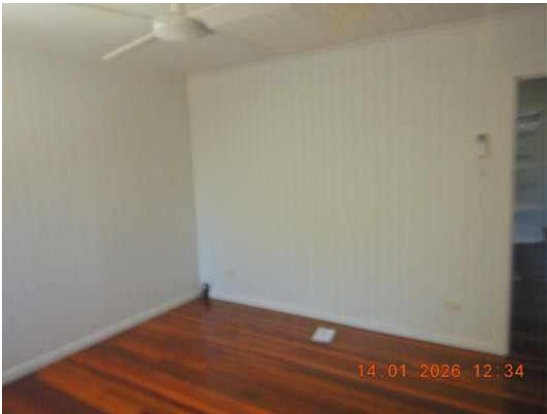
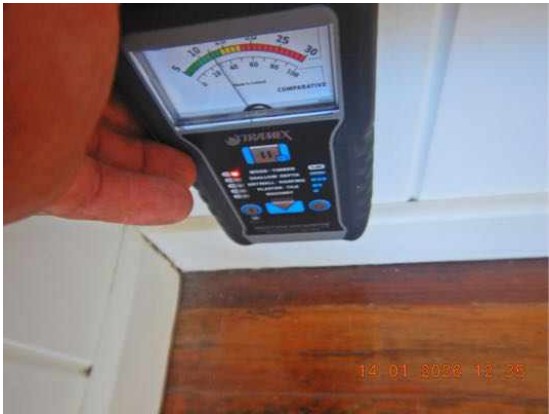
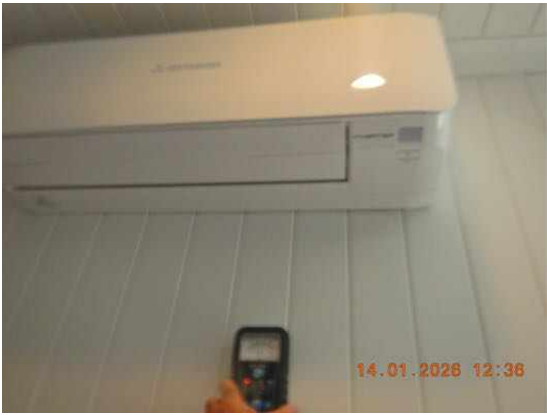
**Defects 3.16**

Building: Main Building  
Location: Bedroom 2 > Rear Right  
Finding: moisture meter readings  
Information: There was a slightly high moisture meter reading of 18 % in the bedroom -2 rear wall window area at the time of this inspection. This can be caused by water ingress into the wall cavity from external sources or a possible plumbing leak . Wet areas can also have a potential failure to the water proofing membrane causing potential water issues. A licensed plumbing contractor or waterproofing contractor should inspect this area and report .

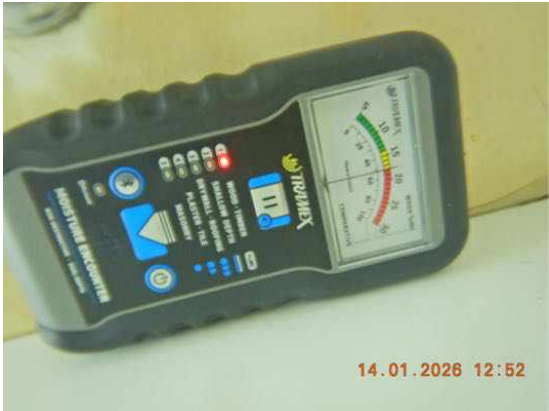
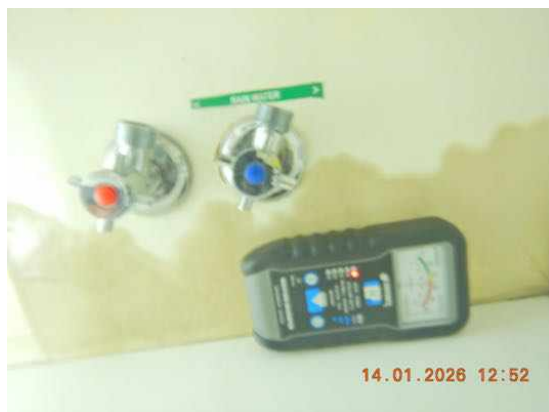
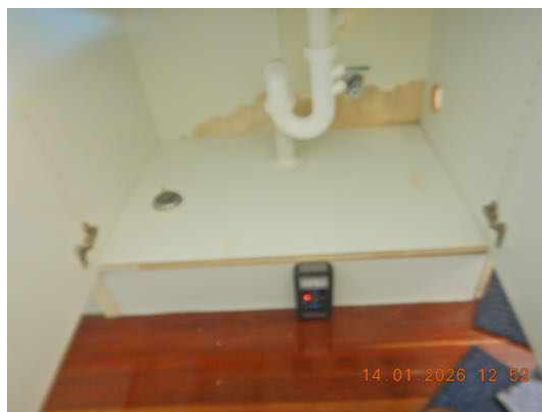
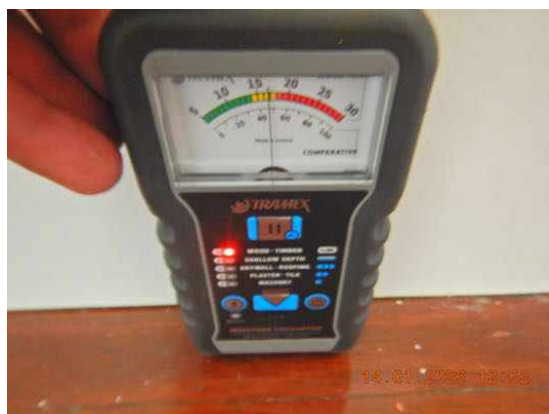
**Defects 3.18**

Building: Main Building  
 Location: Laundry > Rear  
 Finding: Suspected old Water damage.  
 Information: There appears to be old water damage to the rear laundry sink area joinery identified.

Moisture meter readings in this area were in the low range at the time of this inspection, but this area should be monitored for any further moisture deterioration occurring.

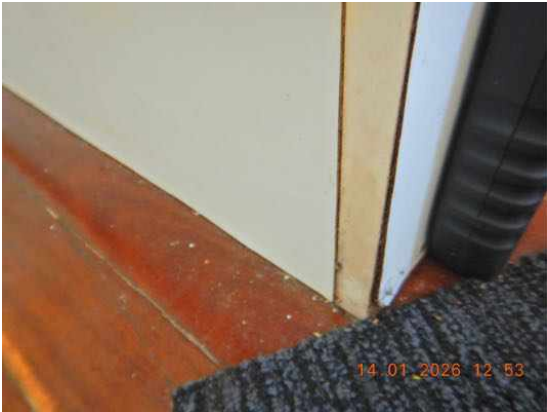
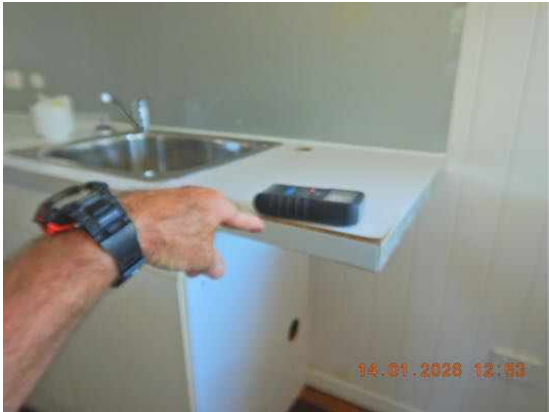
### Defects 3.19

Building: Main Building  
 Location: Laundry > Rear Right  
 Finding: Laundry bench top swollen/ Deterioration  
 Information: The laundry bench top was found to be in a deteriorated condition and is swollen at the right side of the sink.

The under bench door was found to have a damaged hinge and the door was detached, and will require minor repairs.

A handyman could complete this task.

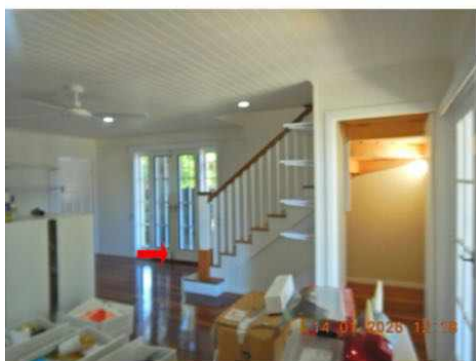
Defects 3.20

Building: Main Building  
 Location: Stairs - Internal > Front Left  
 Finding: Door catch damaged  
 Information: The french door bolt at the top of the door is not secured by a latch plate or hole in the flooring, and will require repair.

The door can be opened without the latch being engaged.

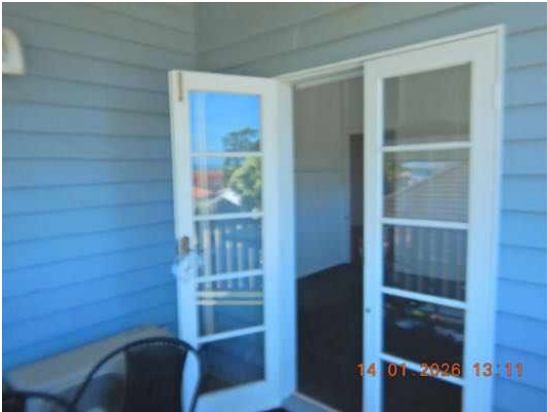
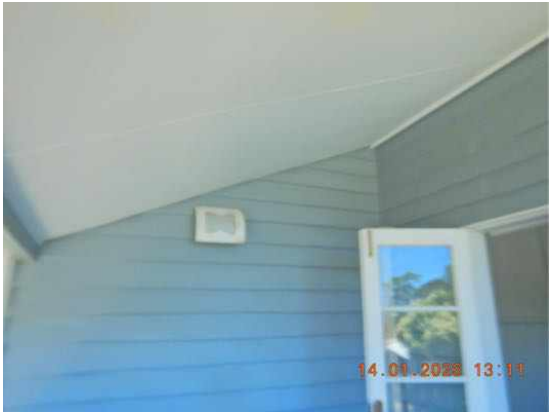
### Defects 3.24

Building:	Main Building
Location:	Bedroom -4/ Deck > Front
Finding:	Building element - Rusted or corroded
Information:	The upstairs bedroom-4 deck steel post shows evidence of minor surface rusting and corrosion, which is likely to have developed as a result of excessive exposure to moisture and or inadequate coatings.

Where possible, the use of galvanized (treated) metals or aluminium coated metals aid in rust prevention, as does regular general maintenance. Rust formation can be controlled with coatings, such as paint, that isolate the iron from the environment.

Rusting and corrosion should be managed by ideally removing or limiting the affected surface from exposure to moisture. A registered builder may be appointed to replace any building elements that have been severely affected by rust or water damage.

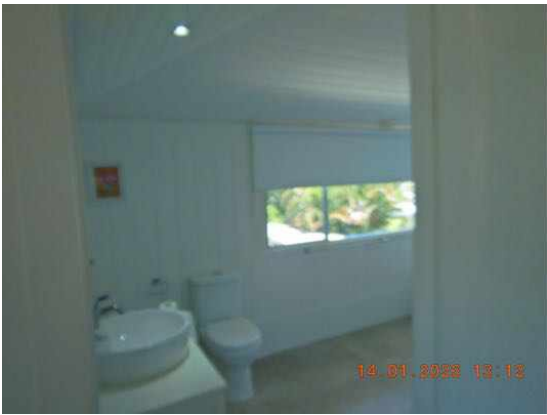
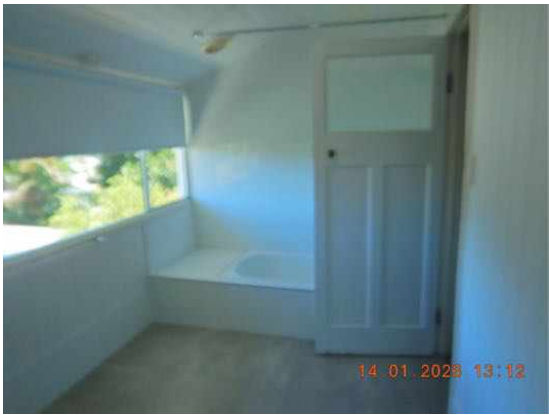
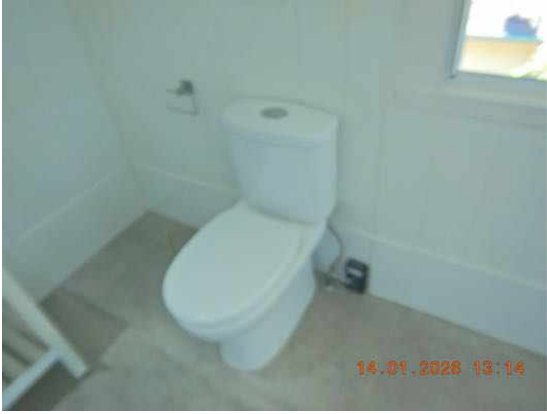
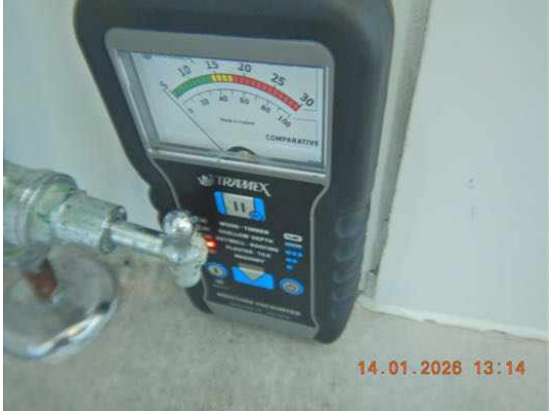
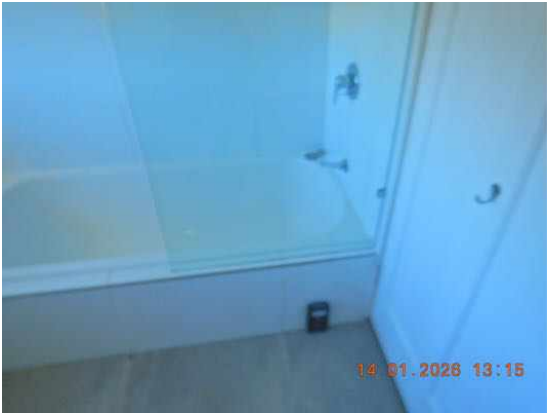
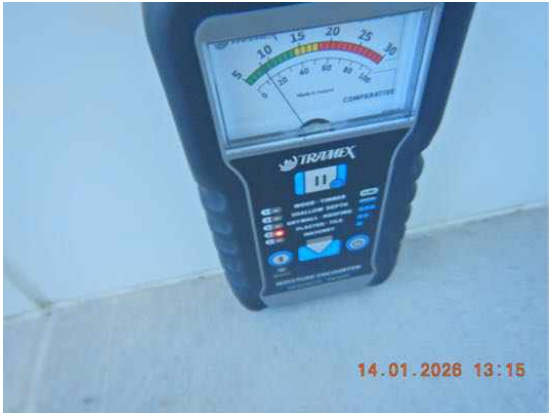
**Defects 3.25**

Building: Main Building  
Location: Bedroom 4/ Ensuite > Front  
Finding: Bathroom door head height.  
Information: The bedroom -4 ensuite door opening was found to only be 1960 mm in height from the floor to the underside of the door frame at the heights point.

This opening does not comply with current Australian standards.

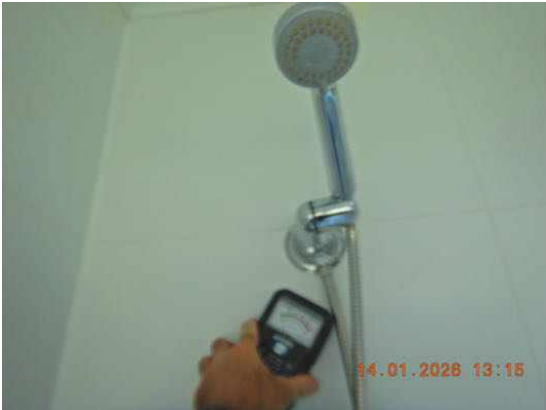
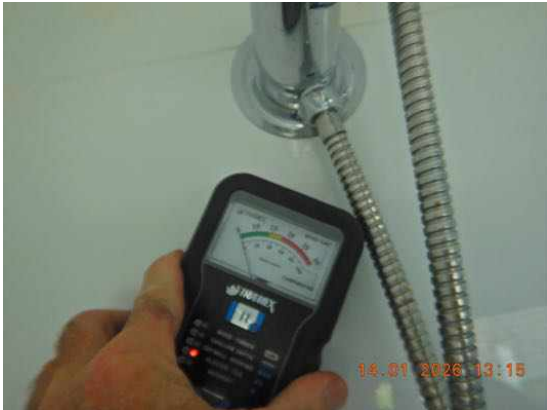
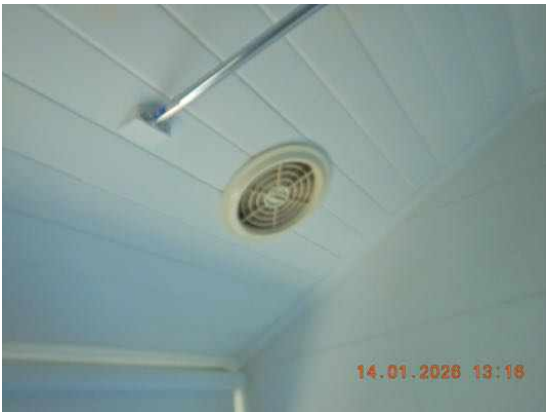
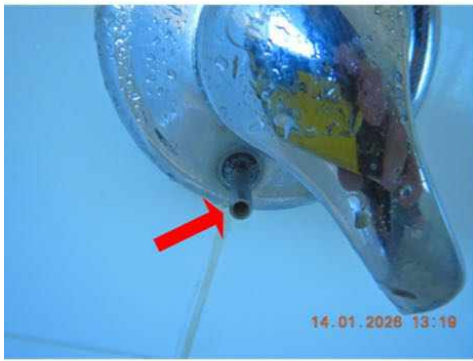
Finding: Shower mixer/diverter  
Information: The bathroom shower/bath wall mixer diverter unit was found to be faulty, and was not allowing the shower bath wall spout to be operational at the time of this inspection .  
The mixer would not allow either outlet to be operated individually as intended for use.  
A plumbing contractor should inspect this unit for repair or replacement.

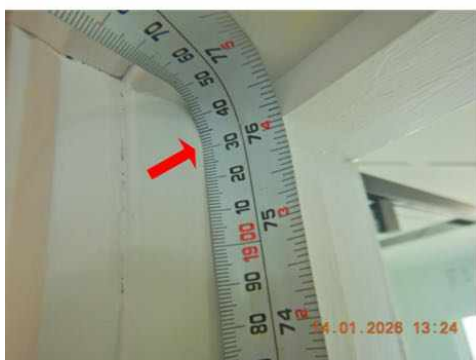
### Defects 3.31

Building:	Main Building
Location:	Bedroom 3/ Ensuite > Front
Finding:	Bathroom door head height.
Information:	<p>The bedroom - 3 ensuite door opening was found to only be 1930 mm in height from the floor to the underside of the door frame at the heights point.</p> <p>Minimum legal height for an internal door opening is 2000 mm.</p> <p>This opening does not comply with current Australian standards.</p>
