# Building and Timber Pest Inspection Report

Inspection Date: Fri, 13 Feb 2026

Property Address: 16B Alfred St, Mascot NSW 2020,  
Australia

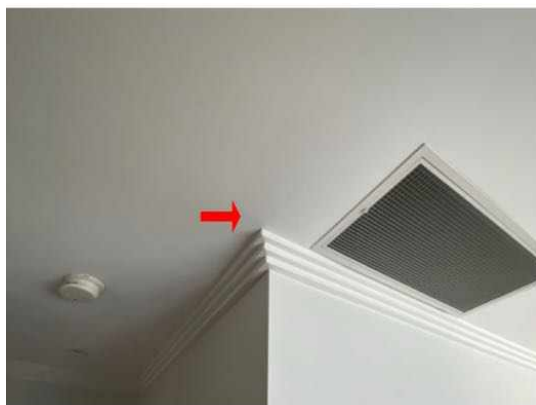
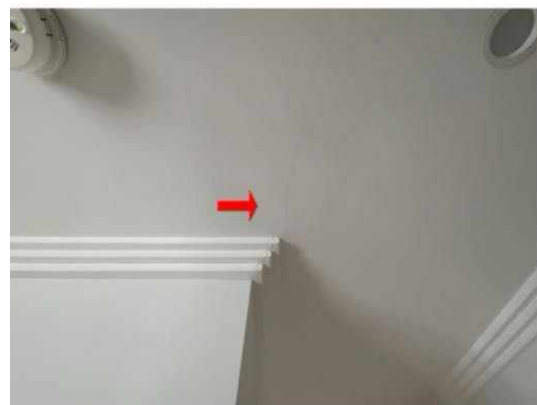
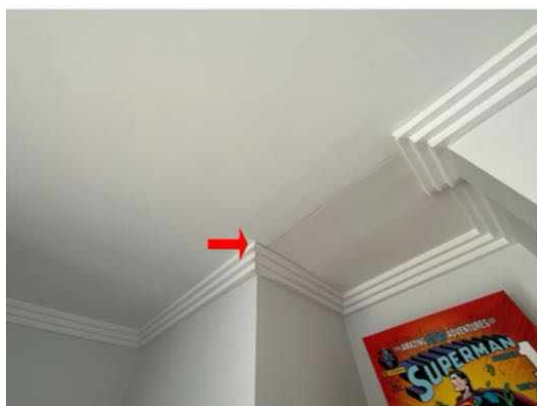
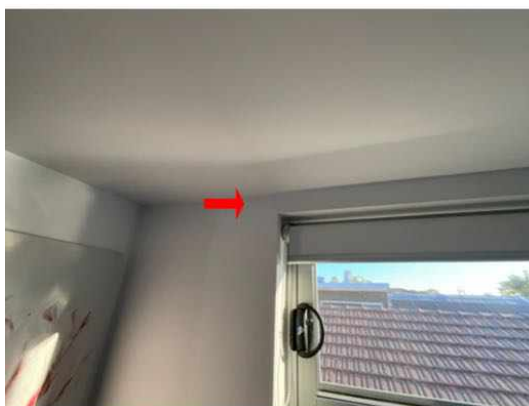
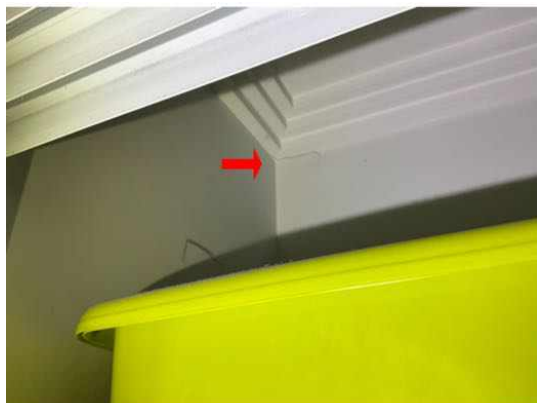
#### Finding 3.01

Building:	Main Building
Location:	Internal Areas
Finding:	Cracking - Damage Category 1 - Fine (up to 1mm)
Information:	Although fine cracks are quite noticeable, they are often only considered to be an appearance defect, and usually do not indicate any structural damage. Generally, the cause of a fine crack is indicative of a separation between building materials and finishes (e.g. paint, plaster, etc.) along joins.

Cracking of this nature can generally be repaired with minor sanding, filling and/or repainting. Such works should be performed by a qualified painter or a general handyman.

Monitoring of all cracking should be conducted frequently. Always contact a building inspector should cracks widen, lengthen, or become more numerous.

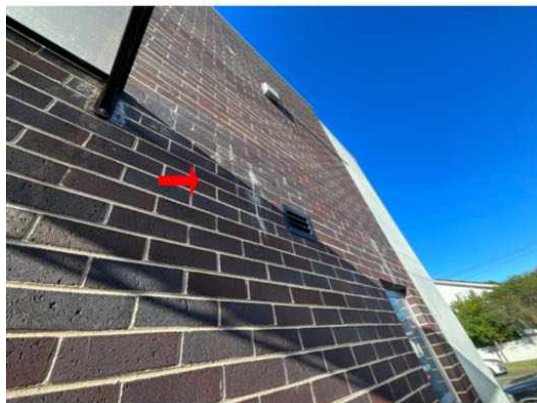
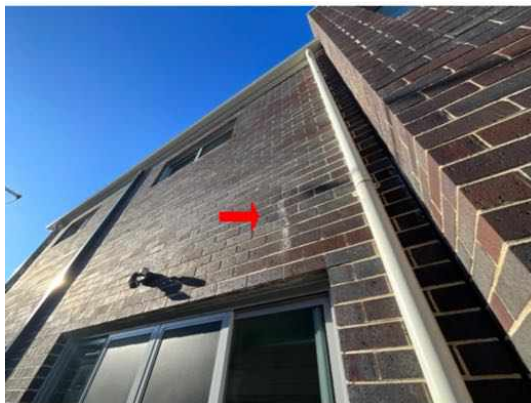
### Finding 3.02

Building:	Main Building
Location:	Exterior walls
Finding:	Brickwork - Efflorescence
Information:	Efflorescence appears to be affecting the brickwork, concrete or tiles in this area. Efflorescence typically occurs when excess salts within the concrete or cement mortar is leached to the surface due to water transfer.

It is typically seen as white salt deposits on the surfaces of concrete pavement or mortar between bricks or tiles. While detracting from the overall appearance of the affected area, efflorescence is not likely to develop into secondary damage if left unmanaged.

Generally, soluble salt deposits can be removed by dry brushing with a stiff-bristled brush. Repeated dry brushing is an ideal treatment for eliminating this forming of efflorescence. A cleaning contractor or general handyperson may be appointed to perform these works at the discretion of the client.

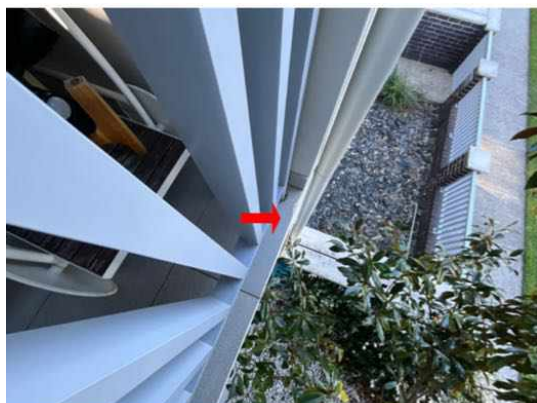
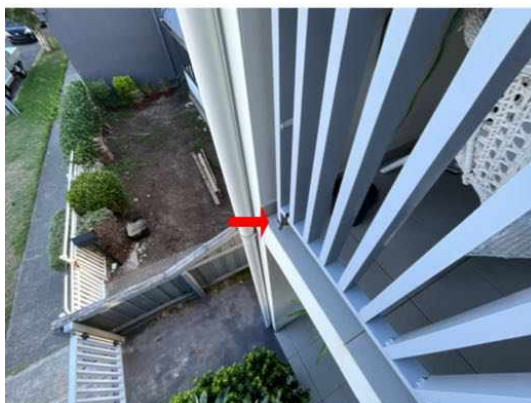
### Finding 3.03

Building:	Main Building
Location:	External Tiled Areas
Finding:	Tile - Cracked or damaged
Information:	Cracking was evident to the tiling in this area at the time of inspection.

I recommend appointing a tiling contractor to see what necessary works are required to replace any damaged tiles.

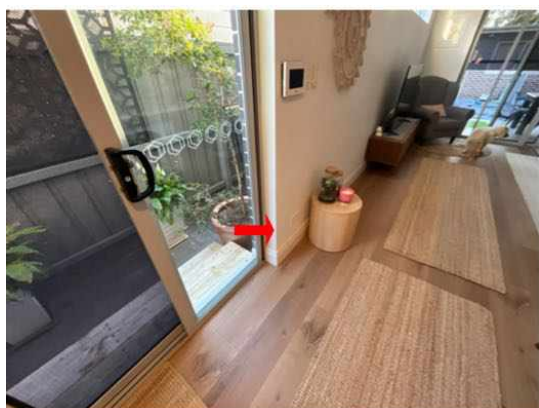
### Finding 3.04

Building:	Main Building
Location:	Lounge Room
Finding:	Damp - Rain penetration
Information:	Rain penetration (also known as penetrating damp) is a common form of dampness that can occur through walls, roofs or openings (e.g. windows).

Common causes include faulty or missing flashing, lack of sealant and lateral damp.

The cause of the water leak should be addressed to prevent further damage. It is recommended that the water leak be resolved prior to any repairs of the damaged area, which may require localised replacement of building materials and refinishing.

I recommend appointing a builder to see what necessary works are required.

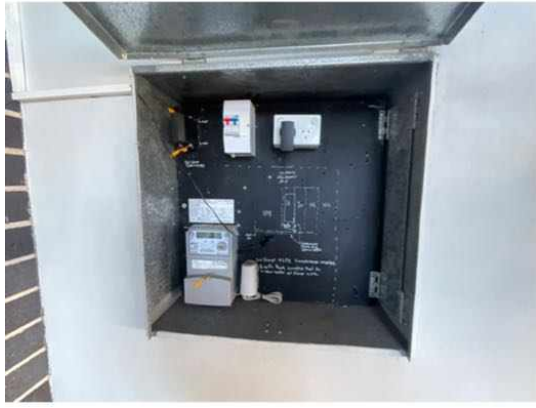
#### Finding 6.01

Building:	Main Building
Location:	All Areas
Finding:	Termite Management System - no evidence of a chemical installation
Information:	The application of a post-construction chemical termite barrier is highly recommended for all properties, particularly if live termite activity has been found on the site previously. Such barriers are highly effective in preventing termite attack on any timber building elements throughout the property.

A durable notice should be placed in the switchboard unit to indicate current termite barriers. At the time of inspection, it appeared as though no termite management system has been installed, with no evidence to suggest preventative works taking place.

The client may consider gaining further advice from a pest controller as to the costs and procedures involved with this application. It is recommended that obtaining such advice be a short-term priority.
