Building Inspection Report

Inspection Date: Thu, 5 Feb 2026

Property Address: 5/12-14 Purkis St, Camperdown NSW 2050,
Australia

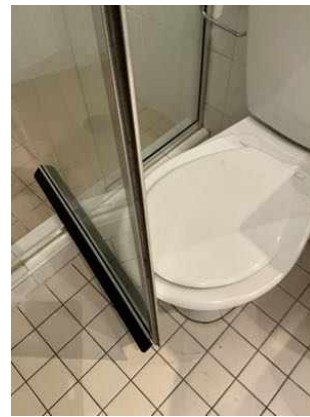
Defects 1.02

Location: Bathroom
Finding: Shower screen - Hitting toilet
Information: A safety hazard was identified in the bathroom of the property. The issue pertains to the shower screen, which, when fully opened, makes contact with the adjacent toilet. This situation poses an immediate risk to the safety and well-being of occupants due to the potential for accidents and injuries.

Collision between the shower screen and the toilet can cause injury to individuals using the bathroom, particularly if the shower screen shatters upon impact. The repeated contact between the shower screen and the toilet can also result in damage to both fixtures, leading to costly repairs or replacements.

This is to be addressed prior to handover.

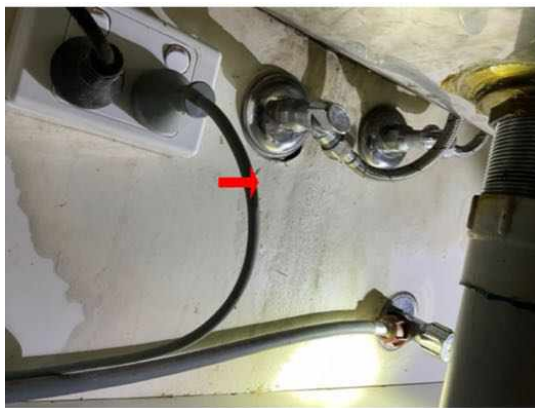
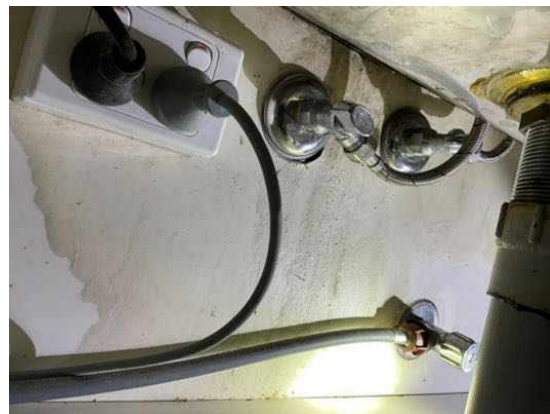
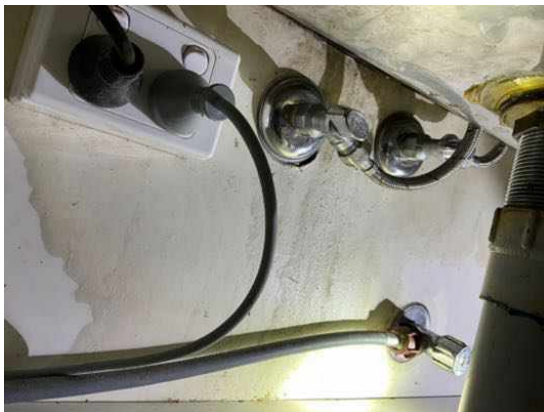
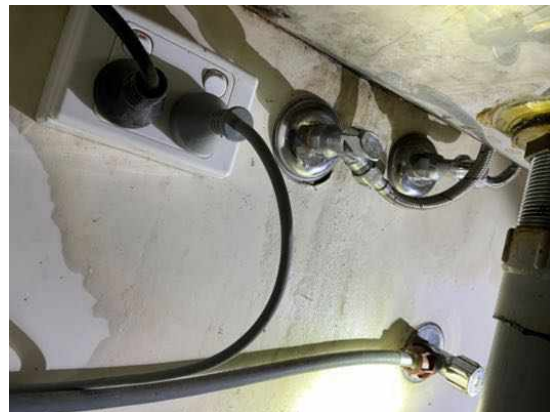
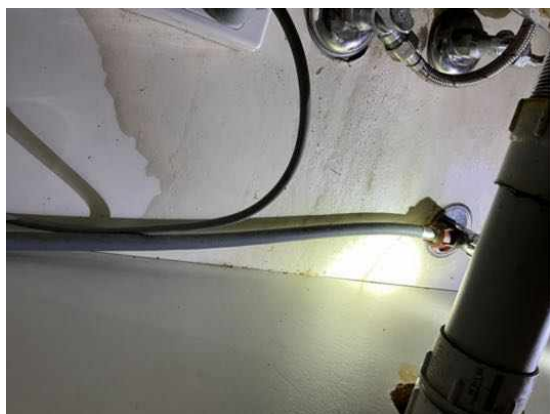
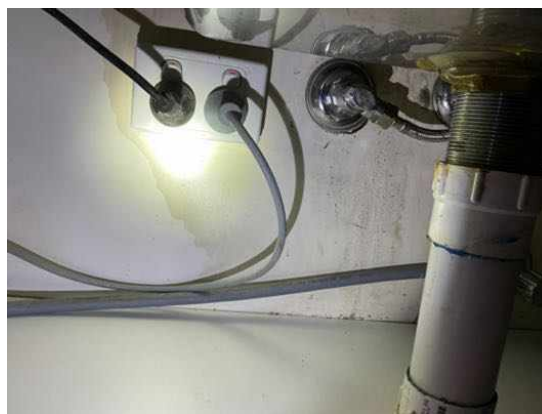
Defects 2.01

Building: Main Building
Location: Kitchen
Finding: Water damage
Information: The area has sustained water damage resulting in potential structural issues. This

damage compromises both the aesthetic and functional aspects.

To fix this issue, you should consider contacting a professional:

1 **Plumber:** If the water damage is due to plumbing issues, a plumber can fix leaks and ensure there are no further water-related problems.

2 **General Contractor:** If the damage is extensive and affects the surrounding area, a general contractor can coordinate the repair work, including any related structural or cosmetic repairs.

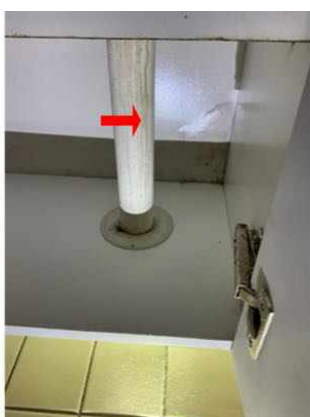
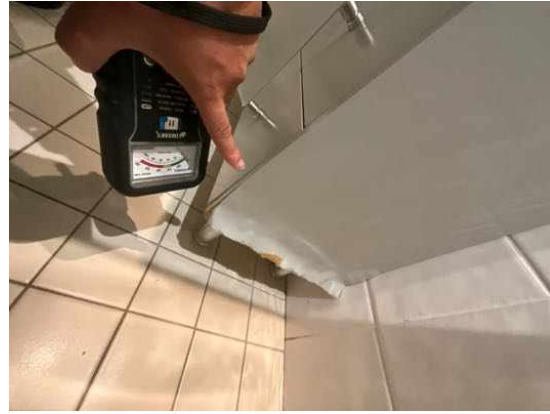
Defects 2.02

Building:	Main Building
Location:	Bathroom
Finding:	Water damage
Information:	The area has sustained water damage resulting in potential structural issues. This damage compromises both the aesthetic and functional aspects.

To fix this issue, you should consider contacting a professional:

1 **Plumber:** If the water damage is due to plumbing issues, a plumber can fix leaks and ensure there are no further water-related problems.

2 **General Contractor:** If the damage is extensive and affects the surrounding area, a general contractor can coordinate the repair work, including any related structural or cosmetic repairs.

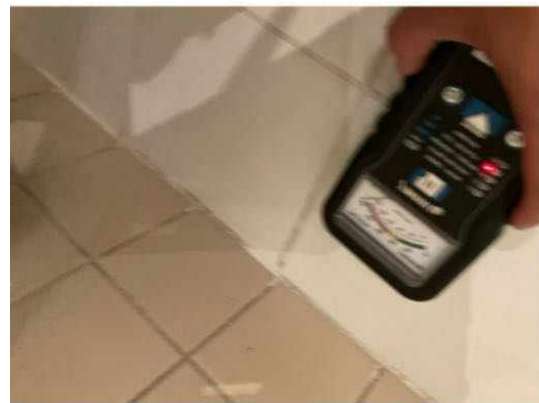
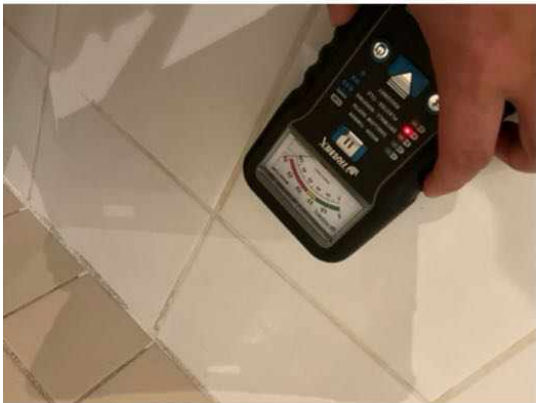
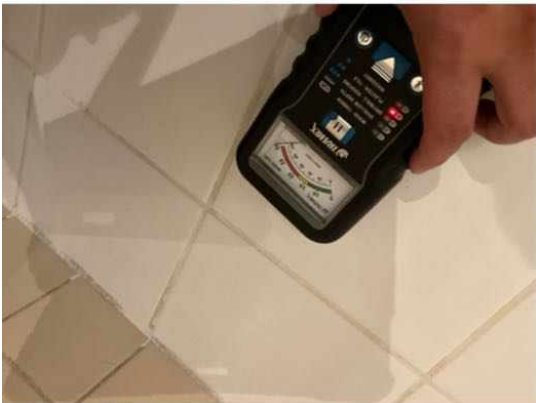
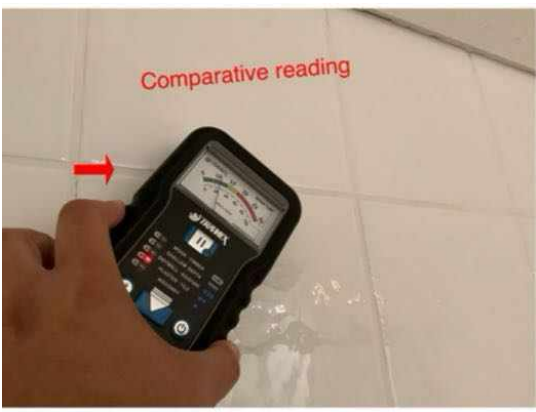
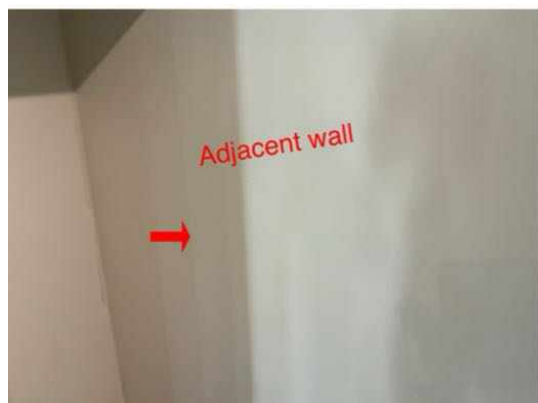
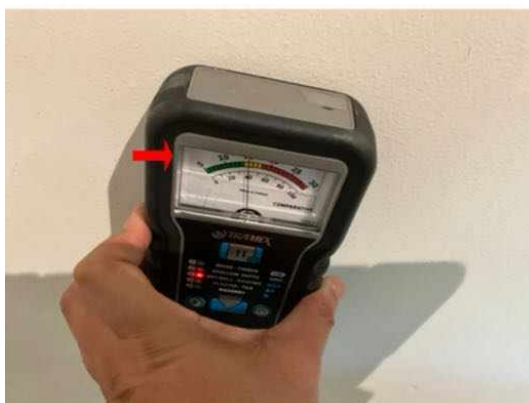
Defects 2.03

Building:	Main Building
Location:	Bathroom
Finding:	Evidence of excessive moisture was present at the time of inspection
Information:	Excessive moisture is present behind the bathroom tiles, indicating a potential water leakage issue within the wall.

The prolonged presence of moisture can lead to mold growth, deteriorate the structure, and create an environment conducive to health hazards. Additionally, it may compromise the adhesive holding the tiles, leading to their detachment.

A licensed plumber or a qualified contractor specializing in water damage remediation should investigate the source of the moisture, fix any leaks, and address the damage. Additionally, replacing affected tiles and ensuring proper waterproofing are crucial to preventing future issues.

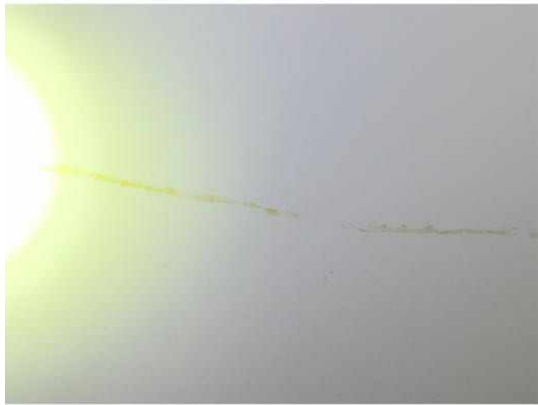
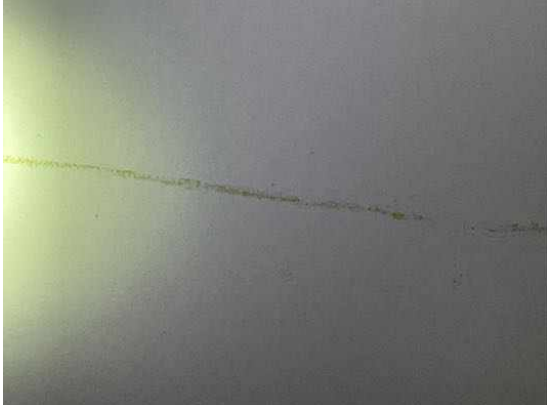
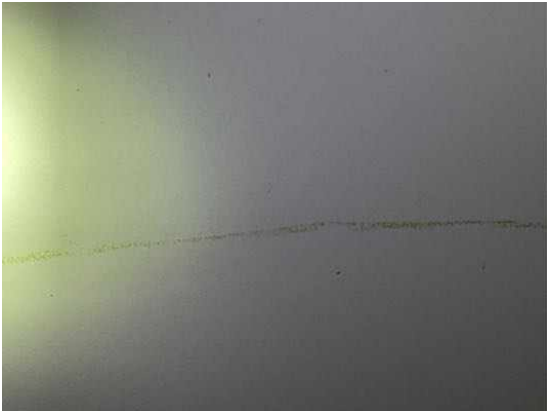
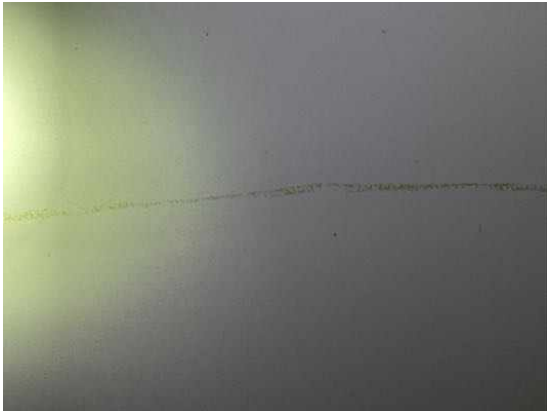
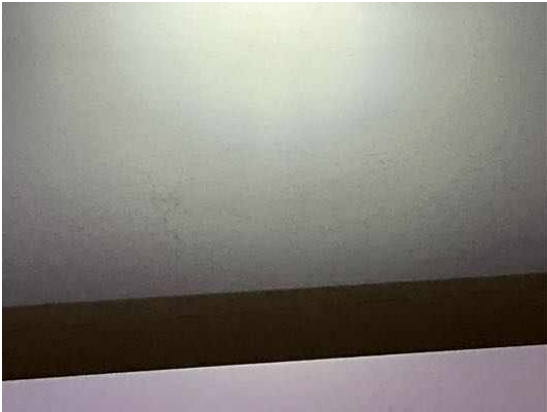
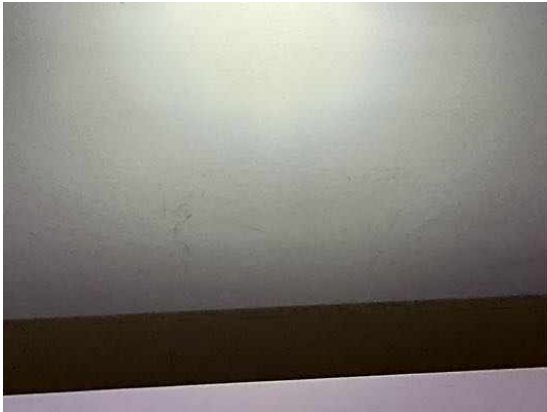
Defects 3.01

Building:	Main Building
Location:	All Areas
Finding:	Paint surface - Scratches
Information:	Scratches have been identified on the paint surface, detracting from the overall appearance and quality of the painted surface.

1. Aesthetic Degradation: Scratches mar the appearance of the painted surface, diminishing its visual appeal and potentially lowering property value.
2. Corrosion Vulnerability: Exposed areas of bare metal due to scratched paint are susceptible to corrosion, leading to structural damage and compromised durability.
3. Environmental Hazards: Scratched paint can release hazardous chemicals into the environment, posing risks to both human health and the ecosystem.

A qualified painter should address the issue promptly to repair the scratched paint. Depending on the severity of the scratches, repair options may include sanding, priming, and repainting the affected area to restore the integrity and appearance of the paint surface.

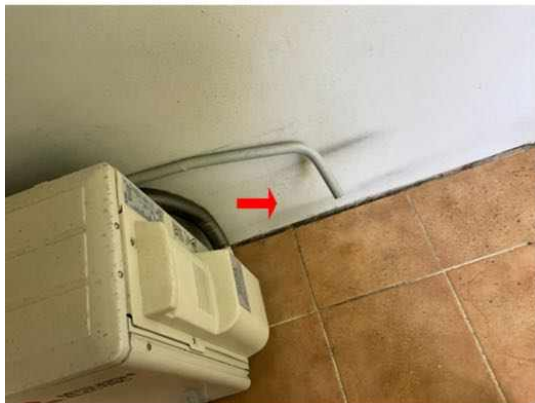
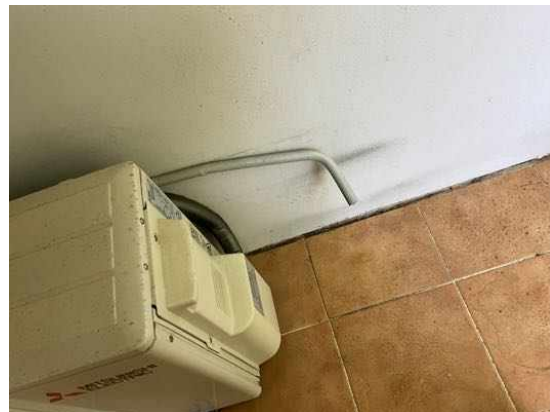
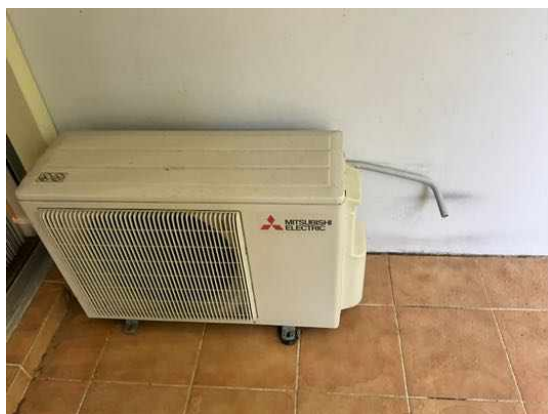
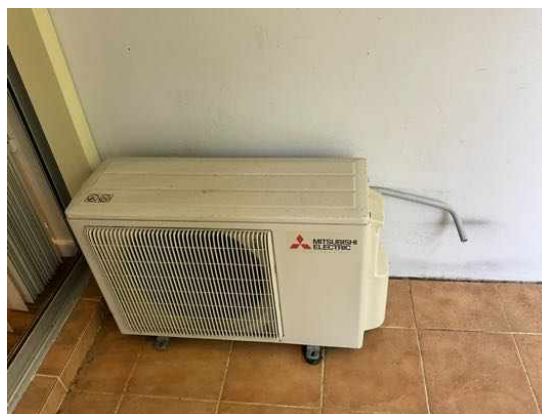
Defects 3.03

Building:	Main Building
Location:	Balcony
Finding:	Air conditioner - Disconnected overflow
Information:	The Air Conditioner (A/C) overflow was found to be disconnected from storm water drainage and is creating excessive moisture in the surrounding area.

Such leaking creates an environment which is conducive to an array of defects, including water damage to associated building elements and the attraction of termite or timber pest infestation.

It is highly recommended that a licensed plumber be appointed to connect the A/C overflow in order to prevent such an environment from being created. These minor works should be carried out as soon as possible.

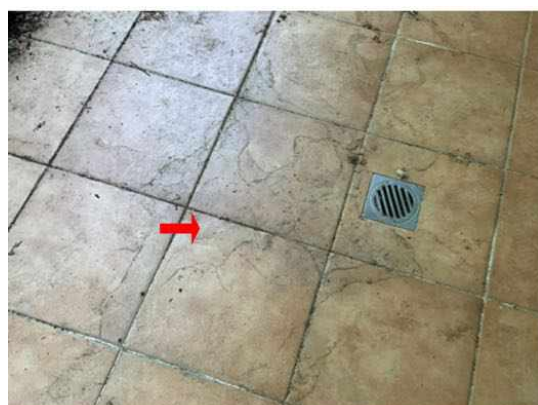
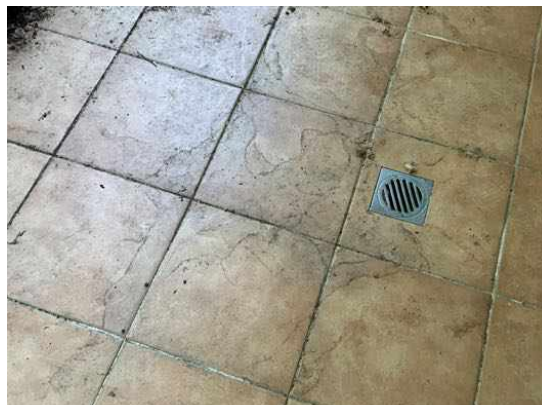
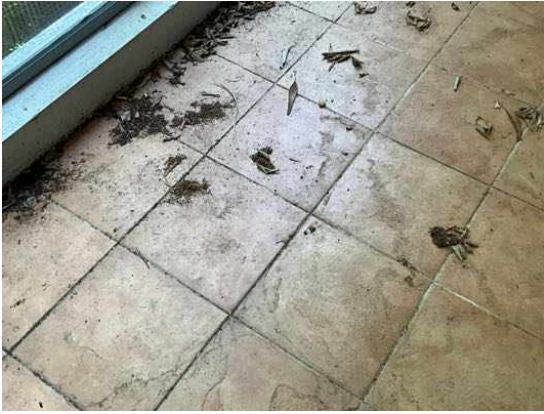
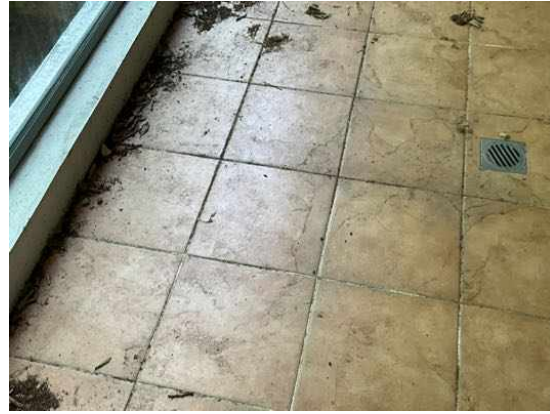
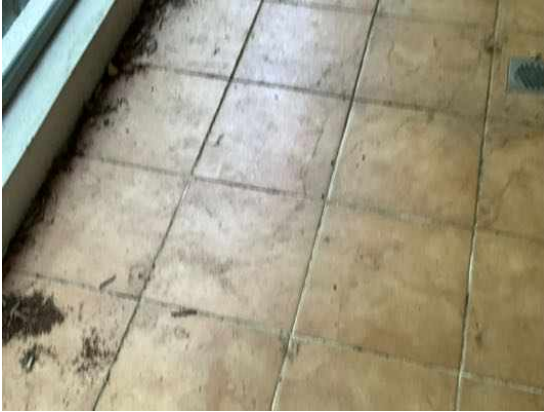
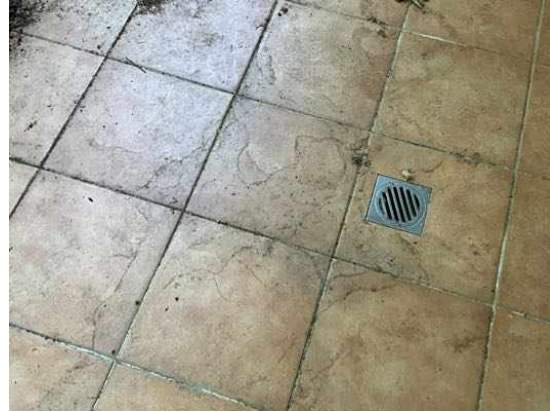
Defects 3.04

Finding: Water staining

Information: Water staining was evident in this area at the time of inspection. Water staining indicates that surfaces have been exposed to excessive moisture over time. The minerals and other elements in the water lead to staining, which may graduate to corrosion and deterioration if left unmanaged.

While mostly an appearance defect, water staining can be indicative of more serious defects, which may be currently concealed by other building elements.

Where water staining is active, a licensed plumber must be consulted to identify the cause of the staining and to provide advice on any reparation works that may be required. Replacement of any broken or damaged structures is advised.

Conversely, where water staining is old and inactive, affected building materials may be repaired or replaced at client discretion. A qualified carpenter or registered builder may be appointed to perform these works.

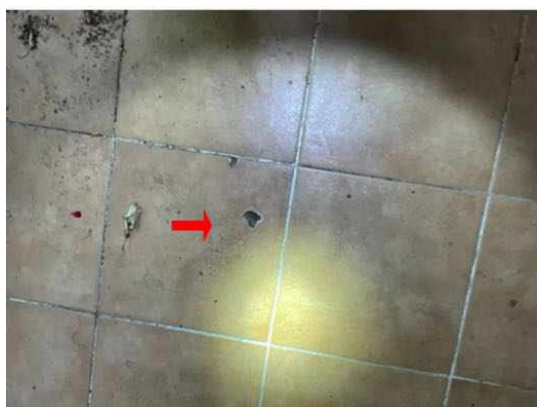
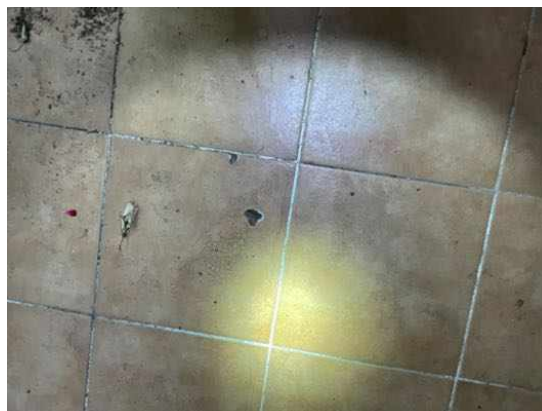
Defects 3.06

- Injury Risk: The sharp edge of the chipped tile can cause cuts if someone accidentally steps on or touches it.
- Water Damage Risk: If the chipped area becomes larger, water may seep through, potentially damaging the subfloor or causing mold growth.

- Tiler or Handyman: A professional tiler or a handyman should be contacted to replace the chipped tile or, if feasible, repair it to prevent further damage or injury.

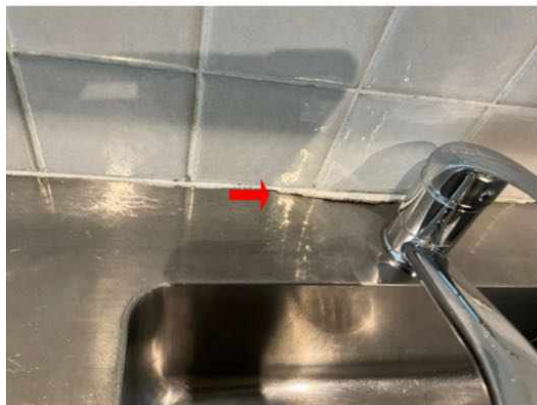
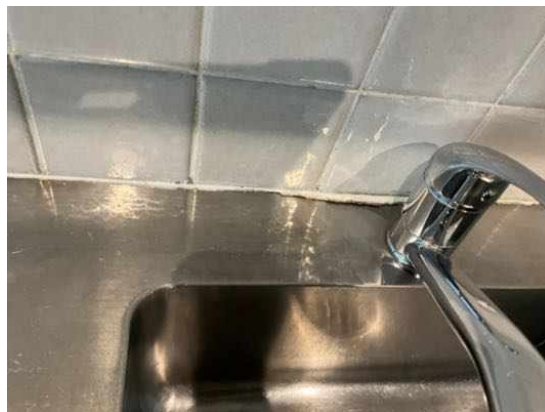
Defects 3.07

Building: Main Building
 Location: Kitchen
 Finding: Silicone Sealant - Deteriorated Around Basin
 Information: The silicone seal around the basin has deteriorated, with visible gaps and discolouration noted along the edges.

Water penetration through the deteriorated seal may cause damage to surrounding surfaces, promote mould growth, and lead to deterioration of adjacent materials.

A licensed plumber or qualified handyman should remove the old sealant and reapply a sanitary-grade silicone to ensure watertight protection.

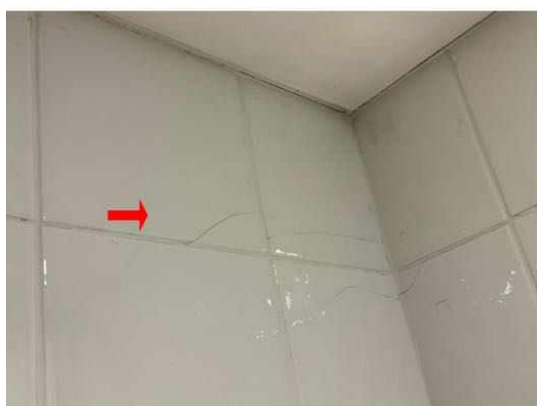
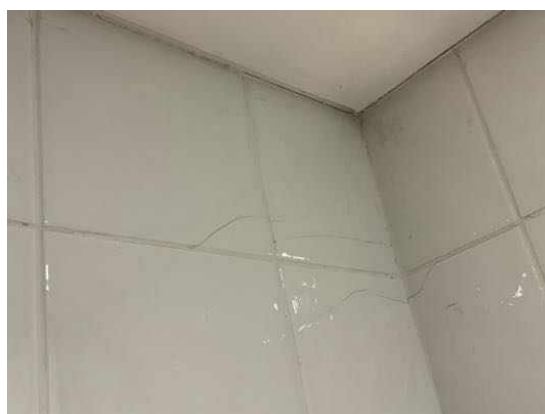
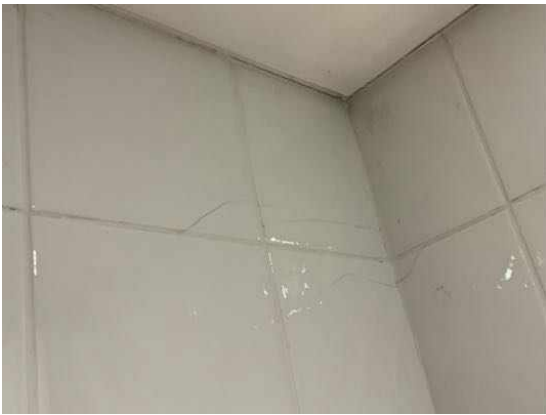
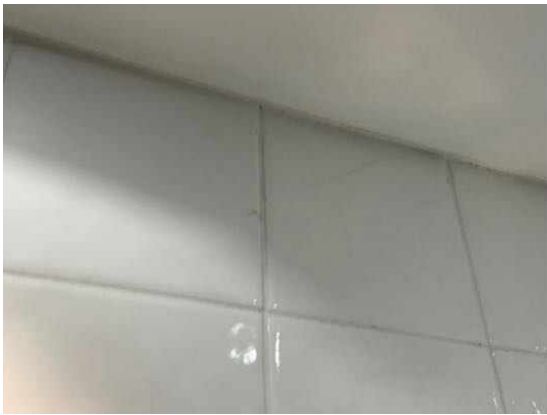
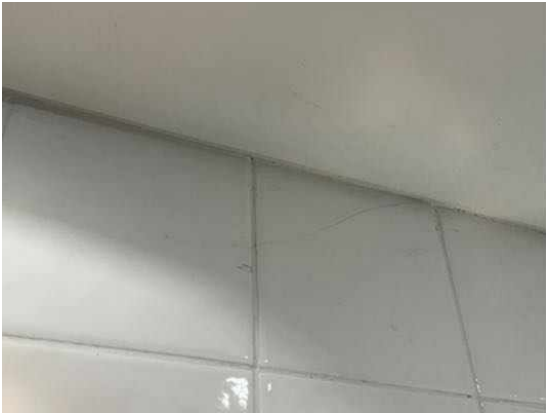
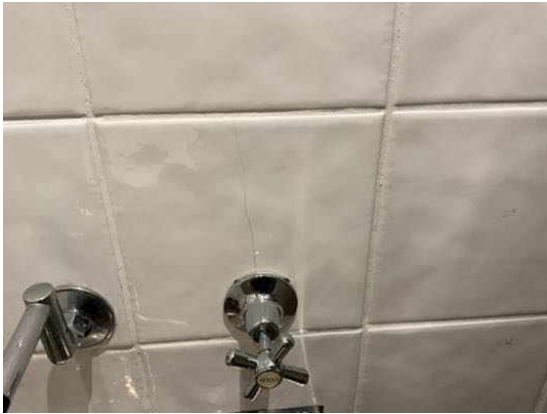
Defects 3.08

Building: Main Building
 Location: Bathroom
 Finding: Tiles - Cracked or damaged
 Information: Cracking was evident to the tiling in this area at the time of inspection. While the cracking appears to be minor, this area is frequently exposed to water, allowing potential for water penetration into adjoining sections of walls or flooring.

If left unmanaged, water penetration to these areas may lead to subsequent water damage, which is likely necessitate repair work to affected building elements.

A tiling contractor should be appointed to ensure that no further water damage occurs. The re-application of silicone and grouting throughout remaining tile work is also advised, to further protect the area against water penetration.

Where water penetration has led to water damage, appointment of a relevant tradesperson may be required to repair damaged building elements.

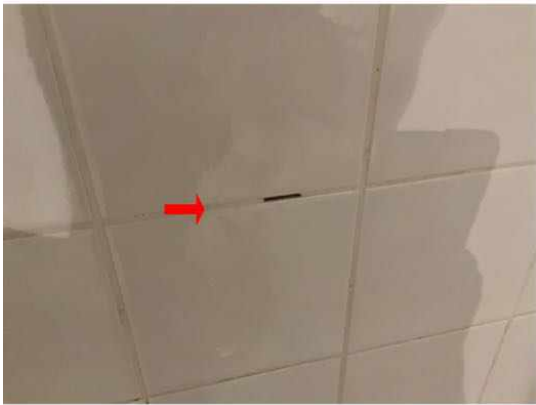
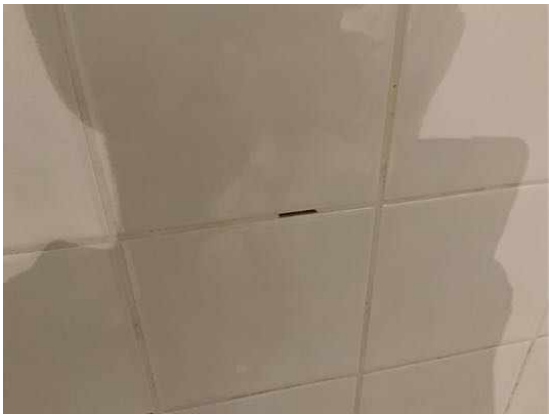
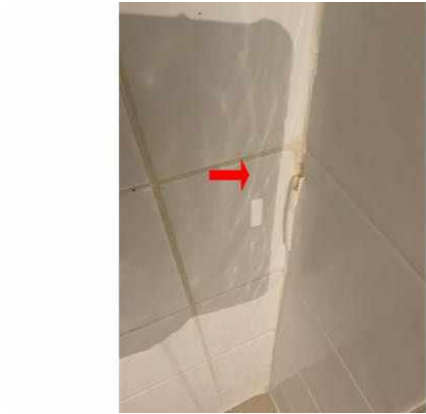
Defects 3.09

Building:	Main Building
Location:	Bathroom
Finding:	Sealant and grouting - Missing or damaged
Information:	It was noted on inspection that sealant or grout is degraded to the tiled shower alcove and or other areas of the bathroom.

Different materials and floor areas move at different rates, generally causing cracking to grout or sealant at this point. A flexible sealant is required to allow for expected expansion and contraction, while keeping the joint water tight and protective of all associated building materials.

There appears to be excessive mould to the sealant and grout which will likely require scraping out and replacement.

Flexible and mould resistant materials should be applied to affected areas to prevent any subsequent water damage that is likely to occur. Regular maintenance and replacement of damage or missing or damaged sealant and grout is highly recommended to the wet areas, as this is a regular wear and tear defect. Sealant and grouting in areas that come into regular contact with water should be maintained for the long term care of your property.

A sealant specialist or tiling contractor should be appointed to complete these works as soon as possible
