# Building and Timber Pest Inspection Report

Inspection Date: Thu, 12 Mar 2026

Property Address: 26 Katrina Cct, Corowa NSW 2646,  
Australia

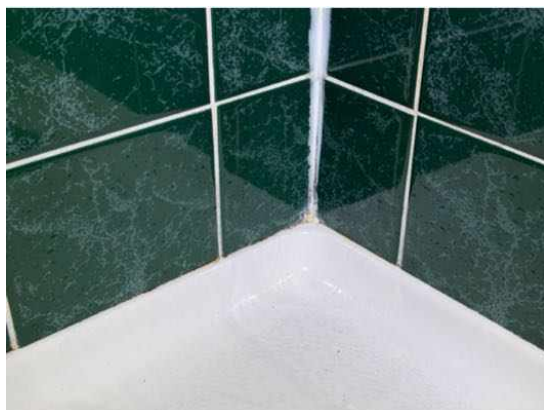
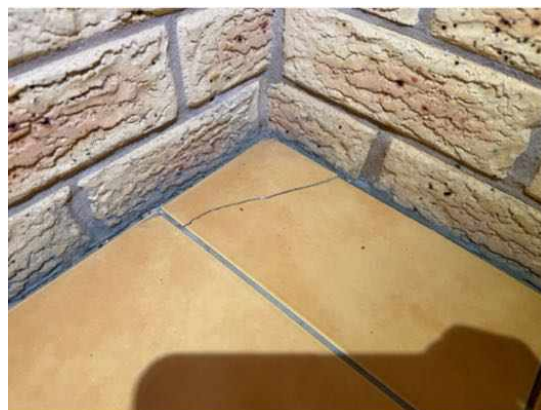
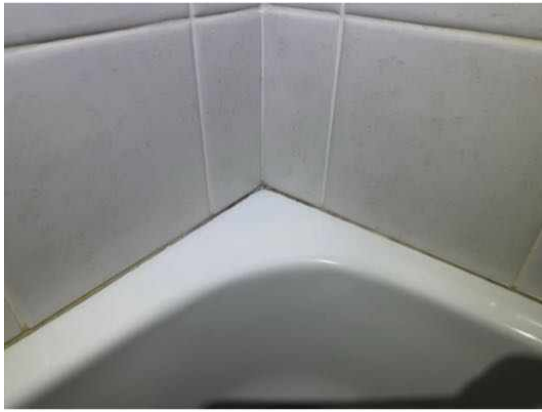
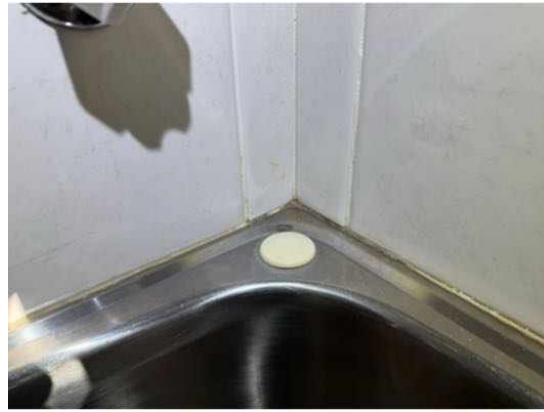
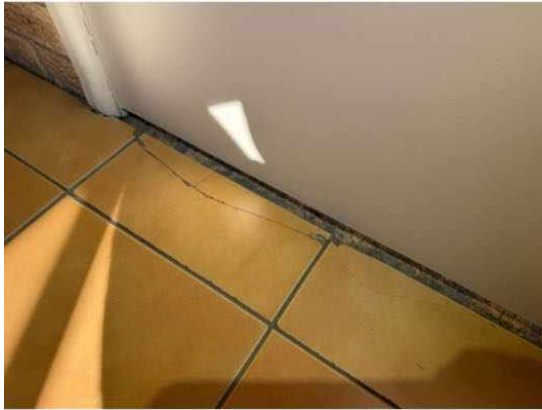
#### Finding 3.01

Building: Main Building  
Location: Tiled Areas  
Finding: Sealant / grouting - deteriorated or missing & Cracked Tiles  
Information: It appears that the sealant and grout is slightly weathered in some tiled areas, a common defect in buildings of a similar age. Areas of cracked tiles were also noted.

Sealant and grouting in areas that come into regular contact with water should be maintained for the long term care of your property.

Recommend engaging a licensed tiling contractor in the short term, to provide maintenance works where necessary.

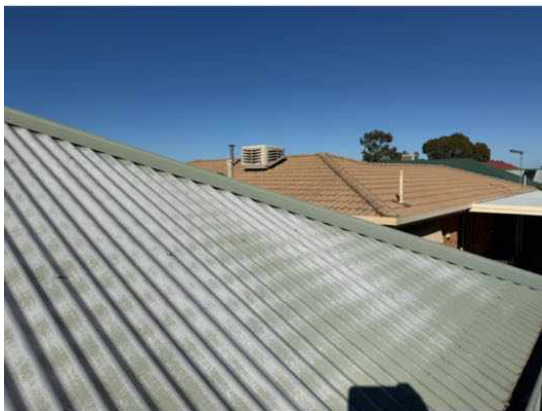
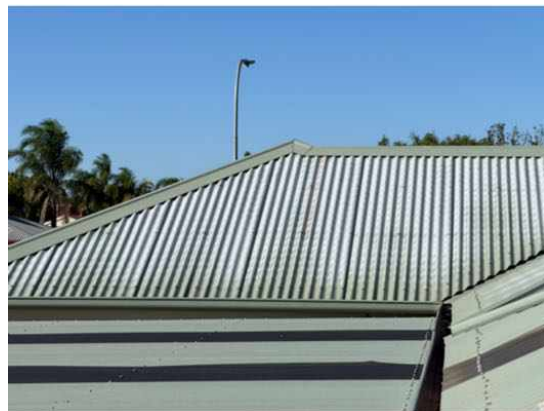
### Finding 3.02

Building:	Main Building
Location:	Roof Exterior
Finding:	Roof Exterior - Weathered / Faded
Information:	Areas of general fading of the roof exterior coating were noted. While weathering of the roof exterior is consistent with the age of the property, maintenance works are advised, to avoid further deterioration. Recommend engaging a licensed roofing contractor, to provide further advice regarding future maintenance works needed.

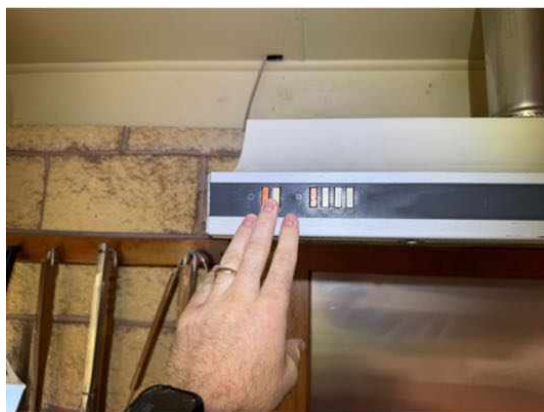
### Finding 3.03

Building:	Main Building
Location:	Extension Kitchen
Finding:	Rangehood - Not Operating
Information:	It appears that the range hood above the BBQ was not operating at the time of inspection. The client should contact a licensed electrician at their convenience to provide further advice and remedial works where necessary.

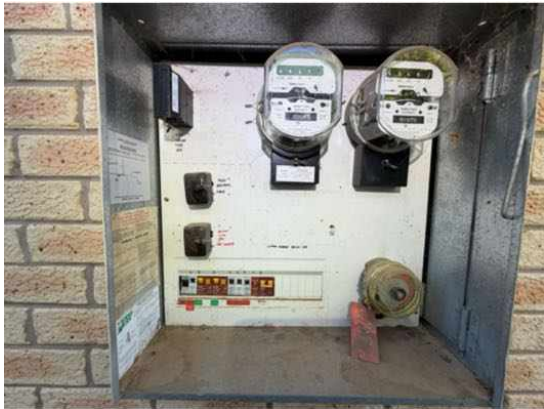
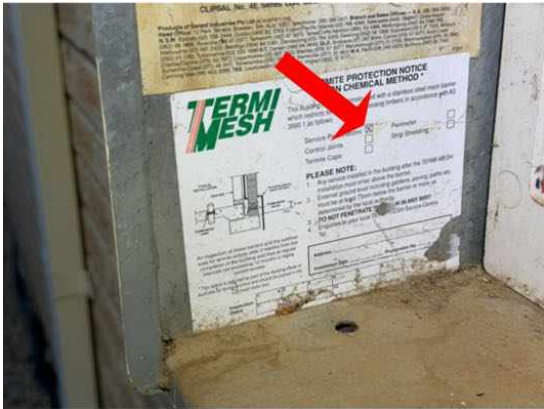
### Finding 6.01

Building:	Main Building
Location:	Switchboard
Finding:	Termite Management System - no evidence of a chemical installation
Information:	<p>The application of a chemical termite barrier is recommended, as it appears there is only a physical barrier (termi-mesh) installed around the penetrations. Generally, a durable notice is placed in the meter box to indicate current termite barriers.</p> <p>Such barriers are effective in preventing termite attack on the building and therefore should be installed.</p> <p>Recommend seeking further advice from a licensed pest controller.</p>

Installation of a termite barrier is recommended as there was no evidence of installation of a previous chemical barrier. However, a durable notice was identified in the switchboard, indicating that termi-mesh has been installed to the penetrations. 12 monthly termite inspections, conducted by a qualified termite inspector are also advised. Recommend consulting with the pest controller that installed the system to provide further advice regarding the barrier and to provide future management plan.

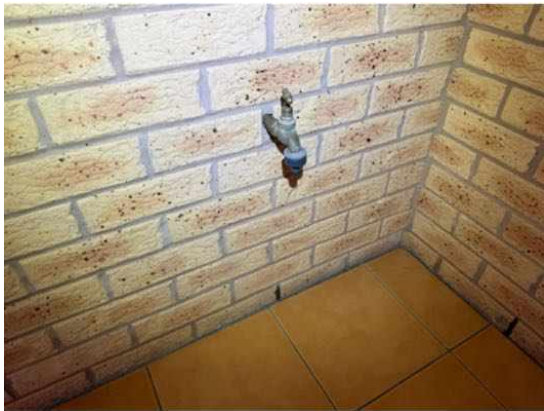
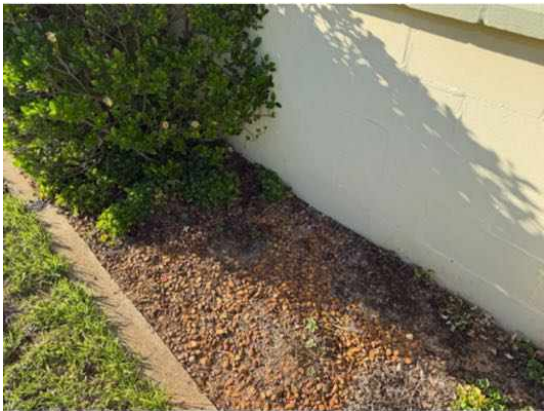
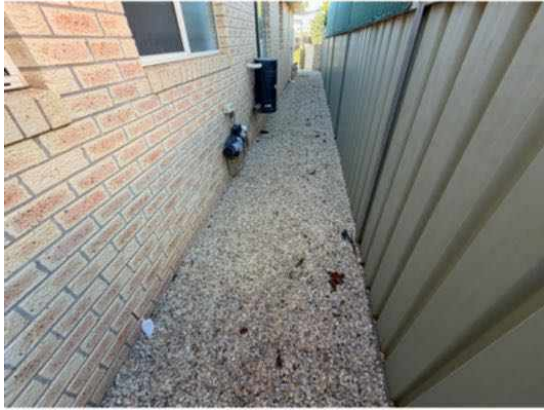
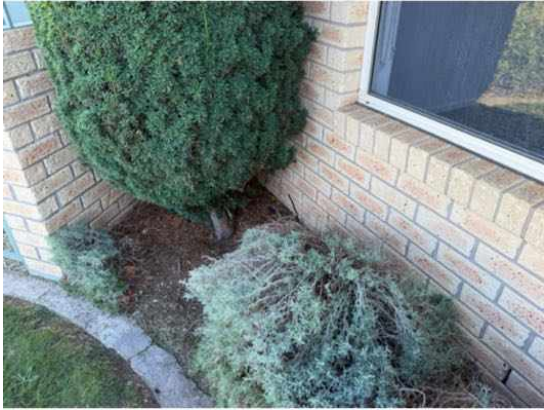
**Finding 6.02**

Building: Main Building  
 Location: All external areas  
 Finding: Potential Water pooling - against property  
 Information: Potential areas of water pooling around the perimeter of the property were identified.

Where insufficient drainage of taps & garden beds against the house are present, water pooling is likely to occur, and can create areas conducive to timber pests. Recommend consulting with a licensed plumber and/or landscaping contractor to provide further advice.

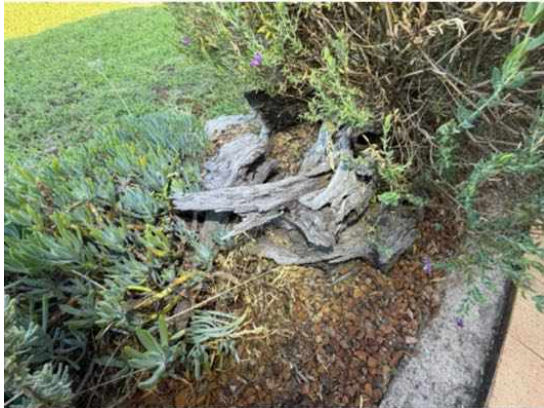
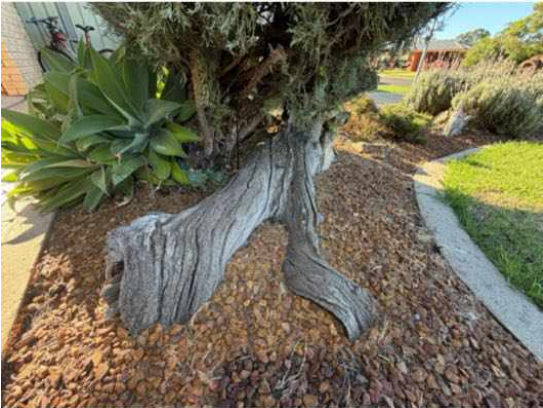
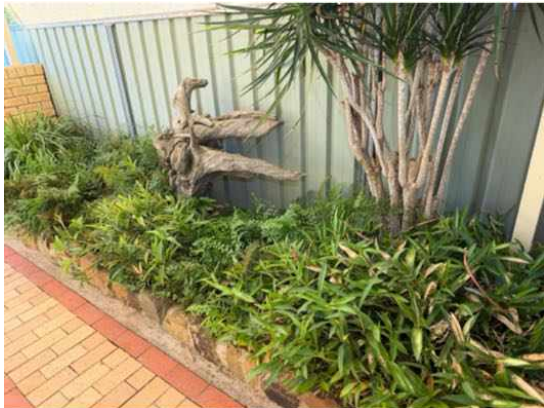
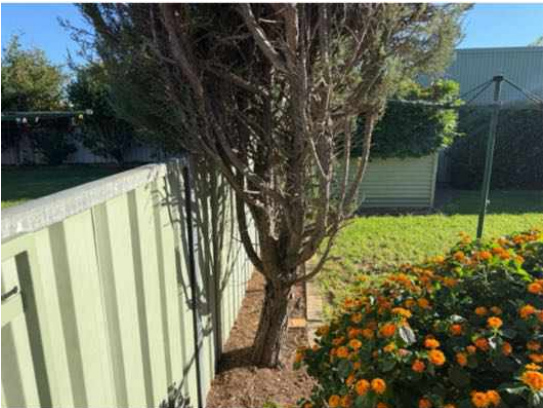
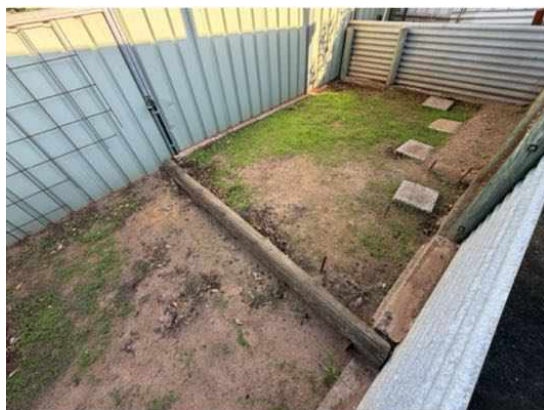
**Finding 6.03**

Building: Main Building  
Location: All External Areas  
Finding: Timber in direct ground contact & trees - conducive to termites  
Information: Where timber materials are in direct contact with the ground and consequently moisture, they become conducive to termite activity. The landscaping timbers, timber debris, and trees surrounding the building create an environment conducive to termite activity.

Where feasible, any timbers in direct contact with the ground should be removed and any trees in close proximity to the building should be removed or test drilled (inspected) at least annually to reduce the risk of termite infestation & detect any early signs of termite activity.

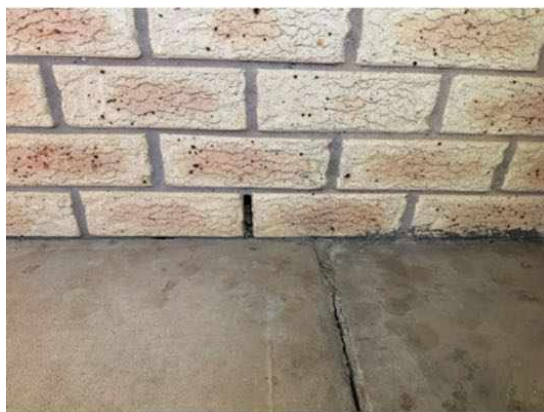
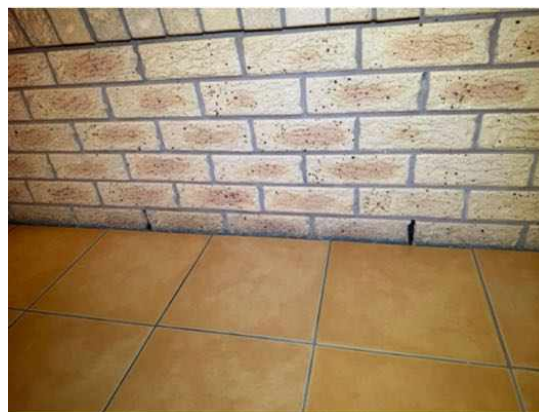
### Finding 6.04

Building:	Main Building
Location:	Carport
Finding:	Weep holes - Blocked
Information:	It appears some weep holes of the brickwork are blocked by the external finished ground level. This can restrict moisture escape and can create conducive conditions to termite activity. This also allows for termites to bypass any termite barriers & allows for concealed entry into the building.

As it may not be feasible to lower external ground levels, it is advised that these areas are frequently inspected by a licensed pest controller.

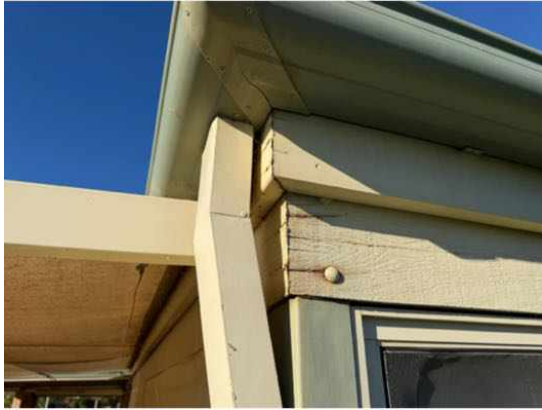
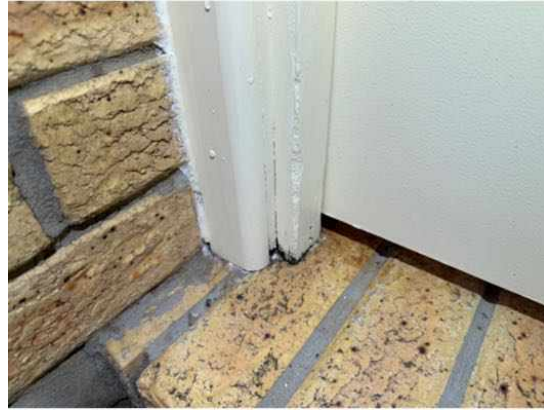
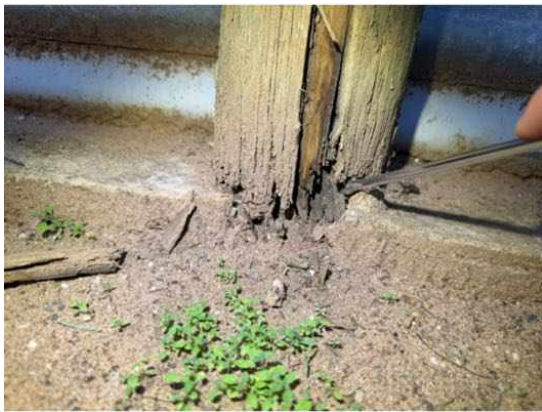
### Finding 7.01

Building:	Main Building
Location:	Rear Carport, posts, Architrave
Finding:	Fungal decay & weathering
Information:	Areas of fungal decay (wood rot) were identified at but not limited to the bottom of some door architraves, external posts and carport framing.

For areas of fungal decay, the client can engage a licensed carpenter at their discretion to provide maintenance works. For areas of general weathering, it is advised the client engage a licensed painter to apply protective sealant or coating to areas of weathered external timbers.

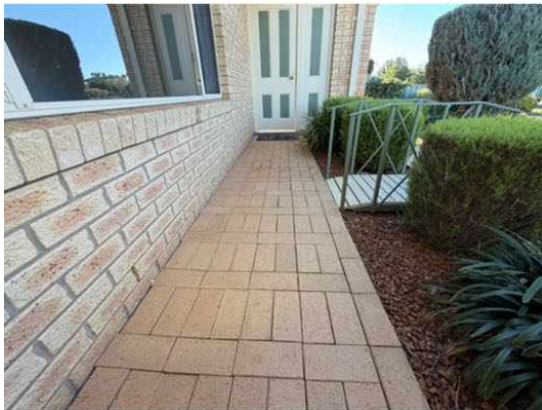
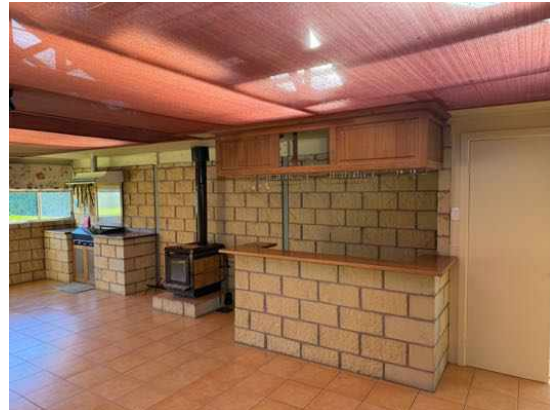
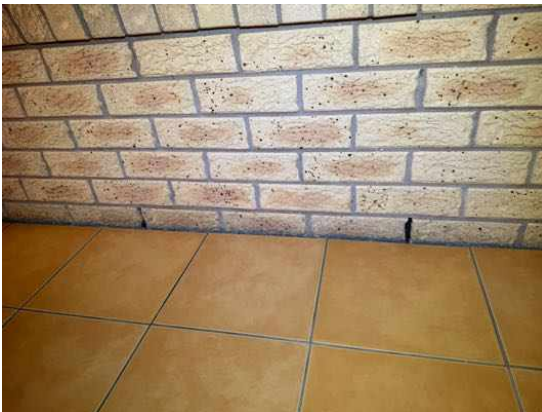
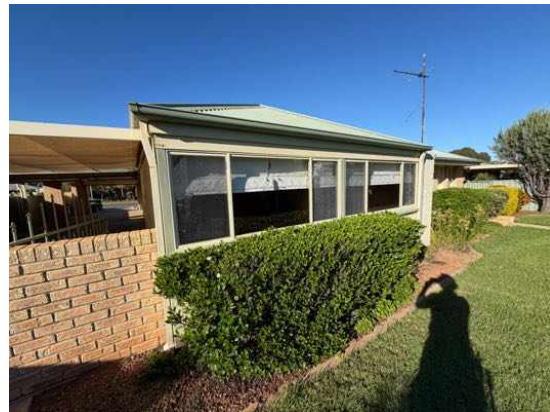
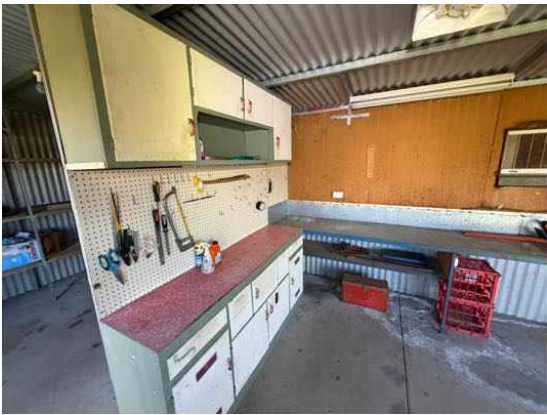
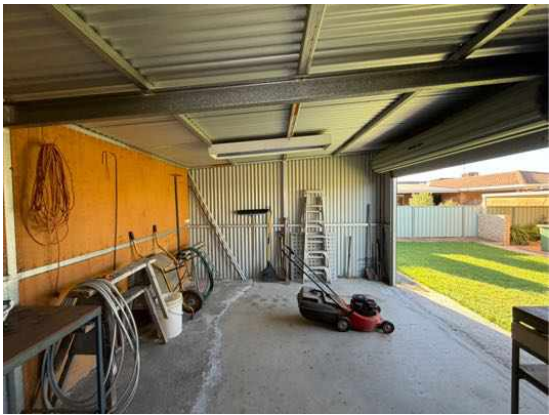
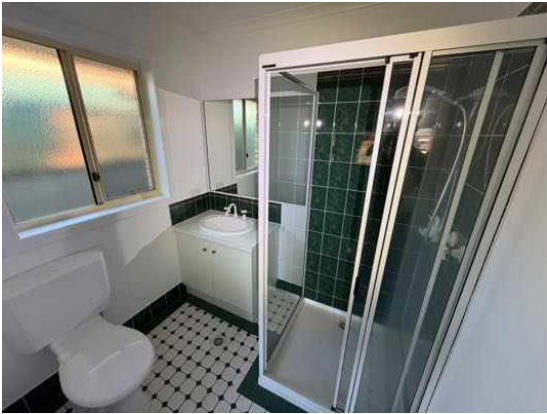
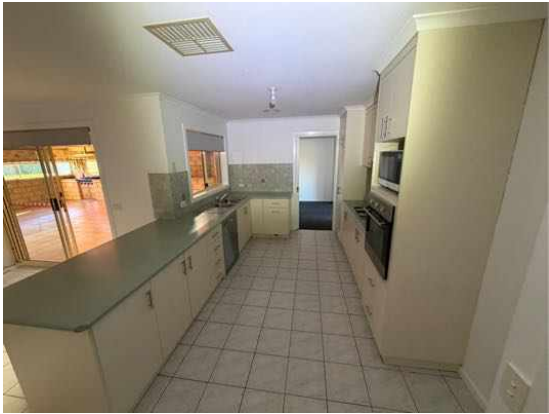
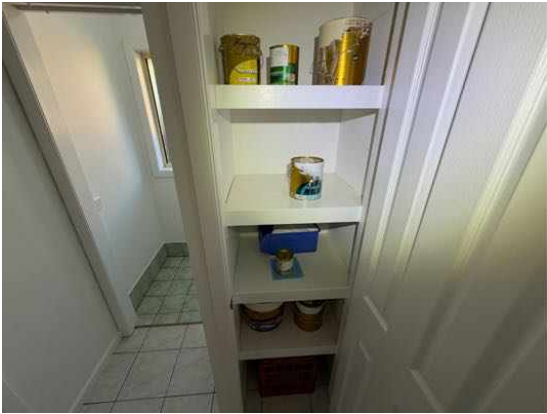
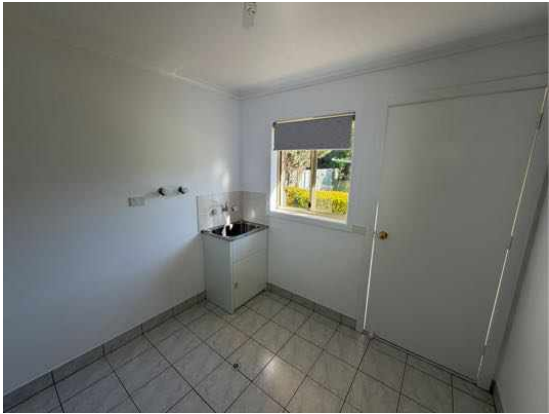
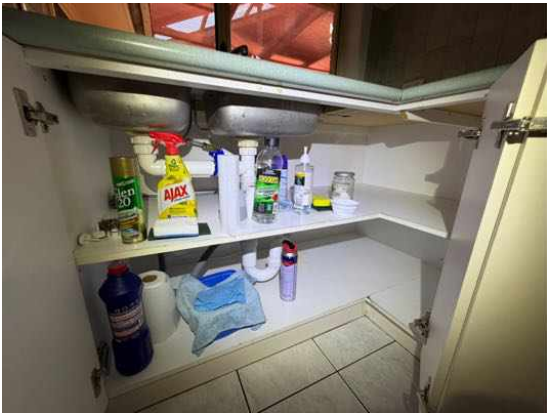
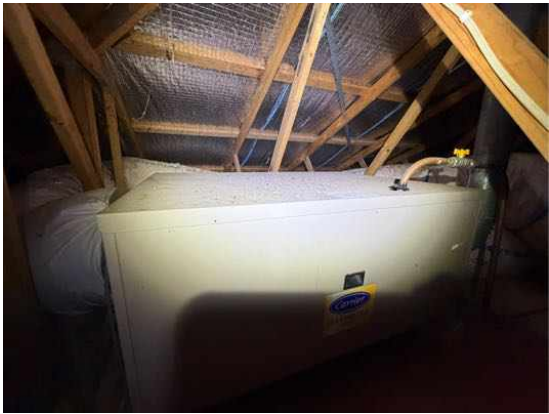
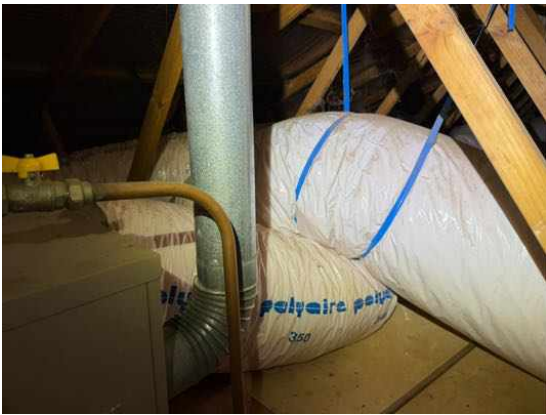
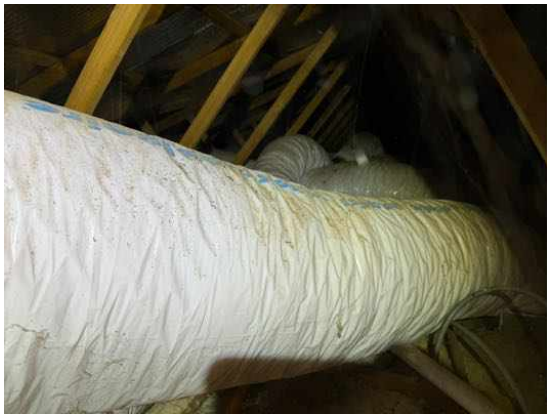
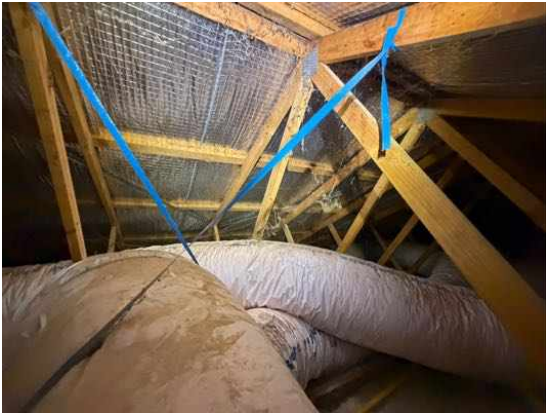
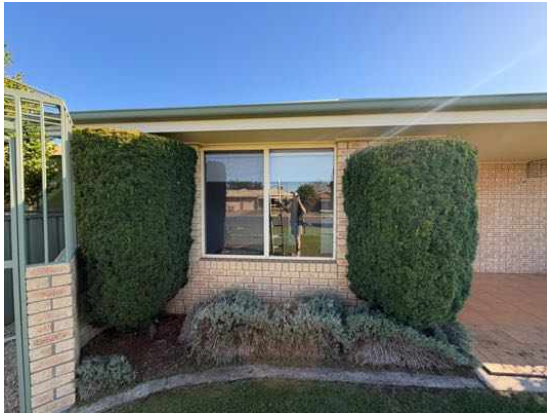
Building: Main Building  
Location: All Areas  
Finding: Additional Photos - Obstructions and Limitations  
Information: These photographs are an indication of the obstructions and limitations which impeded full inspection of the property at the time of inspection. These obstructions can hide an array of defects and should be removed to allow full inspection to be carried out. A re-inspection is recommended once the areas are made accessible.

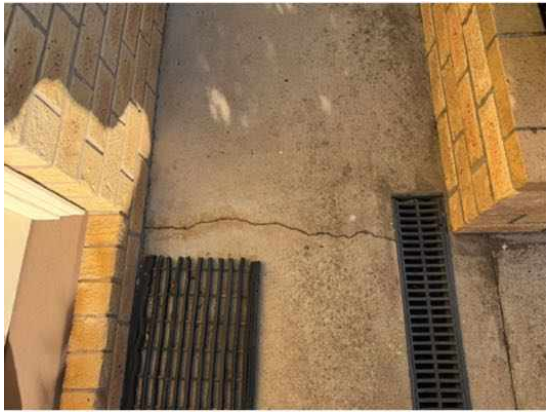
Building: Main Building  
Location: Footpath  
Finding: Cracking - Pavement & Footpath  
Information: It was noted there is cracking in some areas of the pavement. Cracks in the pavement are a common occurrence in houses of a similar age.

Recommend that the client monitor the cracking. A licensed concreter can be engaged at clients discretion, should cracks widen, lengthen, or become more numerous.

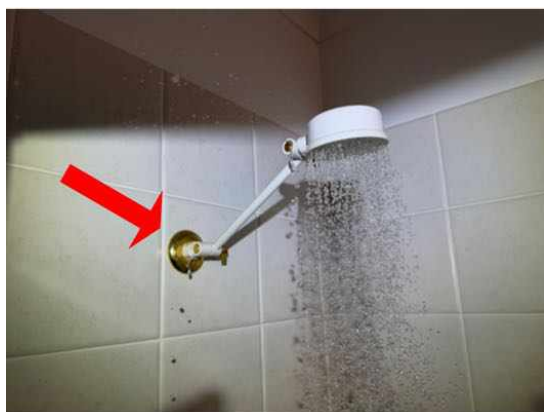
Building: Main Building  
Location: Shower Head  
Finding: Shower Head - Leaking  
Information: Minor leaking was identified at, but not limited to the shower head of the main bathroom. Recommend engaging a licensed plumber at clients discretion, to provide maintenance works.

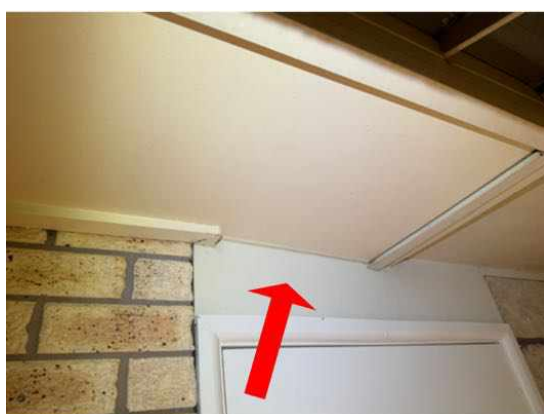
Building: Main Building  
Location: Eave  
Finding: Eaves - Uneven  
Information: It appears that a section of the eaves was uneven at the time of inspection. It is advised that the client should monitor the area. Should further unevenness occur, a licensed carpenter can be engaged at clients discretion to provide remedial works.

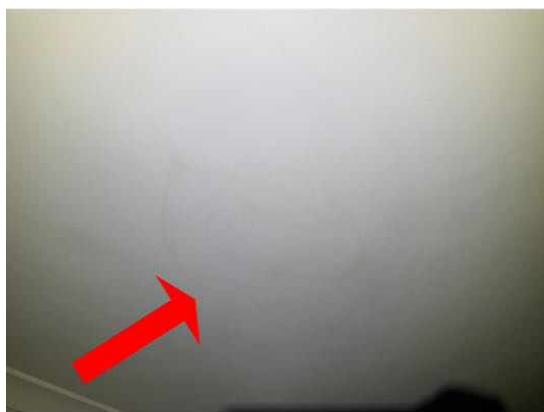
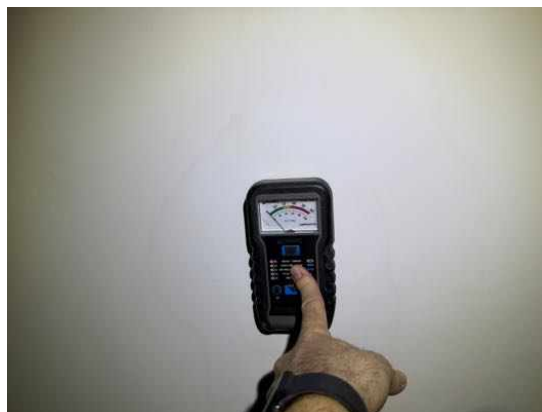
Building: Main Building  
Location: Bedroom Ceiling

Finding: Water Staining Present  
 Information: It appears that water staining was present at but not limited to, the bedroom ceiling. No high moisture was evident in the area at the time of inspection.

Recommend that the client monitor the area and engage a licensed roof plumber promptly, should the leak persist or return.

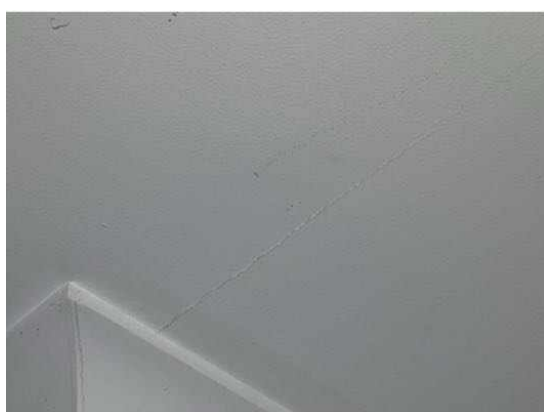
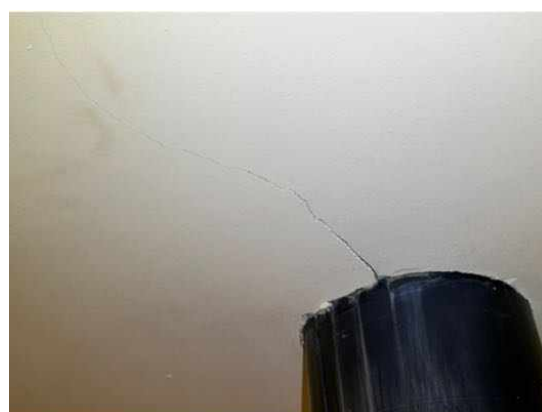
Building: Main Building  
 Location: Kitchen & Extension Ceiling  
 Finding: Plaster - Cracking  
 Information: There appears to be minor cracking in some areas of the ceiling linings. Cracking of this type is common in buildings of a similar age.

Although this is mostly a visual defect, it is advised that the client monitor these areas.

Should cracking widen, lengthen, or become more numerous, the client should consult with a structural engineer for further evaluation.

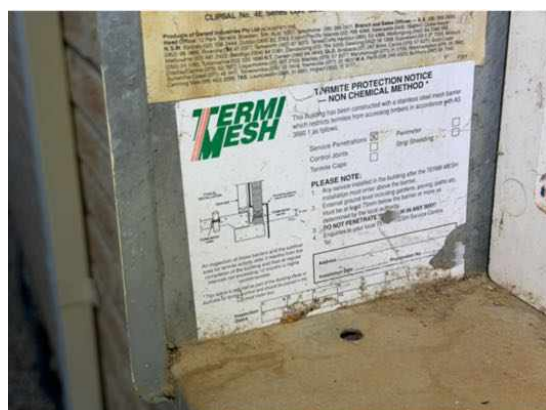
Building:	Main Building
Location:	Switchboard
Finding:	Evidence of a previous termite management system (termi-mesh)
Information:	A durable notice has been installed in the meter box, indicating that a previous termite management system has been installed. The type of termite system that has been installed is termi-mesh, which is a physical barrier that prevents concealed termite entry into the building and forces termites out into the open. This system has only been installed to the penetrations.

Regular 12 monthly inspections should be conducted by a qualified termite inspector, to identify any timber-pest activity. Recommend consulting with the pest controller that installed the system to provide further advice regarding the barrier and to provide future management plan.
