# Building and Timber Pest Inspection Report

Inspection Date: Fri, 20 Feb 2026

Property Address: 2/46 Sadie St, Glenroy VIC 3046, Australia

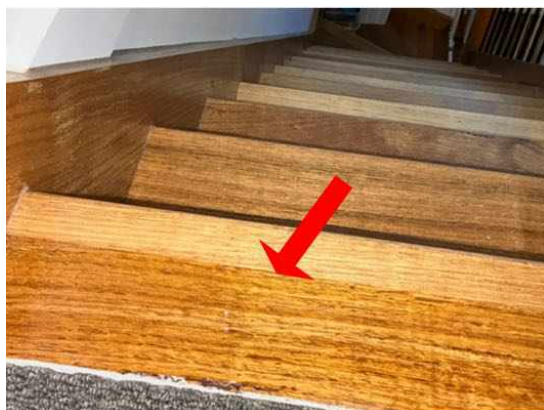
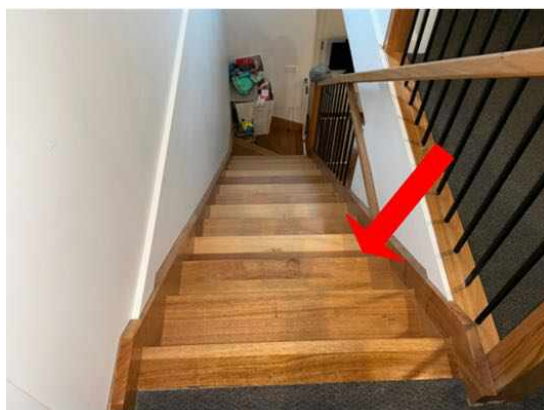
Building: Main Building  
Location: Stairs - Internal  
Finding: Stairs slippery finish  
Information: It was observed that the polished timber stairs were finished in a coating that has no slip index rating and appears to be quite smooth

A general handyman or specialist flooring/painting contractor should review as soon as possible.

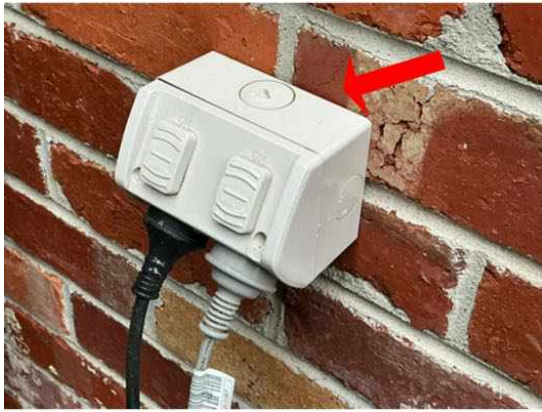
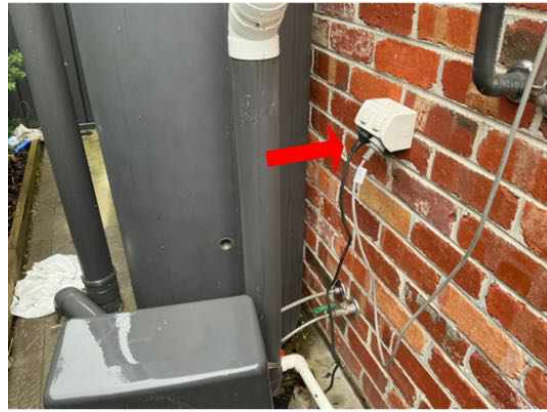
### Finding 1.02

Building: Main Building  
 Location: Exterior walls - rear  
 Finding: External power point not sealed AS 3000  
 Information: It was observed that the external power point to external wall was not adequately sealed from moisture ingress.

All external power points are to be sealed (generally at the top) to prevent moisture ingress to the fitting.

Moisture inside a fitting can caused earth leakage,power cut out and could cause injury to persons

A licensed electrician should review immediatly

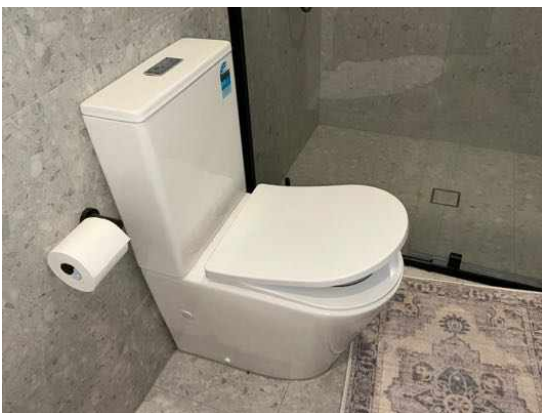
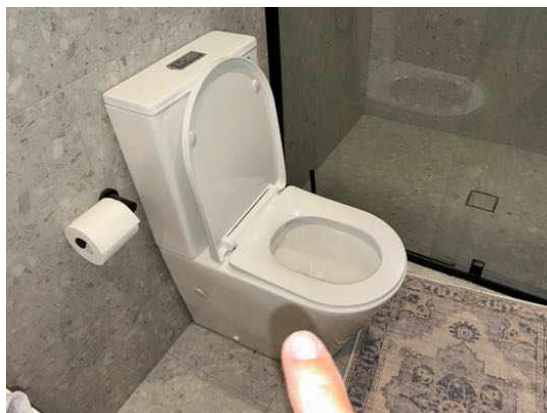
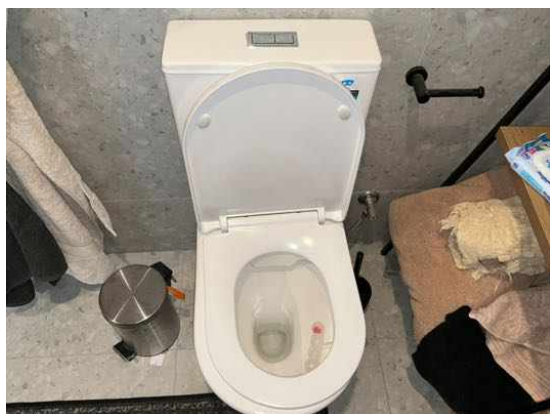
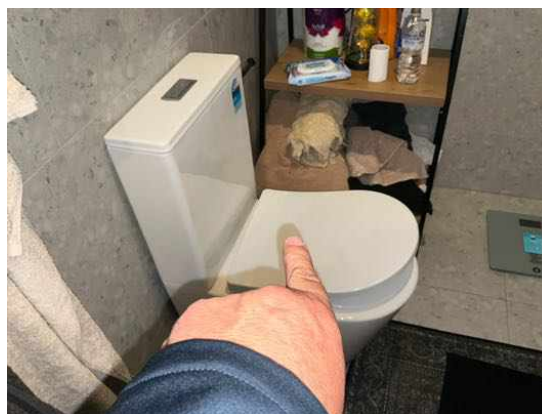
**Finding 1.03**

Finding: Toilet seat loose

Information: It was observed that the toilet seats throughout the building are loose and unstable.

Loose seats can cause fall injury to persons while in use and lead to serious injury

A licensed sanitary plumber should be engaged to review prior to use

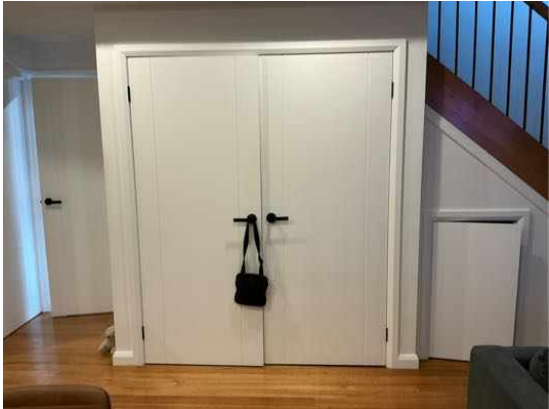
Building: Main Building  
 Location: Laundry  
 Finding: Door - Binding/jamming  
 Information: Binding and/or jamming of this laundry door is evident during standard operation. This defect inhibits the functionality of the affected door as well as creating potential for secondary defects to associated building elements, such as damage to the floor covering.

A door that binds to flooring or to the associated door frame may have several causes, ranging from minor defects, such as poor installation of the door or deteriorated hinges, through to major structural issues, such as damage to subfloor structures.

Where door binding/jamming appears to indicate major structural issues, a registered builder specialising in re-stumping should be appointed to provide an estimate on the cost of rectification.

For minor causes, a qualified carpenter or general handyperson should be appointed to perform minor rectification works at client discretion.

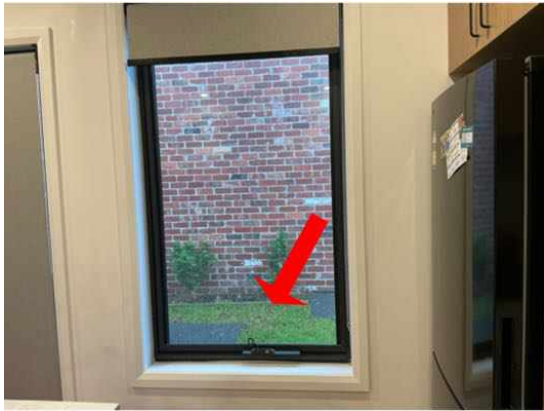
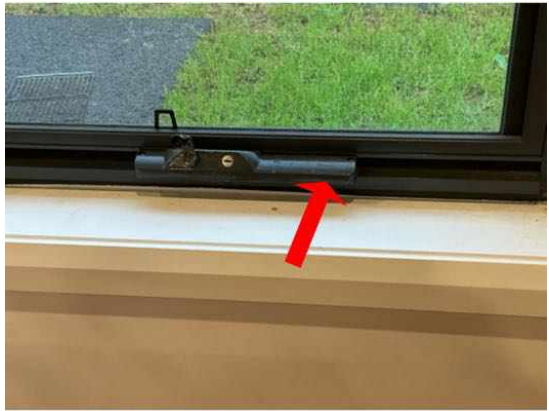
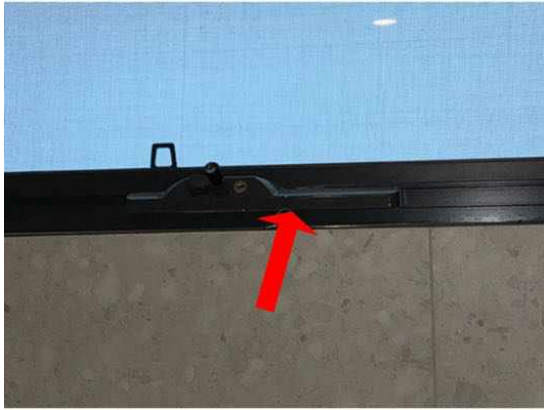
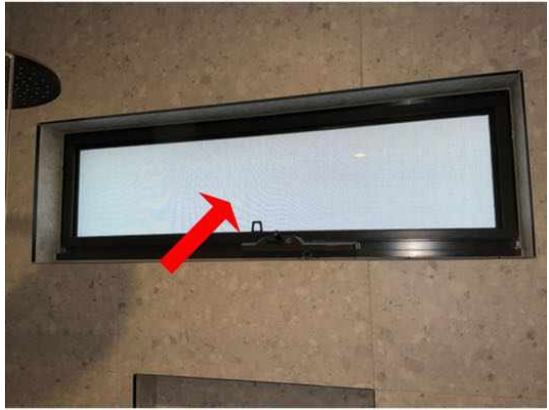
**Finding 3.02**

Building: Main Building  
 Location: All Areas  
 Finding: Locked windows  
 Information: It was noted at the time of the inspection that the operation of several windows was unable to be tested as they were locked or had damaged winders/locks

The windows should be re-inspected once they have been unlocked.

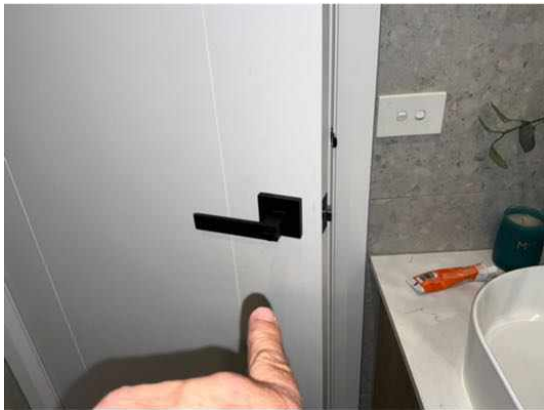
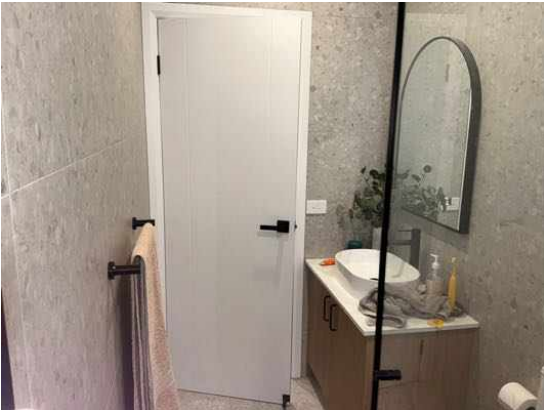
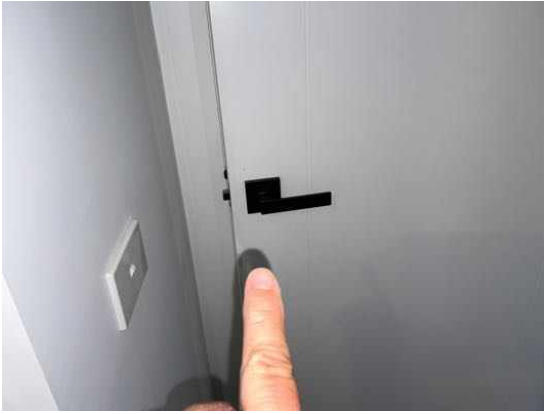
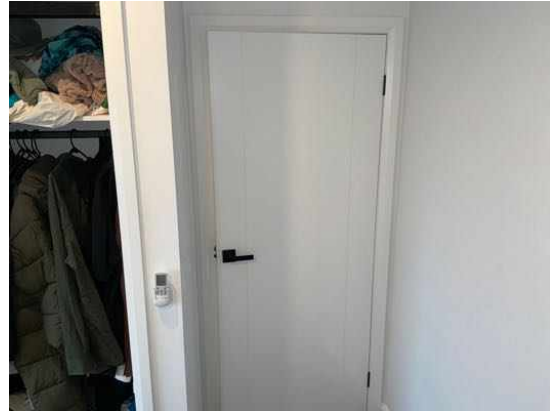
**Finding 3.03**

Information: It was noted that several doors are not latching during operation at the time of inspection. Whilst detracting from the functionality of this building element, this minor defect may also be a security risk, and may therefore have serious implications if left unattended.

It is suspected that this defect has occurred due to minor issues with the associated hinges. Such damage is identified as general wear and tear, which is expected for building elements of this age.

A qualified carpenter or general handyperson may be appointed to perform rectification works as necessary, at client discretion. If left unattended, further functional impairment is likely to occur.

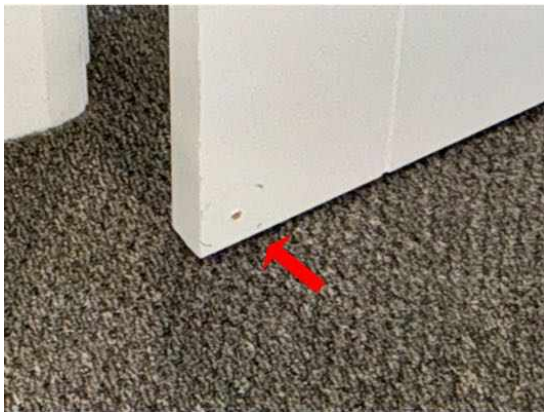
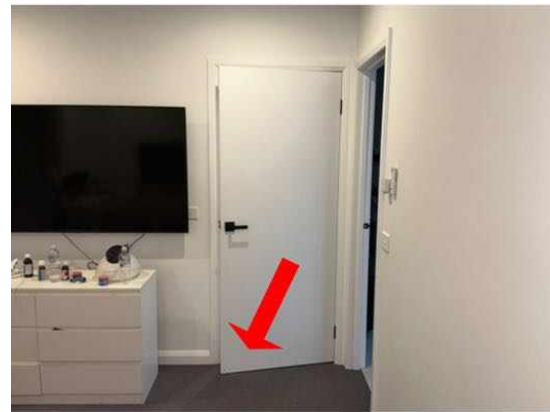
### Finding 3.04

Building: Main Building  
 Location: Bedroom - Master  
 Finding: Door cushion missing  
 Information: It was observed that the door cushion to the MBR door was missing.

Missing door cushions allow the door handle to strike the wall or other doors when the door is opened. This can cause damage to the plaster walls.

A handyman should be engaged to provide a new door cushion at the owners convenience .

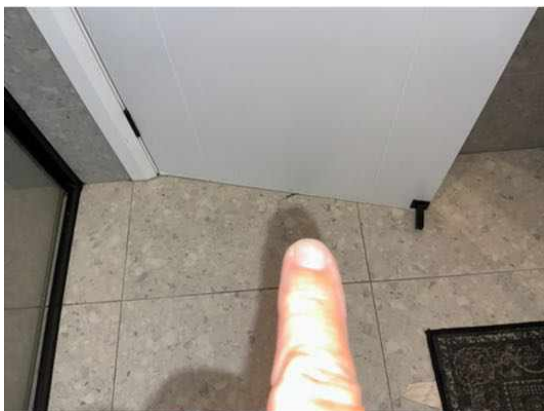
### Finding 3.05

Building: Main Building  
 Location: Ensuite  
 Finding: Door binding  
 Information: It was noted at the time of the inspection that the door to bathroom ( master) was binding on the floor. The closing operation appears to have resistance when closing as the door is in operation.

A qualified carpenter should be engaged to review as the owners discretion.

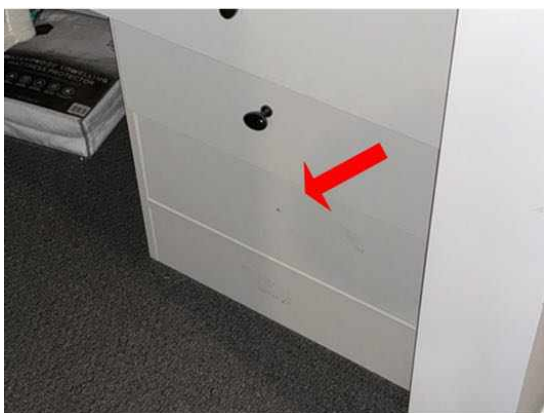
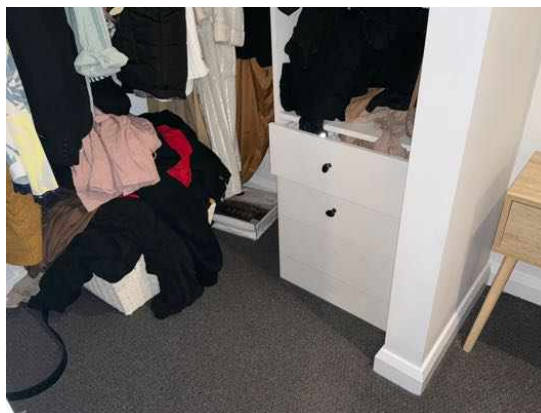
### Finding 3.06

Building: Main Building  
 Location: Walk In Robe  
 Finding: Drawer knob missing  
 Information: It's was noted at the time of the inspection that a drawer know was missing in the walk in wardrobe .

Without the knob the drawer could be hard to operate as intended.

A general handyman should review at the owners discretion

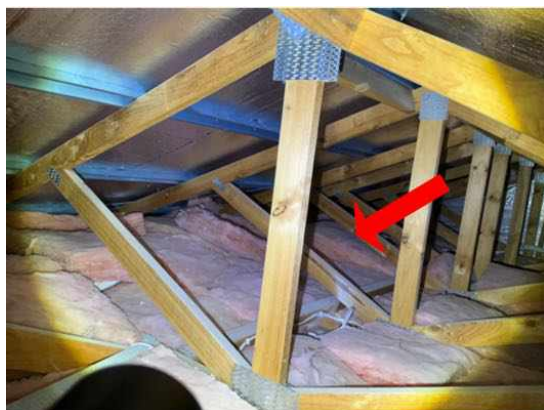
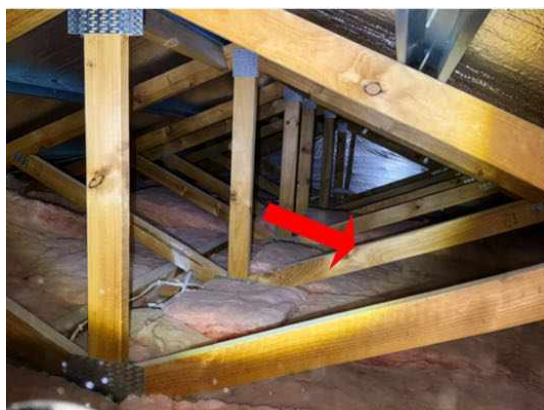
| Information: | Exhaust fans should from the fan to the outside atmosphere. This is to prevent condensation, unwanted smells and the build up of moisture in the roof void. Roof insulation was also covering the fans. |

A licensed plumber or licensed electrician should review immediately

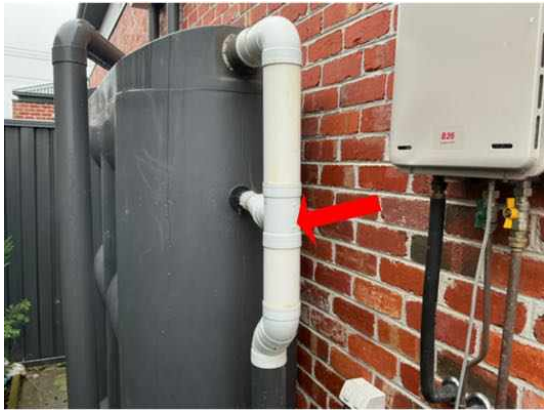
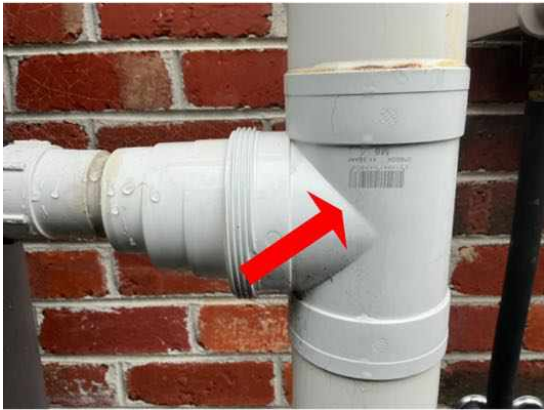
Building: Main Building  
Location: All External Areas  
Finding: Downpipes PVC not painted NH  
Information: It was observed that some PVC pipes were not UV protected with suitable paint.

UV damage will cause the downpipes to become brittle and prematurely deteriorate the PVC.

The downpipes should be painted with a suitable paint to protect against UV damage to protect against UV damage.

A general handyman should be engaged to review at the owners discretion.

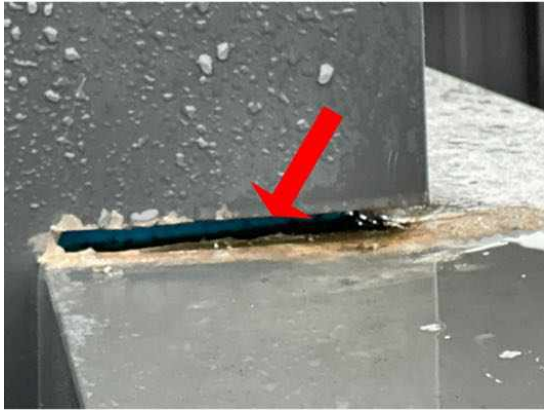
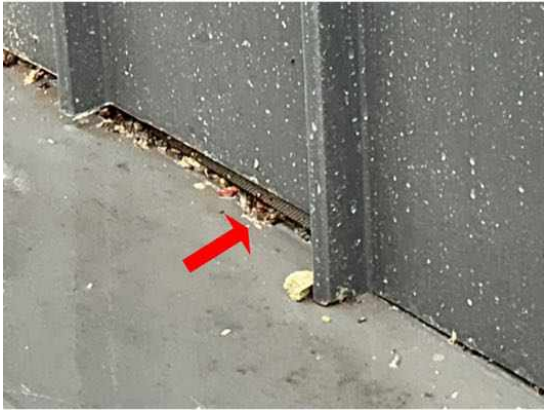
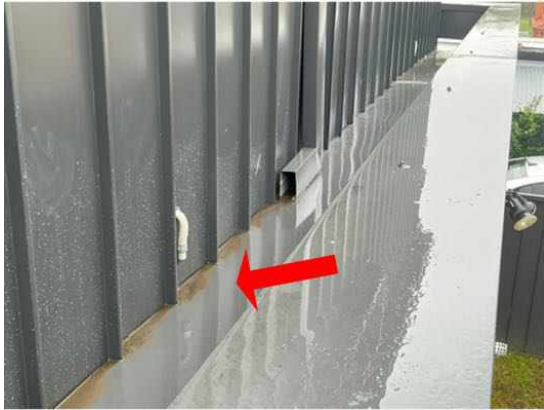
### Finding 3.11

| Finding: | Building not sealed against moisture ingress |
| Information: | It was observed that the metal cladding to the first floor was cut short of the horizontal roof decking and was demonstrating gaps and poor workmanship. Water and moisture can wick up underneath the cladding and allow a moisture ingress into the building. The substrate underneath was also visible. Unattended to, premature deterioration of other building elements could occur, which could cause mould growth and provide an environment for termite infestation and fungal attack of timbers. |

A licensed roof plumber should be engaged to review as soon as possible

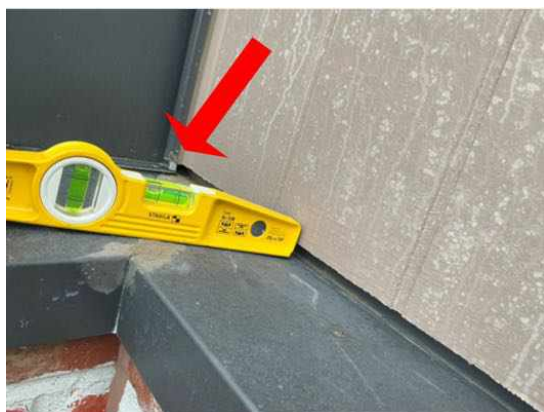
| Information: | It was observed that the roof flashing was installed falling towards the building. |

Flashings falling in the wrong direction can cause water penetration into the building and pooling of water along the flashing reducing the durability of the flashing. This defect would be considered non-compliant to the current building regulations and standards.

Flashings and cappings are defective if a minimum fall of three degrees is not provided across the width of the flashing to divert water run off away from the building.

A licensed roof plumber should rework at the owners discretion.

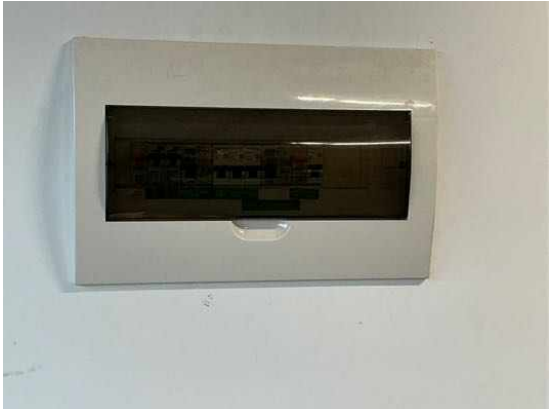
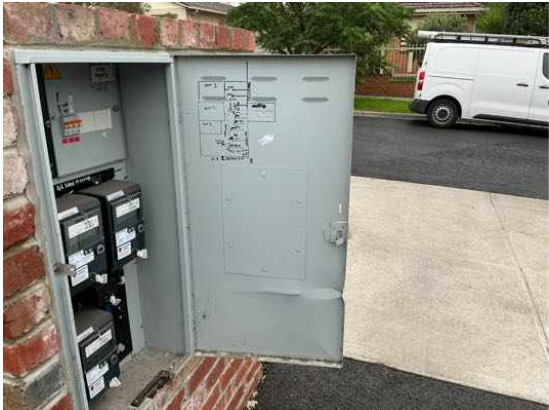
Building: Main Building  
 Location: Meter Box  
 Finding: Termite Management System - no evidence of a chemical installation  
 Information: The application of a post-construction chemical termite barrier is highly recommended for all properties, particularly if live termite activity has been found on the site previously. Such barriers are highly effective in preventing termite attack on any timber building elements throughout the property.

A durable notice should be placed in the switchboard unit to indicate current termite barriers. At the time of inspection, it appeared as though no termite management system has been installed, with no evidence to suggest preventative works taking place.

The client may consider gaining further advice from a pest controller as to the costs and procedures involved with this application. It is recommended that obtaining such advice be a short-term priority.

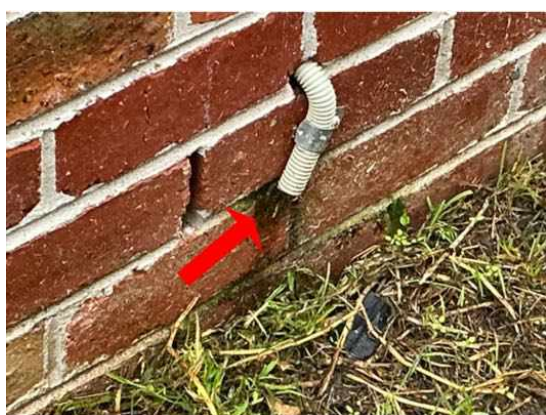
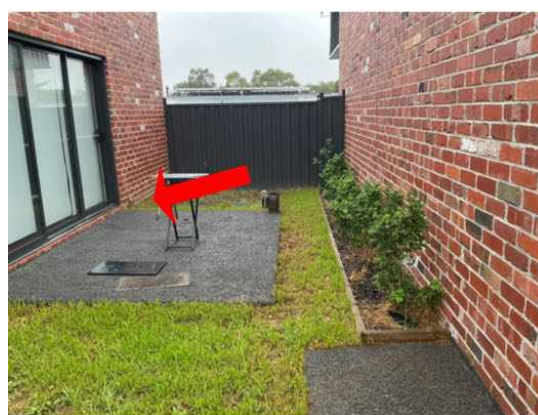
## Finding 6.02

| Finding: | Air conditioner condenser pipe not connected |
| Information: | The A/C Condenser overflows were found to be disconnected from the stormwater system and is creating excessive moisture to the surrounding area. |

Such leaking creates an environment which is conducive to an array of defects including water damage to associated building materials and the attraction of termites or timber pest infestation.

A Licensed plumber should be engaged to review as soon as possible
