Building and Timber Pest Inspection Report

Inspection Date: Fri, 27 Mar 2026

Property Address: 1 Annie Ct, Moama NSW 2731, Australia

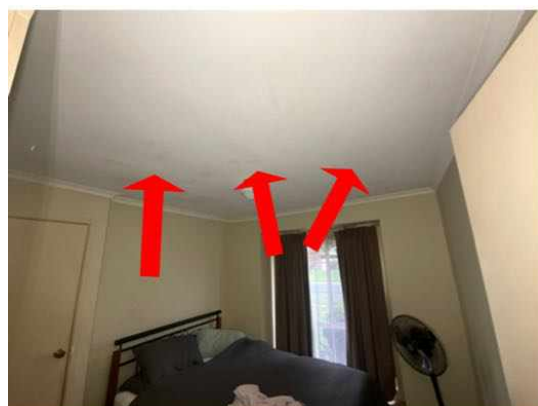
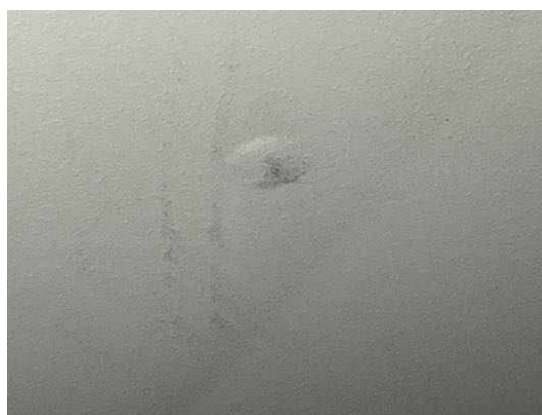
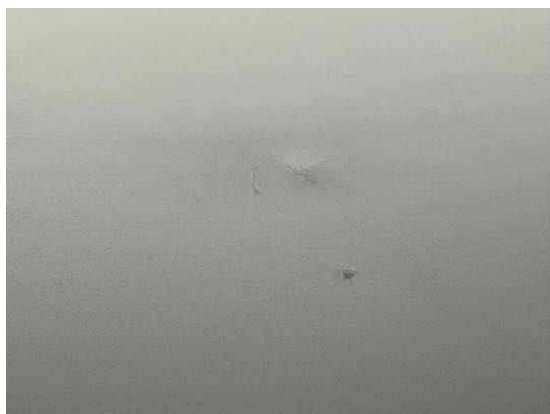
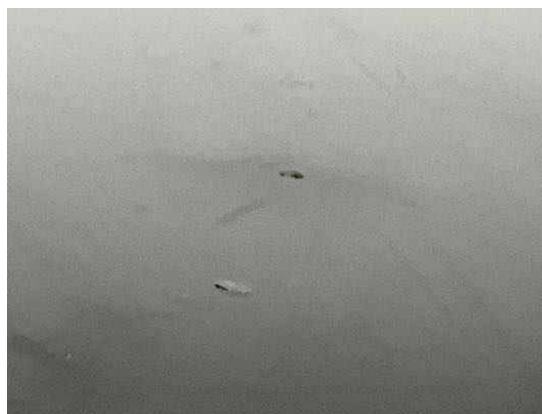
Finding 3.01

Building: Building 1
Location: Bedroom 2
Finding: Ceiling nails - Popping
Information: Numerous popped nails were identified in the internal ceiling at the time of inspection. Nails and screws hold simply by the friction between them and the surface they are applied to. Over time, the nails and screws can back out, which is often a result of general ageing and deterioration of the building structure.

If left unmanaged, the ceiling sheets may become loose and unstable, increasing the rate of deterioration of the internal ceiling and creating potential for the development of secondary defects.

Re-fastening of popped nails will help to maintain the stability of the internal ceiling and associated building elements. Such minor works will also help to improve the appearance of the affected area and secure the ceiling sheets, so as to prevent the onset of ceiling sagging. These works should be performed by a qualified carpenter or plasterer at client discretion.

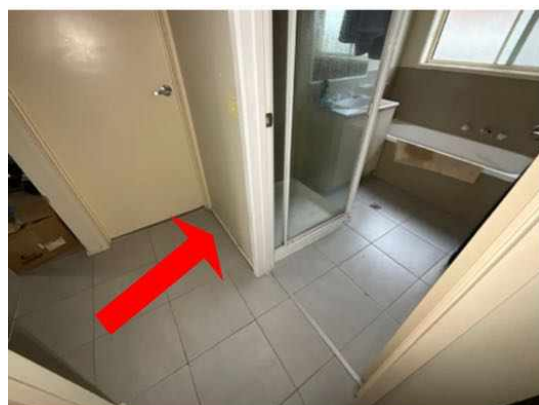
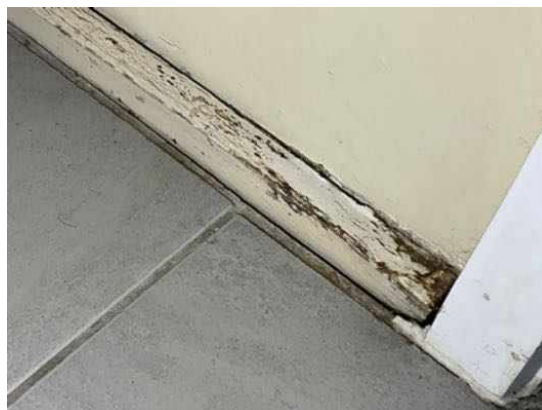
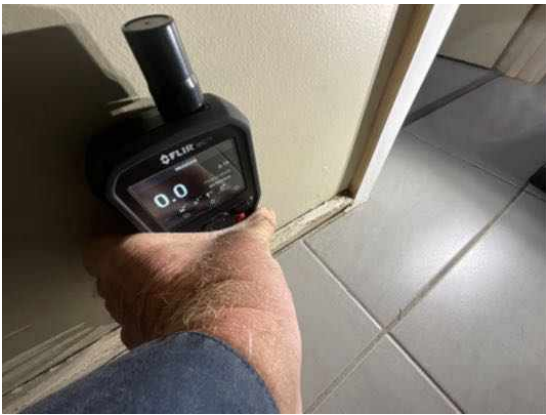
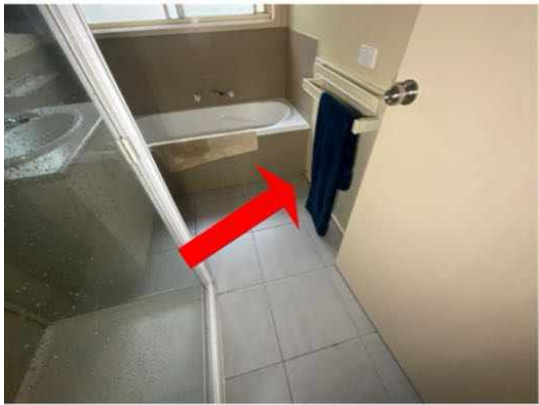
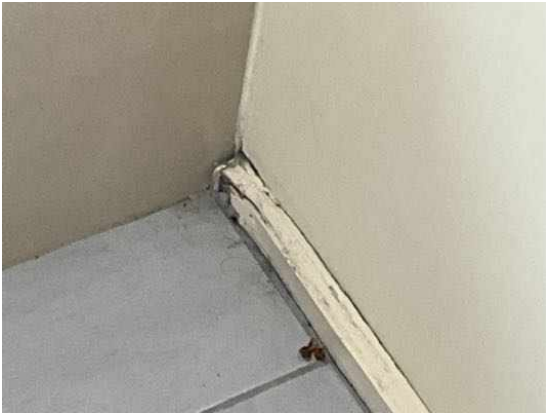
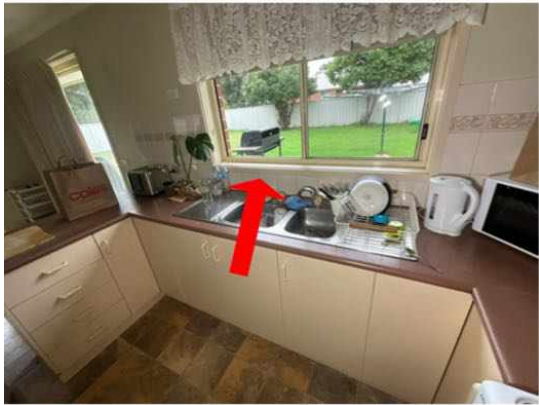
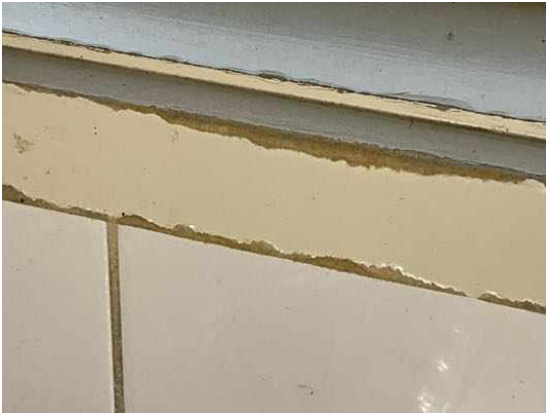
Finding 3.02

Building: Building 1
Location: Hall, bathroom, kitchen
Finding: MDF- Moisture affected
Information: The Particle board (MDF) in this area has been affected by excess moisture. This moisture has caused swelling of the material. A lack of effective paint or other coating has probably allowed the moisture to penetrate and deteriorate the material over time.

In cases of minor swelling a painter or Handy person could re-paint and restore the area.

In cases where the material is structurally compromised a carpenter or General handy person could be contacted to replace the damaged elements and complete all needed restoration.

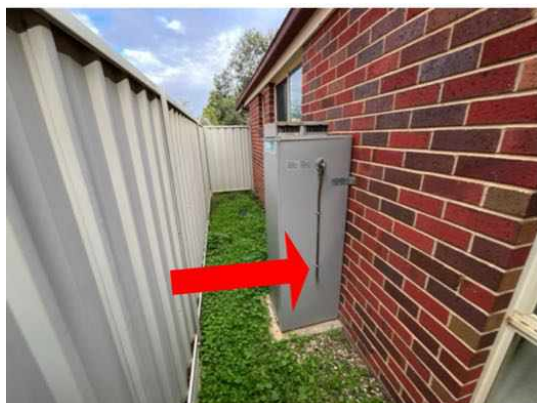
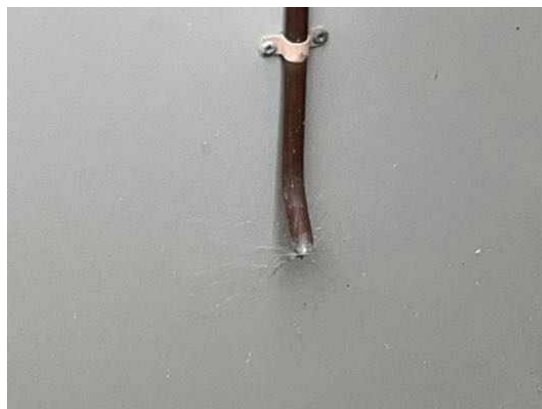
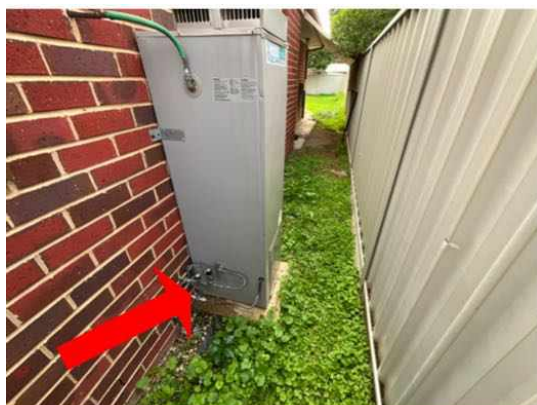
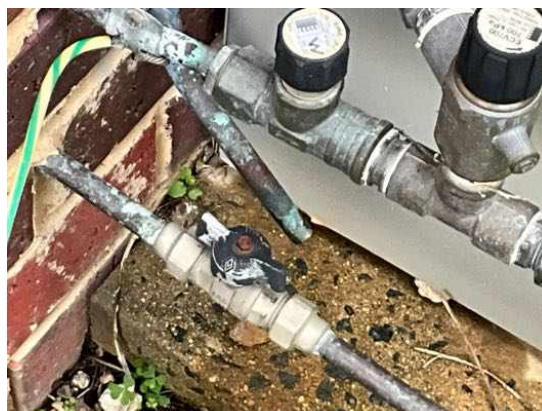
Finding 6.01

Building: Building 1
 Location: Yard - Side
 Finding: HWS Overflow - Not Connected
 Information: The Hot Water System (HWS) overflow was found to be disconnected from storm water drainage and is creating excessive moisture in the surrounding area.

These damp conditions can lead to secondary defects such as rot, rust or corrosion of associated building elements, the formation of fungal decay, or even the creation of potential slip hazards. When coupled with poor site drainage, pooling of water may also attract termite activity to this area.

It is highly recommended that a licensed plumber be appointed to connect the HWS overflow in order to prevent such an environment from being created. These minor works should be carried out as soon as possible.

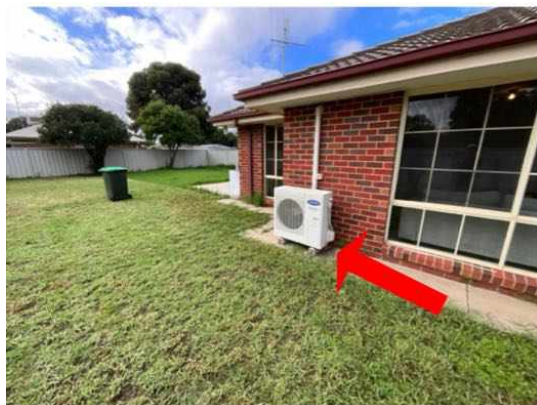
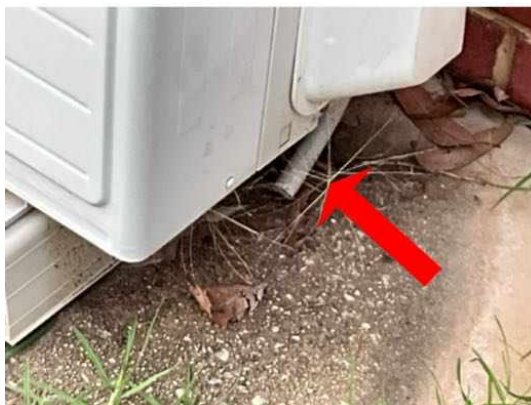
Finding 6.02

Building: Building 1
 Location: Yard - Back
 Finding: Air conditioner - Disconnected overflow
 Information: The Air Conditioner (A/C) overflow was found to be disconnected from storm water drainage and is creating excessive moisture in the surrounding area.

Such leaking creates an environment which is conducive to an array of defects, including water damage to associated building elements and the attraction of termite or timber pest infestation.

It is highly recommended that a licensed plumber be appointed to connect the A/C overflow in order to prevent such an environment from being created. These minor works should be carried out as soon as possible.

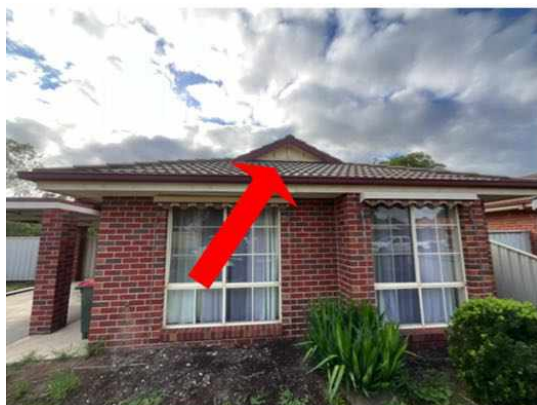
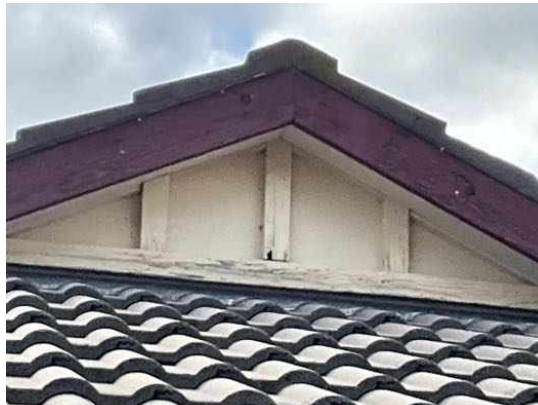
Finding 6.03

Building: Building 1
 Location: Roof Exterior
 Finding: Timber - exposed to weather
 Information: External timbers that are frequently exposed to harsh weather conditions require adequate protection in order to maintain their condition. Where timbers have not been painted or treated adequately, general deterioration is likely to occur at an accelerated rate.

If left unattended, replacement of these timbers is likely to be necessary in the short-term future. Adequate treatment of these timbers is required as soon as possible by a painting contractor or general handyman.

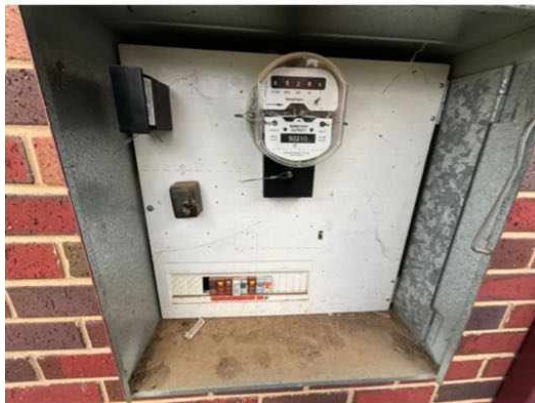
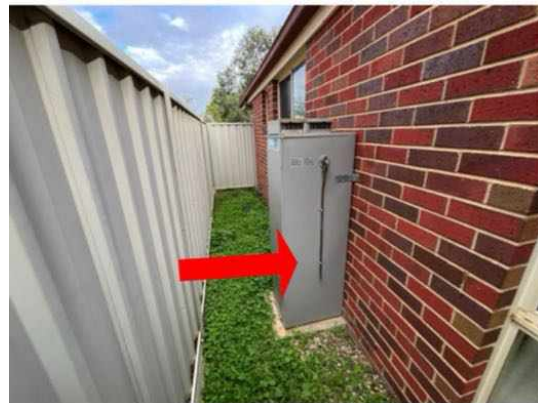
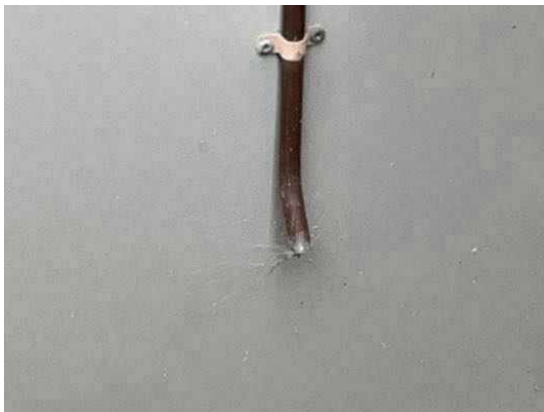
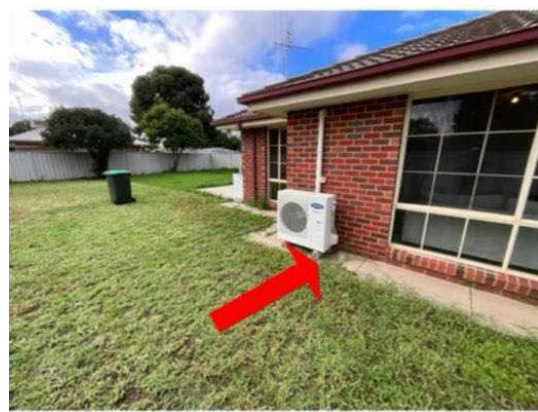
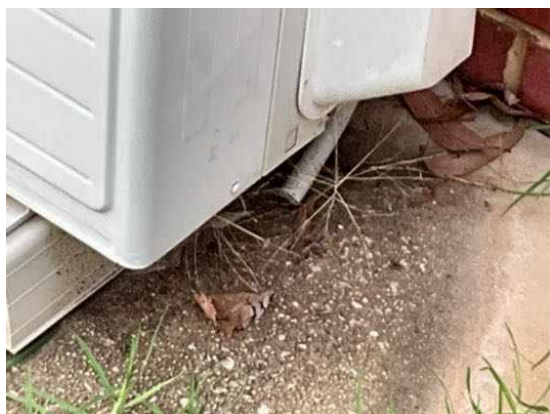
Finding 6.04

Building: Building 1
 Location: All External Areas
 Finding: Termite Management System - no evidence of a chemical installation
 Information: The application of a post-construction chemical termite barrier is highly recommended for all properties, particularly if live termite activity has been found on the site previously. Such barriers are highly effective in preventing termite attack on any timber building elements throughout the property.

A durable notice should be placed in the switchboard unit to indicate current termite barriers. At the time of inspection, it appeared as though no termite management system has been installed, with no evidence to suggest preventative works taking place.

The client may consider gaining further advice from a pest controller as to the costs and procedures involved with this application. It is recommended that obtaining such advice be a short-term priority.

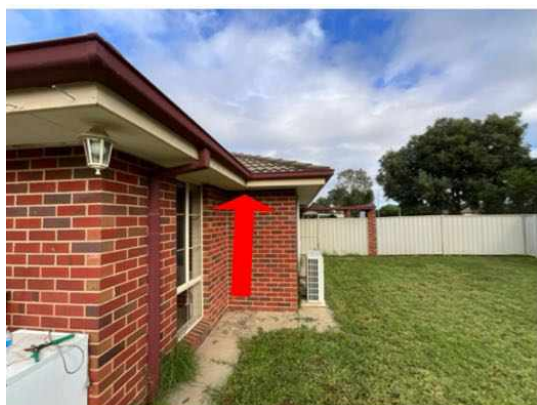
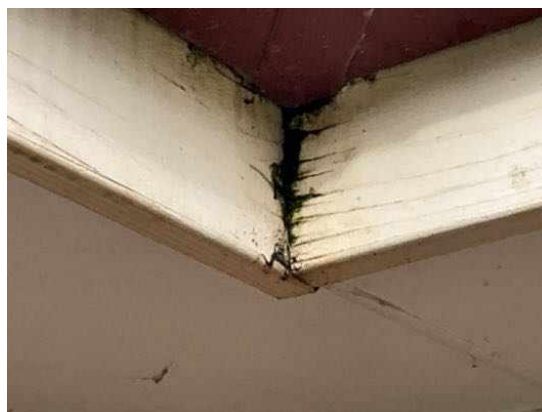
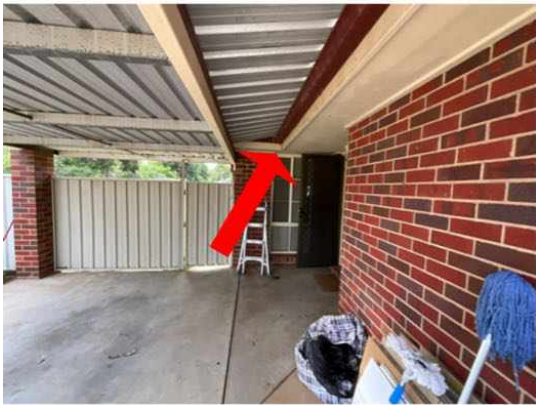
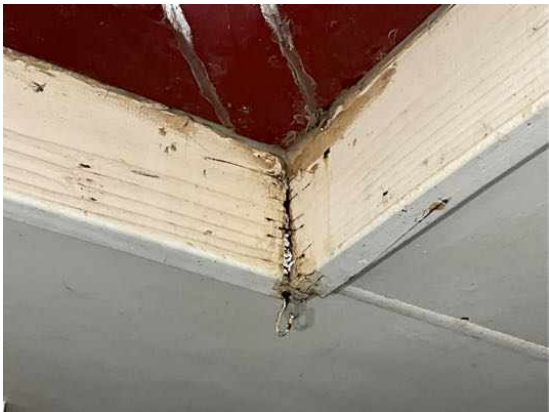
Finding 7.01

Building:	Building 1
Location:	Eaves
Finding:	Fungal decay - present (localised)
Information:	Fungal decay also known as wood decay or wood rot generally refers to the deterioration of timber elements when in contact with excessive levels of moisture for a prolonged period of time.

The development of fungal decay is accelerated by temperatures in the range of 5degreeC to 40degreeC as well as the presence of oxygen. Generally fungal decay develops on timber elements that are in use in an external environment which are exposed to rain penetration.

In this case although the affected timber element is in a decaying state the extent of any visible damage appears to be localised to a specific area and is yet to spread to other parts of the building element or affect adjoining structures. The fungal decay is therefore likely to be of a relatively superficial nature with minimal impact on the structural integrity or tensile strength of the timber element.

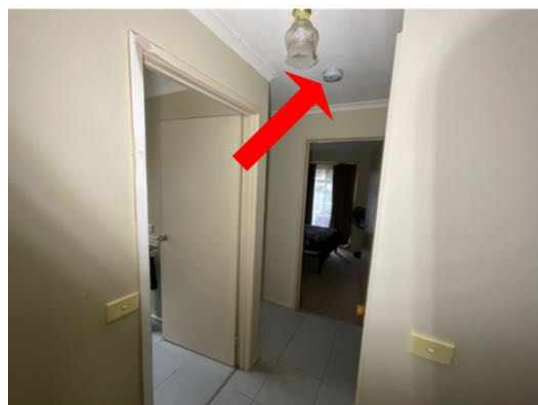
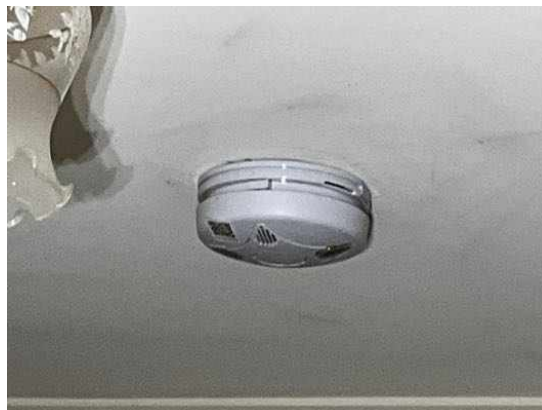
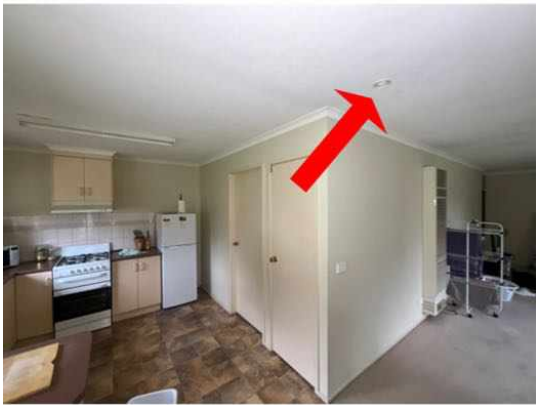
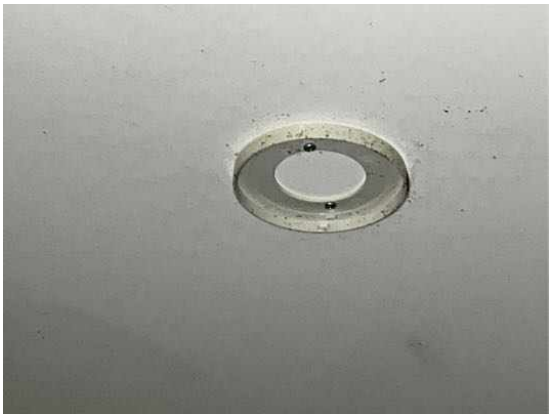
Building:	Building 1
Location:	All Internal Areas
Finding:	Smoke Detectors and Alarms
Information:	Reporting on Smoke Detectors or Alarms, including hard wired smoke detection systems and their legislative requirements, is outside the Scope of this Report.

Please note that this defect is highlighted as a caution only. We suspect, based on our experience in the building industry, that the absence of smoke detectors, or their poor condition, should be addressed as a matter of urgency to improve occupant safety.

Further Inspection and/or advisory services is necessary to provide advice on the sufficiency, type and location of smoke detectors, and to test the functionality of all devices. Greater requirements for fire safety and detection exist for commercial buildings.

Always ensure sufficient working and suitable smoke detectors are installed prior to occupying any building. Additionally, it is advised that all smoke detectors be tested by the homeowner on a monthly basis.

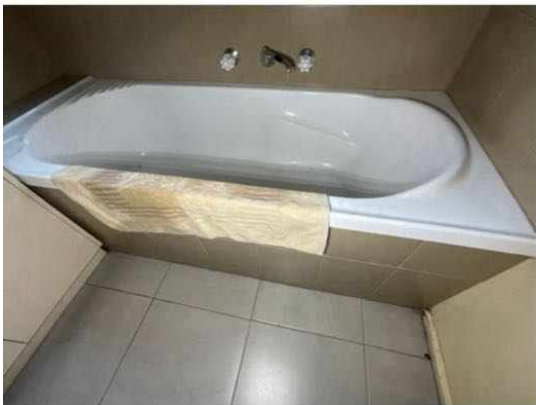
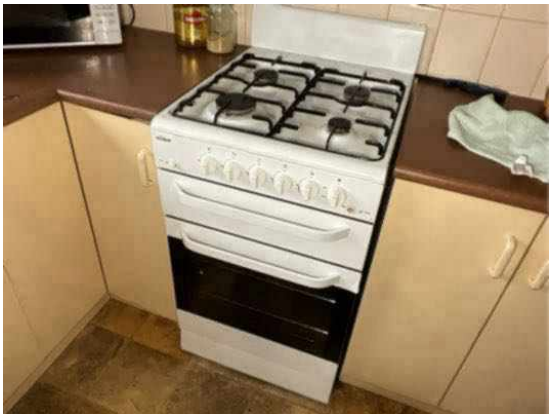
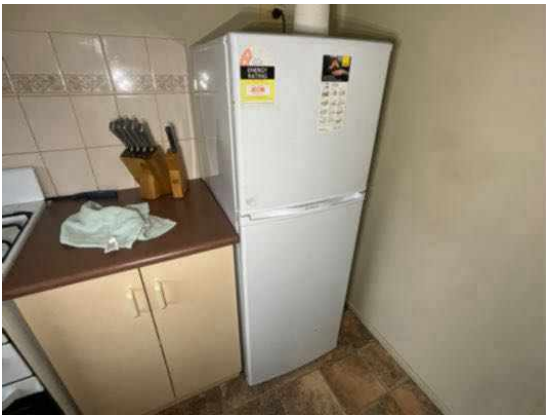
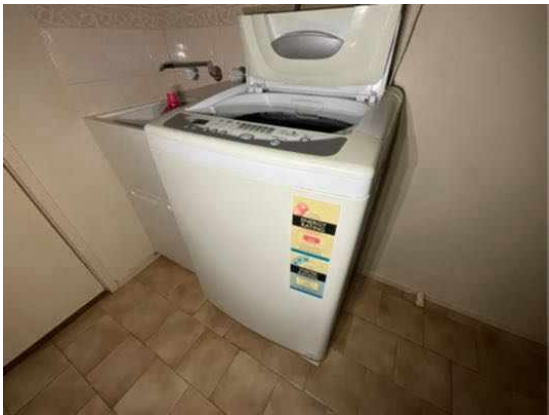
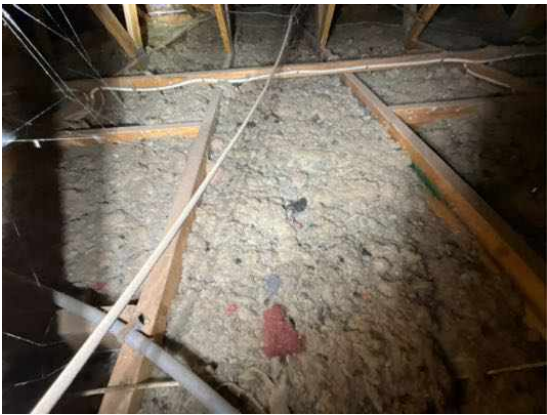
Building: Building 1
Location: All Areas
Finding: Additional Photos - Obstructions and Limitations
Information: These photographs are an indication of the obstructions and limitations which impeded full inspection of the property at the time of inspection. These obstructions can hide an array of defects and should be removed to allow full inspection to be carried out. A re-inspection is recommended once the areas are made accessible.
