Building Inspection Report

Inspection Date: Wed, 21 Jan 2026

Property Address: 803/1 Moreland Street Footscray

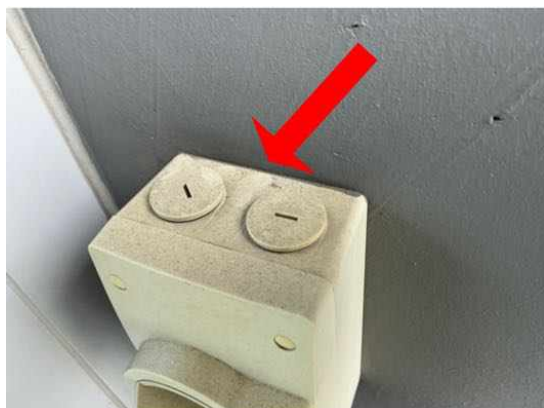
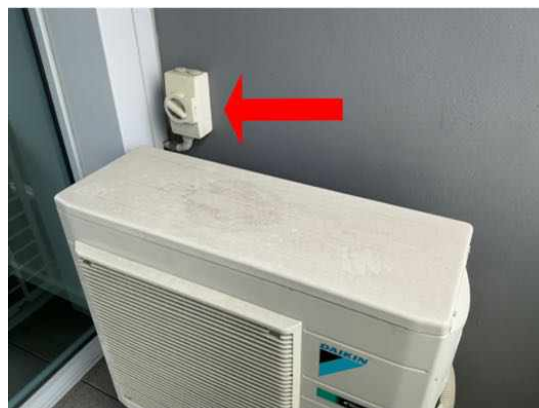
Defects 1.01

Building:	Main Building
Location:	Basement
Finding:	External electrical point not sealed
Information:	It was observed that the external electrical point to the external wall was not adequately sealed from moisture ingress as per AS 3000.

All external power points are to be sealed (generally at the top) to prevent moisture ingress to the fitting.

Moisture inside a fitting can cause earth leakage, power cut out and could cause injury to persons

A licensed electrician should review immediately

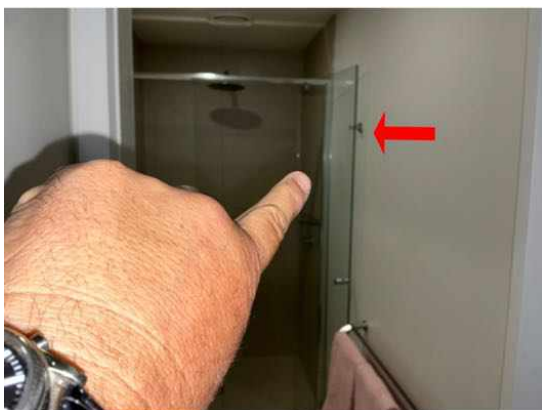
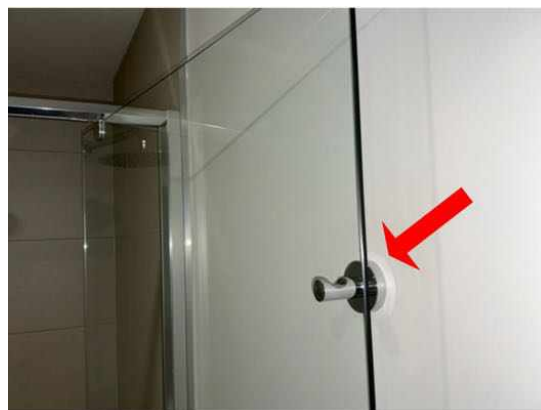
Defects 1.02

Building:	Main Building
Location:	Bathroom
Finding:	Shower door obstructed
Information:	It was noted at the time of the inspection that the glass shower door to the bathroom was hitting the clothes hook on the wall due to there being no door cushion installed.

The shower glass door could shatter and cause injury if the glass door is opened hard against the wall and allowed to hit the metal hook.

A general handyman should be engaged to review immediately

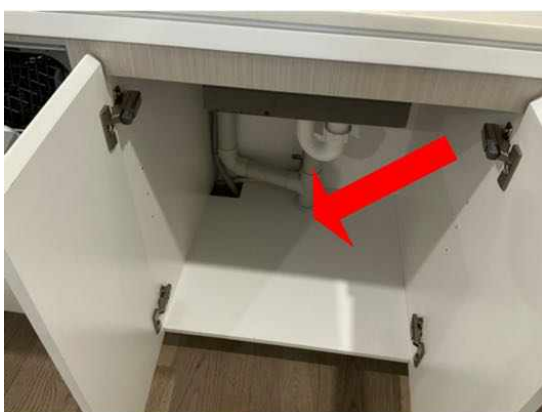
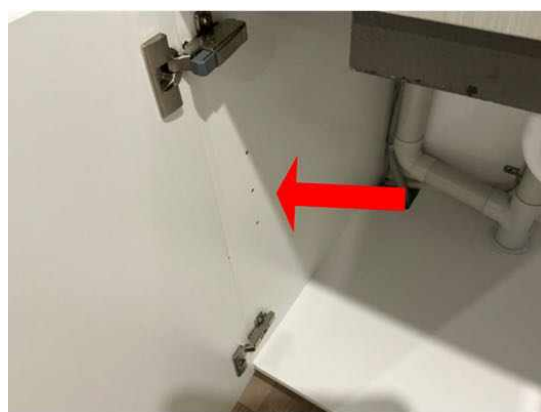
Defects 3.01

Building: Main Building
 Location: Kitchen
 Finding: Cabinet – kitchen – sink
 Information: It was observed that the shelf was missing to the sink cabinet in the kitchen.

Missing shelves reduce the amount of storage available for cooking and cleaning equipment.

A general handyman should be engaged to review at the owners discretion

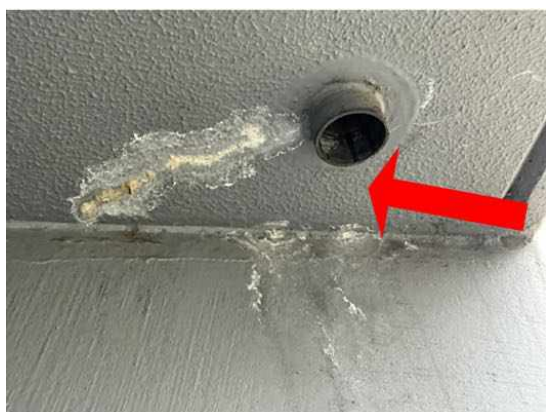
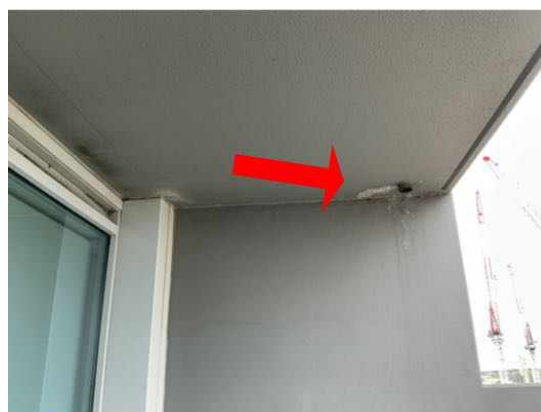
Defects 3.02

Building: Main Building
 Location: Balcony

Finding: Efflorescence-balcony ceiling
 Information: Efflorescence is a white powdery deposit which was observed around the balcony overflow. excessive water and moisture has deposited dissolving soluble salts on the ceiling. Water staining has also occurred.

While largely cosmetic it may point to underlying water and moisture issues which can lead to long term deterioration of the balcony ceiling finish if not addressed.

No leaking was observed to the balcony tiling at the time of the inspection.

A licensed plumber should be engaged to review at the discretion of the owner

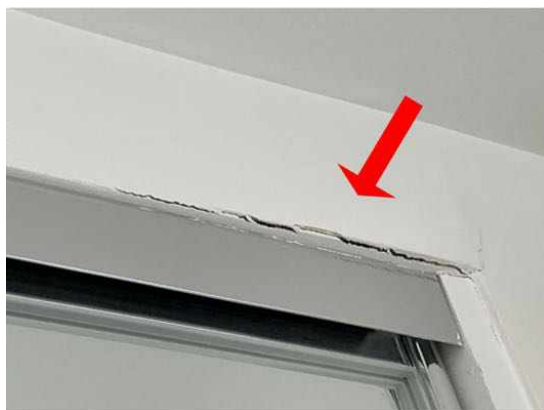
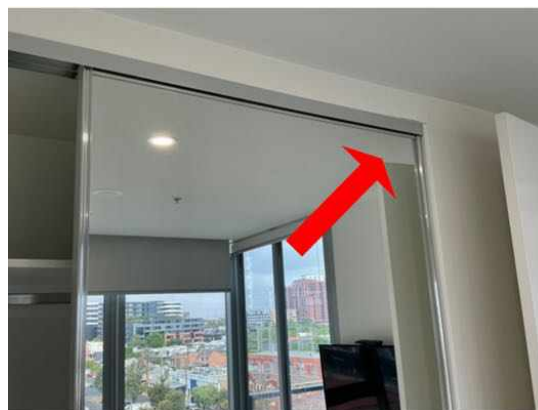
Defects 3.03

Building: Main Building
 Location: Bedroom 2
 Finding: Cracking - Damage Category 1 - Fine (up to 1mm)
 Information: Although fine cracks are quite noticeable, they are often only considered to be an appearance defect, and usually do not indicate any structural damage. Generally, the cause of a fine crack is indicative of a separation between building materials and finishes (e.g. paint, plaster, etc.) along joins.

Cracking of this nature can generally be repaired with minor sanding, filling and/or repainting. Such works should be performed by a qualified painter or a general handyman.

Monitoring of all cracking should be conducted frequently. Always contact a building inspector should cracks widen, lengthen, or become more numerous.

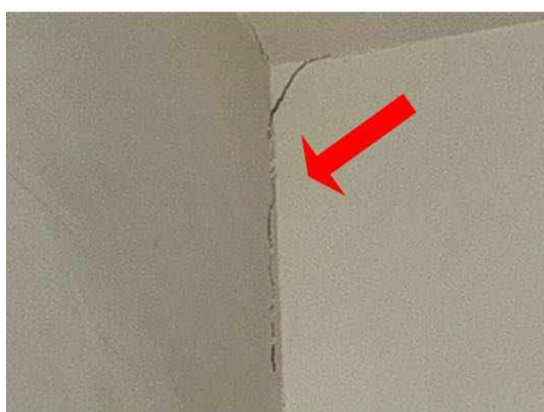
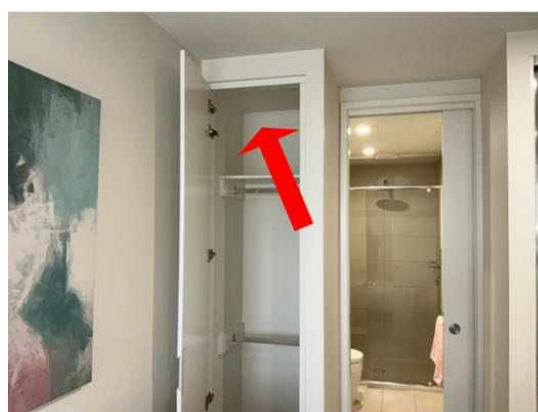
Defects 3.04

Building:	Main Building
Location:	Bedroom - Master
Finding:	Cracking - Damage Category 1 - Fine (up to 1mm)
Information:	Although fine cracks are quite noticeable, they are often only considered to be an appearance defect, and usually do not indicate any structural damage. Generally, the cause of a fine crack is indicative of a separation between building materials and finishes (e.g. paint, plaster, etc.) along joins.

Cracking of this nature can generally be repaired with minor sanding, filling and/or repainting. Such works should be performed by a qualified painter or a general handyman.

Monitoring of all cracking should be conducted frequently. Always contact a building inspector should cracks widen, lengthen, or become more numerous.

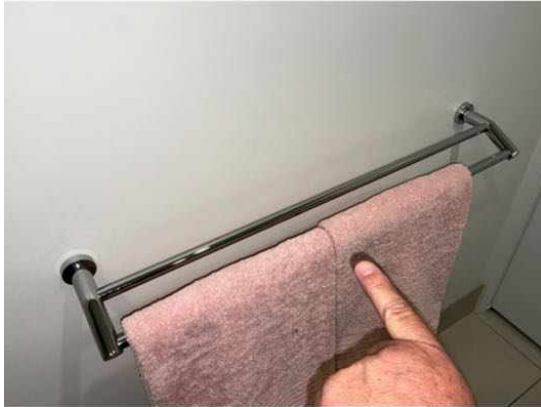
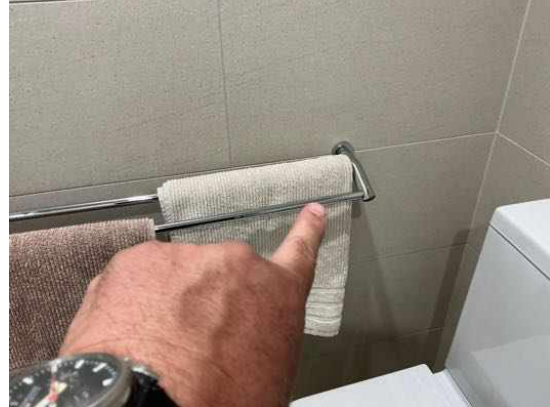
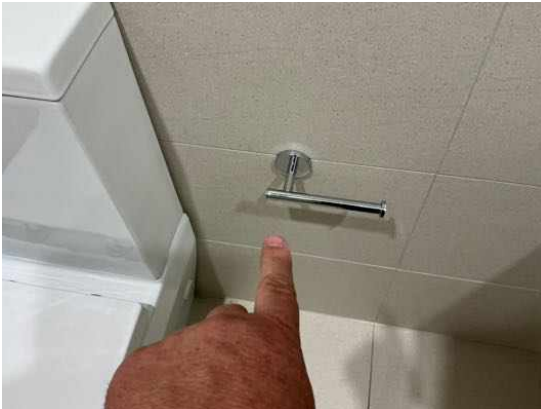
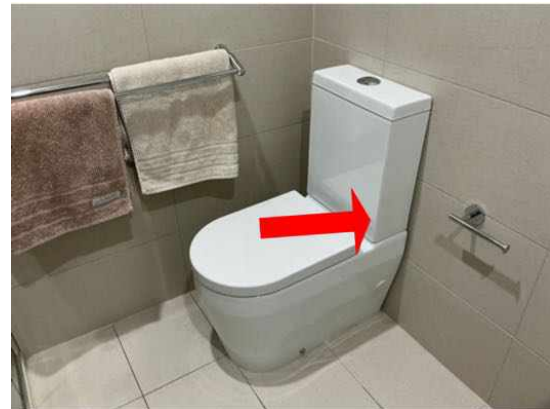
Defects 3.05

Building:	Main Building
Location:	Bathroom and ensuite
Finding:	Towel rail and WC roll holder - Loose
Information:	The towel rails were found to be loose in the bathroom and ensuite at the time of

inspection. While not a major operational defect, function can deteriorate if the problem is left unmanaged.

It is advised that the homeowner performs remedial works to re-attach the towel rail to its original fixing. A general handyman may be required to perform these works.

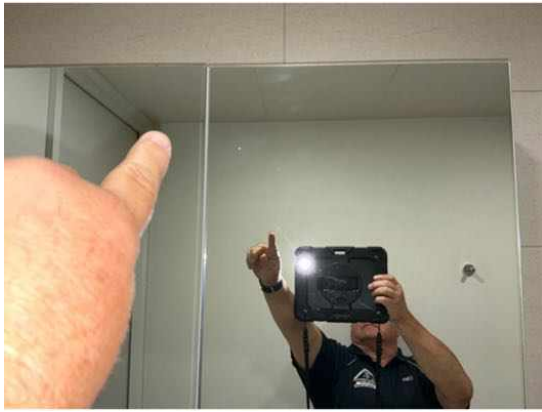
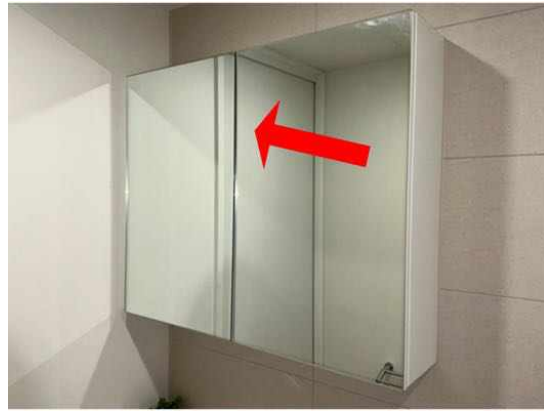
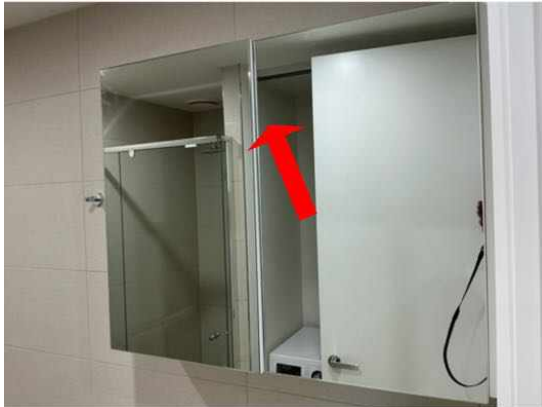
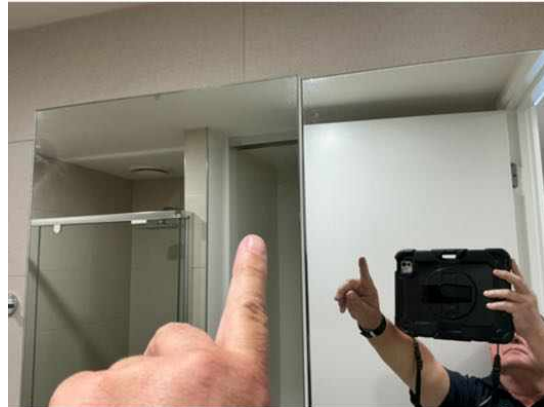
Defects 3.06

Building: Main Building
 Location: Bathroom and ensuite
 Finding: Cabinet doors adjustment
 Information: It was observed that the shaving cabinet doors to the bathroom and ensuite require adjustment.

Unattended to the doors will continue to jam and operate ineffectively, which in time could cause further damage to the doors

A qualified carpenter call General handyman should be engaged to review at the owners discretion

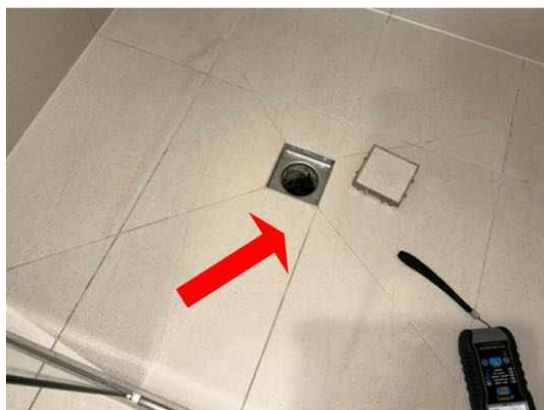
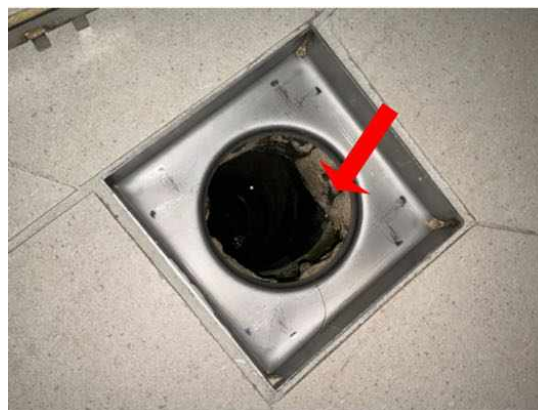
Defects 3.07

Building: Main Building
 Location: Bathroom
 Finding: Shower floor waste - part of obstructed
 Information: It was noted at the time of the inspection that the shower base floor waste was part obstructed with tile grout. This has been inside the waste since construction.

Shower wastes should be free of obstructions and enable water to egress the shower closet in an efficient manner. Partial obstructions can cause blockages after a period of usage.

A waterproof contractor or general handyman should be engaged to review at the owner discretion

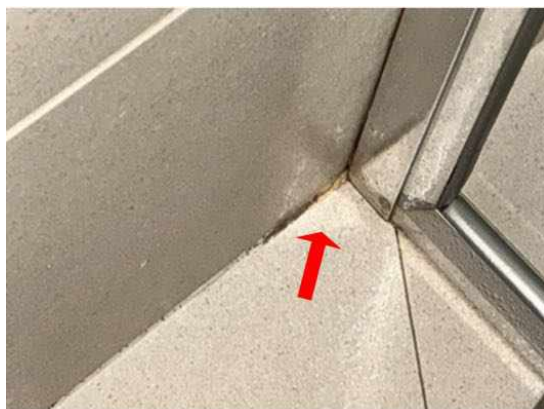
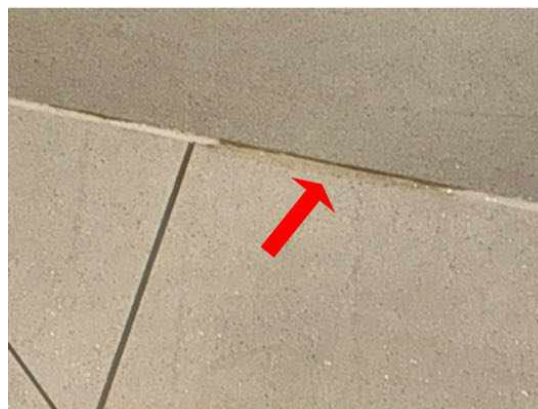
Defects 3.08

Building:	Main Building
Location:	Bathroom
Finding:	Sealant and grouting - Missing or damaged
Information:	It was noted on inspection that sealant has degraded to the tiled shower alcove.

Different materials and floor areas move at different rates, generally causing cracking to grout or sealant at this point. A flexible sealant is required to allow for expected expansion and contraction, while keeping the joint water tight and protective of all associated building materials.

There appears to be minor mould to the sealant which will likely require scraping out and replacement.

Flexible and mould resistant materials should be applied to affected areas to prevent any subsequent water damage that is likely to occur. Regular maintenance and replacement of damage or missing or damaged sealant and grout is highly recommended to the wet areas, as this is a regular wear and tear defect. Sealant and grouting in areas that come into regular contact with water should be maintained for the long term care of your property.

A sealant specialist or tiling contractor should be appointed to complete these works as soon as possible

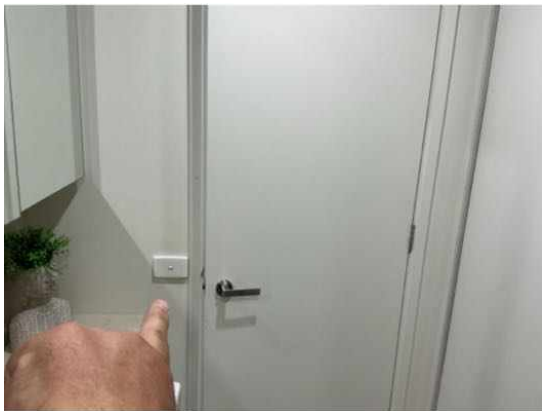
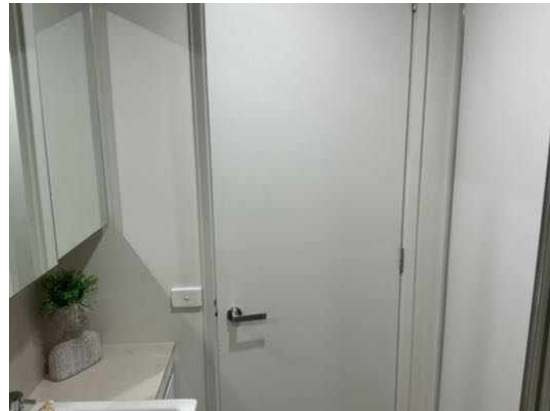
Defects 3.09

Building: Main Building

Location: Ensuite

Finding: Door handle - Not latching

Information: It was noted that the door in the ensuite was not latching during operation at the time of inspection. Whilst detracting from the functionality of this building element.

It is suspected that this defect has occurred due to minor issues with the associated hinges. Such damage is identified as general wear and tear, which is expected for building elements of this age.

A qualified carpenter or general handyperson may be appointed to perform rectification works as necessary, at client discretion. If left unattended, further functional impairment is likely to occur.

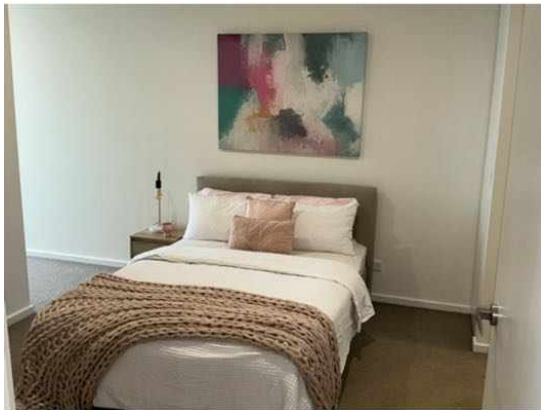
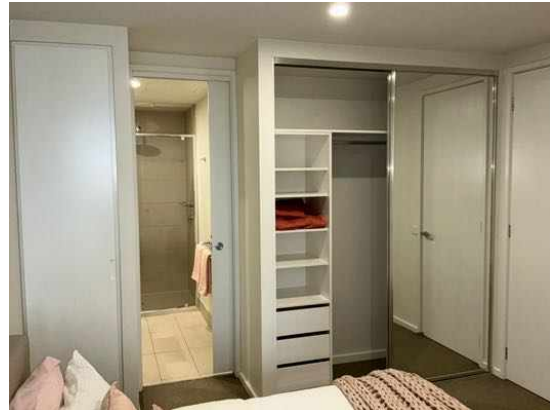
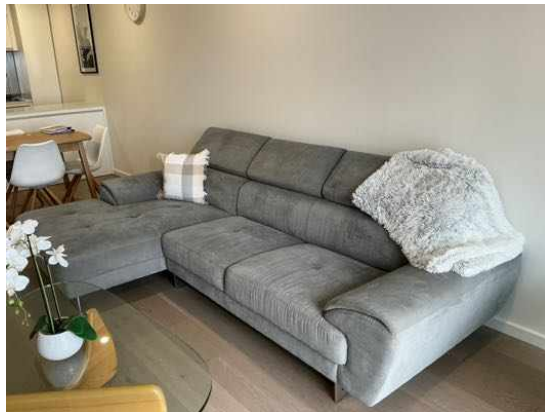
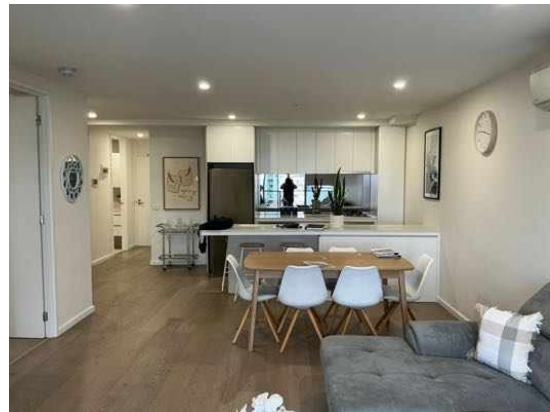
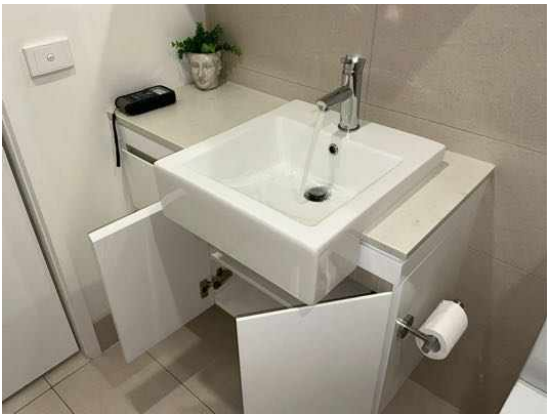
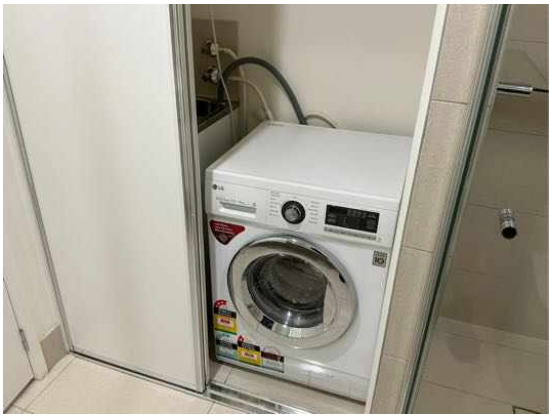
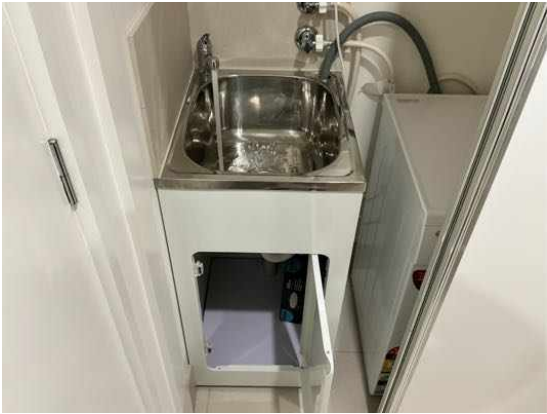
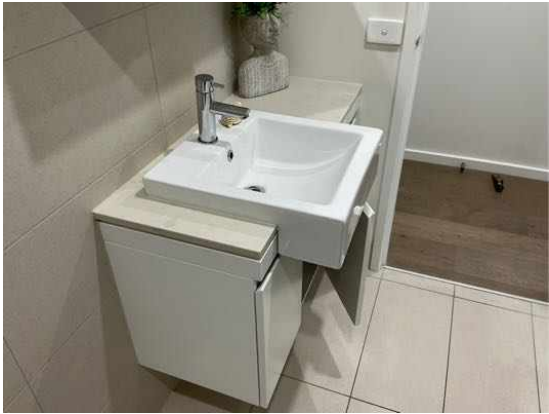
Noted Item

Building: Main Building
Location: All Internal Areas
Finding: Additional Photos - Obstructions and Limitations
Information: These photographs are an indication of the obstructions and limitations which impeded full inspection of the property at the time of inspection. These obstructions can hide an array of defects and should be removed to allow full inspection to be carried out. A re-inspection is recommended once the areas are made accessible.
