Building and Timber Pest Inspection Report

Inspection Date: Wed, 1 Apr 2026

Property Address: 81 Regent St, Shepparton VIC 3630,
Australia

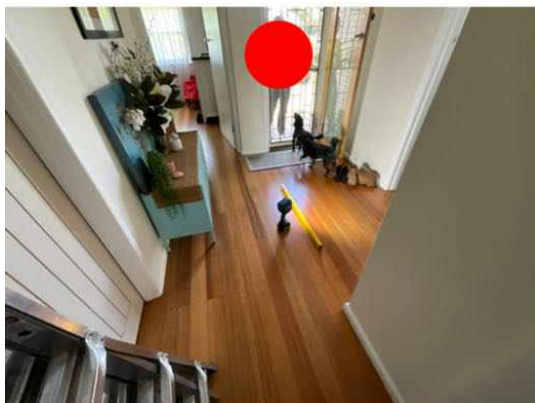
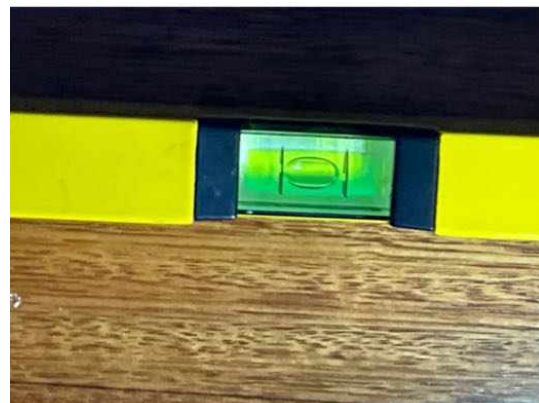
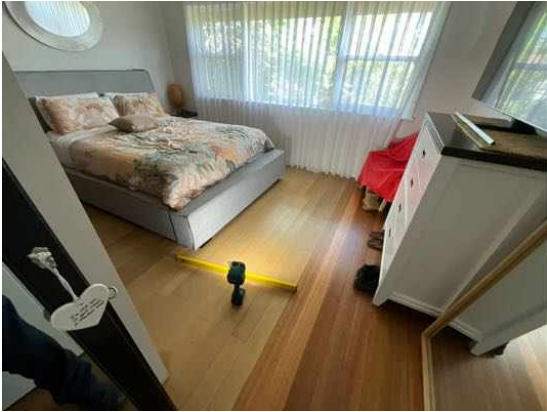
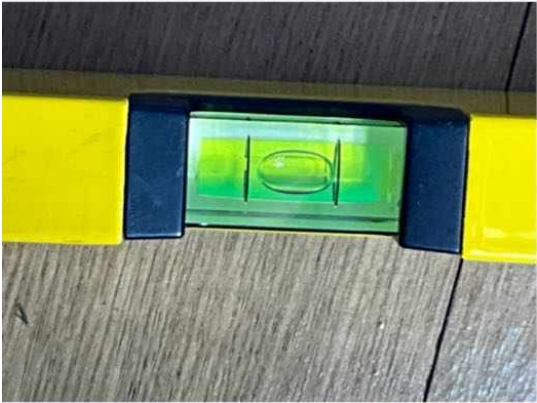
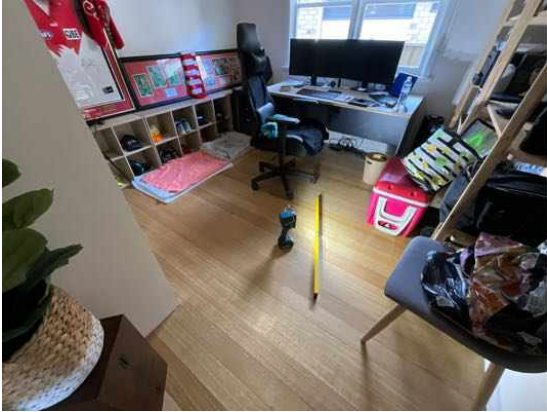
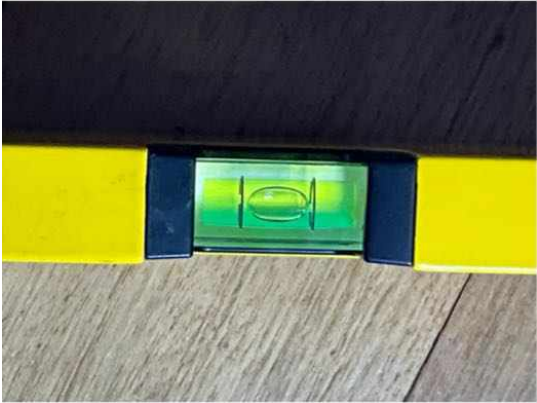
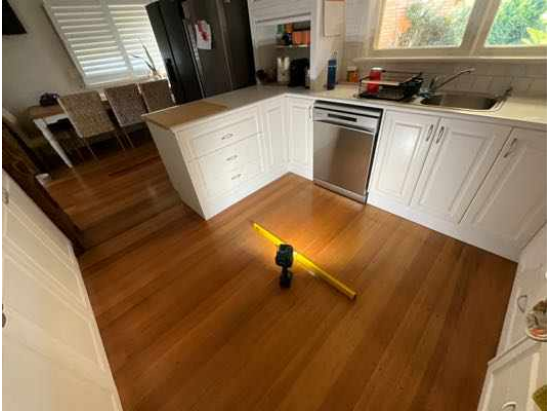
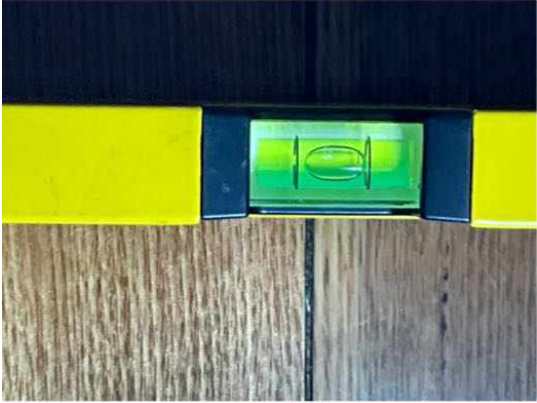
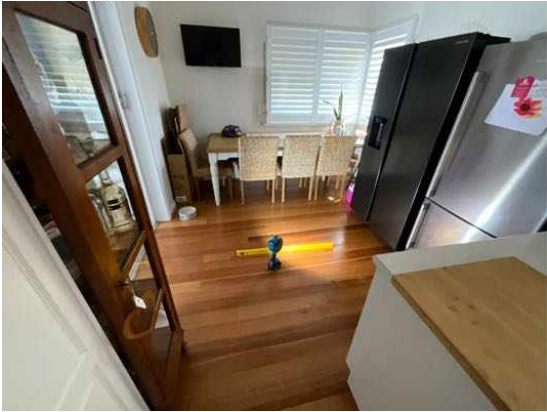
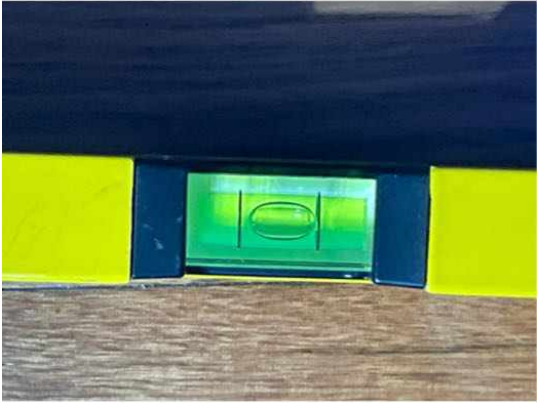
Finding 3.01

Building: Building 1
Location: All Internal Areas
Finding: Flooring - Uneven
Information: The internal flooring in this area is out of level and uneven. Uneven flooring is likely to indicate minor defects such as expected movement of the foundations of the property, but may also indicate subsidence of the associated subfloor stumps.

It is advised that the flooring be closely monitored to identify any further movement. Where flooring remains relatively unchanged for an extended period of time (i.e. several months), it is likely that this defect has been caused by expected movement of the foundations of the property.

However, where flooring is uneven further, potentially invasive inspection of the subfloor structures and stumps in this area is required. In this case, works to repair are likely to be required, and would be carried out by a registered builder specialising in re-stumping.

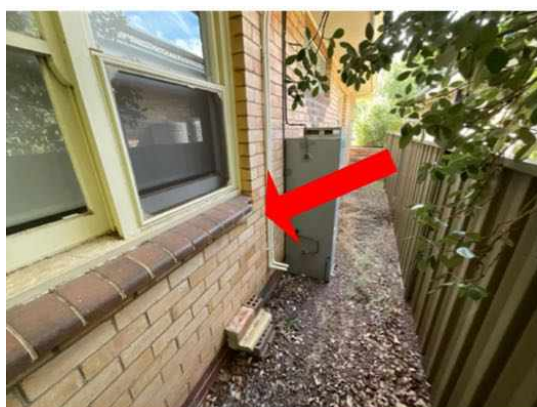
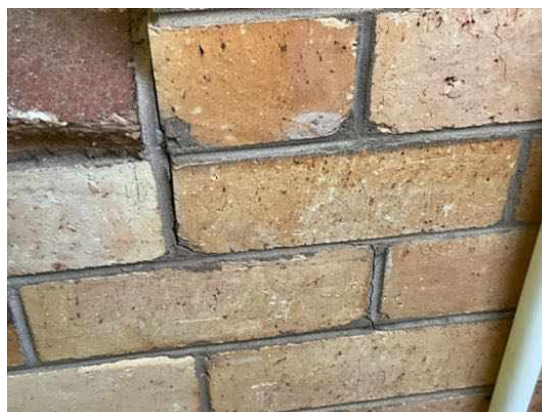
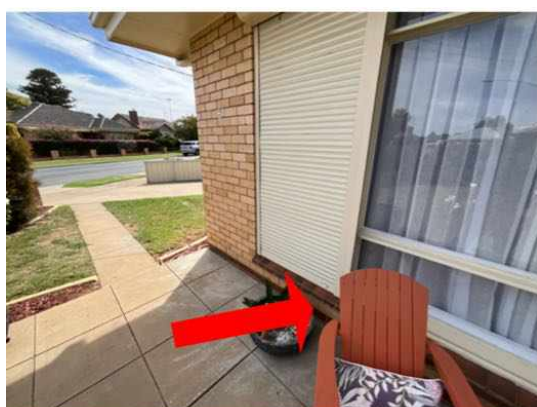
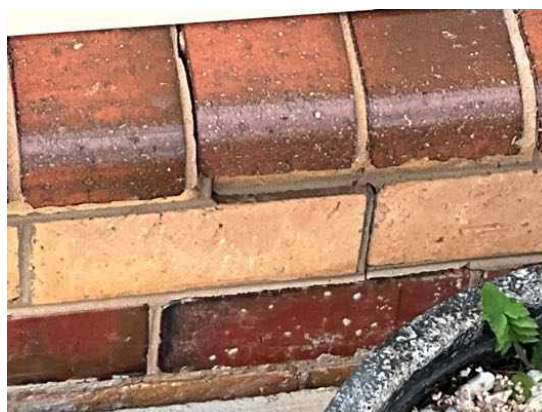
Finding 3.02

Building: Building 1
 Location: Yard - Side, front
 Finding: Brickwork - Step cracking
 Information: Step cracking was identified to the brickwork in this area at the time of inspection. Step cracking, which is similar to other forms of cracking, has a variety of possible causes. However, the most common is the subsidence of adjacent footings.

Step cracking is a relatively common defect, and is most likely to occur adjacent to windows, doors and other openings. Mortar failure in the gaps between affected bricks indicates the stresses and tensions affecting the wall.

Where step cracking is extensive or severe, the client is advised to consult a structural engineer. Minor step cracking can be used as a warning sign to address factors causing stress to the wall, which can include the effect of surrounding trees, water leaks, soil erosion, or even the presence of reactive soils in the surrounding area.

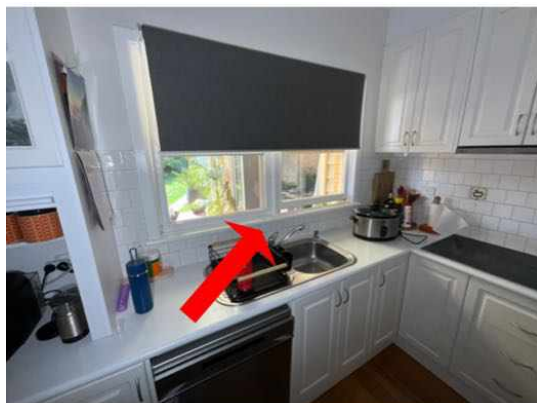
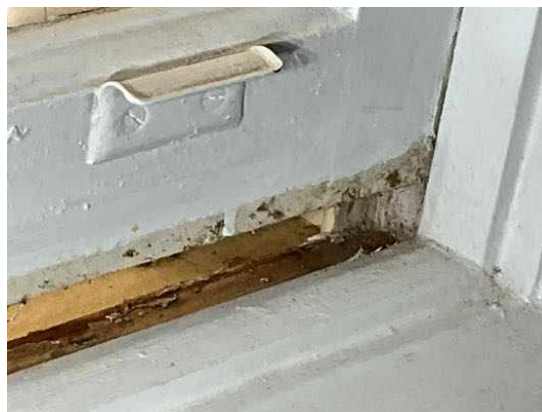
Finding 3.03

Building: Building 1
 Location: Kitchen
 Finding: Windows - Stiff to slide
 Information: Several windows throughout the property were jammed and difficult to operate at the time of the inspection. Windows provide ventilation to the adjoining area and should

be at a fully operational level to ensure user comfort. Restricted function of the window may also pose as a potential safety hazard if required for emergency egress from the building.

Generally, factors such as general age of the building element and a lack of maintenance are the usual causes for this type of defect.

Replacement of window hardware or frame may be required, as well as minor repairs and cleaning. A registered builder or general handy person will be required to repair the affected windows.

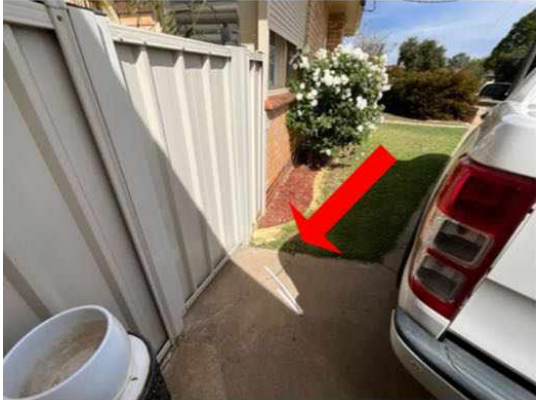
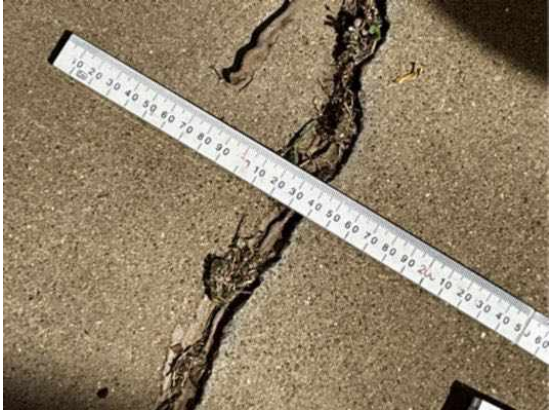
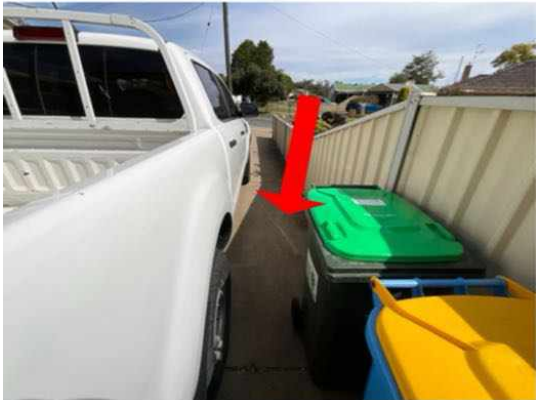
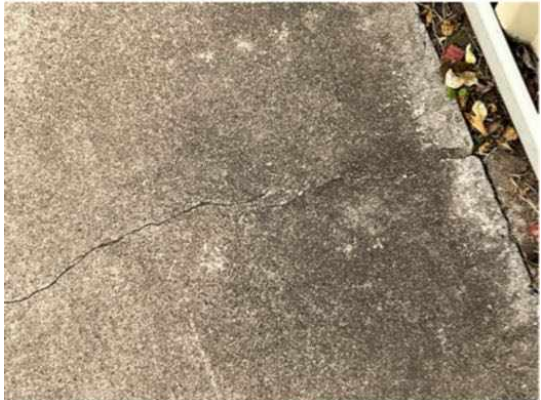
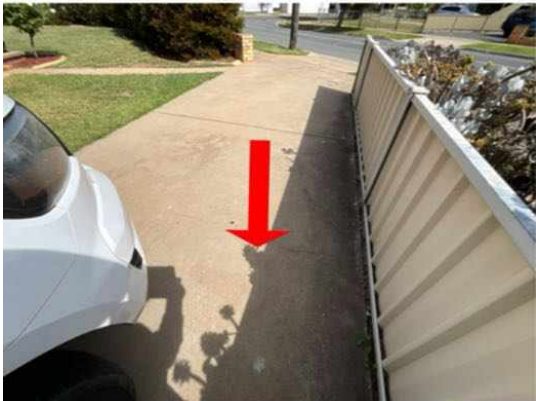
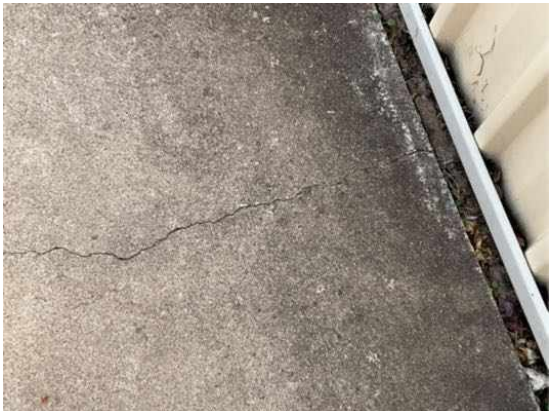
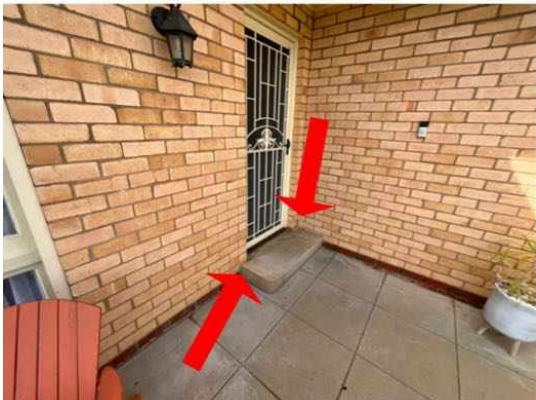
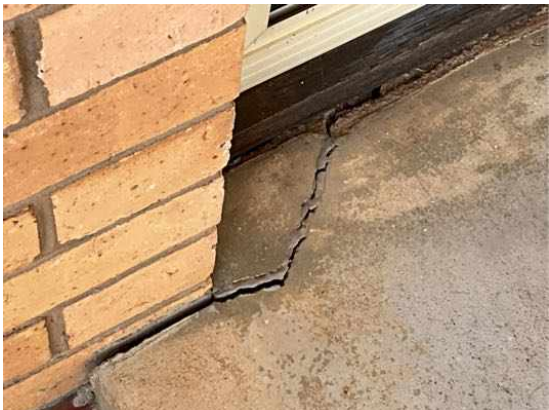
Finding 3.04

Building:	Building 1
Location:	Driveway, entry
Finding:	Cracking - External Concrete Paving Damage Category 2 - Distinct (less than 3mm)
Information:	Distinct cracks were identified in external concrete paving. Distinct cracks are generally found in older concrete paving, and may also present as a trip hazard as consequence of an uneven or curved surface.

General age and expected deterioration of the paved areas is a common cause of this type of cracking. However, expansion and contraction of the slab may also have occurred due to environmental factors. Such factors include variable moisture and weather conditions, the presence of trees and their roots having a settling or lifting affect on the soil, or the effect of load bearing, e.g. heavy vehicles over a sustained period of time.

Cracking to this degree may also be due to poor original installation of the concrete. Factors such as poor compaction of the sub surface and/or inadequate reinforcing of the slab may create cracking and other secondary defects.

Repairs are likely to be required to prevent further cracking and to reduce hazards associated with cracking, such as tripping. Monitoring of all cracking should be conducted frequently. Always contact a building inspector should cracks widen, lengthen, or become more numerous.

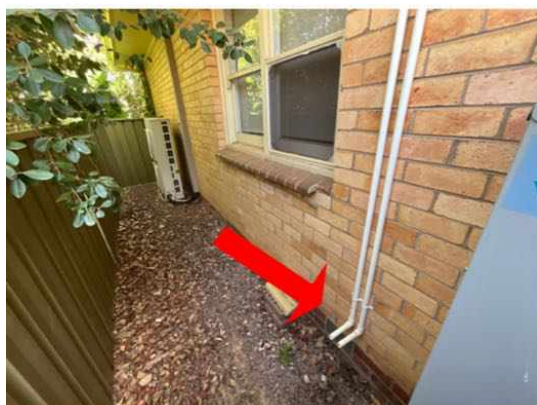
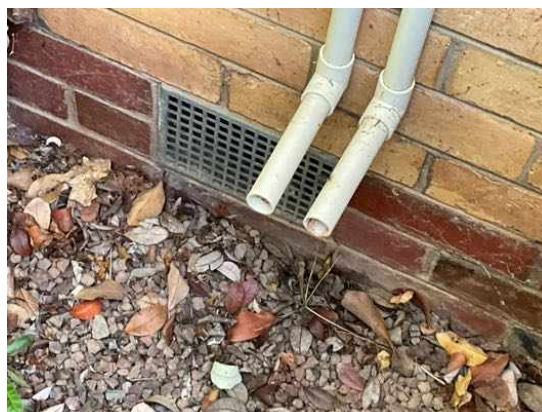
Finding 6.01

Building: Building 1
 Location: Yard - Side
 Finding: Air conditioner - Disconnected overflow
 Information: The Air Conditioner (A/C) overflow was found to be disconnected from storm water drainage and is creating excessive moisture in the surrounding area.

Such leaking creates an environment which is conducive to an array of defects, including water damage to associated building elements and the attraction of termite or timber pest infestation.

It is highly recommended that a licensed plumber be appointed to connect the A/C overflow in order to prevent such an environment from being created. These minor works should be carried out as soon as possible.

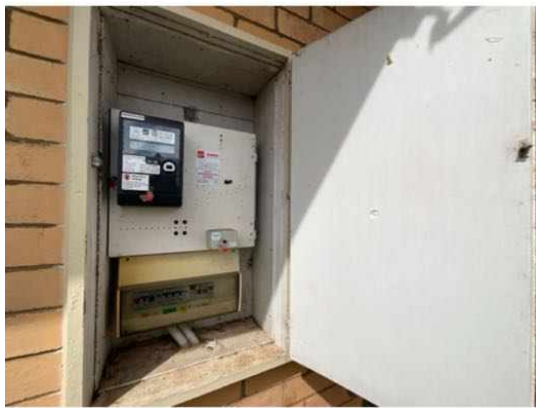
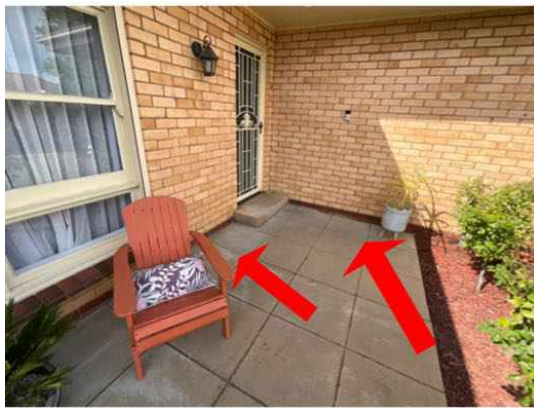
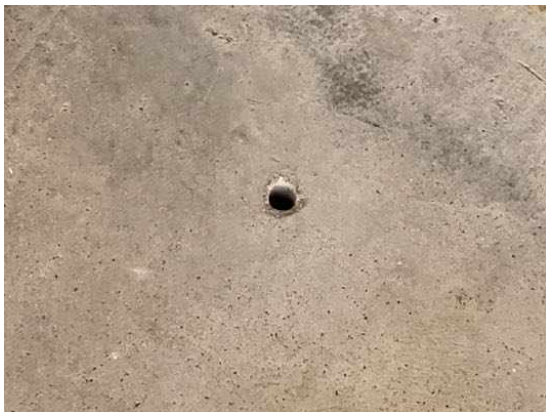
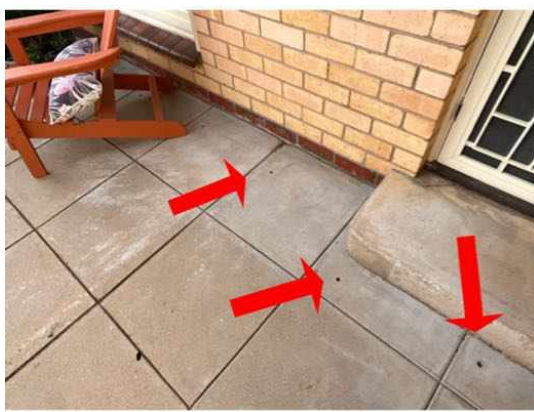
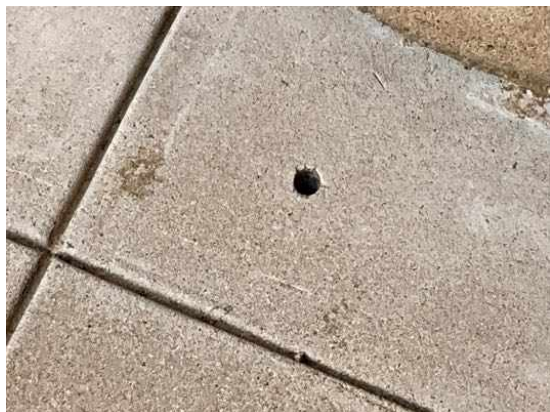
Finding 6.02

Building: Building 1
 Location: All External Areas
 Finding: Termite Management System - no evidence of a chemical installation
 Information: The application of a post-construction chemical termite barrier is highly recommended for all properties, particularly if live termite activity has been found on the site previously. Such barriers are highly effective in preventing termite attack on any timber

building elements throughout the property.

A durable notice should be placed in the switchboard unit to indicate current termite barriers. At the time of inspection, it appeared as though no termite management system has been installed, with no evidence to suggest preventative works taking place.

The drill holes may be part of a previous termite treatment. However, the holes appear to be too far apart for current termiticide methods. They may alternatively be underpinning work for the patio area.

The client may consider gaining further advice from a pest controller as to the costs and procedures involved with this application. It is recommended that obtaining such advice be a short-term priority.

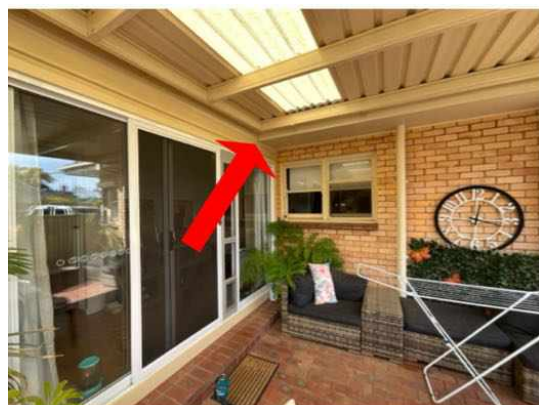
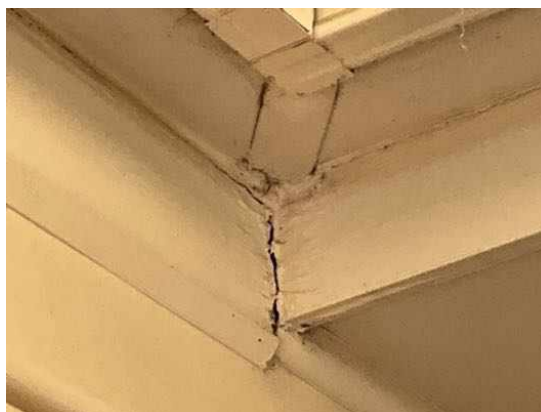
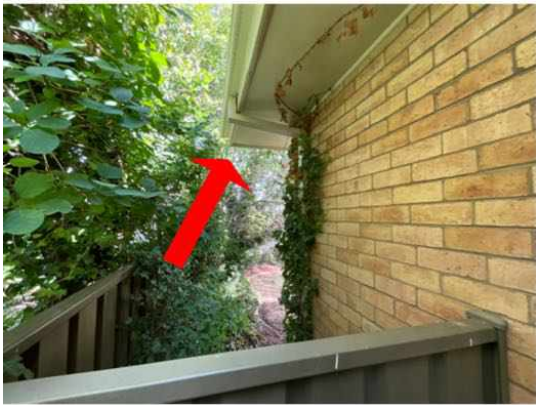
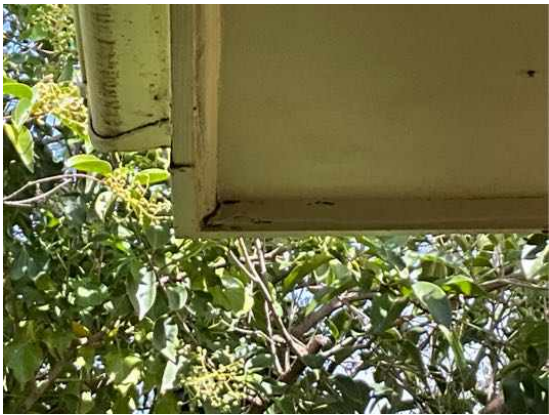
Finding 7.01

Building:	Building 1
Location:	Eaves
Finding:	Fungal decay - present (localised)
Information:	Fungal decay also known as wood decay or wood rot generally refers to the deterioration of timber elements when in contact with excessive levels of moisture for a prolonged period of time.

The development of fungal decay is accelerated by temperatures in the range of 5degreeC to 40degreeC as well as the presence of oxygen. Generally fungal decay develops on timber elements that are in use in an external environment which are exposed to rain penetration.

In this case although the affected timber element is in a decaying state the extent of any visible damage appears to be localised to a specific area and is yet to spread to other parts of the building element or affect adjoining structures. The fungal decay is therefore likely to be of a relatively superficial nature with minimal impact on the structural integrity or tensile strength of the timber element.

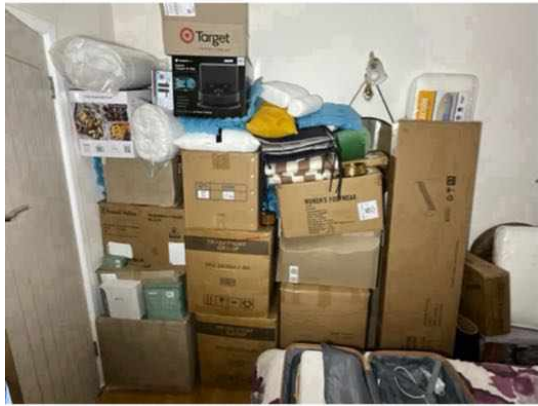
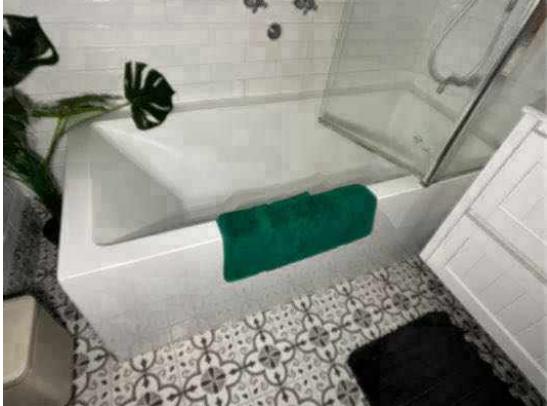
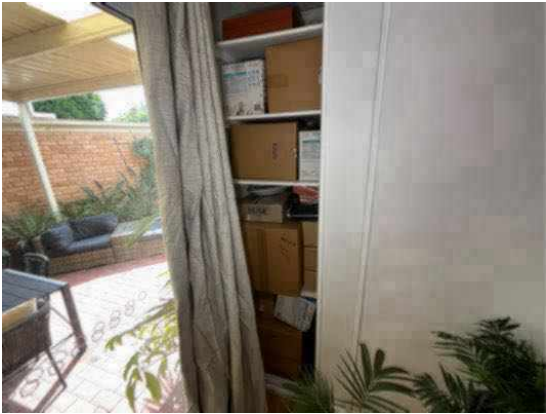
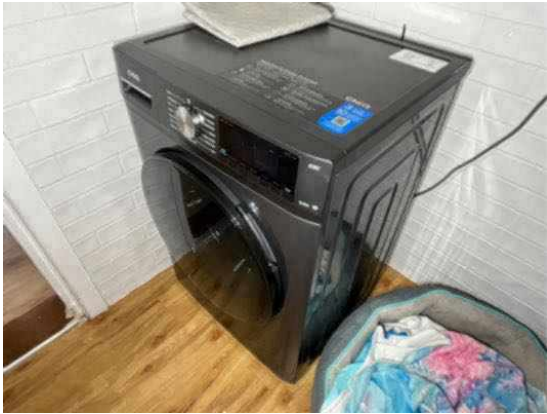
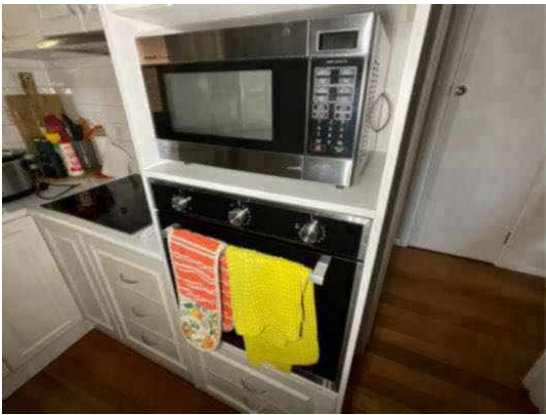
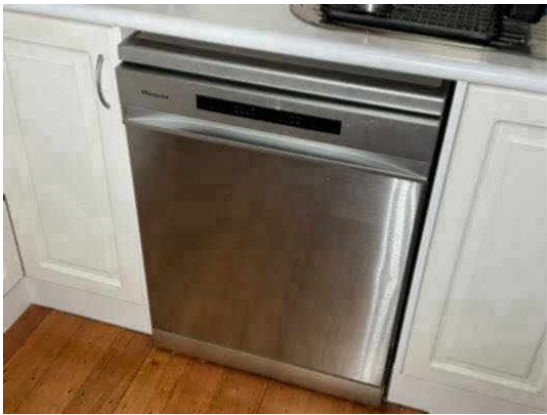
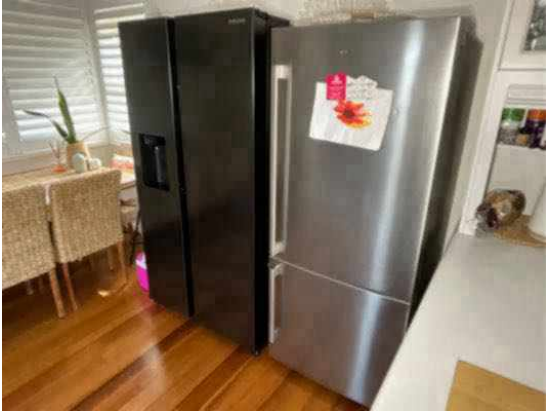
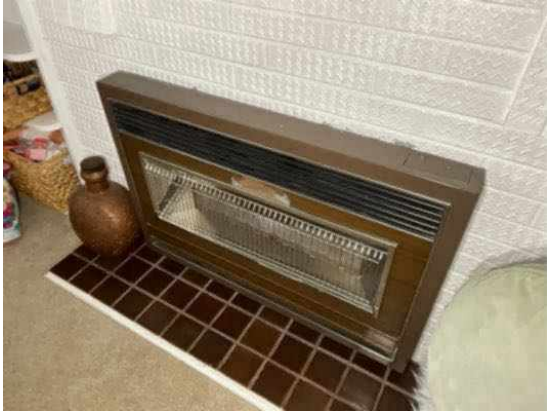
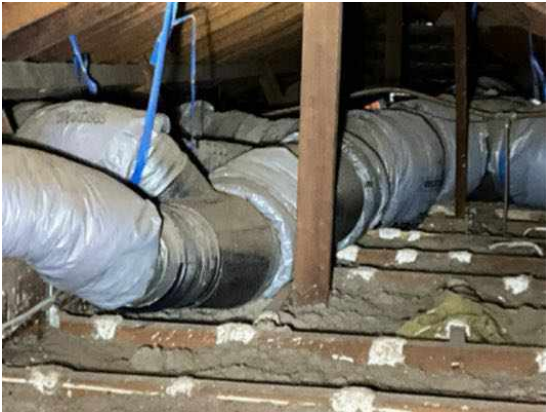
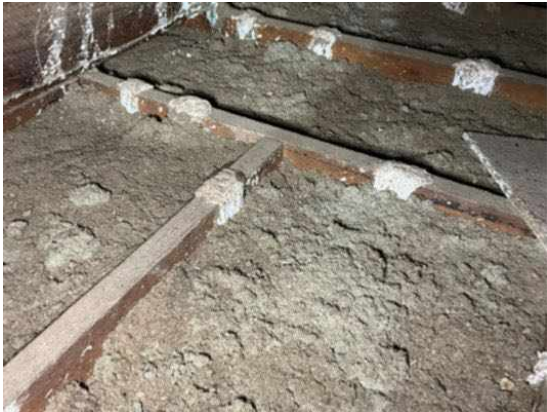
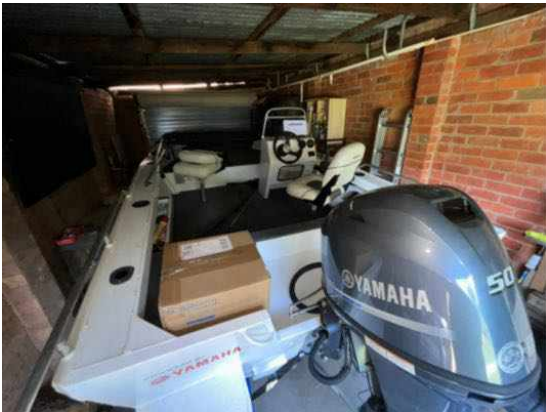
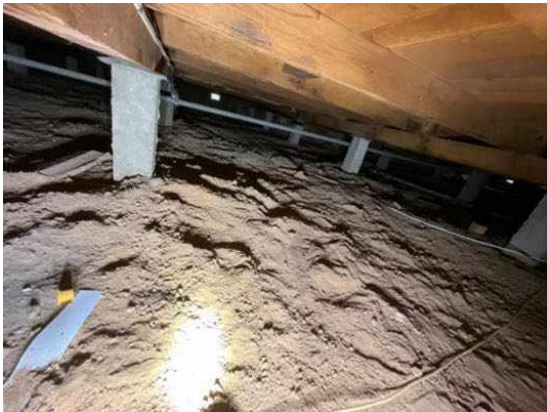
Noted Item

Building: Building 1
Location: All Areas
Finding: Additional Photos - Obstructions and Limitations
Information: These photographs are an indication of the obstructions and limitations which impeded full inspection of the property at the time of inspection. These obstructions can hide an array of defects and should be removed to allow full inspection to be carried out. A re-inspection is recommended once the areas are made accessible.
