# Building and Timber Pest Inspection Report

Inspection Date: Tue, 17 Mar 2026

Property Address: 25 Jacob Cres, Glenroy NSW 2640,  
Australia

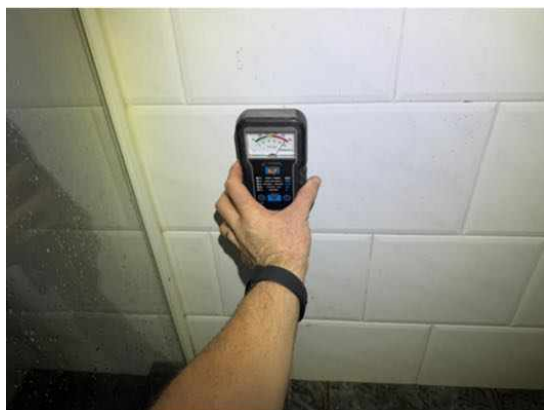
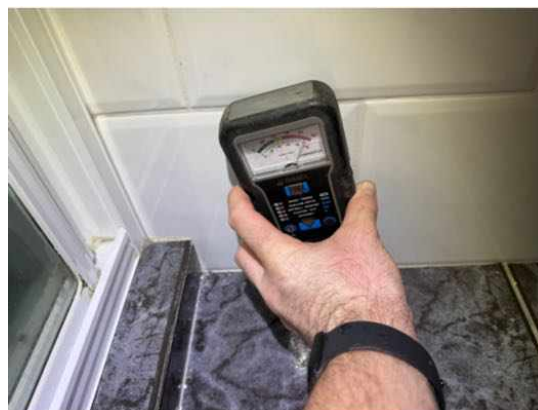
#### Finding 3.01

Building: Main Building  
 Location: Ensuite Shower  
 Finding: Shower - High Moisture  
 Information: It appears that high moisture is present at but not limited to, the base of the ensuite shower walls. Potential causes of leaking include but are not limited to loose or damaged plumbing fittings and fixtures, and/or deteriorated seals.

Areas of leaking and high moisture create an environment conducive to termite activity. Recommend engaging a licensed plumber promptly, to identify the cause of the moisture and provide remedial works where necessary.

Evidence of high moisture was identified at, but not limited to the base of the ensuite shower walls. Recommend engaging a licensed plumber promptly, to identify the cause of the high moisture & provide remedial works where necessary.

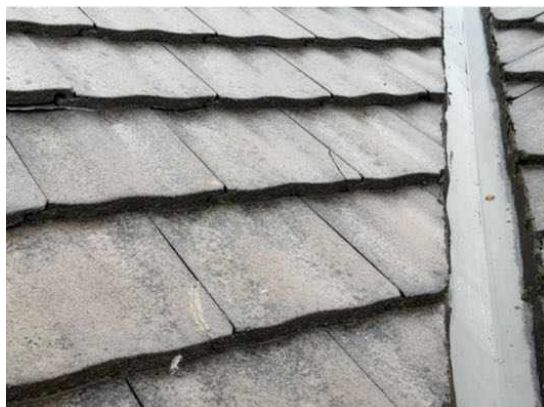
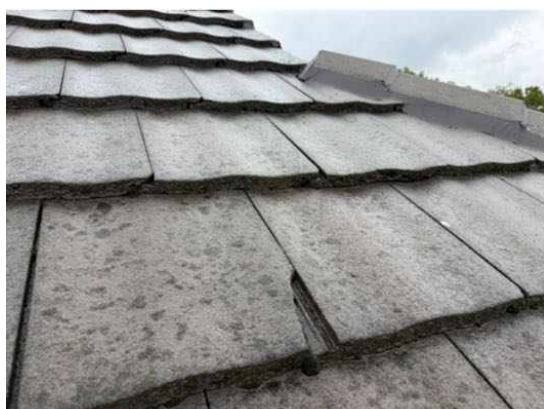
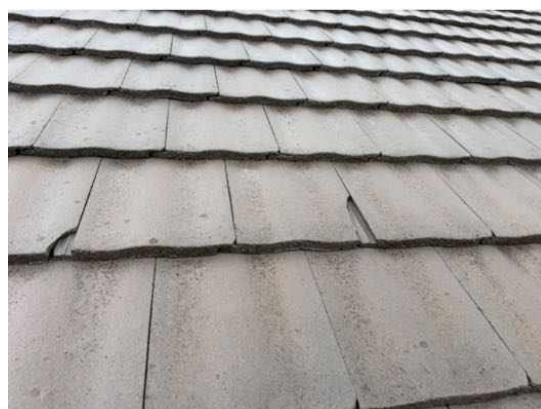
#### Finding 3.02

Building: Main Building  
 Location: Roof Exterior  
 Finding: Roof Exterior - Chipped Roof Tiles  
 Information: Areas of chipped roof tiles were identified to the roof exterior. While weathering of the tiles is consistent with the age of the property, maintenance works are advised.

Where left unmanaged, deteriorating and damaged roof tiles are likely to lead to secondary defects, including water leaks.

Several cracked and chipped roof tiles were identified to the roof exterior. Recommend consulting with a licensed roofing contractor in the short term, to provide maintenance works where necessary.

Recommend consulting with a licensed roofing contractor in the short term, to provide further advice on maintenance works needed.

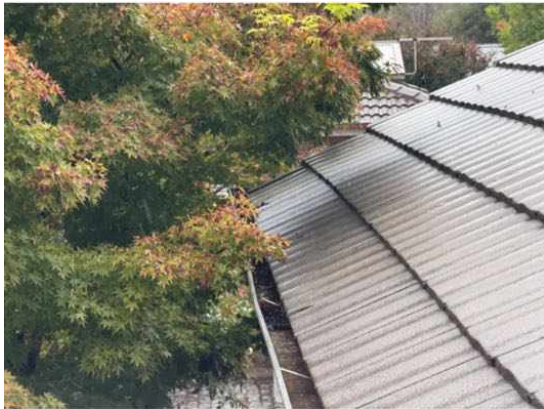
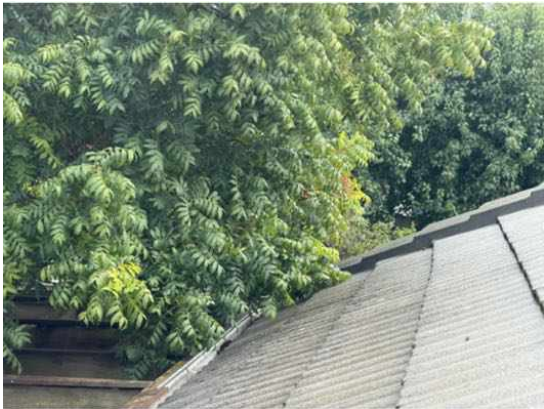
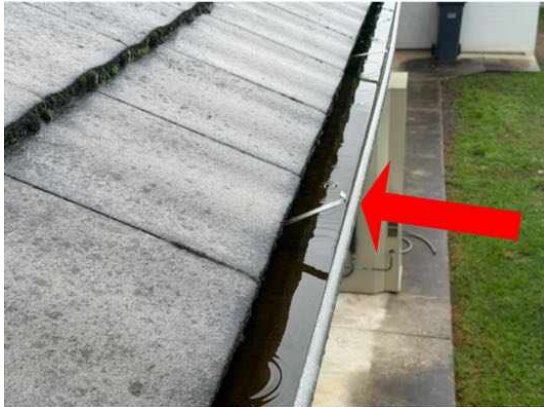
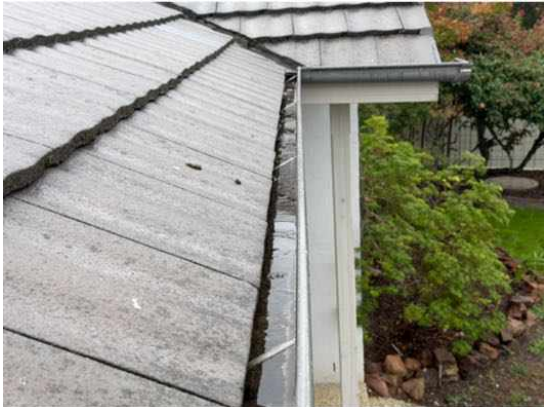
### Finding 3.03

Building:	Main Building
Location:	Guttering
Finding:	Gutters - Debris & Water pooling
Information:	Water pooling and debris were noted in sections of the guttering at the time of inspection, likely due to sagging of the gutters. A loose clip was also noted.

Recommend engaging a licensed roof plumber in the short term, to provide further advice & maintenance works to ensure adequate roof drainage is achieved. All debris and overhanging vegetation should be cleared to ensure proper drainage and prevent overflows.

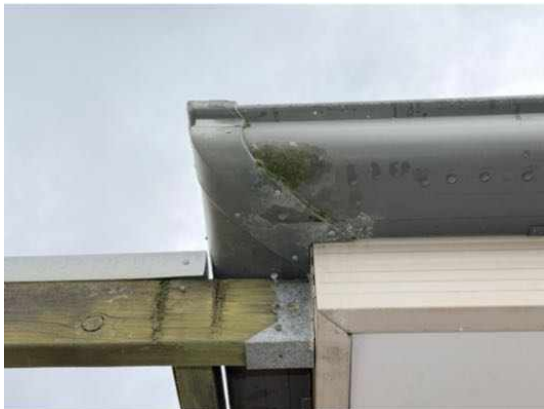
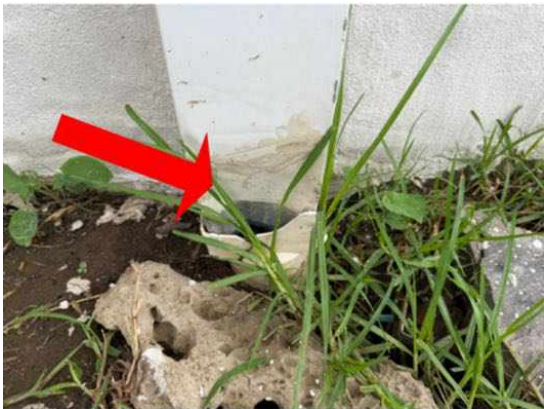
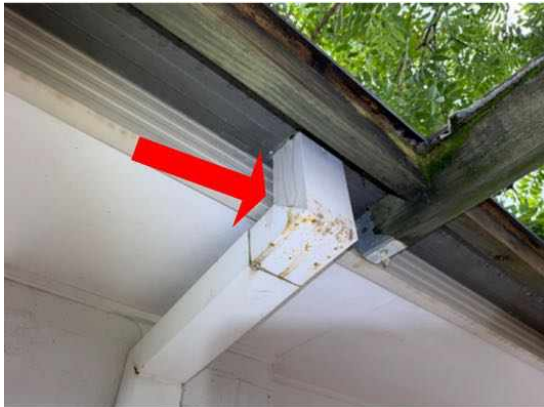
**Finding 3.04**

Building: Main Building  
Location: Gutters & Down-pipes  
Finding: Roof Plumbing - Evidence of leaking / damage  
Information: It appears that areas of the roof plumbing showed signs of leaking and surface rust. The base of a down-pipe was also found to be damaged.

Recommend engaging a licensed roof plumber, in the short term to provide maintenance works where necessary.

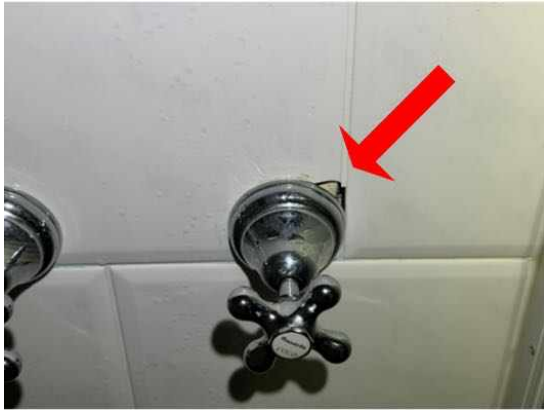
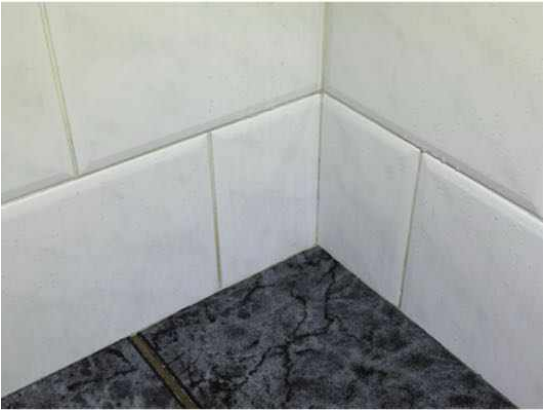
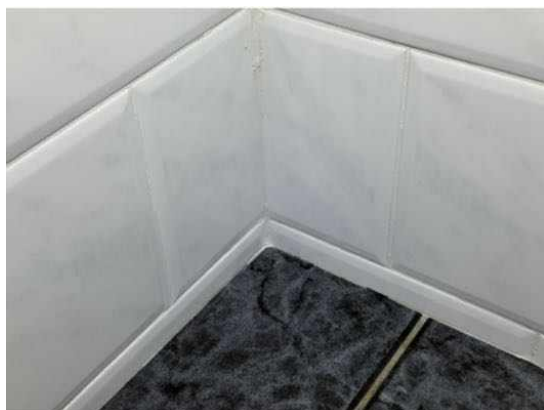
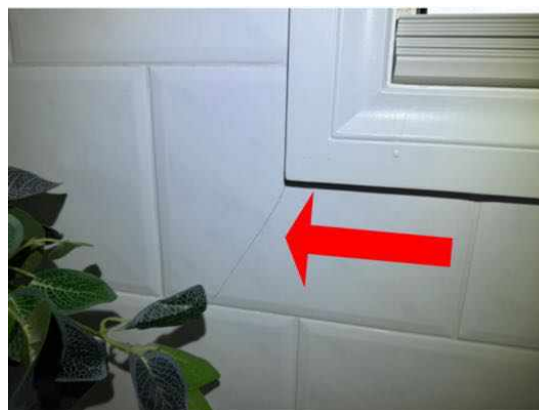
**Finding 3.05**

Building: Main Building  
Location: Tiled Areas  
Finding: Sealant / grouting - deteriorated or missing & Cracked Tile  
Information: It appears that the sealant and grout has weathered/deteriorated in some tiled areas, a common defect in buildings of a similar age. A cracked tile was also noted to the bathroom.

Sealant and grouting in areas that come into regular contact with water should be maintained for the long term care of your property.

Recommend engaging a licensed tiling contractor in the short term, to provide maintenance works where necessary.

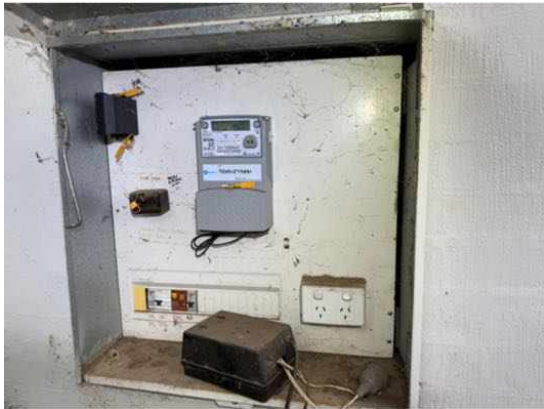
### Finding 6.01

Building: Main Building  
 Location: Switchboard  
 Finding: Termite Management System - no evidence of a chemical installation  
 Information: The application of a termite barrier is strongly recommended, as it appears no termite management system has been installed, with no evidence or durable notice to suggest works taking place. Generally, a durable notice is placed in the meter box to indicate current termite barriers.

Such barriers are highly effective in preventing termite attack on the building and therefore should be installed.

Recommend seeking further advice from a licensed pest controller.

Installation of a termite barrier is recommended as there was no evidence of installation of a previous termite management system. 12 monthly termite inspections, conducted by a qualified termite inspector are also advised. Recommend engaging a licensed pest controller, to provide further advice.

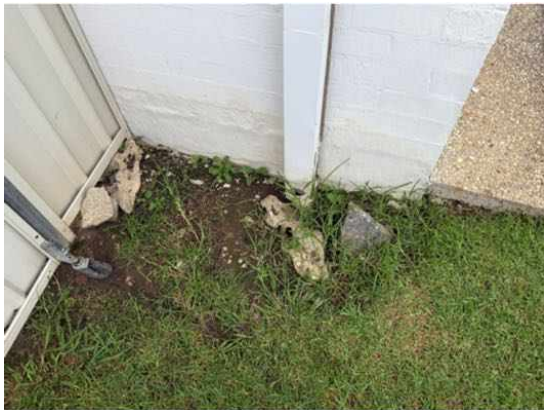
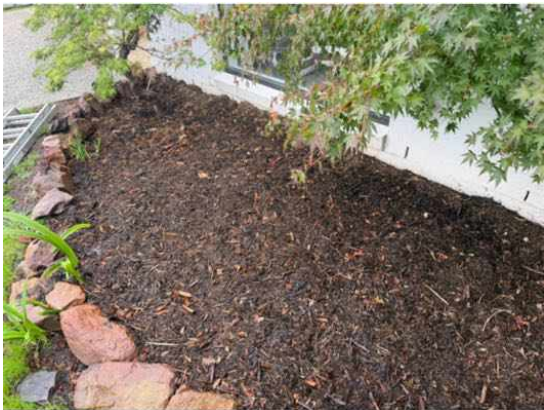
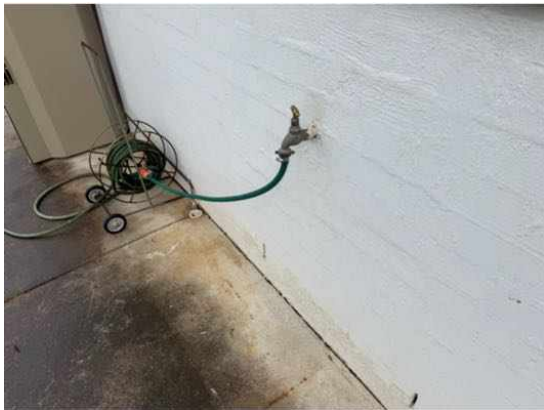
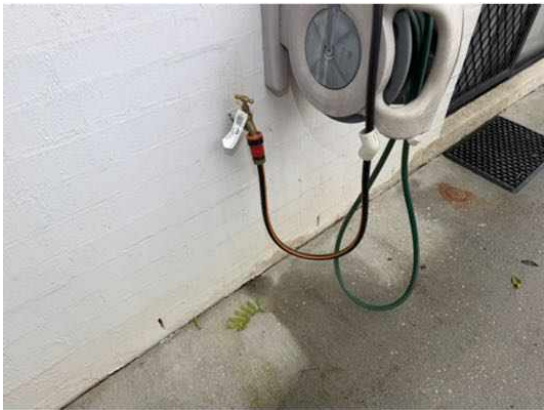
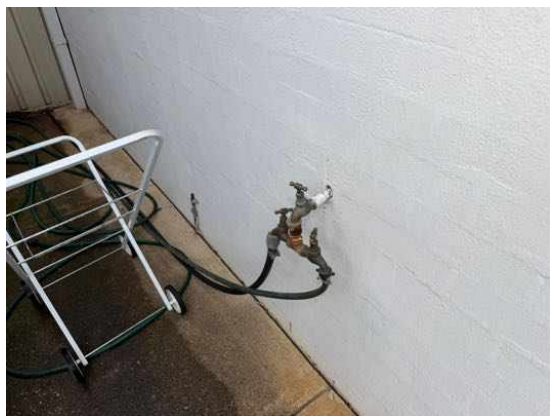
**Finding 6.02**

Building: Main Building  
Location: All external areas  
Finding: Potential Water pooling - against property  
Information: Potential areas of water pooling around the perimeter of the property were identified. Where insufficient site drainage, drainage of taps, and garden beds against the house are present, water pooling is likely to occur, and can create areas conducive to timber pests.

Recommend consulting with a licensed plumber and/or landscaping contractor to provide further advice.

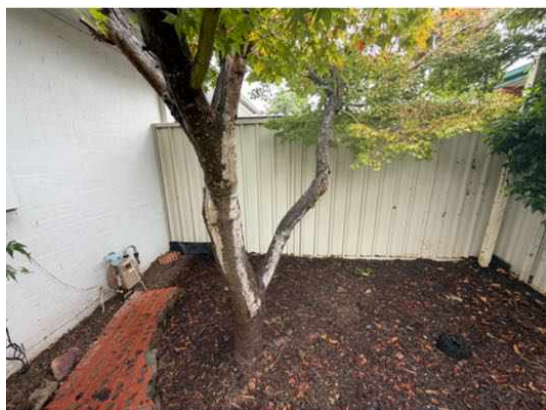
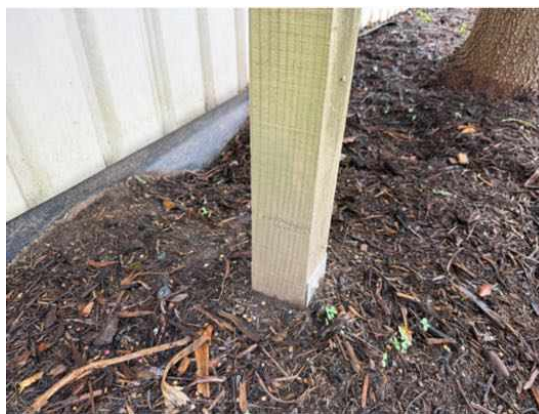
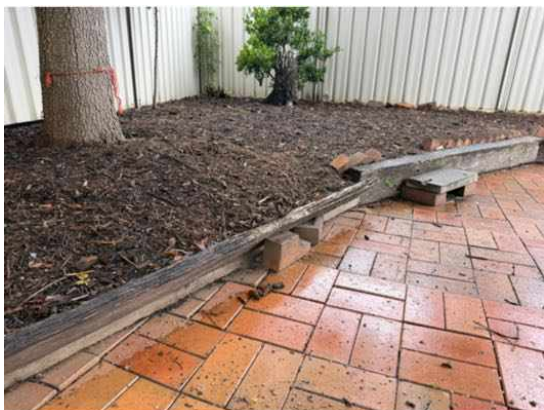
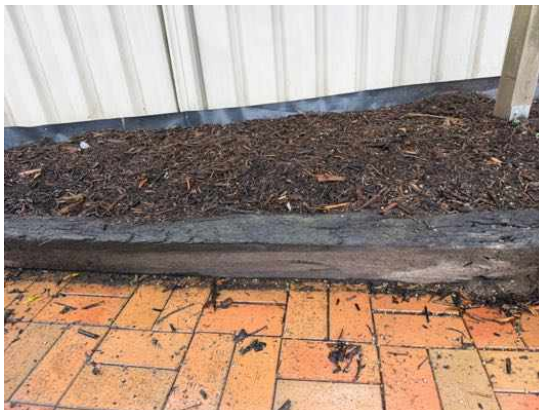
### Finding 6.03

Building:	Main Building
Location:	All External Areas
Finding:	Timber in direct ground contact & trees - conducive to termites
Information:	Where timber materials are in direct contact with the ground and consequently moisture, they become conducive to termite activity. The tree stumps, landscaping timbers, and trees surrounding the building create an environment conducive to termite activity.

Where feasible, any timbers in direct contact with the ground should be removed and any trees in close proximity to the building should be removed or test drilled (inspected) at least annually to reduce the risk of termite infestation & detect any early signs of termite activity.

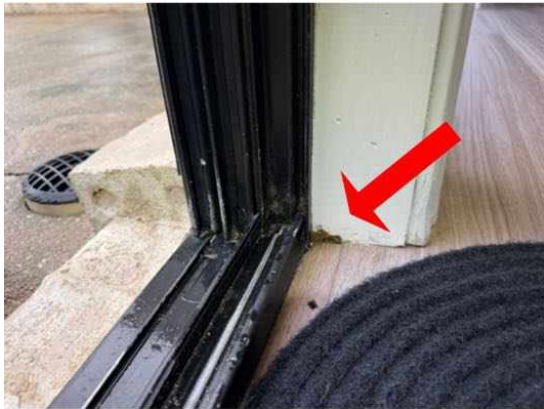
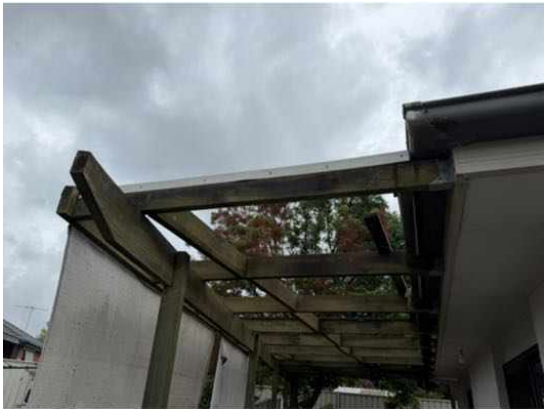
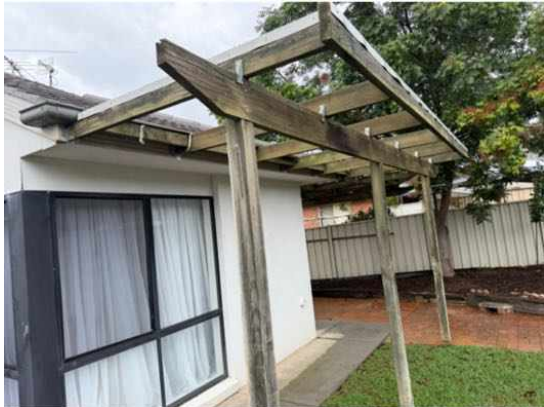
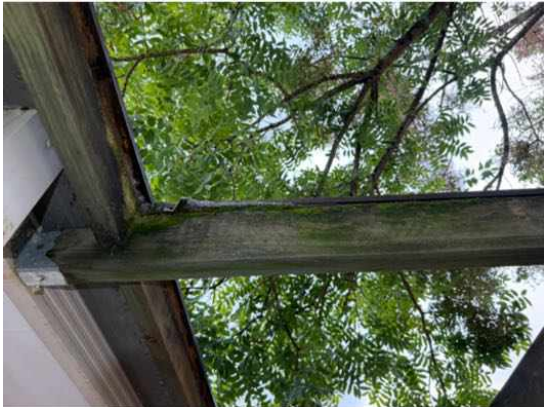
### Finding 7.01

Building:	Main Building
Location:	Patio framing, door frame
Finding:	Fungal decay & weathering
Information:	Areas of fungal decay (wood rot) were identified at but not limited to the dining room door frame, and the patio/verandah framing.

For areas of fungal decay, the client can engage a licensed carpenter at their discretion to replace affected materials. For areas of general weathering, it is advised the client engage a licensed painter to apply protective sealant or coating to areas of weathered external timbers.

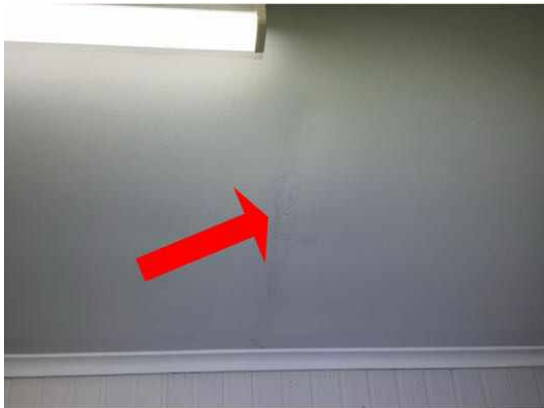
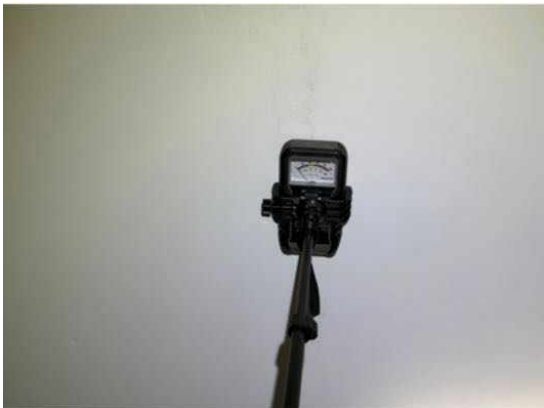
Building: Main Building  
 Location: Garage ceiling, beneath laundry & kitchen sink  
 Finding: Water Staining Present  
 Information: It appears that water staining was present at but not limited to, the garage ceiling and beneath the laundry & kitchen sink. Potential causes of leaking include deteriorated roof cladding or damaged plumbing fittings and fixtures.

No high moisture was evident in these areas at the time of inspection. Recommend that the client monitor these areas. Should leaking persist or return, a licensed plumber should be engaged promptly, to provide remedial works.

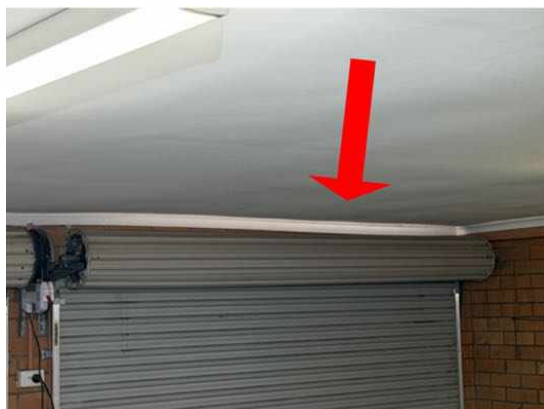
Building: Main Building  
 Location: Garage  
 Finding: Garage Ceiling - Sagging  
 Information: Sections of the garage ceiling appeared to be slightly sagging. Causes of ceiling sagging include fixings (e.g. nails or glue) that have become loose and require re-fixing. Recommend that the client monitor the sagging.

Should the sagging develop, a licensed plasterer should be engaged to provide maintenance works where necessary.

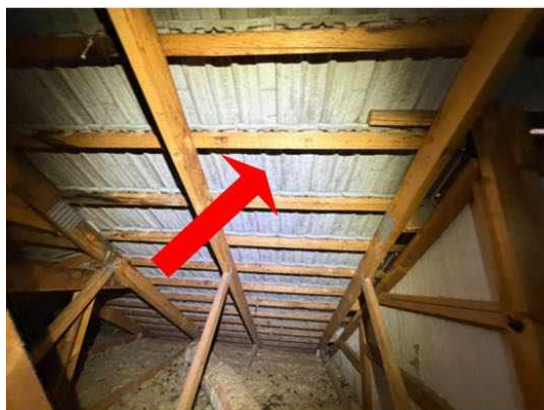
Building: Main Building  
 Location: Roof Void  
 Finding: Sarking - Not Present  
 Information: It is noted for your information that sarking has not been installed on the roof. Sarking is a laminated aluminium foil applied to the interior of the roof covering, assists in insulating the property and acting as a vapour-barrier to the roof void.

The client can consult with a licensed roofing contractor at their discretion, to provide further advice.

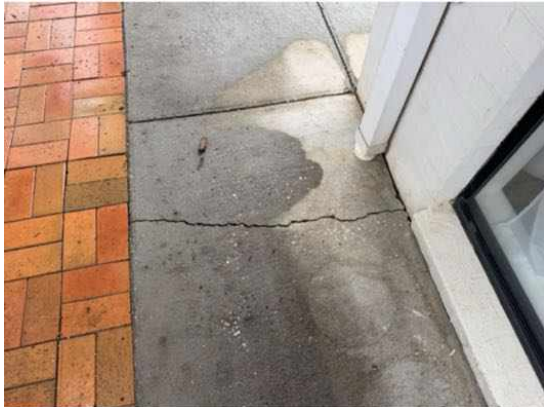
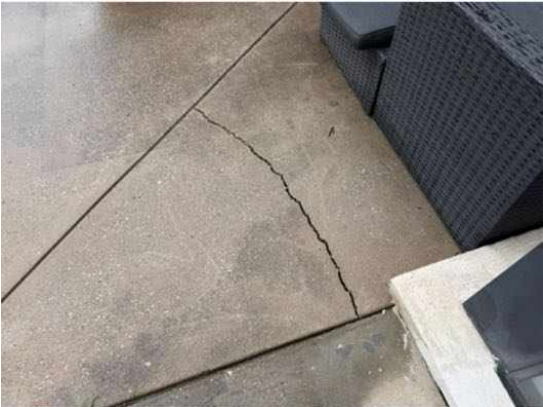
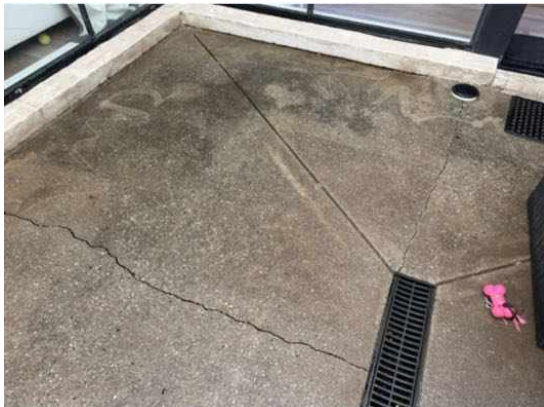
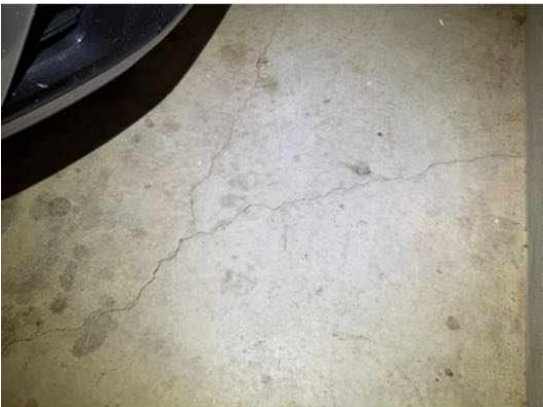
Building: Main Building  
Location: Pavement & Garage  
Finding: Cracking - Pavement & Garage Slab  
Information: It was noted there is cracking in areas of the pavement and garage slab. Cracks in the pavement and slabs are a common occurrence in houses of a similar age. Recommend that the client monitor the cracking. A concrete specialist can be engaged at clients discretion, should cracks widen, lengthen, or become more numerous.
