Building and Timber Pest Inspection Report VR

Inspection Date: Fri, 13 Feb 2026

Property Address: 108 Bilga Cres, Malabar NSW 2036,
Australia

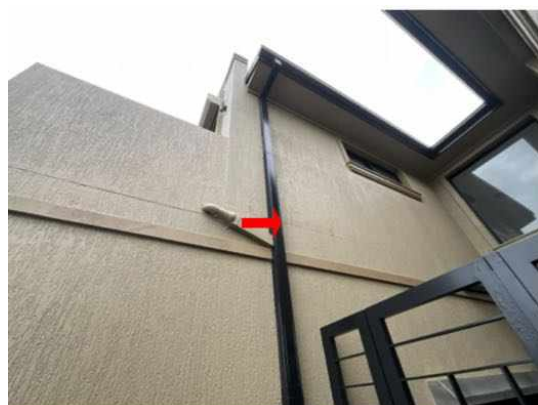
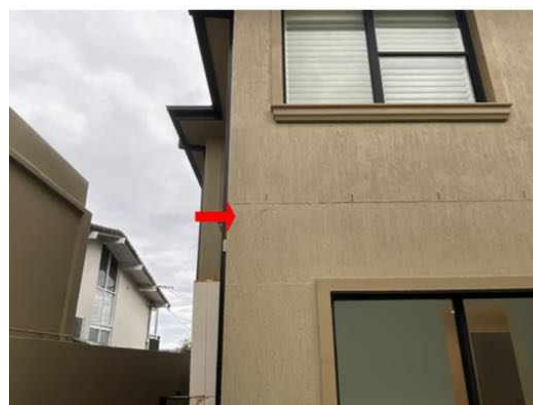
Finding 3.01

Building:	Main Building
Location:	Exterior walls
Finding:	Cracking - Damage Category 2 - Noticeable (up to 5mm)
Information:	Noticeable cracks are a common occurrence as a result of many primary defects. Such causes may include age, general wear and tear, expected building movement, general expansion/contraction of building materials in different weather conditions, and/or minor failings in the installation or application of building materials.

I recommend monitoring and if further cracking is evident appoint a bricklayer to see what works are required.

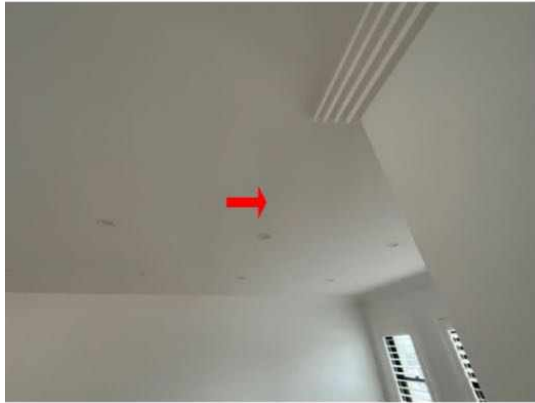
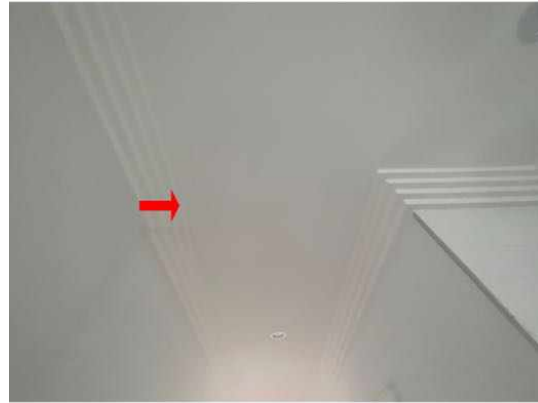
Finding 3.02

Building:	Main Building
Location:	Internal Areas >
Finding:	Cracking - Damage Category 1 - Fine (up to 1mm)
Information:	Although fine cracks are quite noticeable, they are often only considered to be an appearance defect, and usually do not indicate any structural damage. Generally, the cause of a fine crack is indicative of a separation between building materials and finishes (e.g. paint, plaster, etc.) along joins.

Cracking of this nature can generally be repaired with minor sanding, filling and/or repainting. Such works should be performed by a qualified painter or a general handyman.

Monitoring of all cracking should be conducted frequently. Always contact a building inspector should cracks widen, lengthen, or become more numerous.

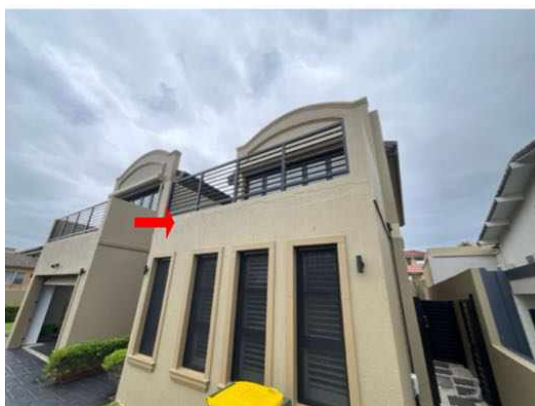
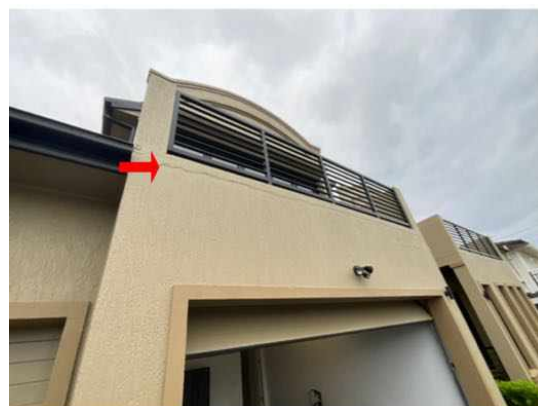
Finding 3.03

Finding: Render - Drummy

Information: Drummy rendered areas were identified at the time of inspection. The term 'drummy' refers to render that has become detached from its fixing, despite it still being solid. Such defects are generally caused by physical or moisture damage to the area. Drummy render may also be a direct result of poor workmanship during the construction process.

Render may swell and shrink with changes in air humidity if the area has sustained moisture damage. Any exposure to moisture is capable of causing rendered areas to become drummy and/or cracked over a prolonged period of time. Drummy render generally requires chipping off and re-rendering or painting.

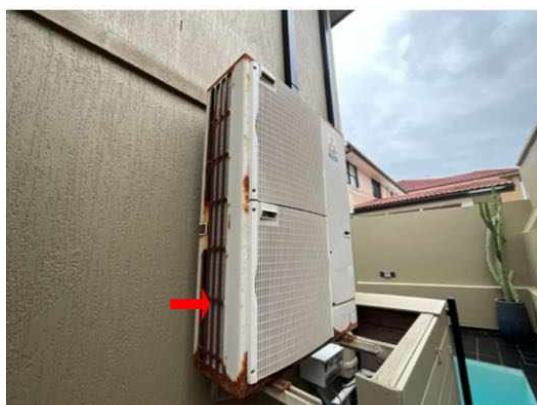
Finding 3.04

Building:	Main Building
Location:	External Areas
Finding:	Building element - Rusted or corroded
Information:	This building element shows evidence of rusting and corrosion, which is likely to have developed as a result of excessive exposure to moisture and or inadequate coatings.

As surface rust provides no protection to the underlying iron, the deteriorating condition is likely to worsen if not addressed in the short-term future.

Where possible, the use of galvanized (treated) metals or aluminium coated metals aid in rust prevention, as does regular general maintenance. Rust formation can be controlled with coatings, such as paint, that isolate the iron from the environment.

Rusting and corrosion should be managed by ideally removing or limiting the affected surface from exposure to moisture.

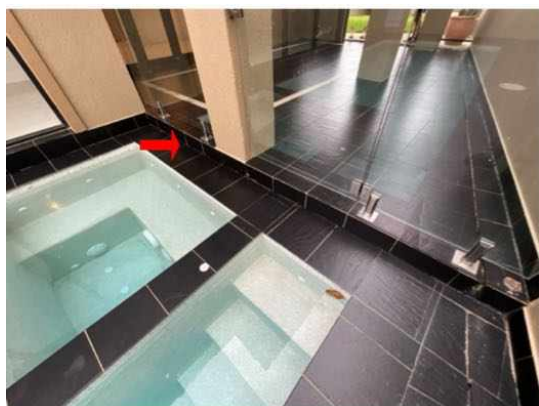
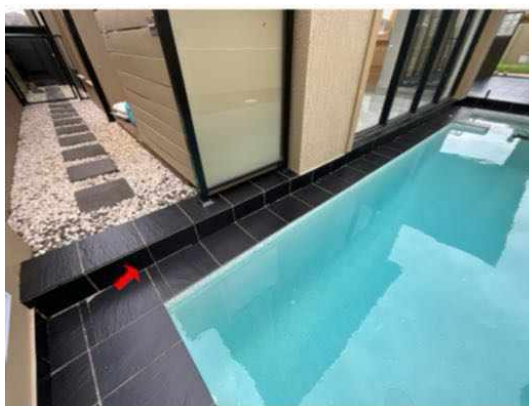
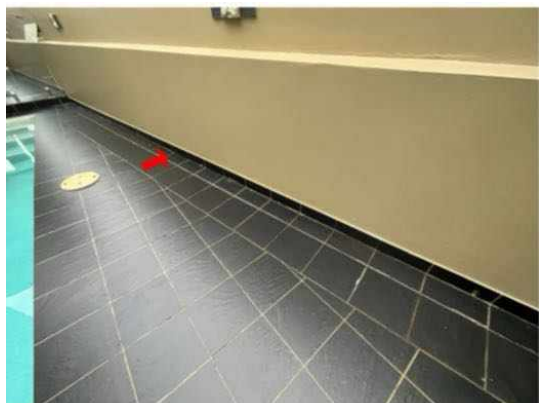
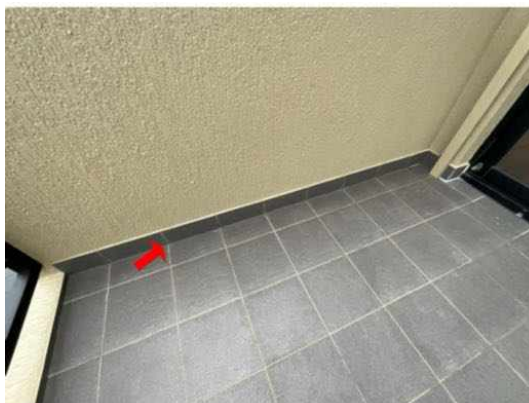
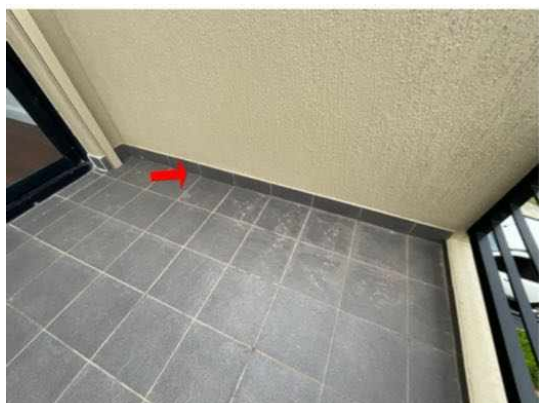
Finding 3.05

Building:	Main Building
Location:	Pool Area & Balcony
Finding:	Sealant - Not installed
Information:	There was no sealant installed in this area.

I recommend appointing a handyman to see what necessary works are required.

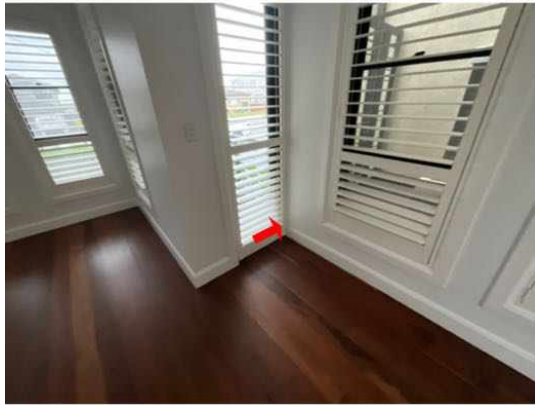
Finding 3.06

Building:	Main Building
Location:	Bedroom
Finding:	Damp - Rain penetration
Information:	Rain penetration (also known as penetrating damp) is a common form of dampness that can occur through walls, roofs or openings (e.g. windows).

Common causes include faulty or missing flashing, lack of sealant and lateral damp.

The cause of the water leak should be addressed to prevent further damage. It is recommended that the water leak be resolved prior to any repairs of the damaged area, which may require localised replacement of building materials and refinishing.

I recommend appointing a builder to see what necessary works are required.

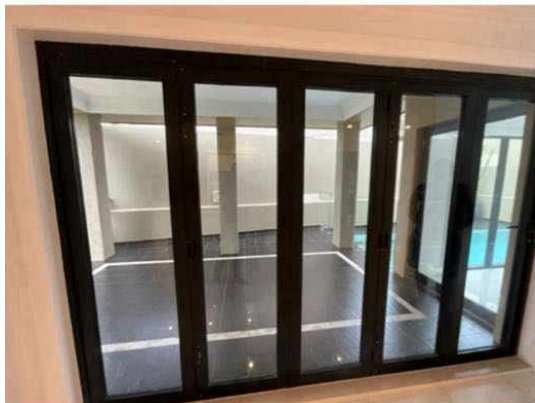
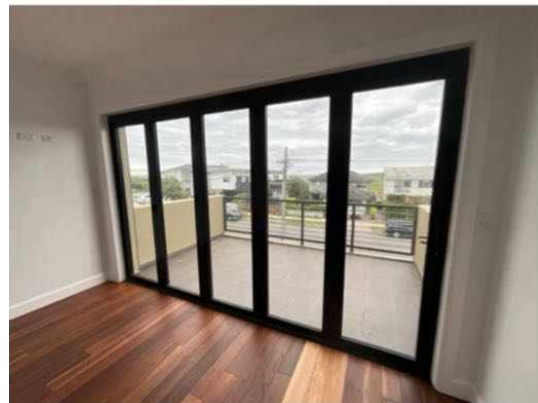
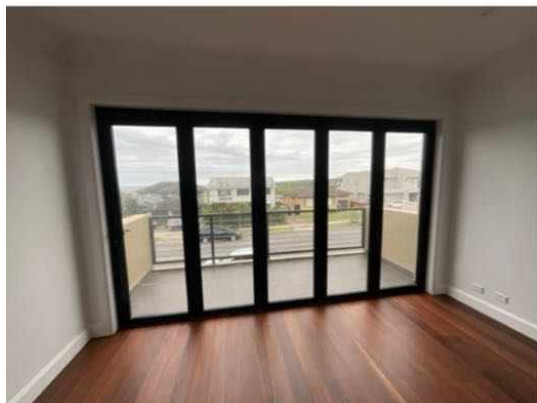
Finding 3.07

Building:	Main Building
Location:	Lounge Room & Bedrooms
Finding:	Deteriorated Bifold Door Hardware
Information:	The hardware to the bifold door is showing signs of deterioration in areas, including wear and corrosion.

Deteriorated hardware may affect the smooth operation and alignment of the door and could lead to further mechanical failure if not addressed.

The bifold door hardware should be inspected and repaired or replaced as required to ensure proper and safe operation.

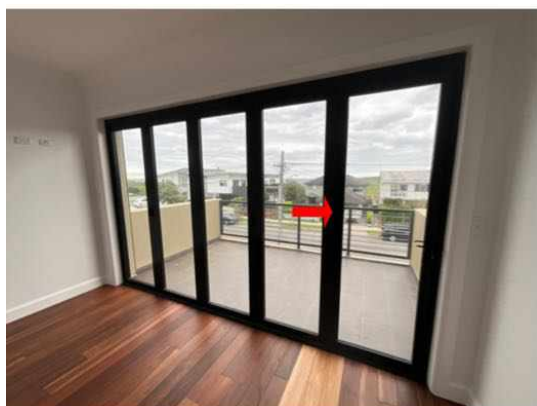
Finding 3.08

Building:	Main Building
Location:	Bedroom
Finding:	Aluminium Door - Binding/jamming
Information:	Binding and/or jamming of this door is evident during standard operation. This defect inhibits the functionality of the affected door as well as creating potential for secondary defects to associated building elements, such as damage to the floor covering.

For minor causes, a qualified carpenter or general handyperson should be appointed to perform minor rectification works at client discretion.

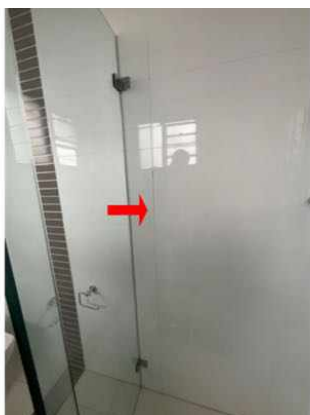
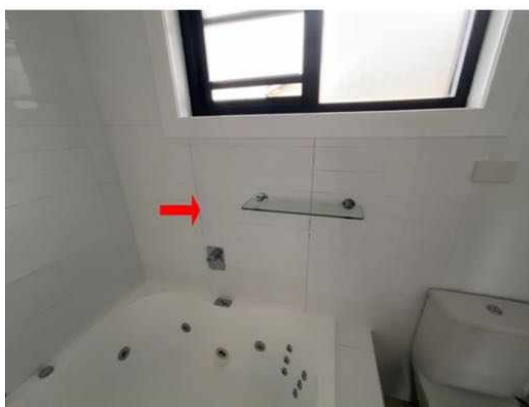
Finding 3.09

Building:	Main Building
Location:	Ensuite & Bathroom
Finding:	Grout - Missing
Information:	Grout is missing in this area. Grout is used to protect gaps and crevices in building materials to ensure that they are water-tight and prevent water penetration to the associated structures.

Where grout is missing, a tiling contractor should be appointed to apply grout and re-apply any silicone where necessary. Failure to do so is likely to lead to water damage

to the surrounding area.

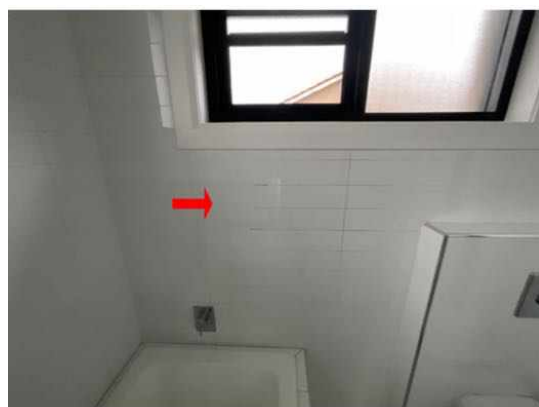
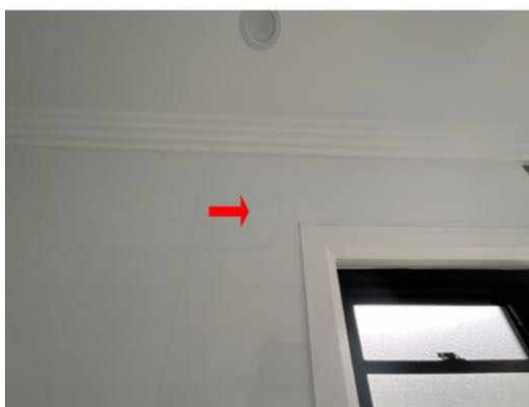
Finding 3.10

Building:	Main Building
Location:	Ensuite
Finding:	Tile - Cracked or damaged
Information:	Cracking was evident to the tiling in this area at the time of inspection.

I recommend appointing a tiling contractor to see what necessary works are required to replace any damaged tiles.

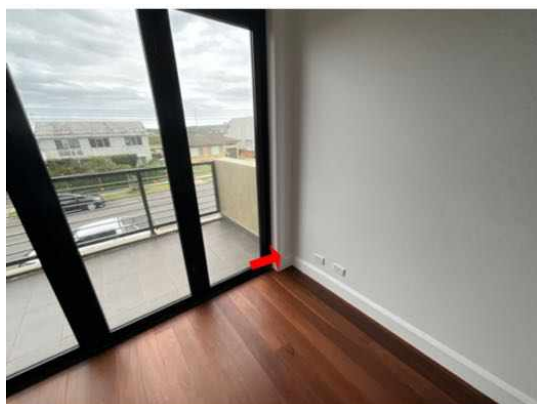
Finding 3.11

Building:	Main Building
Location:	Bedroom - Master
Finding:	Damp - Rain penetration
Information:	Rain penetration (also known as penetrating damp) is a common form of dampness that can occur through walls, roofs or openings (e.g. windows).

Common causes include faulty or missing flashing, lack of sealant and lateral damp.

The cause of the water leak should be addressed to prevent further damage. It is

recommended that the water leak be resolved prior to any repairs of the damaged area, which may require localised replacement of building materials and refinishing.

I recommend appointing a builder to see what necessary works are required.

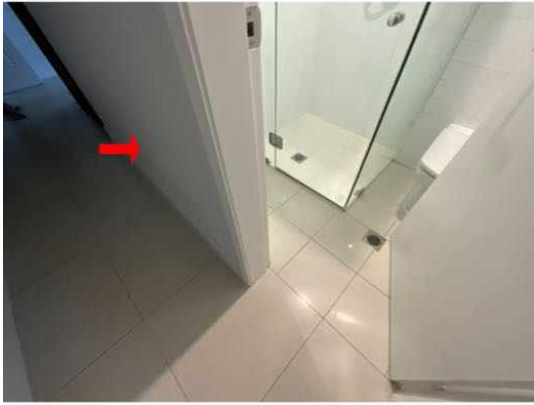
Finding 3.12

Building:	Main Building
Location:	Bathroom (Lower Level)
Finding:	Shower - Damp
Information:	Damp is evident to the lower 300mm of wall to the shower alcove. This defect is quite common, and is suspected to have been caused by moisture permeating through the grouting in this area, which shows evidence of deterioration.

Damp (or structural damp) refers to the presence of unwanted moisture in the structure of a building, either as the result of intrusion from outside, or condensation from within the structure. In the shower area, internal water leaks or other sources of excessive moisture are generally the cause of damp.

Consultation with a qualified plumber or bathroom specialist is advised to identify the cause of damp and to perform remedial works as required.

Always ensure that sealant and grout is in good condition to prevent any moisture issues occurring in the future.

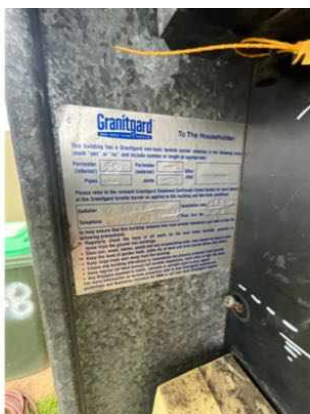
Building: Main Building
 Location: All Areas
 Finding: Evidence of a previous termite management system was identified
 Information: There are a number of factors which indicate the presence of a previously installed or applied termite barrier. The most common are a durable notice (to the inside of your meter box) observable physical barriers installed to building perimeter and in ground reticulation systems.

Where a Termite Management System has been identified you should refer to the type of barrier date of installation warranty conditions and any documentation provided by a builder or past owner. Consult the company who installed the barrier to confirm whether the system is still under warranty.
