## Building Inspection Report

Inspection Date: Wed, 25 Feb 2026

Property Address: a4409/1 Hamilton Cres, Ryde NSW 2112,  
Australia

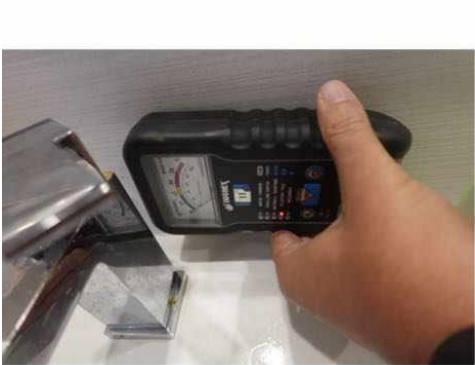
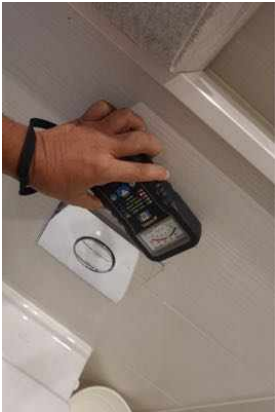
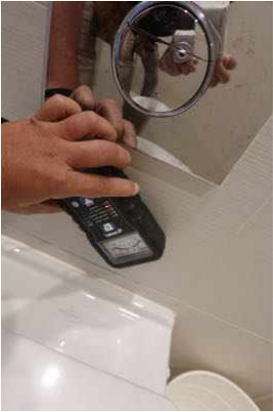
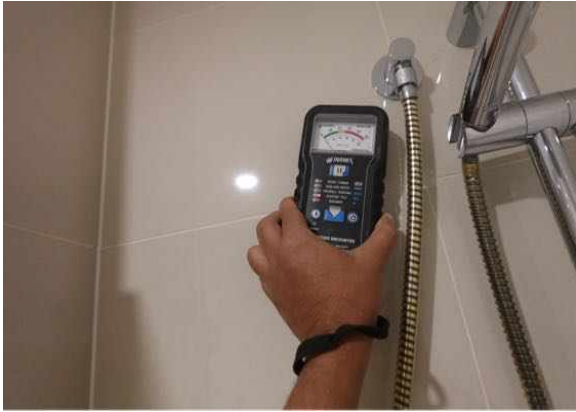
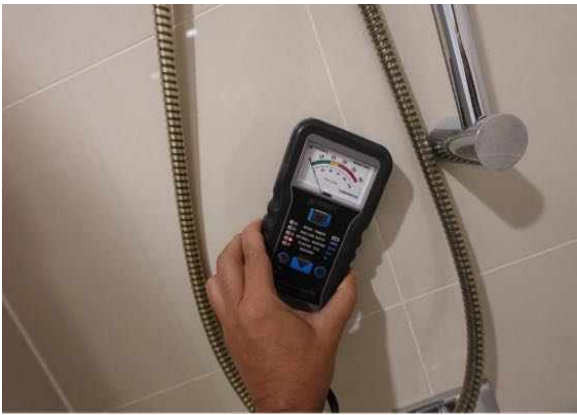
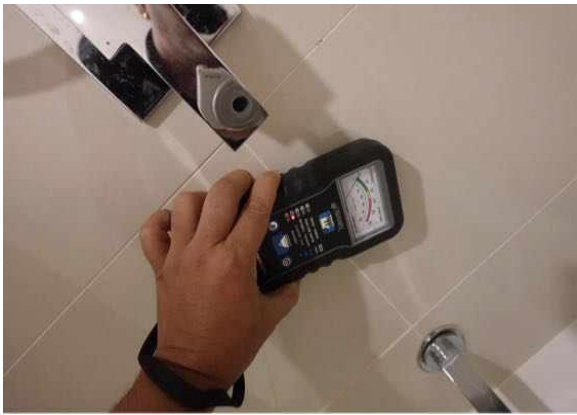
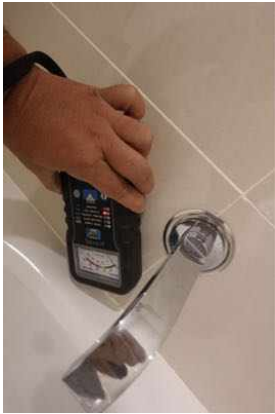
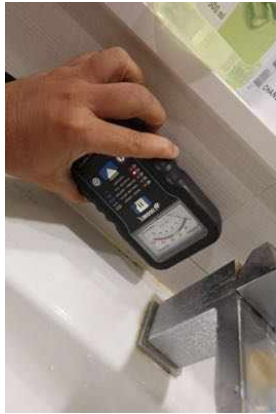
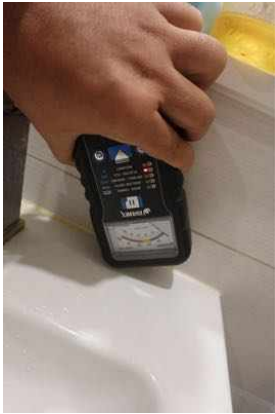
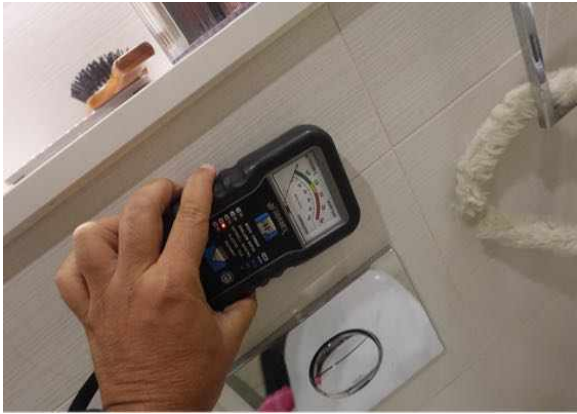
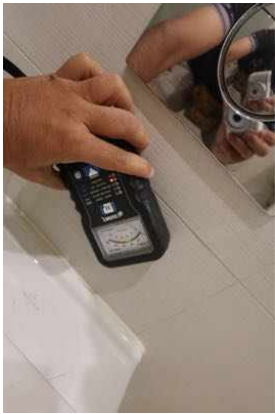
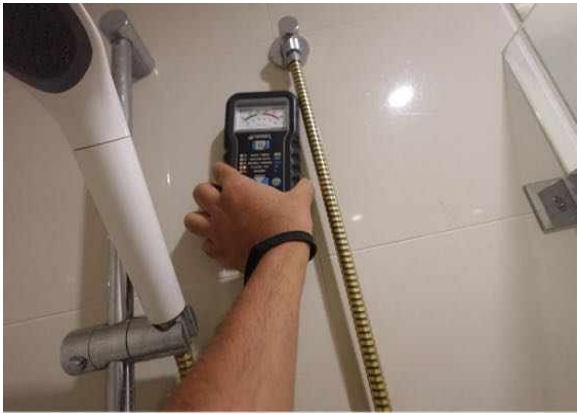
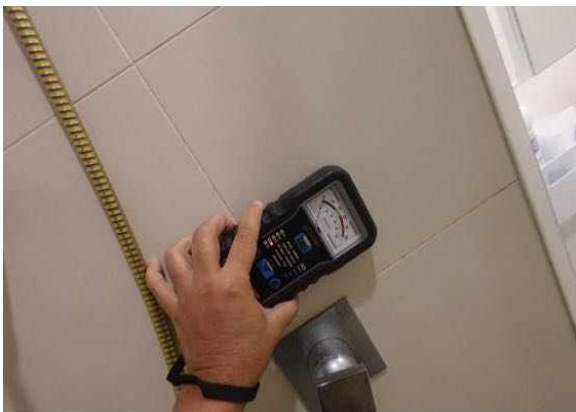
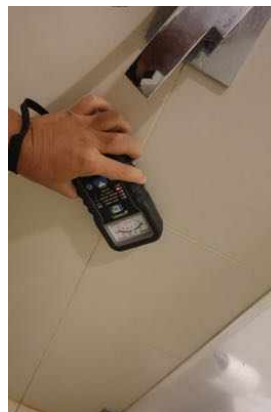
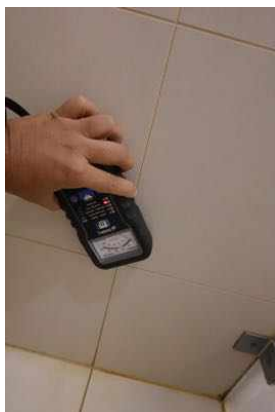
Building: Main Building  
Location:  
Finding: Moisture check  
Information: During inspection, moisture meter was used and no high moisture detected at the time of inspection.

Please note if the wet areas have not been used for some time, moisture readings would not vary significantly and this can lead to erroneous results.

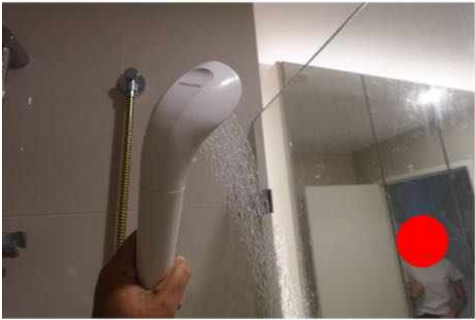
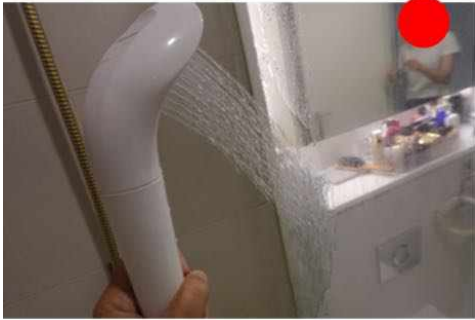
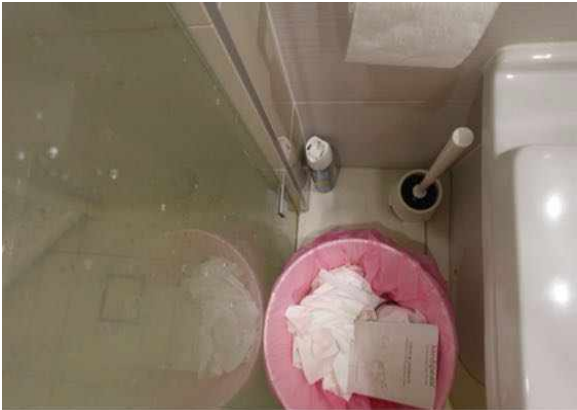
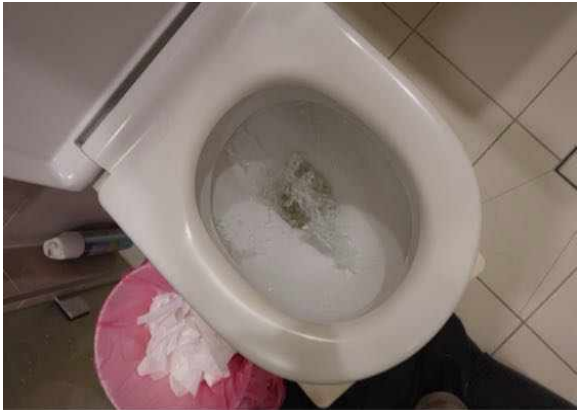
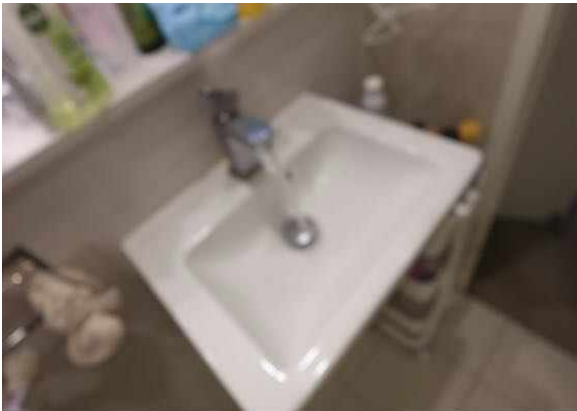
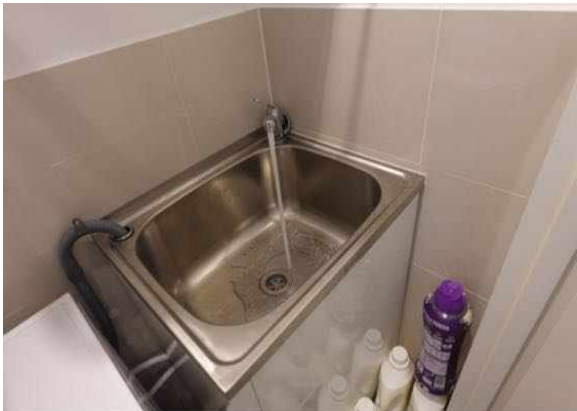
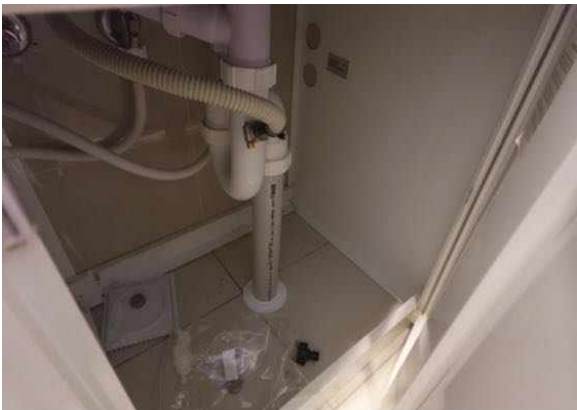
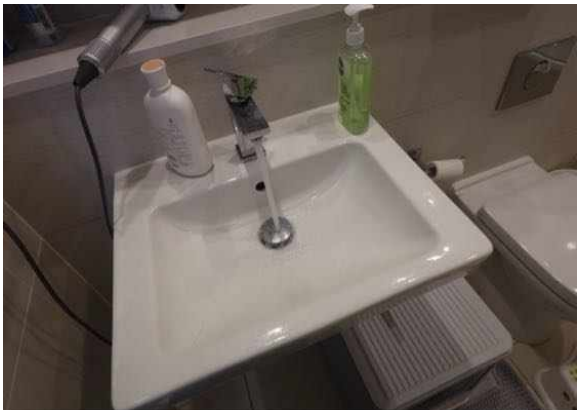
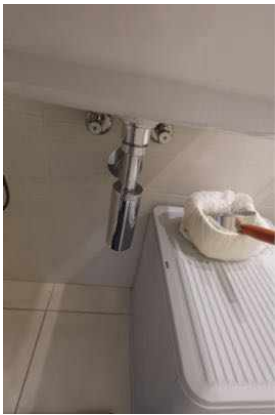
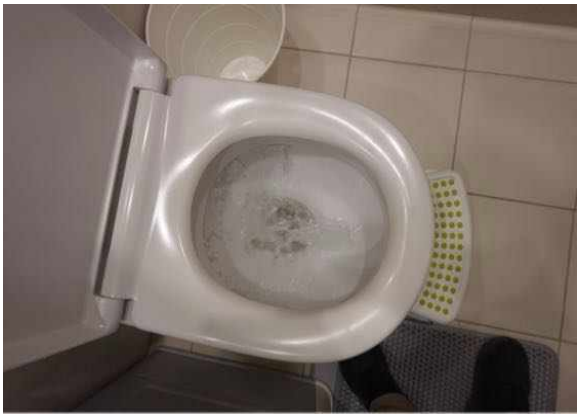
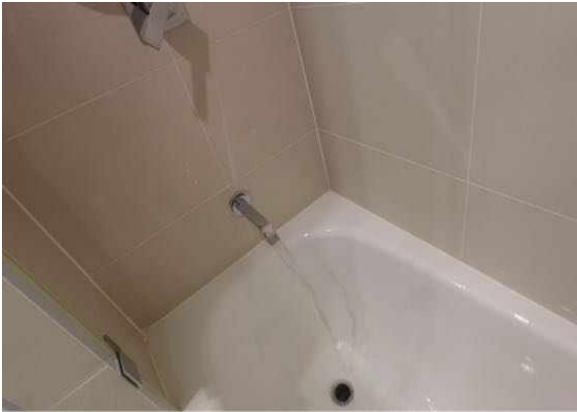
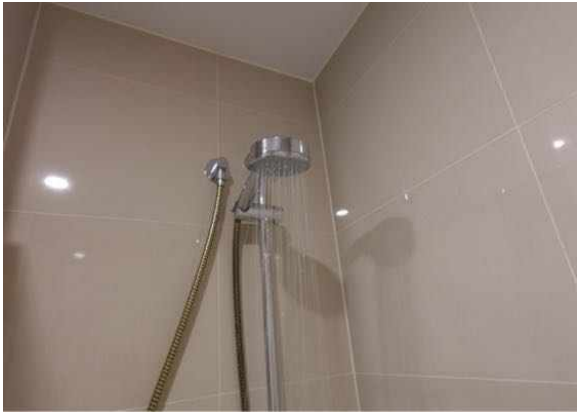
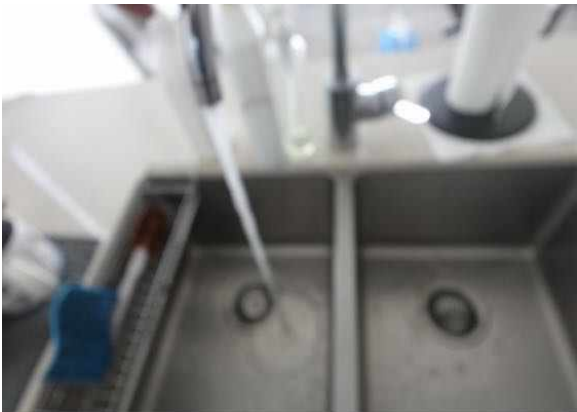
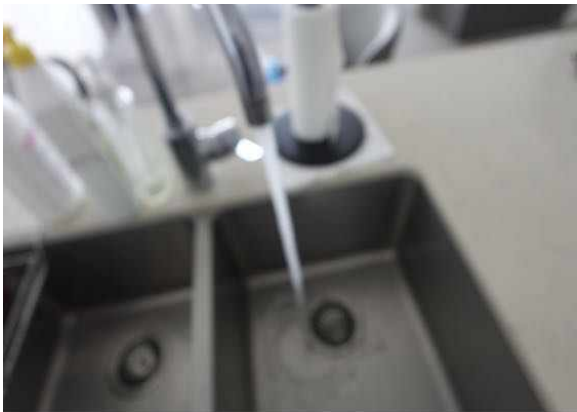
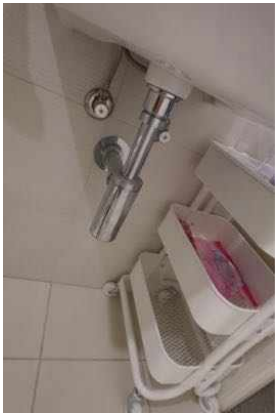
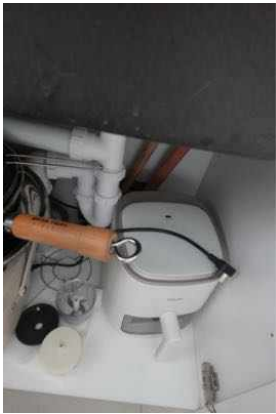
Building:	Main Building
Location:	All internal areas
Finding:	Taps, toilets and sinks tested : Visual only
Information:	Taps, drainage and toilets were checked for water flow and drainage was checked for leakage.

Unless identified in a separate defect, no remedial work appears to be required on these items at the time of the inspection.

Plumbing inspections are outside the scope of the building inspection and must be conducted by a Licensed plumber separately.

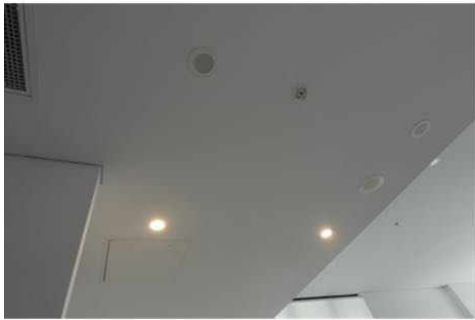
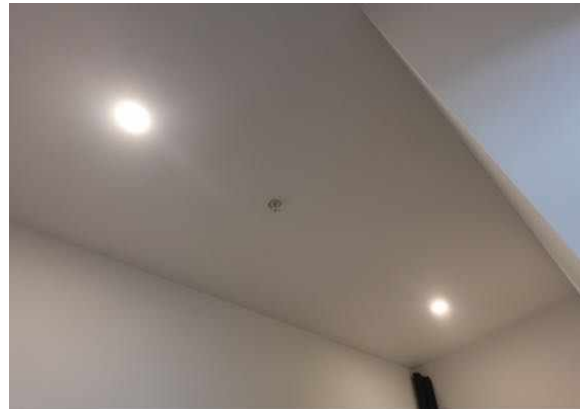
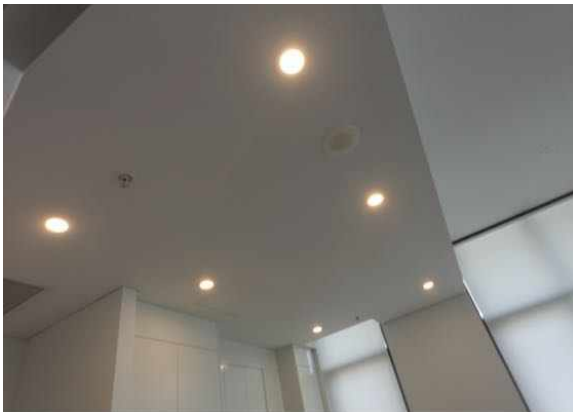
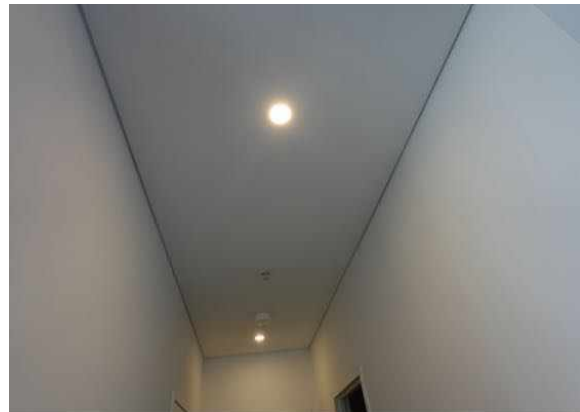
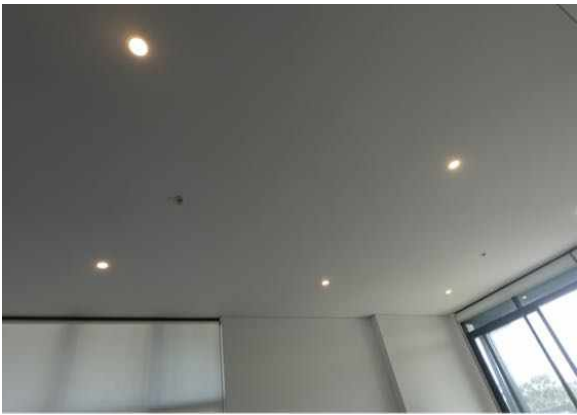
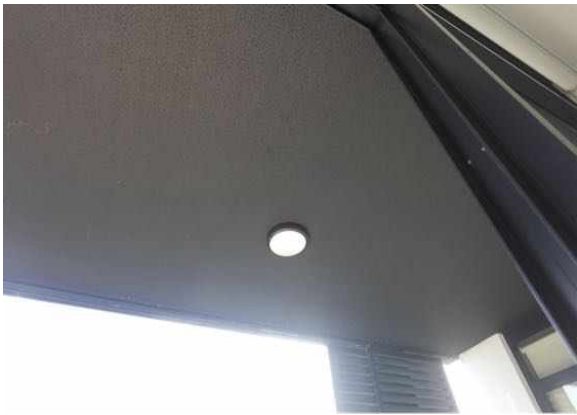
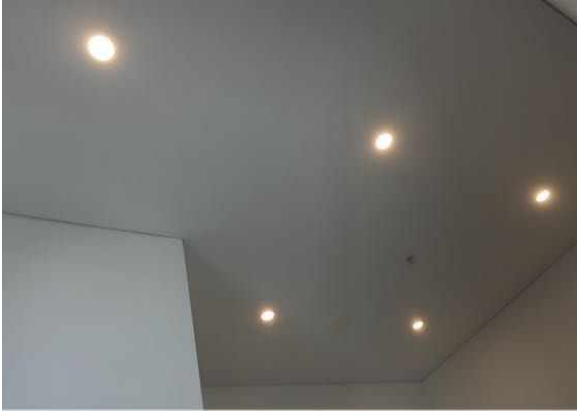
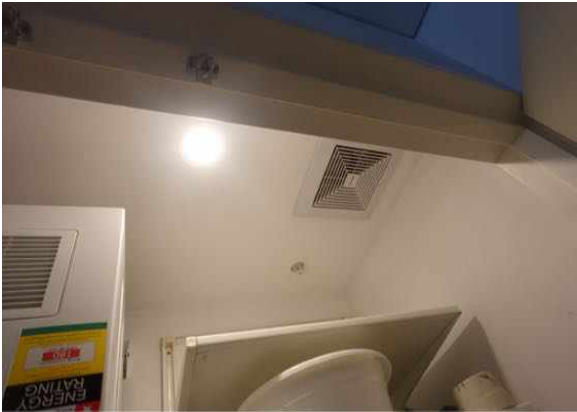
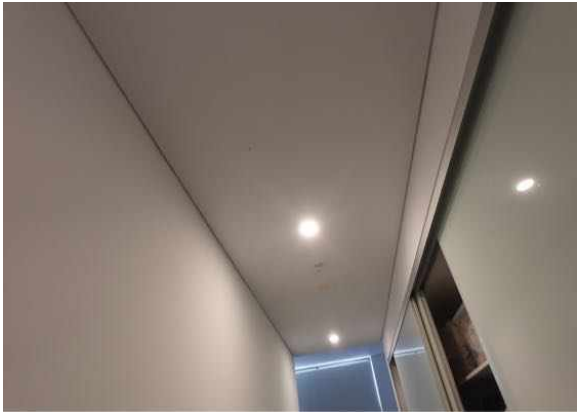
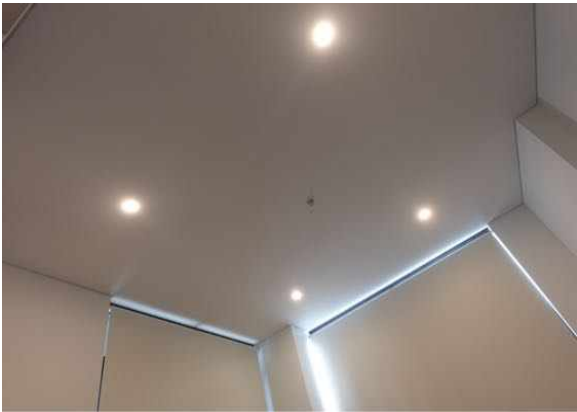
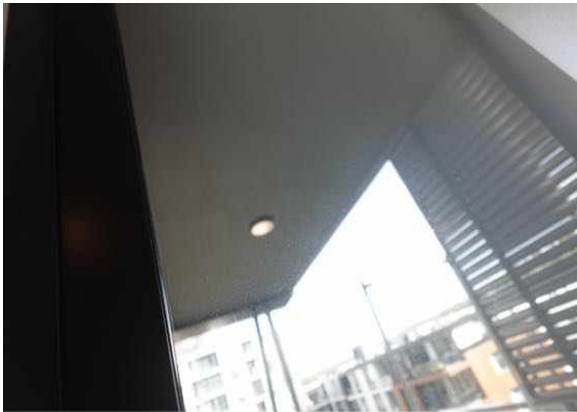
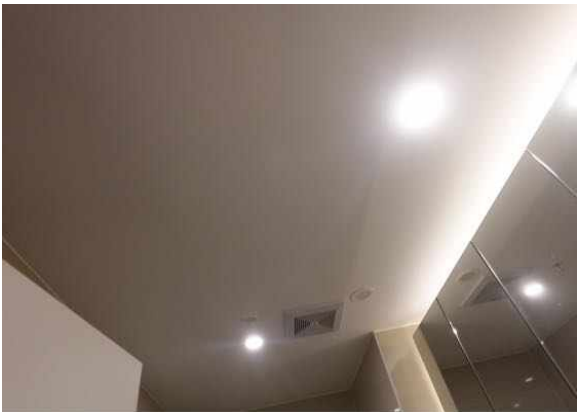
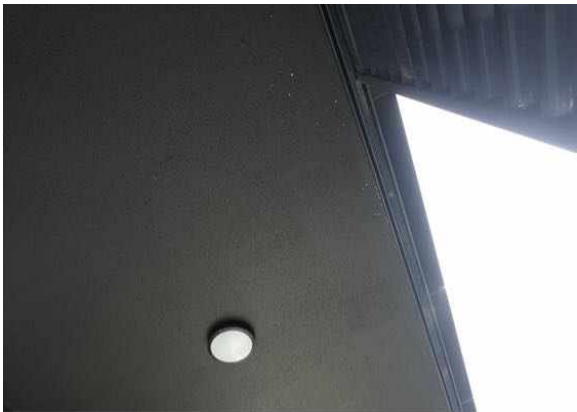
Building: Main Building  
Location: All Lights  
Finding: Electrical switches and light tested : Visual only  
Information: Electrical inspections are outside the scope of the building inspection and must be conducted by a Licensed and registered Trades person.

It is highly recommended that the client makes arrangements to have the electrical checked by a licensed tradesperson to ensure that they are working safely and efficiently.
