Building and Timber Pest Inspection Report

Inspection Date: Fri, 30 Jan 2026

Property Address: 1A Roland Rd, Rostrevor SA 5073, Australia

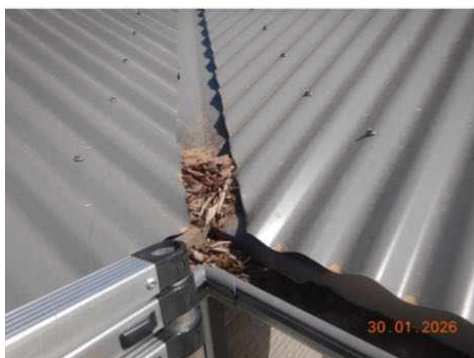
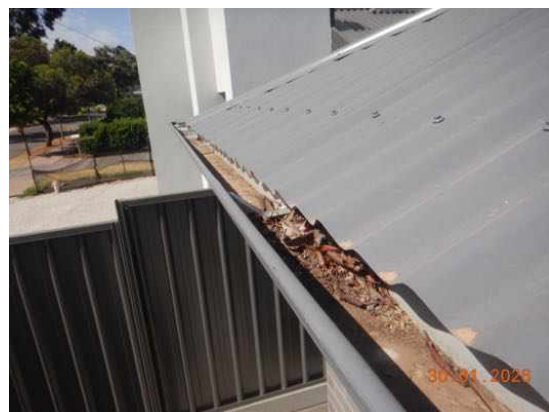
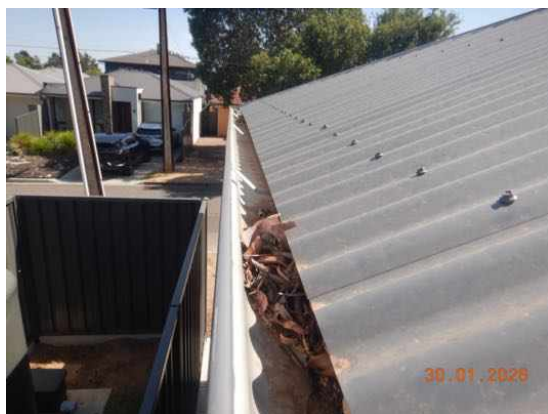
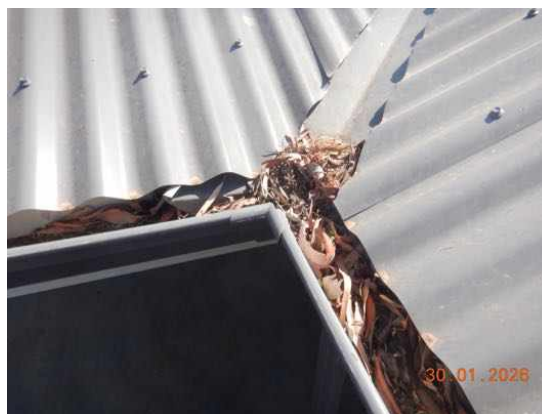
Finding 2.01

Building: Building 1
Location: Roof Exterior
Finding: Gutters - Blocked
Information: Roof plumbing structures, such as guttering and downpipes, should be free of all debris to prevent blockages. Blockages of the guttering and downpipes will lead to pooling and accumulated water overflows, which is likely to subsequently flood eaves and exterior walls.

At the time of inspection there were varying levels of blocked gutters evident mainly above the laundry door with a bird nest under the solar panels.

Blocked gutters are likely to lead to high levels of moisture in the affected areas. Such moisture will not only cause rust and decay of the associated building materials, but can also provide conditions that are conducive to termite and timber pest activity. Blockages in gutters should therefore be removed immediately to ensure dry conditions are maintained.

Consult a Licensed Plumber for further specific advice on remedial works that may be required. In the interim, it is highly advised that blocked gutters be removed by the homeowner or a general handyperson as a matter of urgency. Bird proofing the solar panels should be considered also.

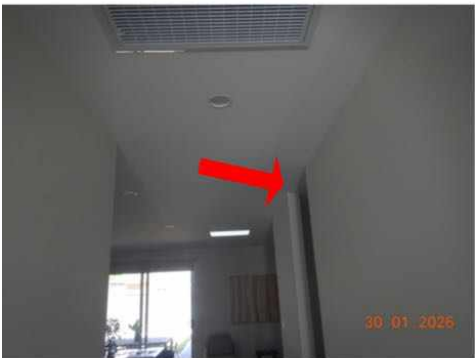
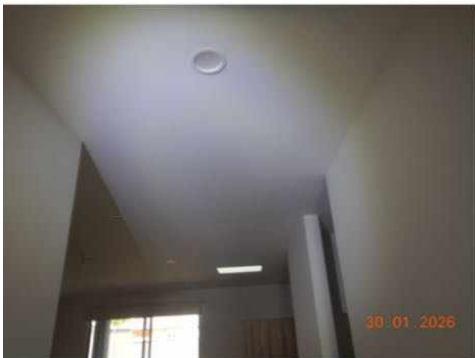
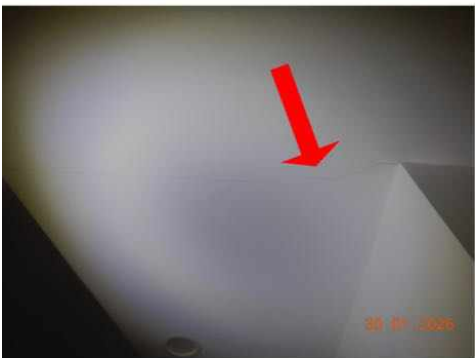
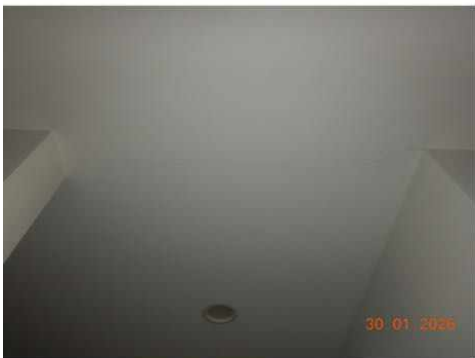
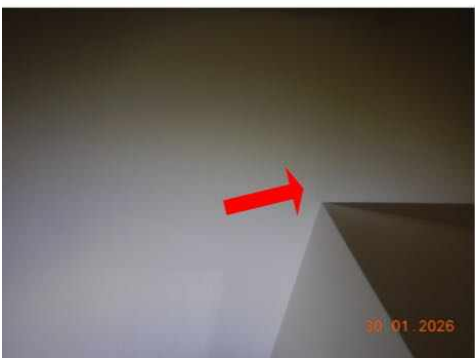
Finding 3.01

Building:	Building 1
Location:	Kitchen
Finding:	Cracking - Damage Category 1 - Fine (up to 1mm)
Information:	There were fine cracks evident to the ceiling adjacent to the kitchen at the time of inspection.

Although fine cracks are quite noticeable, they are often only considered to be an appearance defect, and usually do not indicate any structural damage. Generally, the cause of a fine crack is indicative of a separation between building materials and finishes (e.g. paint, plaster, etc.) along joints.

It would be wise to install a control joint at this point to prevent further cracking in the future.

Cracking of this nature can generally be repaired with minor sanding, filling and/or repainting. Such works should be performed by a qualified painter or a general handyman.

A licensed Plasterboard contractor should be appointed to install articulation joints to the ceiling to prevent further movement.

Monitoring of all cracking should be conducted frequently. Always contact a building inspector should cracks widen, lengthen, or become more numerous.

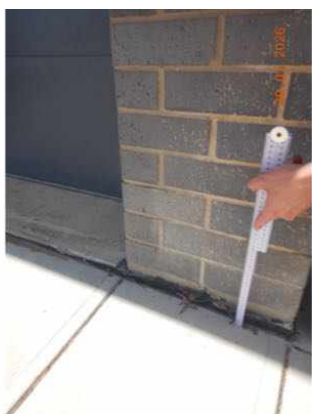
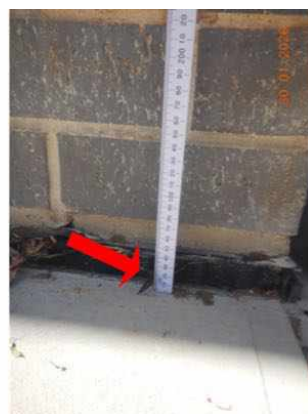
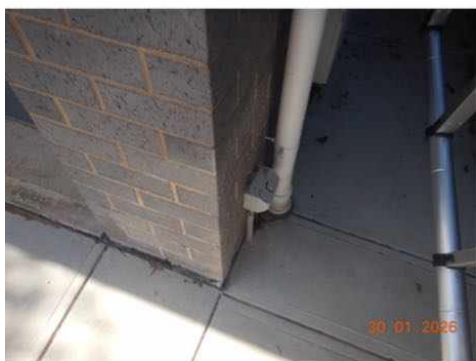
Finding 6.01

Building: Building 1
 Location: All External Areas
 Finding: Slab Edge - Exposure Steel frame
 Information: An inspection zone of at least 75mm in relation to the exposed slab edge, between the bottom brick and the perimeter pavement, is required. This inspection zone should be maintained in order to force termites into the open where they can be detected more readily during regular inspections. The slab edge should not be concealed by anything that may prevent inspection of the area, including render, landscaping, soil, turf, paving, concrete cladding or other structures.

If the slab edge is not properly exposed there is a high risk of termite attack. The risk is lessened with steel frame construction however still present.

Where the slab edge cannot be properly inspected, it is highly recommended that termite or timber pest inspections be carried out every 12 months to aid protection of the property against infestation.

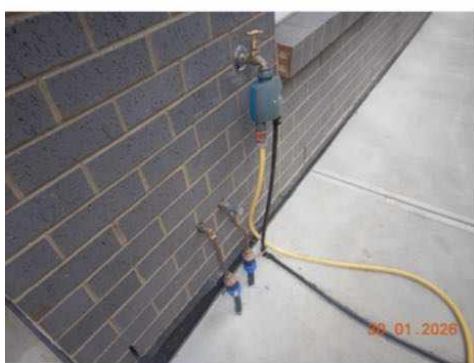
Finding 6.03

Building: Building 1
 Location: Yard - Side
 Finding: Air conditioner and or external tap - No drainage
 Information: Moisture around the perimeter of the building should be minimised to ensure that the area is kept dry and stable which in turn reduces the risk of water damage and termite infestation.

There appears to be no drainage points set up to the air conditioning unit, and or the external tap. While this is not a legal requirement it is recommended to reduce the risk of moisture related issues and the creation of an environment conducive to termite activity.

It is recommended that a licensed plumber be appointed to set up drainage in order to prevent such an environment from being created.
