## Building and Timber Pest Inspection Report

Inspection Date: Tue, 3 Feb 2026

Property Address: 34 Ursula St, Winston Hills NSW 2153,  
Australia

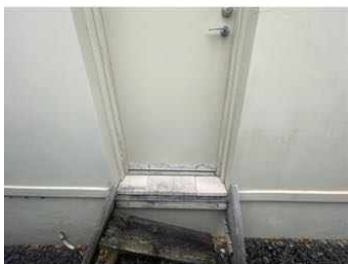
#### Finding 1.01

Building:	Main Building
Location:	Laundry
Finding:	Stairs – Timber Tread – Broken (Safety Hazard)
Information:	During the inspection, a broken timber stair tread was observed to the internal-to-external stair. The damaged tread does not provide a stable or continuous walking surface and presents a safety hazard due to the increased risk of trips, falls, or foot breakthrough. Given the safety risk, this item should be addressed as soon as possible.

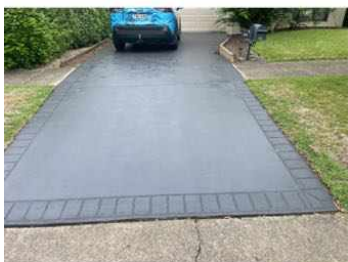
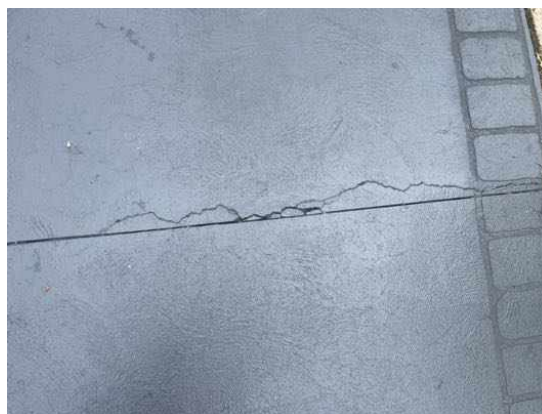
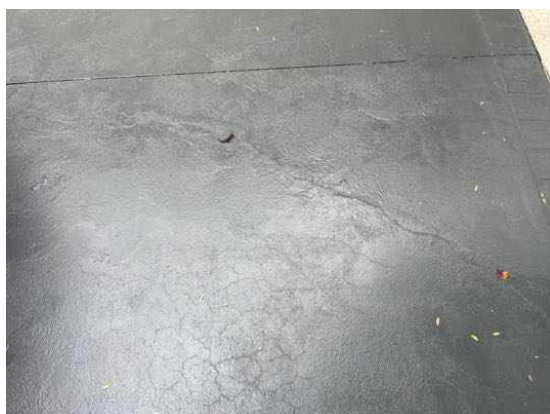
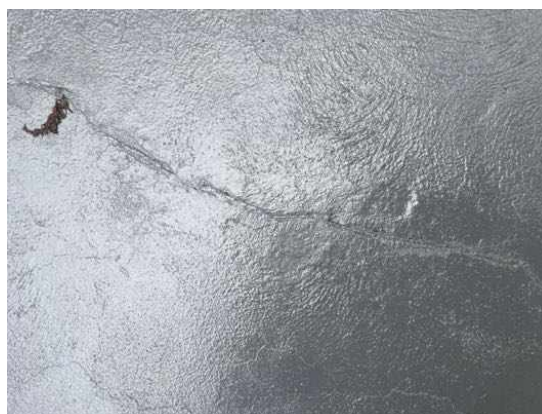
Building:	Main Building
Location:	Driveway
Finding:	Cracking - External Concrete Paving Damage Category 1 - Fine (less than 2mm)
Information:	Fine cracks were identified in external concrete paving. Although fine cracks are quite noticeable, they are often only considered to be an appearance defect, and usually do not indicate any structural damage. To be considered a Category 1 or fine crack, the crack is found to be less than 2mm in width.

Generally the cause of a hairline crack in existing concrete paving such as driveways and pathways is indicative of the expansion and contraction of the concrete. Such

causes are generally due to environmental factors, such as moisture levels, weather conditions, root systems of nearby trees or the soil types on which they are laid.

Fine cracks may also be due to poor original installation of the concrete. Factors such as poor compaction of the sub surface and/or inadequate reinforcing of the slab may create cracking and other secondary defects.

Monitoring of all cracking should be conducted frequently. Always contact a building inspector should cracks widen, lengthen, or become more numerous.

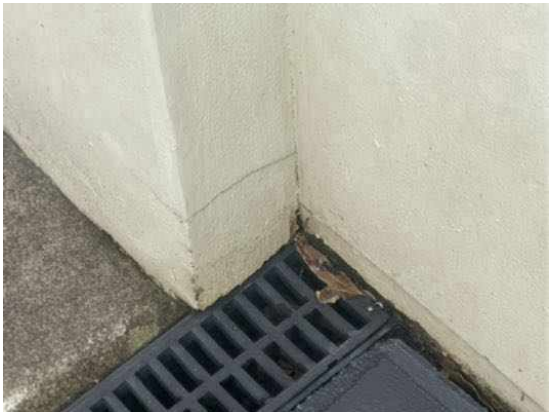
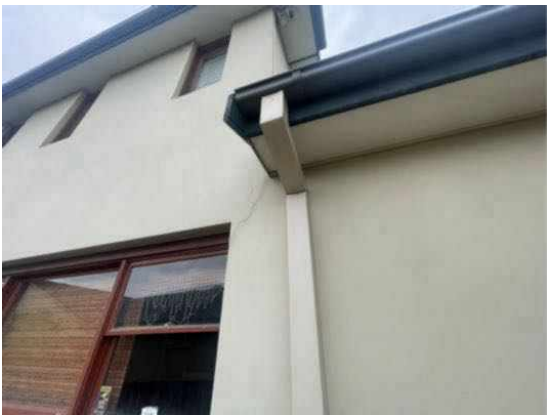
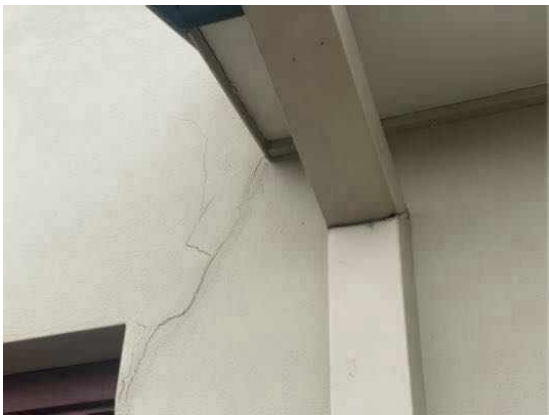
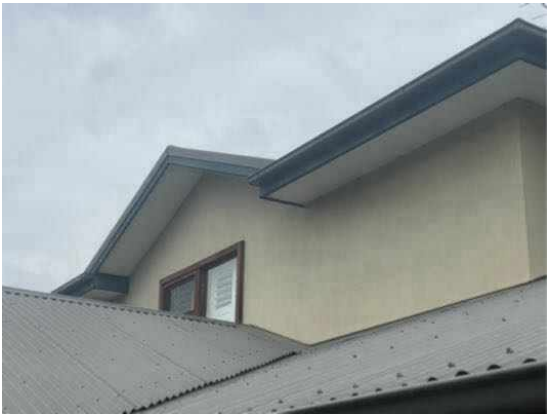
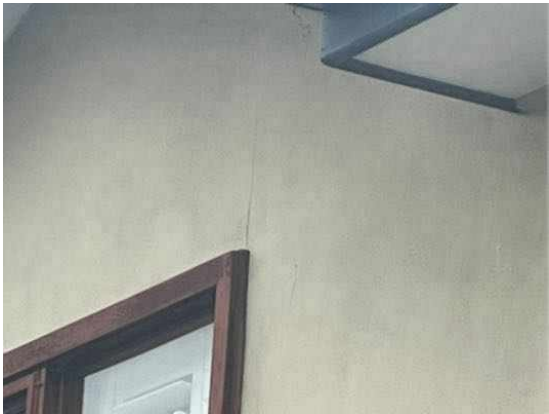
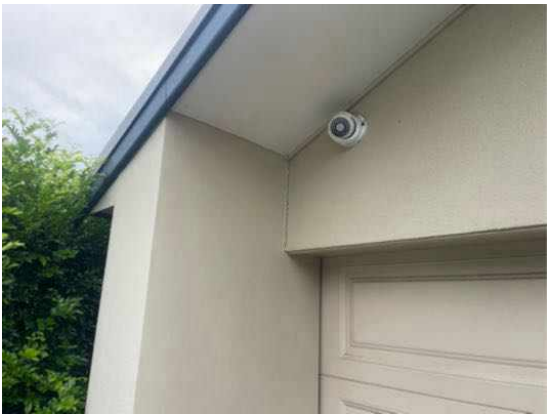
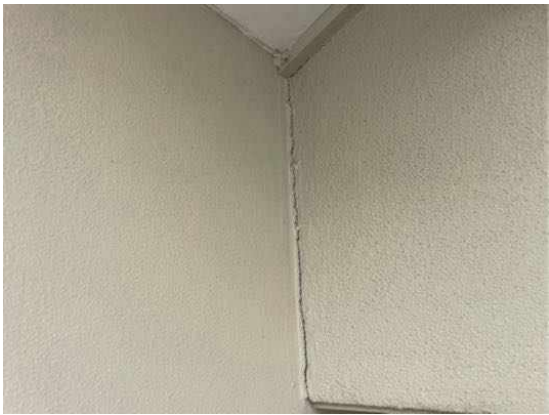
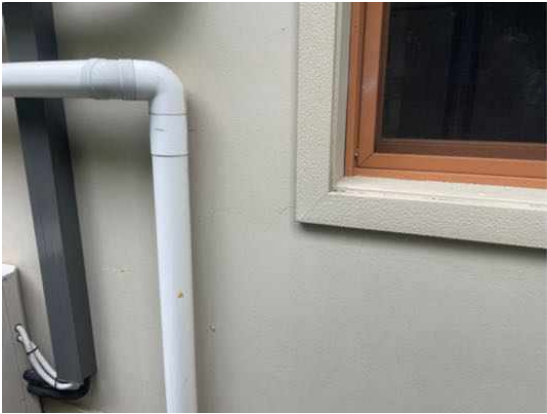
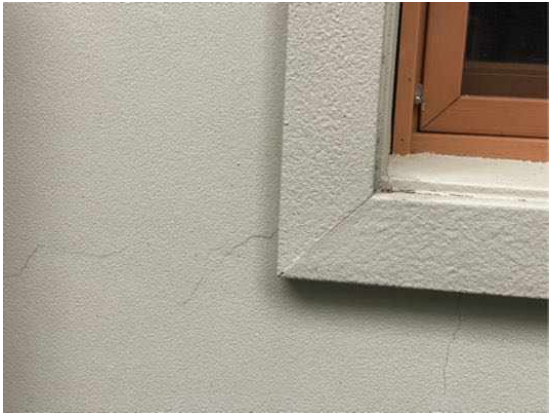
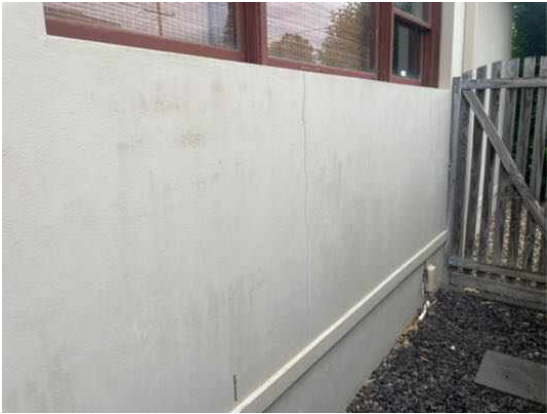
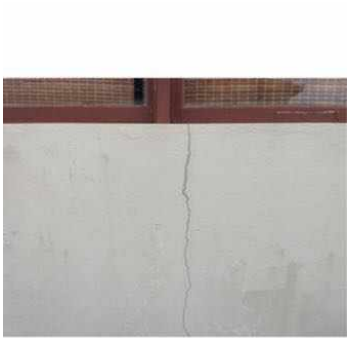
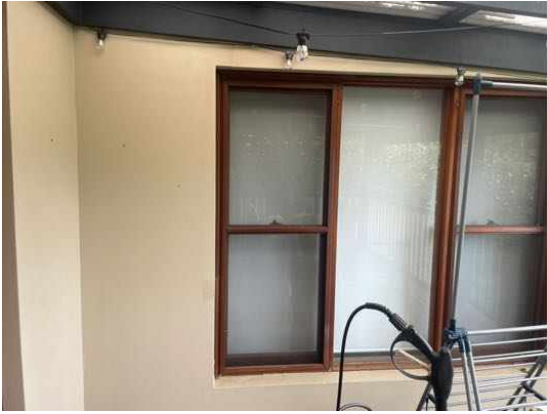
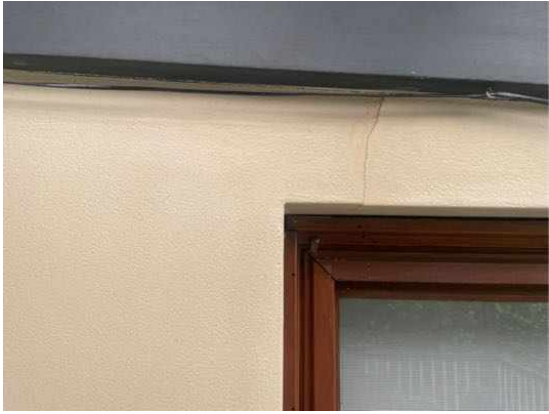
### Finding 3.02

Building:	Main Building
Location:	All External Areas
Finding:	Cracking - Damage Category 1 - Fine (up to 1mm)
Information:	Although fine cracks are quite noticeable, they are often only considered to be an appearance defect, and usually do not indicate any structural damage. Generally, the cause of a fine crack is indicative of a separation between building materials and finishes (e.g. paint, plaster, etc.) along joins.

Cracking of this nature can generally be repaired with minor sanding, filling and/or repainting. Such works should be performed by a qualified painter or a general handyman.

Monitoring of all cracking should be conducted frequently. Always contact a building inspector should cracks widen, lengthen, or become more numerous.

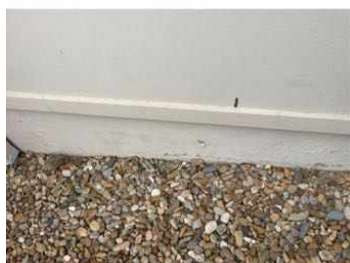
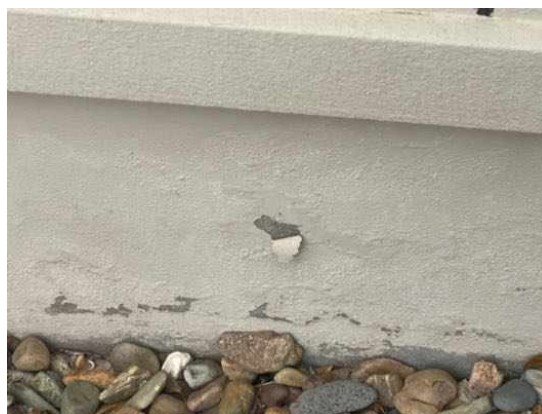
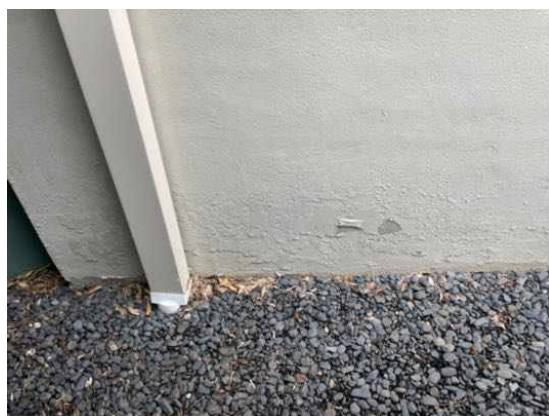
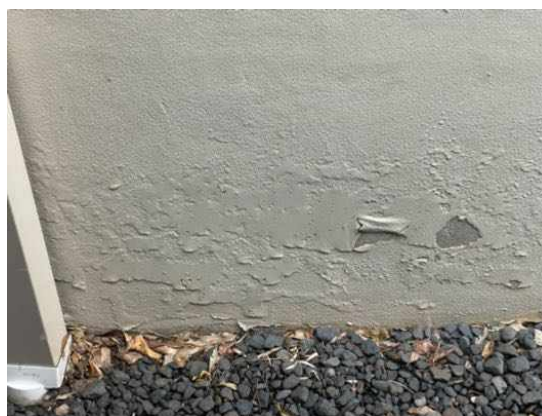
Finding 3.03

Building:	Main Building
Location:	All External Areas
Finding:	External painting deteriorated
Information:	Much of the external paintwork including but not limited to windows, fascias, guttering, veranda and other external fitments have been neglected and require attention to prepare and re-paint.

Whilst incomplete or missing paint finish is generally an appearance defect, it can also lead to the development of secondary building defects over time. Incomplete areas of paint finish expose the area to moisture, potentially accelerating the deterioration of underlying building materials.

Degraded paint finishes should be sanded back, filled, leveled and painted, as applicable. Where inadequate or missing paint protection has led to the deterioration of the associated building element, repair and/or replacement of this building element may be required.

A painting contractor should be appointed as soon as possible to perform necessary works to aid the appearance of the affected area and to ensure the area is protected against further deterioration. Alternatively, the homeowner following manufacturer instructions may perform these works.

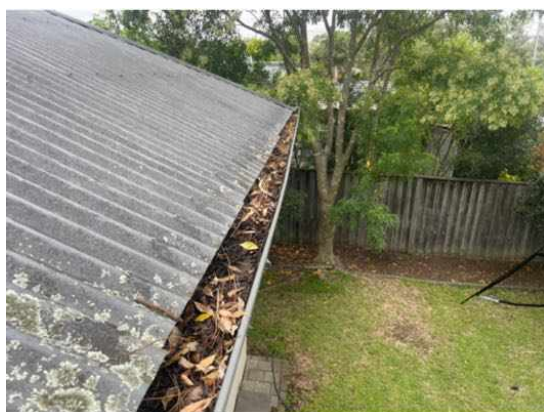
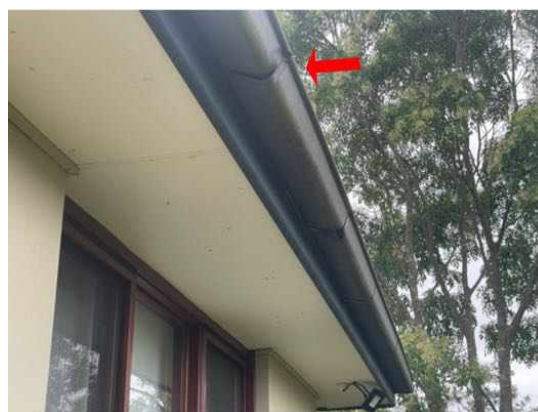
### Finding 3.04

Building:	Main Building
Location:	Rear Elevation
Finding:	Damaged Gutters
Information:	The damaged gutter at the corner junction was observed during the inspection. This issue was identified as the gutter no longer functions as intended, showing signs of deterioration that may affect stormwater drainage.

The defect is located at the corner junction of the roofline, where water flow is most concentrated. If the damage is not rectified in a timely manner, it may cause overflow and moisture ingress, leading to potential secondary defects in surrounding building elements.

It is recommended that a licensed roofing or guttering contractor be engaged to carry out the repair or replacement. Addressing this issue promptly will ensure the guttering system remains functional and helps protect the property from future water damage.

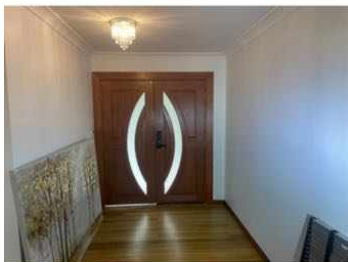
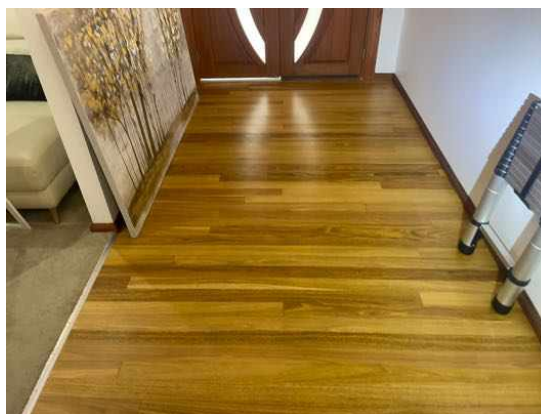
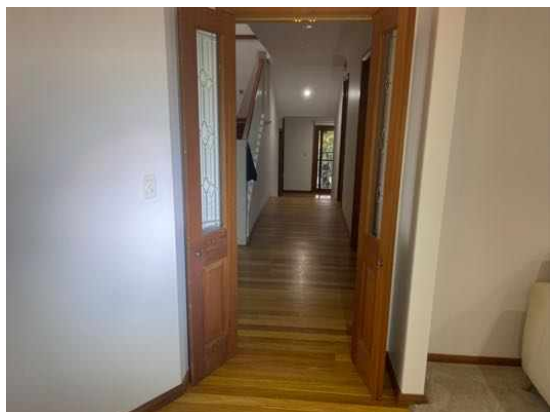
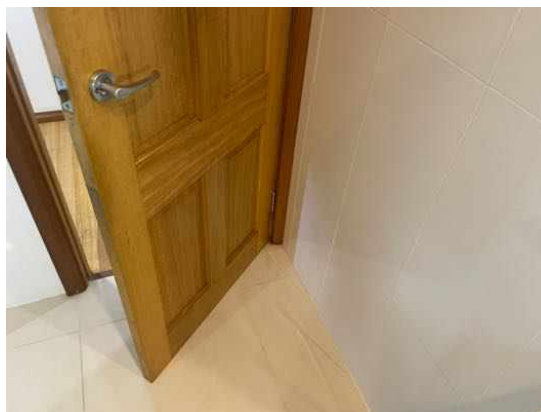
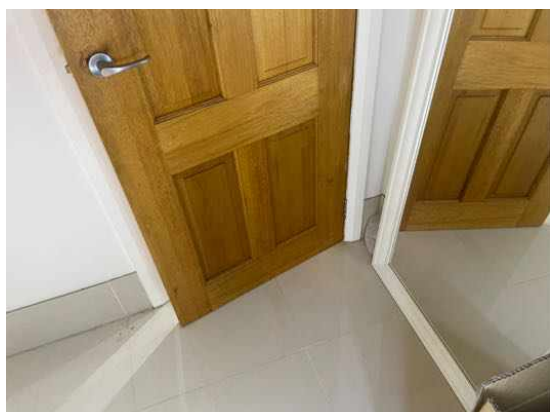
### Finding 3.05

Building:	Main Building
Location:	All Internal Areas
Finding:	Door stop - Missing
Information:	The door stop is missing or is inadequate to stop the door handle from damaging the wall. Although some building elements may seem irrelevant or unnecessary, all building elements play a key role in the operation and function of the overall structure and its performance.

Re-installation or replacement of the door stop is advised as soon as possible to prevent any subsequent damage to the door or associated structures. A general handyman may be appointed to perform these works at client discretion.

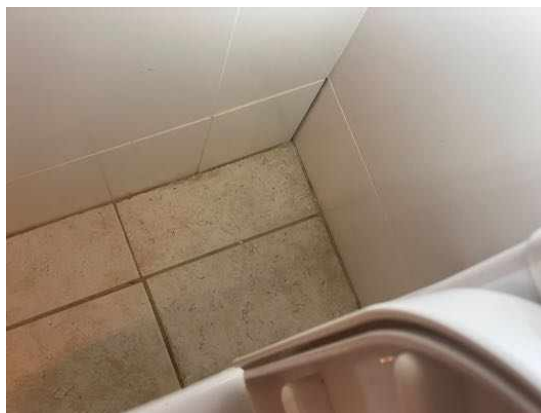
### Finding 3.06

Building: Main Building  
 Location: Bathroom  
 Finding: Tiles - Missing Sealants and/or Grouts  
 Information: During the inspection, sections of the existing tiled surfaces were observed with missing, cracked, or deteriorated grout and/or sealant. These gaps were visible along tile joints and at junctions where tiles meet adjoining walls, skirtings, or fixtures.

The deterioration has likely occurred over time due to general wear, building movement, or ongoing moisture exposure. Missing or damaged grout and sealant allow water to penetrate behind tiles, which can lead to staining, mould growth, or damage to the substrate and surrounding finishes.

It is recommended that the affected areas be re-grouted and re-sealed by a qualified tiler or trade as a short-term priority to maintain a watertight finish and prevent further deterioration.

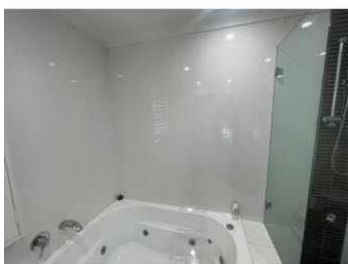
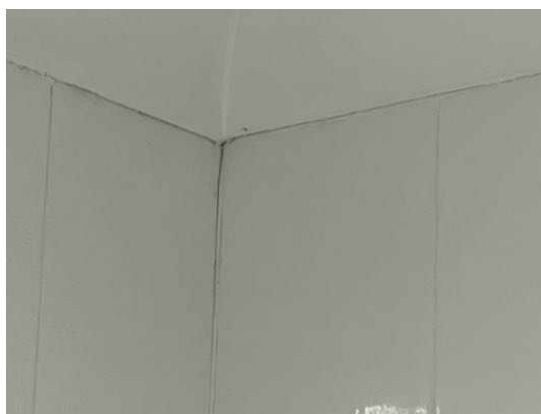
### Finding 3.07

Building: Main Building  
 Location: Ensuite - Master  
 Finding: Tiles - Missing Sealants and/or Grouts  
 Information: During the inspection, sections of the existing tiled surfaces were observed with missing, cracked, or deteriorated grout and/or sealant. These gaps were visible along tile joints and at junctions where tiles meet adjoining walls, skirtings, or fixtures.

The deterioration has likely occurred over time due to general wear, building movement, or ongoing moisture exposure. Missing or damaged grout and sealant allow water to penetrate behind tiles, which can lead to staining, mould growth, or damage to the substrate and surrounding finishes.

It is recommended that the affected areas be re-grouted and re-sealed by a qualified tiler or trade as a short-term priority to maintain a watertight finish and prevent further deterioration.

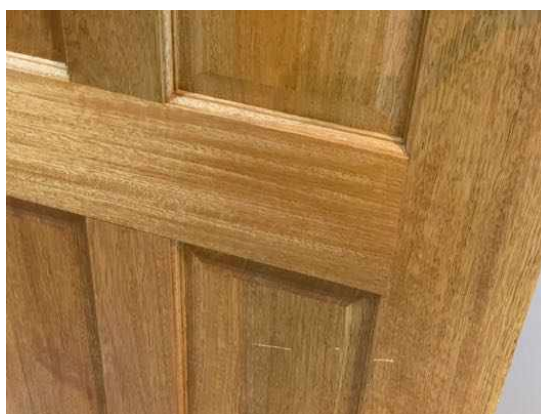
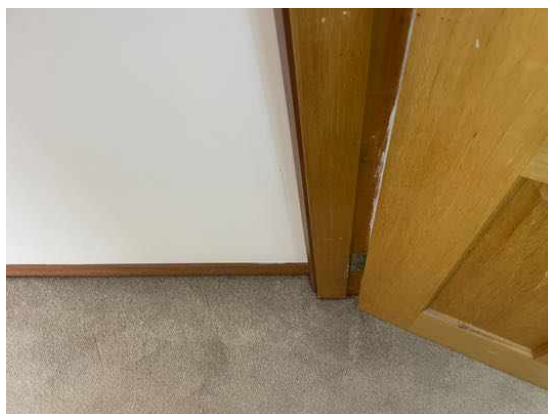
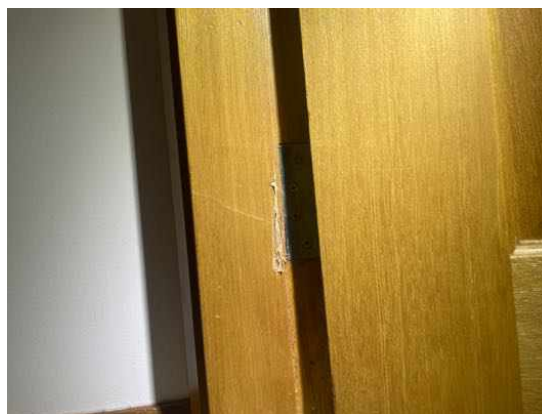
Information: Some areas of the painted wall surfaces, ceilings, door frames, and other internal finishes were observed to have marks and scuffs, likely resulting from the normal use of the property. These marks do not indicate structural damage but have affected the overall aesthetic appearance of the internal spaces.

If left unaddressed, the marks may become more noticeable over time, particularly in high-traffic areas, which could reduce the visual appeal of the interiors. The integrity of the paint and finishes is not compromised, but cosmetic touch-ups may be required to maintain a uniform presentation.

It is recommended that the affected surfaces be cleaned or repainted in the near future by a suitably qualified tradesperson to restore the appearance and uniformity of the internal finishes. Regular maintenance of painted surfaces, including walls, ceilings, and trims, can help prolong their life and visual quality.

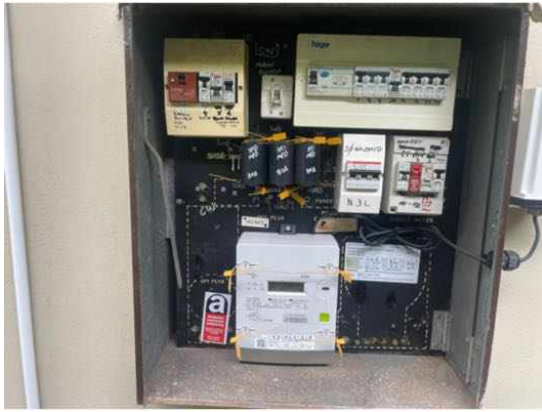
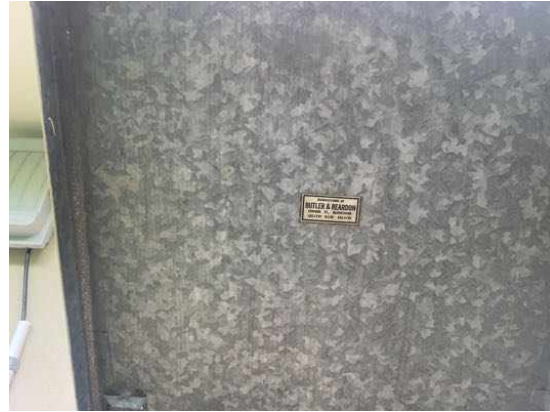
Building:	Main Building
Location:	Electrical Switchboard
Finding:	Termite Management System - no evidence of a chemical installation
Information:	The application of a post-construction chemical termite barrier is highly recommended for all properties, particularly if live termite activity has been found on the site previously. Such barriers are highly effective in preventing termite attack on any timber building elements throughout the property.

A durable notice should be placed in the switchboard unit to indicate current termite barriers. At the time of inspection, it appeared as though no termite management system has been installed, with no evidence to suggest preventative works taking place.

The client may consider gaining further advice from a pest controller as to the costs and procedures involved with this application. It is recommended that obtaining such advice be a short-term priority.

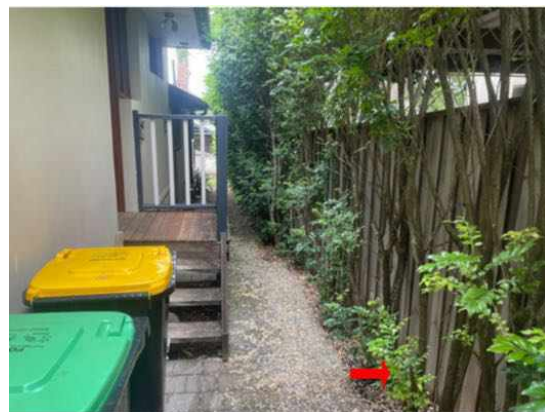
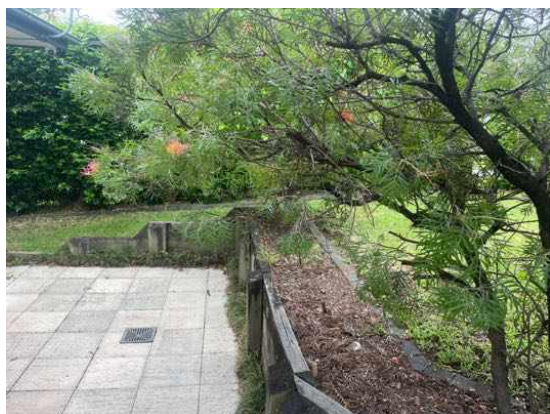
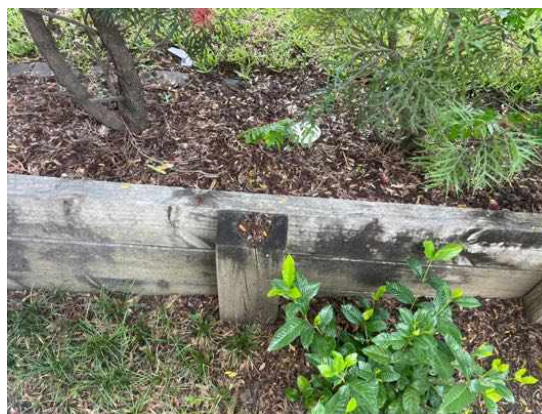
## Finding 6.02

Information: Any timbers in direct ground contact provide opportunity for concealed termite entry and are likely to be subject to premature rot and decay as the soil retains moisture or damp conditions against the timbers.

Remove untreated timber that is in direct contact with external grounds. Consider replacement with more durable materials i.e. treated timber or non timber elements. Frequent pest inspections are advised to readily identify any termite activity in these areas.

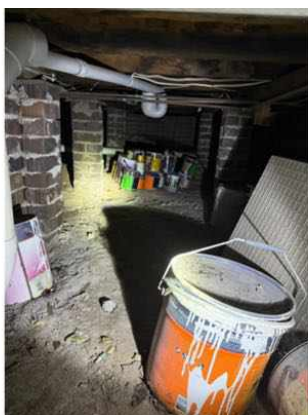
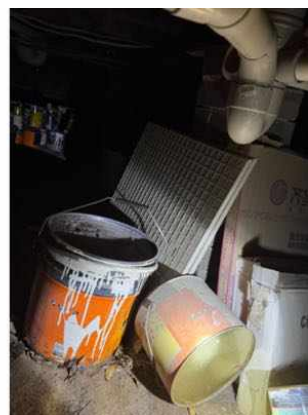
### Finding 6.03

Building:	Main Building
Location:	Building perimeter/interior/subfloor/roof space
Finding:	Stored timbers - subfloor space or external area
Information:	The storing of timbers in the subfloor space or around the external property increases the risk of termite activity being present. As they are likely to come into contact with weather conditions or excessive moisture wood rot is likely to develop on timbers that are not treated.

It is highly recommended that any stored timbers be immediately removed from areas in which they may attract any termite / timber pest attack. Minimisation of risk / prevention of termite attack is far more adequate than dealing with the presence of termite activity.

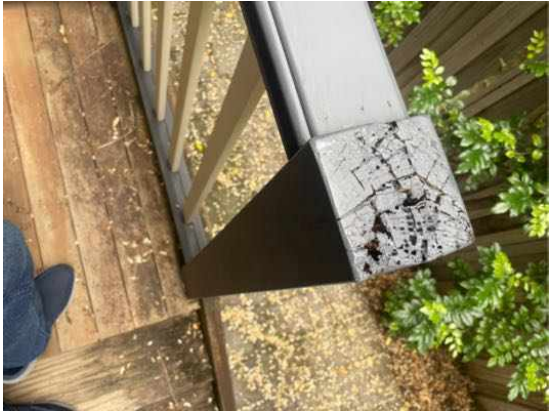
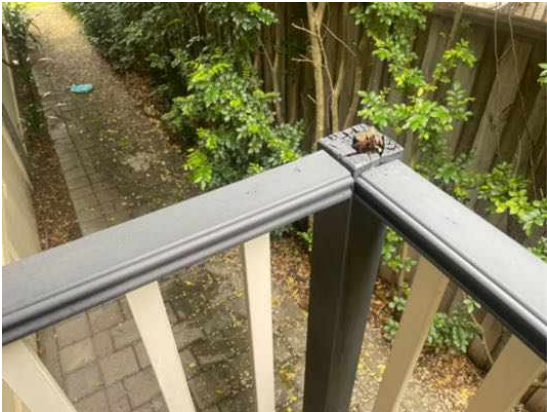
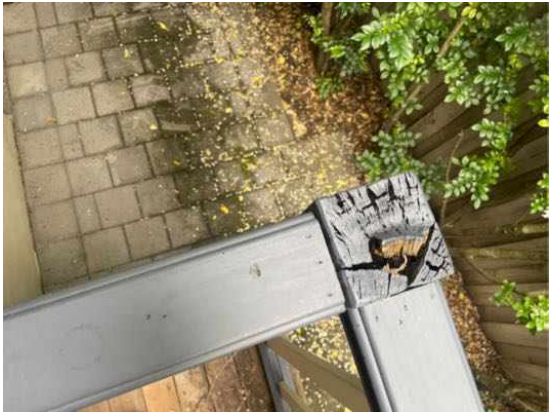
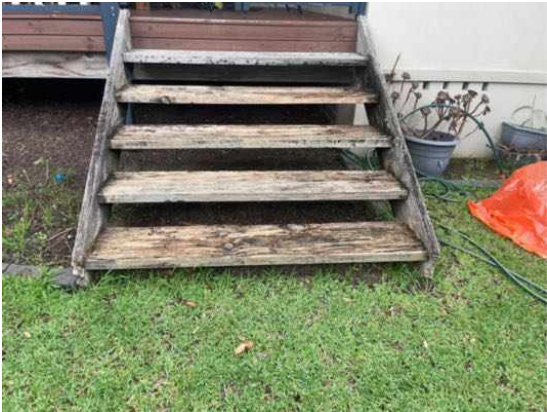
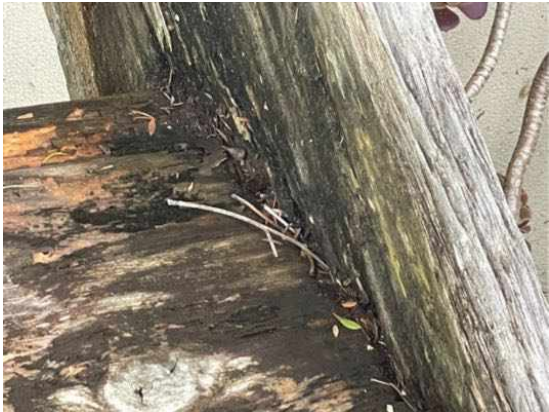
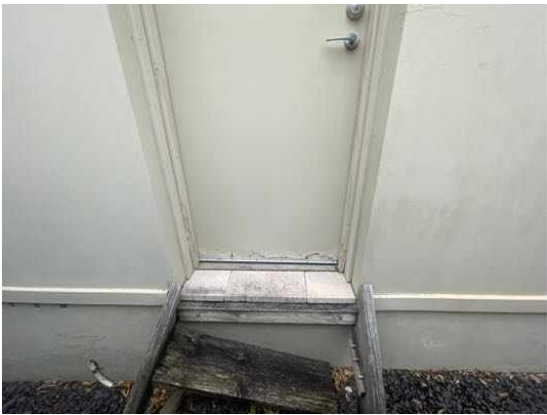
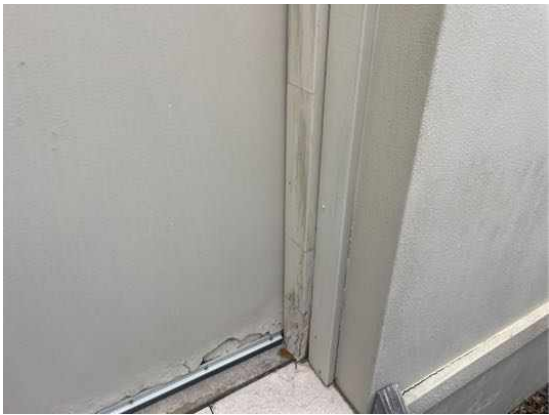
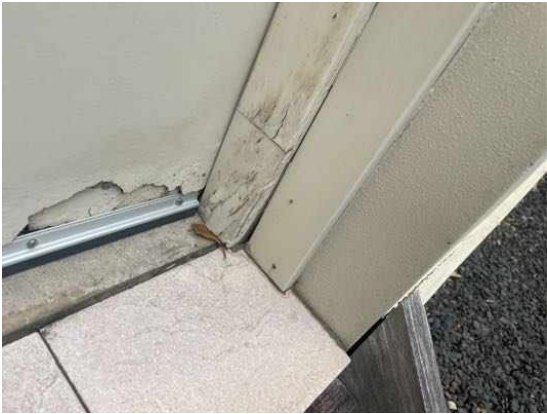
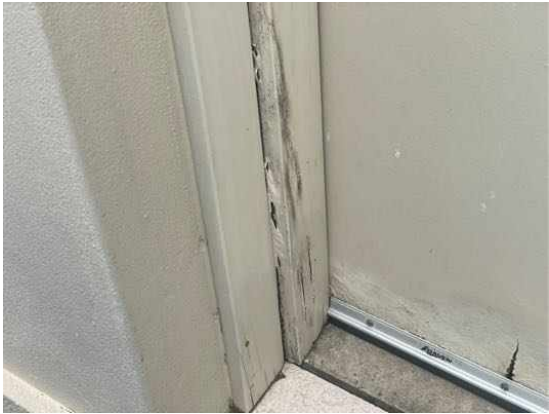
### Finding 6.04

Building:	Main Building
Location:	Yard
Finding:	Wood rot-external timbers
Information:	Wood rot which is technically known as Fungal Decay occurs when timbers and other cellulose building materials are exposed to damp conditions on an ongoing basis. This could be the result of exposure to weathering in the long term or the pooling of water

or absorbed moisture from other abutting building materials. It is advisable to remove these affected timbers to prevent any chance of attack in the future.

Wood decay is more susceptible to termite attack and these timbers should be replaced to limit termite attack.

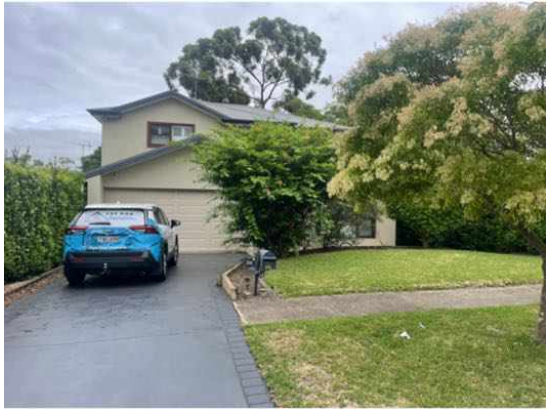
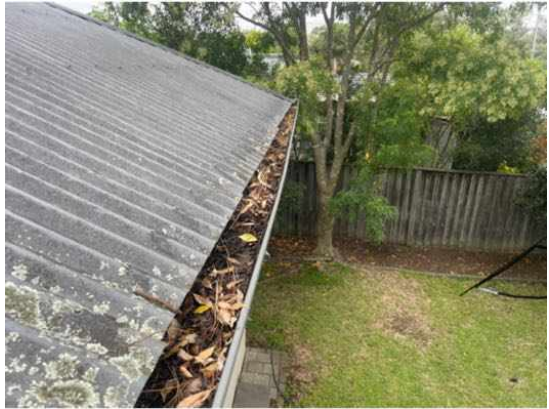
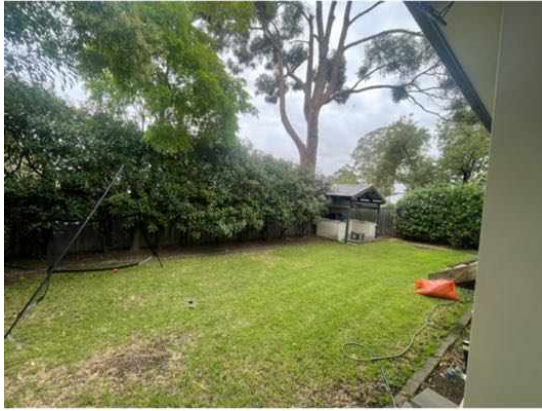
**Finding 6.05**

Building: Main Building  
Location: Yard  
Finding: Large trees/stumps within 30m of house  
Information: There are a number of large trees/stumps within 30m of the house which may contain natural termite activity. It is important to monitor these areas to ensure no natural activity is allowed to progress into the main house.

Regular inspections are recommended. Consider test drilling any large trees.

A pest controller can be contacted to carry out such testing at the owners discretion.

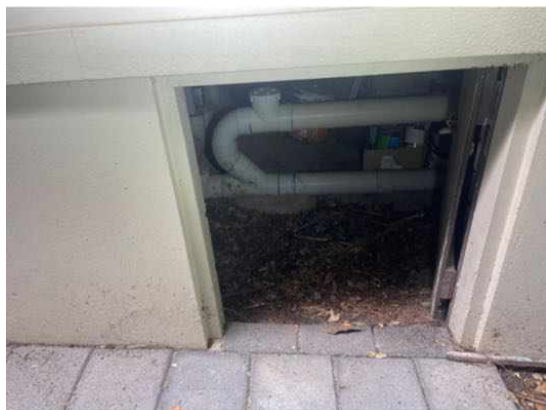
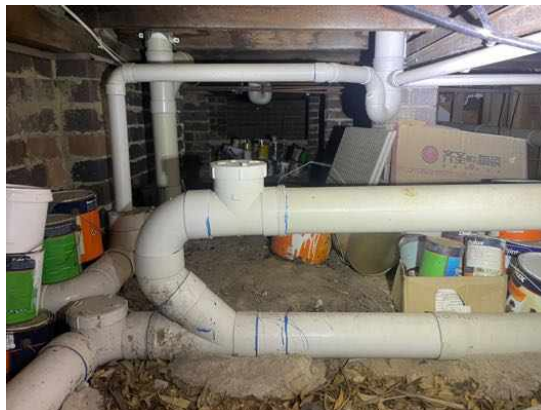
Building:	Main Building
Location:	Subfloor
Finding:	Subfloor Access – Obstructed
Information:	At the time of inspection, the subfloor entry was obstructed by drainage infrastructure,

which prevented safe access. As a result, the subfloor area could not be inspected, and no comment can be made regarding the condition of subfloor elements, including structural members, moisture conditions, ventilation, pest activity, or services. This limitation may conceal defects or issues that were not reasonably accessible at the time of inspection.

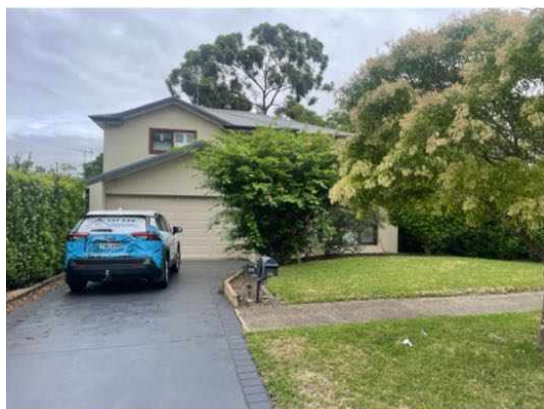
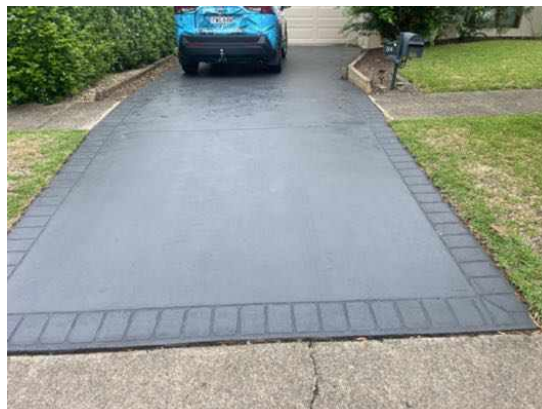
At the time of inspection, access and visibility were restricted in multiple areas of the property due to obstructions, site conditions, and physical constraints present on the day. Areas affected by restricted or obstructed access included the subfloor, interior areas, exterior areas, roof cavity, and roof exterior. As a result, these areas could not be fully inspected, and the inspection was limited to building elements that were reasonably accessible and visible at the time.

Where access was restricted or obstructed, no assessment could be made regarding the condition or performance of concealed or inaccessible building elements, including structural components, moisture conditions, waterproofing, drainage, insulation, services, or pest-related issues. Defects or deterioration may exist in these areas but were not reasonably detectable during the inspection. The findings and comments in this report should therefore be read in conjunction with these access limitations.
